ELECTRONICS RELIABILITY FRACTURE MECHANICS

VOLUME 2. FRACTURE MECHANICS

Final Report for Period May 1987 - September 1991

FLIGHT DYNAMICS DIRECTORATE
WRIGHT LABORATORY
AIR FORCE SYSTEMS COMMAND
WRIGHT-PATTERSON AIR FORCE BASE, OHIO 45433-6553

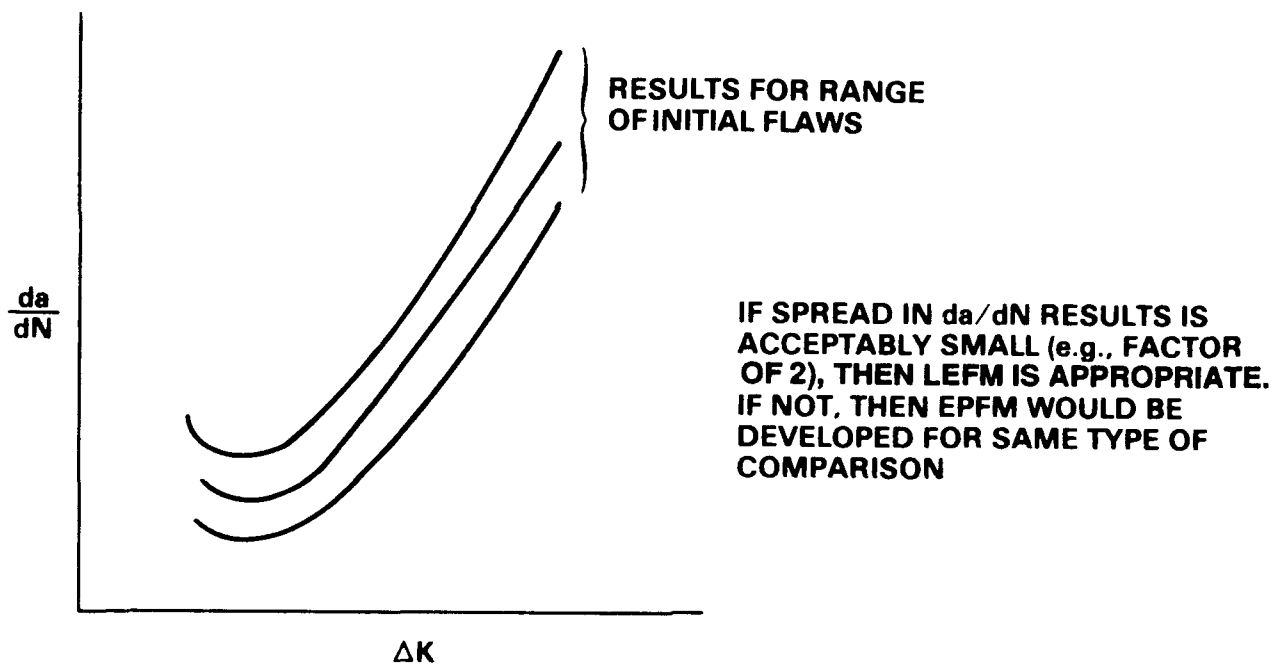
Figure 2-3. Basis for a Decision on Fracture Mechanics Approach

For example, if the results of wire fatigue tests indicate that the predominance of the lifetime is consumed in growing a crack, then a fracture mechanics approach is, by definition, appropriate. The simplest such approach assumes that small-scale yielding conditions are met whereupon linear elastic fracture mechanics (LEFM) is valid. The crack driving force parameter in LEFM is the stress intensity factor, conventionally denoted by K . In fatigue, it follows that the key parameter is the change in K from the maximum to the minimum load. This is commonly denoted as ΔK . If the crack growth per loading cycle is expressed as da/dN , fatigue results might then be as shown in Figure 2-3.

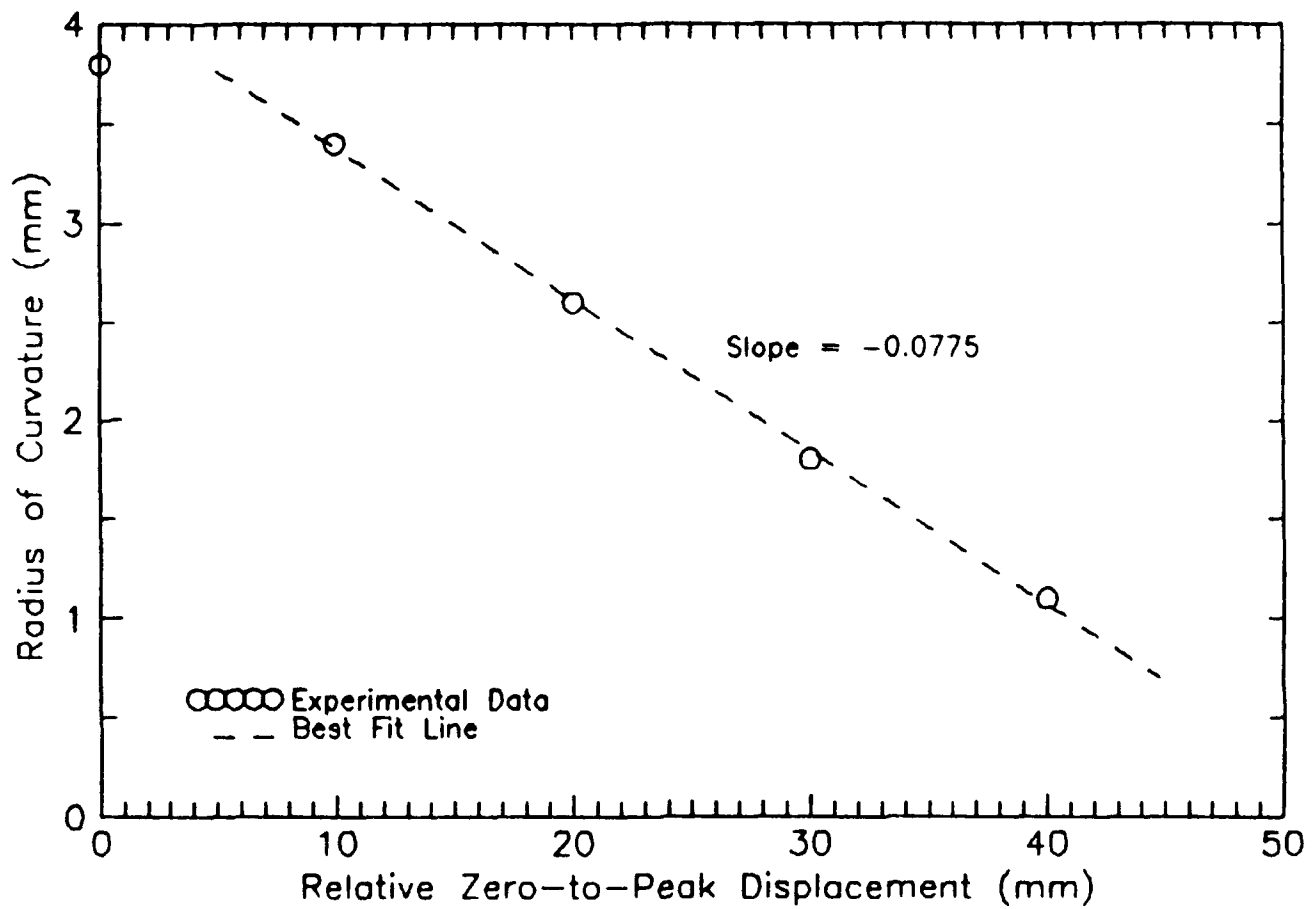
Figure 3-4. Experimental Relationship Between the Radius of Curvature and the End Displacement .

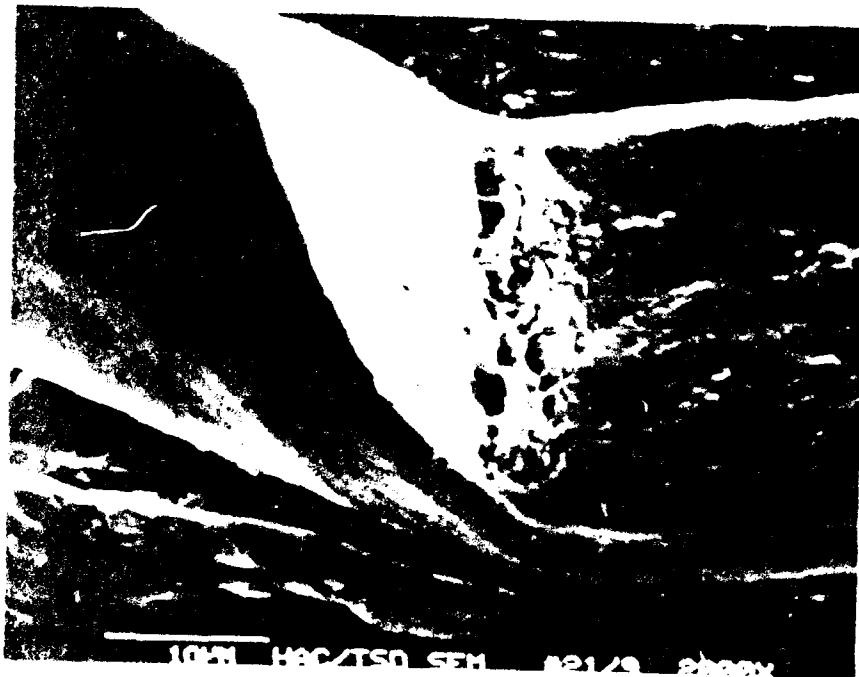
Figure H-84. Another View of Sample 21 Pin 9 Wire Bond Before Current Pulsing
