TNO-rapport  
PML 1992-13

Instrumented experiments aboard the frigate "WOLF".  
Wolf II: Measurement results of the 12 kg TNT  
experiment in the crew front sleeping  
compartment

Within the framework of the research into the vulnerability of ships, an experimental investigation took place in 1989 aboard the frigate "WOLF" of the "Roofdierklasse" (PCE 1604 class) (Wolf, Phase II).

In this report the recordings of an instrumented experiment in the crew front sleeping compartment are presented. During this experiment, a non-fragmenting charge of 12 kg TNT was initiated.

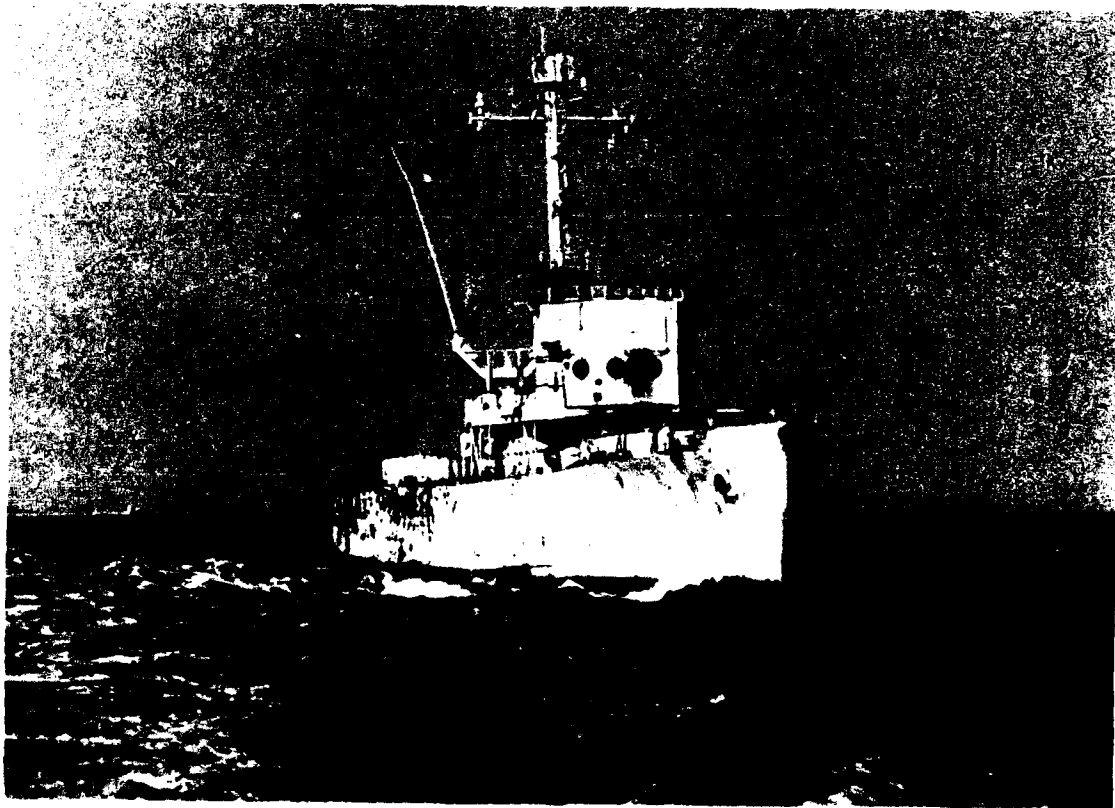
Figure 1 Wolf frigate

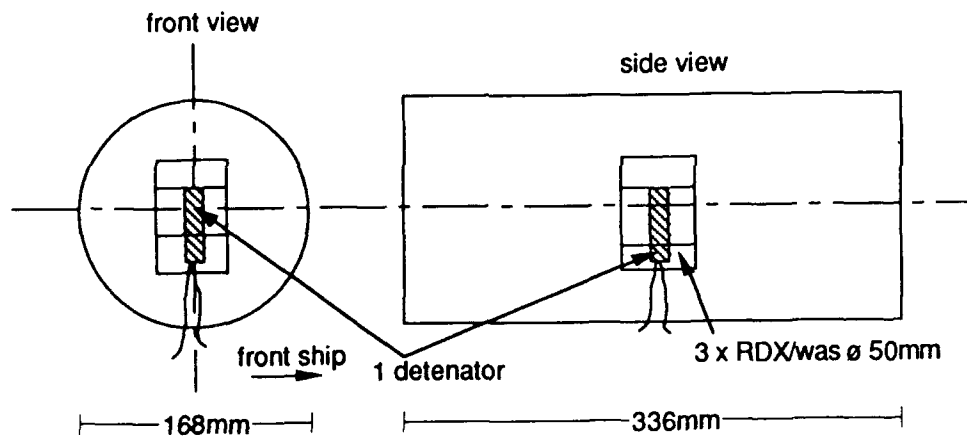
The charge used during this particular experiment was a cast cylindrical charge with  $L/D=2$ ,  $D=168$  mm, resulting in a bare charge of 12 kg TNT. The charge was placed in the centre of the compartment at midheight. This location corresponds with the 3 kg TNT experiment, however the charges' geometries differ considerably. The charge was ignited at its centre with one electrical detonator (No. 8) and a booster of three RDX cartridges ( $L/D=1$ ,  $D=50$  mm). The geometry and orientation as well as an impression of the charge are shown in Figures 2 and 3. Figure 4 shows the compartment after the experiment was performed.

Figure 2 Geometry of the charge

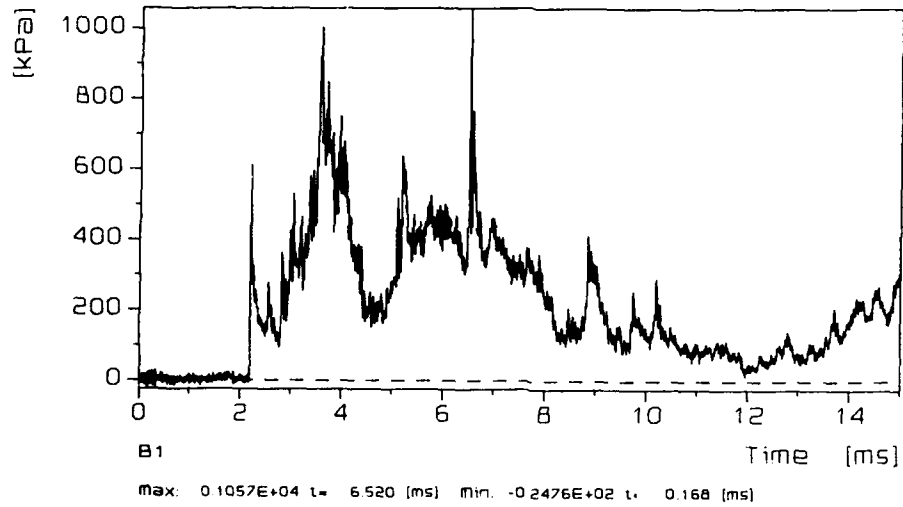
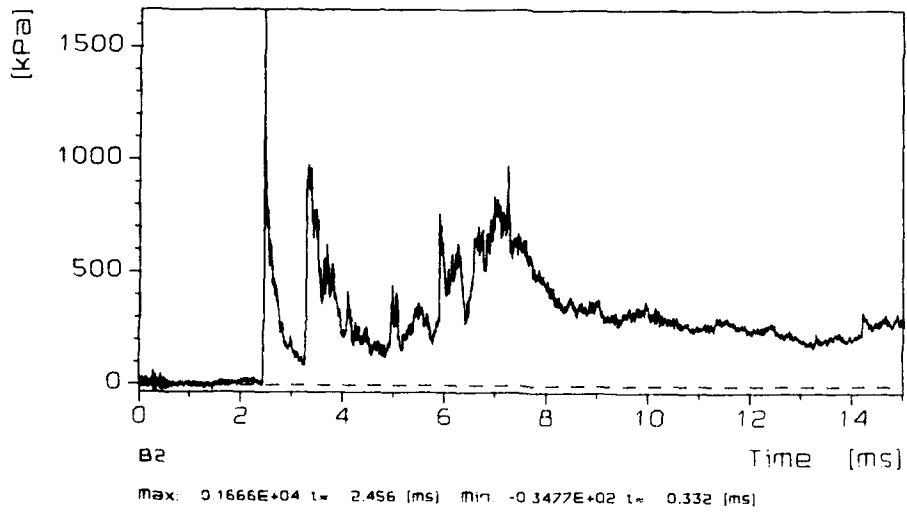
The recorded pressure signals are presented in Figures 7, 8 and 9. At first glance, these recordings show reliable signals. Transducer B4 seems to drift, probably due to temperature influences. This drift also became apparent from the 3 kg TNT recording. The strong negative pressure registered by transducer B6 after 8 ms could not be explained. This may be due to reflections. The transducer was mounted on the ceiling at the edge of the experiment compartment.

Figure 7 Pressure signals B1 (SB hull) and B2 (PS hull)

Comparing the arrival times of the shock front shows that in some situations the predicted shock front arrival overrates the recordings (B1, B2, B3), whereas for the remaining transducers, the theoretical values underrate them.

The theoretical and recorded peak pressures do not fit very well. In some situations, the theoretical predictions overestimate the recordings (B2) by up to a factor 2, others underrate the recordings by up to a factor 4 (B6). Transducers B1 and B2, located symmetrically with respect to the centre of the charge, show a considerable discrepancy in peak pressures although the arrival times of the shock front correspond well. The theoretical predicted peak pressure appeared to be the averaged value of B1 and B2.

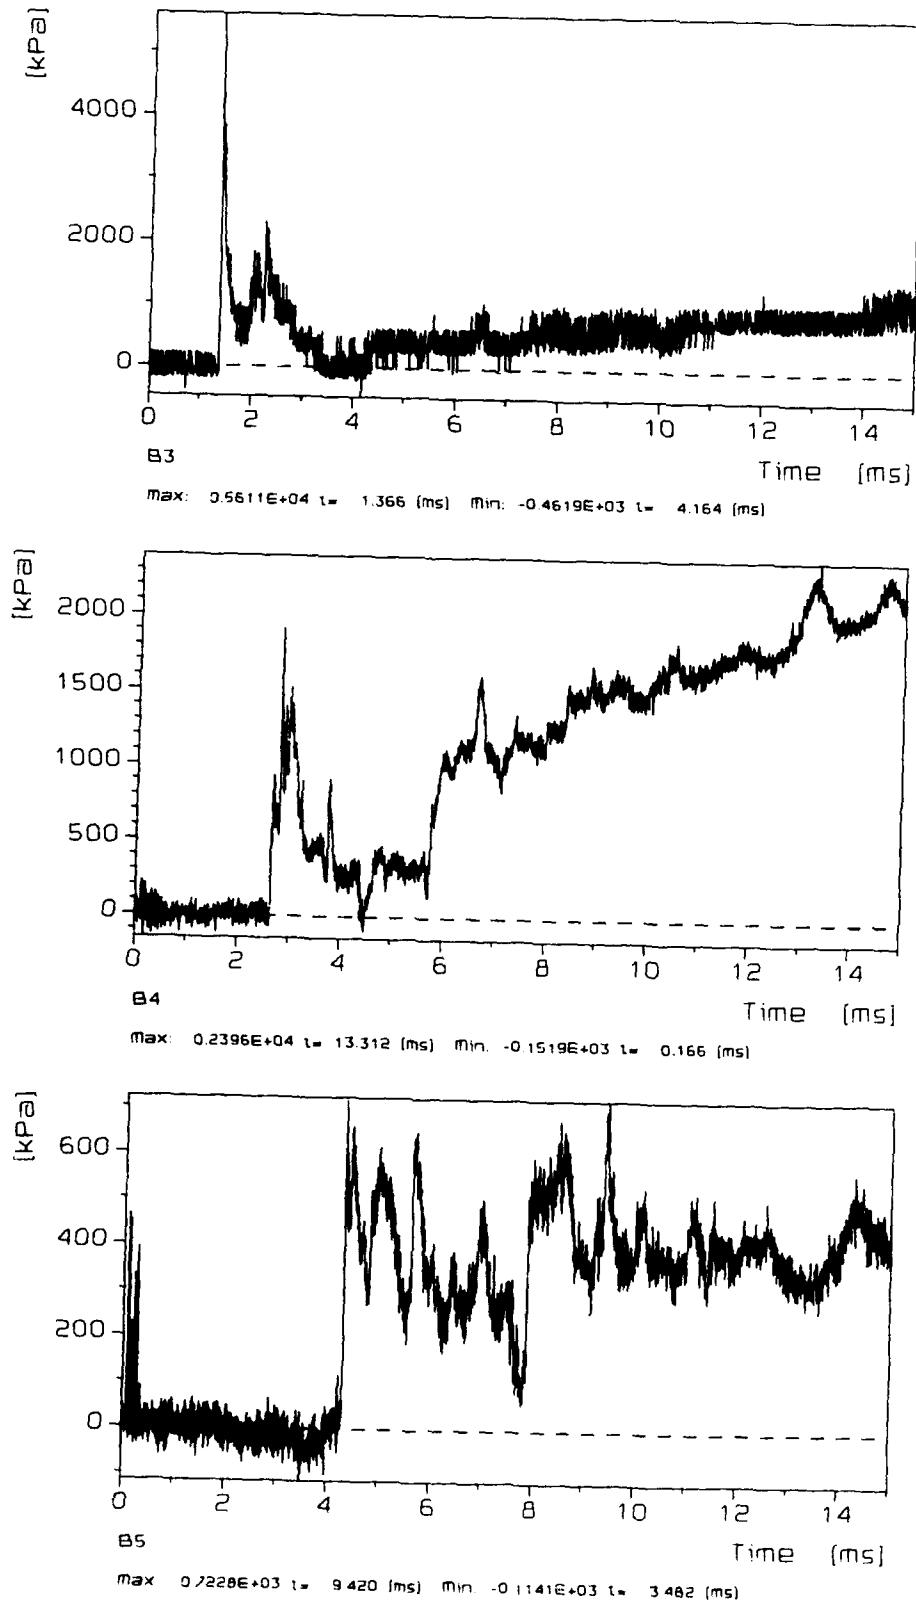
Figure 8 Pressure signals B3, B4 and B5 (BHD 32)

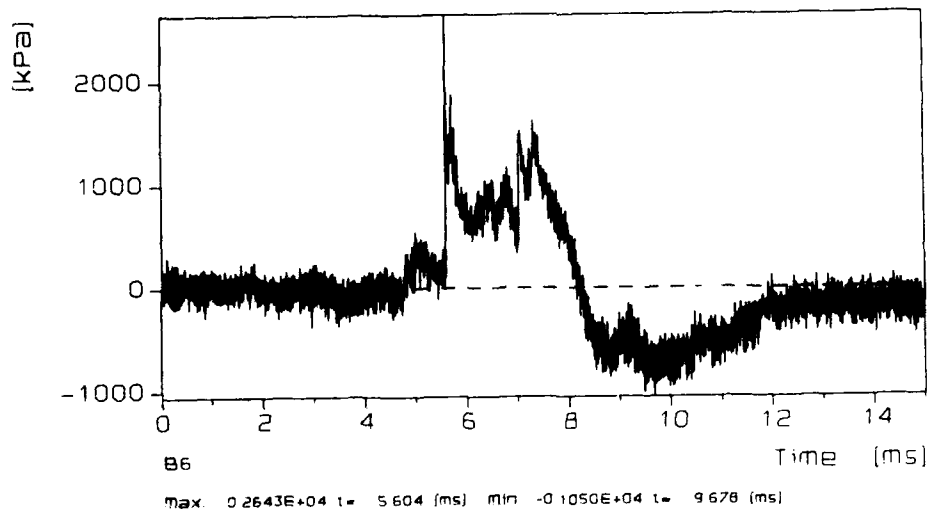
Figure 9 Pressure signal B6 (on ceiling corner)

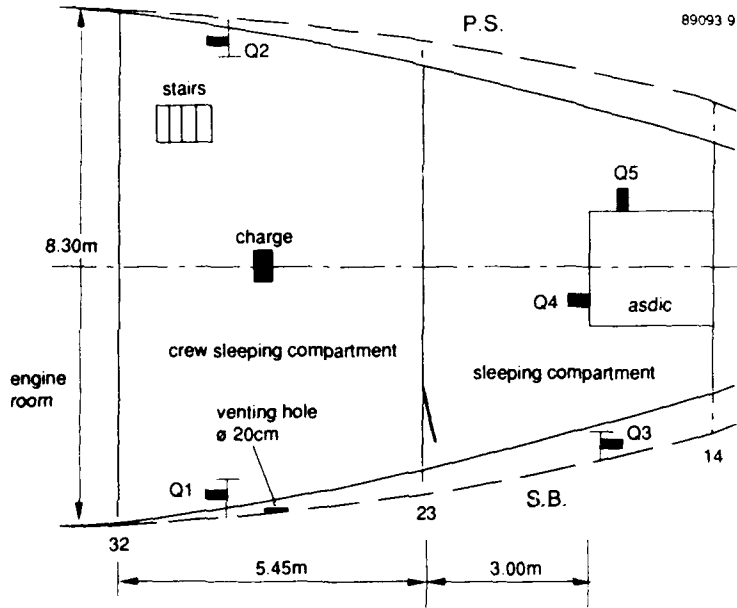
The quasi-static pressure was registered with piezo resistive transducers at six different locations (Q1-Q6). Two transducers (Q1, Q2) were placed in the crew sleeping compartment. The other transducers were placed in the neighbouring compartments, i.e. three transducers (Q3, Q4, Q5) in the corporals' sleeping quarters/mess, one (Q6) in the officers' room which is located above the experiment compartment. The positions of the transducers are summarized in Table 4 and shown schematically in Figures 10 and 11.

Figure 10 Schematic illustration of the quasi-static pressure transducers positions

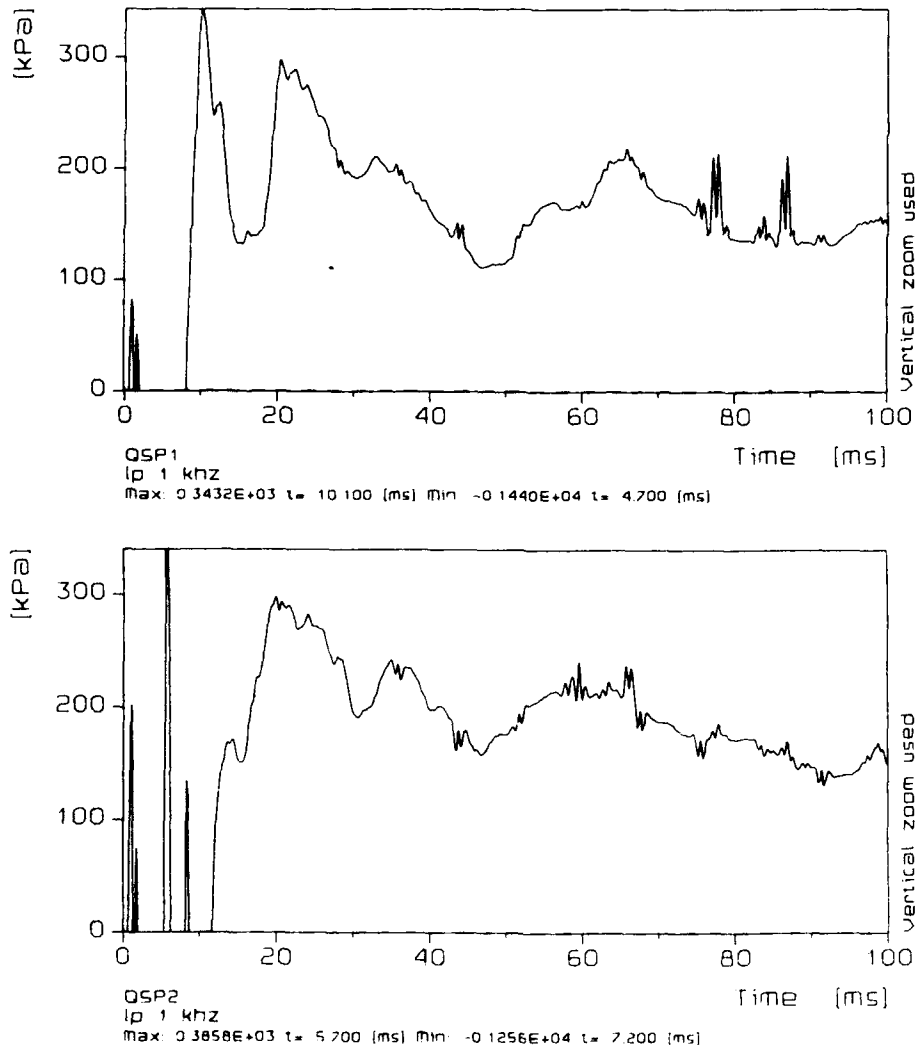
The registered quasi-static pressures are presented in Figures 12-15. Unfortunately, transducer Q6 malfunctioned after 100 ms. Transducers Q3, Q4, Q5 and Q6 were placed in the adjacent compartments. From their figures it appears that these transducers start reacting after 10-15 ms and the quasi-static pressure increases up to  $\pm 200$  kPa ( $t=50$  ms). During this time period, the quasi-static pressure in the experiment compartment drops to  $\pm 200$  kPa, i.e. at  $t=50$  ms the quasi-static pressure in the experiment compartment as well as in the adjacent compartments was  $\pm 200$  kPa. Later on, the quasi-static pressure had comparatively decayed.

Figure 12 Quasi-static pressure signals Q1, Q2 (in the experiment compartment) (short time base)

From this it may be deduced that the damage to the bulkhead was realized in the first 15 ms, thus effecting a drastic enlargement of the experiment compartment.

460 kPa. These theoretical values overestimate the quasi-static pressures of Q1 and Q2 (in the experiment compartment) (300 kPa), although one should realize that the 'leakage' to the adjacent compartments already started after 15 ms.

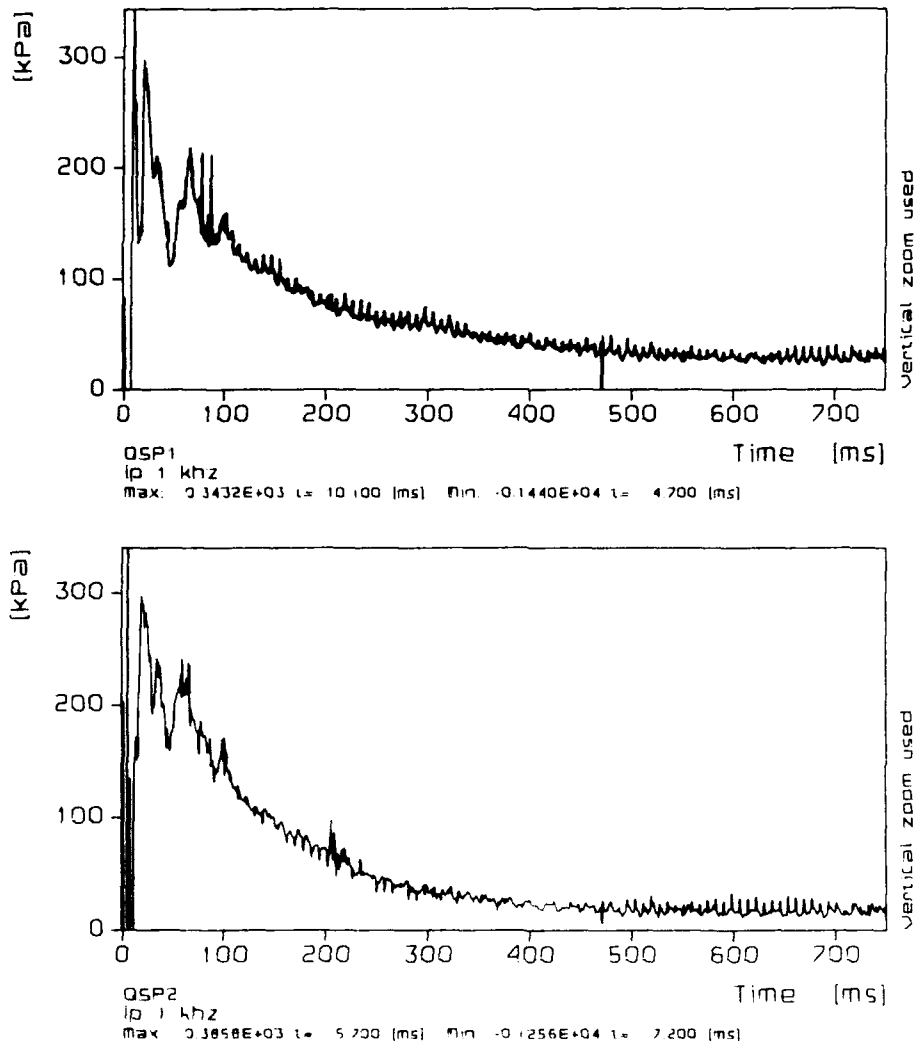
Figure 13 Quasi-static pressure signals Q1, Q2 (in the experiment compartment)

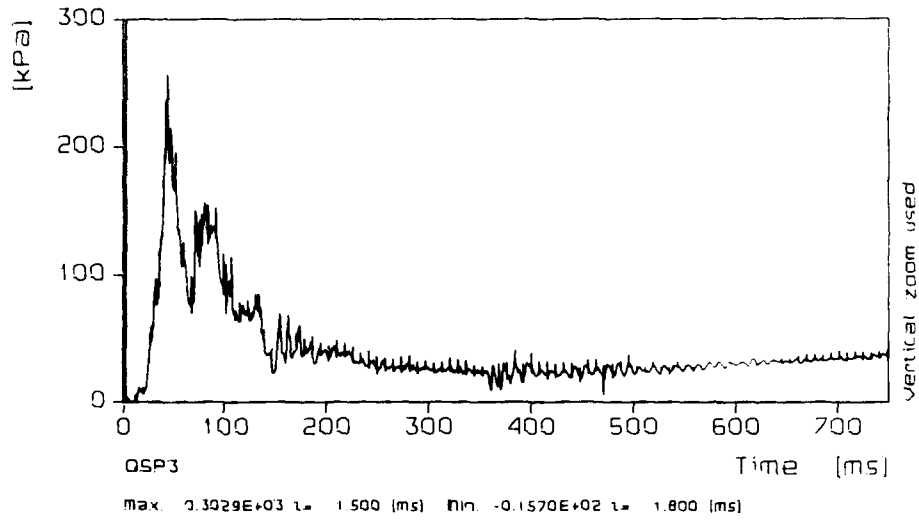
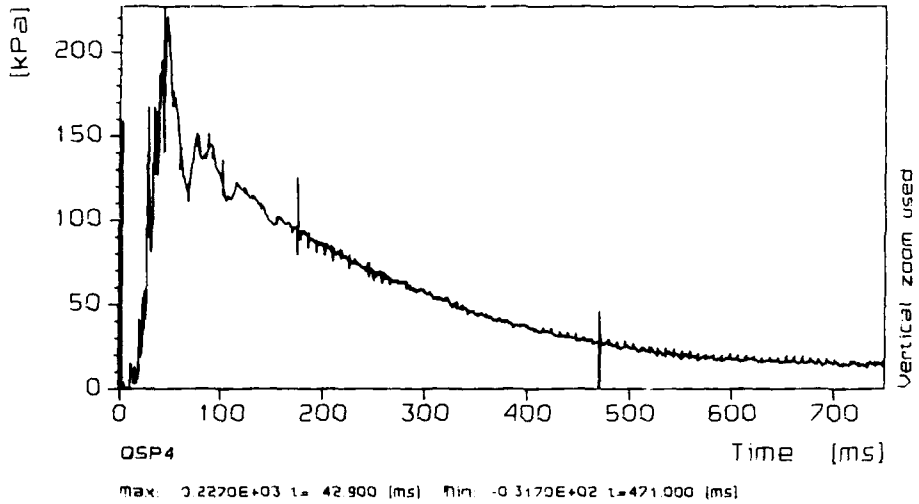
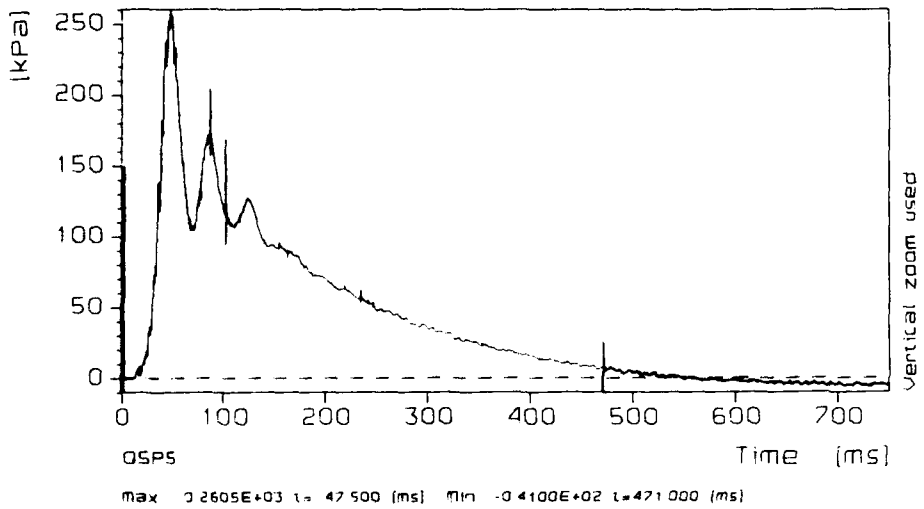
Figure 14 Quasi-static pressure signals Q3, Q4 and Q5

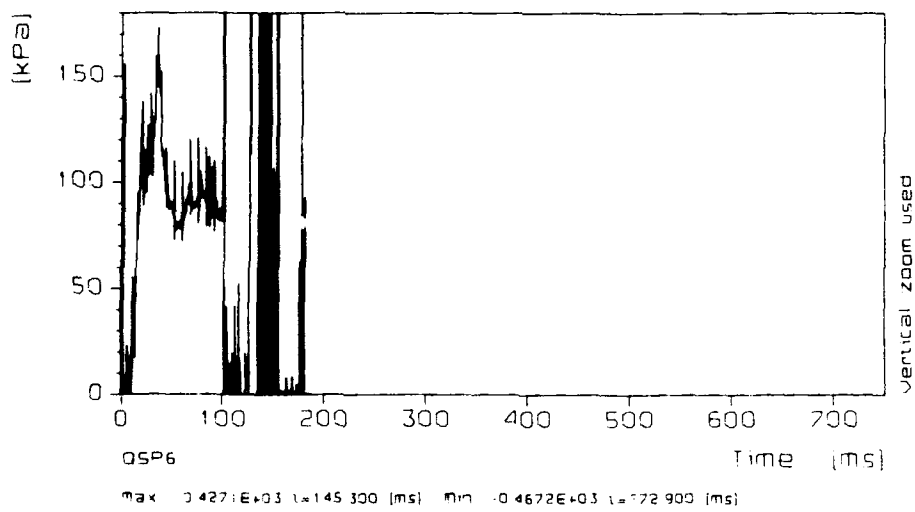
Figure 15 Quasi-static pressure signal Q6

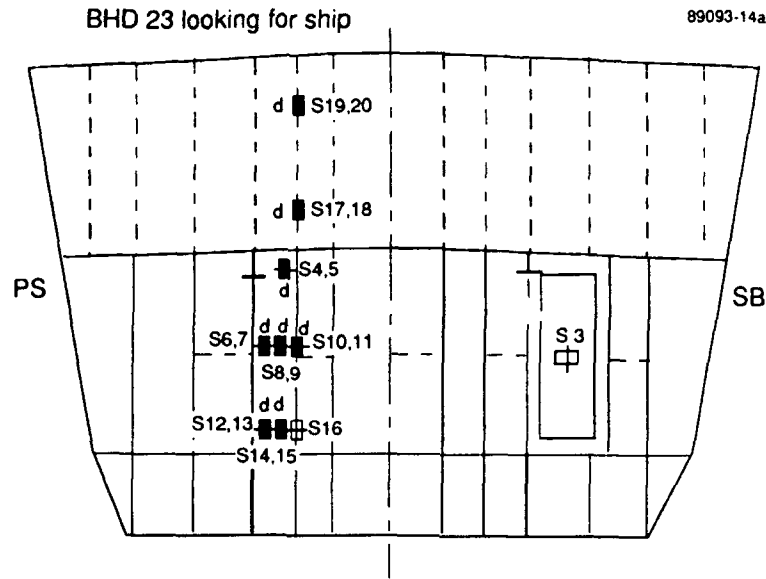
Figure 18 Schematic illustration of strain gauges position on BHD 23

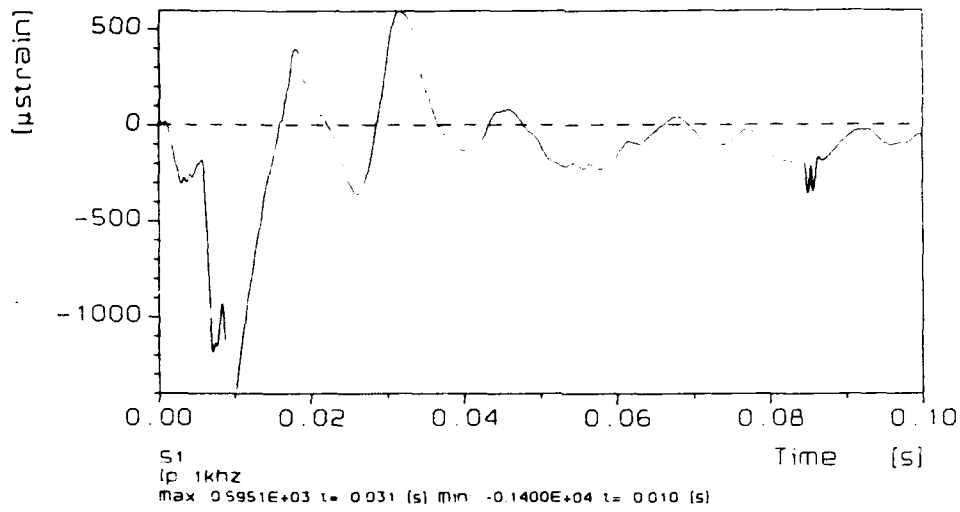
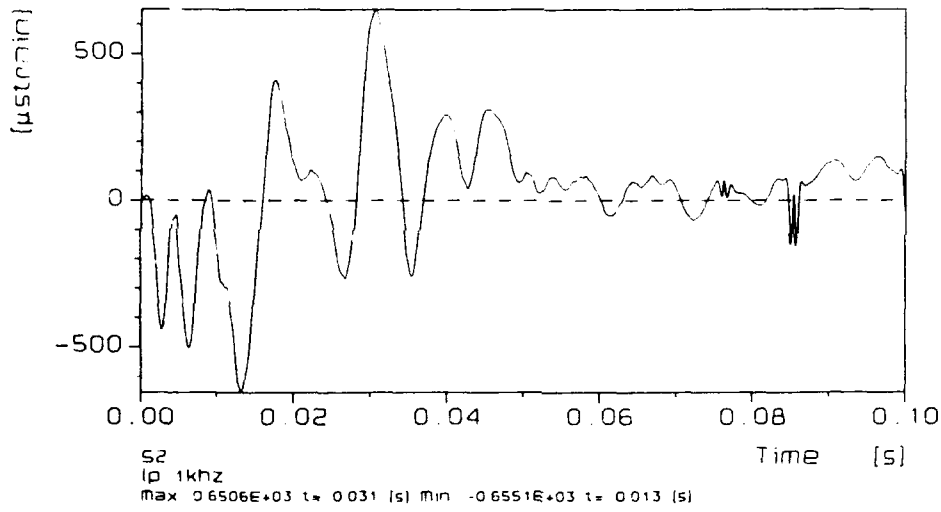
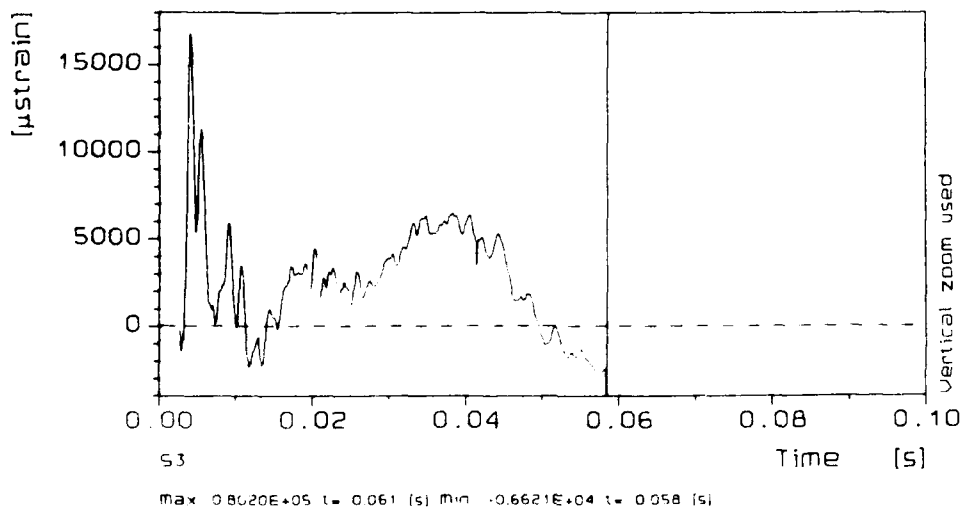
Figure 21 Strain gauge response S1, S2 (hull experiment compartment), S3 (BHD 23)

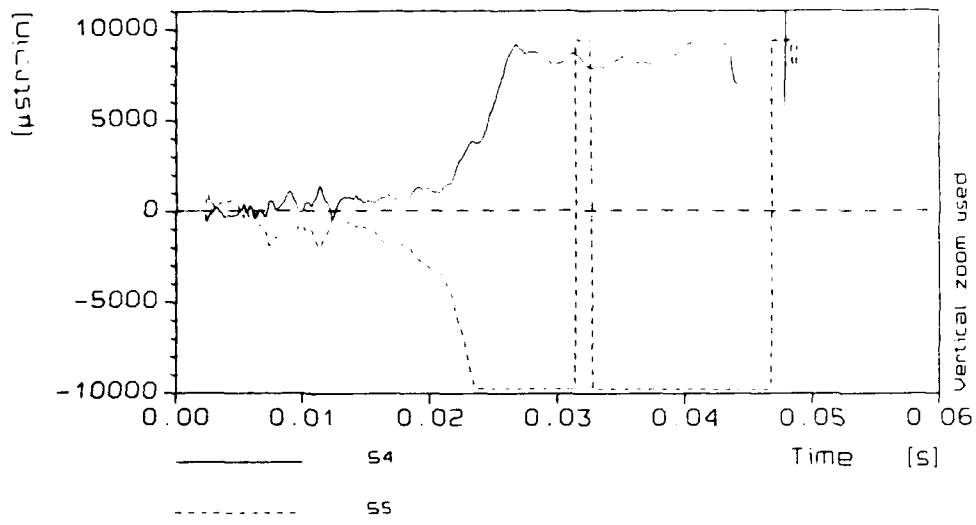
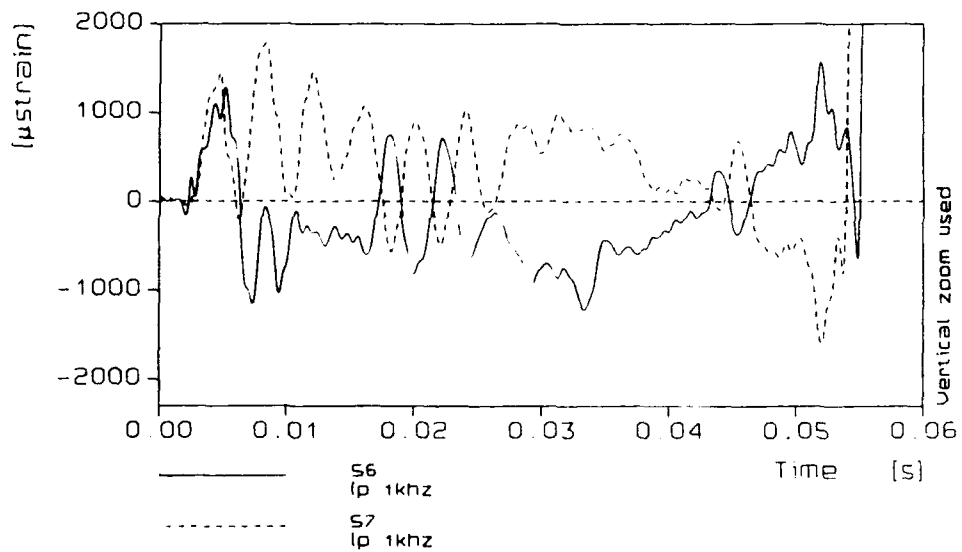
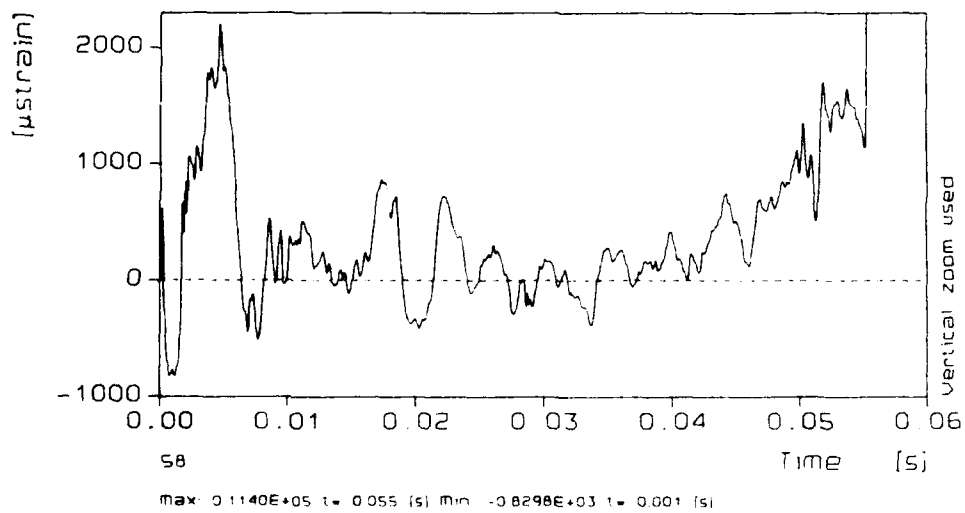
Figure 22 Strain gauge response S4 and S5, S6 and S7, S8 (BHD 23)

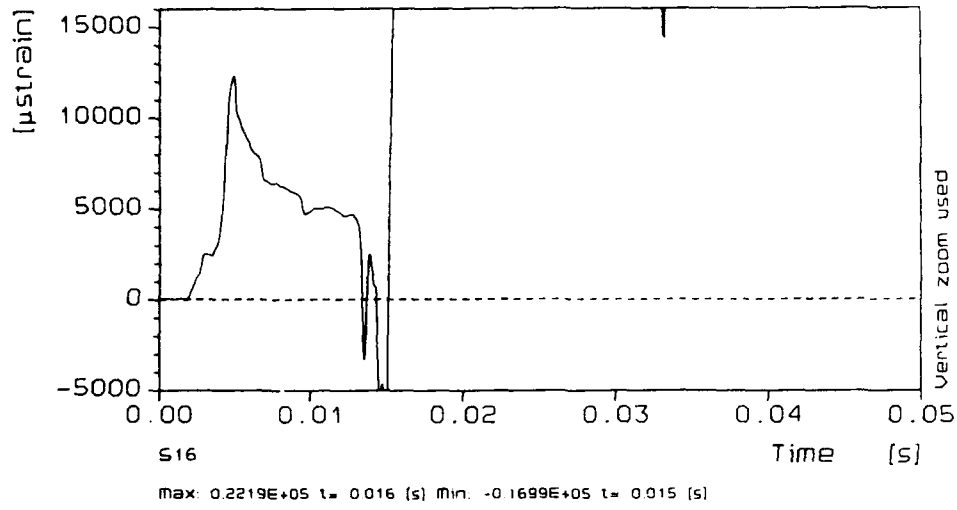
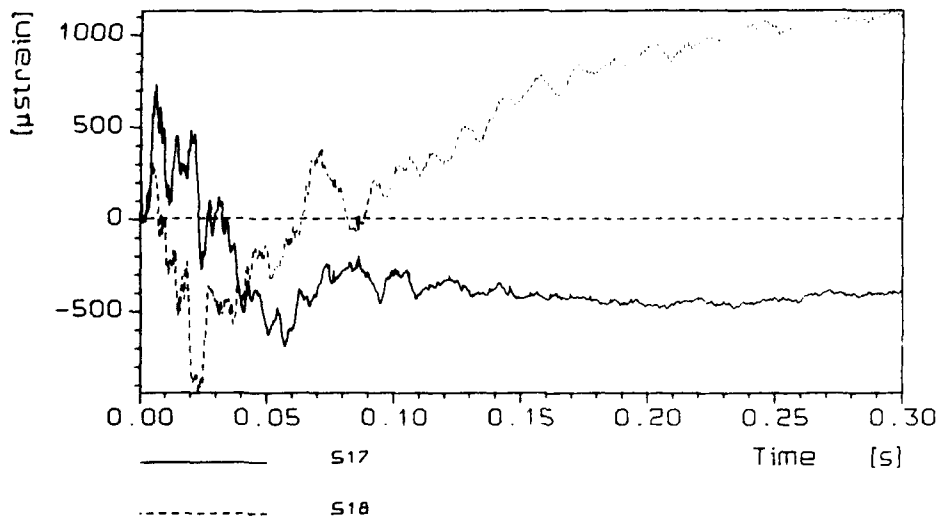
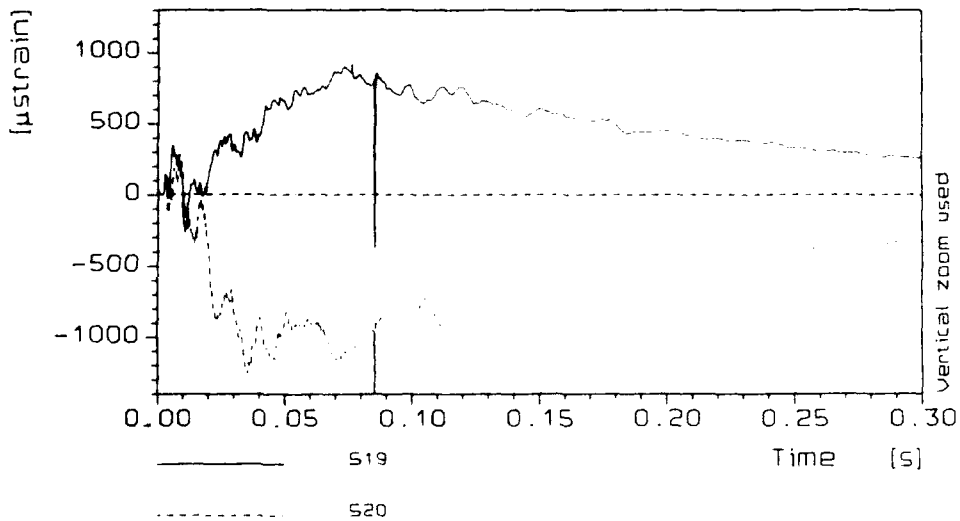
Figure 24 Strain gauge response S16, S17 and S18, S19 and S20 (BHD 23)

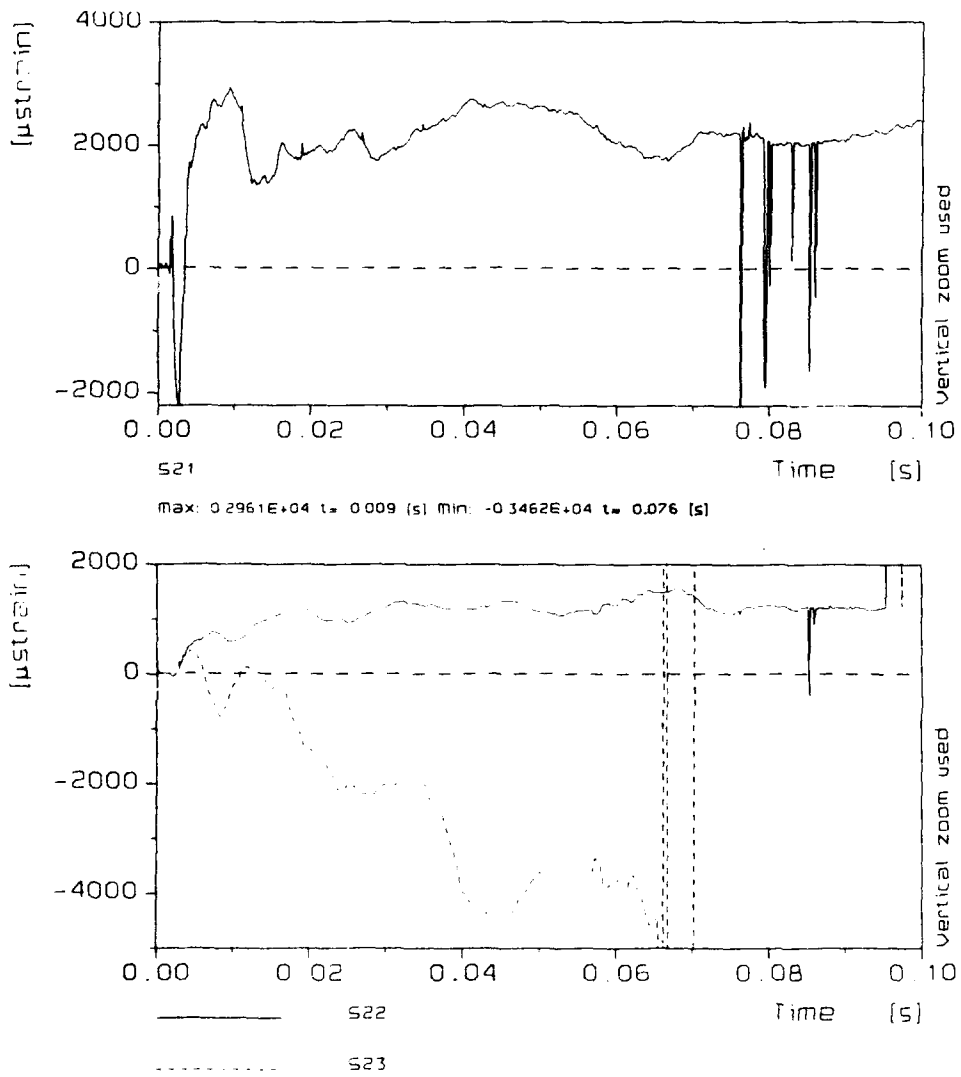
Figure 25 Strain gauge response S21, S22 and S23 (BHD 32)

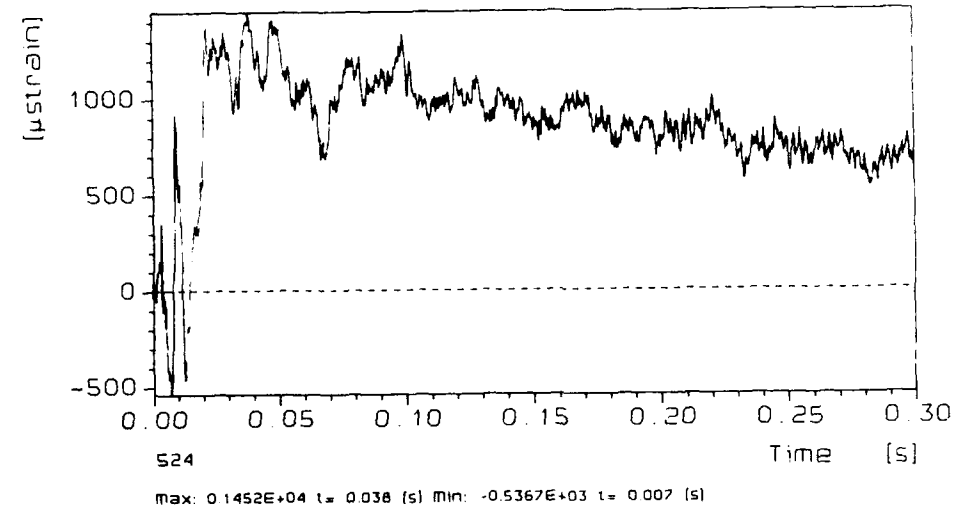
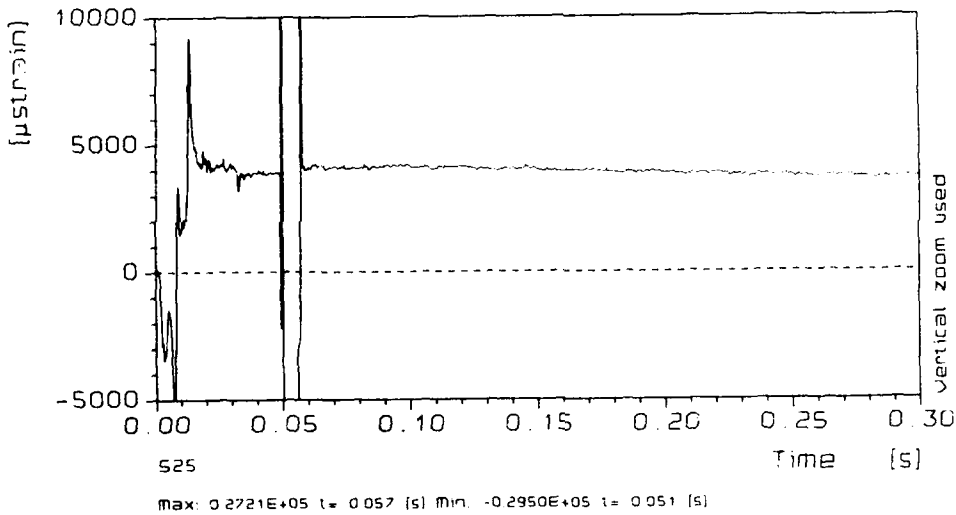
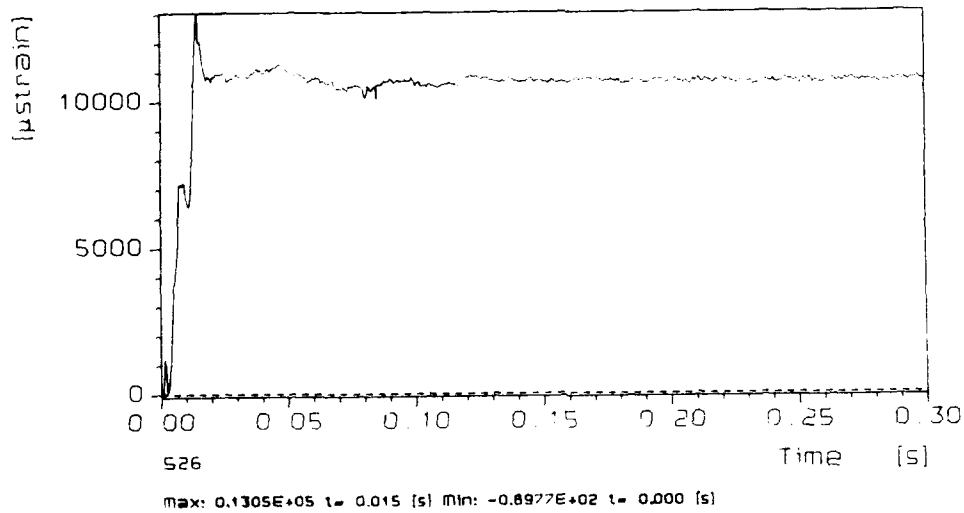
Figure 26 Strain gauge response S24, S25, S26 (floor officers' compartment)

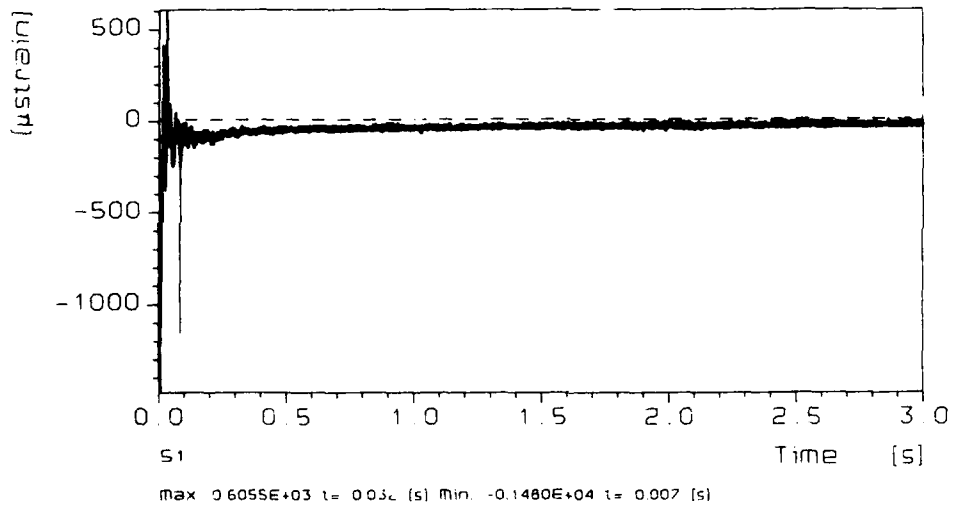
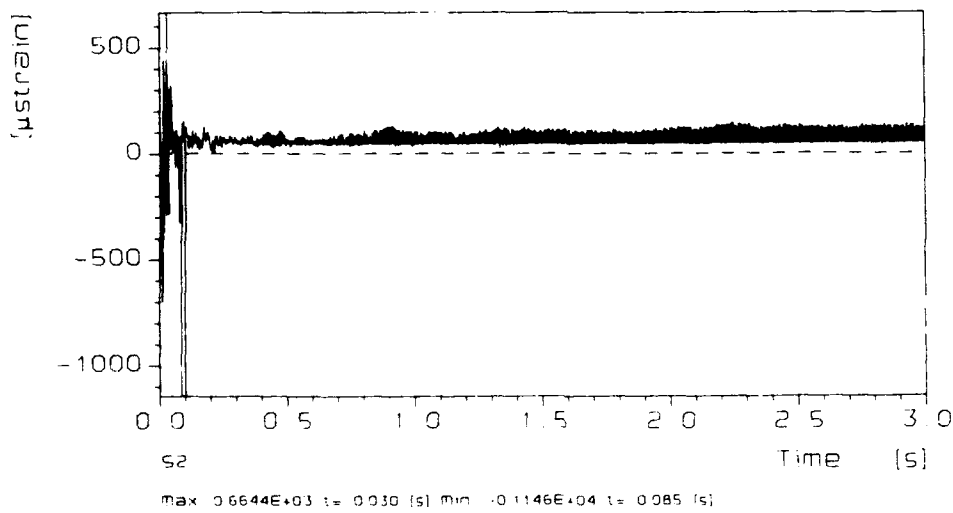
Figure 27 Strain gauge response S1, S2 (hull experiment compartment)

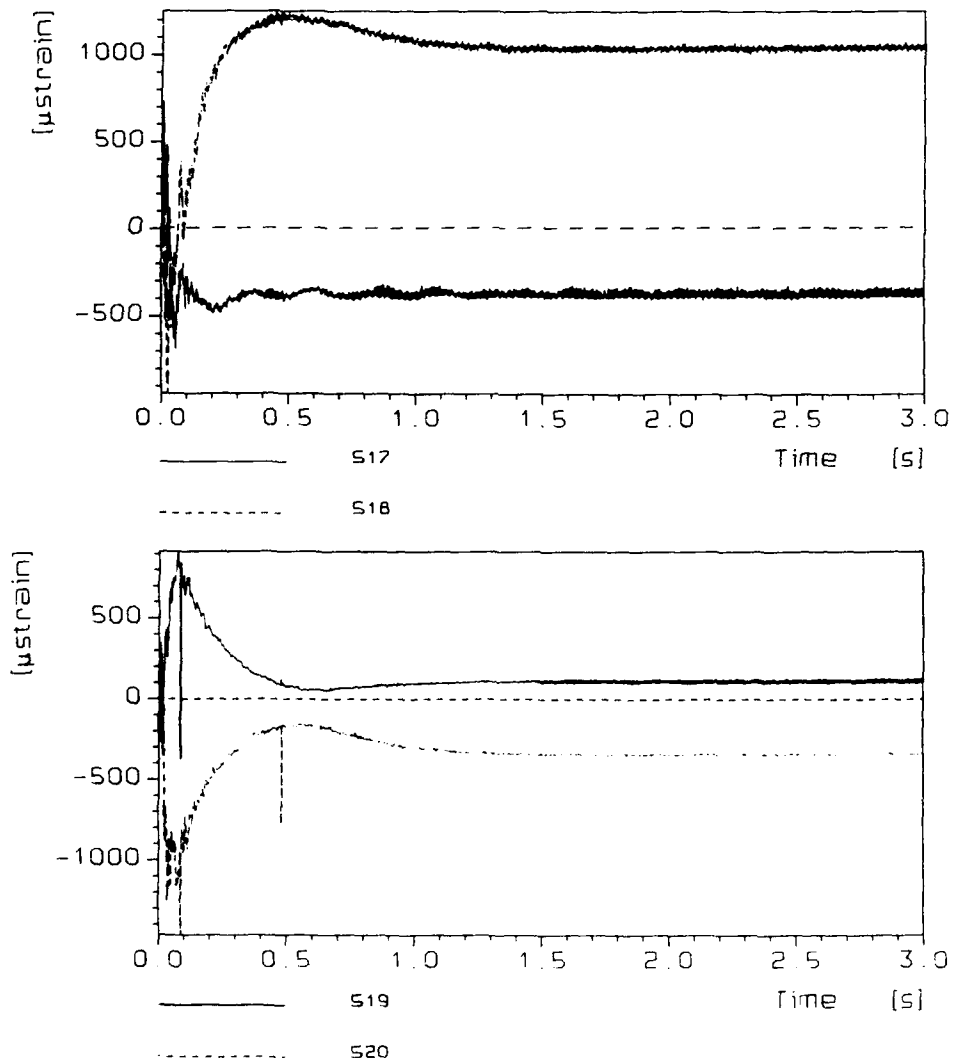
Figure 28 Strain gauge response S17 and S18, S19 and S20 (BHD 23)

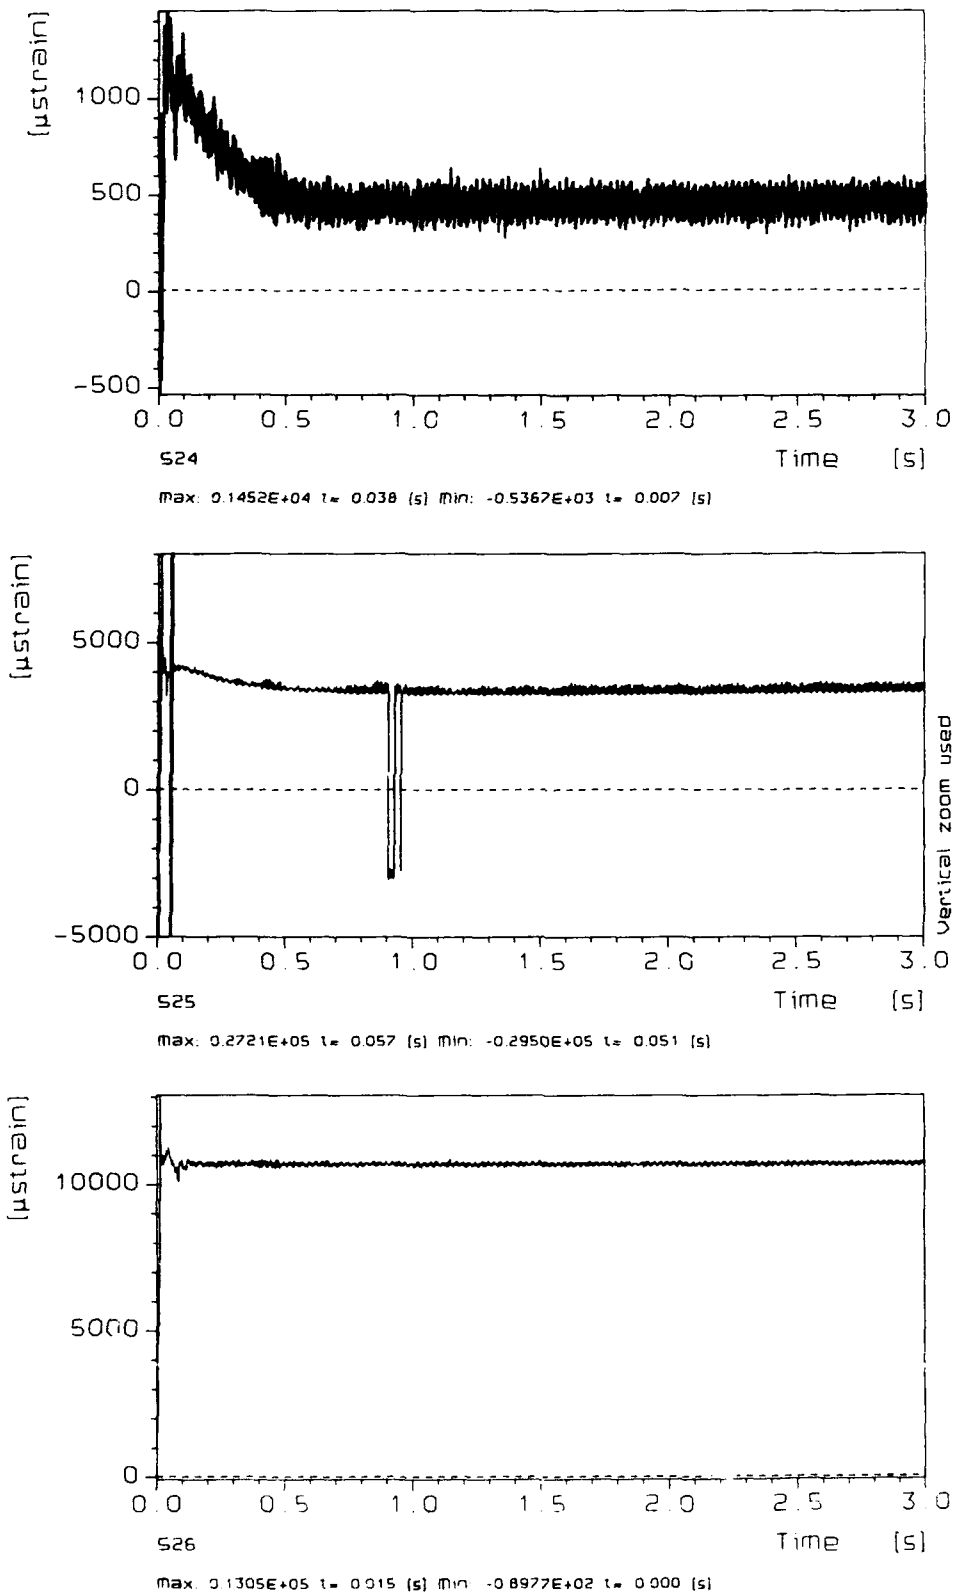
Figure 29 Strain gauge response S24, S25, S26 (floor of officers' compartment)

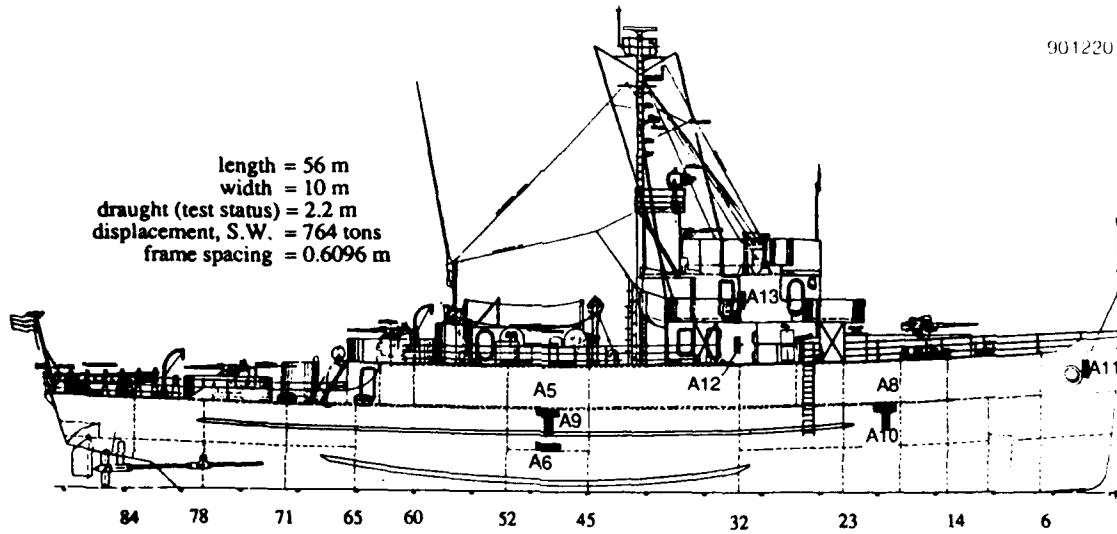
Figure 30 Schematic illustration of the positions of the accelerometers

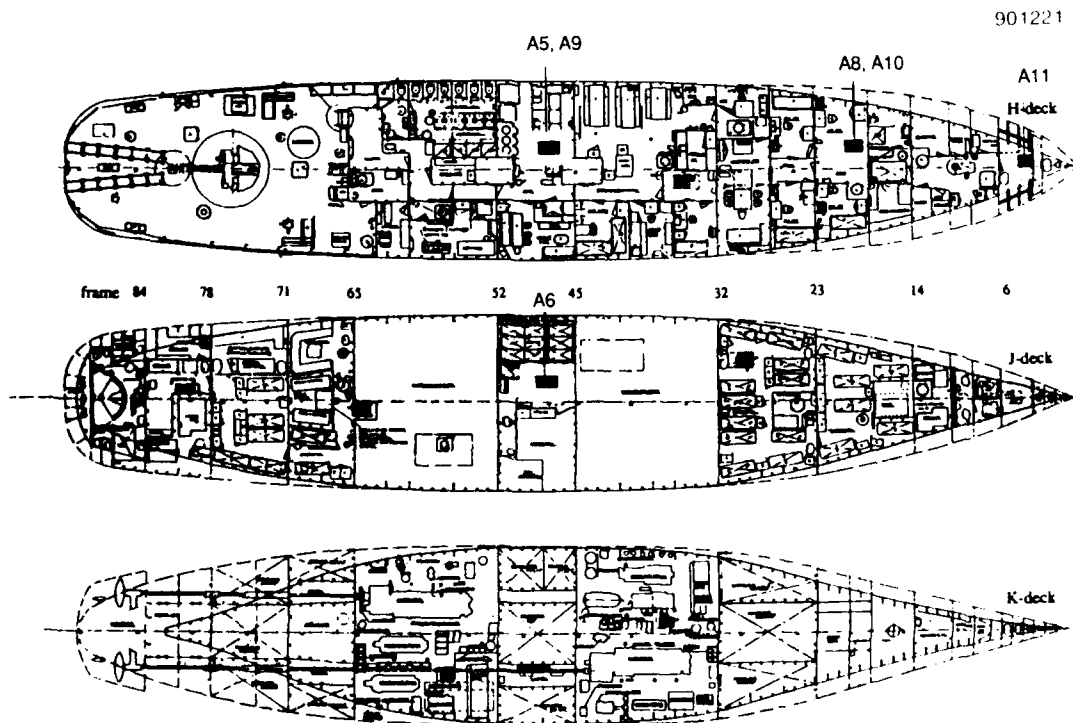
Figure 31 Schematic illustration of the positions of the accelerometers

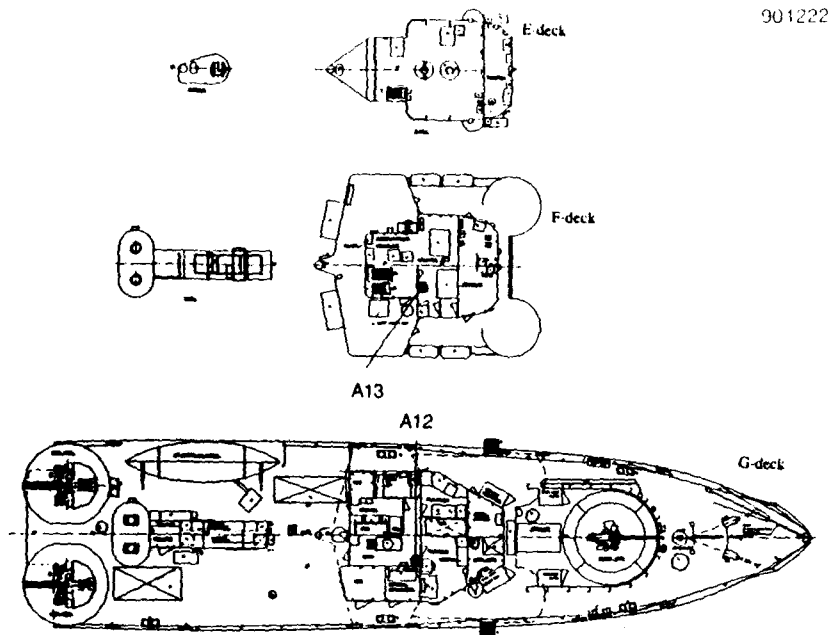
Figure 32 Schematic illustration of the positions of the accelerometers
