TNO-rapport  
PML 1992-13

Instrumented experiments aboard the frigate "WOLF".  
Wolf II: Measurement results of the 12 kg TNT  
experiment in the crew front sleeping  
compartment

Within the framework of the research into the vulnerability of ships, an experimental investigation took place in 1989 aboard the frigate "WOLF" of the "Roofdierklasse" (PCE 1604 class) (Wolf, Phase II).

In this report the recordings of an instrumented experiment in the crew front sleeping compartment are presented. During this experiment, a non-fragmenting charge of 12 kg TNT was initiated.

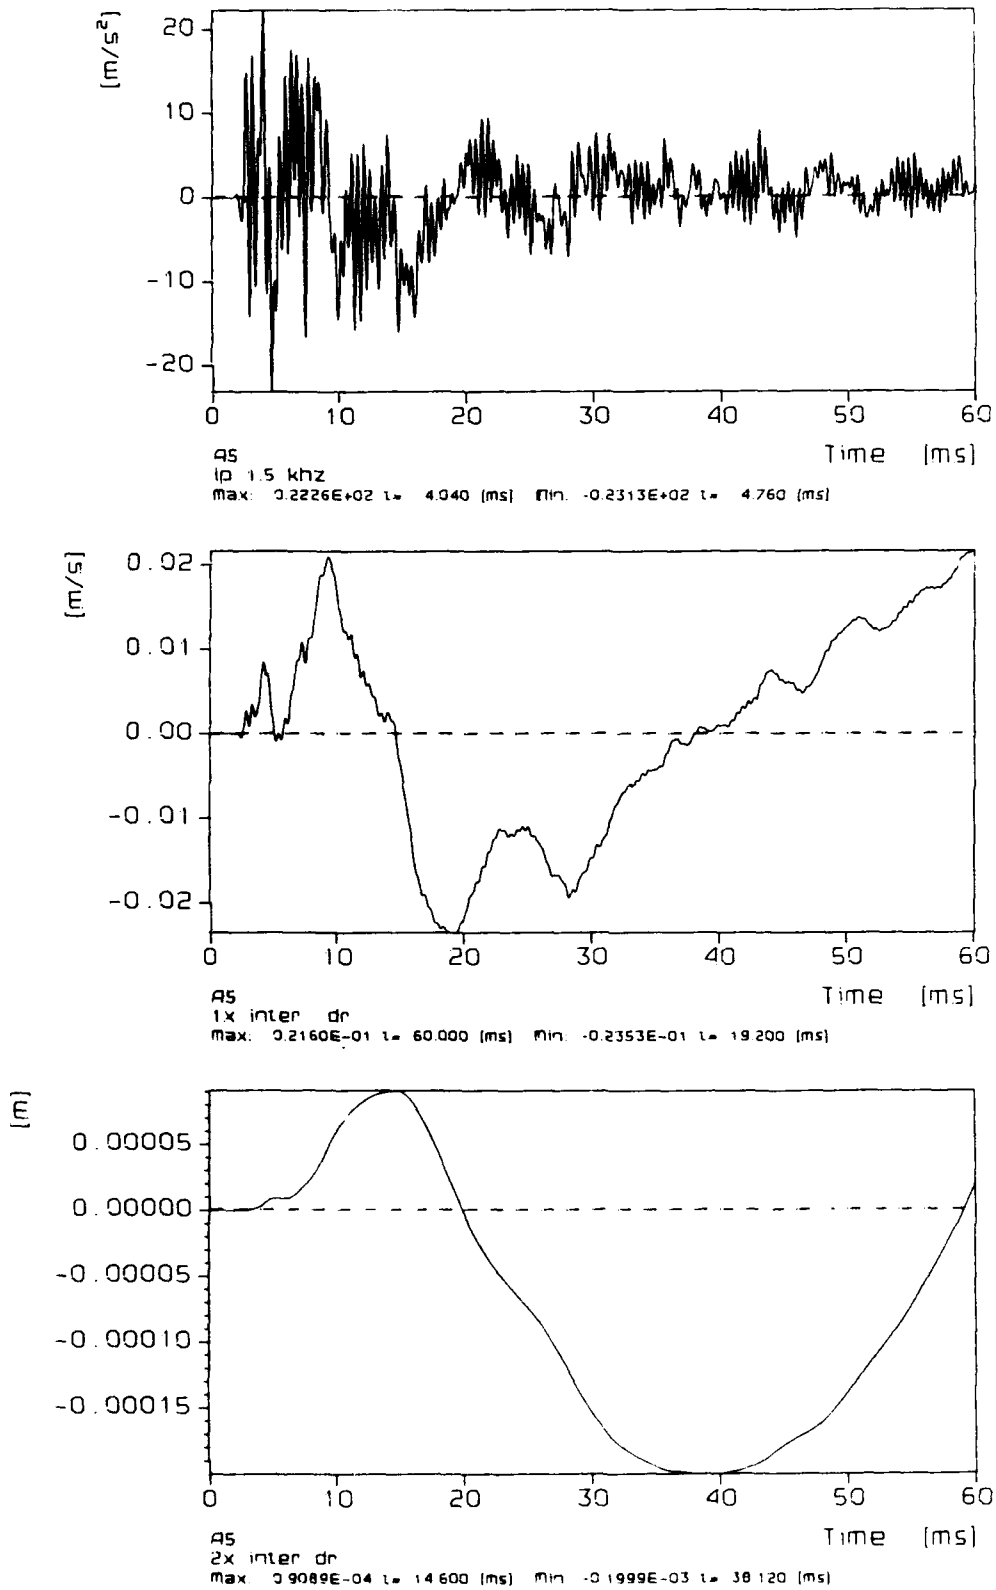
Figure 33 Accelerometer A5

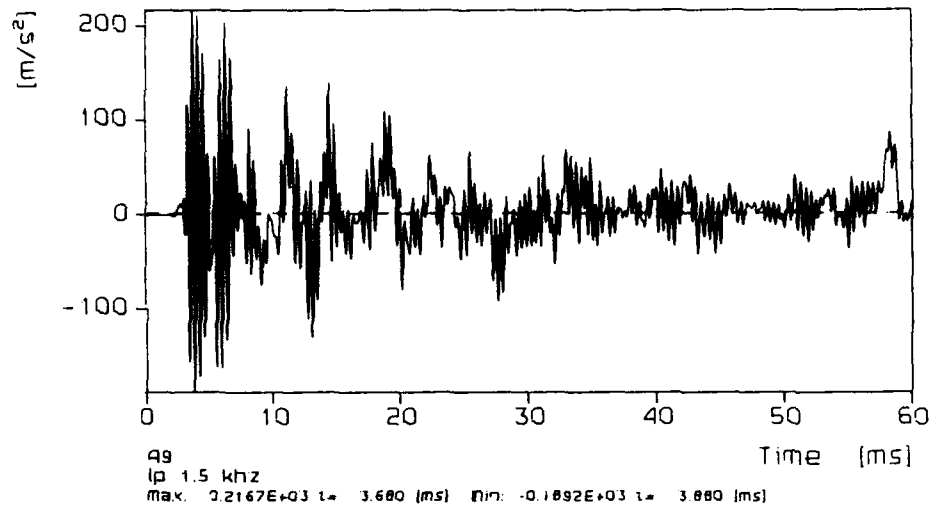
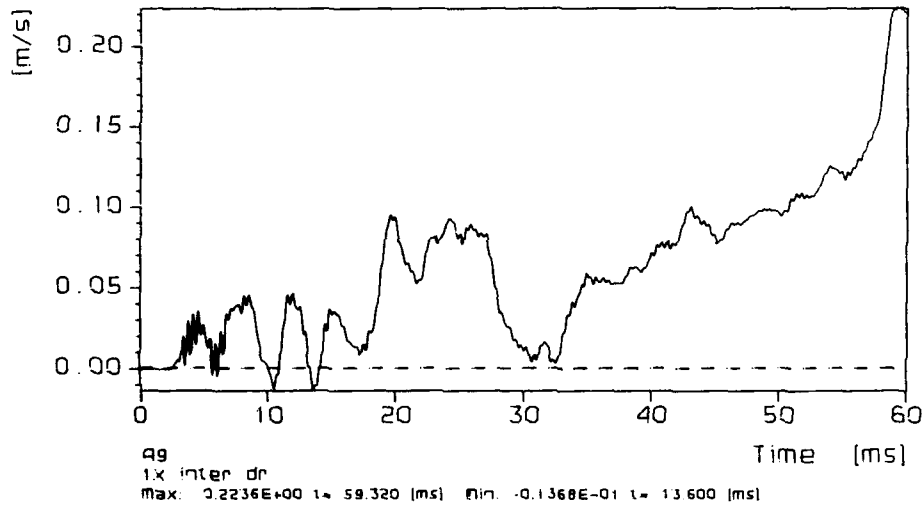
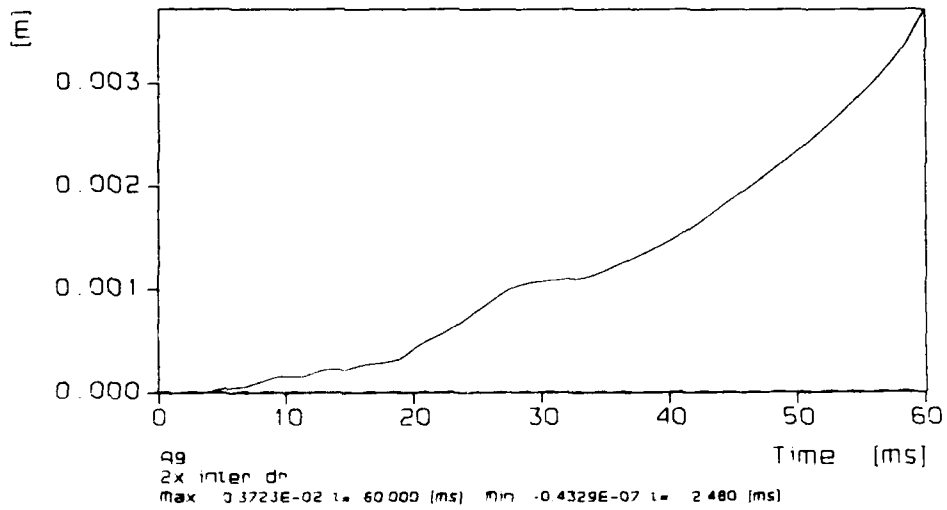
Figure 36 Accelerometer A9

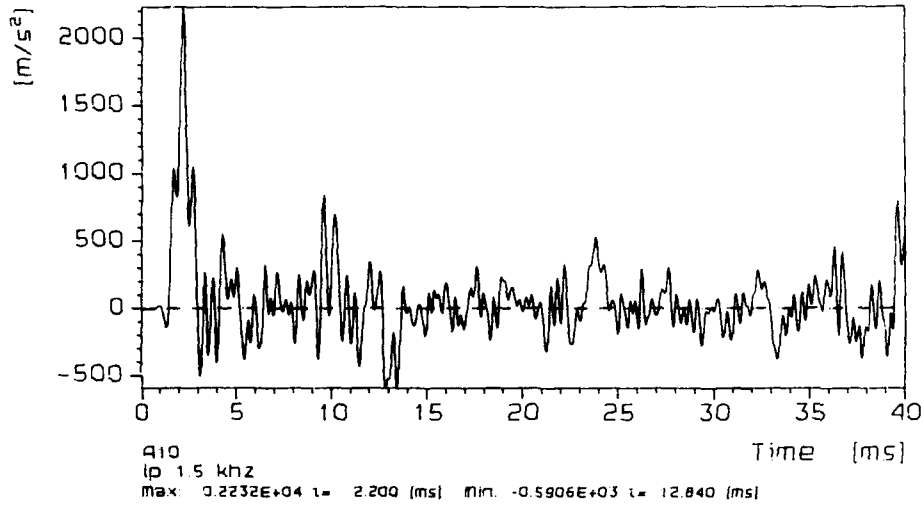
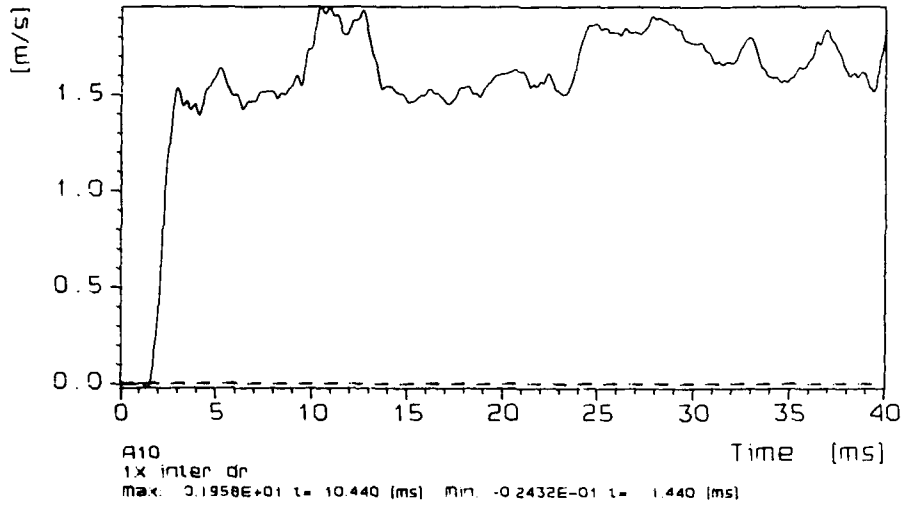
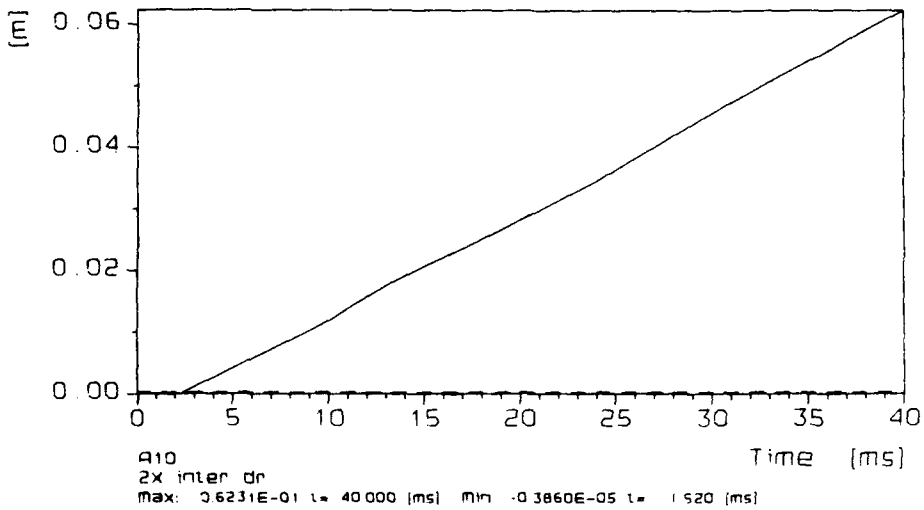
Figure 37 Accelerometer A10

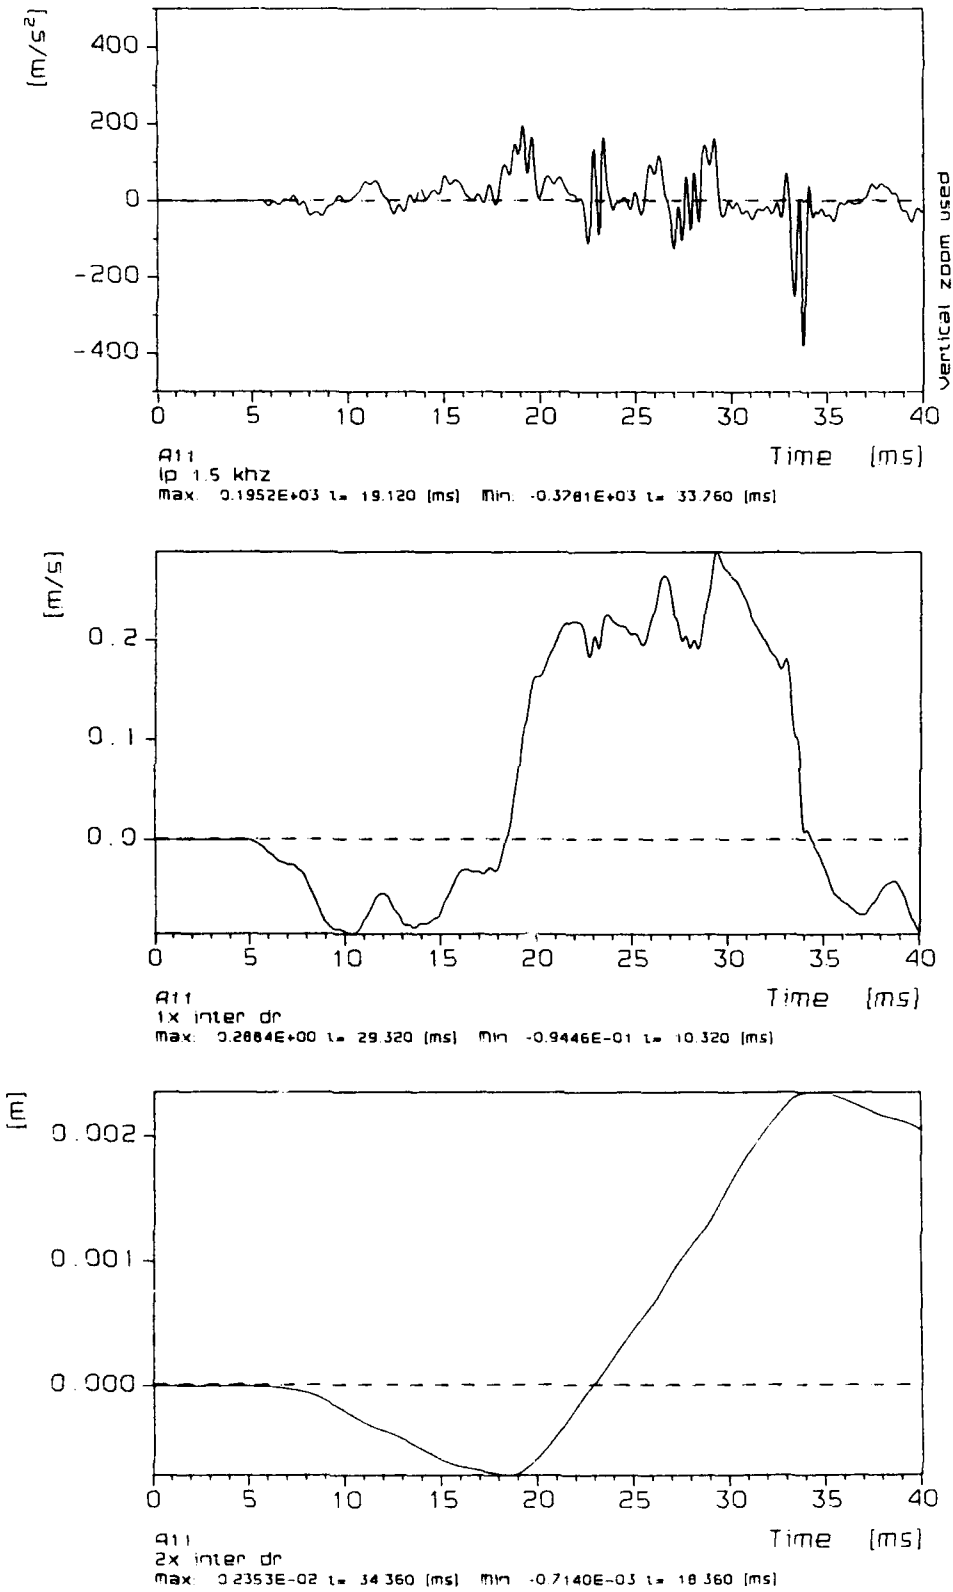
Figure 38 Accelerometer A11

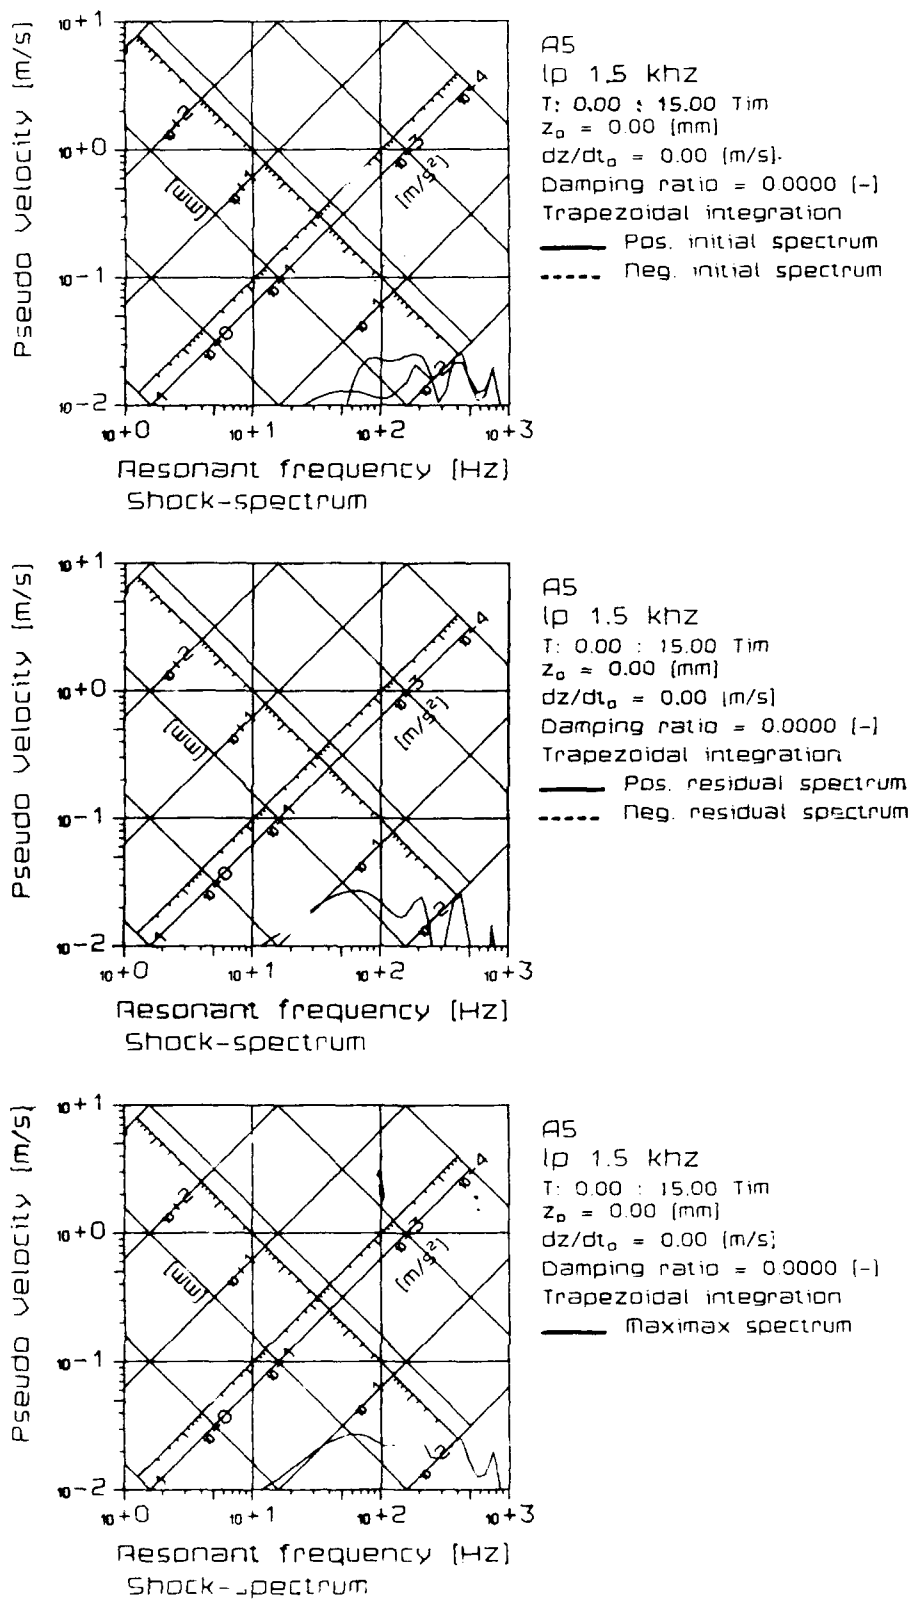
The (undamped) shock spectra are also included in this report in Figures 40-46. The positive and negative residual shock spectra are identical because damping was omitted.

Figure 40 Shock spectra of accelerometer A5

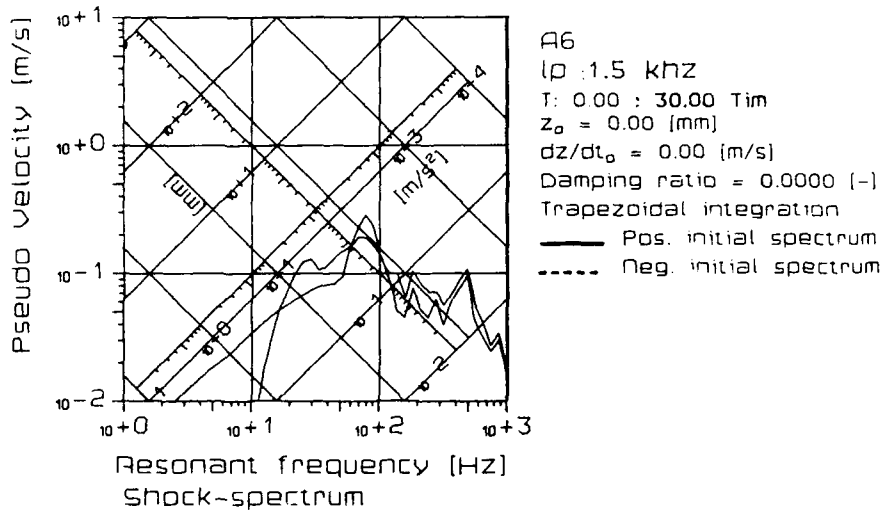
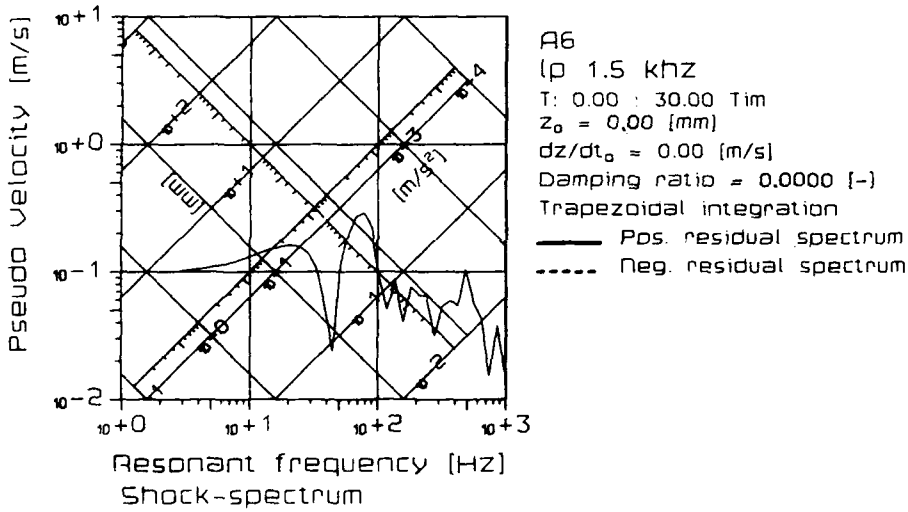
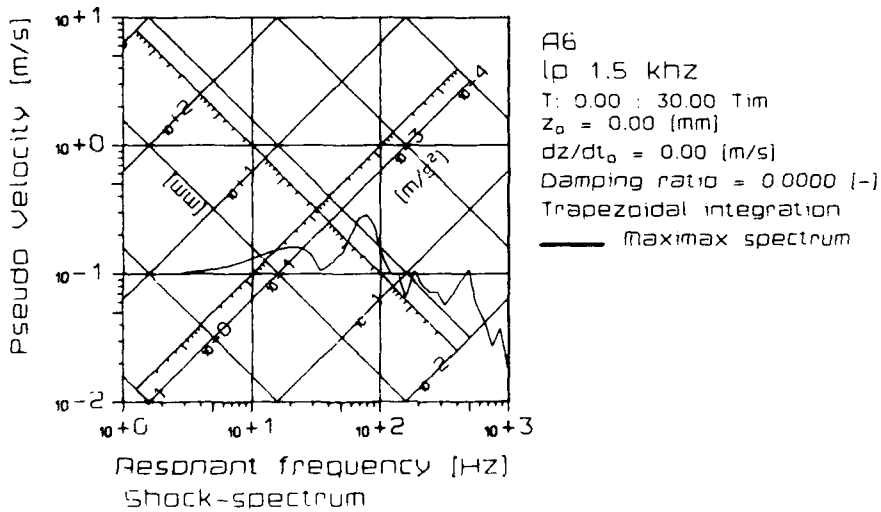
Figure 41 Shock spectra of accelerometer A6

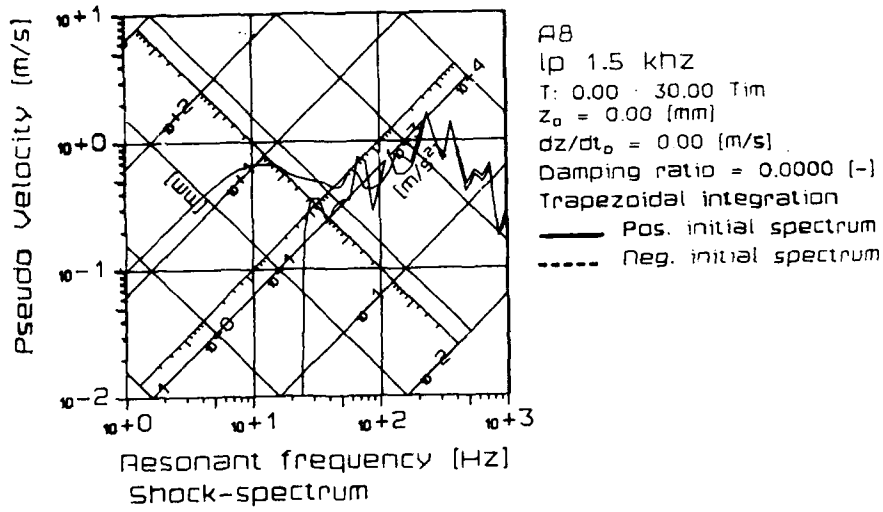
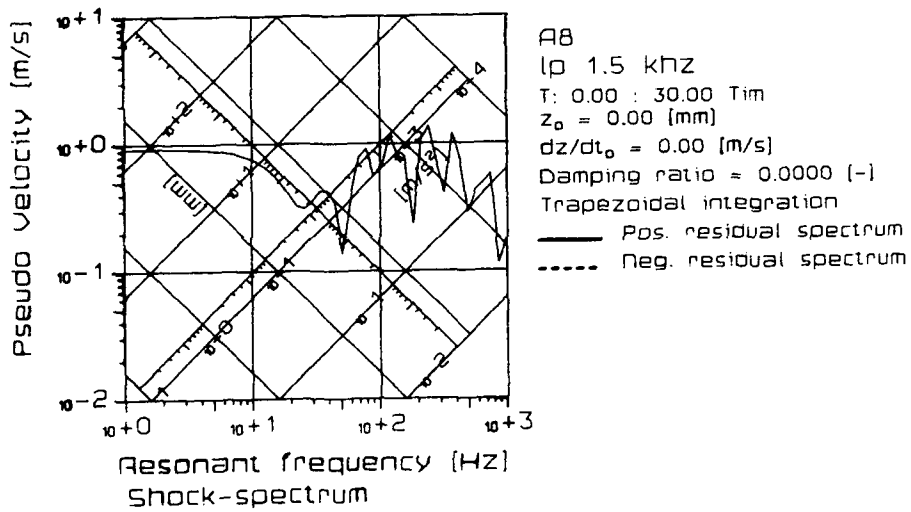
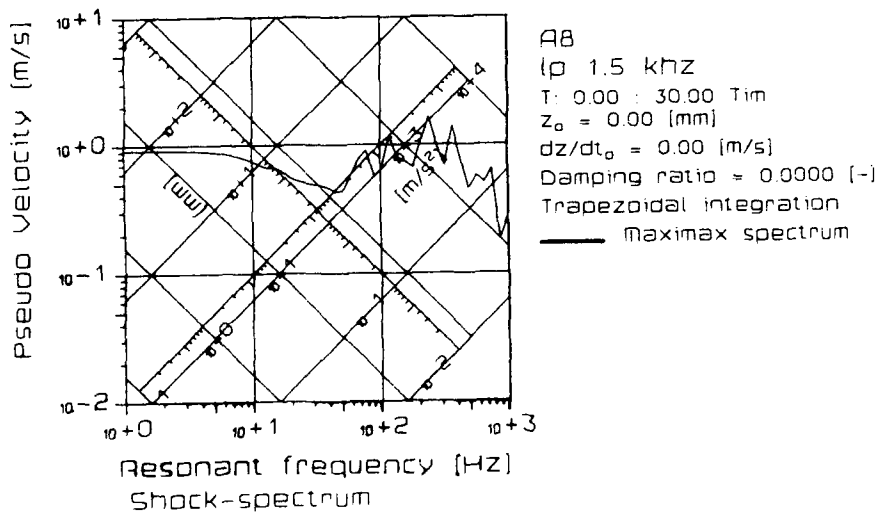
Figure 42 Shock spectra of accelerometer A8

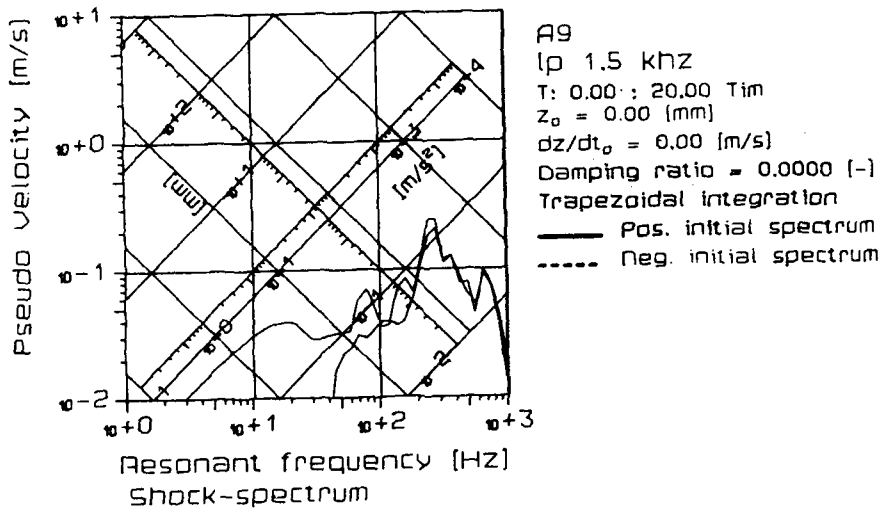
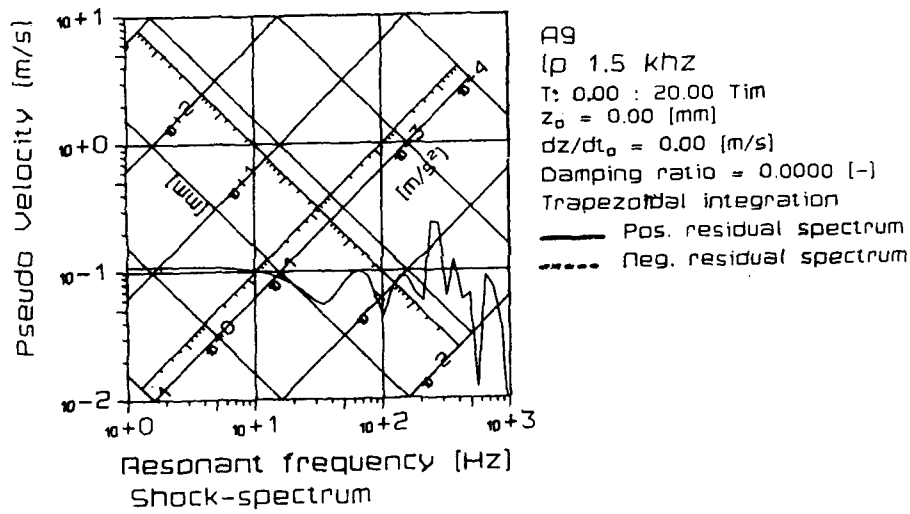
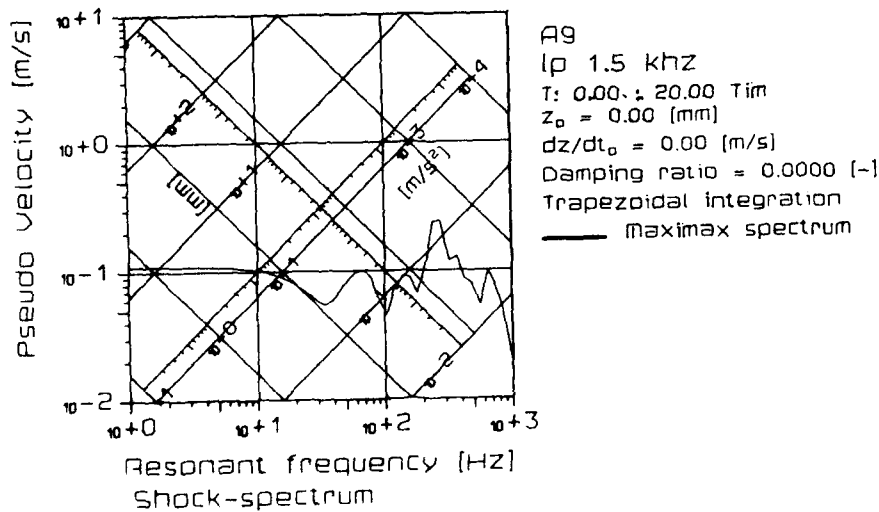
Figure 43 Shock spectra of accelerometer A9

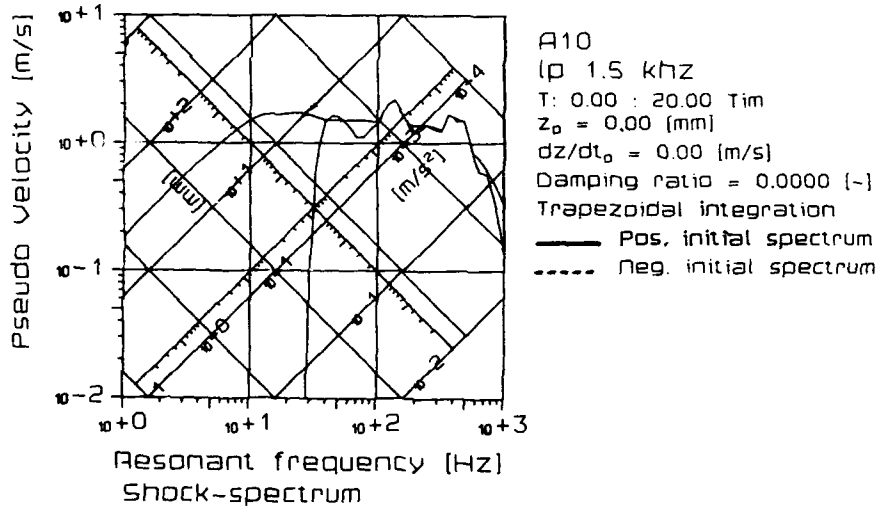
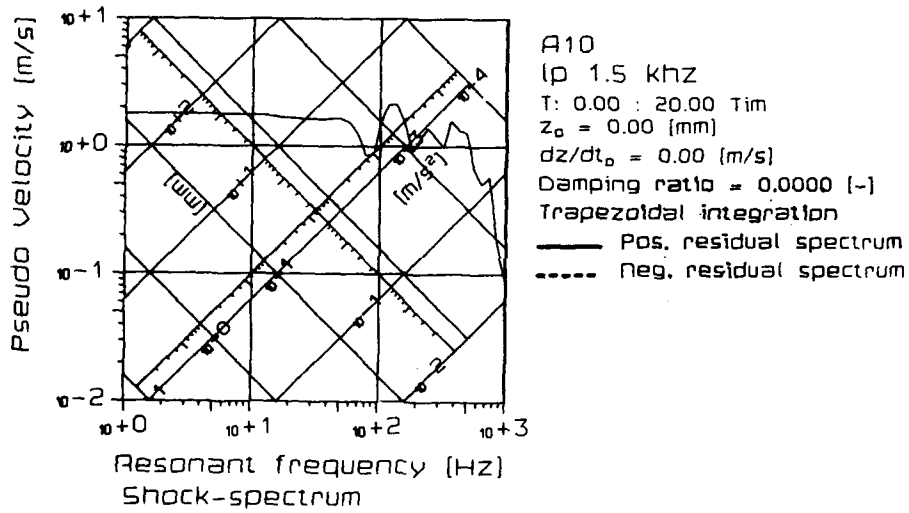
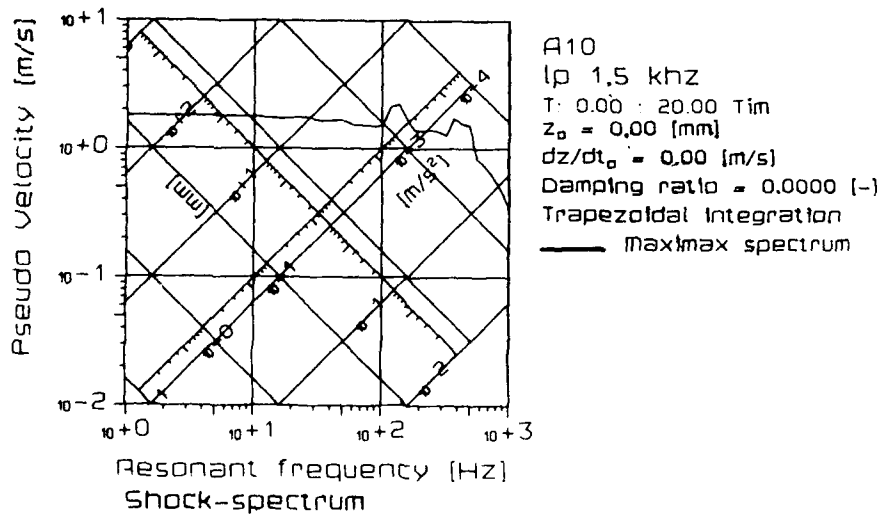
Figure 44 Shock spectra of accelerometer A10

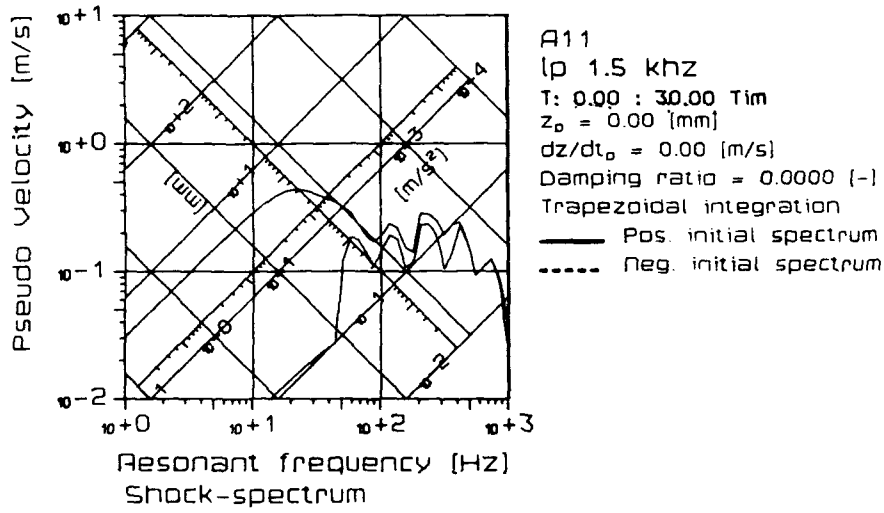
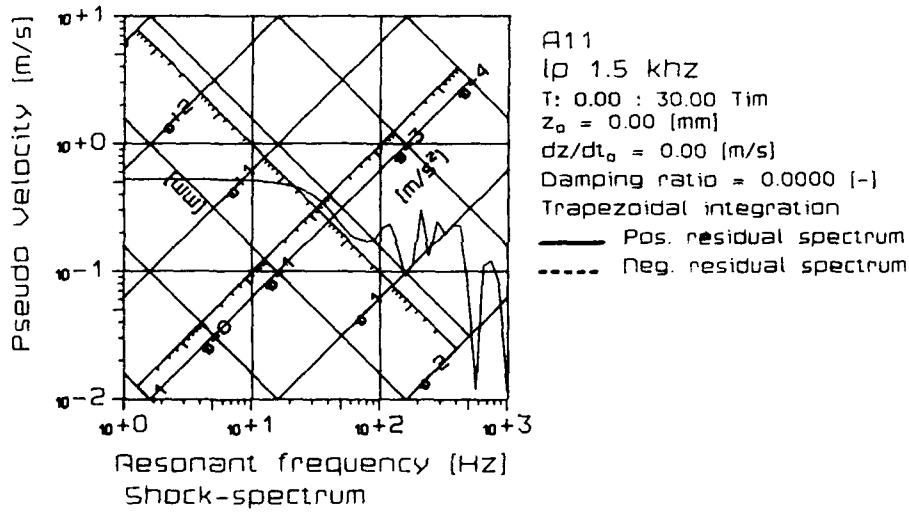
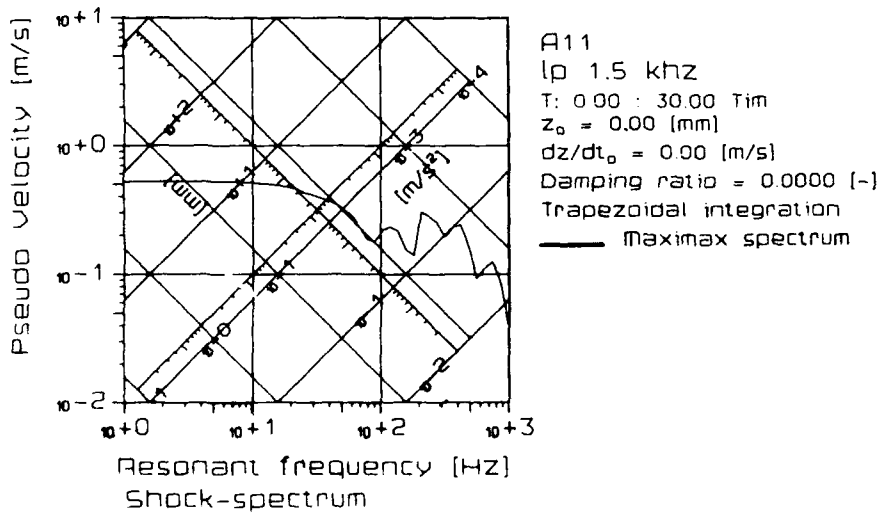
Figure 45 Shock spectra of accelerometer A11

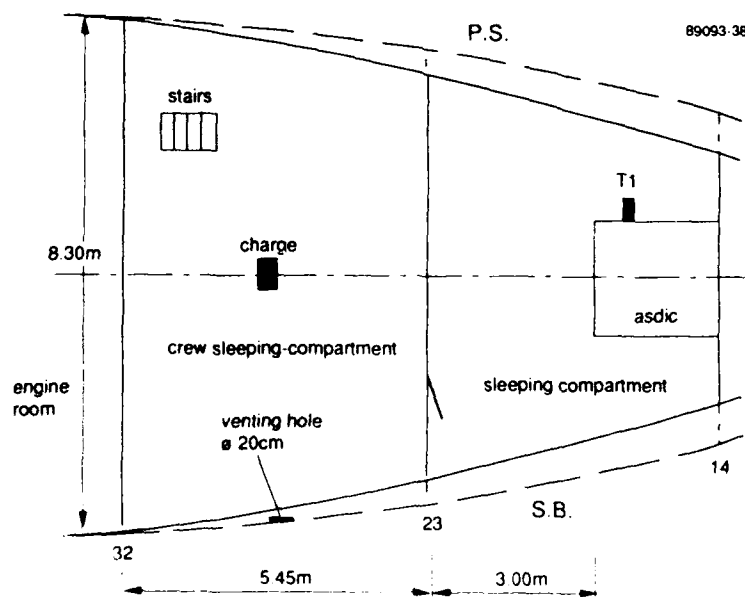
Device	Height	Position
T1	113 cm	115 cm from BHD 14 on ASDIC room in the vicinity of Q5

Figure 47 Schematic illustration of the position of the temperature transducer

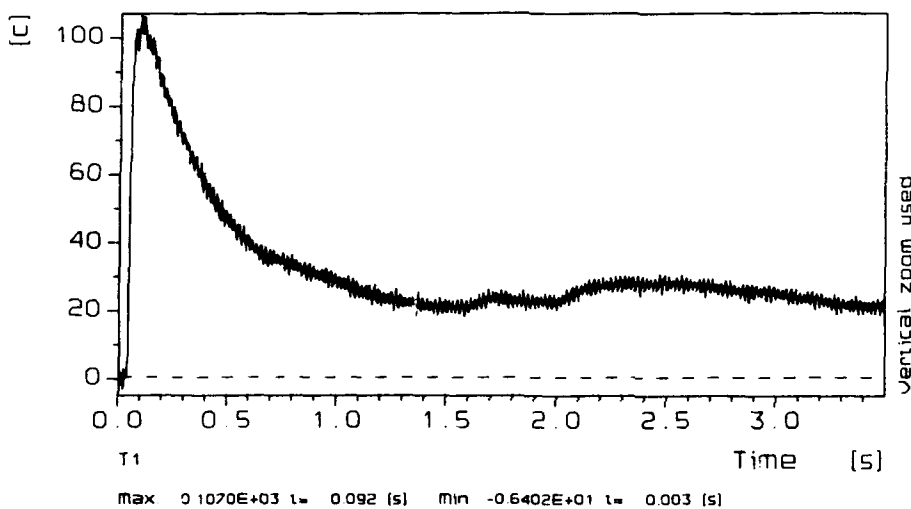
In Figure 48, the registered temperature increase signal is shown. It appeared that the temperature measurement resulted in a reliable signal, although the transducer malfunctioned during the 3 kg TNT experiment earlier that day.

Figure 48 Temperature behaviour, relative to the ambient temperature

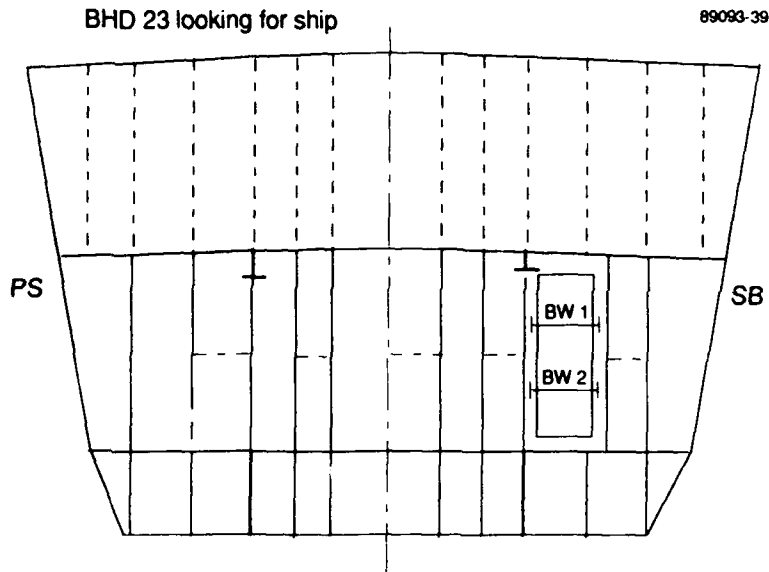
In order to determine the possible moment of collapse of the watertight door in BHD 23, two breakwires were used. They were mounted behind the watertight door, one third and two-thirds of the way up the door. These wires were outside the experiment compartment.

Figure 49 Schematic illustration of the breakwire positions in BHD 23

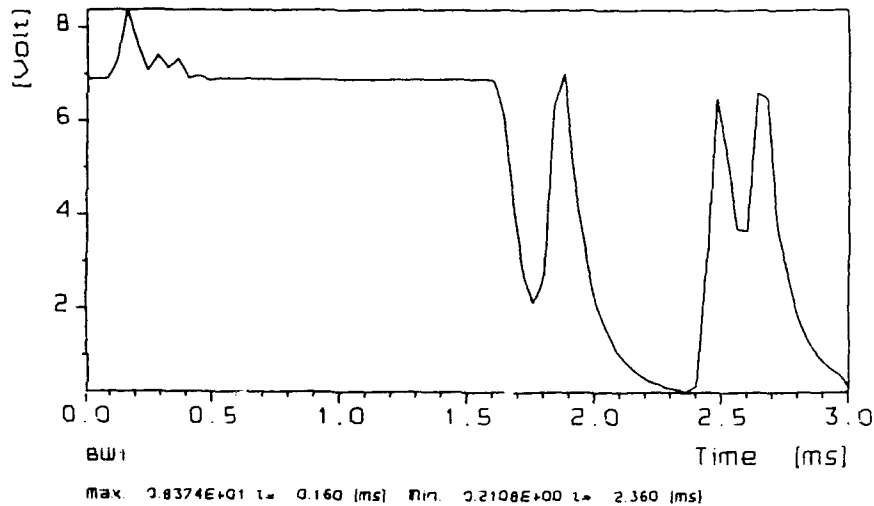
In Figure 50, the registered signal BW1 is shown. It must be noted that the door collapsed during this experiment. Unfortunately the BW2 signal malfunctioned during the experiment.

Figure 50 The registered breakwire signal

The breakwire measurement method used, breakwires in combination with microswitches, is too sensitive to shock.

Regarding the fall in the quasi-static pressure signals Q1 and Q2 at about 10-15 ms, and the start of the quasi-static pressure signals in the adjacent compartments after 10-15 ms, the collapse of the door and BHD 23 must have also taken place during this time period.
