MISCELLANEOUS PAPER GL-92-34

GEOPHYSICAL INVESTIGATION AT DUGWAY PROVING GROUND, UTAH

Geotechnical Laboratory

Final Report

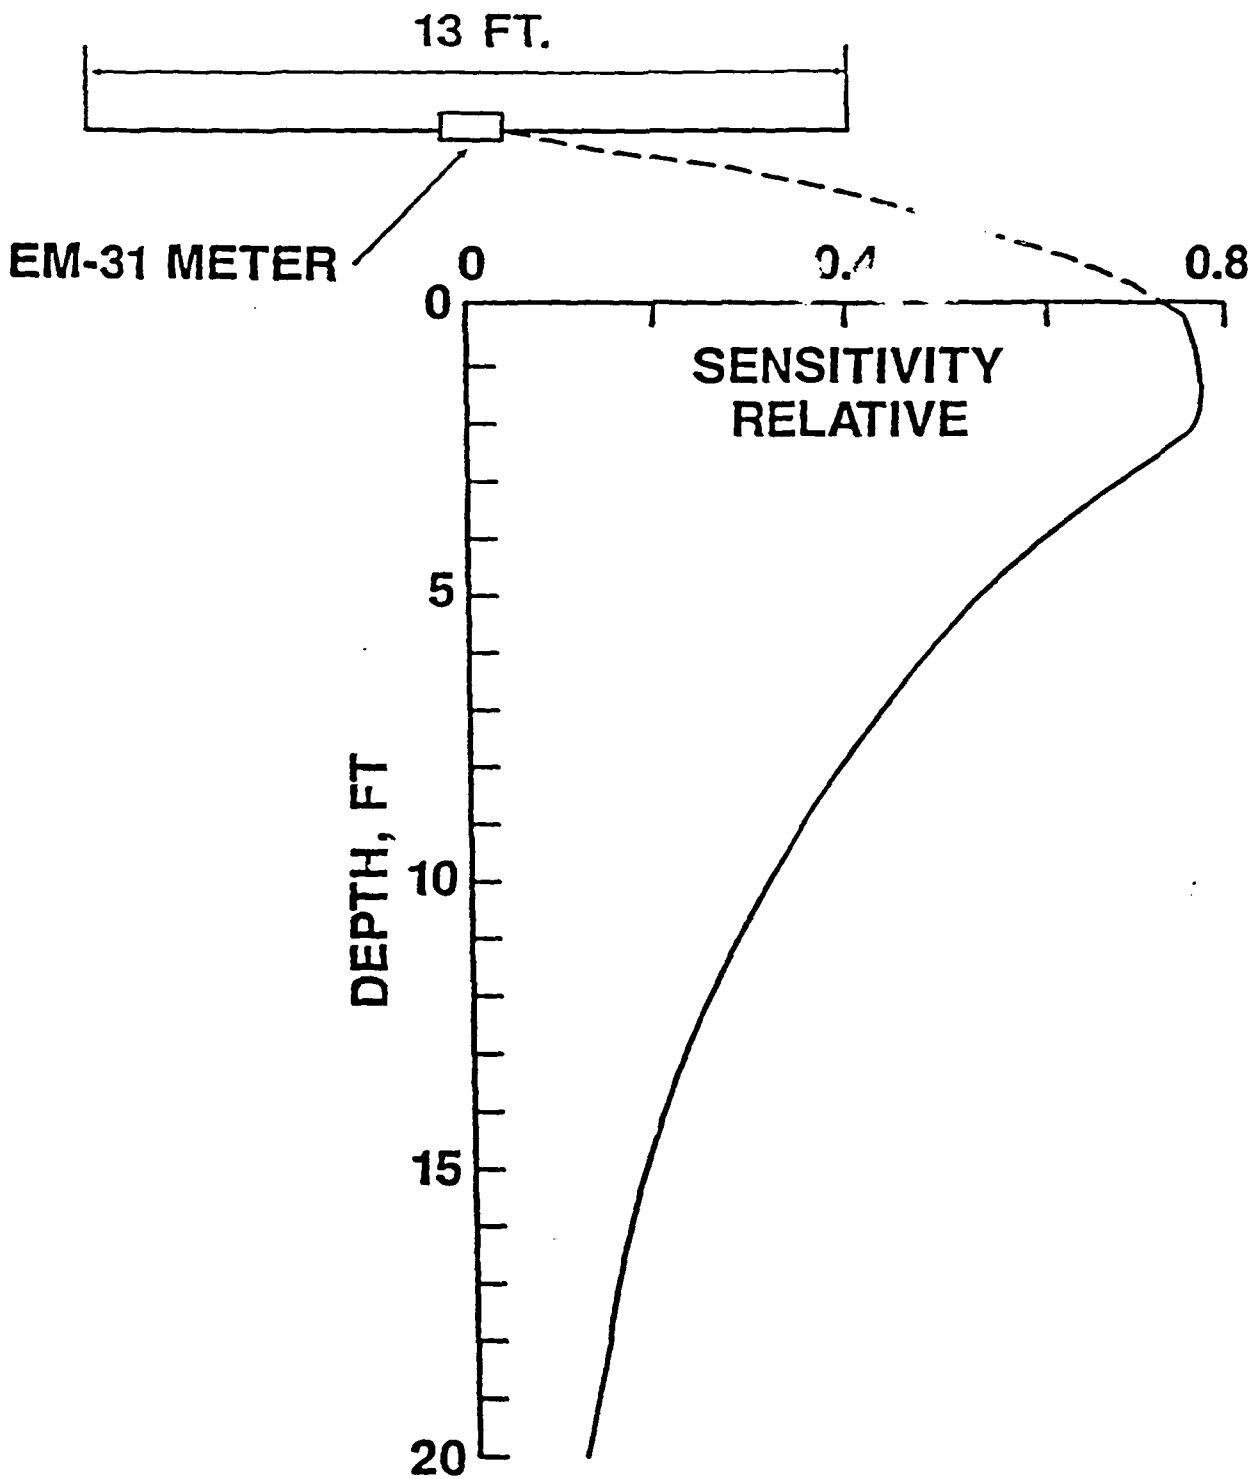
Figure 3. Sensitivity versus depth for the EM-31 terrain conductivity meter

to distinguish. The EM-31, when carried at a usual height of approximately 3 ft, is most sensitive to features at a depth of about 1 ft. Half of the instrument's readings result from features shallower than about 9 ft, and the remaining half from below that depth (Bevan 1983). Figure 3 more clearly illustrates the effect of depth on instrument sensitivity with the dashed lines depicting the sensitivity of the instrument to objects between it and the ground surface. The instrument can be operated in both a horizontal and vertical dipole orientation (Figure 4) with correspondingly different effective depths of exploration. The instrument is normally operated with the dipoles vertically oriented (coils oriented horizontally and co-planar) which gives the maximum depth of penetration. The instrument can be operated in a continuous or a discrete mode.

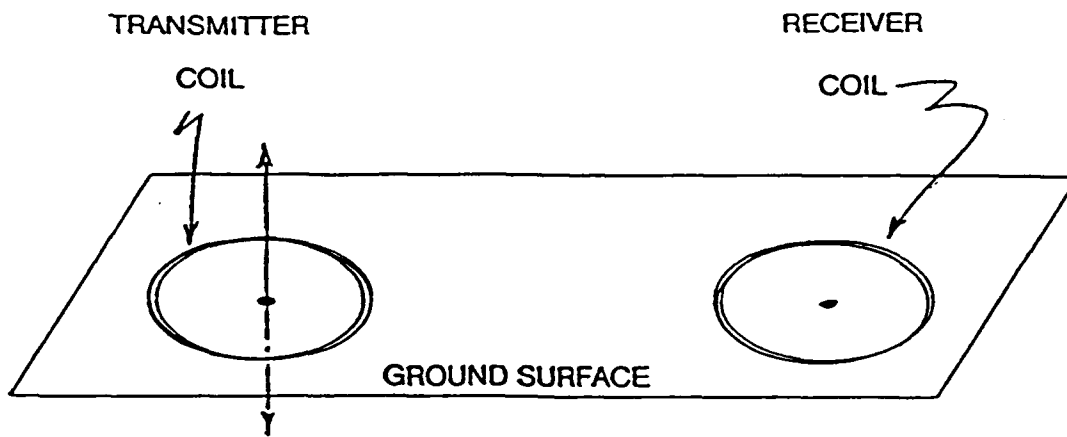
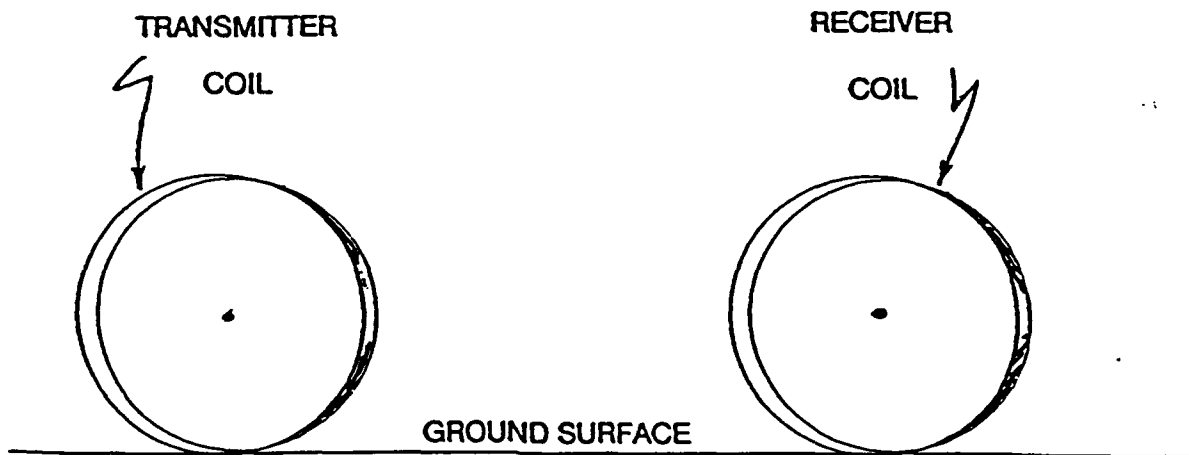
VERTICAL DIPOLE - HORIZONTAL COILS

HORIZONTAL DIPOLE - VERTICAL COILS

Figure 4. Schematic illustration of the EM-31 transmitter and receiver coil orientations

6. The EM equipment used in this survey consists of a transmitter and receiver coil set a fixed distance apart. The transmitter coil is energized with an alternating current at an audio frequency (kHz range) to produce a time-varying magnetic field which in turn induces small eddy currents in the ground. These currents then generate secondary magnetic fields which are sensed together with the primary field by the receiver coil. The units of conductivity are millimhos per meter (mmho/m) or, in the SI system milliSiemens per meter (mS/m). The EM data are then presented in profile plots or as isoconductivity contours if data are obtained in a grid form. A more thorough discussion on EM theory and field procedures is given by Butler (1986), Telford et al. (1973) and Nabighian (1988).

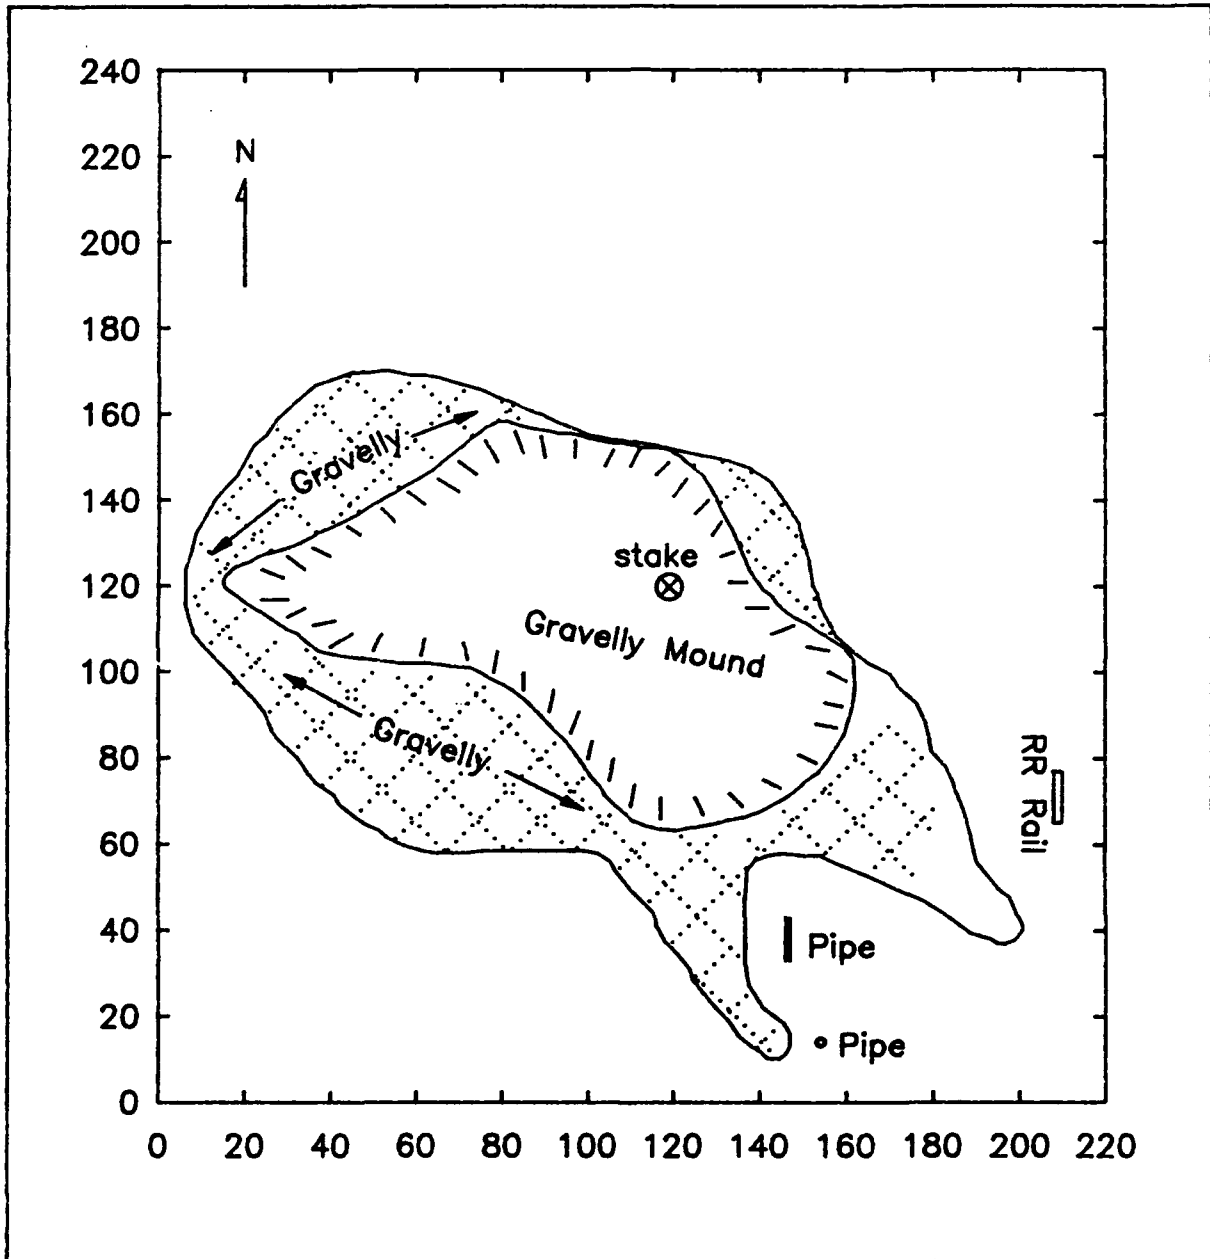
Figure 9. Area of investigation, Site 186

18. Site 186 was located to the west of Falconer Road (Figure 8). The center portion of this site was characterized by a mound consisting of gravel-to boulder-sized material (Figure 9). Oluic and Campbell (1992) report that this site contains a covered pit in which VX land mines were destroyed. A grid 240 ft by 220 ft was used to encompass the rocky mound. Figures 10 through 15 show the profile and contour maps obtained from the EM-31 and magnetometer surveys. The prominent anomaly detected by the EM-31 and the magnetometer was located in the center of the grid and approximately centered on coordinate (110E,100N). The EM-31 conductivity detected other minor anomalies across the site (Figures 10 and 11). The EM-31 in-phase results showed an increasing trend in values from the southwest to the northeast (Figures 12 and 13). In addition to the large anomaly centered in the grid, the magnetometer detected two anomalous areas centered on coordinates

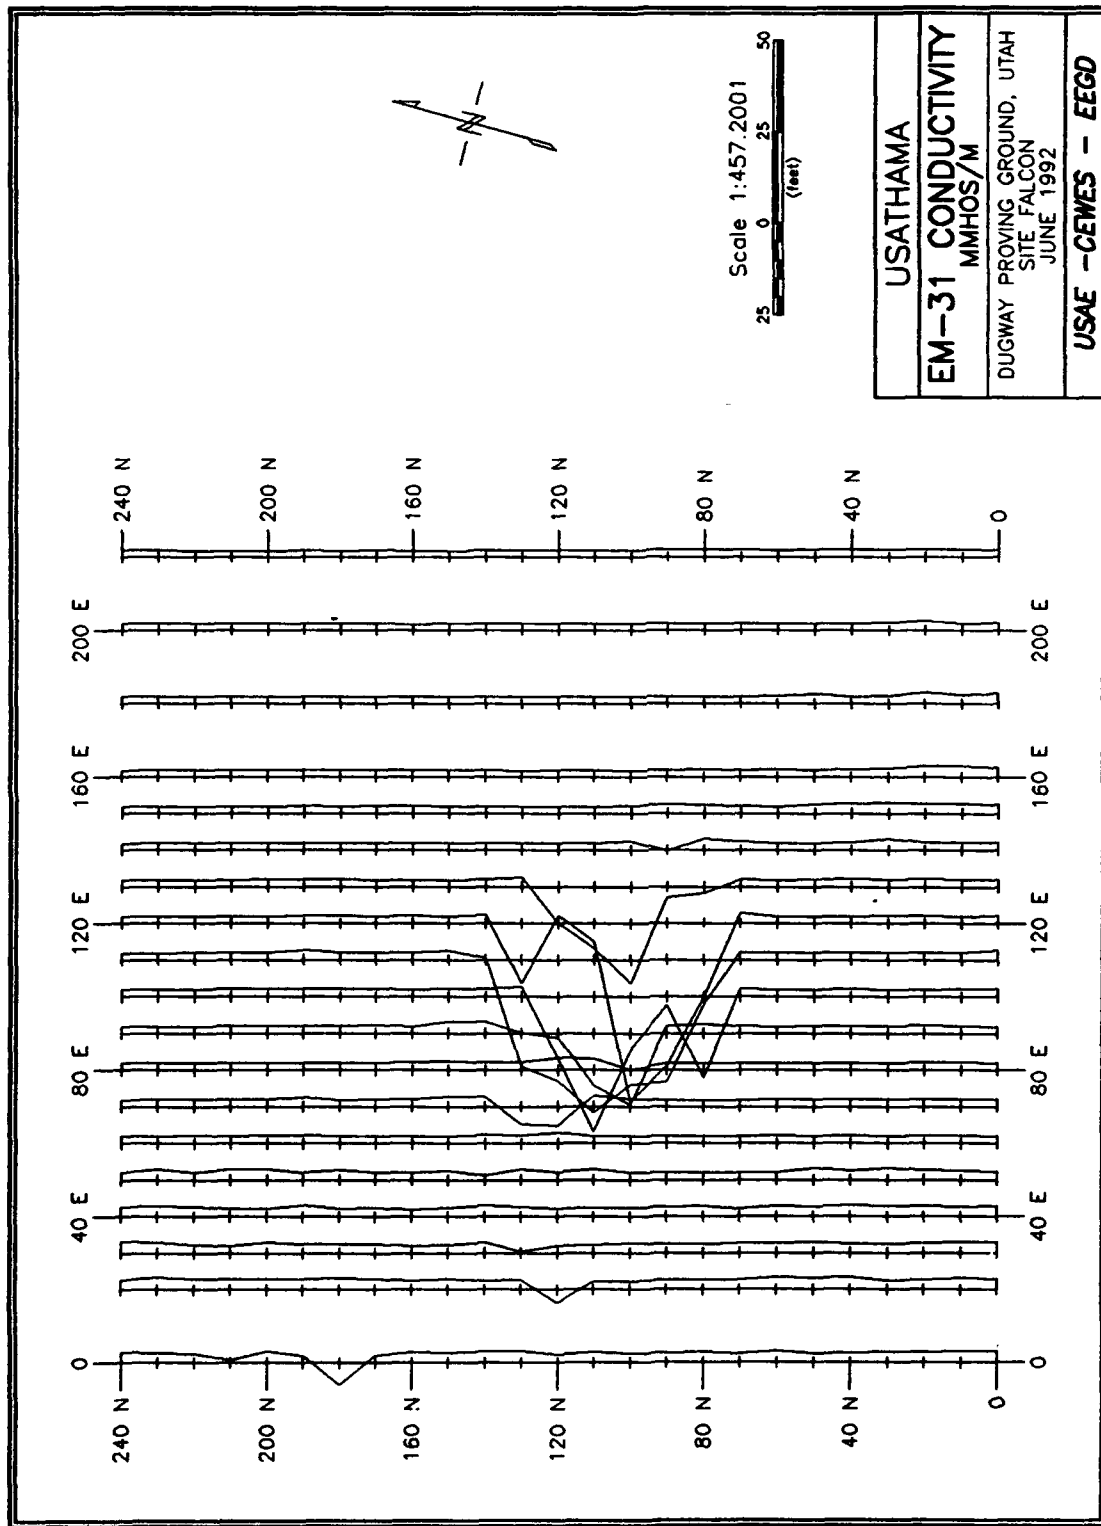
Figure 11. EM-31 conductivity results, profile lines, Site 186

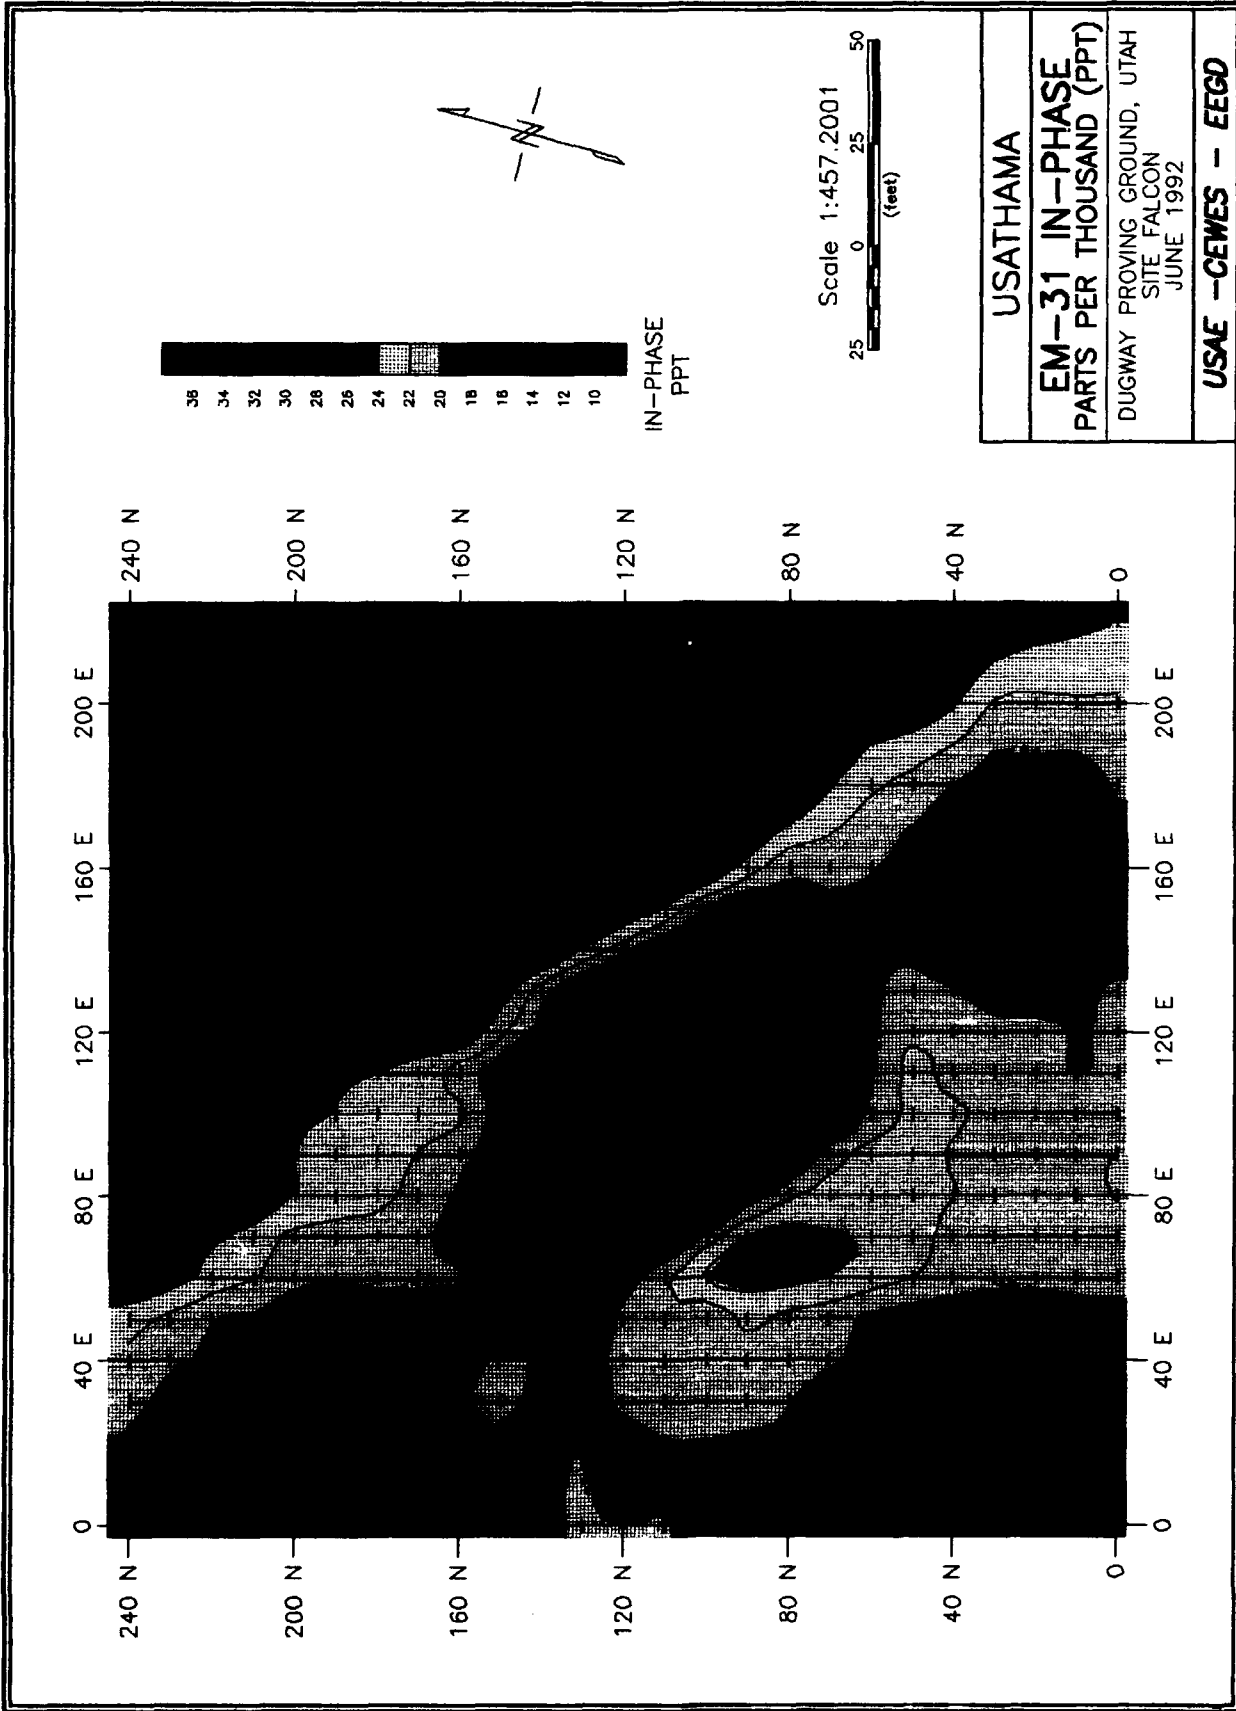
Figure 12. EM-31 in-phase results, contour plot, Site 186

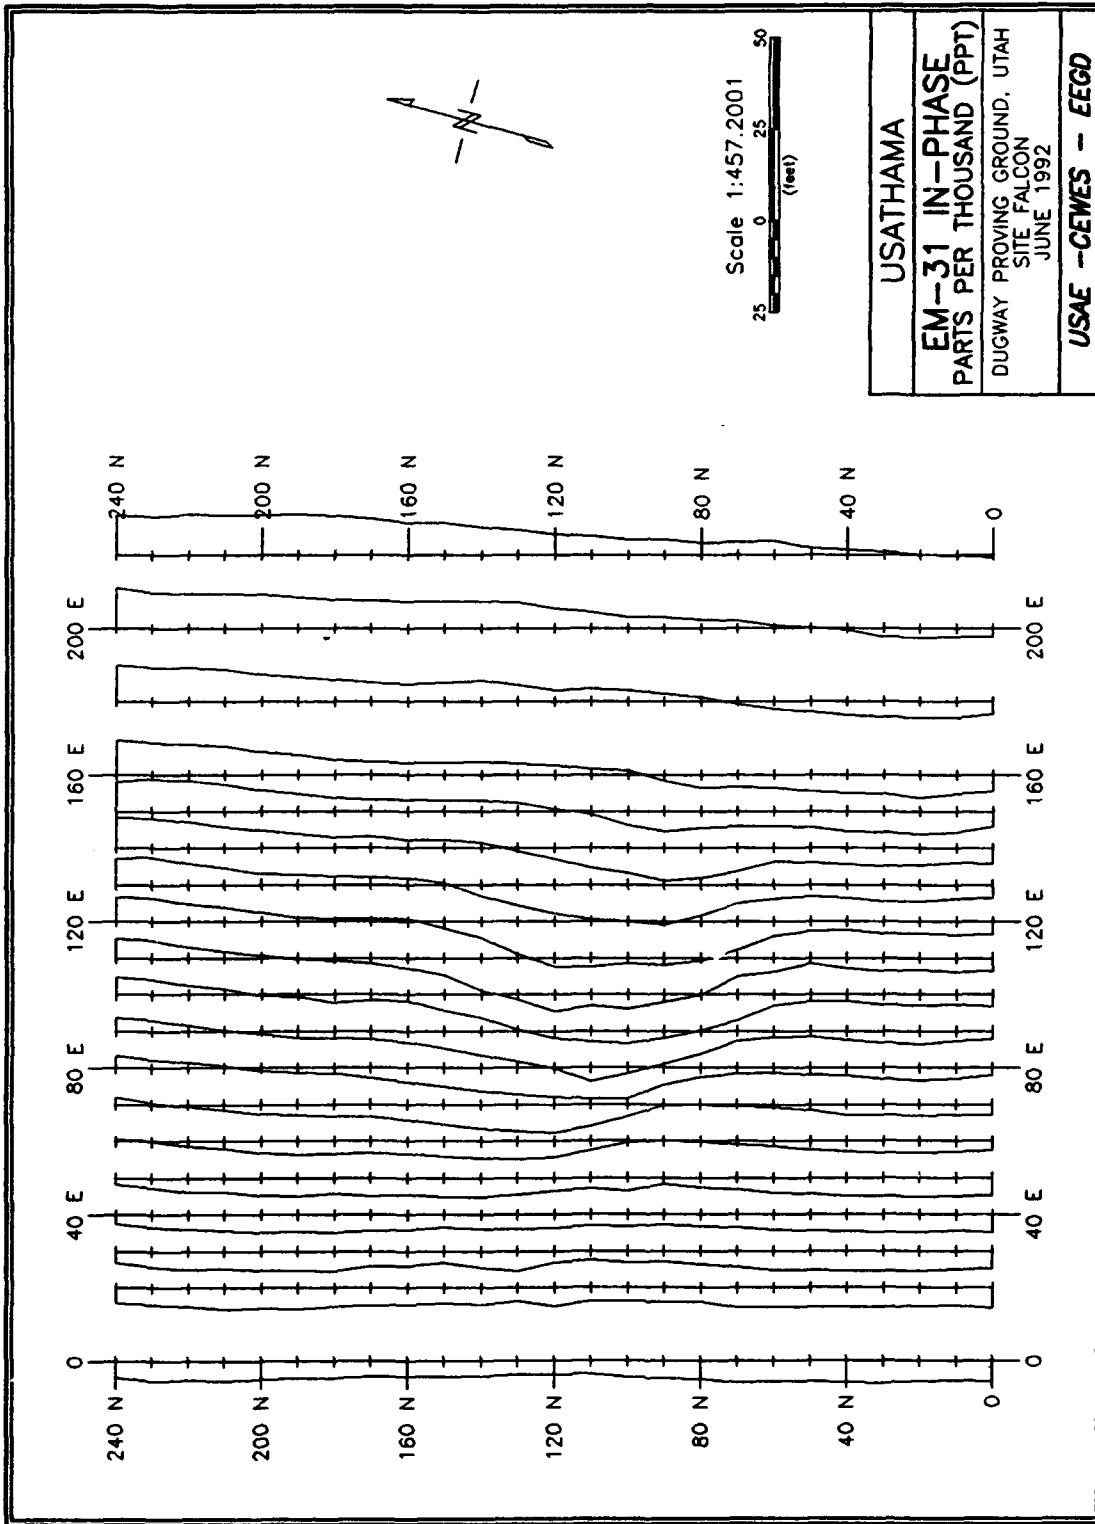
Figure 13. EM-31 in-phase results, profile lines, Site 186

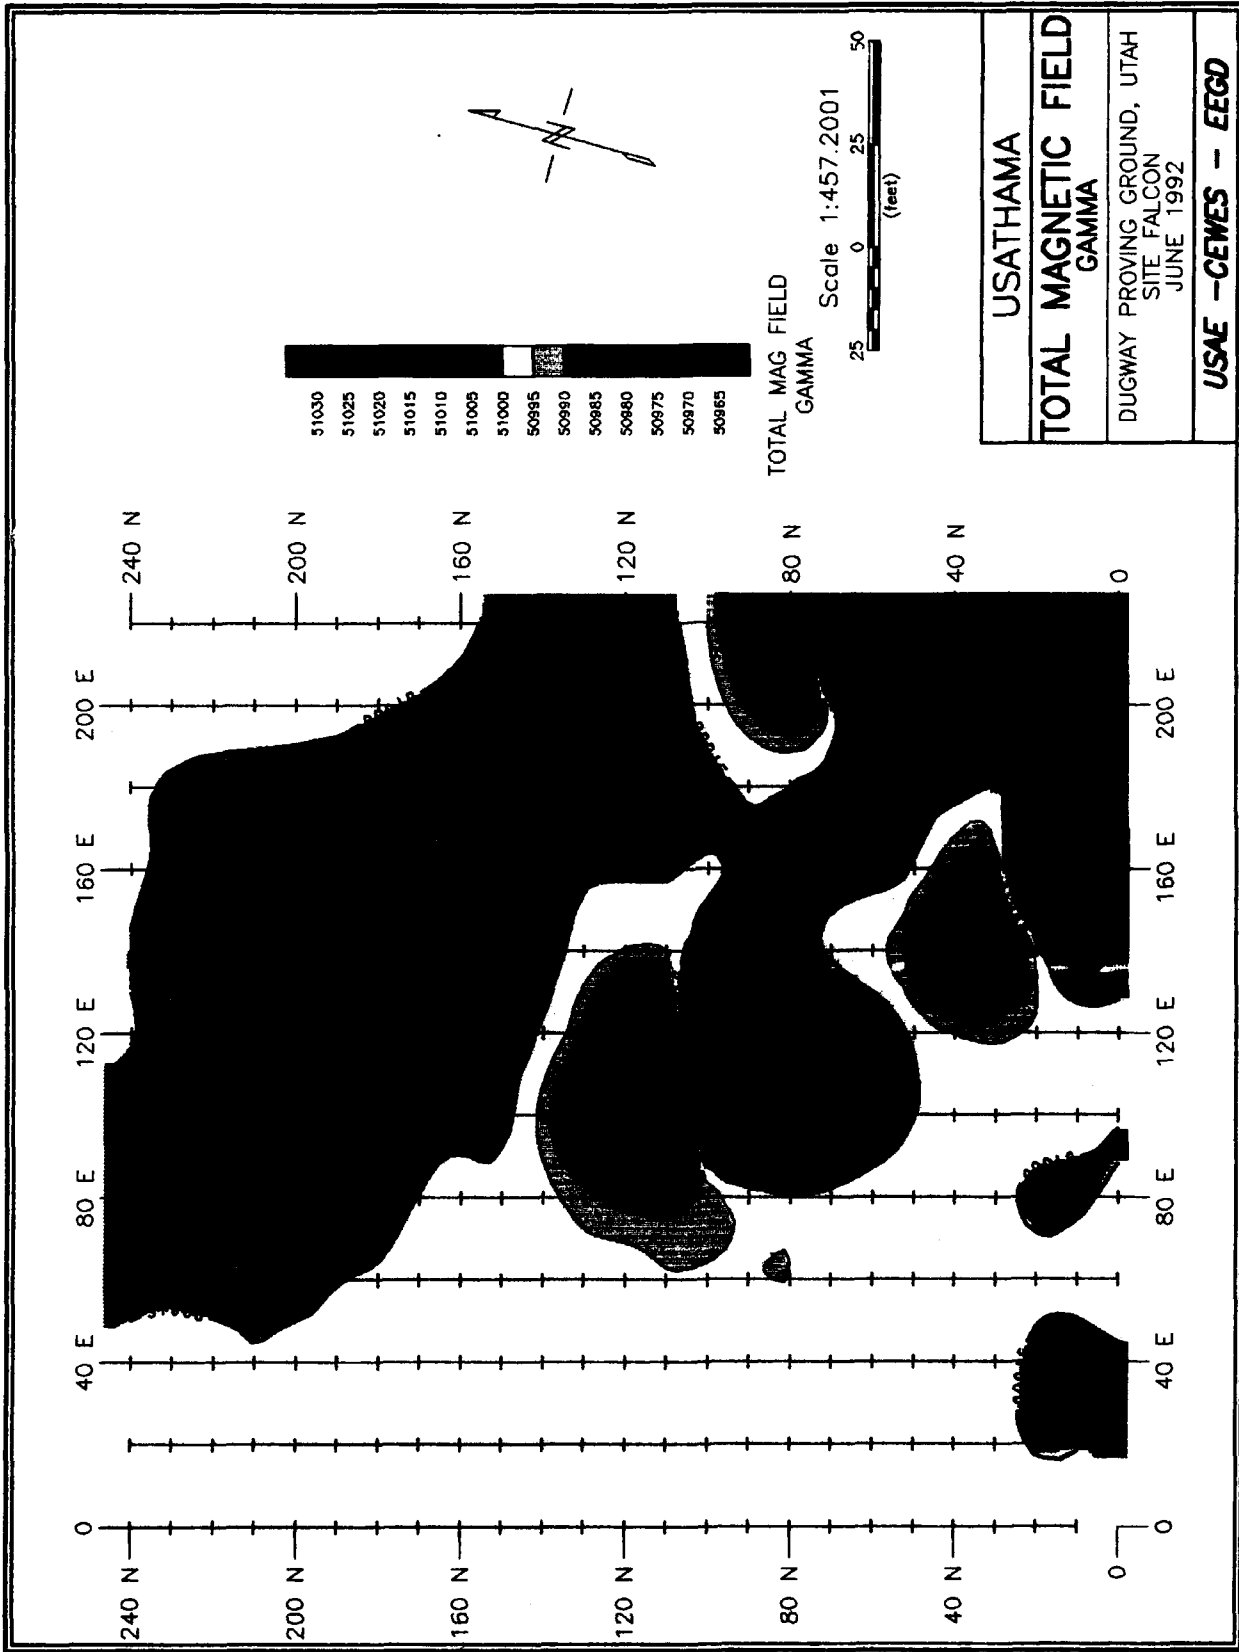
Figure 14. Total magnetic field results, contour plot, Site 186

(150E,20N) and (220E,70N) as shown in Figures 14 and 15. The anomaly centered at (150E,20N) correlates with the location of metal pipes laying on the surface whereas, the interpreted anomaly at (220E,70N) is due to a section of railroad rail also laying on the ground surface.

Anomaly Location	EM-31		Mag	Anomaly Description and Interpretation
	Q	I		
(110E,100N)	X	X	X	Relatively low EM-31 cond. and in-phase readings. High-low magnetic anomaly. Anomaly probably due to buried ferrous object.
(150E,20N)			X	The location of this anomaly correlates well with the location of pipes laying on the ground surface.
(220E,70N)			X	The location of this anomaly correlates well with the location of a section of railroad rail laying on the ground surface.

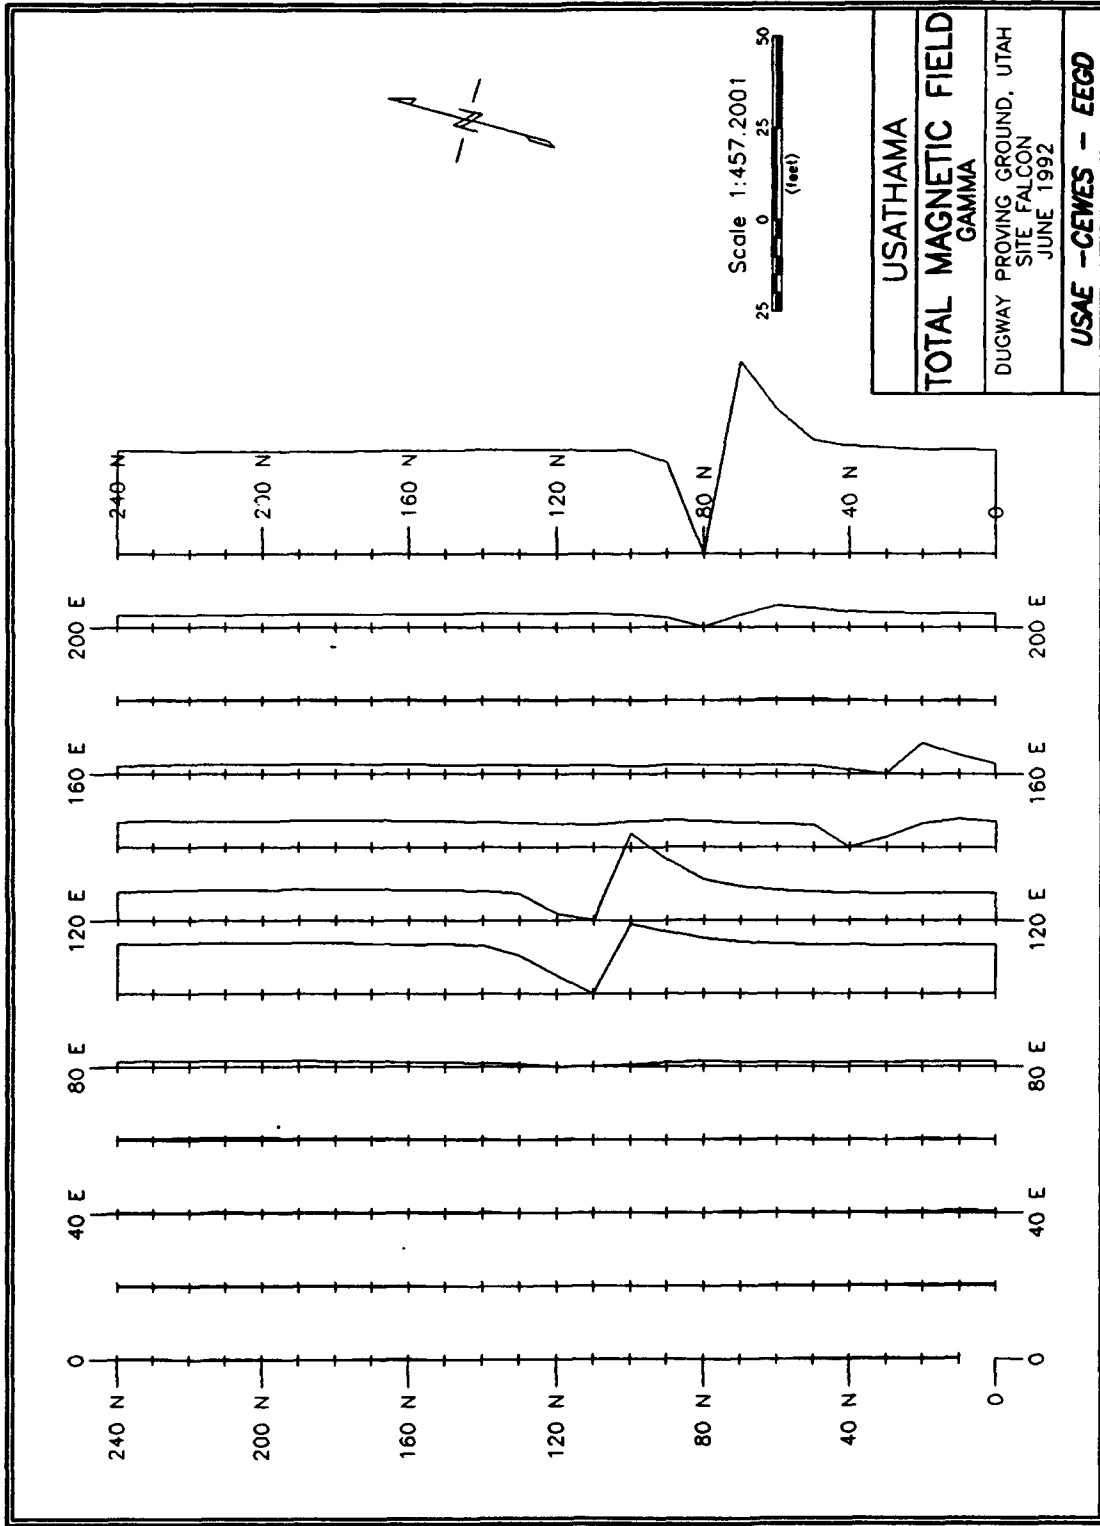
Figure 15. Total magnetic field results, profile plot, Site 186

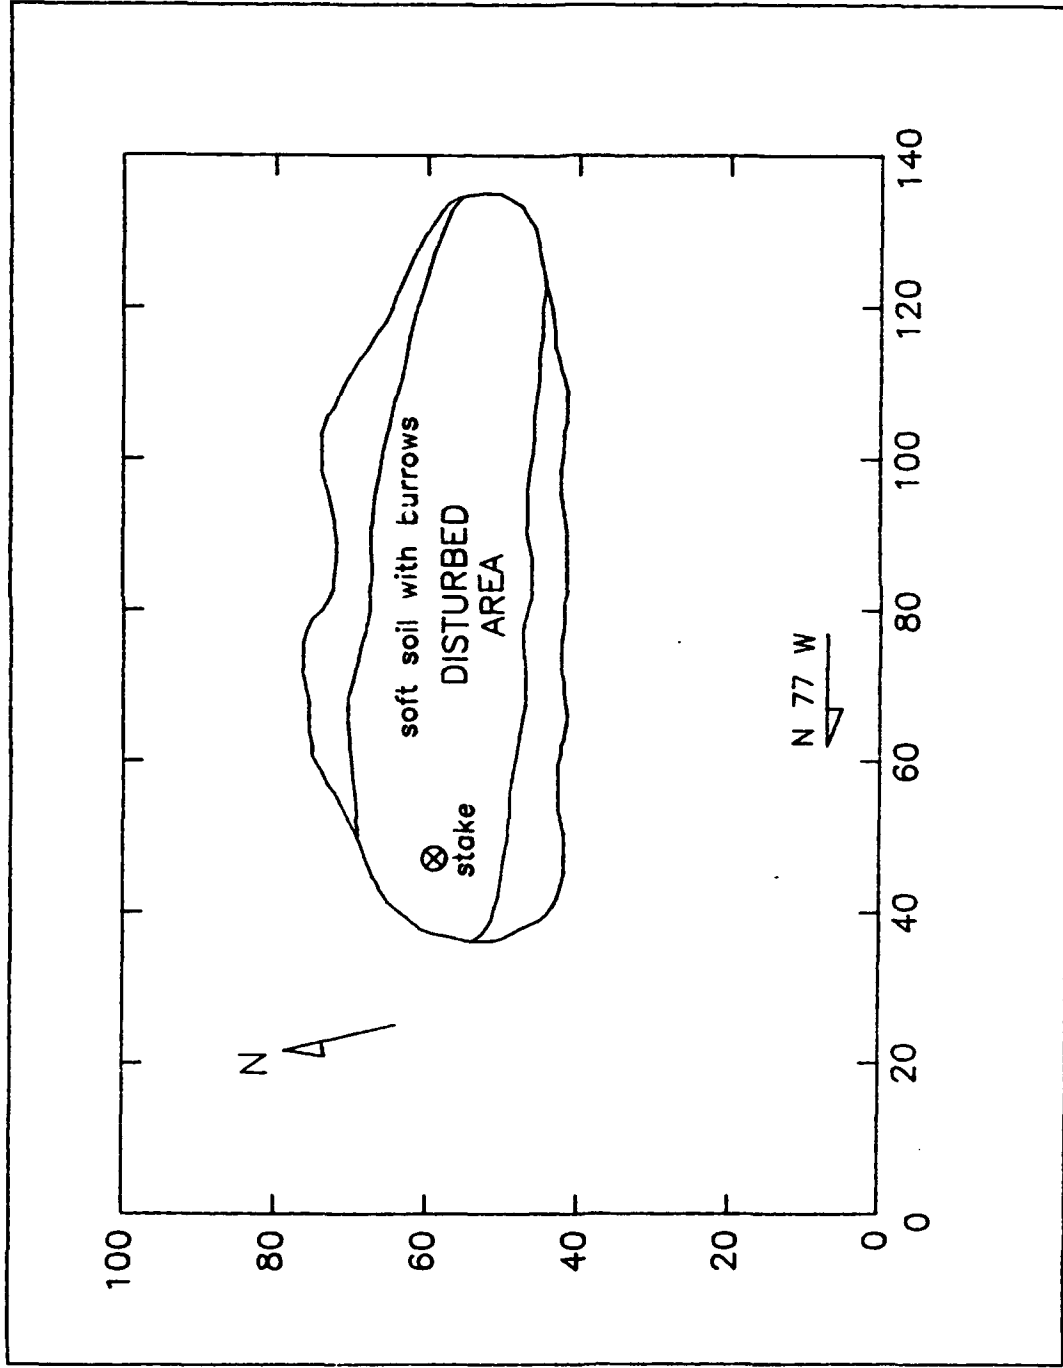
Figure 16. Area of investigation, Site 188

19. Site 188, located on the northwest side of Granite Peak, consisted of possibly several covered pits in which solid waste, mainly grease and wood, was disposed (Oluic and Campbell 1992) (Figure 6). The site was swept with the EM-31, EM-38 and magnetometer. An area with dimensions 100 ft by 140 ft was gridded and examined more closely with the EM-31 and magnetometer (Figure 16). The gridded site was selected because there was the appearance of disturbed soil and animal burrows. The EM-31 conductivity, EM-31 in-phase, and magnetometer results for Site 188 are presented in Figures 17 through 22. The EM-31 conductivity data indicated relatively low readings in an area centered on approximate coordinate (120E,60N) and higher readings on the western edge of the site (Figures 17 and 18). The area with the lower readings corresponds well with the location of the disturbed area shown in Figure 16. The EM-31 in-phase data indicates a general trend increasing from the southeast towards the northwest (Figures 19 and 20). The results of the total field magnetics indicated a magnetically "quiet" site with no interpreted anomalies (Figures 21 and 22). The range of the magnetic readings was only about 8 nt.

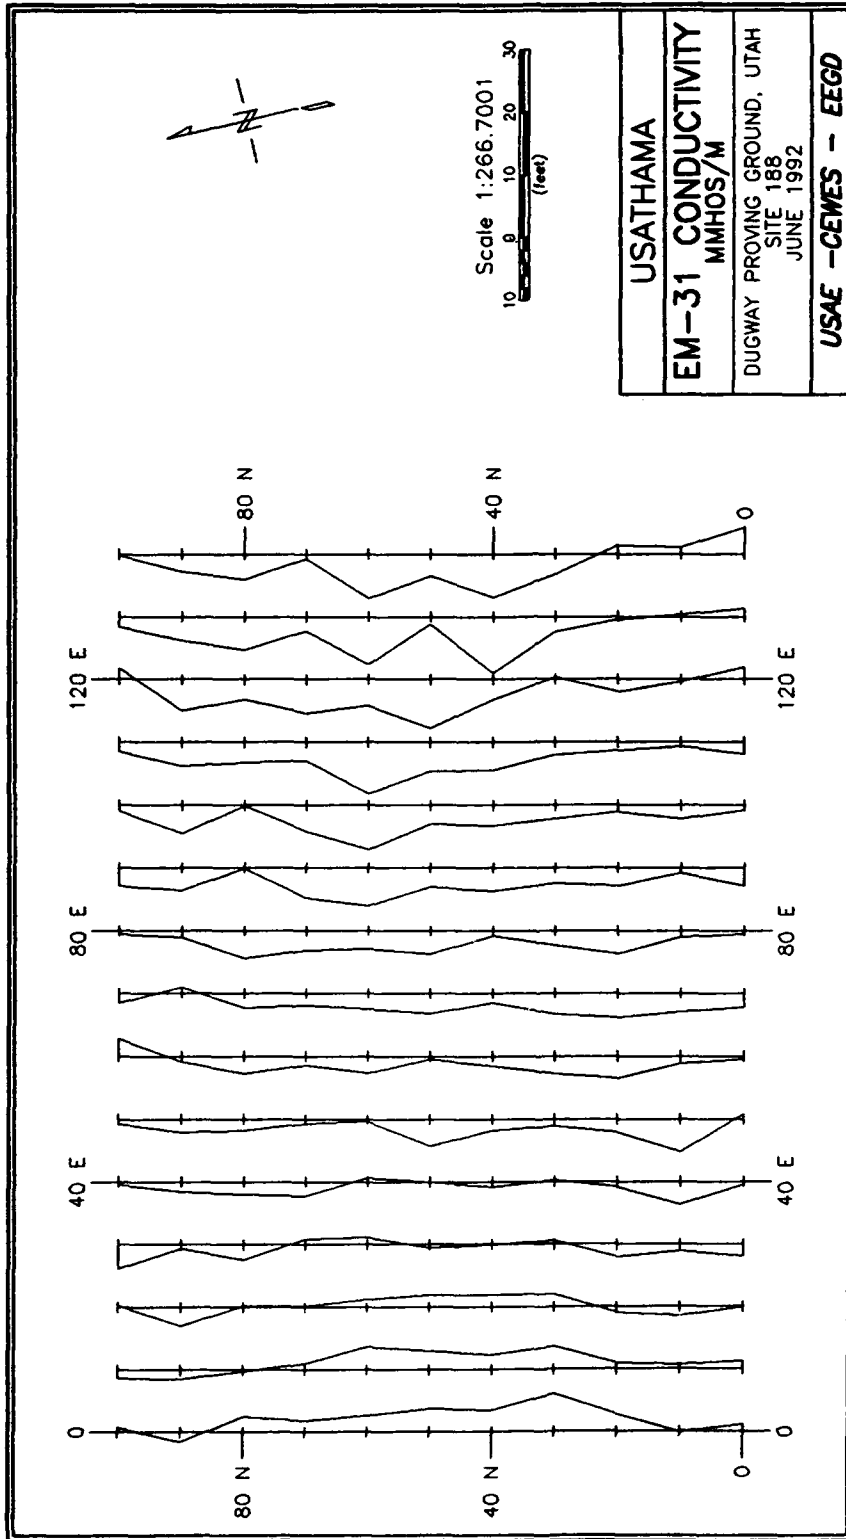
Figure 18. EM-31 conductivity results, profile lines, Site 188

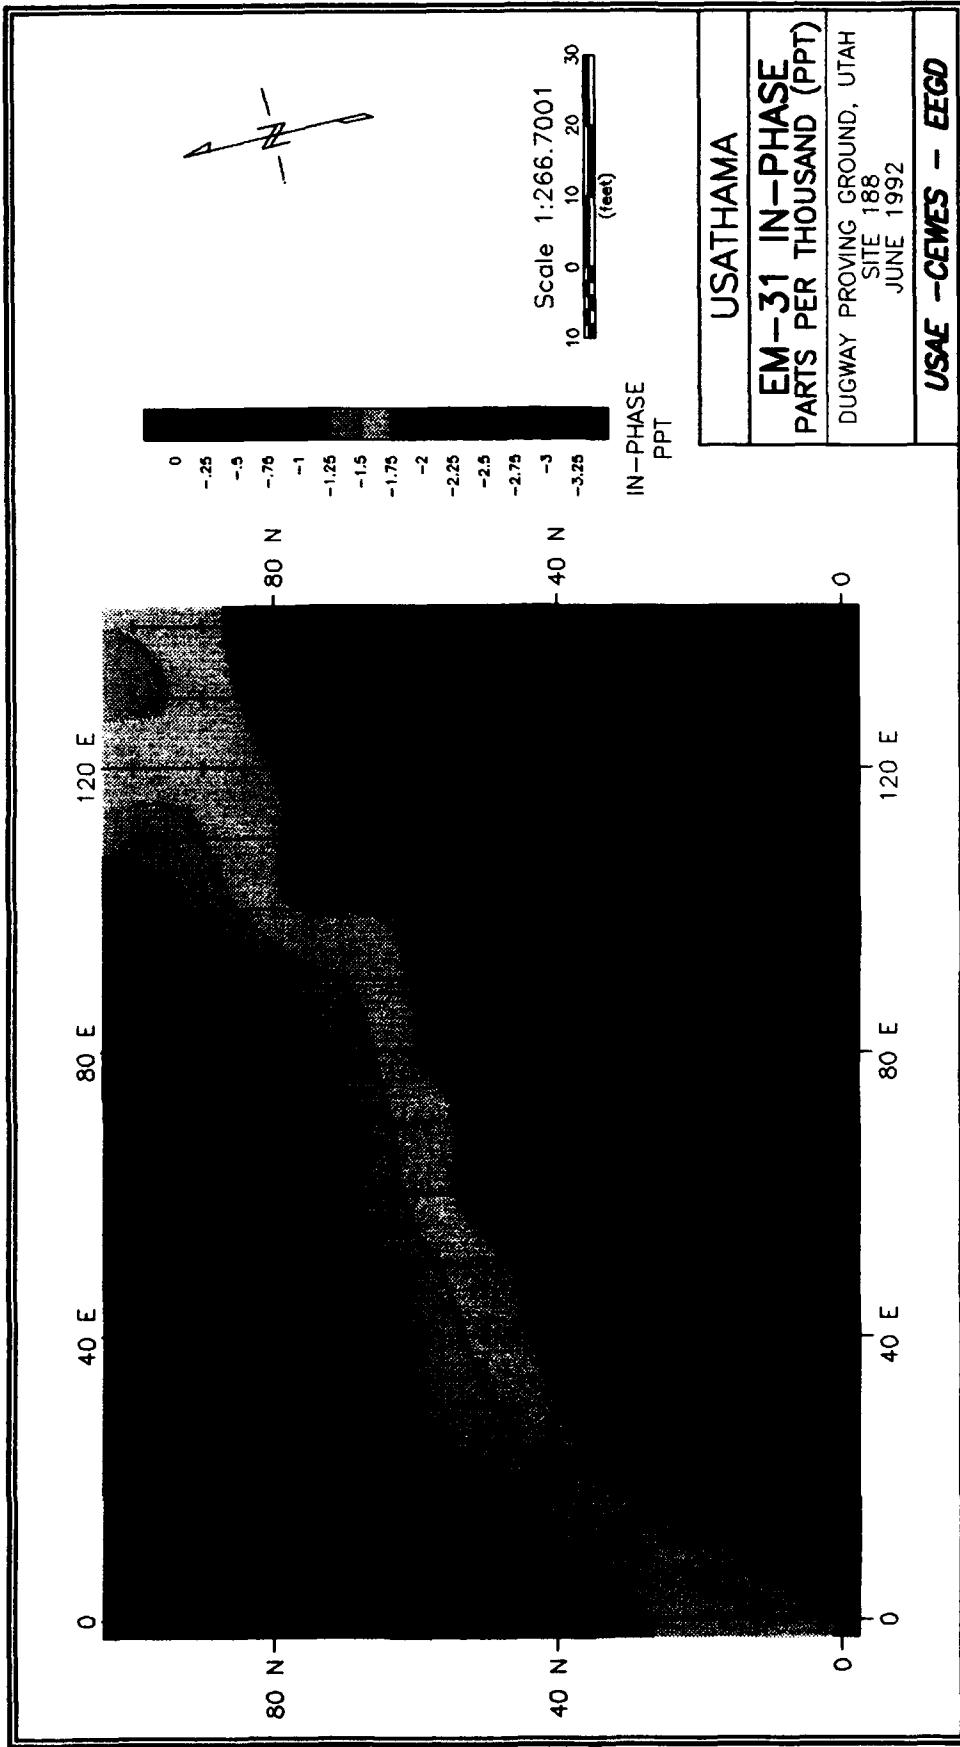
Figure 19. EM-31 in-phase results, contour plot, Site 188

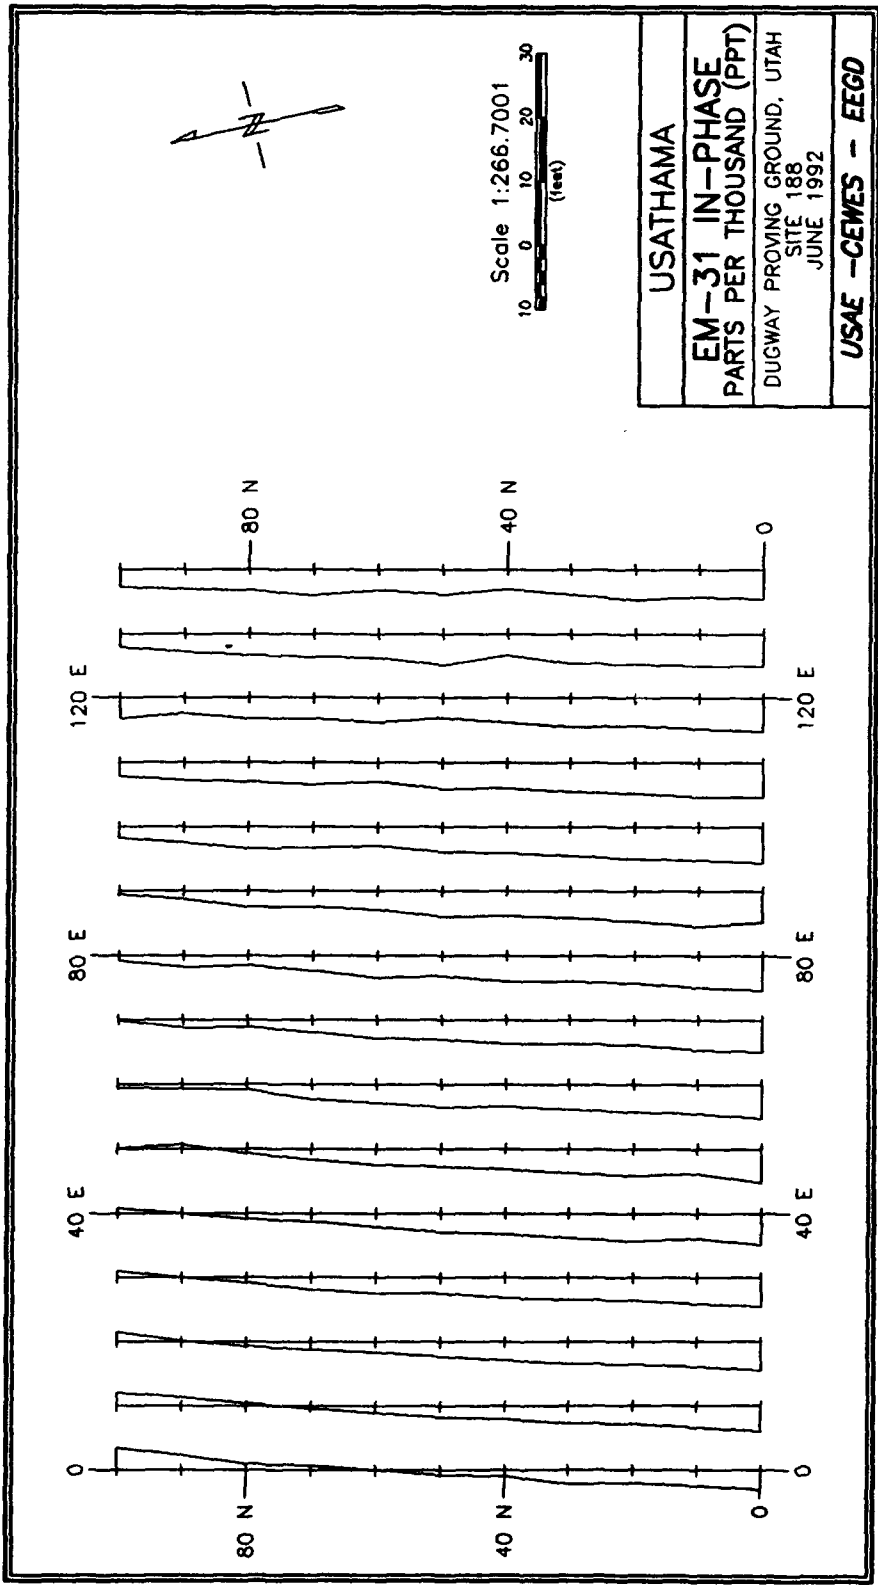
Figure 20. EM-31 in-phase results, profile lines, Site 188

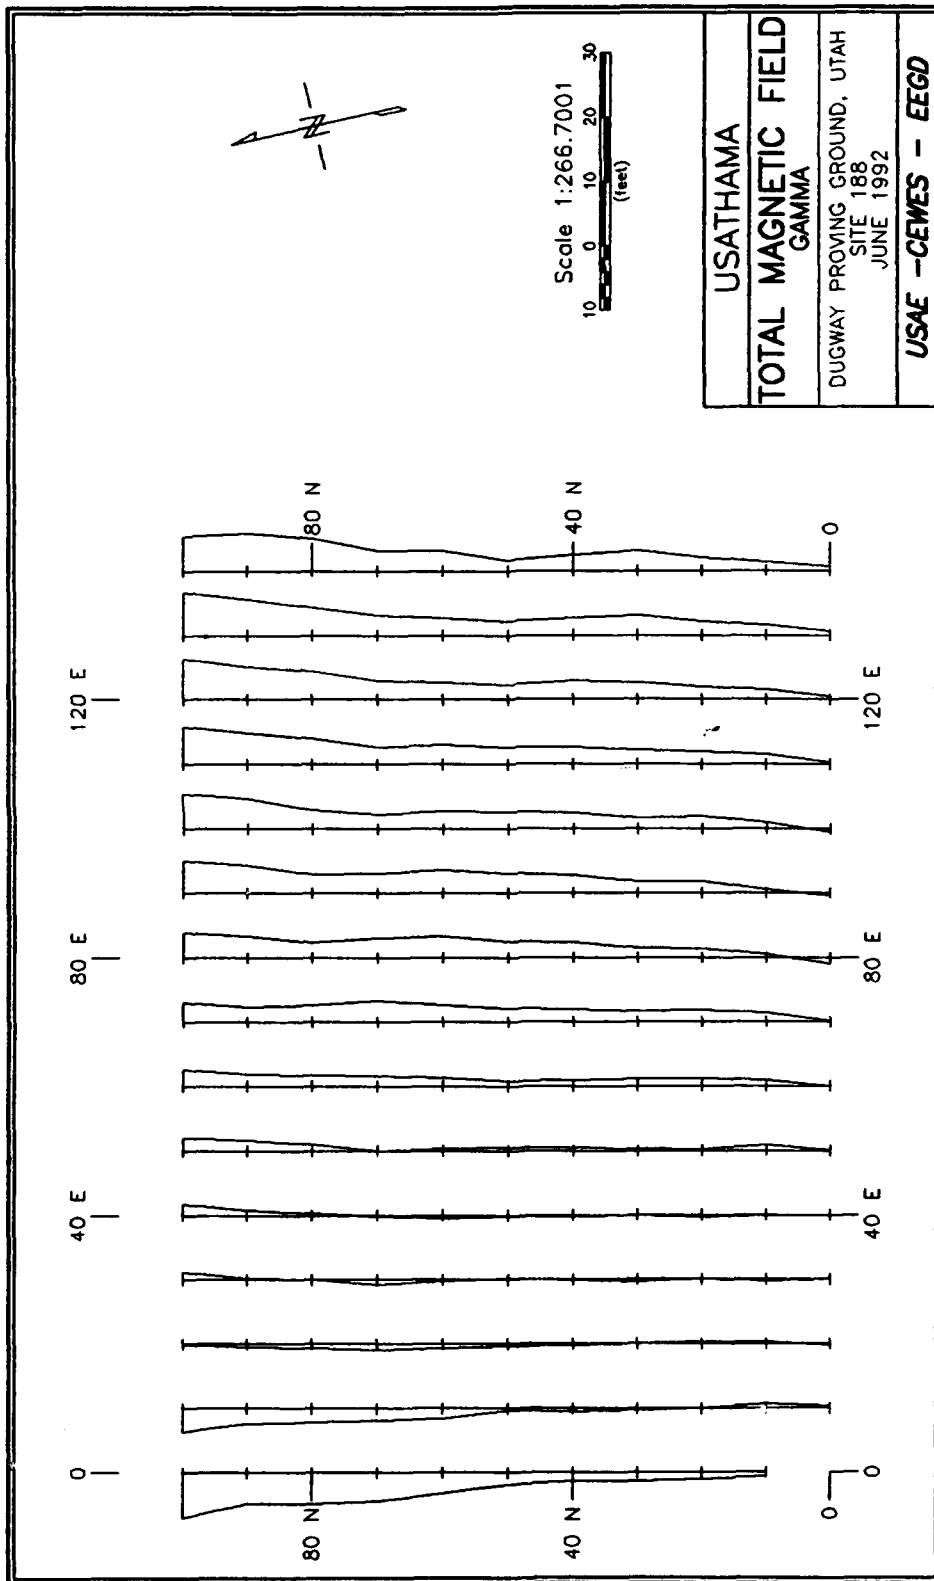
Figure 22. Total magnetic field results, profile plot, Site 188
