MISCELLANEOUS PAPER GL-92-34

GEOPHYSICAL INVESTIGATION AT DUGWAY PROVING GROUND, UTAH

Geotechnical Laboratory

Final Report

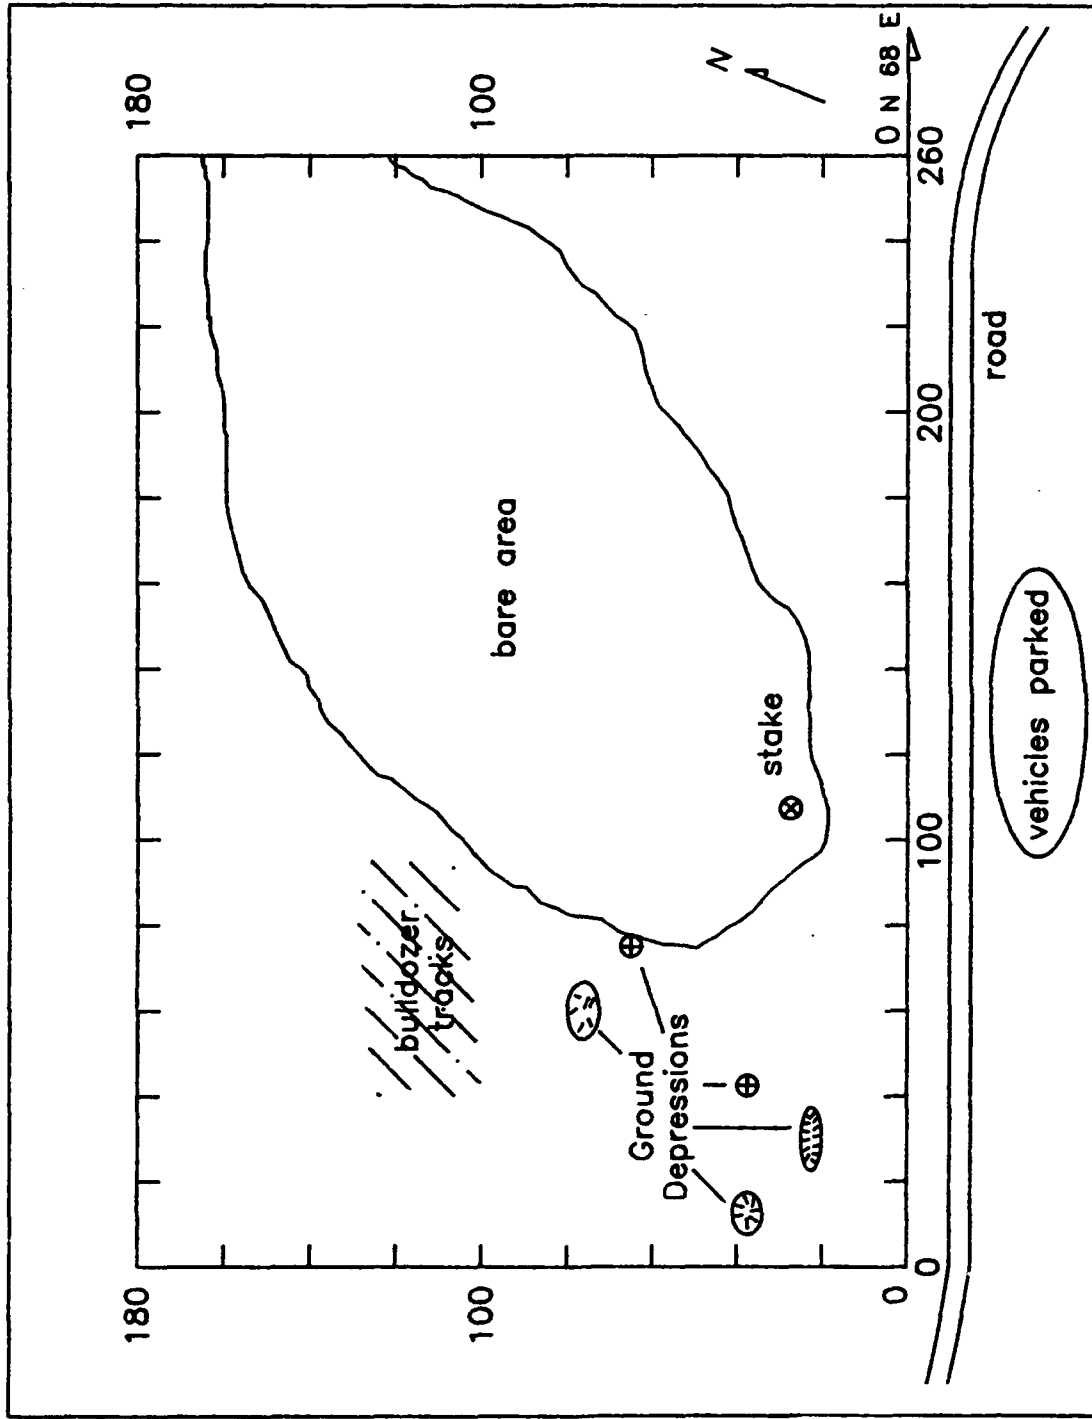
Figure 24. Area of investigation, Site 189

20. Site 189 was located south-southeast of Granite Peak and approximately 0.25 miles east of Government Well No. 52 (Figure 23). This site supposedly consisted of covered pit(s) which contained projectile parts and mustard containers (Oluic and Campbell 1992). The area was swept with the EM-31, EM-38, and the magnetometer to determine the area needing closer investigation. An area 260 ft by 180 ft was selected for gridding based on the results of the sweeps and the existence of a bare area and various small depressions (Figure 24). The EM-31 conductivity and in-phase results indicated anomalously low readings in the southwestern and southeastern portions of the site (Figures 25 through 28). Also, two areas with anomalously low readings centered on approximate coordinates (150E,90N) and (220E,110N) were detected by the EM-31 conductivity and in-phase. This area corresponds, in general, to the location of the bare spot. The results of the total magnetic field indicated no anomalous readings (Figures 29 and 30). The apparently low readings indicated in the southern portion of the site are caused by three vehicles parked nearby.

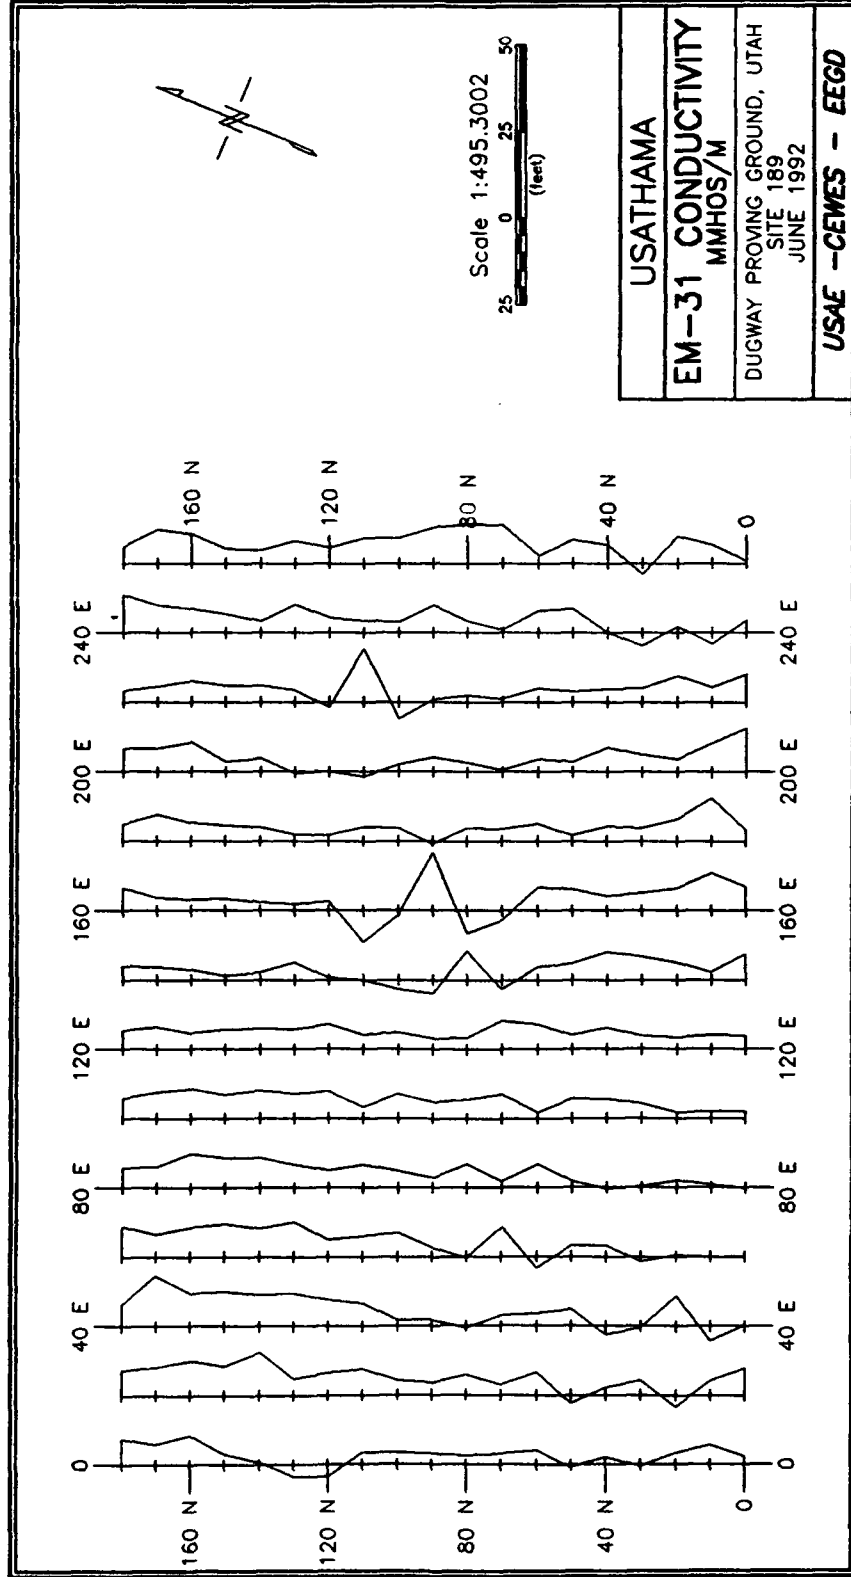
Figure 26. EM-31 conductivity results, profile lines, Site 189

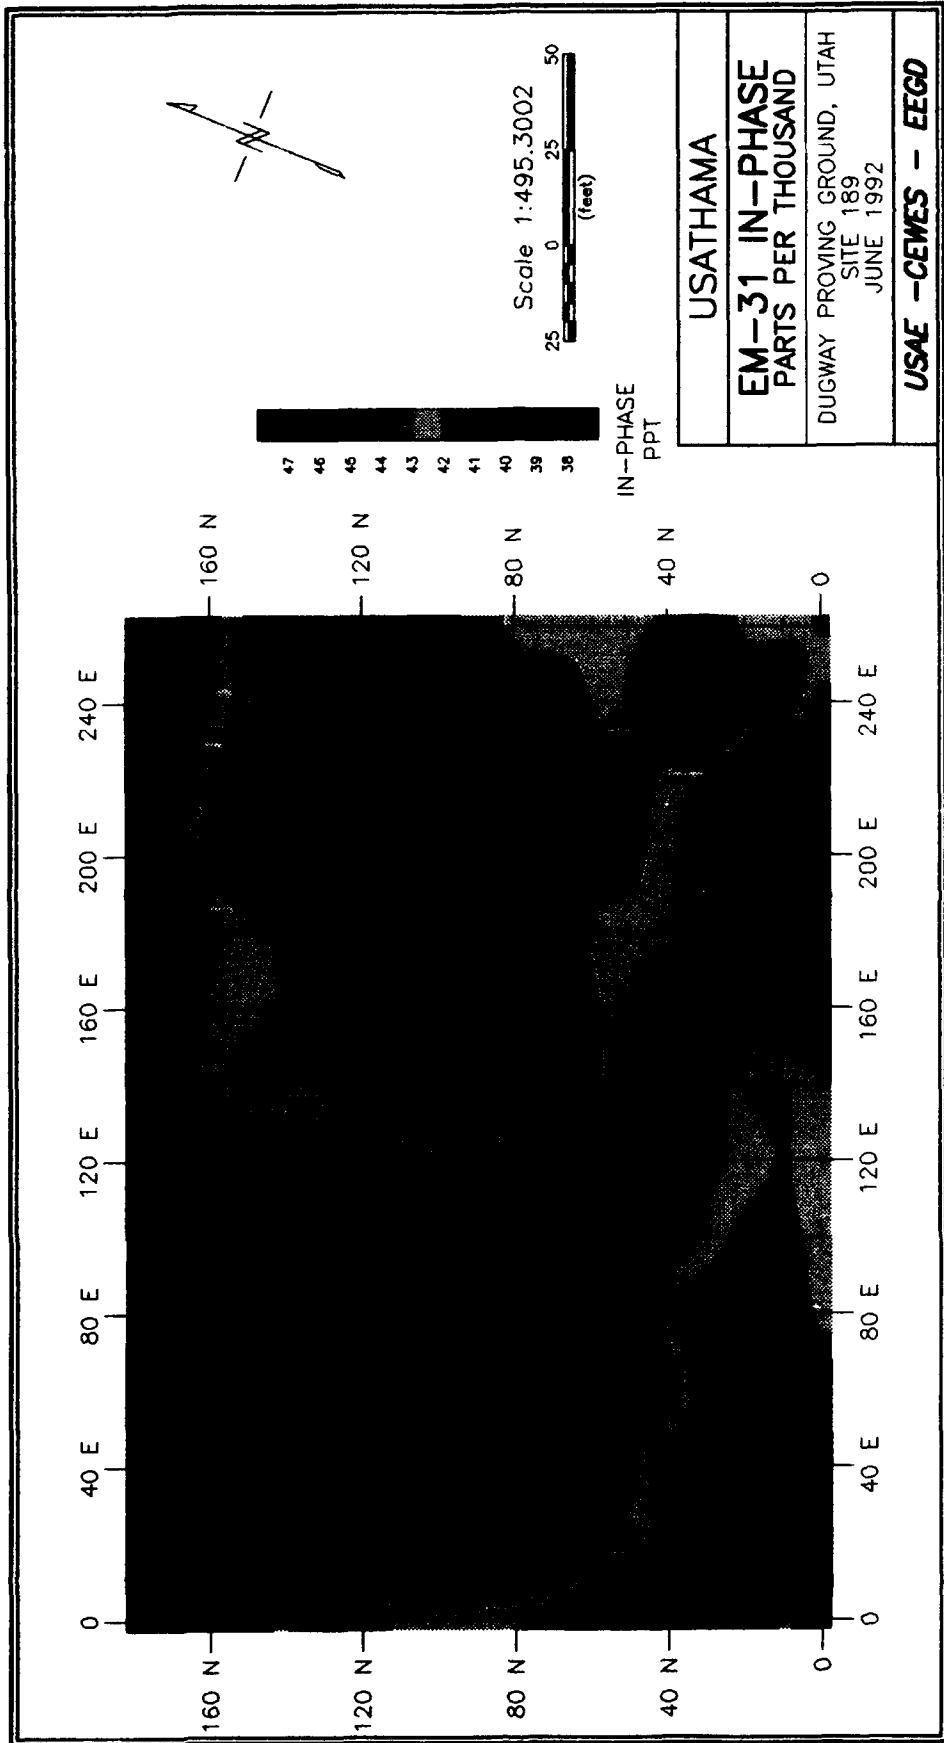
Figure 27. EM-31 in-phase results, contour plot, Site 189

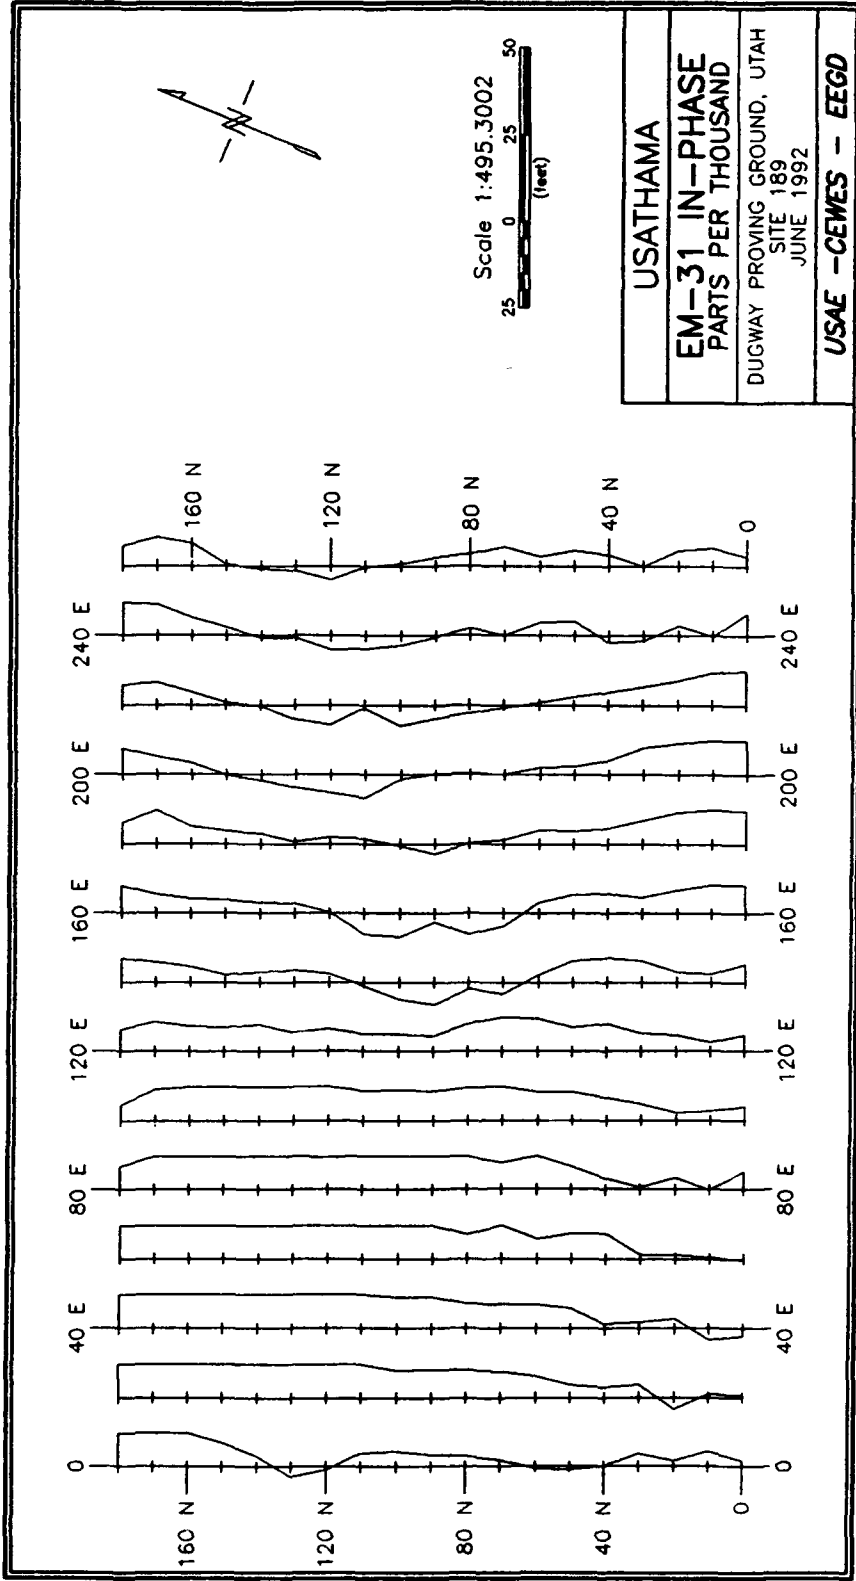
Figure 28. EM-31 in-phase results, profile lines, Site 189

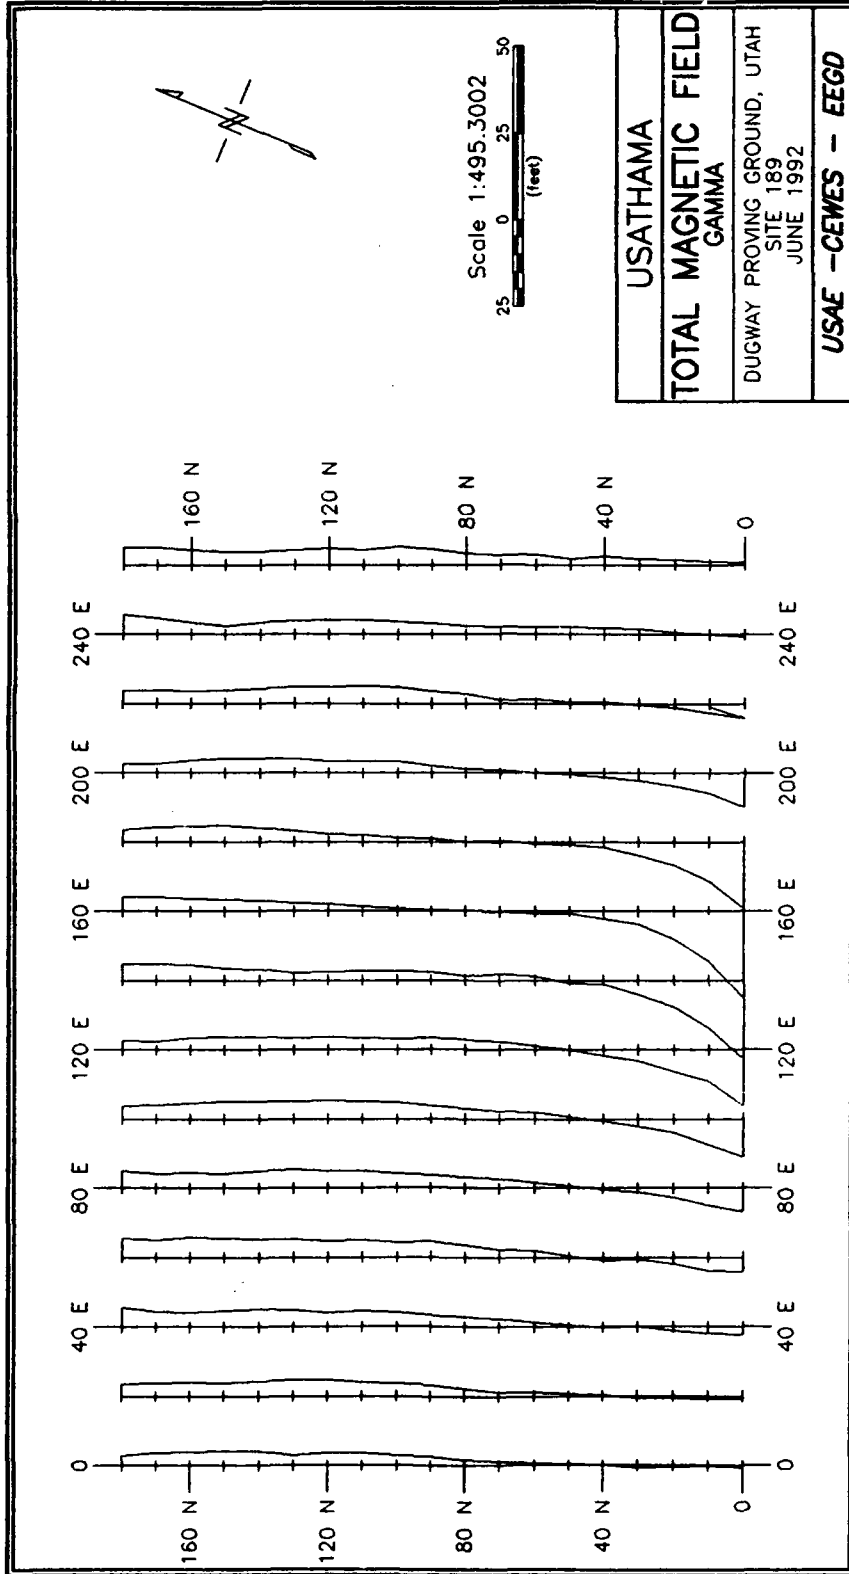
Figure 30. Total magnetic field results, profile plot, Site 189

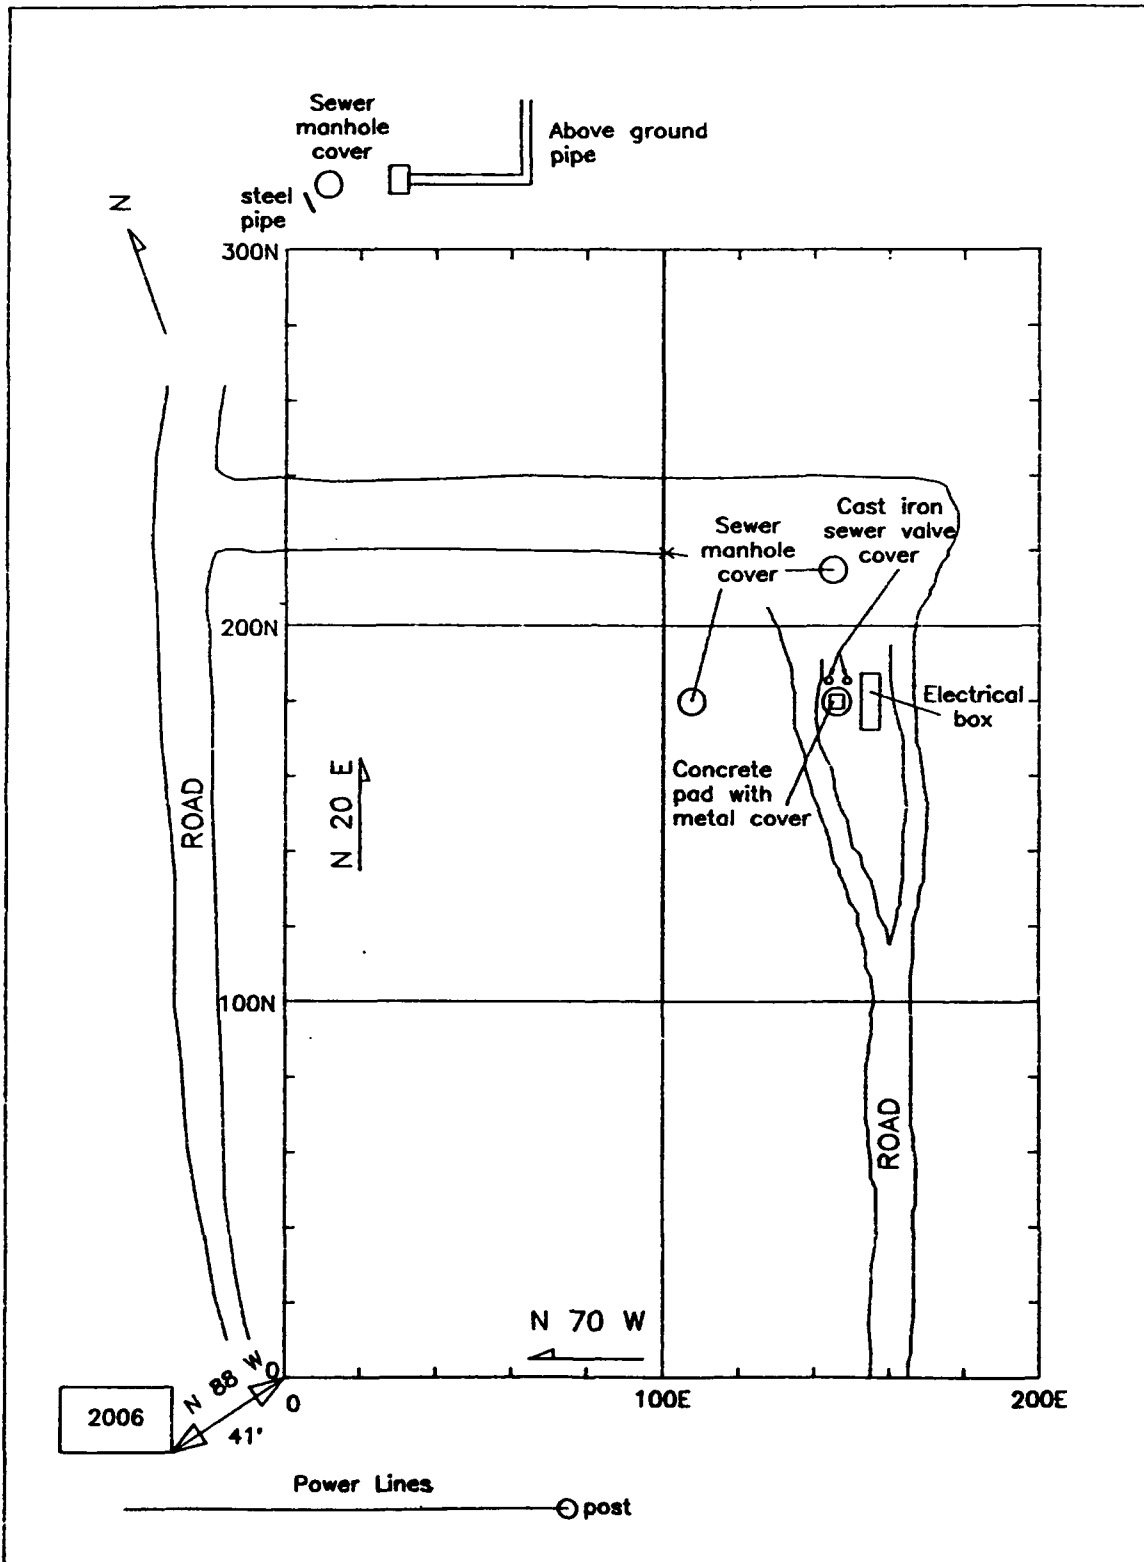
Figure 32. Area of investigation, Site 193

21. Site 193 was located in the Baker Area of DPG (Figure 31). More specifically, the site was located northeast of Building 2006 and covered an area 200 ft by 300 ft as shown in Figure 32. Oluic and Campbell (1992) report that the site consisted of an old pit possibly containing hazardous compounds. Zones with anomalously low and high values were detected by the EM-31 conductivity and in-phase. A zone with relatively low readings, centered between approximate coordinates (30E-60E,180N-240N) was detected by the EM-31 conductivity and in-phase as shown in Figures 33 through 36. Both EM-31 phases detected a northeast-southwest trending low originating at (00E,130N) and ending at approximately (70E,150N). The EM lows located in the southwestern portion of the site may be caused by a nearby building and/or power line. Both EM phases show relatively high zones in the northeastern part of the site between (120E-200E,260N-300N) and in the east central part near (180E,190N). A small conductivity low was detected at (160E,30N) as shown in Figures 33 and 34. The EM-31 in-phase data shows a north-south linear trending along line 160E and extending from approximately 10N to 200N as shown in Figure 35 and 36. The results of the total magnetic field survey detected two anomalous zones; the first at (60E,300N) and the second at (150E,190N) as shown in Figures 37 and 38. The first magnetic anomaly correlates well with the location of an above ground pipeline whereas, the second anomaly coincides with the location of an electrical control box, a concrete pad with a metal cover, and two small cast iron valve covers.

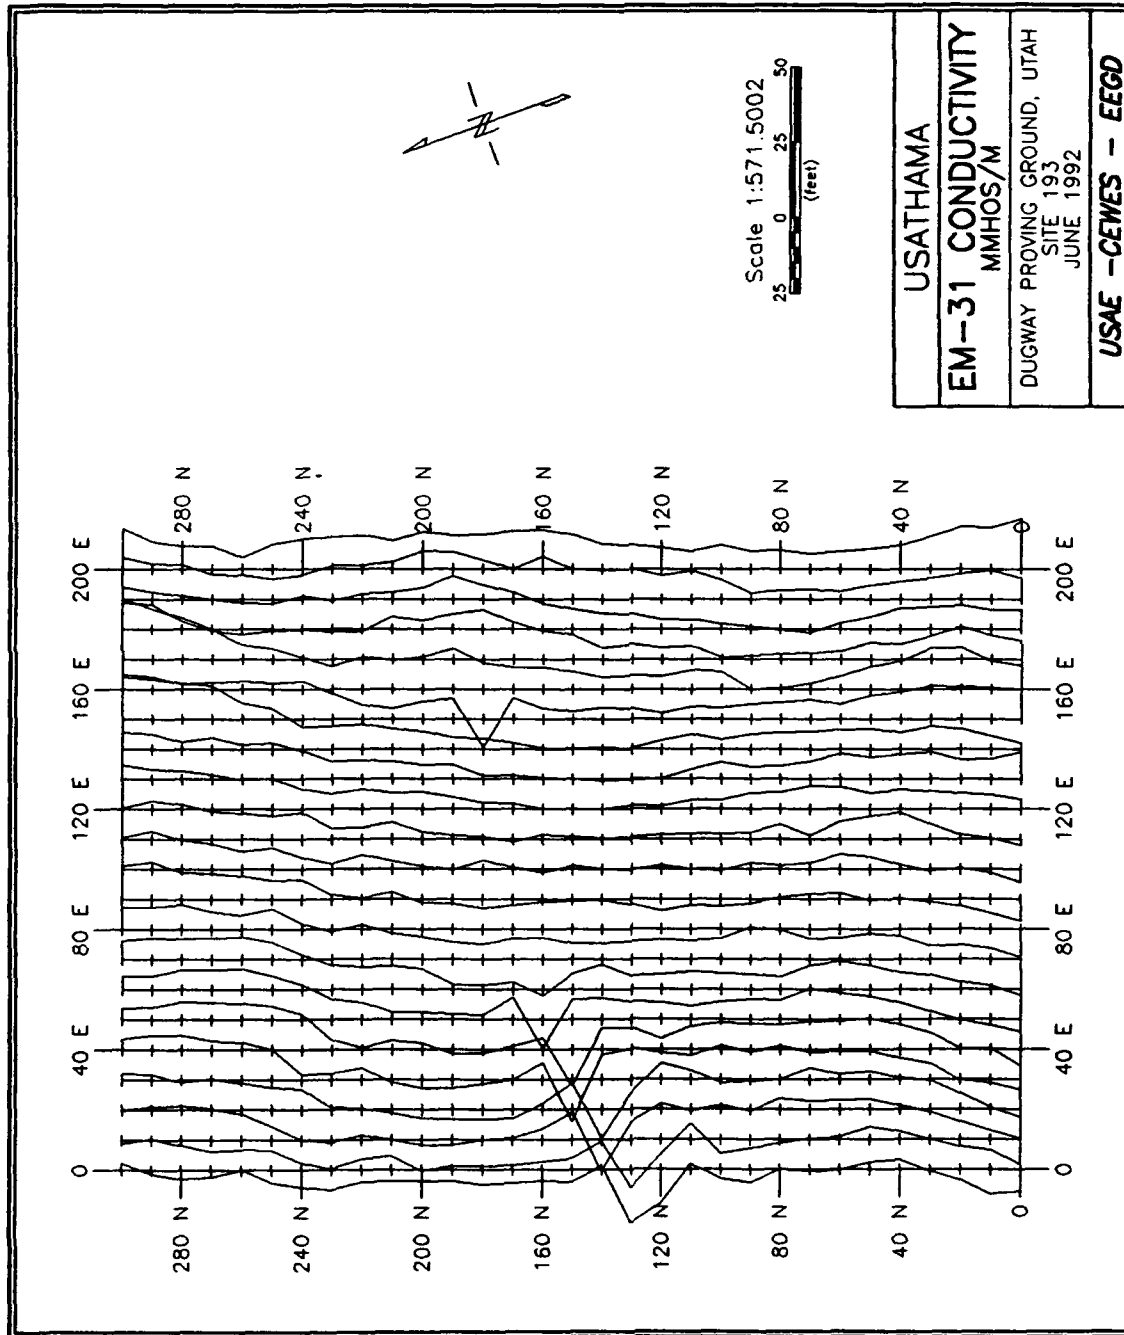
Figure 34. EM-31 conductivity results, profile lines, Site 193

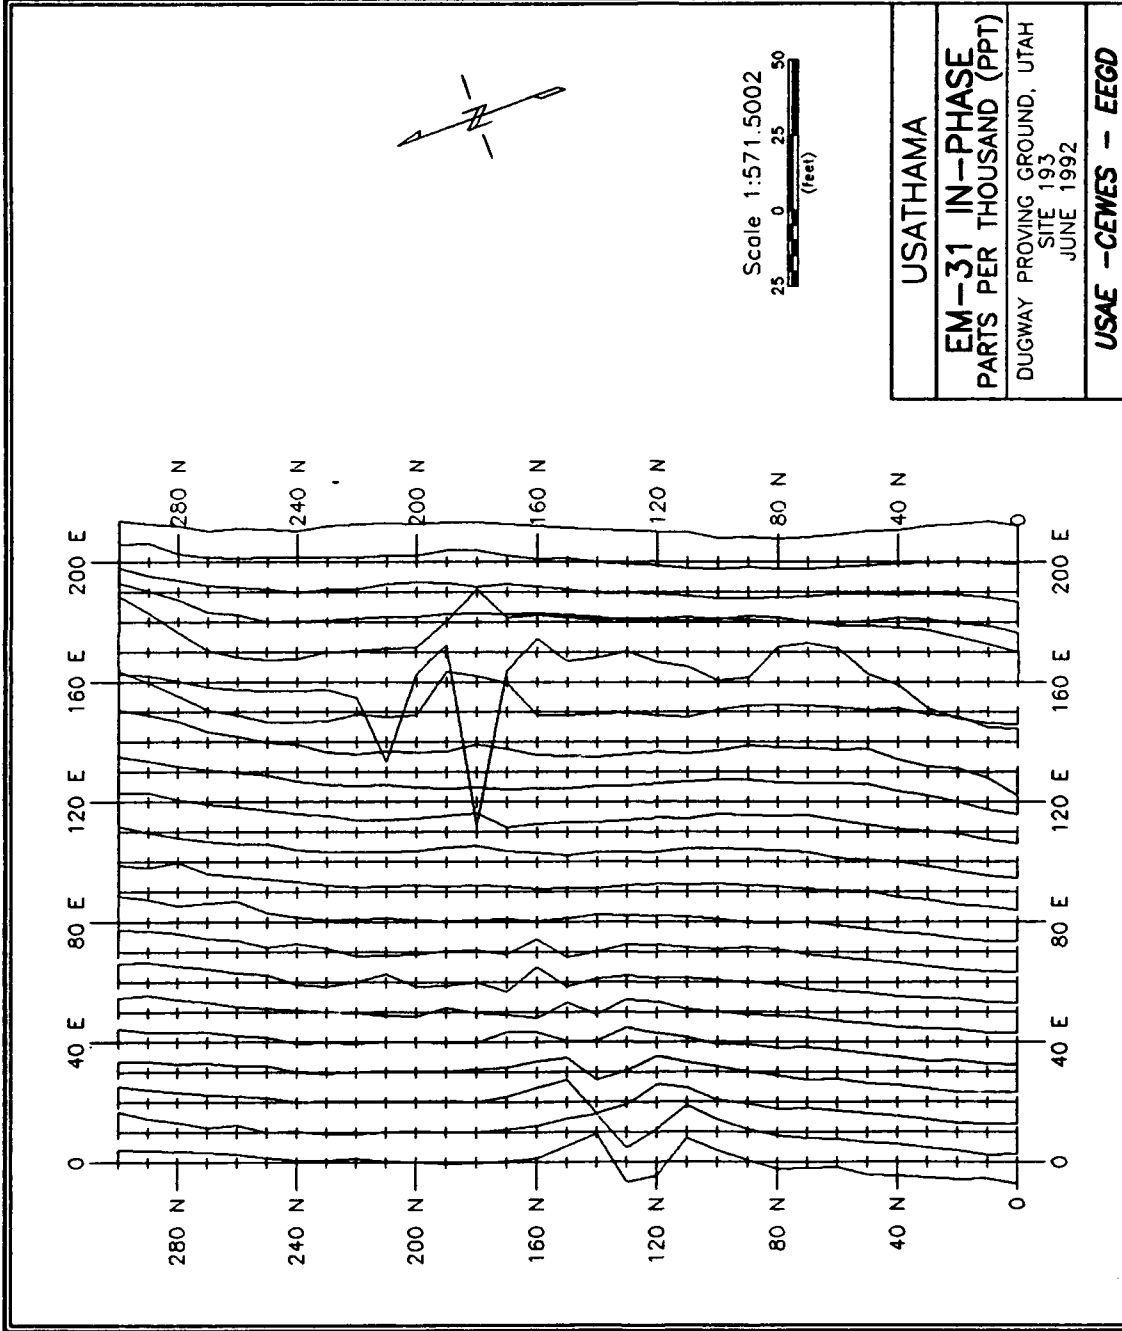
Figure 36. EM-31 in-phase results, profile lines, Site 193

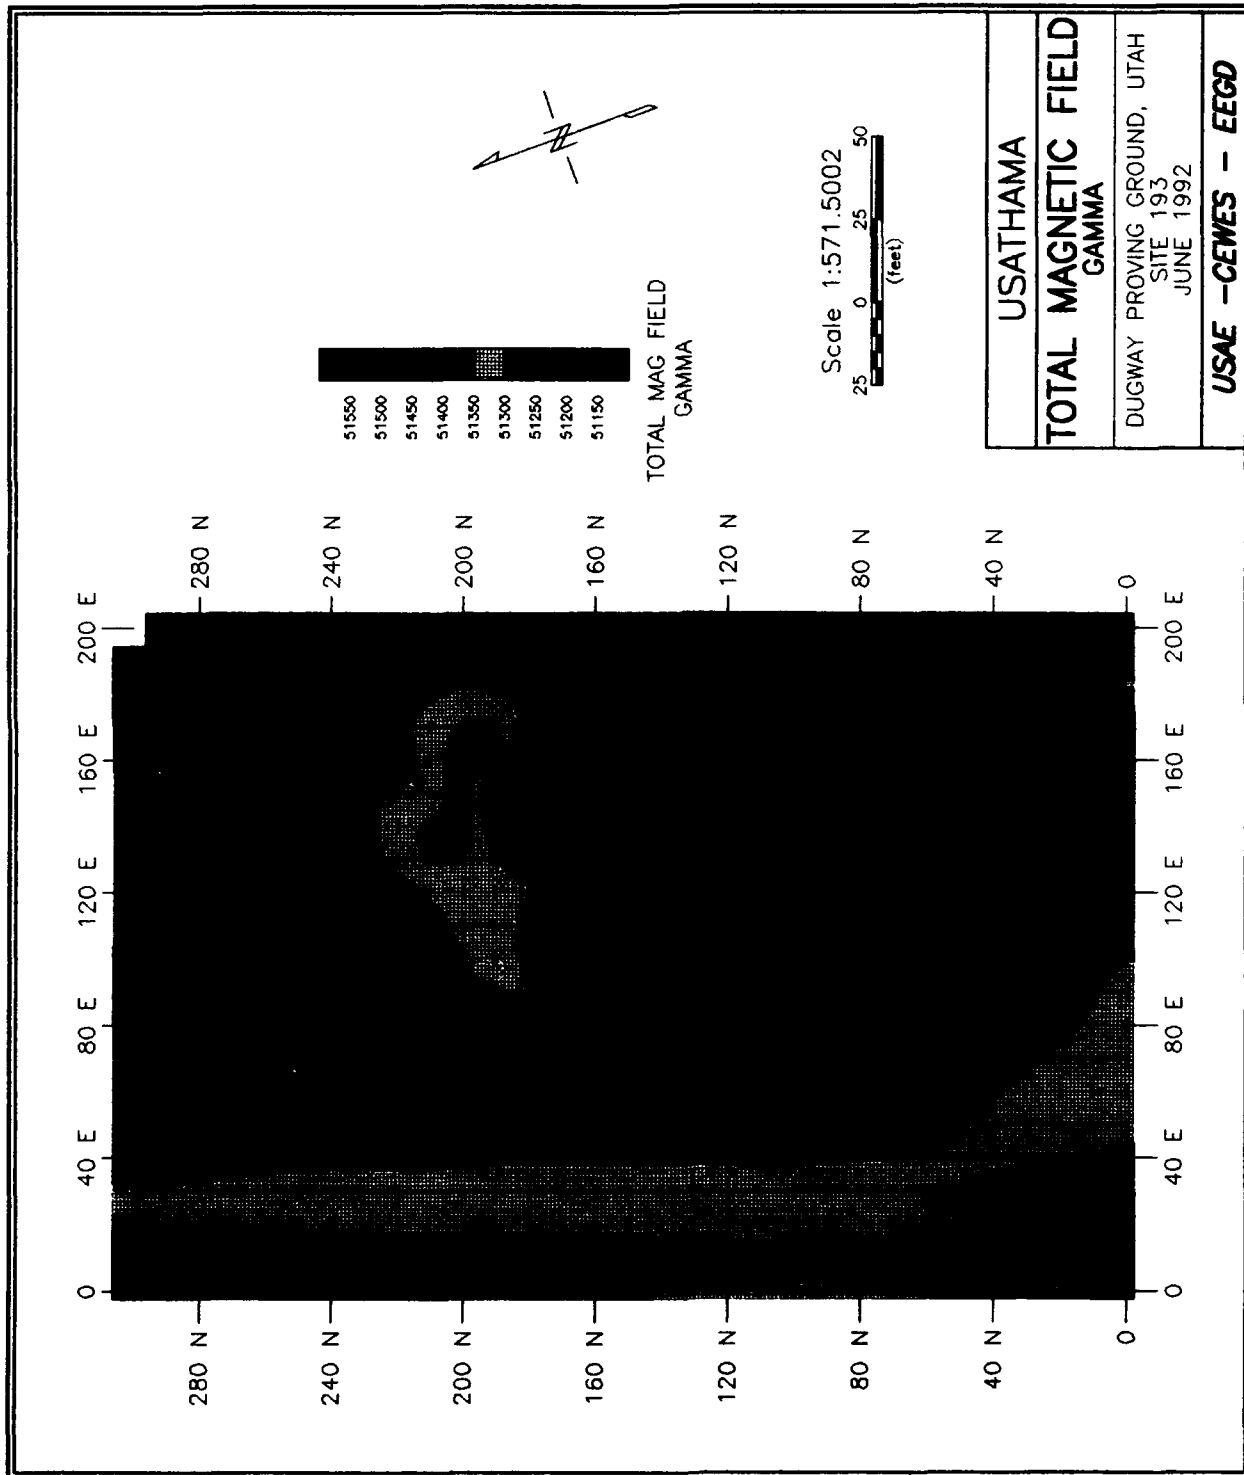
Figure 37. Total magnetic field results, contour plot, Site 193

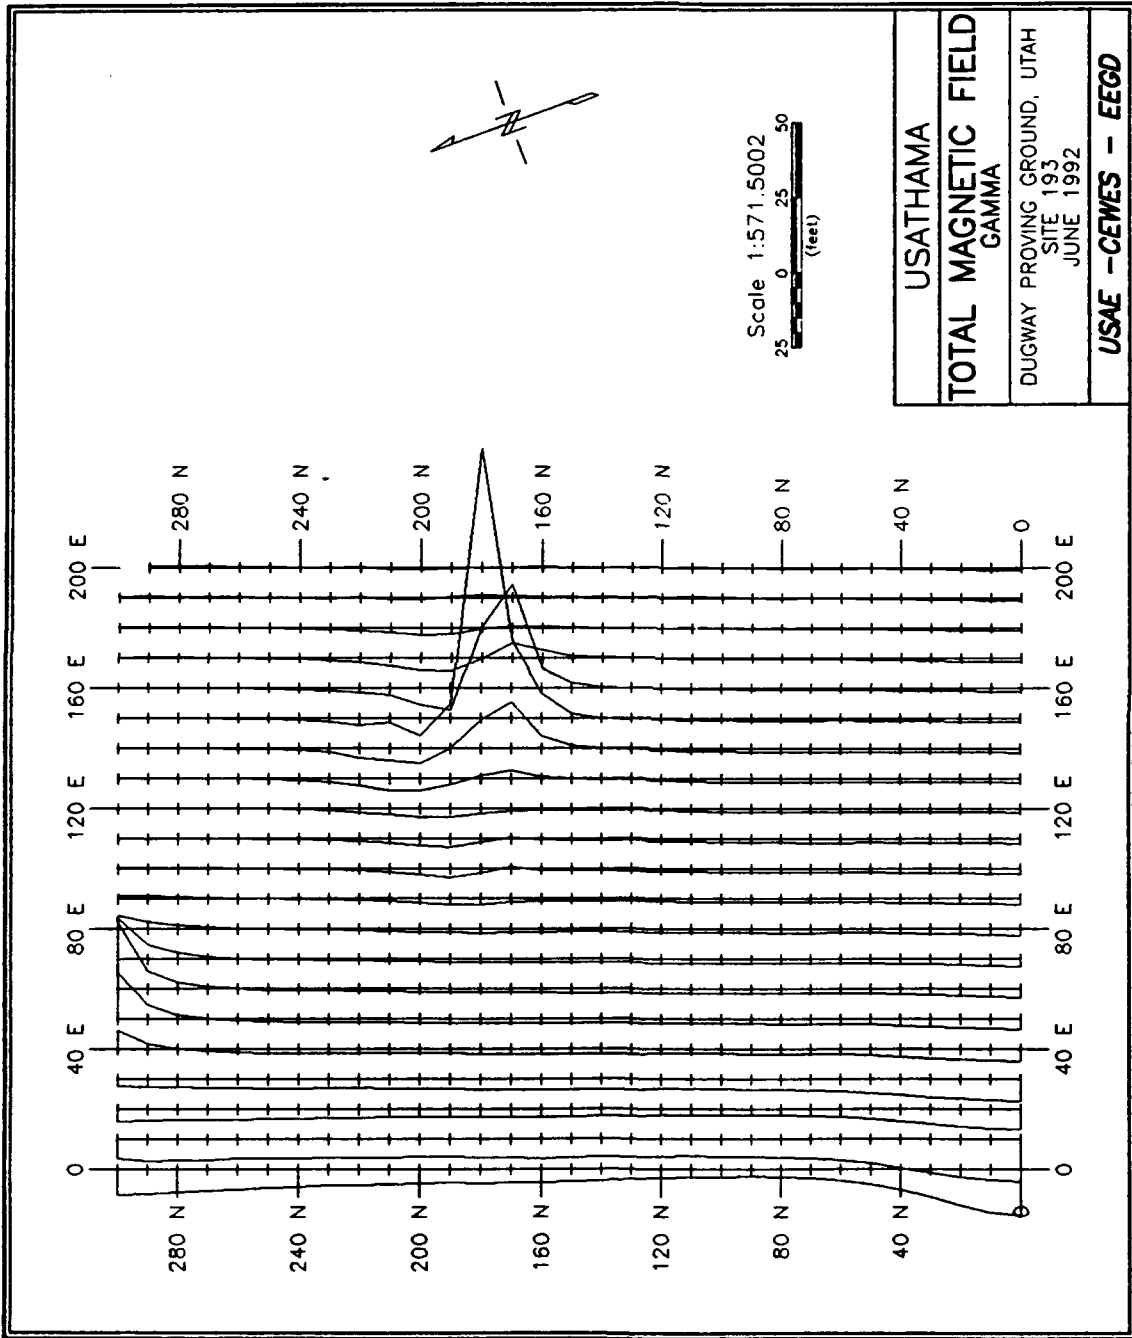
Figure 38. Total magnetic field results, profile plot, Site 193

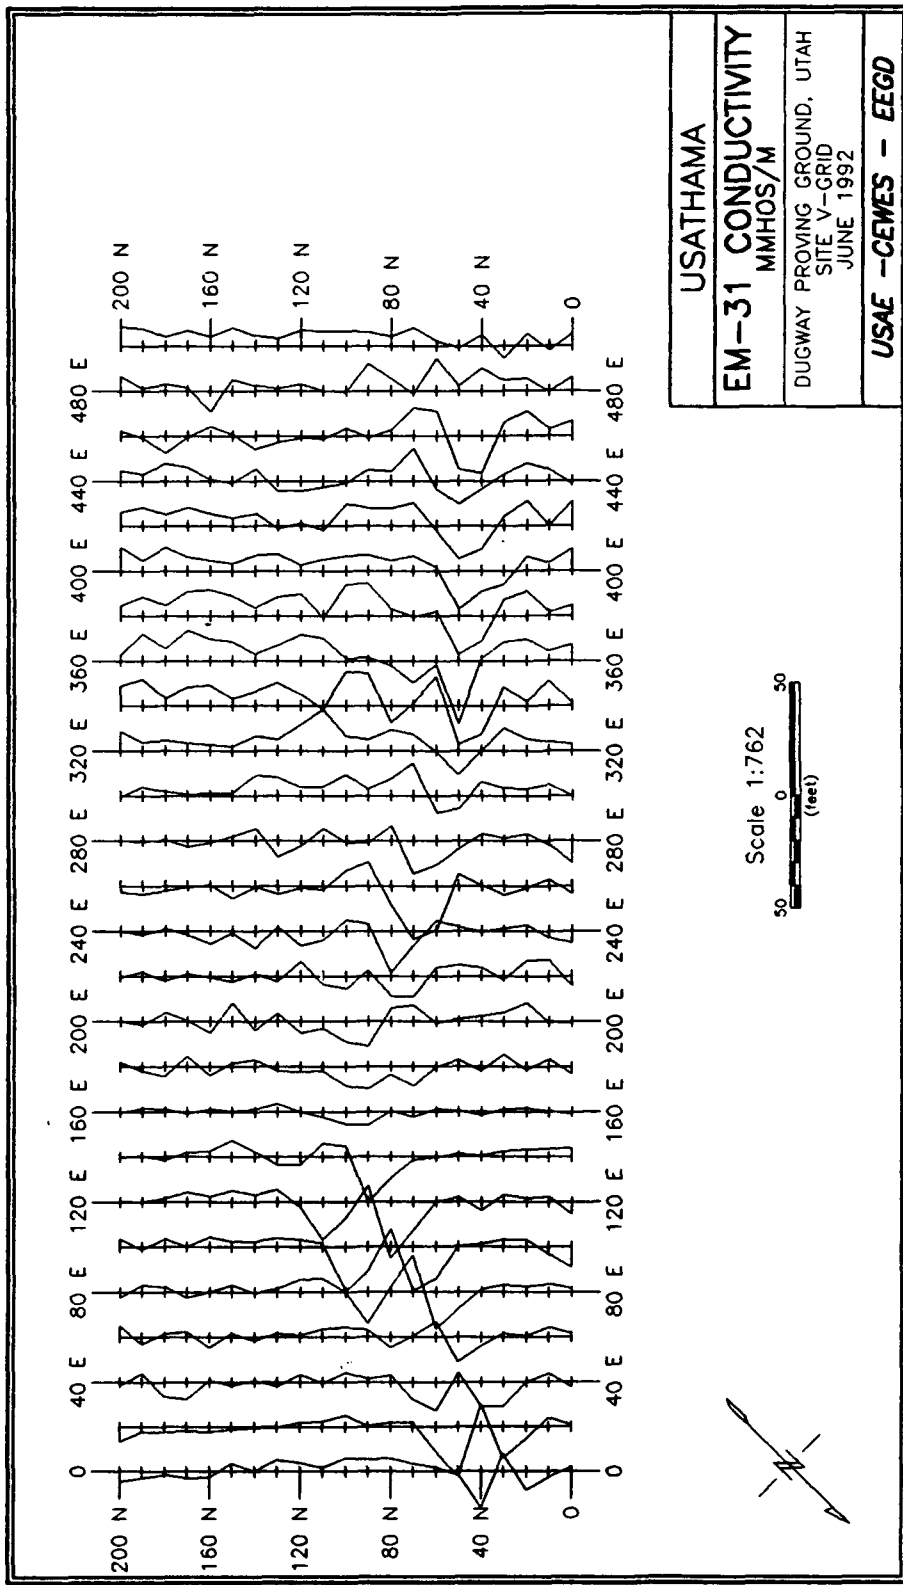
Figure 42. EM-31 conductivity results, profile lines, Site 196

the ridge (Figures 41 and 42). The right-hand portion of the site was characterized by higher conductivity measurements. The EM-31 in-phase data shows three areas along the ridge that are identifiable by pairs of "bulls eye-like" highs separated by an area of relatively low readings (Figures 43 and 44). This type of feature is the expected characteristic high-low-high signature when crossing a metallic object. The EM lows situated between the pair of EM highs were located approximately at (260E,70N), (400E,50N) and (460E,40N). The EM-31 inphase readings did not appear to be significantly affected by the trench. The total field magnetic readings detected three significant anomalous areas characterized as "high-low" pairs (Figures 45 and 46). These anomalies are probably caused by buried ferrous objects. The objects are interpreted as being located at (280E,70N), (380E,50N) and (440E,30N). These three areas agree very well with the location of the three anomalies interpreted from the EM-31 in-phase data.

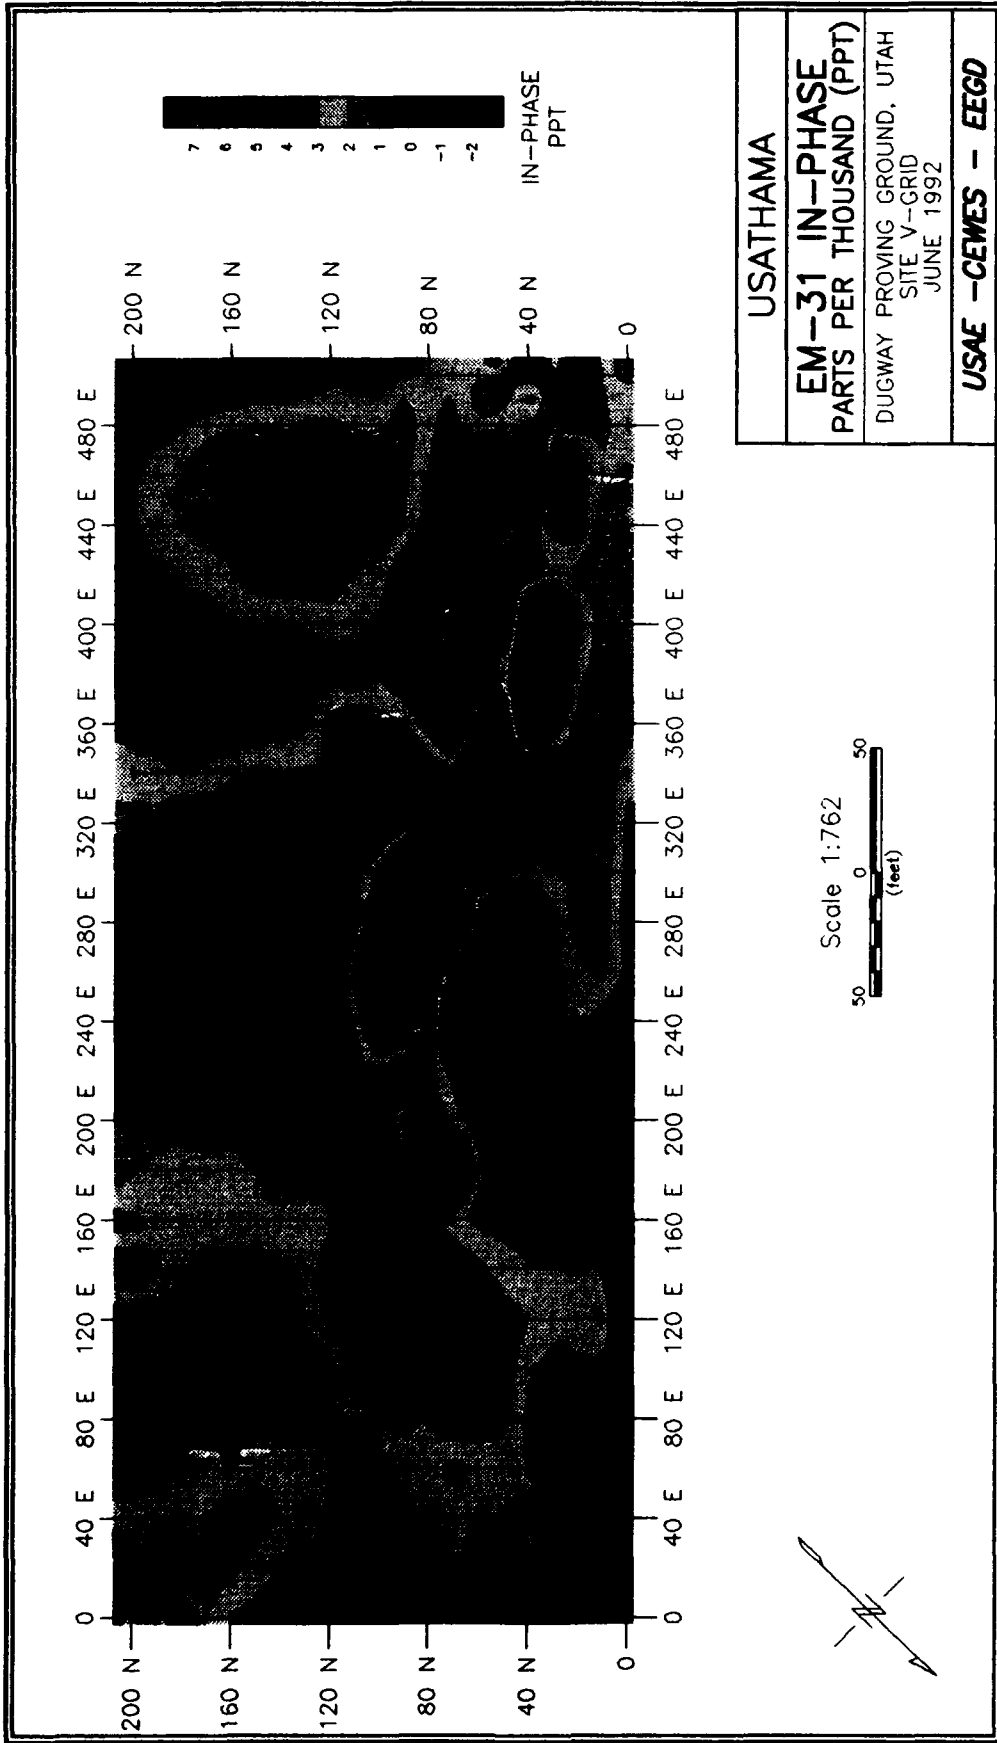
Figure 43. EM-31 in-phase results, contour plot, Site 196

Anomaly Location	EM-31		Mag	Anomaly Description and Interpretation
	Q	I		
(270E,70N) (390E,50N) (450E,40N)	X	X	X	Very large anomalies indicated by the EM and magnetometer. Anomalies occur along ridge. Probably buried ferrous material.
(180E,80N)		X	X	Small anomaly detected with the EM-31 in-phase and magnetometer. The location of this anomaly correlates well with the location of a section of landing mat and a stainless steel pan laying on the ground surface.

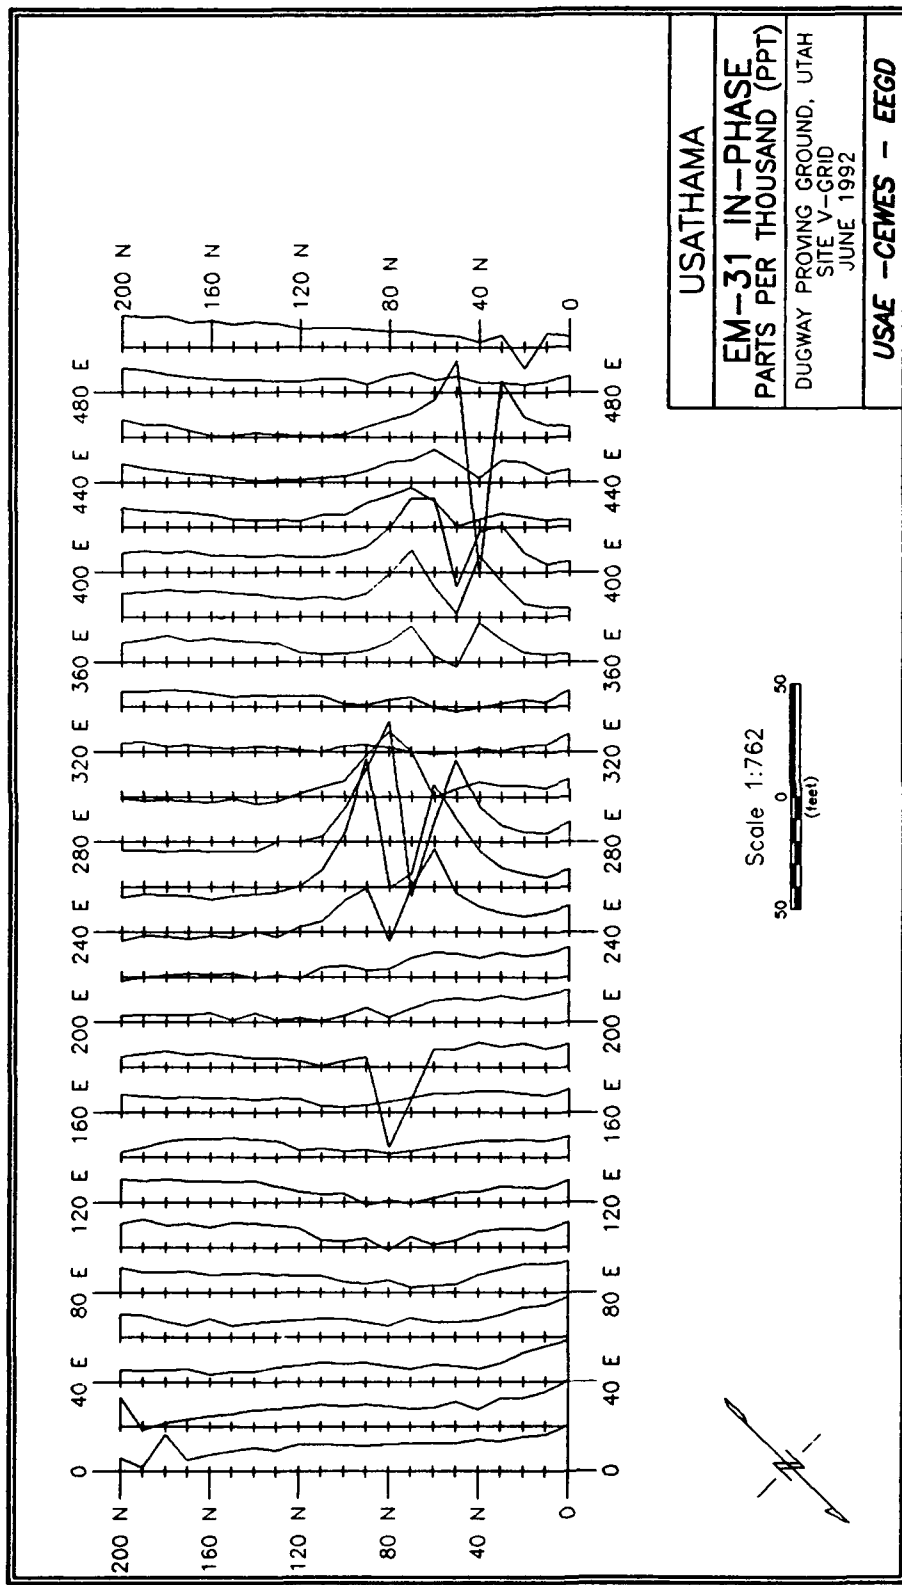
Figure 44. EM-31 in-phase results, profile lines, Site 196
