MISCELLANEOUS PAPER GL-92-34

GEOPHYSICAL INVESTIGATION AT DUGWAY PROVING GROUND, UTAH

Geotechnical Laboratory

Final Report

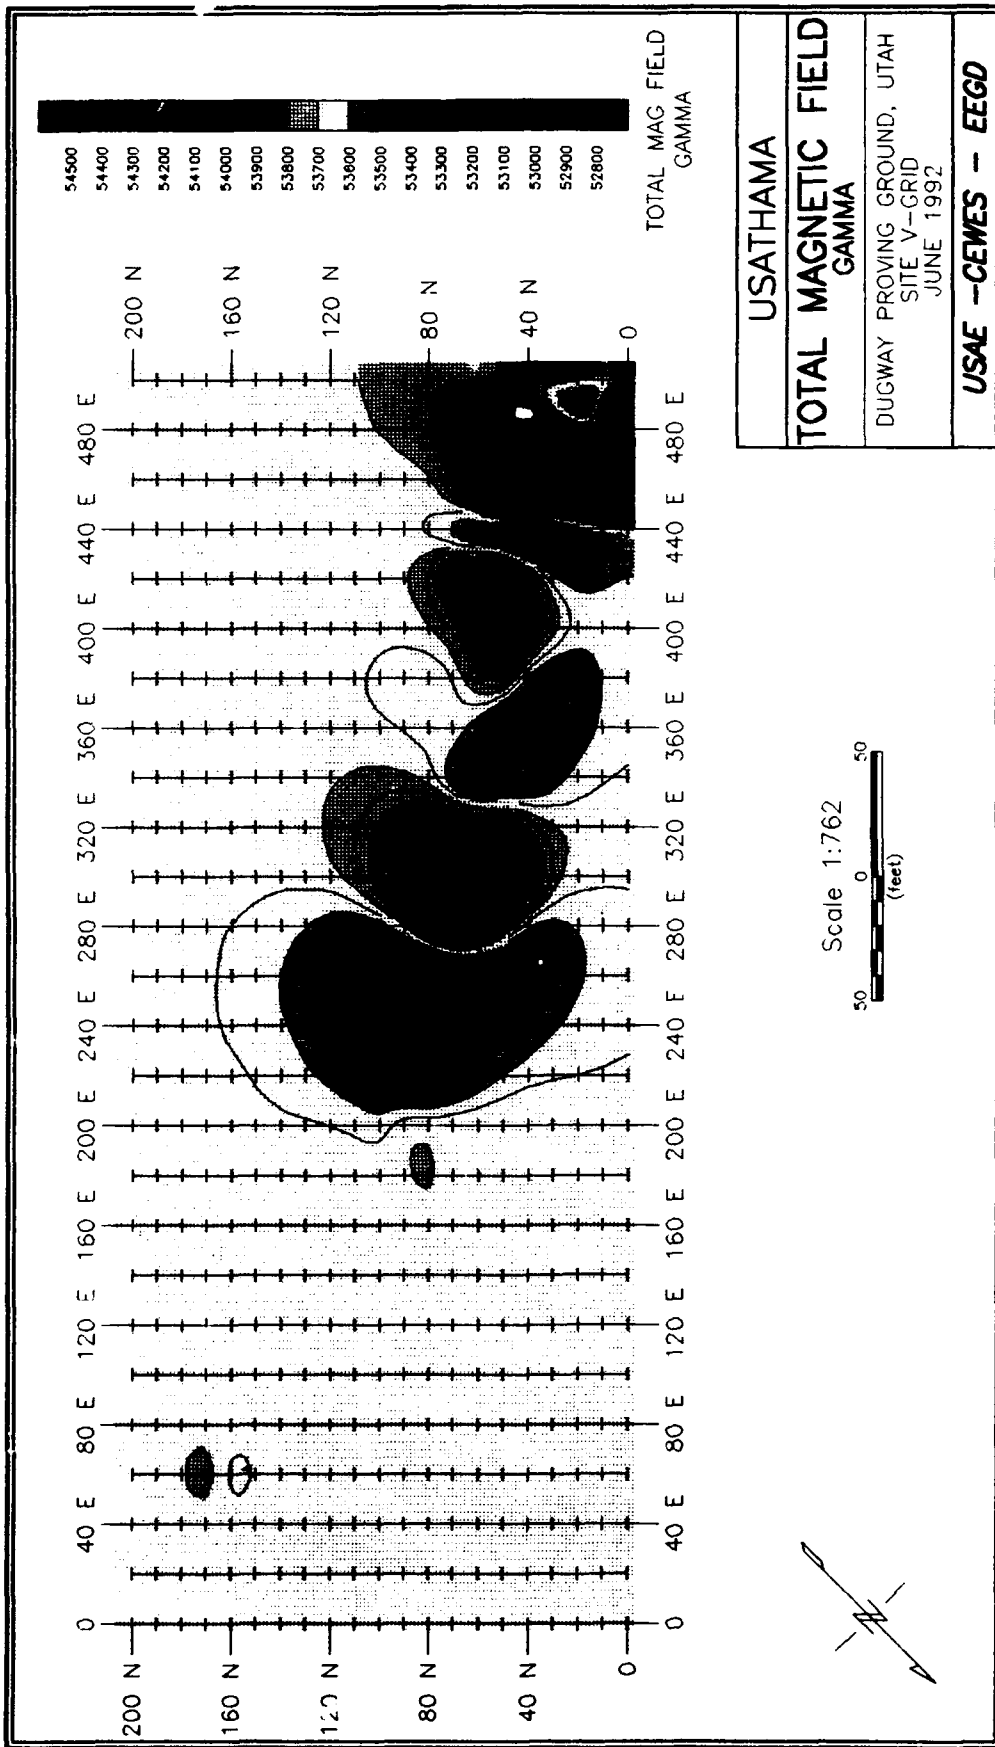
Figure 45. Total magnetic field results, contour plot, Site 196

the ridge (Figures 41 and 42). The right-hand portion of the site was characterized by higher conductivity measurements. The EM-31 in-phase data shows three areas along the ridge that are identifiable by pairs of "bulls eye-like" highs separated by an area of relatively low readings (Figures 43 and 44). This type of feature is the expected characteristic high-low-high signature when crossing a metallic object. The EM lows situated between the pair of EM highs were located approximately at (260E,70N), (400E,50N) and (460E,40N). The EM-31 inphase readings did not appear to be significantly affected by the trench. The total field magnetic readings detected three significant anomalous areas characterized as "high-low" pairs (Figures 45 and 46). These anomalies are probably caused by buried ferrous objects. The objects are interpreted as being located at (280E,70N), (380E,50N) and (440E,30N). These three areas agree very well with the location of the three anomalies interpreted from the EM-31 in-phase data.

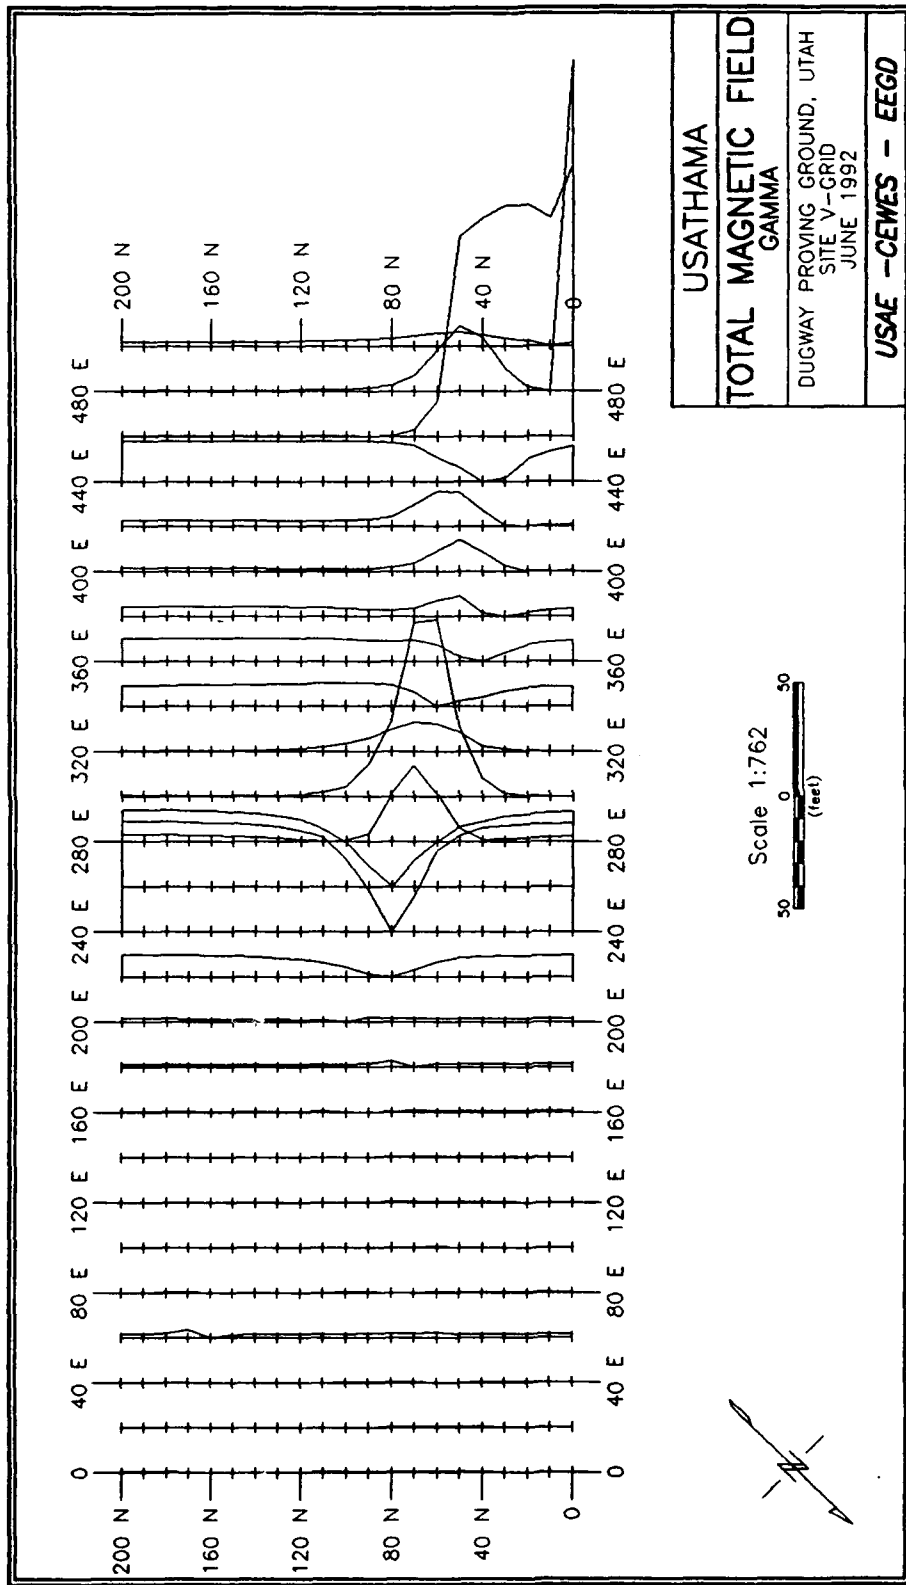
Figure 46. Total magnetic field results, profile plot, Site 196

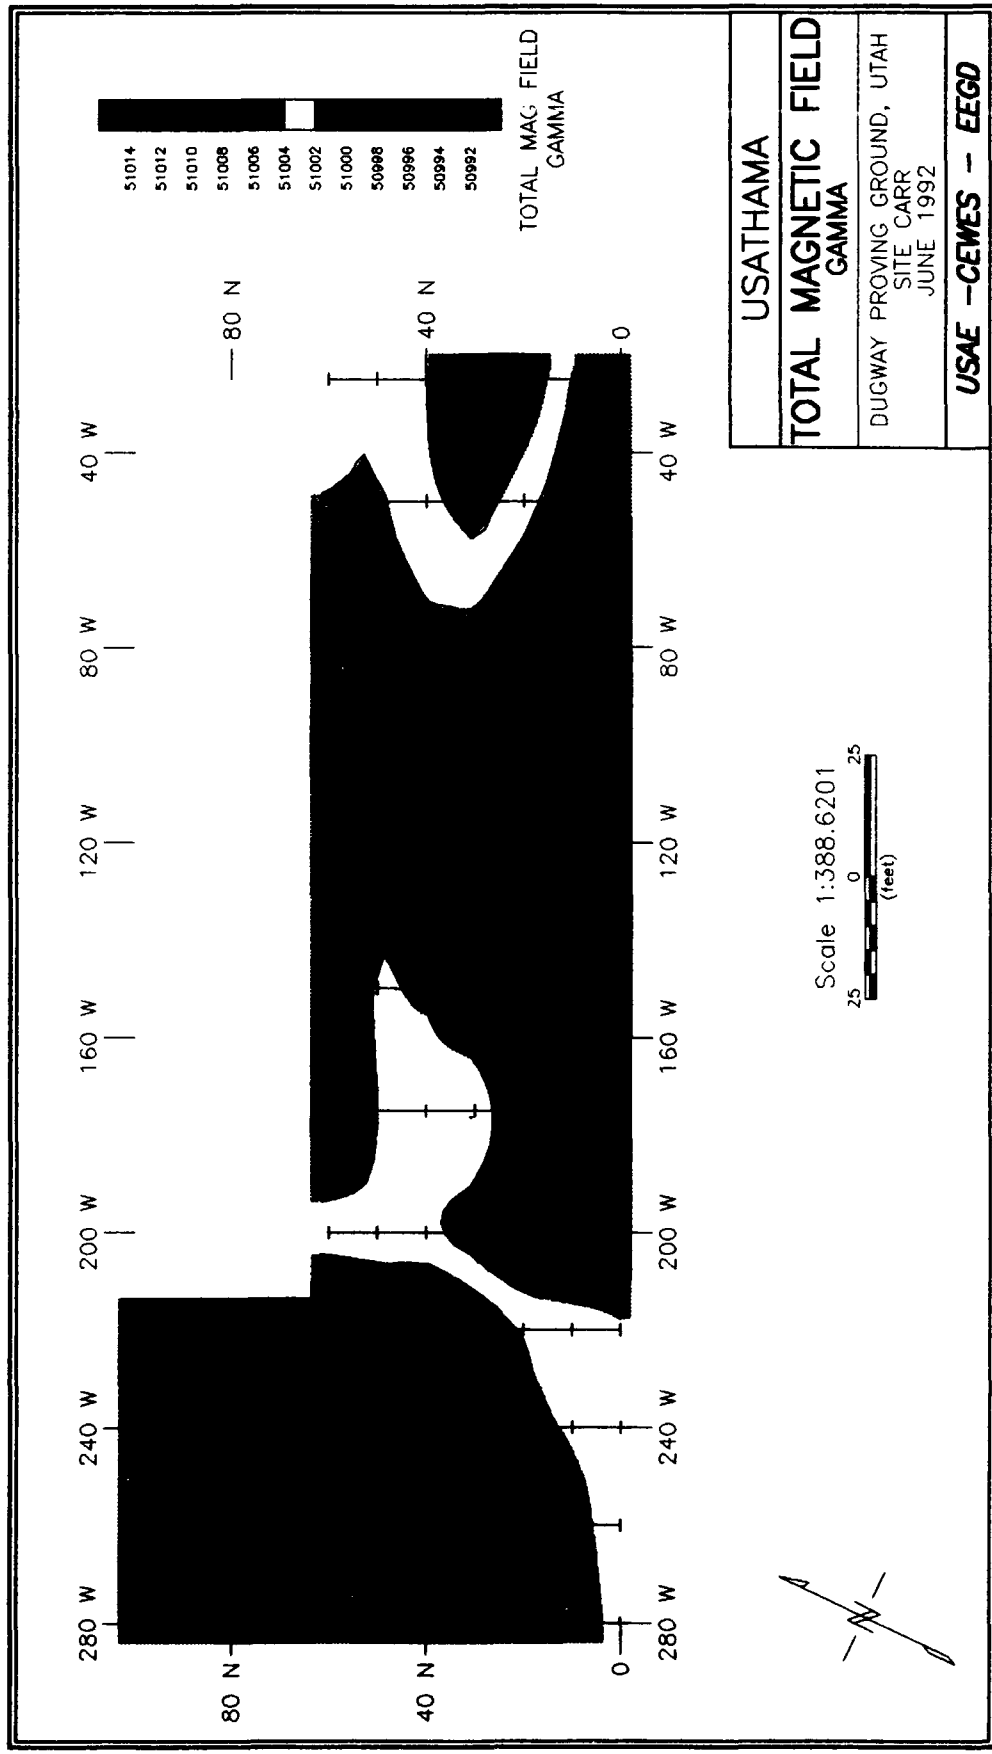
Figure 49. Total magnetic field results, contour plot, Site Carr

5 ft by 5 ft fenced area and it is not known what, if anything, is buried within the area. The site was swept with the EM-31 and no anomalous features were detected. However, because of the suspicious nature of the ridge and fenced area, a grid was set up for the magnetometer. The grid was approximately 280 ft by 100 ft as shown in Figure 49. Prior to conducting the magnetometer survey, the metal fence was pulled-up and moved away from the gridded area, to a location far enough away from the grid to prevent interference with the magnetometer. A magnetic high is noted in the northwest section of the site and is probably caused by the pulled-up metal fence (Figures 49 and 50).
