FINAL REPORT
JUNE 1992

REPORT NO. 92-10

AMMUNITION CERTIFICATION
OF U.S. MARINE CORPS (USMC)
M927A1 AND
M923A1 TRUCKS

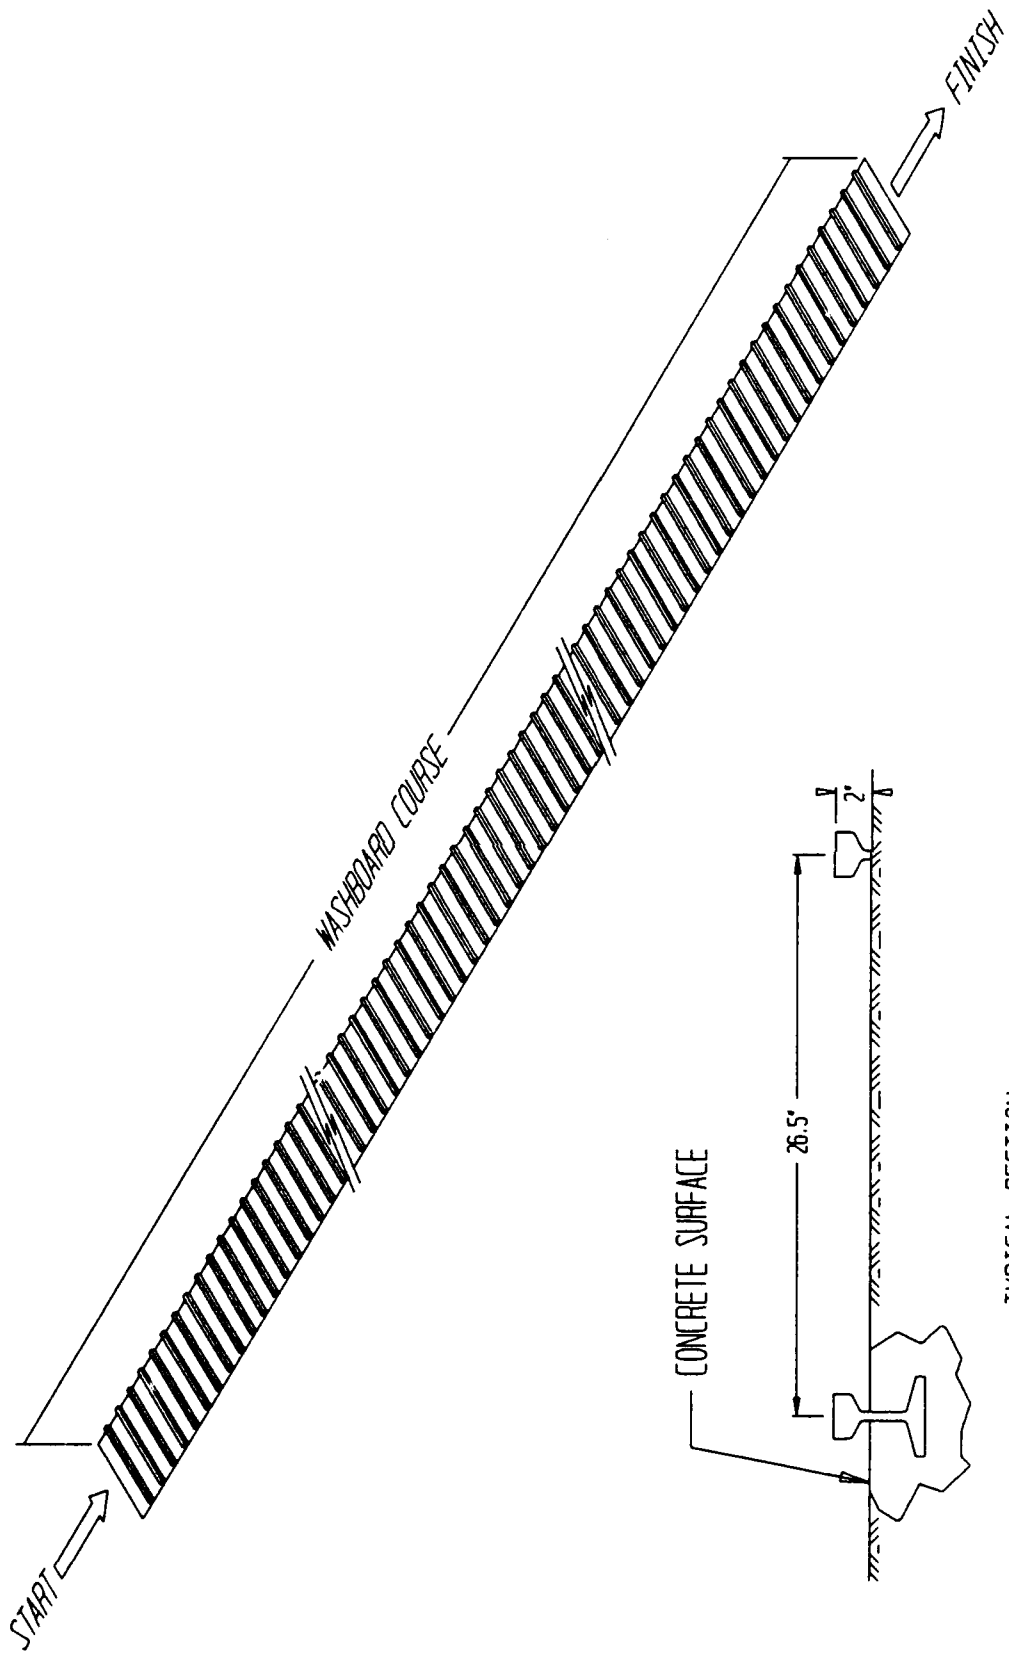
FIGURE 2

4. Test Method No. 6 - (Washboard Course). The USMC truck loaded with MILVAN/SIXCONS was driven over the washboard course (figure 2) at a speed which produced the most violent response of the vehicle. The washboard course is constructed as shown in figure 2.

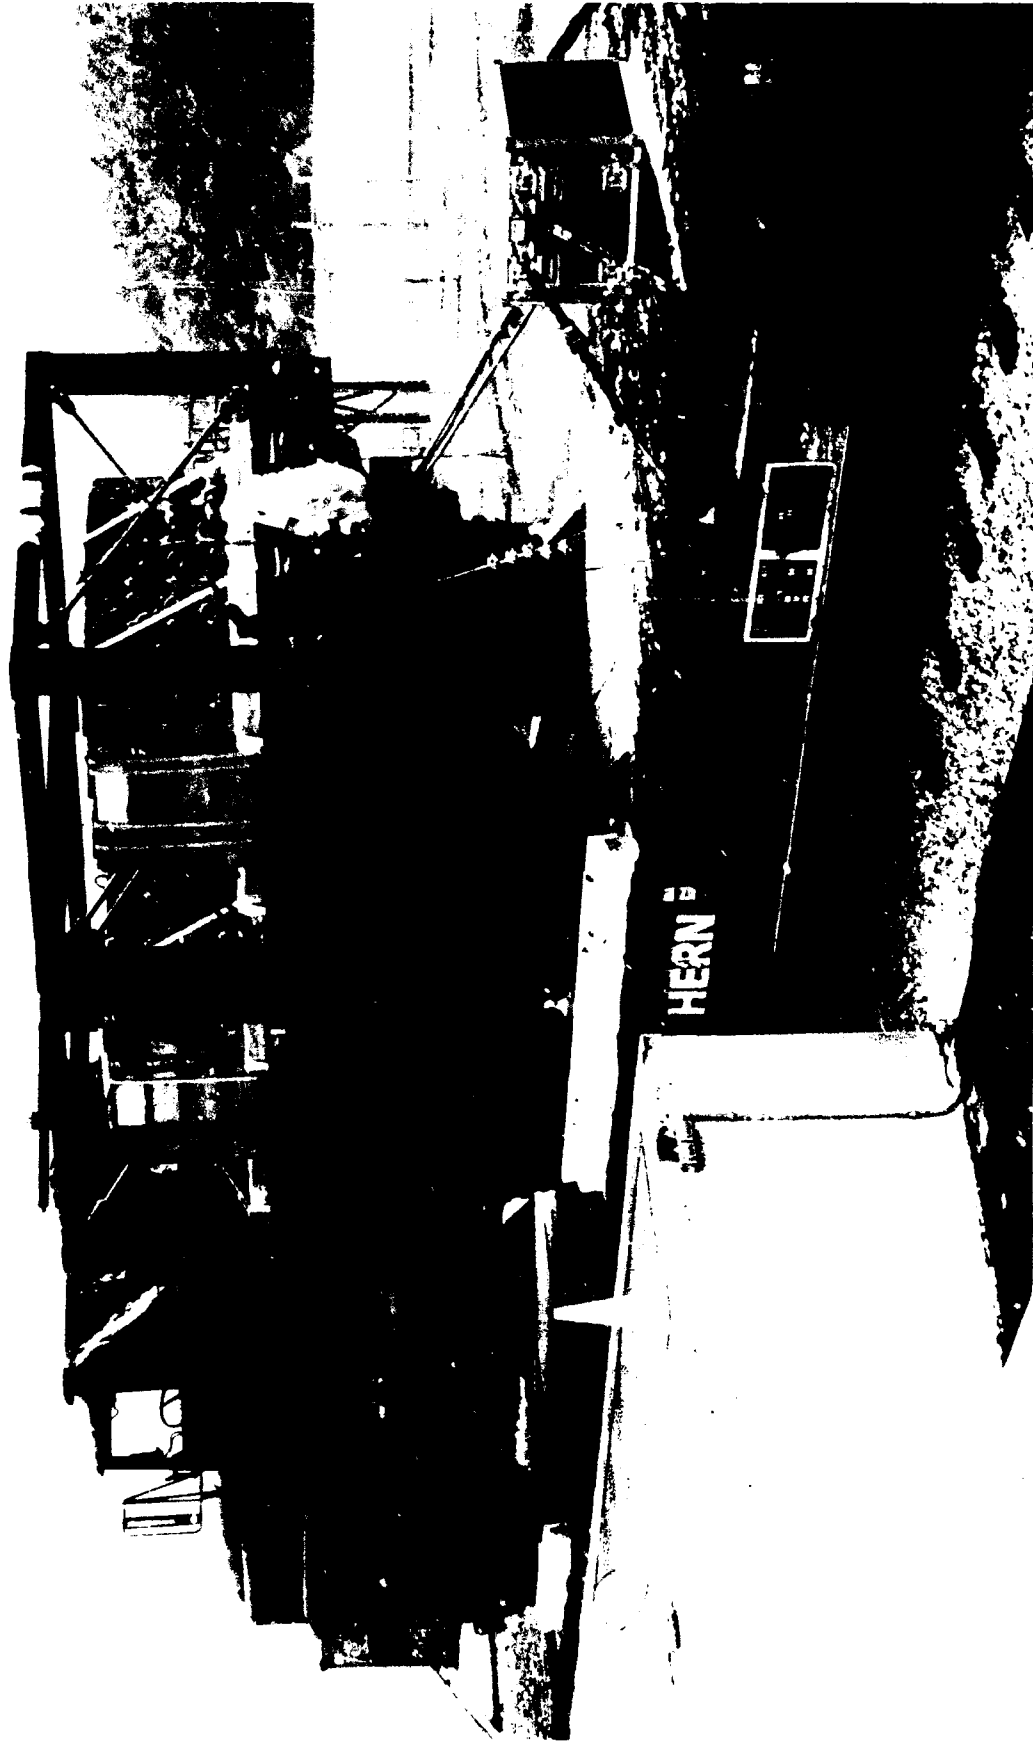
| U.S. ARMY DEFENSE AMMUNITION CENTER AND SCHOOL - SAVANNA, IL | Photo No. A0317-SPN92-180-1620. This photo shows the M923A1 5-ton truck mount cabled to an instrumented flatcar for rail impact testing. |

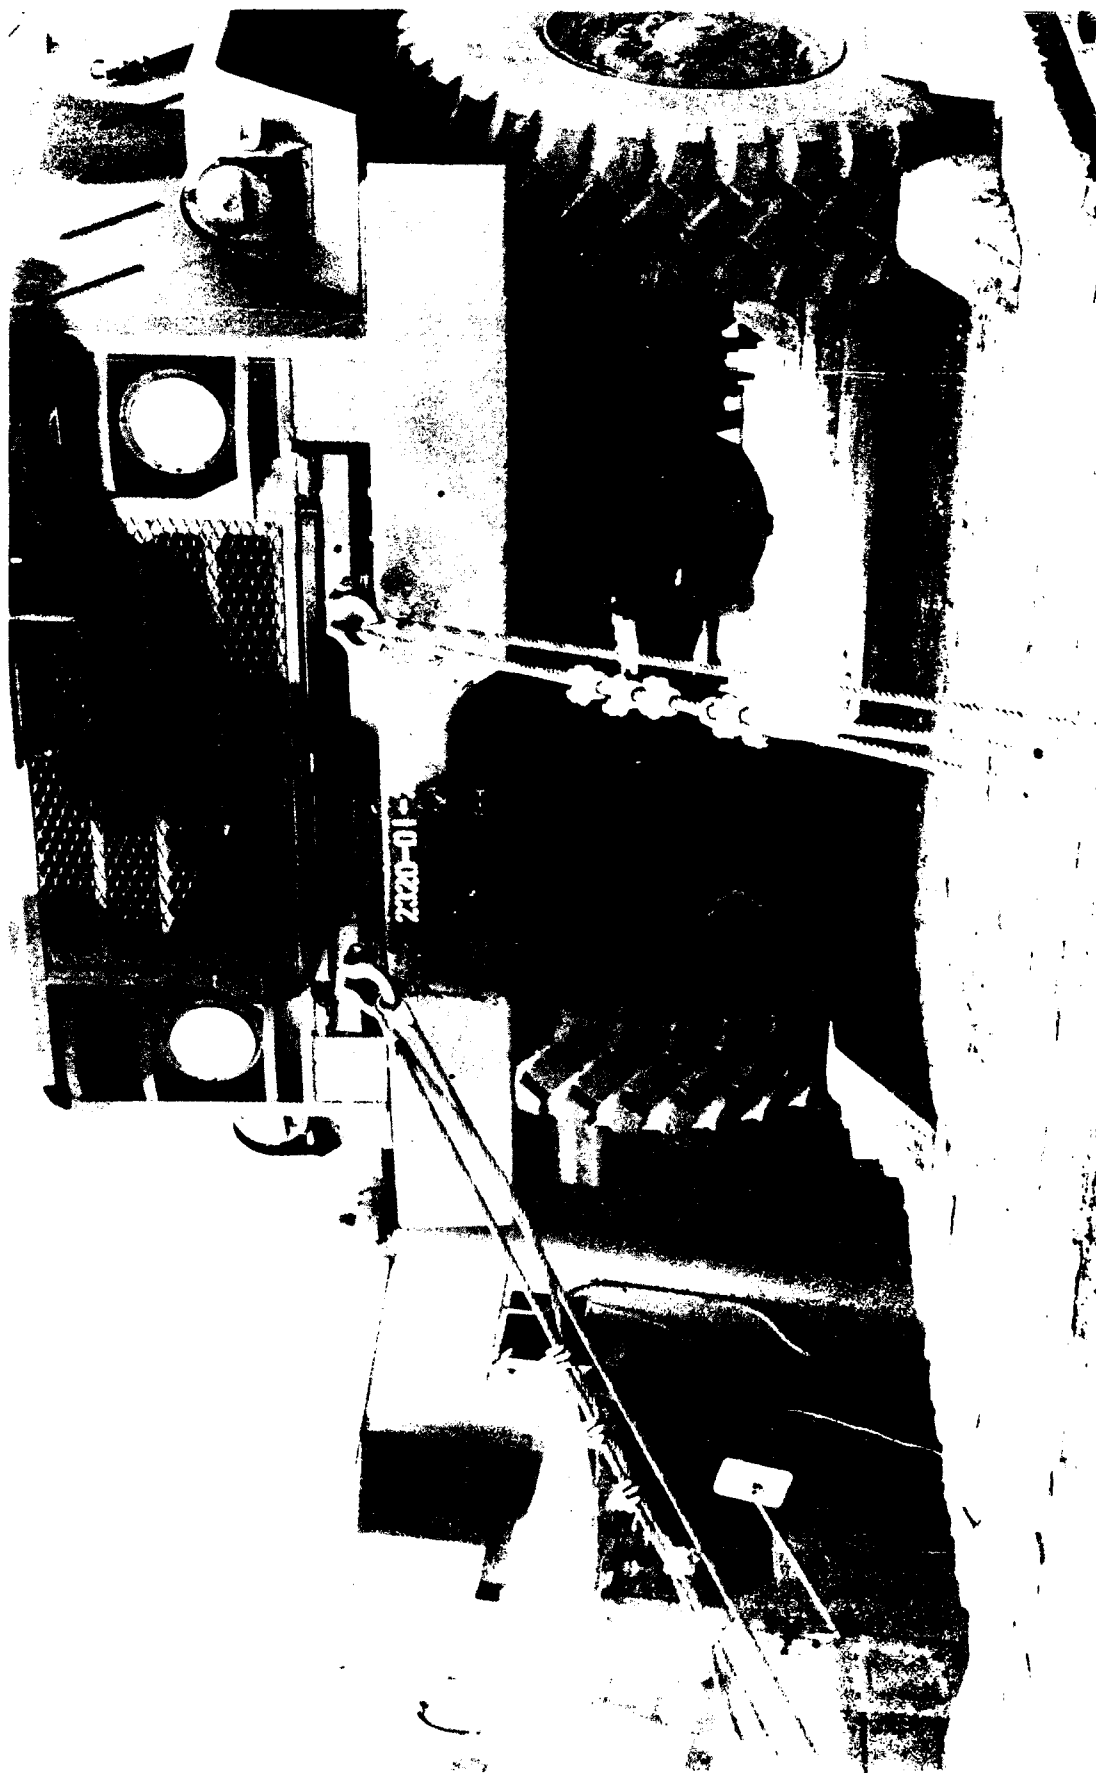
Photo No. A0317-SPN92-180-1593. This photo shows the tiedown configuration used to secure the M923A1 5-ton truck to a flatcar for rail transportation. The shackles mounted on the bumper are not the standard issue. Previous testing has shown that the shackles used here will withstand the rail transportation environment, while those issued with the truck do not. The stock number for these replacement shackles is NSN 4030-01-222 6037.

1. The front shackles on each truck must be replaced as the ones delivered were not strong enough to secure the trucks in a rail transportation environment. The replacement shackle which was found to have adequate strength is NSN: 4030-01-222-6037.
