CRACK FORMATION IN F-15 AIRCRAFT CANOPIES

Geoffrey J. Frank  
Gregory J. Stenger

University of Dayton Research Institute  
Dayton, Ohio 45469-0110

Interim Report for Period May 1990 - September 1990

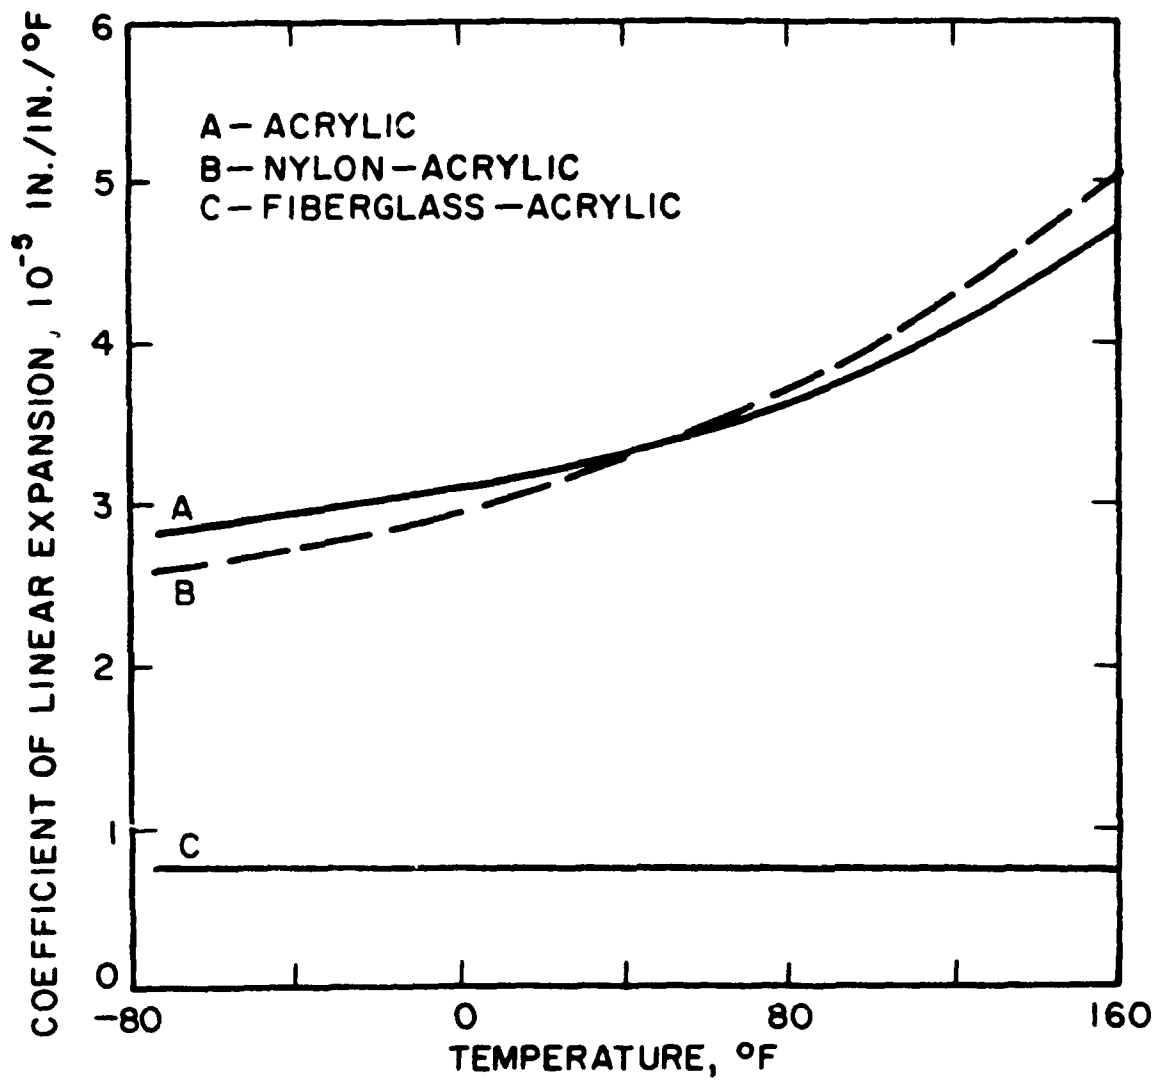
Figure 3 Effect of Temperature on Linear Coefficient of Thermal Expansion for Various Materials (Ref. 1)

The difference in coefficient of thermal expansion between acrylic plastic and fiberglass-acrylic laminate is well known and is presented in Figure 3 (Ref. 1). An analysis was conducted to determine under what conditions the stresses induced in the stretched acrylic plastic due to this thermal mismatch could produce crack propagation in the acrylic.
