Report No. CG-D-13-93

Smoke Control Systems Analyses

Balancing Ducts Versus Door Vents in Class B Bulkheads

W. Mark Cummings

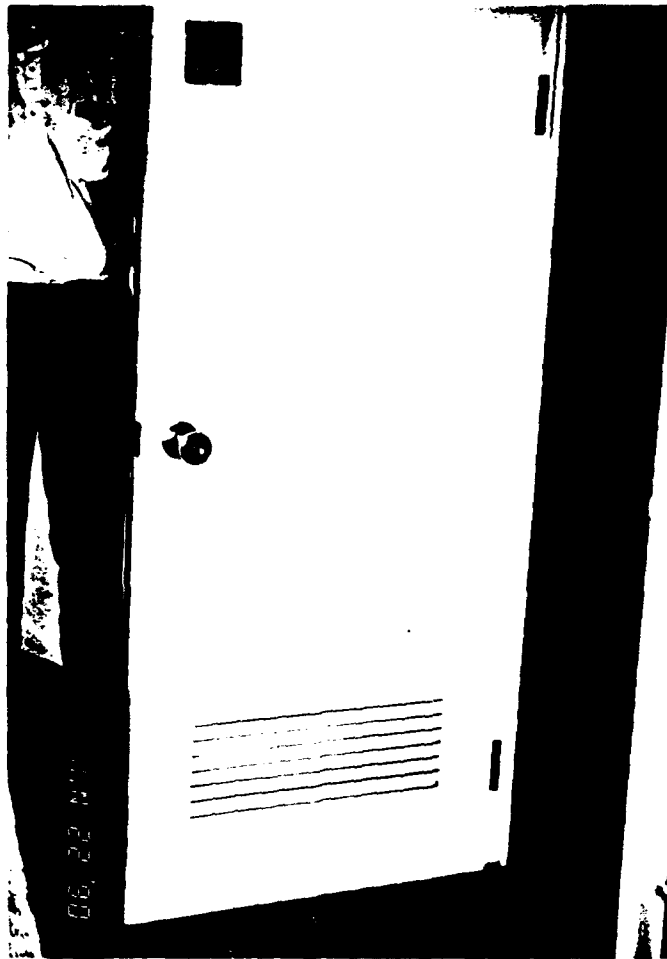
Figure 1-2 Solas-size Door Vent (taken on an actual passenger vessel)

1.2.1 Door Vents: The requirements for door vents vary significantly between the CFR and SOLAS. The CFR allows the vent to be up to 2 ft² (0.186 m²) in area, where SOLAS allows only 0.05 m² (0.54 ft²). Since the majority of ships which the Coast Guard concerns itself must meet SOLAS requirements, the SOLAS-sized vent was used for this test series. Figure 1-2 shows a typical SOLAS-sized door vent similar to that used in this test series.

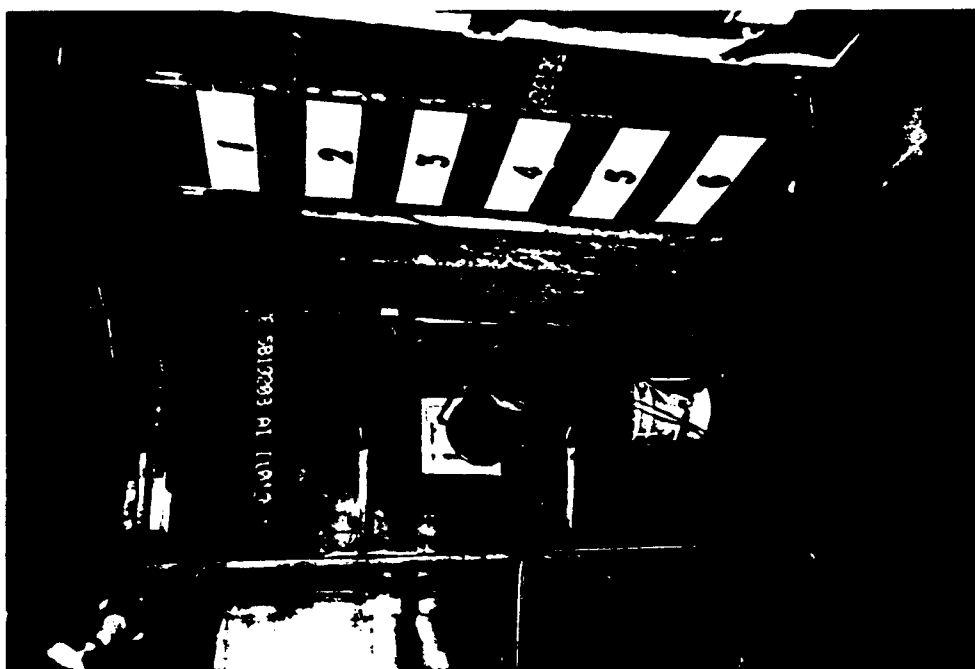
B. Test compartment camera focused on target board. Area 3 target board and instrument tree.
