Miscellaneous Paper W-93-1
August 1993

Proceedings, U.S. Army Corps of Engineers Workshop on Reservoir Shoreline Erosion: A National Problem

26-30 October 1992
McAlester, OK

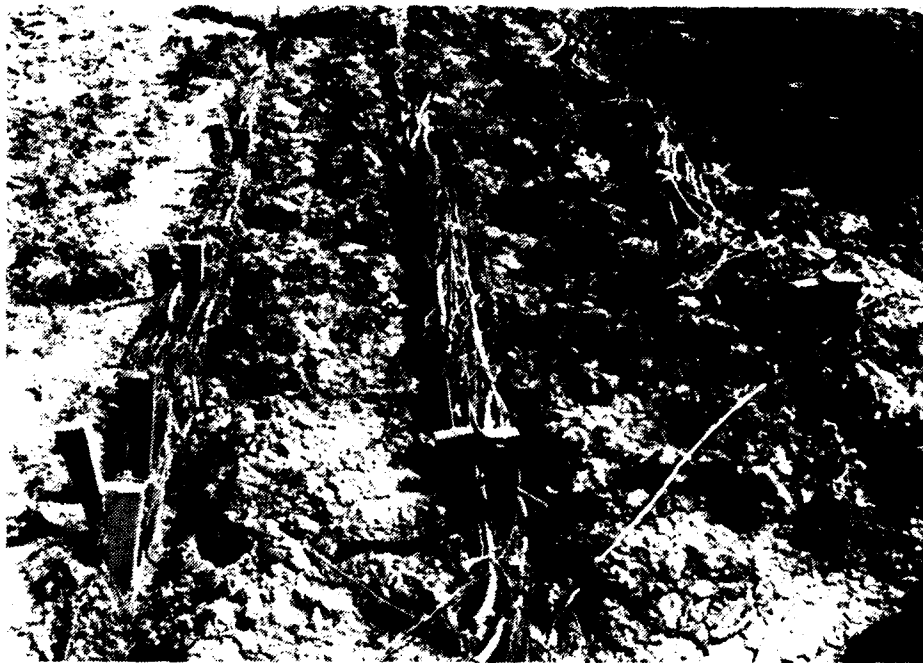
Figure 3. Baker Bay project site, horizontal wattles before initial inundation

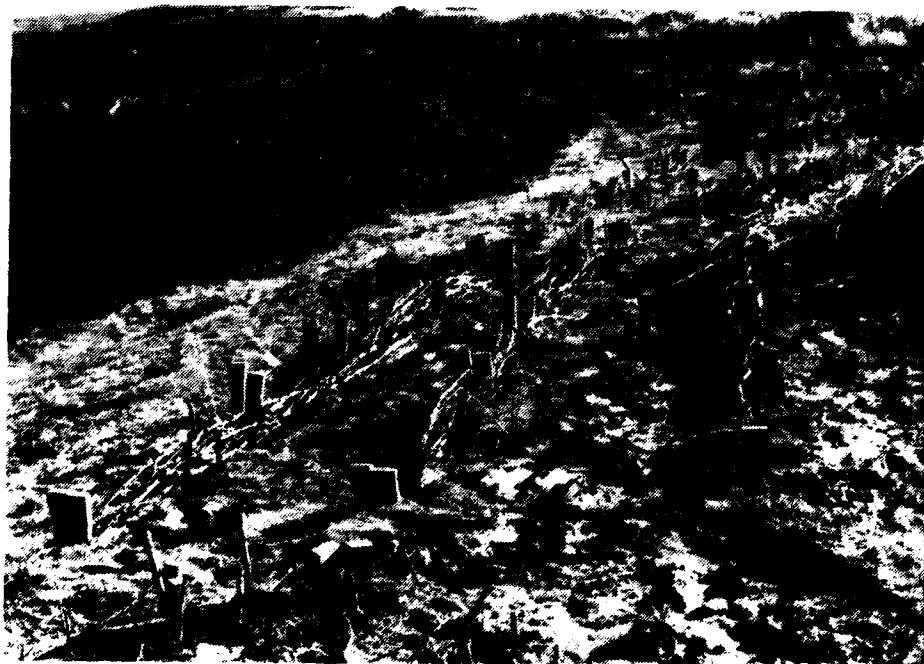
Figure 4. Baker Bay project site, horizontal wattles after three inundations

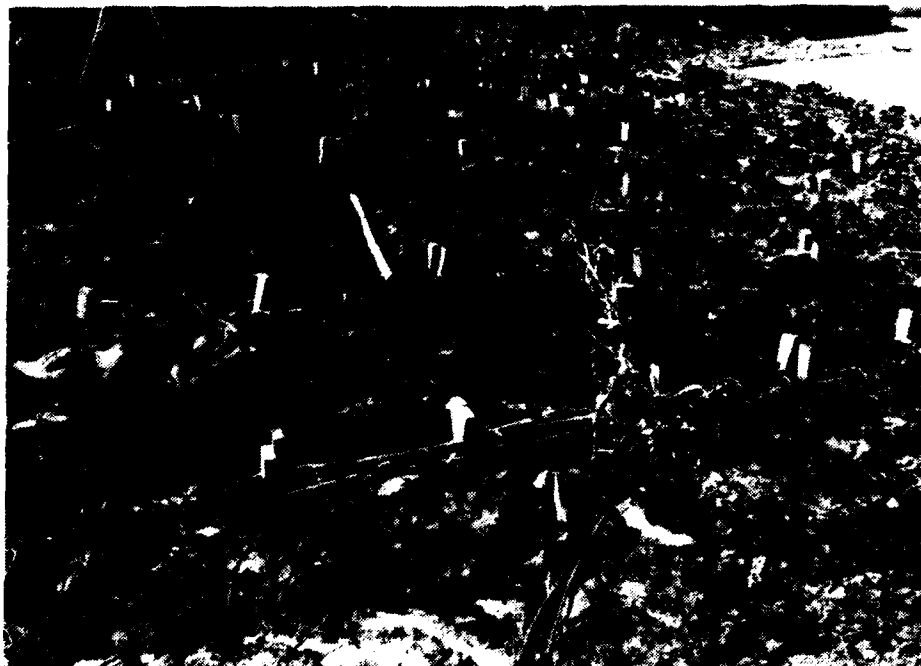
Figure 6. Baker Bay project site, diagonal wattles before inundation

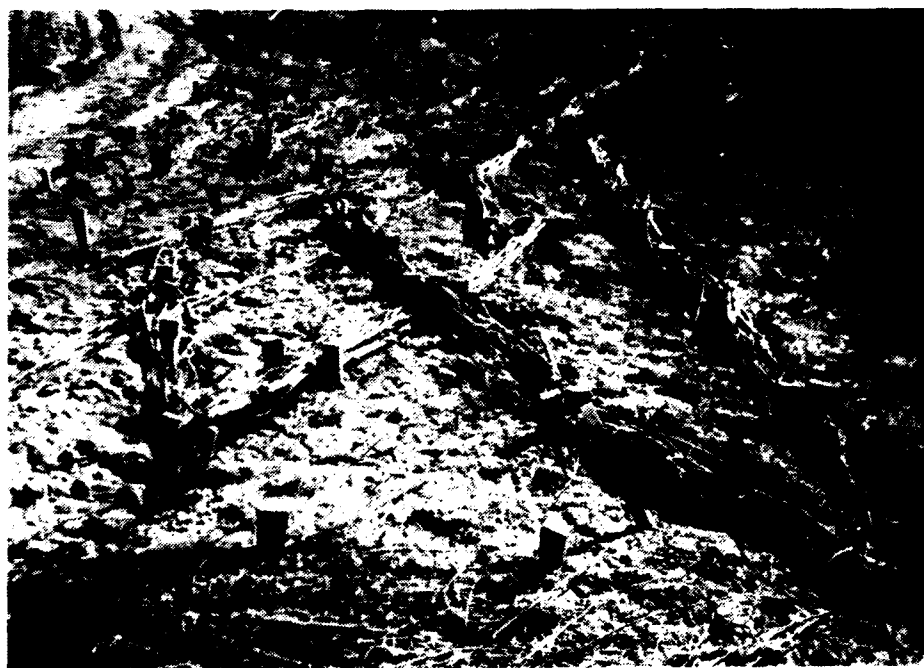
Figure 7. Baker Bay project site, diagonal wattles after two inundations

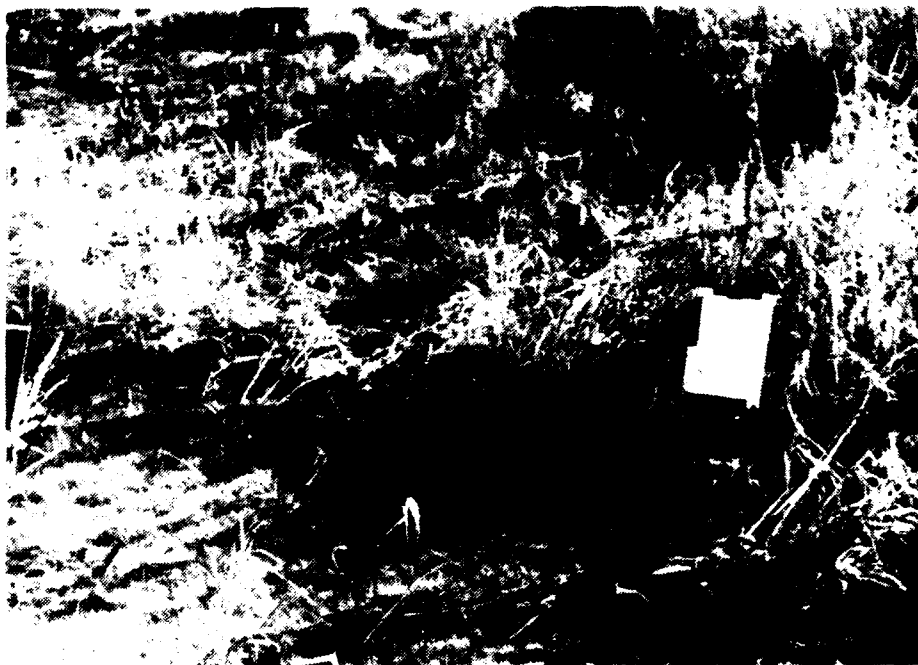
Figure 24. Baker Bay project site willow matting after three inundations.
Note that center left and lower right mats are heavily invaded

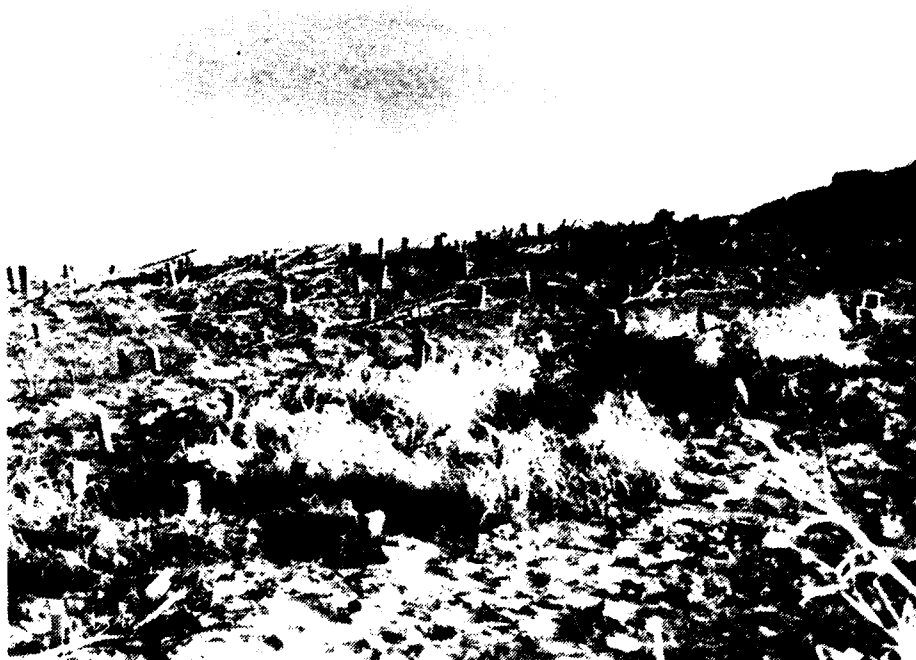
Figure 25. Baker Bay project site, barren wattles after three inundations (lower right and middle left). Note matting in center is heavily invaded and stabilized by reed canarygrass

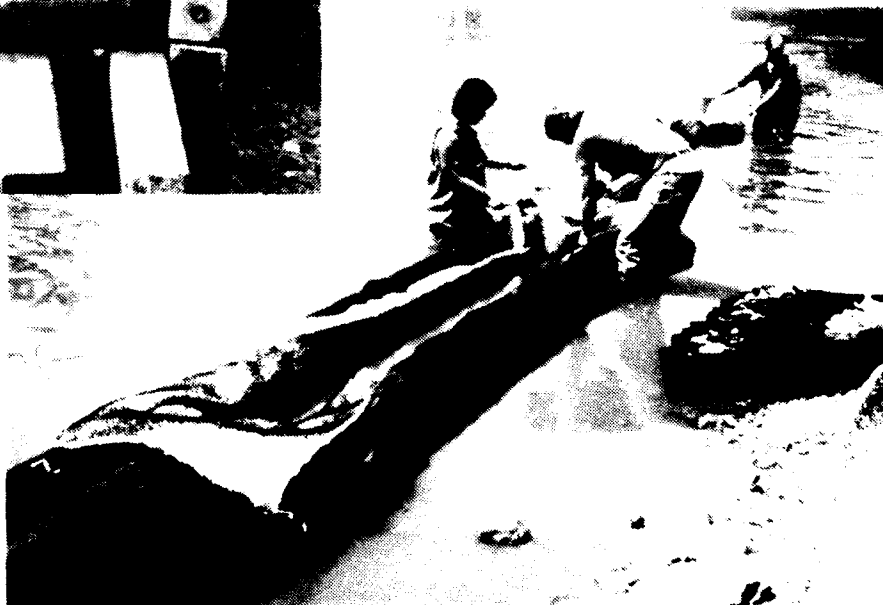
Figure 4. Three floating island designs
