WL-TR-93-4059

RAPIDLY SOLIDIFIED OXIDATION  
RESISTANT NIOBIUM BASE ALLOYS

GENERAL ELECTRIC AIRCRAFT ENGINES  
ONE NEUMANN WAY  
CINCINNATI OH 45215-6301

FINAL REPORT FOR 06/01/87-03/01/92

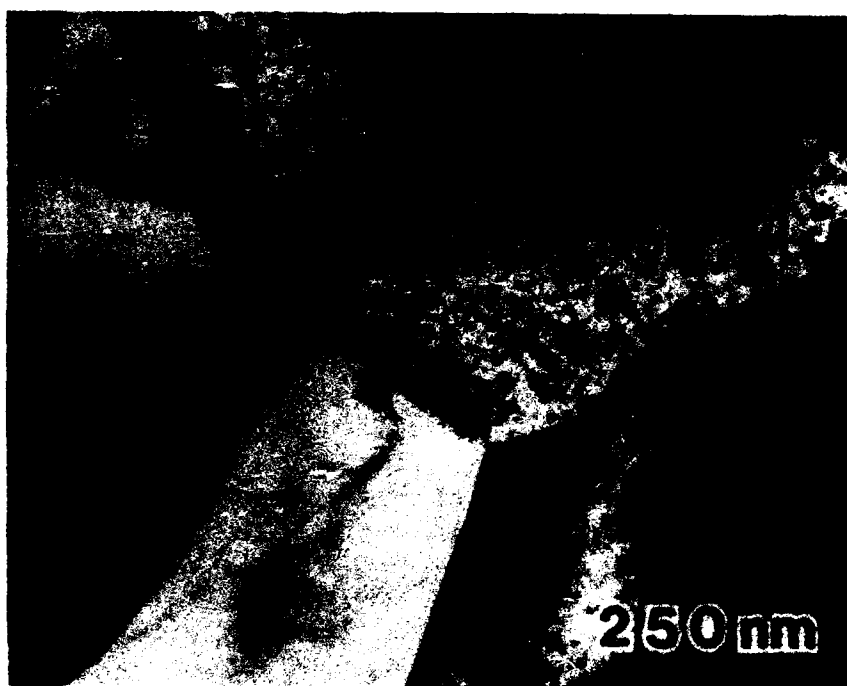
Figure 3.14 Bright field TEM micrograph of as-melt spun Nb-10Al-20Cr (alloy H3).

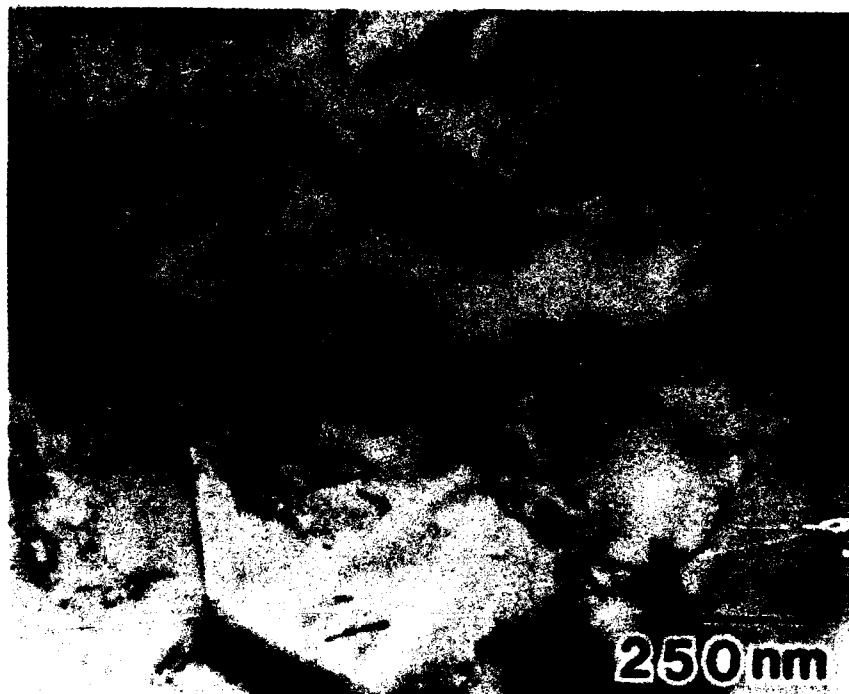
Figure 3.22 Bright field TEM micrograph of Nb-15Al-5Cr (alloy H4) melt-spun ribbon after heat treatment at 600°C for 1 hour.

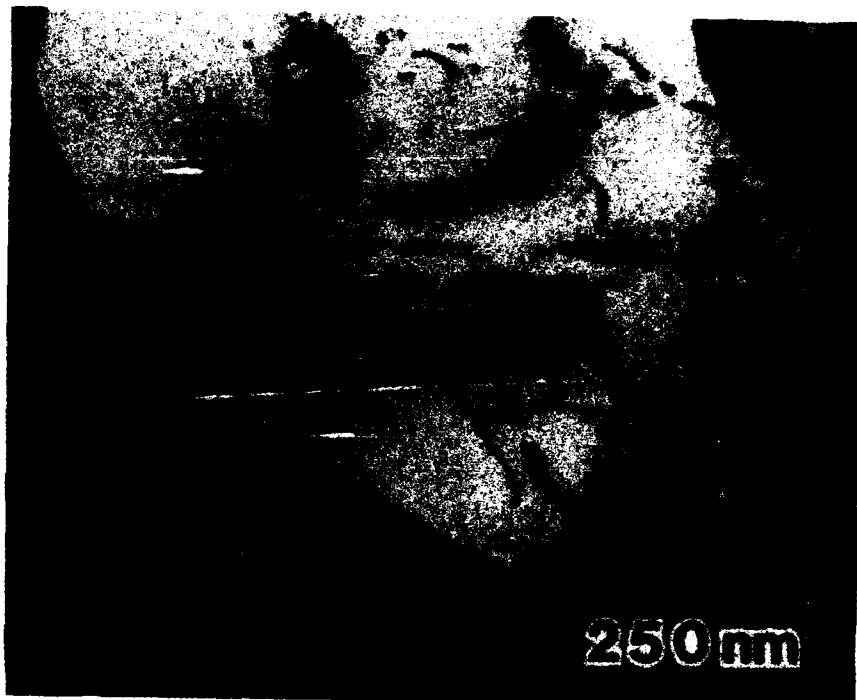
Figure 3.32 Bright field TEM micrograph of as-melt spun Nb-15Al-20Cr-20Ti (alloy H10).

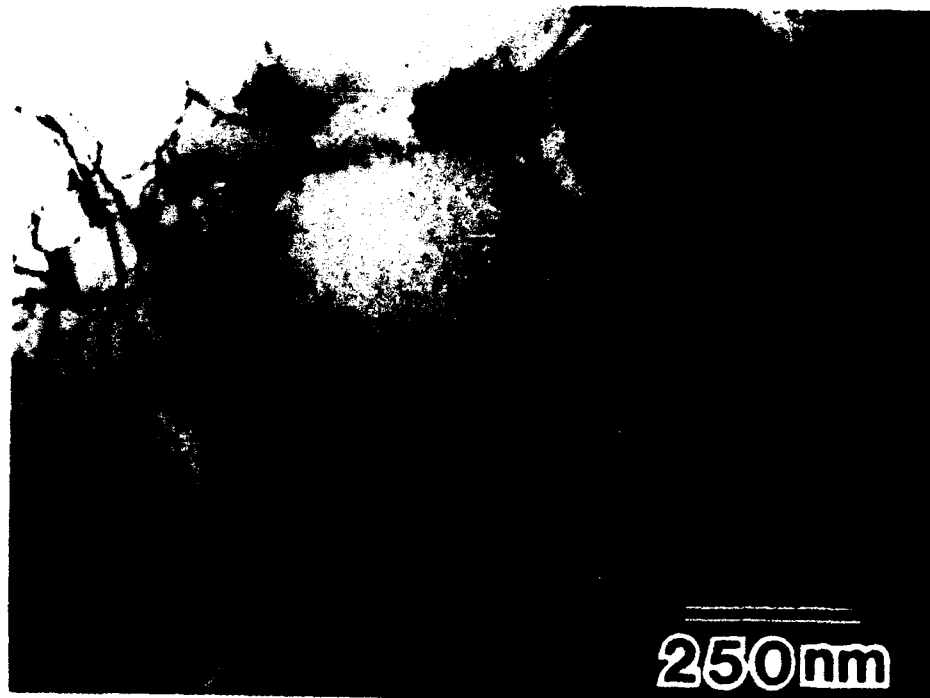
Figure 3.40 Bright field TEM micrograph of as-melt spun Nb-10Al-10Cr-10Ti-15W (alloy S1).

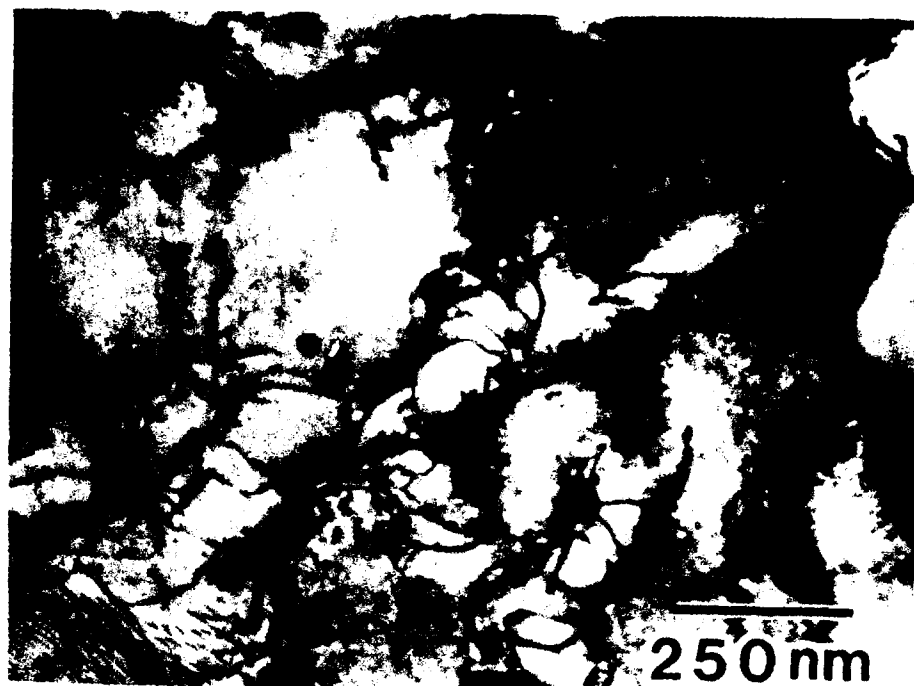
Figure 3.45 Bright field TEM micrograph of as-melt spun Nb-10Al-10Cr-10Ti-10W-1Er (alloy S5)

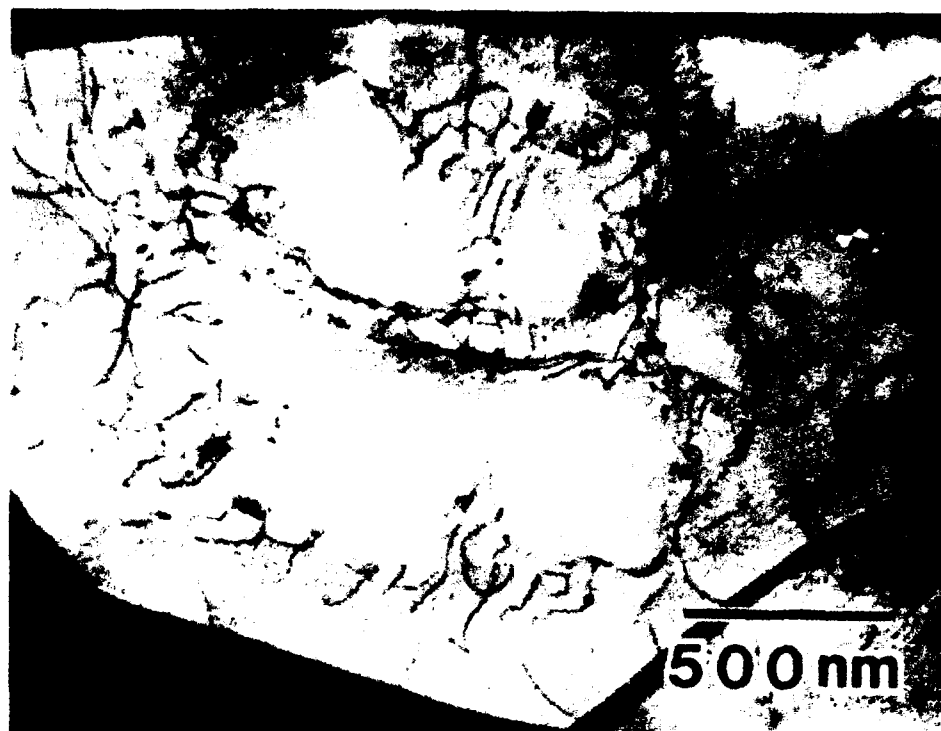
Figure 3.49 Bright field TEM micrograph of as-melt spun Nb-15Ti-15W-3Mo-1Zr-1Er (alloy S7)

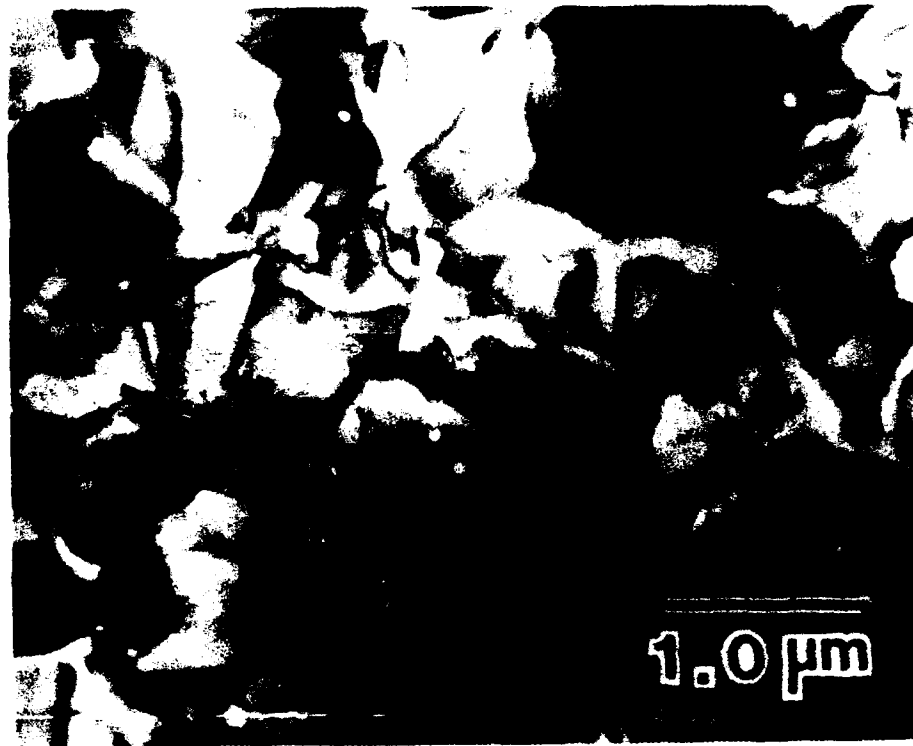
Figure 3.55 Bright field TEM micrograph of as-melt spun Nb-10Al-10Cr-15Ti-15W-1Zr-1Er (alloy S10).

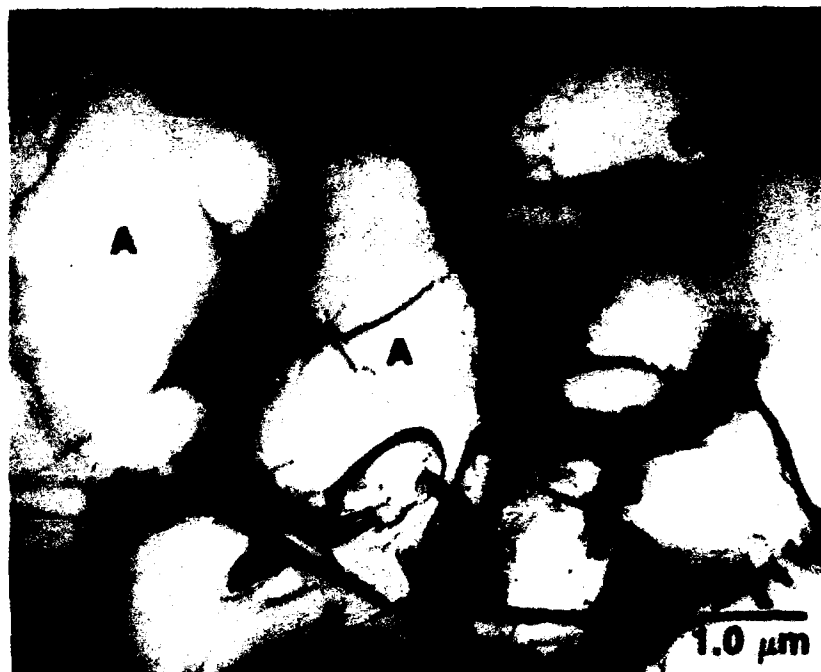
Figure 3.57 Bright field TEM micrograph of as-melt spun and heat treated Nb-10Al-10Cr-15Ti-10W-1Zr-1Er (alloy S11). Heat treatment was at 600°C for 1 hour.

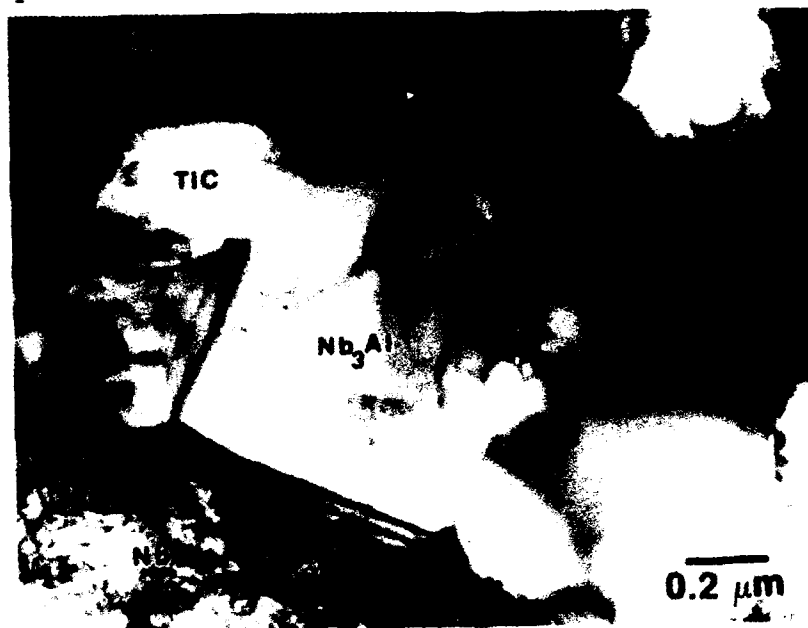
Figure 3.58. Bright-field transmission electron micrographs recorded from typical areas taken from thin foils of powders of alloy P5. Note the dendritic and interdendritic regions, marked A and B, respectively. Also note the presence of small particles, which have been identified as  $\text{Er}_2\text{O}_3$ .

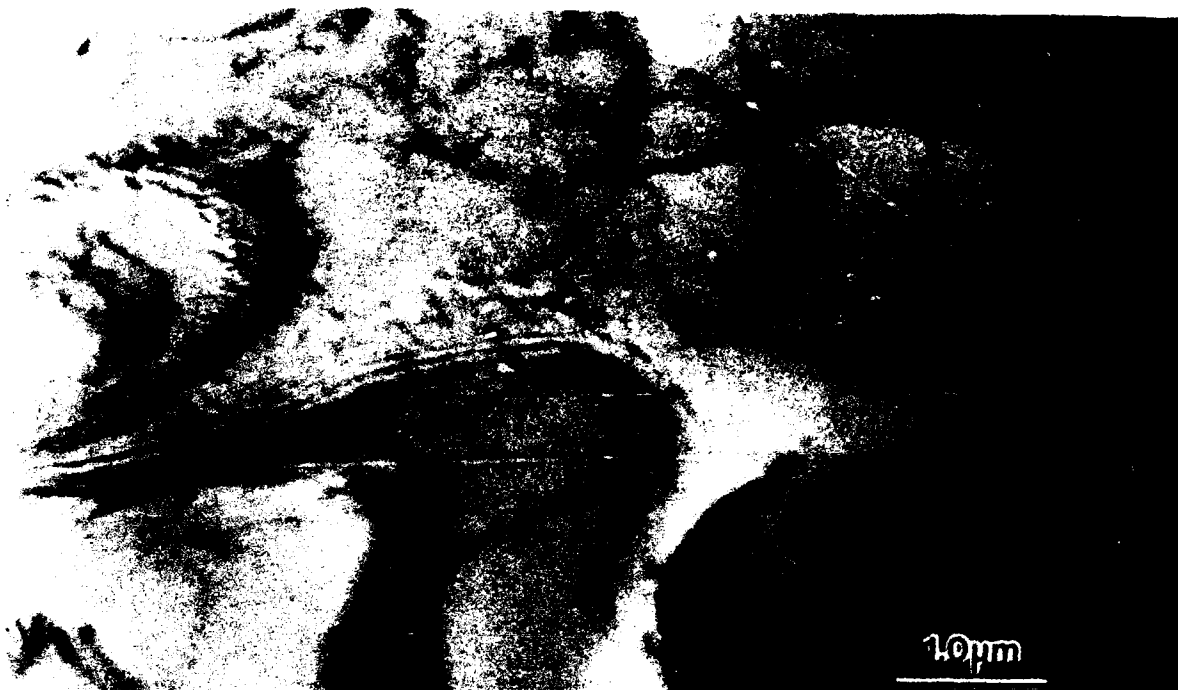
Figure 3.69. Typical bright-field transmission electron micrograph recorded from a thin foil of powder of alloy P8 in the as-atomized condition.

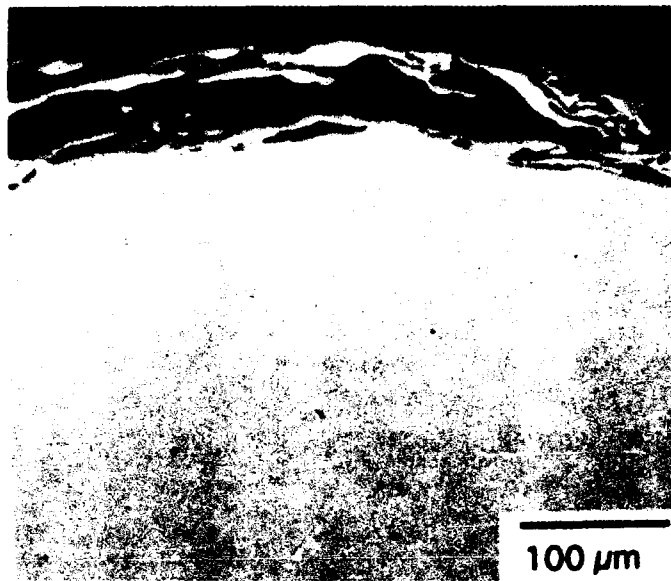
Figure 4.45 Cross sectional optical micrographs of Alloy 14 ( Nb-39Ti-20Al ) after cyclic oxidation at 800°C for 140h. The alloy had good oxidation resistance and segregation was not as apparent as in Alloys 11-13.

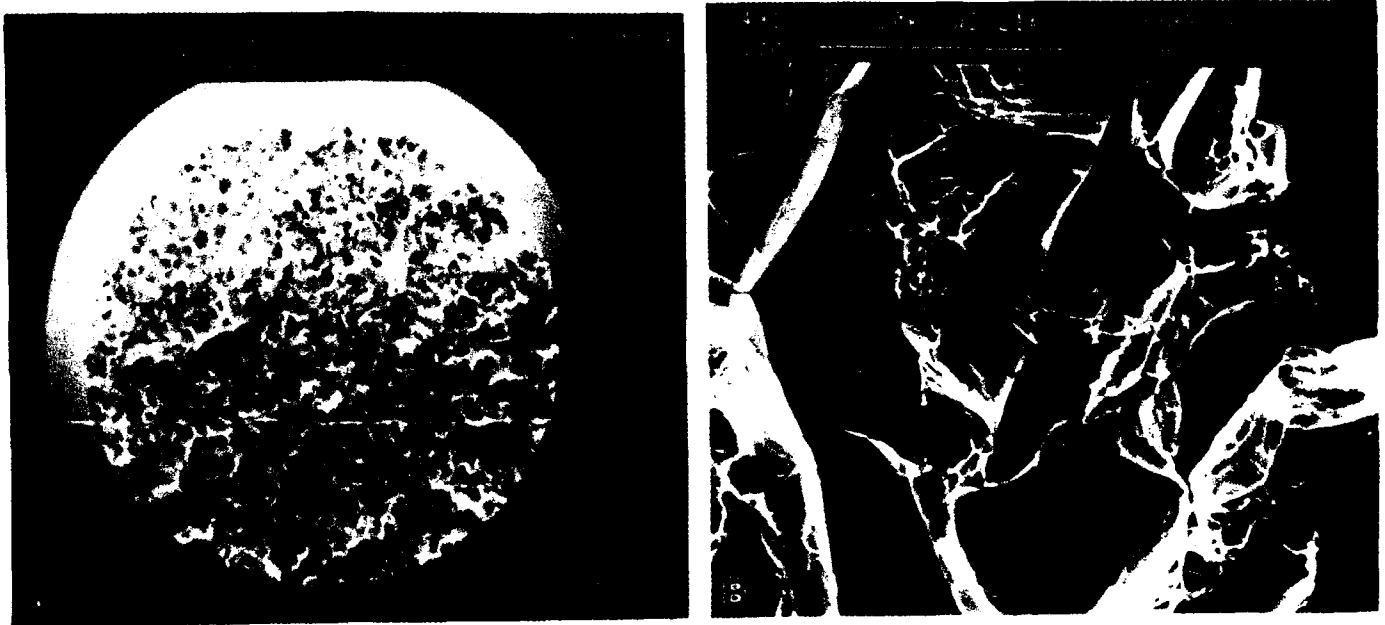
**Figure 5.6** Fracture surface from the room temperature tensile test taken at a) low magnification and b) high magnification showing intergranular failure with a small amount of dimple failure.

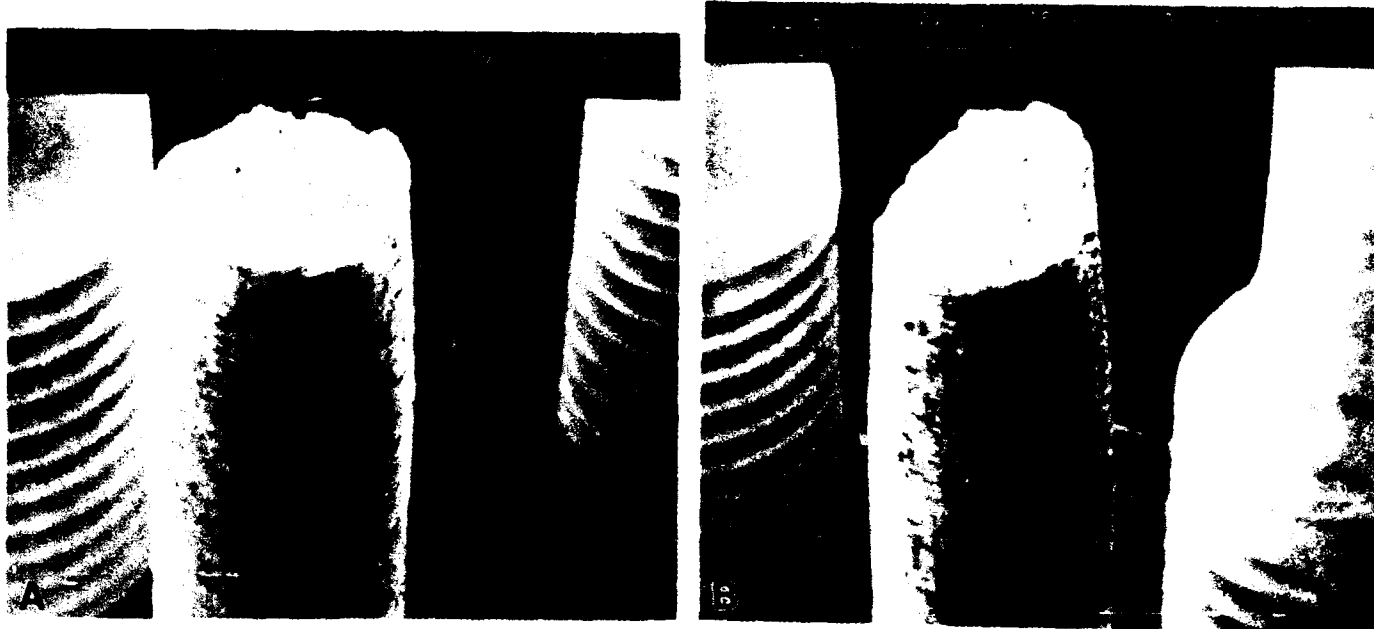
Figure 5.12 Low magnification secondary electron images of specimens which were creep tested at a) 870°C / 275MPa, and b) 870°C / 205 MPa.

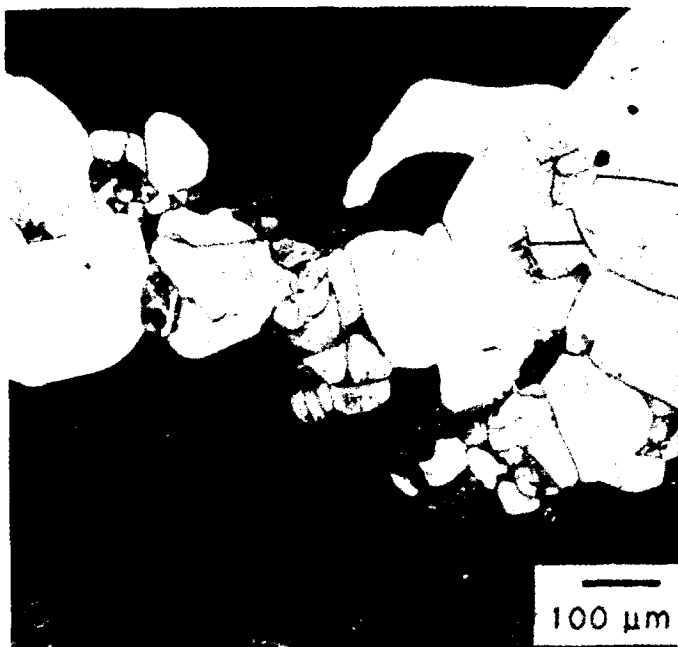
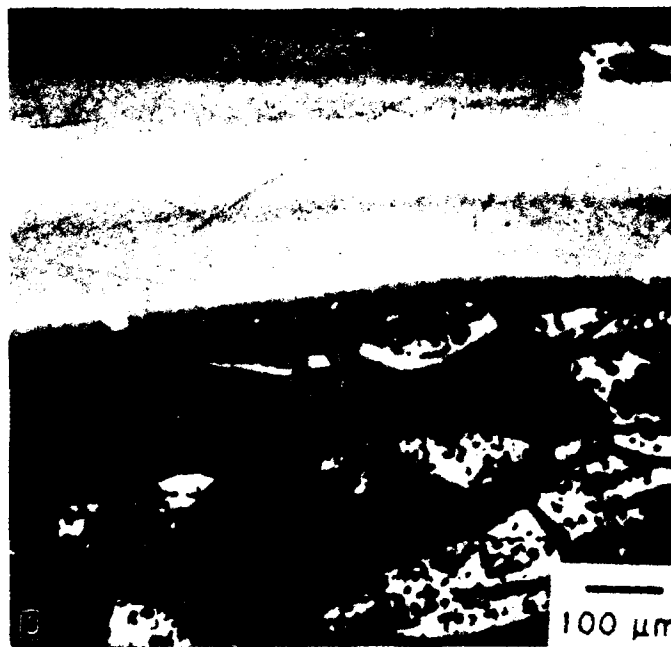
Figure 5.21 Optical micrographs of specimens from Alloy 12 which had been heat treated at a) 900°C / 4h, and b) 950°C / 4h.

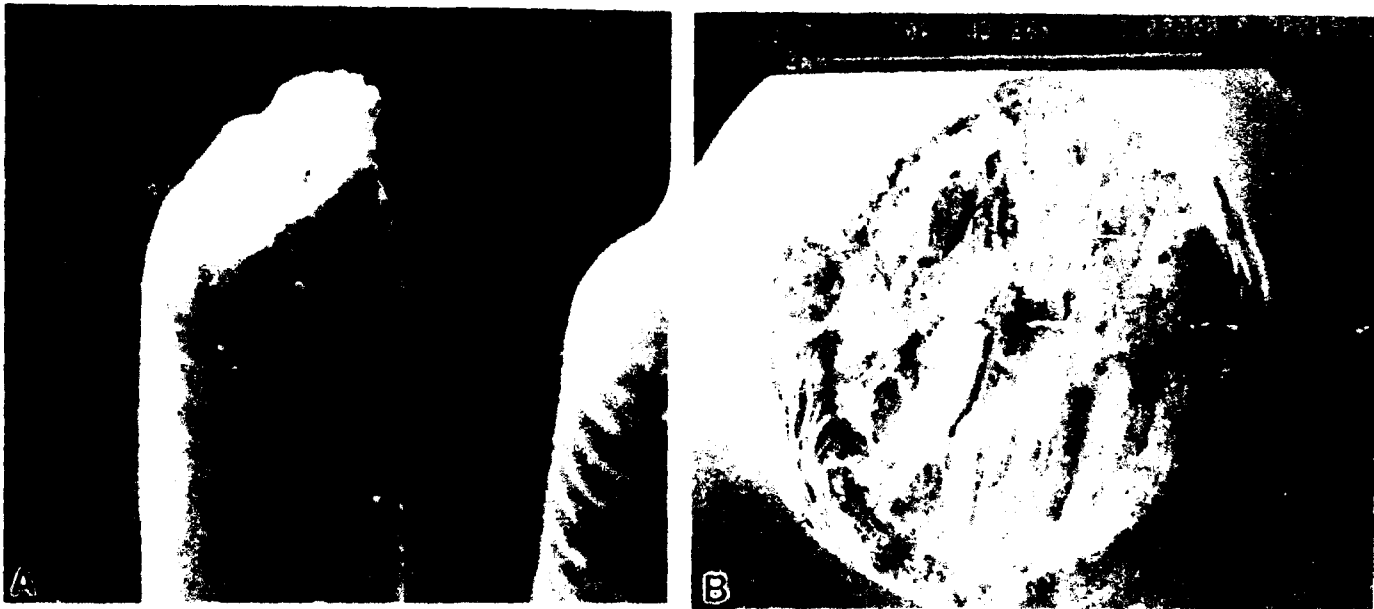
Figure 5.32 Low magnification secondary electron images of a) specimen surface and b) fracture surface from a specimen which was tensile tested at 650°C.

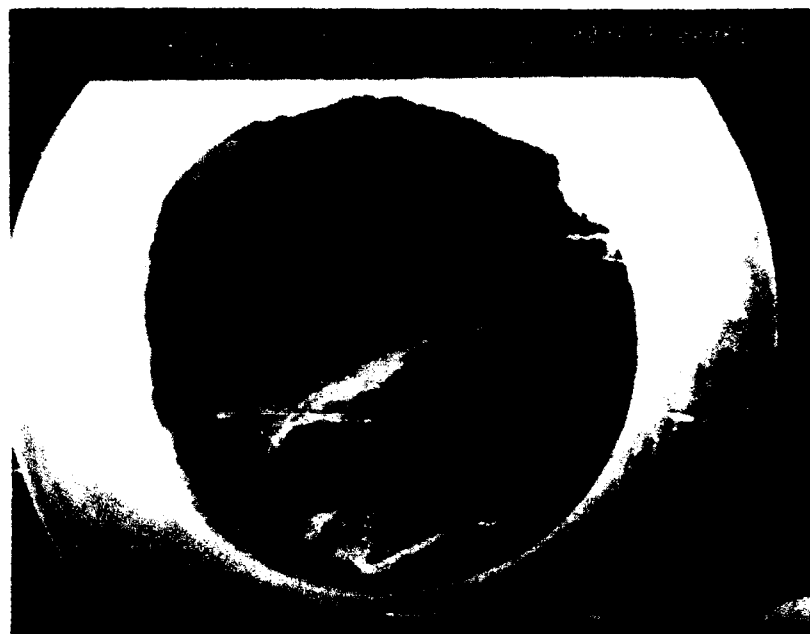
Figure 5.37 Secondary electron micrographs taken at three magnifications from a specimen which had been creep tested to failure in 3.1h at 540°C / 560MPa.

Of the five specimens which were creep tested, three failed within 10 hours, and two were stopped at 100 hours, Table 5.5. Of the three failed specimens, 7T and 7M failed with what appears to be a bimodal fracture surface. The fracture in both specimens appears to have initiated by cleavage failure, Figure 5.37, while the final fracture was by ductile failure mechanisms as shown by the presence of dimples. There was no significant difference observed in the microstructure of these specimens, compared to the tensile specimens, which would cause the observed change in fracture mechanism from ductile failure as shown by dimples to cleavage fracture initiation in the creep test. The brittle region of the fracture surface was tinted, indicating that it had been exposed to the atmosphere longer than the ductile fracture region. At this point the cause of the brittle fracture surface region is not understood. The possibilities are some sort of environmental interaction or a hold time crack growth phenomena. Further investigation would be required to clarify this point. The creep testing which was done at 980°C was similar to the tensile testing done at very high temperature in that the creep test also necked down to a point with high elongations.

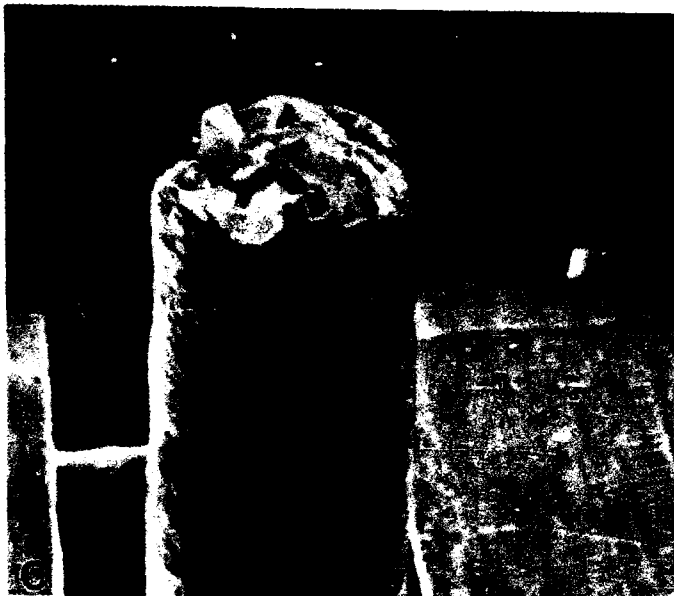
Figure 5.39 Secondary electron images of specimens which were tensile tested following creep for 100 hr at 650°C a) specimen surface, and b) fracture surface and for 100 hr at 760°C c) specimen surface, and d) fracture surface.

Although there had been no plan to perform testing following a stressed exposure, the two unfailed specimens provided the opportunity to do this type of testing. Therefore, the two unfailed specimens were sent back for tensile testing to failure at room temperature to get an indication of the effect of the stressed exposure on properties. Both a 650°C / 175 MPa and a 760°C / 105MPa specimen were available for this testing. The surface condition of the specimens prior to testing is shown in Figure 5.38, and as expected both surfaces were oxidized with the surface of the 760°C specimen being more oxidized than the surface of the 650°C specimen. The results of the tensile testing are shown in the data table. Specimen 6M exhibited approximately a 50MPa drop in both the yield and ultimate strength with a drop in the elongation from about 12% to about 7%. The fractured specimen exhibited grain deformation and reduction of area, Figure 5.39a, in the gauge section. Fractures on the specimen surface perpendicular to the stress axis, and dimples on the fracture surface, Figure 5.39b, were observed. All of these features are similar to features which were seen in the tensile testing which was done in air. Specimen 6B broke during setup, however, an analysis of the fracture surface indicates that the fracture was very similar to that seen in the test done on specimen 6M including dimples on the fracture surface which would indicate a ductile fracture, Figure 5.39c and d. SEM micrographs of the microstructure of both specimens did not reveal any indications of unusual structure which could be expected to significantly affect the properties, Figure 5.40. It appears that the alloy is not seriously degraded by a stressed exposure, at least at temperatures up to 650°C.

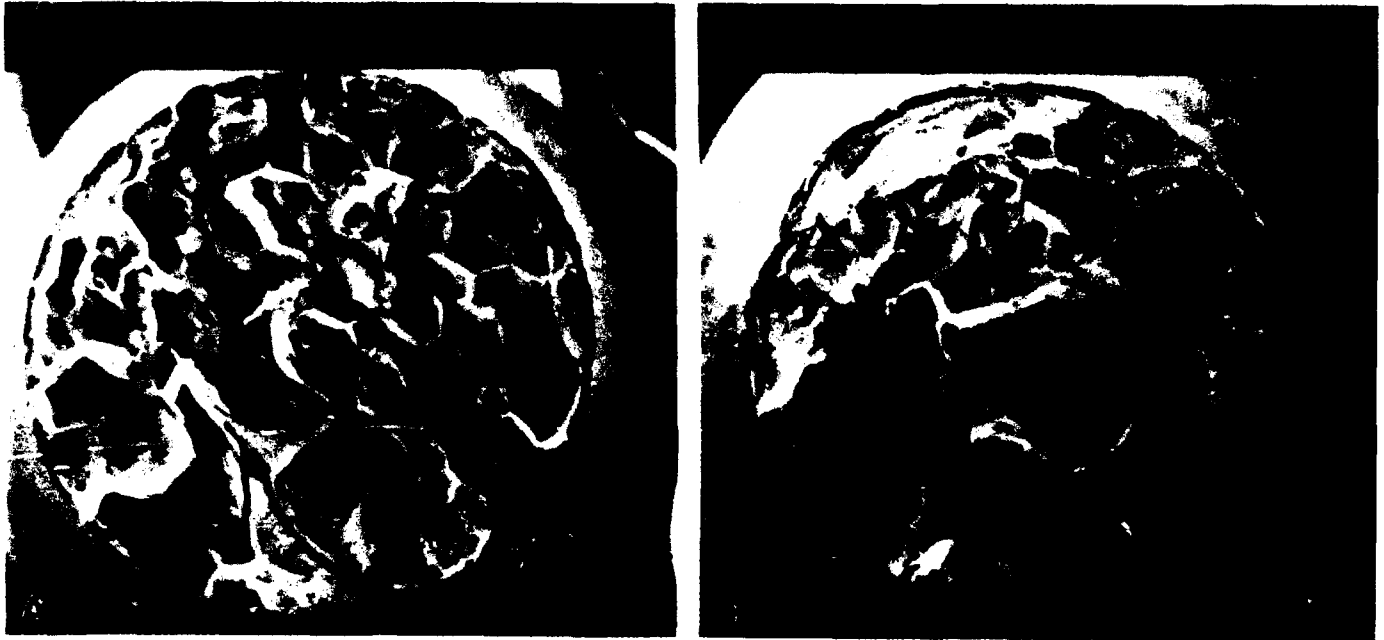
Figure 5.47 Secondary electron images of the fracture surface of specimens which were tensile tested at room temperature following a creep exposure at a) 650°C / 100h, and b) 760°C / 114h.
