Technical Report CERC-93-14  
August 1993

## **Revetment Stability Tests for Sargent Beach, Texas**

Prepared for U.S. Army Engineer District, Galveston

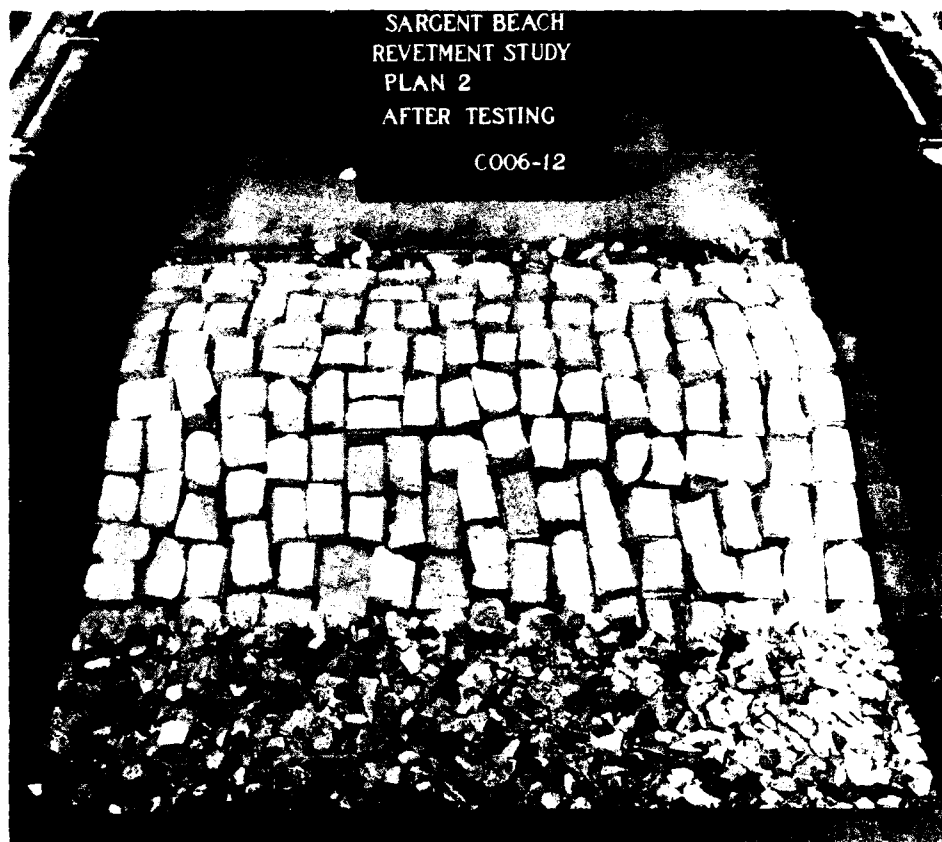
Photo 6. Side view of Plan 2 after wave attack

Photo 7. Sea-side view of Plan 2 after wave attack

Photo 8. Land-side view of Plan 2 after wave attack

Plan 2 was tested for the six-step storm given in Table 2. Only the +4-ft swl was tested, since this water level appeared to be the most critical to toe stability in previous tests of Plan 1. Plan 2 proved to be stable. Similar to Plan 1, minor reorientation of some 200- to 1,000-lb toe stone was observed. Also, several additional 200- to 1,000-lb stones were displaced from the shore-side crest of the structure. The after-testing condition of the structure is shown in Photos 6-8.

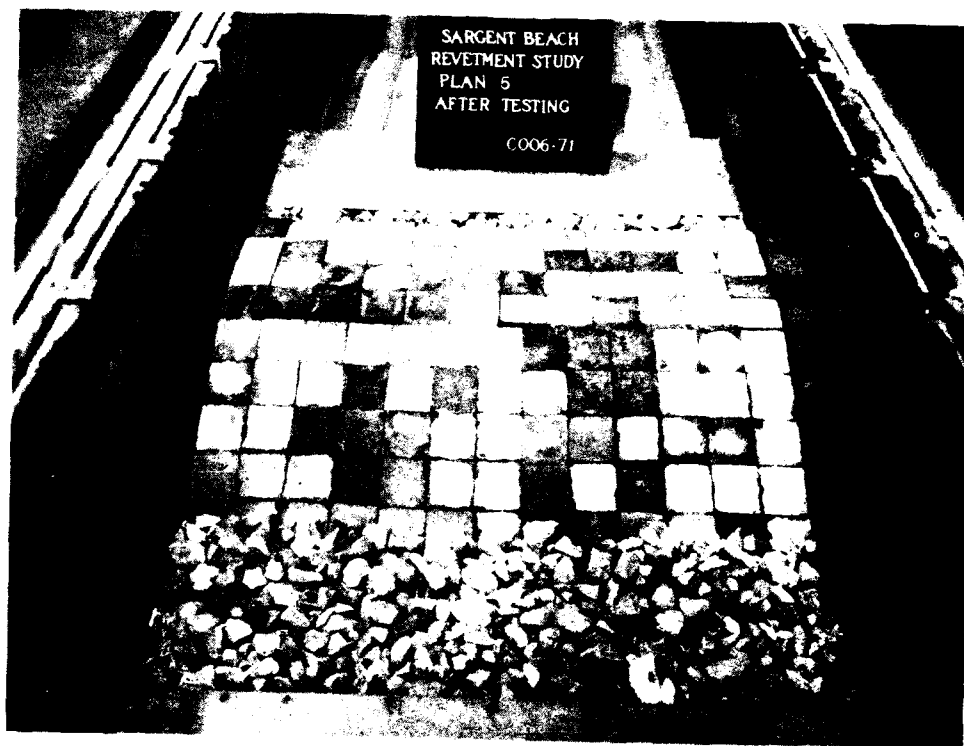
Photo 17. Side view of Plan 5 after wave attack

Photo 18. Sea-side view of Plan 5 after wave attack

Plan 5 (Figure 8) was similar to Plan 4 except it was assumed that the erosion depth in front of the structure was 5 ft less (sea bottom was raised from -8.6 ft mlt to -3.6 ft mlt). Also, the upper toe elevation was raised from -5.0 ft mlt to -3.6 ft mlt. Plan 5 was subjected to the same 24-step test as Plan 1 (Table 1). Testing at the +4-ft swl produced no movement of the concrete blocks. A few of the smaller 200- to 2,000-lb shore-side crest stones were displaced. Two additional crest stones were displaced during continued testing at the +7-, +9.5-, and +14-ft swl's. No movement of the concrete blocks could be detected at any of the swl's. Photos 17 and 18 show the structure after wave attack.

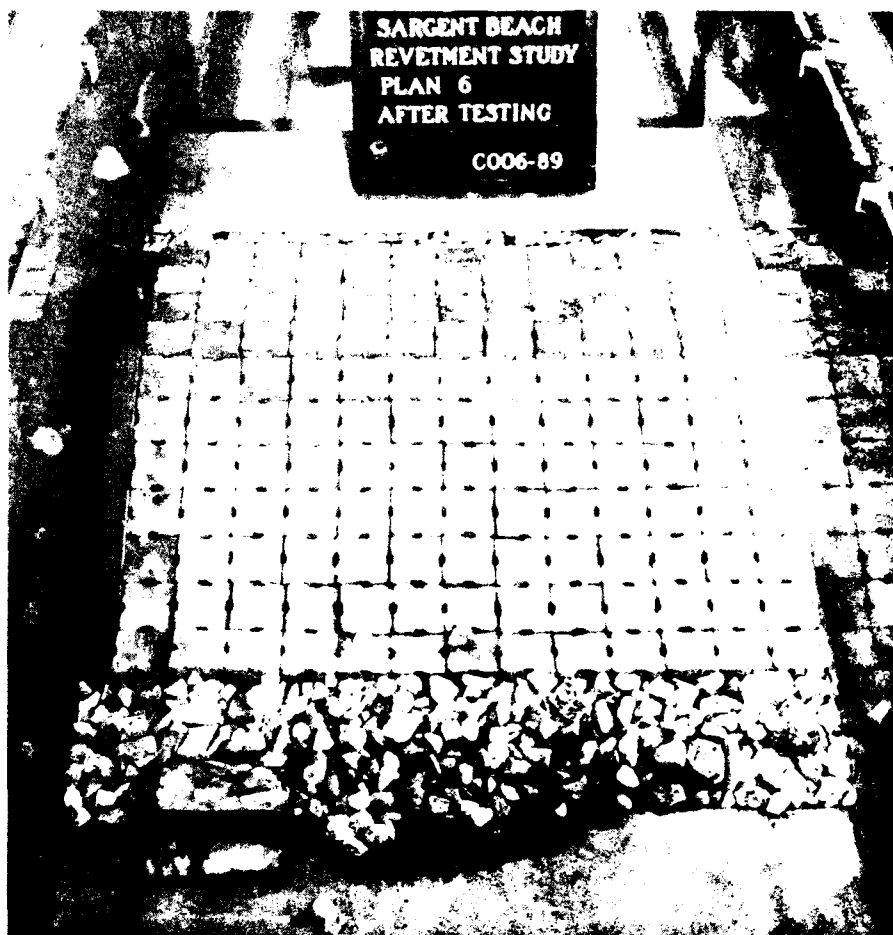
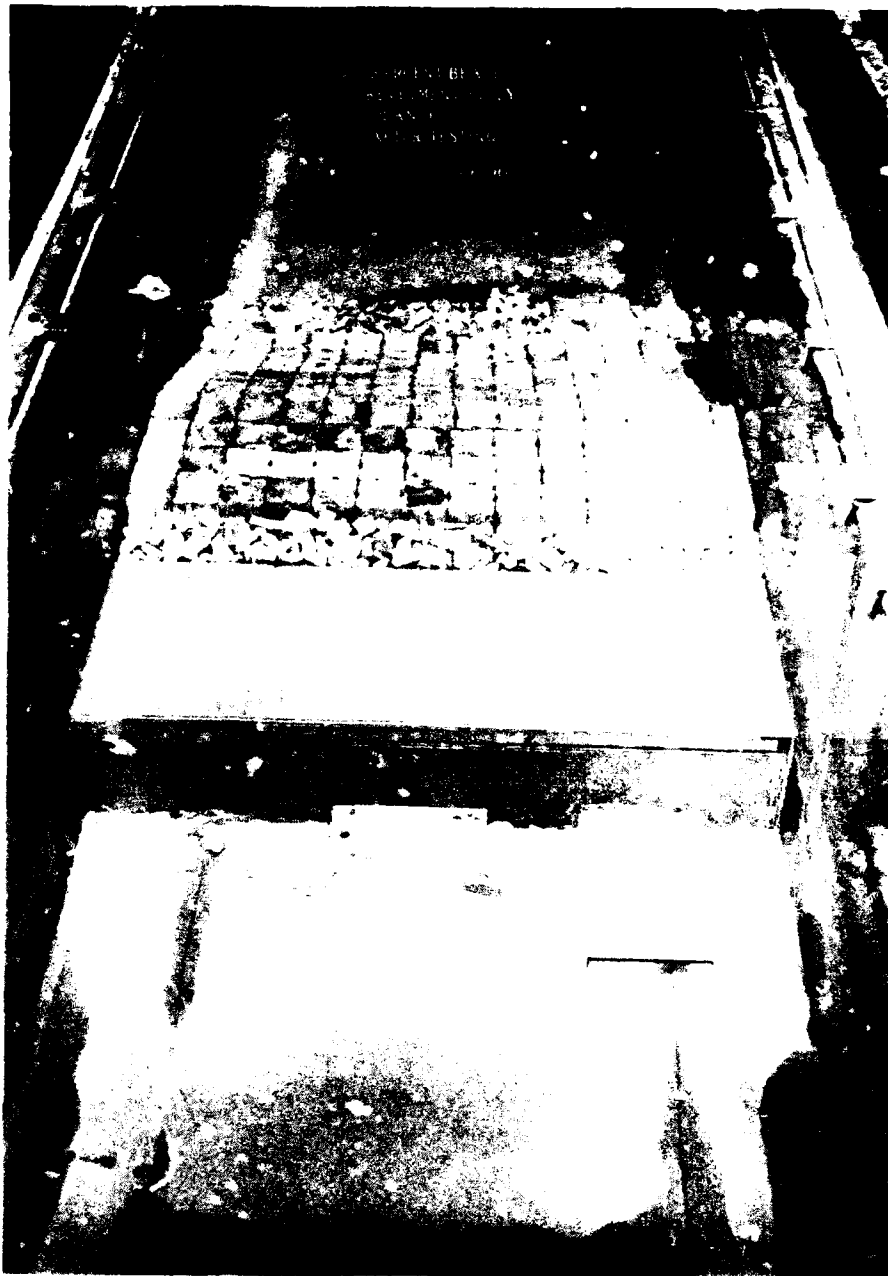
Photo 25. Side view of Plan 6 after testing

Photo 26. Sea-side view of Plan 6 after wave attack

Photo 27. Land-side view of Plan 6 after wave attack

Testing of Plans 1-6 showed wave conditions for the -8.6-ft mlt erosion depth to be significantly more severe than those observed at the -3.6-ft depth; therefore, stability tests for Plans 6 and 6R were conducted only at the -8.6-ft depth and it was assumed results could be conservatively applied to any lesser depth. Plan 6 was subjected to the 16-step test given in Table 5. The concrete blocks proved to be stable for all wave conditions; however, a few of the smaller 200- to 2,000-lb shore-side crest stones were displaced (Photos 25-27).

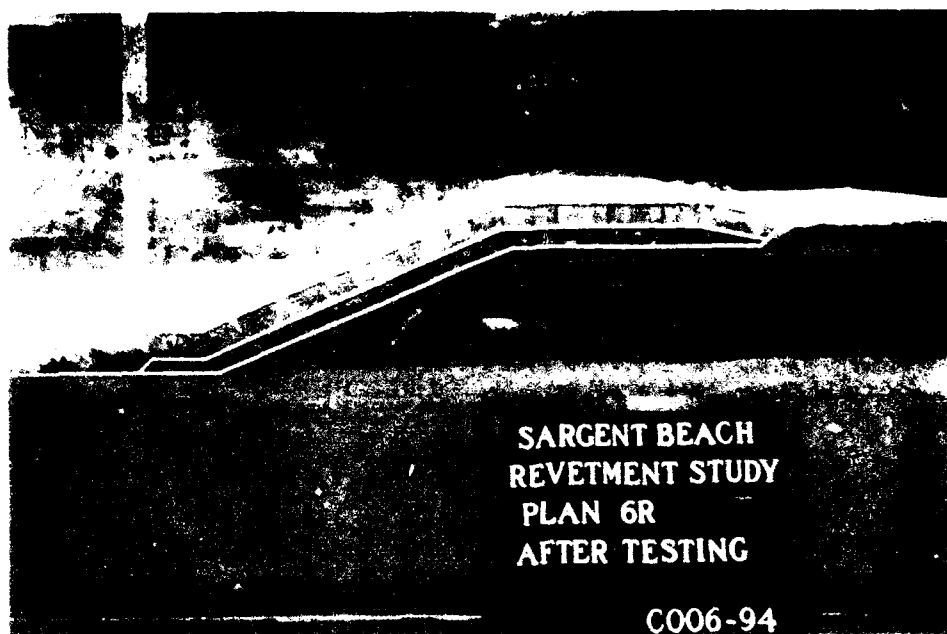
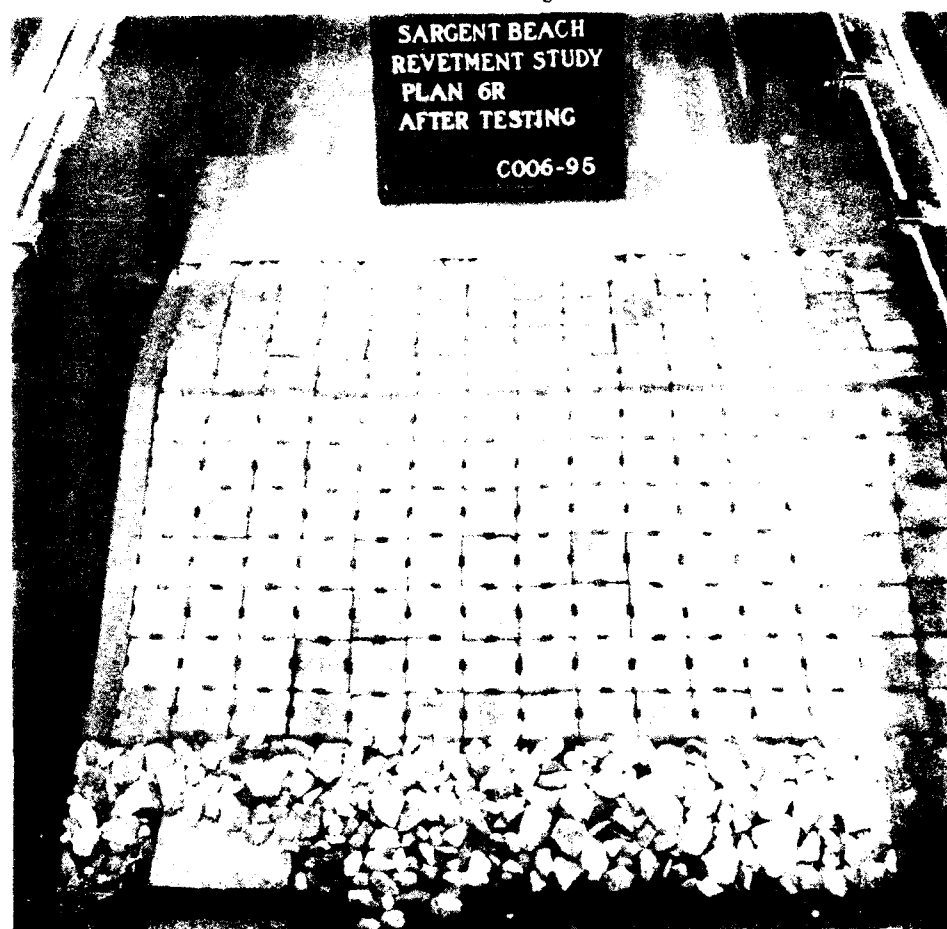
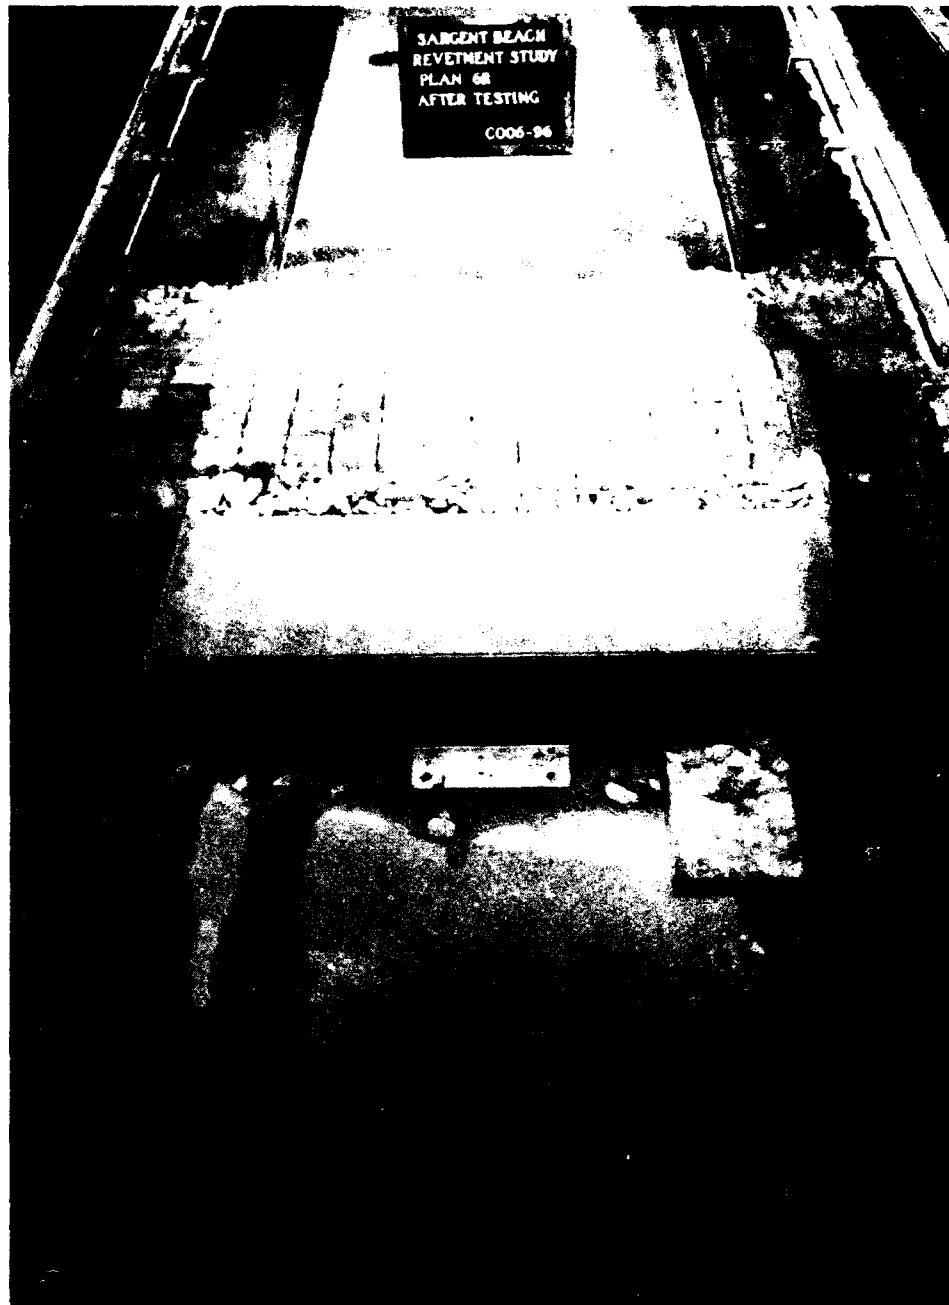
Photo 28. Side view of Plan 6R after testing

Photo 29. Sea-side view of Plan 6R after wave attack

Photo 30. Land-side view of Plan 6R after wave attack

Plan 6R (Figure 9) was a rebuild of Plan 6. It was tested to verify the stability response of the modified concrete blocks. Subjection to the abbreviated worst case hydrograph given in Table 4 produced the same results as the initial test, i.e., no movement of the concrete blocks was detected for any of the wave conditions. Photos 28-30 show the final condition of the test section.

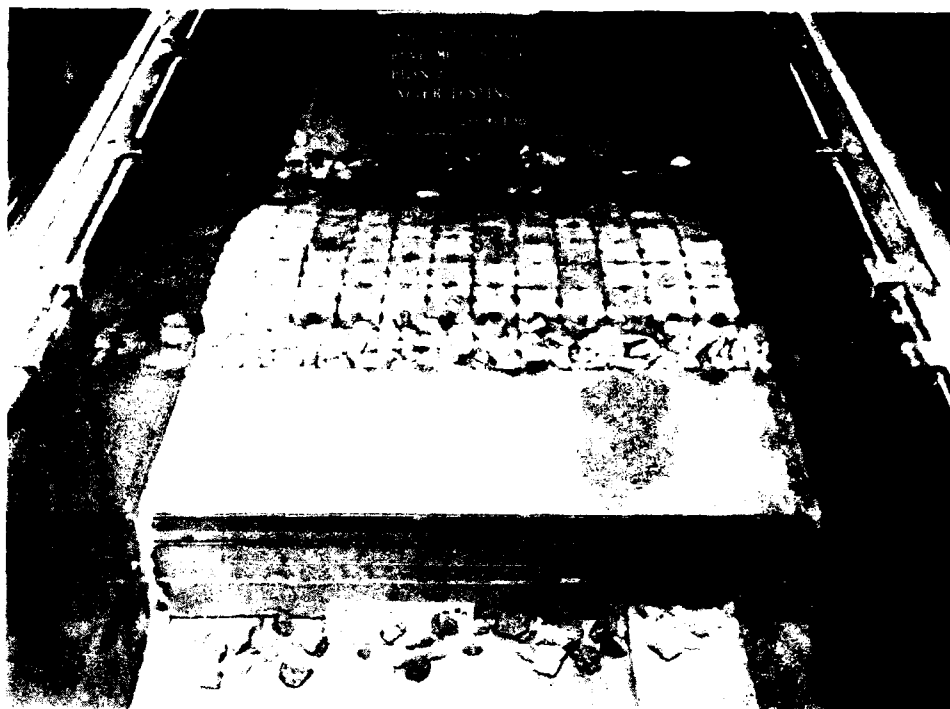
Photo 31. Side view of Plan 7 after wave attack

Photo 32. Sea-side view of Plan 7 after wave attack

Photo 33. Land-side view of Plan 7 after wave attack

Photo 34. Overhead view of Plan 7 after wave attack

Plan 7 was subjected to the 20-step test given in Table 7. Slight seaward shifting of the first row of concrete blocks was initiated at the +4-ft swl. As the toe blocks shifted seaward, the six rows of onslope blocks packed downslope, leaving a gap between them and the three rows of crest blocks. This slow progressive movement continued through the +7-ft swl. At the conclusion of testing, the gap between the slope and crest blocks varied from a few inches to about 1.5 ft (prototype). Individual concrete blocks appeared to be hydraulically stable, i.e., no lifting or displacement was observed. Photos 31-33 show the overall condition of the section after wave attack and Photo 34 shows details of the block separation.

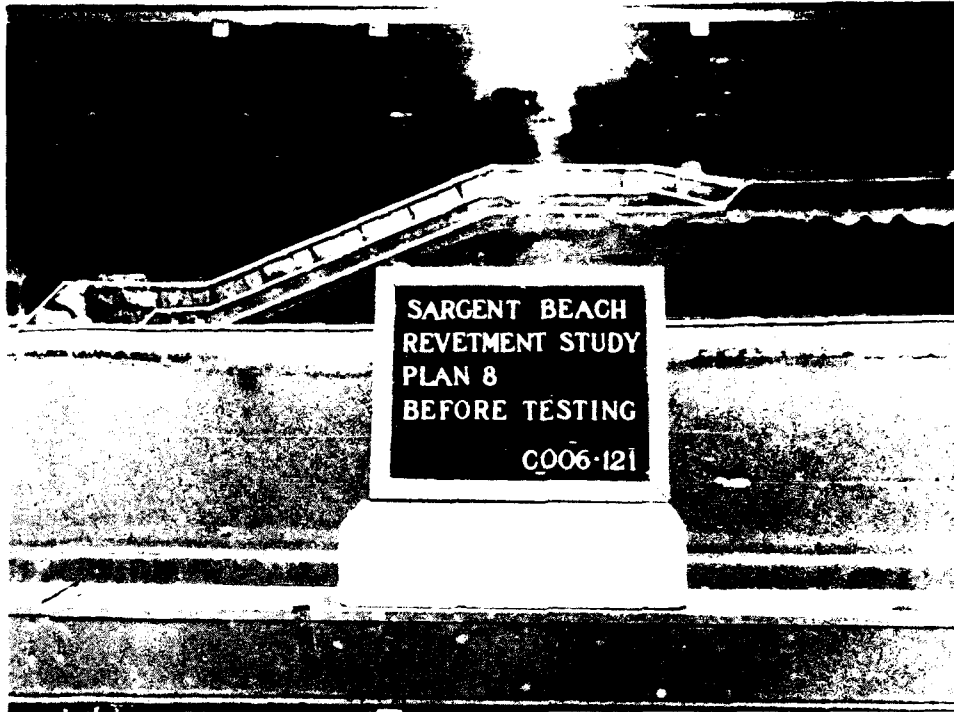
Photo 39. Side view of Plan 8 before wave attack

Photo 40. Sea-side view of Plan 8 before wave attack

Plan 8 (Figure 13 and Photos 39 and 40) was the same as Plan 7, except that the toe stone weight was increased to 200 to 4,000 lb in an effort to improve its stability and hopefully reduce sliding of the concrete blocks. Subjection to the same wave conditions as Plan 7 produced improved results; i.e., the toe stone was stable and the maximum gap between the slope and crest blocks was reduced to about 1 ft (prototype). Photos 41-44 show the structure after wave attack.

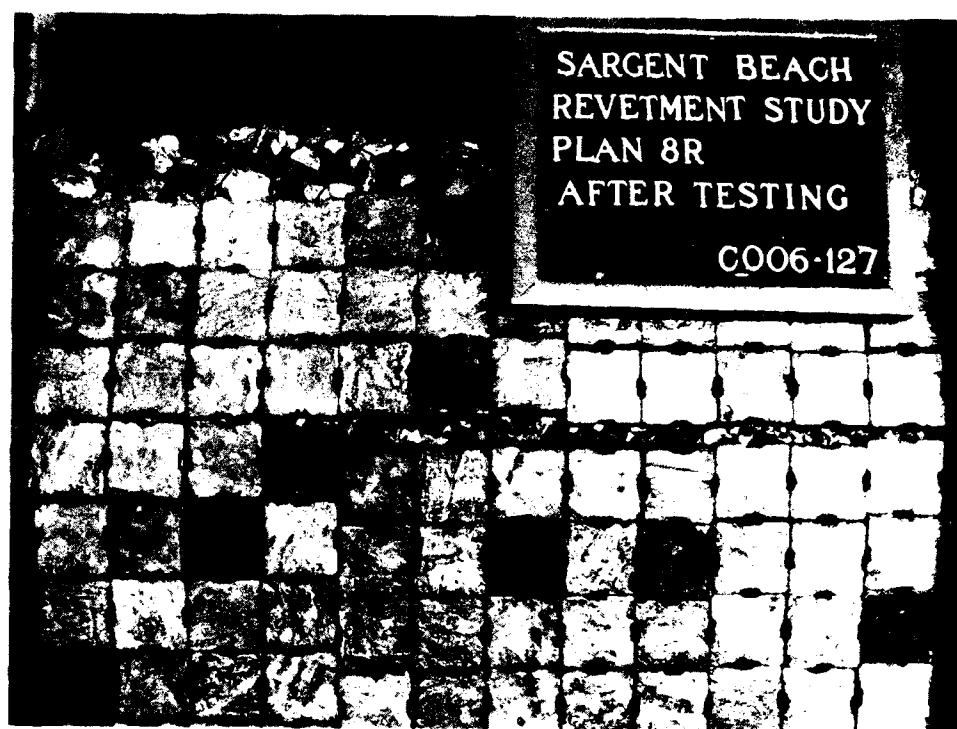
Photo 45. Sea-side view of Plan 8R after wave attack

Photo 46. Overhead view of Plan 8R after wave attack

Plan 8R (Figure 13) was a rebuild of Plan 8. Subjection to the hydrograph given in Table 8 verified results of the first test, i.e., a gap developed between the slope and crest blocks as a result of toe slippage and subsequent downslope slippage of the slope blocks. Again, no lifting or displacement of individual blocks was observed. Photos 45 and 46 show the final condition of the test section.
