TECHNICAL REPORT

HORIZONTAL DRILLING SYSTEM (HDS) FIELD TEST REPORT - FY91

TR-2002-OCN

October 1993

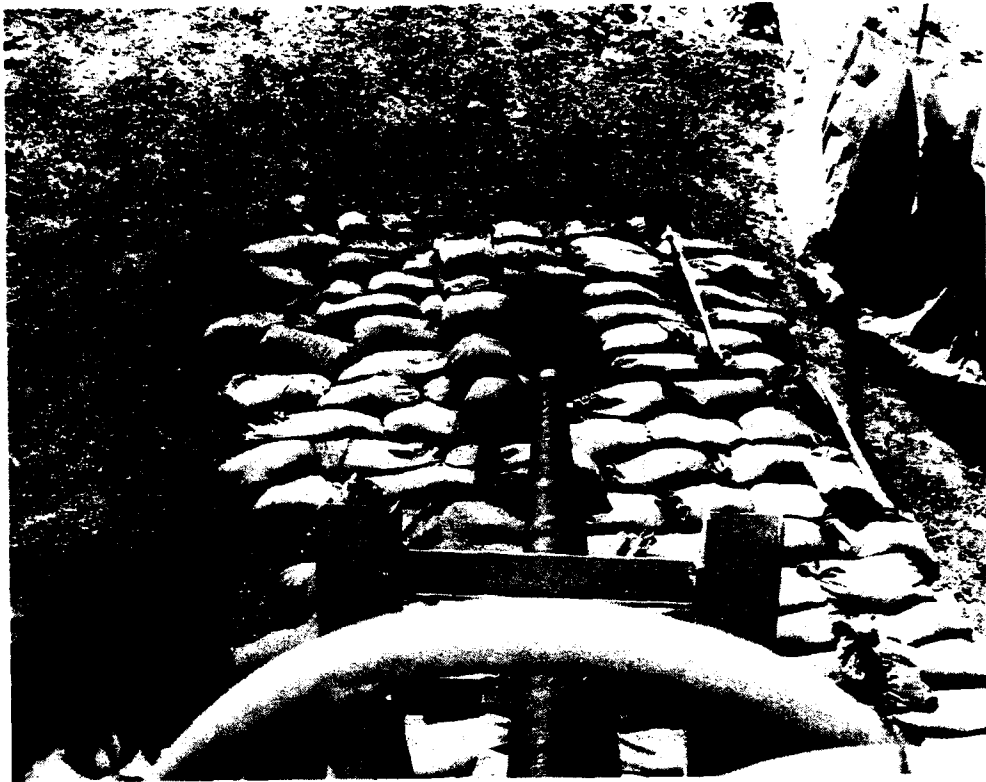
Figure 14
Entrance test A1, initial.

After drilling 110 feet, the drill string was deviating severely. It was backed out and restarted three times in an attempt to straighten the trajectory. The drill string had a tendency to climb sharply (approximately 0.16-inch raise per 12-inch advance); this was causing higher than acceptable levels of drill string torque. The torque was being measured at the launcher aft rotator. The high measured value was primarily due to two conditions: (1) additional reactive loads were present at the points of contact between the drill string and the curved hole, and (2) the drill pipe was rubbing the inside of the forward rotator due to the severe (large) exit angle at the forward rotator. During the second attempt to straighten the trajectory, the drill string was backed out and restarted at a slower advance rate. Unfortunately, the pipe followed the original hole. On the third restart, high pressure and flow was used at the outset. The net effect was to essentially erase the original hole and create a new drilling path. Figure 15 shows the result of using high pressure and flow at the entrance area. The net effect was to wash away the surrounding material and excavate a cavity into the hillside. This was a very undesirable condition both environmentally and in terms of increased suspended pipe length.
