<b>1. AGENCY USE ONLY (Leave blank)</b>		<b>2. REPORT DATE</b> 06/00/89	<b>3. REPORT TYPE AND DATES COVERED</b>	
<b>4. TITLE AND SUBTITLE</b> REMEDIAL INVESTIGATION REPORT, VOLUME VI, SOUTHERN STUDY AREA, FINAL, VERSION 3.3			<b>5. FUNDING NUMBERS</b>	
<b>6. AUTHOR(S)</b>			DAAA15 88 D 0024	
<b>7. PERFORMING ORGANIZATION NAME(S) AND ADDRESS(ES)</b>  EBASCO SERVICES, INC. LAKWOOD, CO			<b>8. PERFORMING ORGANIZATION REPORT NUMBER</b>  89166R01	
<b>9. SPONSORING / MONITORING AGENCY NAME(S) AND ADDRESS(ES)</b>  ROCKY MOUNTAIN ARSENAL (CO.). PMRMA COMMERCE CITY, CO			<b>10. SPONSORING / MONITORING AGENCY REPORT NUMBER</b>	
<b>11. SUPPLEMENTARY NOTES</b>				
<b>12a. DISTRIBUTION / AVAILABILITY STATEMENT</b>  APPROVED FOR PUBLIC RELEASE; DISTRIBUTION IS UNLIMITED			<b>12b. DISTRIBUTION CODE</b>	
<b>13. ABSTRACT (Maximum 200 words)</b>  THE SOUTHERN STUDY AREA (SSA) REPORT INTEGRATES THE STUDY AREA HISTORY, GEOLOGY, AND HYDROLOGY WITH THE RESULTS OF SOIL, SURFACE WATER, GROUND WATER, AIR, BIOTA, AND STRUCTURES INVESTIGATIONS TO DEFINE THE NATURE AND EXTENT OF CONTAMINATION IN THE SOUTHERN PORTION OF RMA.  THE SSA INCLUDES ALL OF SECTIONS 11 AND 12 AND PORTIONS OF SECTIONS 1, 2, 3, AND 7. H

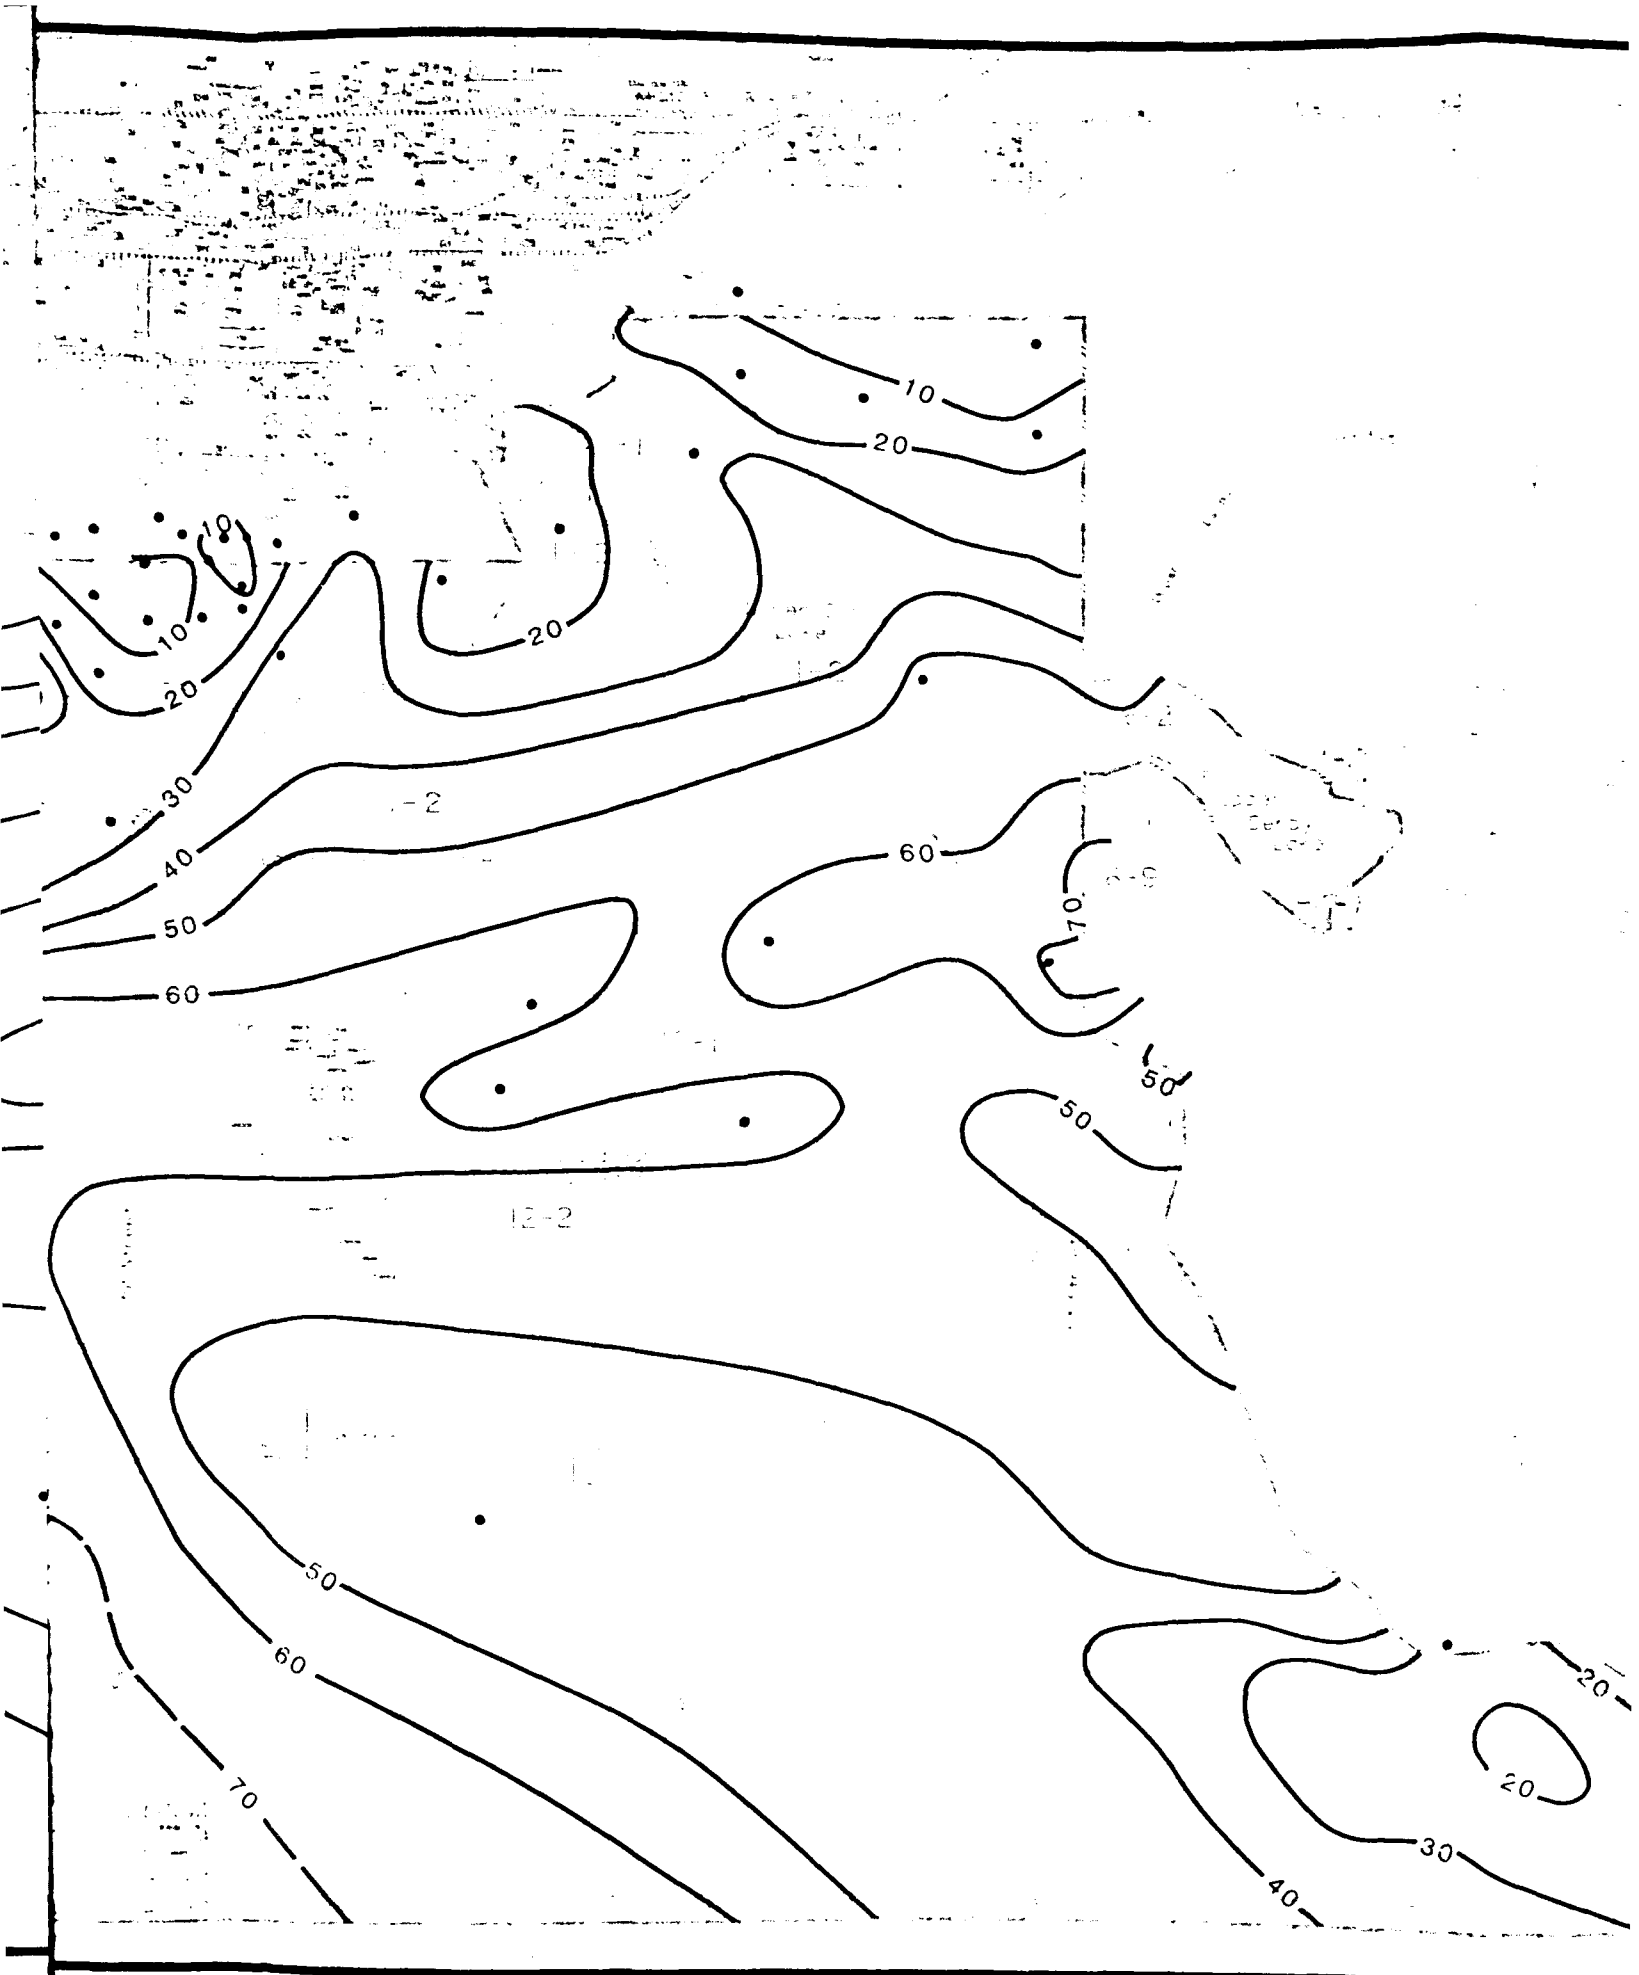
**FIGURE: SSA 1.4-3**  
 Alluvial Units - Southern Study Area  
 Rocky Mountain Arsenal  
 Prepared by:  
 Ebasco Services Incorporated

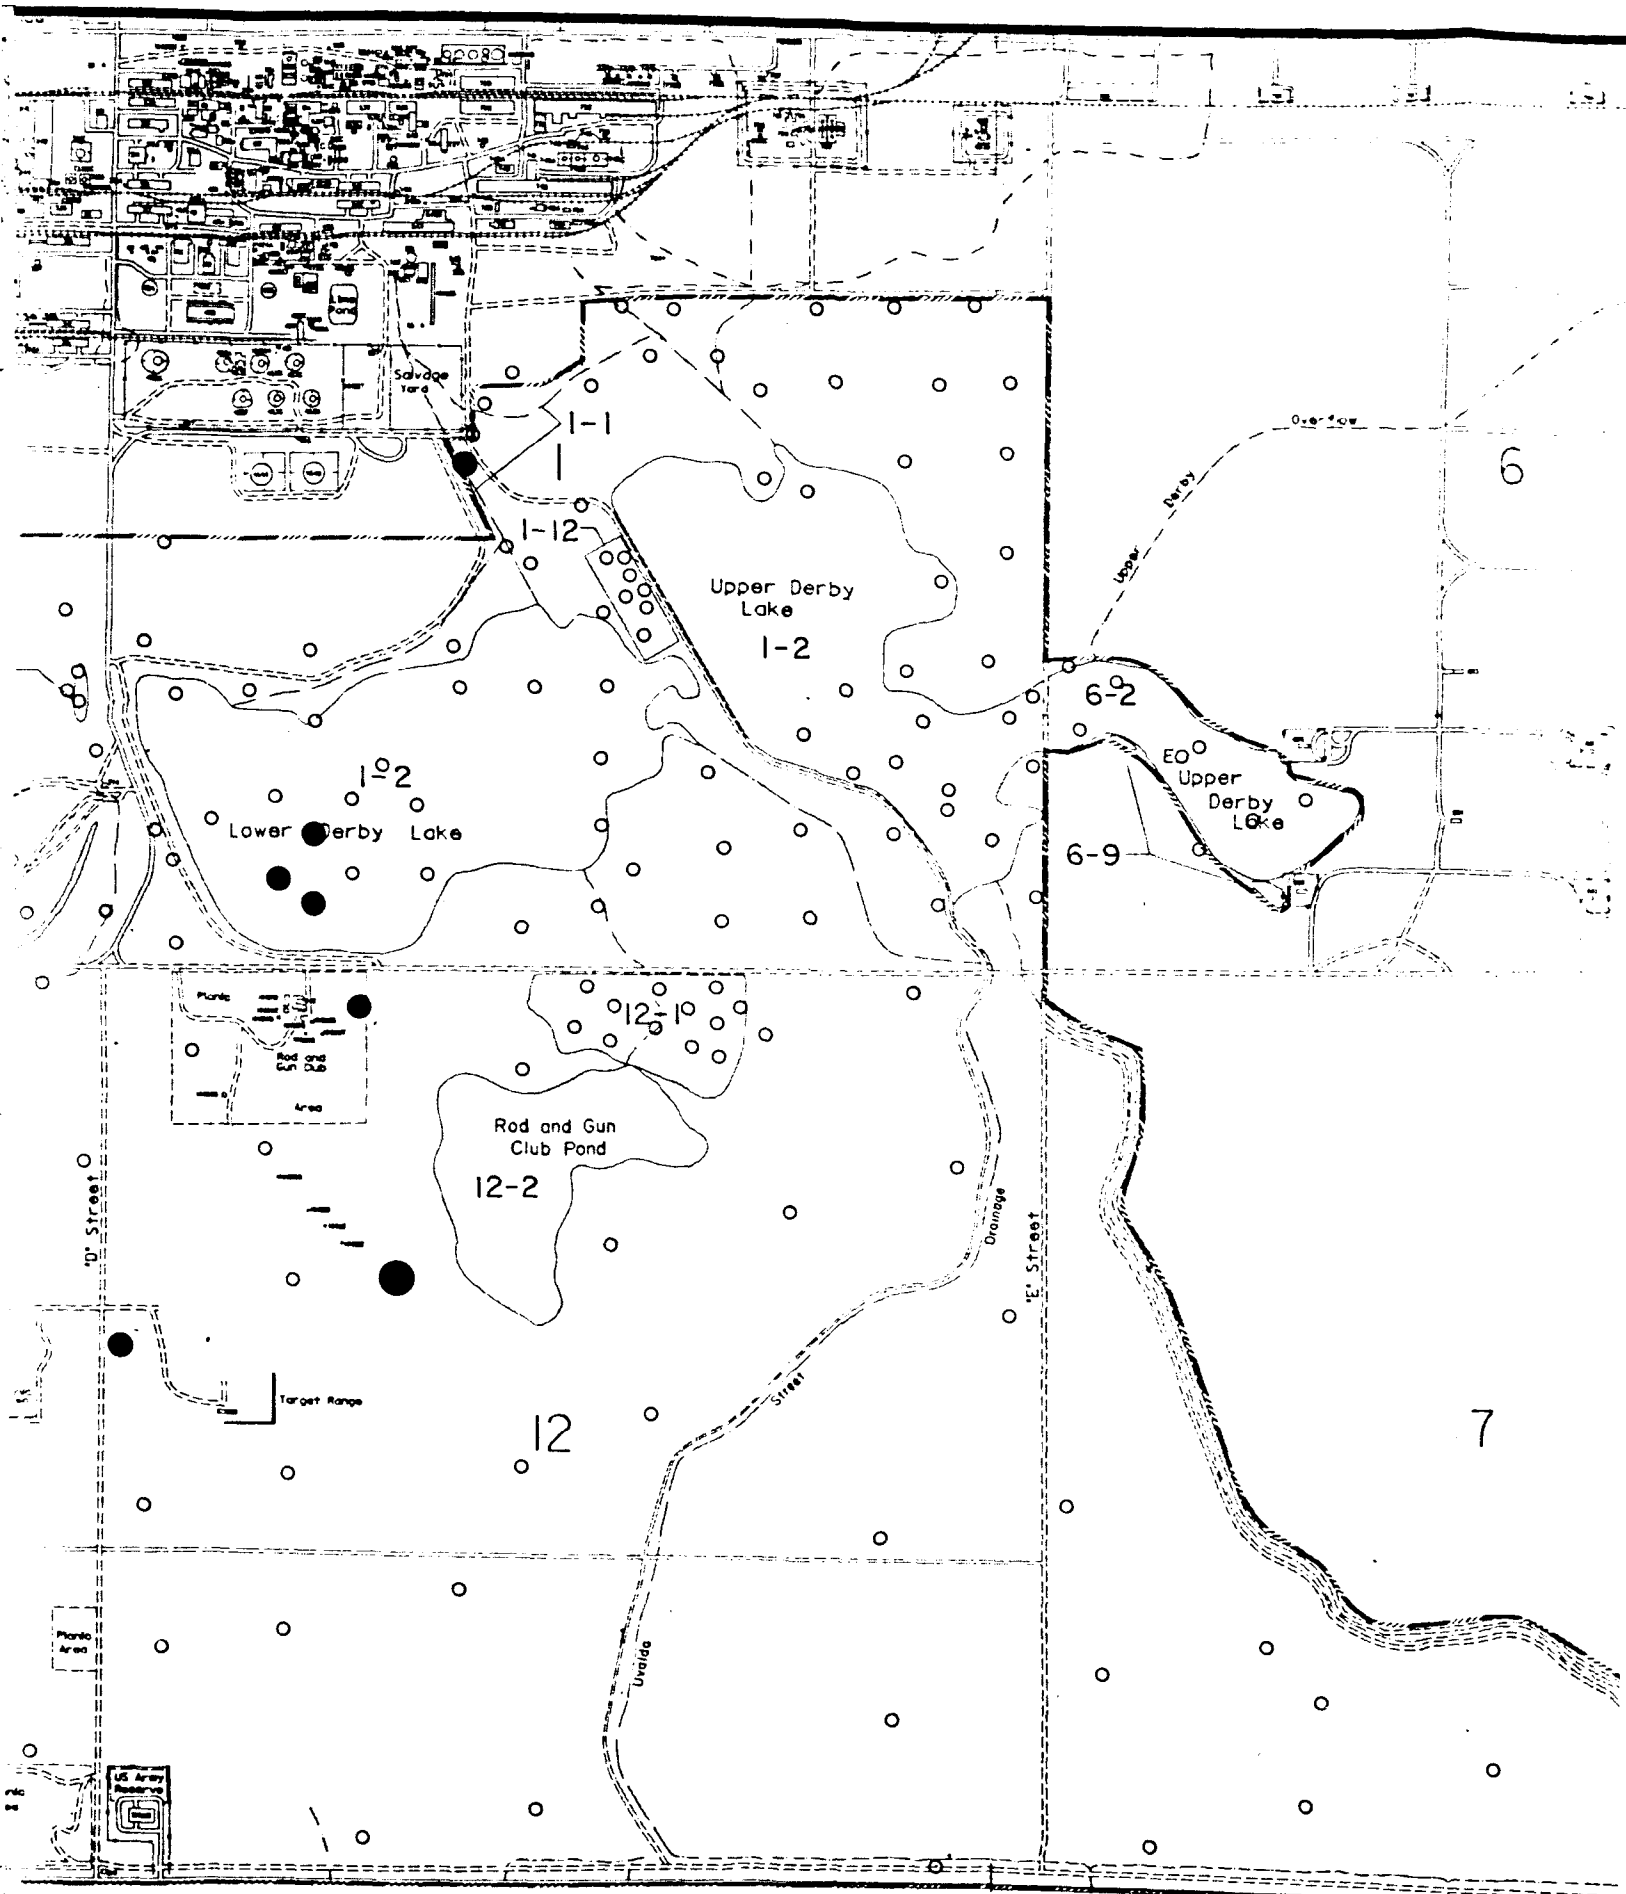
**FIGURE: SSA 2.1-25**  
 ICP Metals in Soils  
 in the 0-2 ft. Depth Interval  
 Rocky Mountain Arsenal  
 Prepared by:  
 Ebasco Services Incorporated

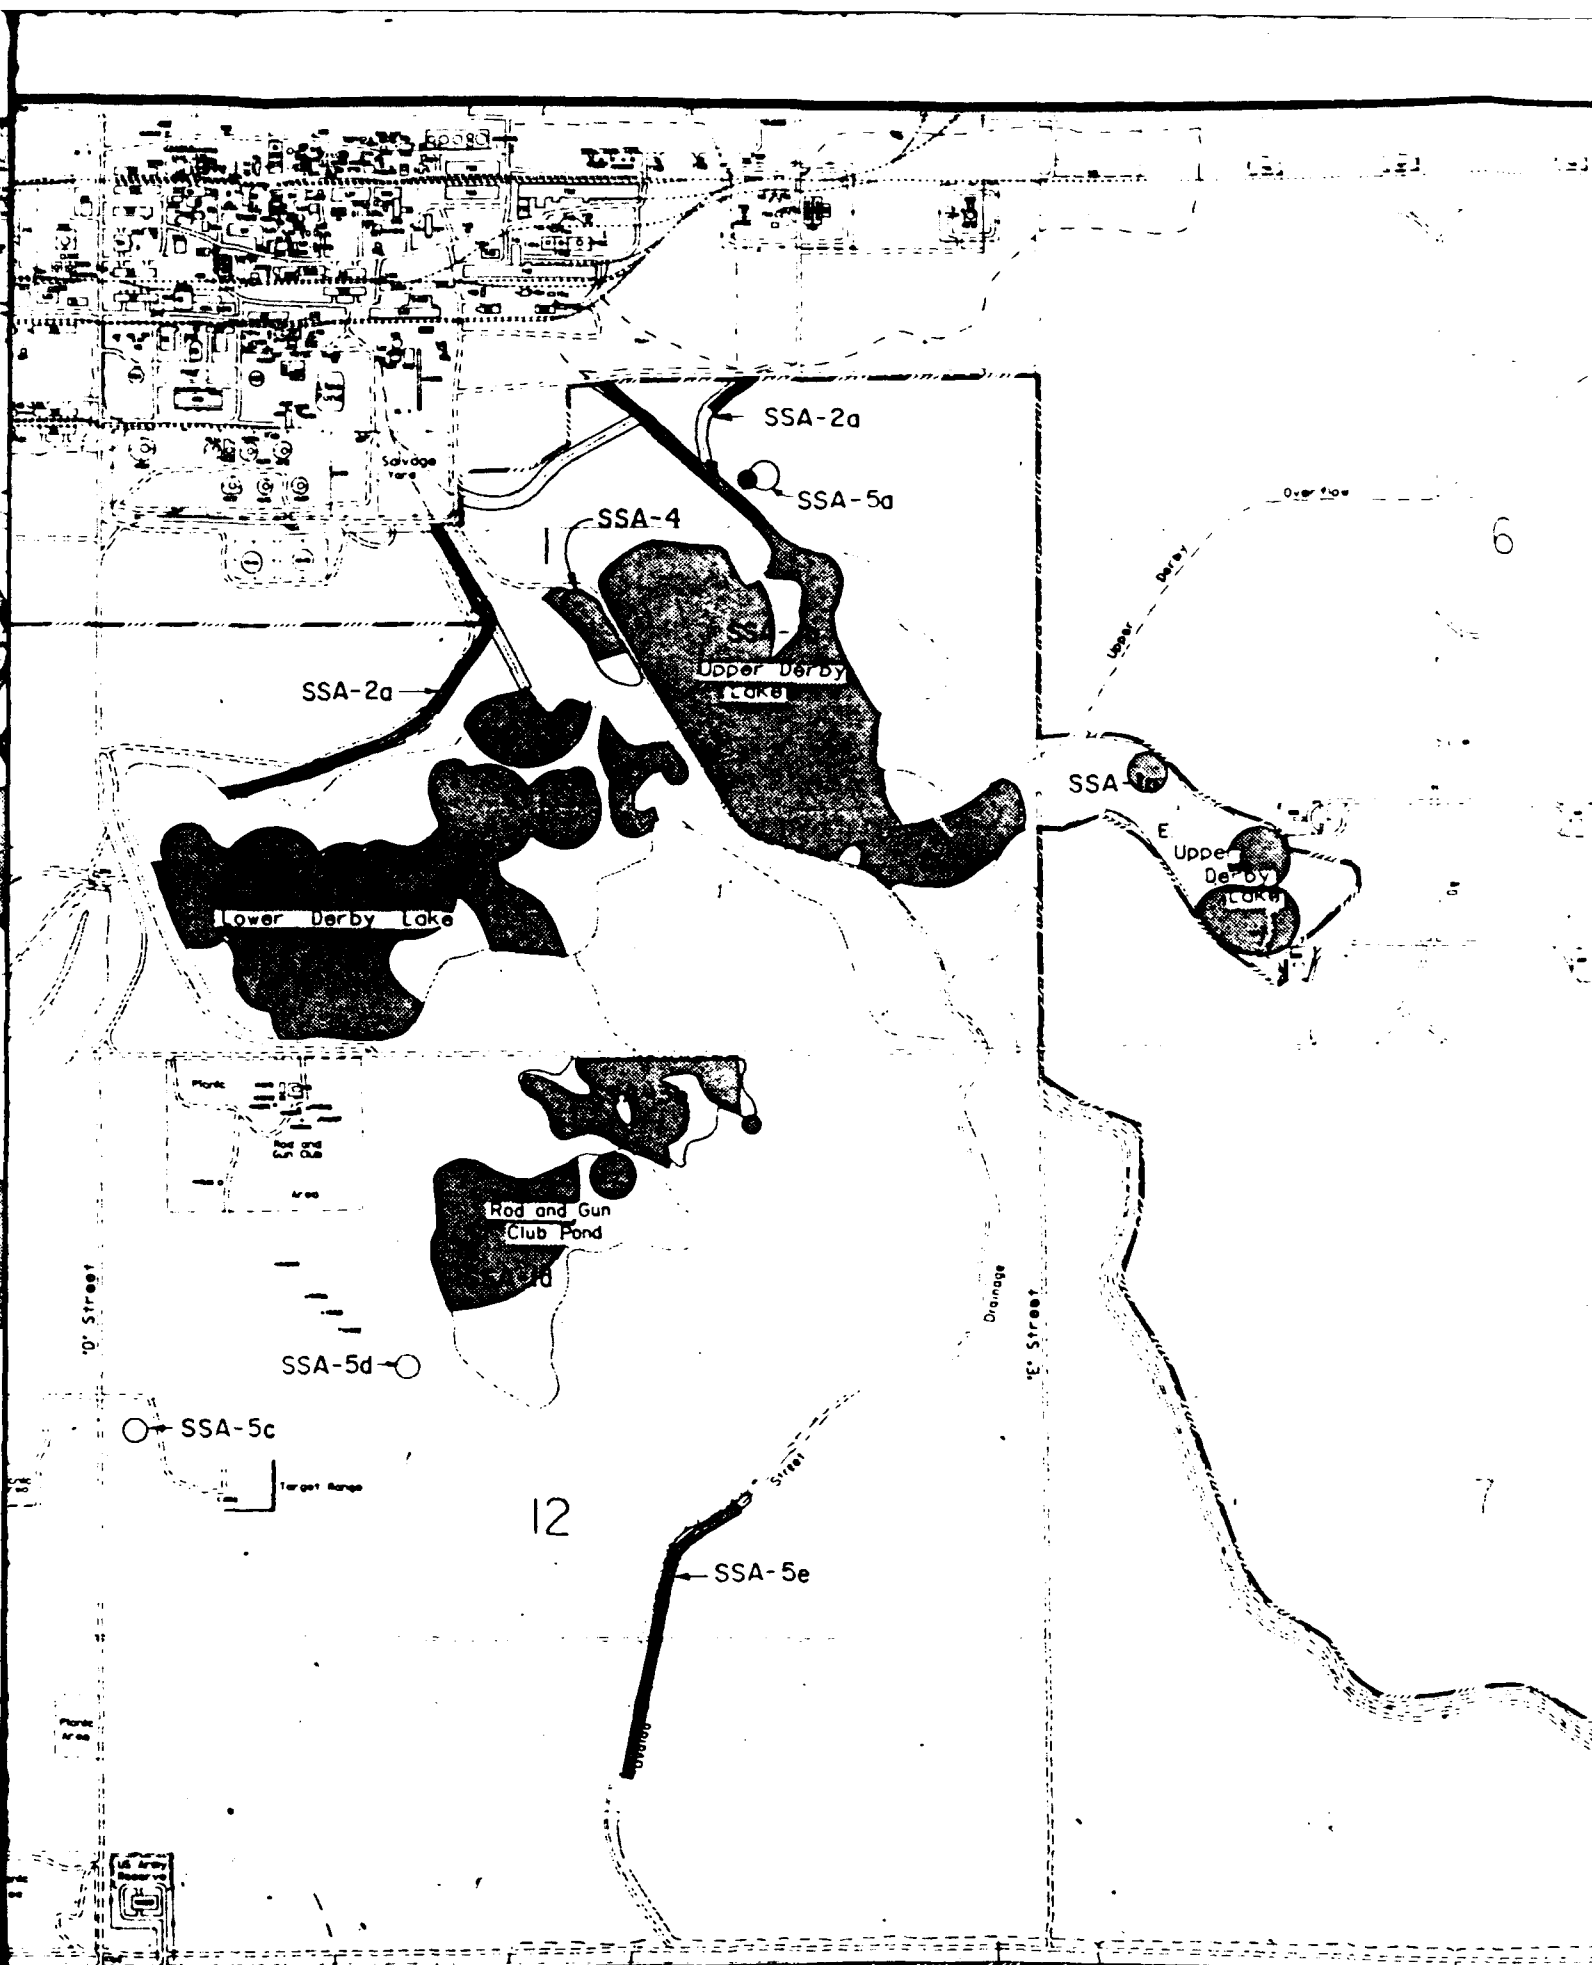
**FIGURE: SSA 3.4-18**  
 Estimated Areal Extent of Potential Contamination  
 for ICP Metals, 0-5 ft. Depth Interval  
 Rocky Mountain Arsenal  
 Prepared by:  
 Ebasco Services Incorporated
