DOT/FAA/CT-93/74
DOT-VNTSC-FAA-93-12

A Laboratory Study of Multiple Site Damage in Fuselage Lap Splices

December 1993

Final Report

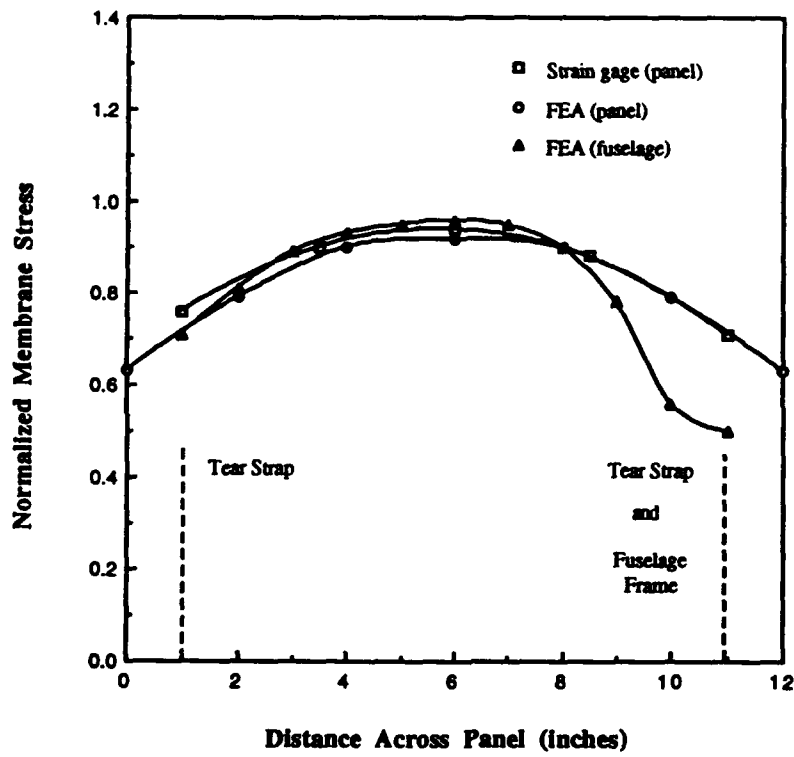
Figure 9: Stress Distributions in the 12 inch Wide Panel and in a Fuselage

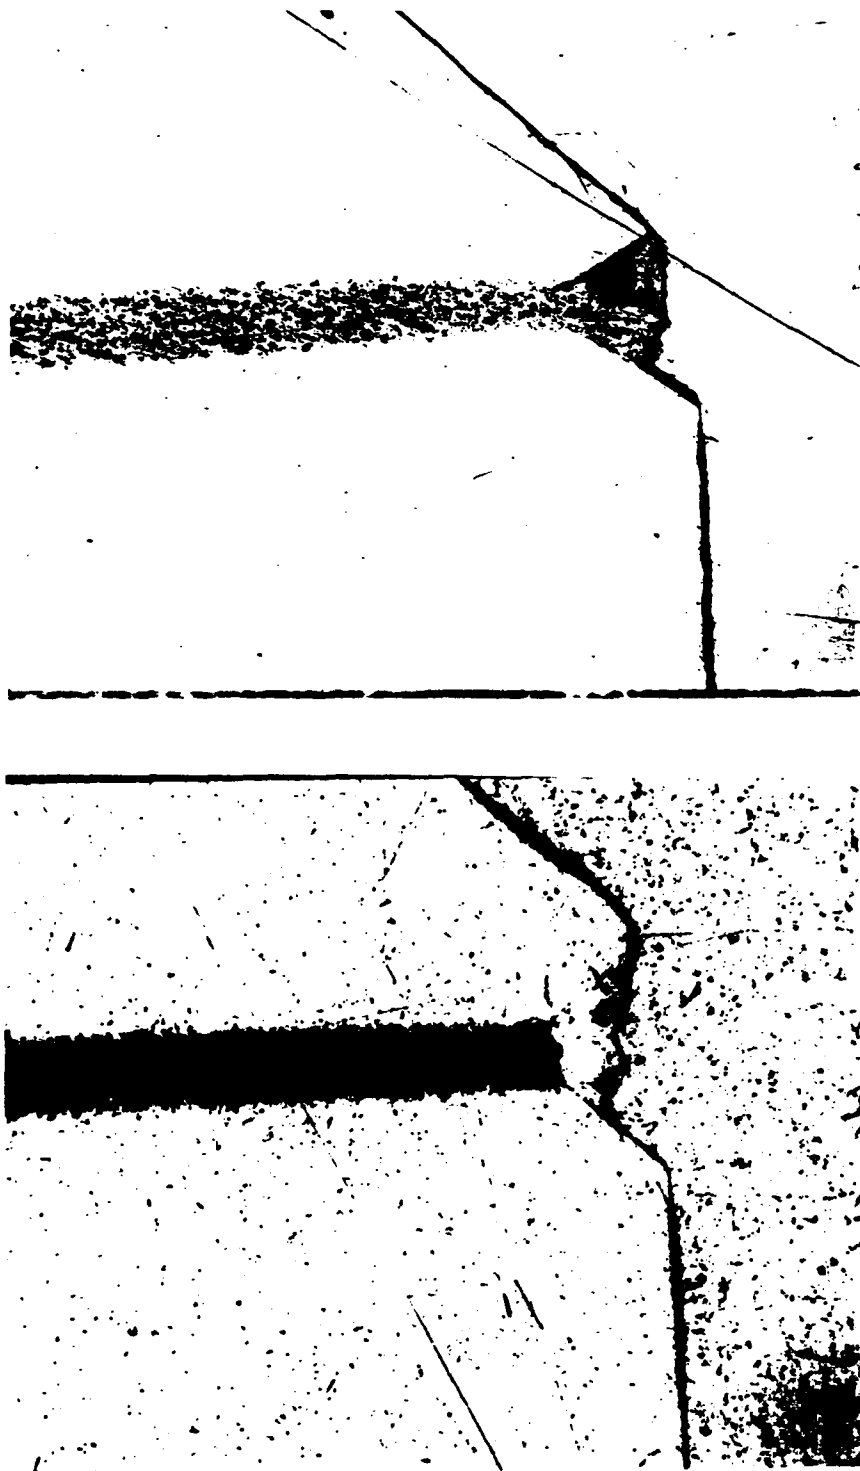
Figure 12: Comparison of Rivet Cross Sections from Two Panel Batches with Different Amounts of Rivet Deformation; Top - Batch 1; Bottom - Batch 2

Some other interesting results emerged from these baseline tests. Cycles to crack initiation varied from 30,000 to 127,000. Although it is not possible to relate these lives to those in aircraft, for which, among other things, the number of flights beyond a no-bond condition is unknown, the range correlates reasonably well with the limited data we do have: 31,301 and 43,000 flights for the B727 examples referred to earlier and approximately 89,000 for the Aloha aircraft. The data of Table 4 also show a substantial difference in fatigue lives between the two batches: average cycles to 0.1 inch cracking of 48,700 for Batch 1 and 96,400 for Batch 2. This difference was due to variation in rivet deformation during installation. Figure 12 shows a magnified cross section of a rivet in the top row from each of the batches. The greater rivet deformation in Batch 2 resulted in a blunting of the knife edge, which is considered to be the primary cause of low fatigue lives in the lap splice joint. Greater rivet deformation is characterized by a larger bucktail diameter. Table 5 compares the average fatigue lives and bucktail diameters for the two batches. While both diameters satisfy specification BAC 5004 the larger diameter is preferred in practice. An auxiliary experimental task was undertaken to better reveal the effect of bucktail diameter on fatigue, the description of which is given in Appendix B. Based on the results described above and in Appendix B, the bucktail diameter was controlled very carefully in all subsequently fabricated panels.

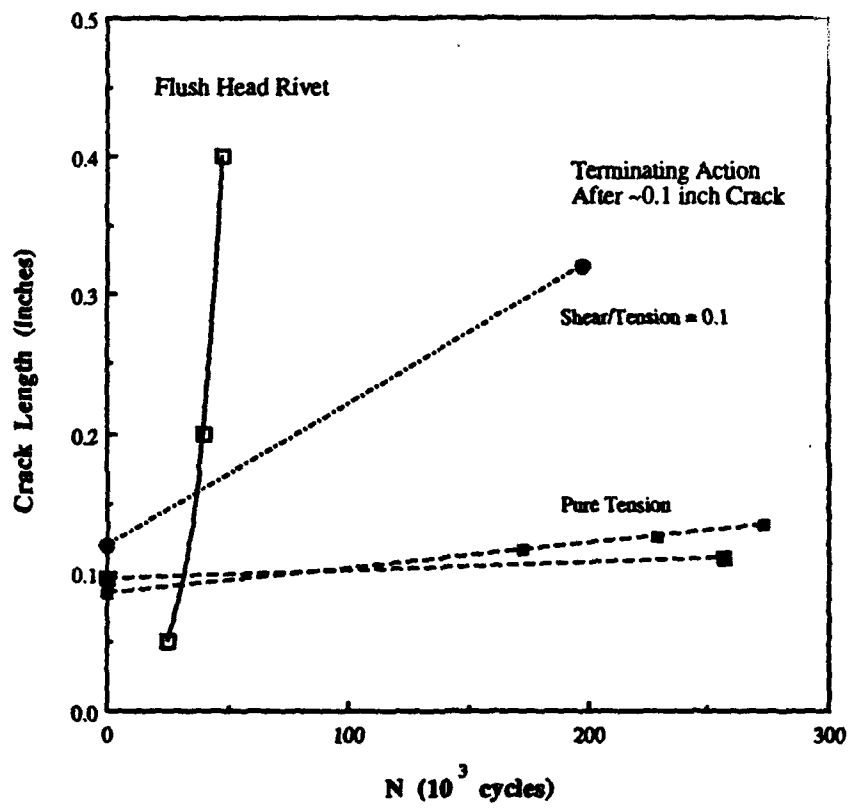
Figure 13: Comparison of Crack Growth Rates for a Baseline Test and for Terminating Action Tests

Table 6 lists the conditions and results of the terminating action tests conducted in pure tension. The results demonstrate a clear benefit of the terminating action to prevent the initiation and growth of cracks in the top row of rivets. Even when 0.1 inch long cracks were allowed to remain after the action, there was substantial retardation of crack growth. This is shown by a comparison of crack length increment vs. number of cycles for a flush head riveted panel and the terminating action panels for which some crack growth did occur, Figure 13.

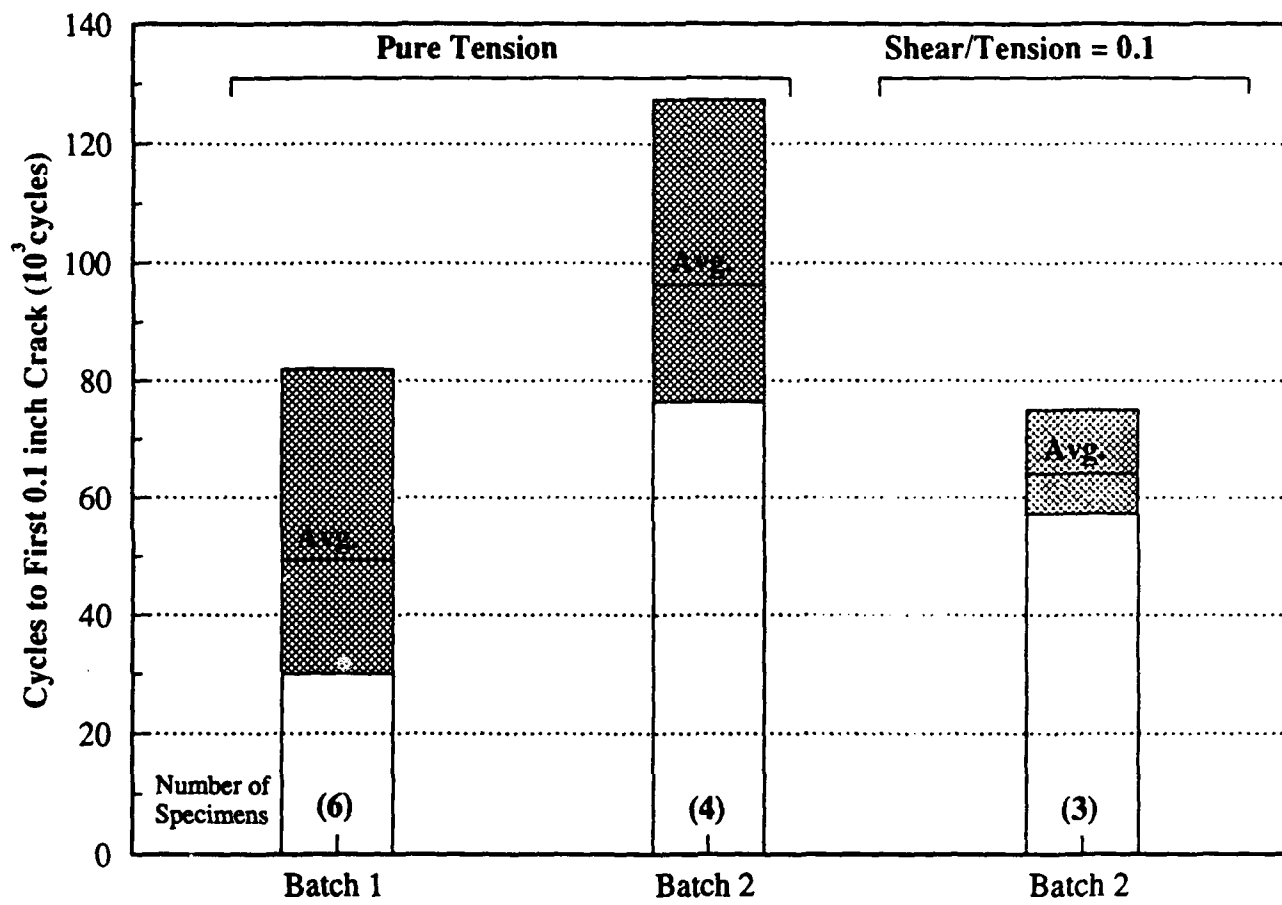
Figure 14: Results from all of the Baseline Tests

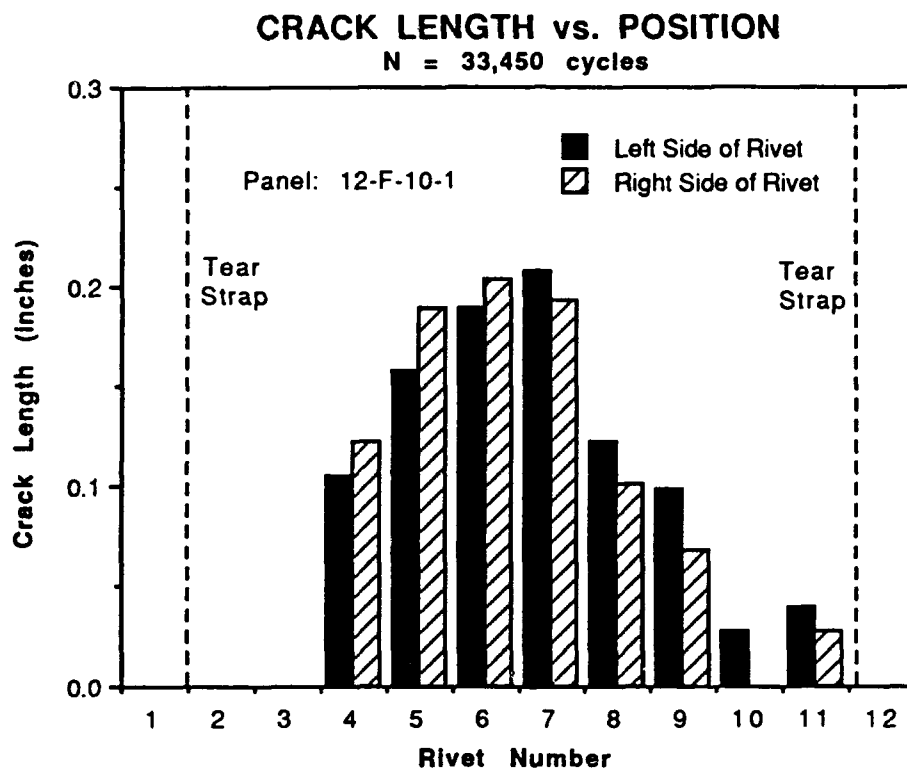
Figure 16: The Crack Pattern from one of the Shear/Tension Tests

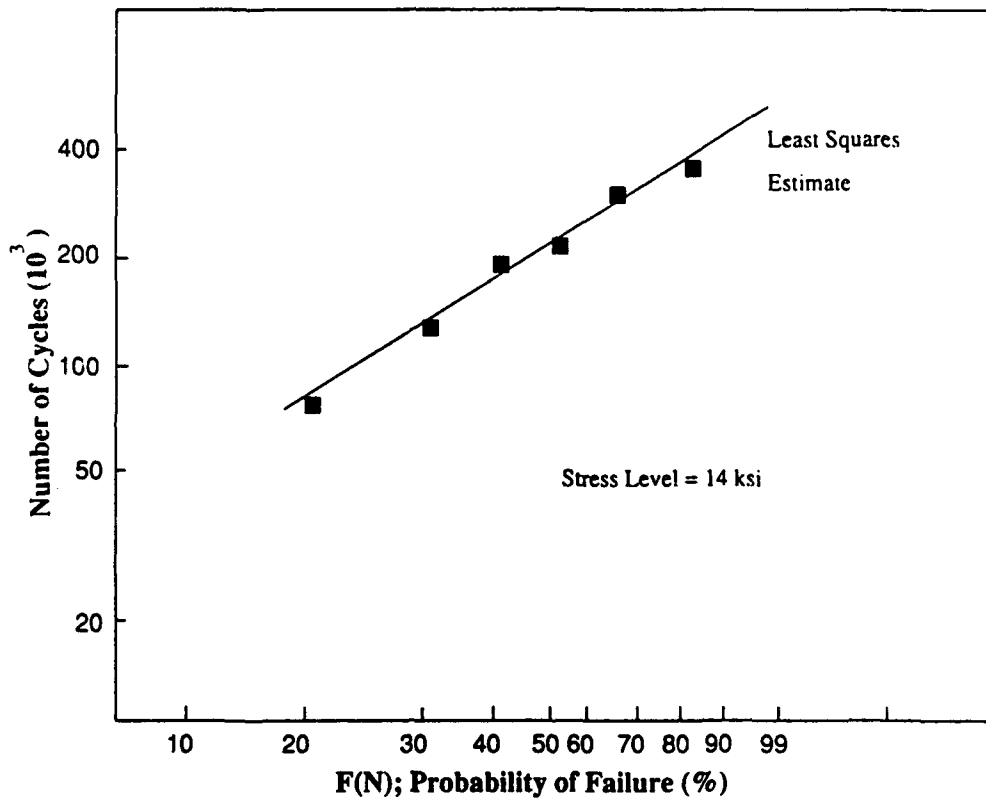
Figure 19: An Example of the Fit of Data From Series IIIA to a Weibull Curve

The parameters N_0 and m were estimated separately from graphs plotted for each of the three stress levels considered. In all three cases the fit of the data to the Weibull distribution was reasonably close; Figure 19 illustrates the goodness-of-fit for results obtained at 14ksi. Although only those panels that actually failed appear on the plot, all test panels were used in determining the failure rate that is depicted in Figure 19. This probability equation was then used to estimate the expected life of unfailed specimens based on the number of cycles they had survived according to computational procedures described in [10]. No censored data were analyzed for MSD.

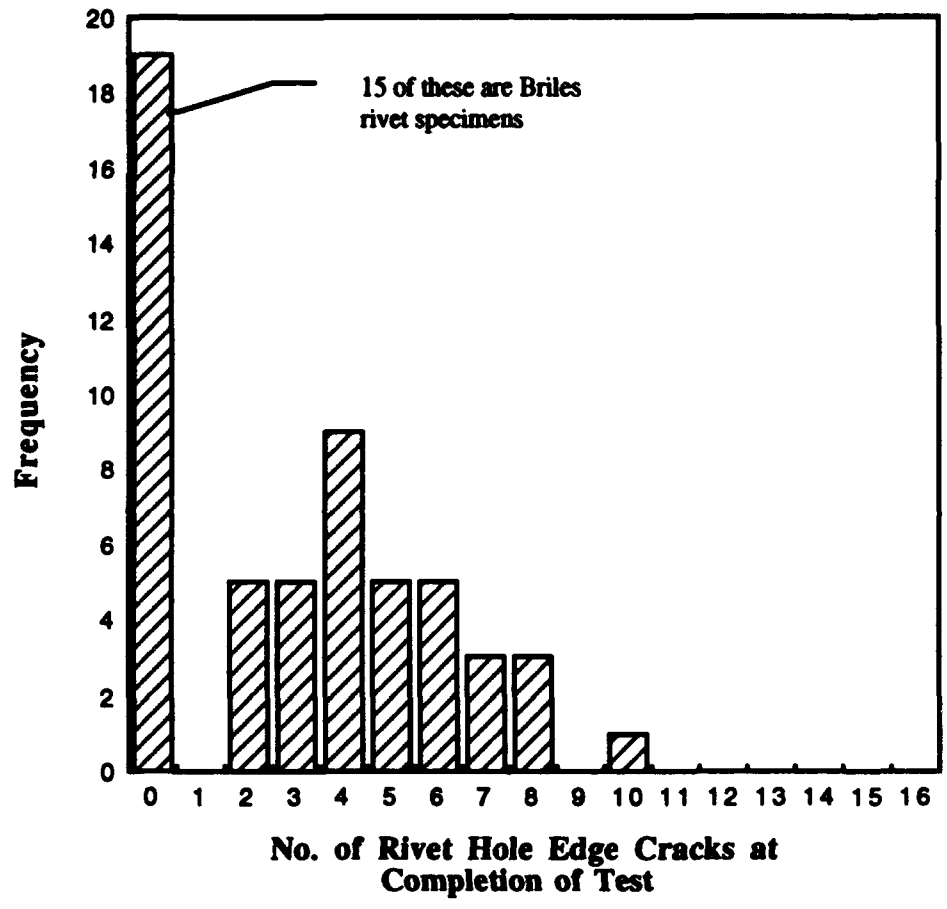
Figure 23: The Distribution of Number of Cracks in Series IIIA Panels

Nevertheless, some of the specimens had as many as 8-10 individual rivet hole cracks at the completion of testing. Figure 23 shows the distribution of top row rivet hole edge cracks at the completion of testing for all specimens tested in Series IIIA.

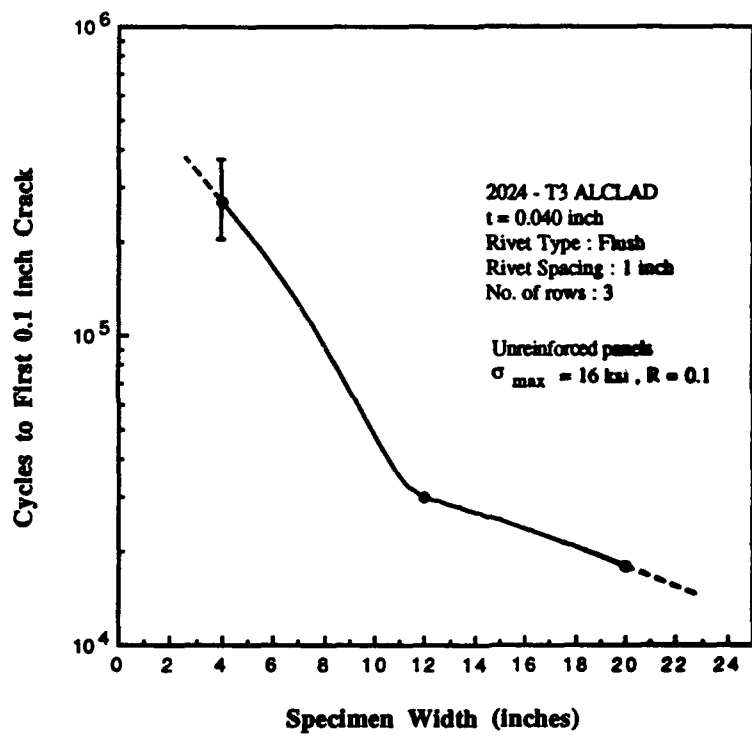
Figure 24: Data Suggesting that there is a Size Effect on Fatigue Life in Test Panels

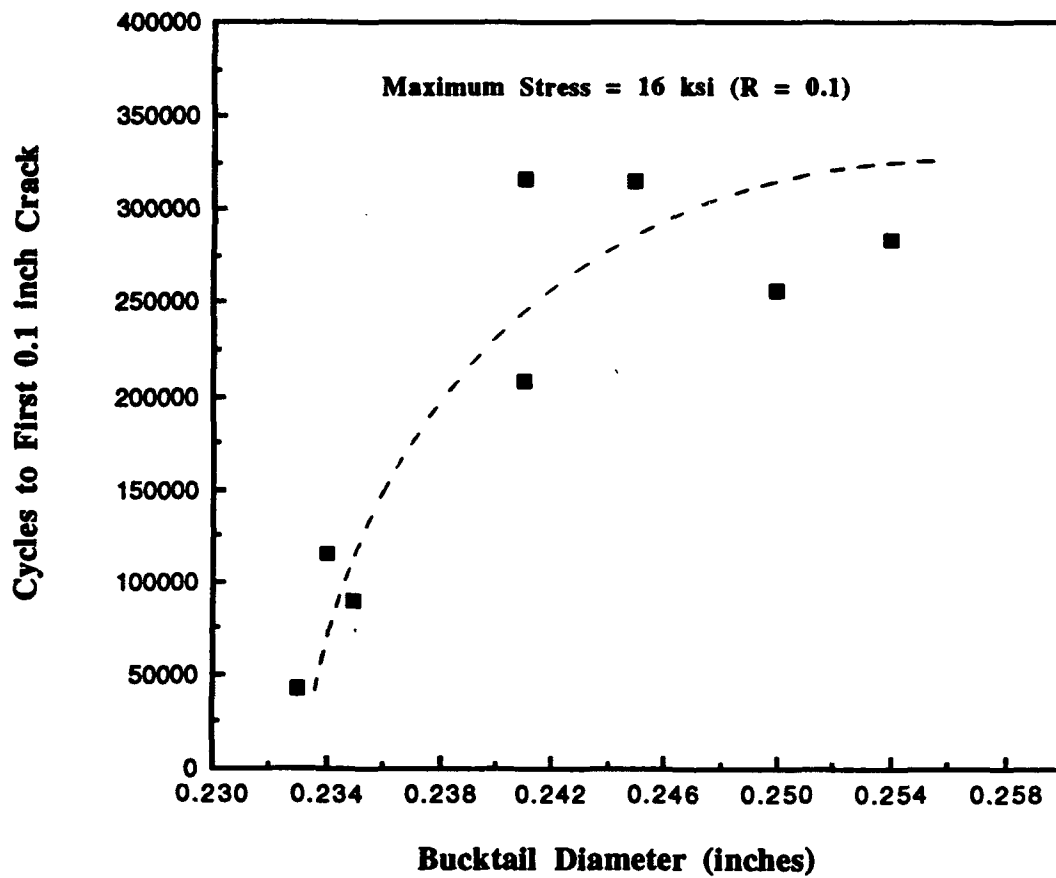
Figure B1: Effect of Bucktail Diameter on Fatigue Life

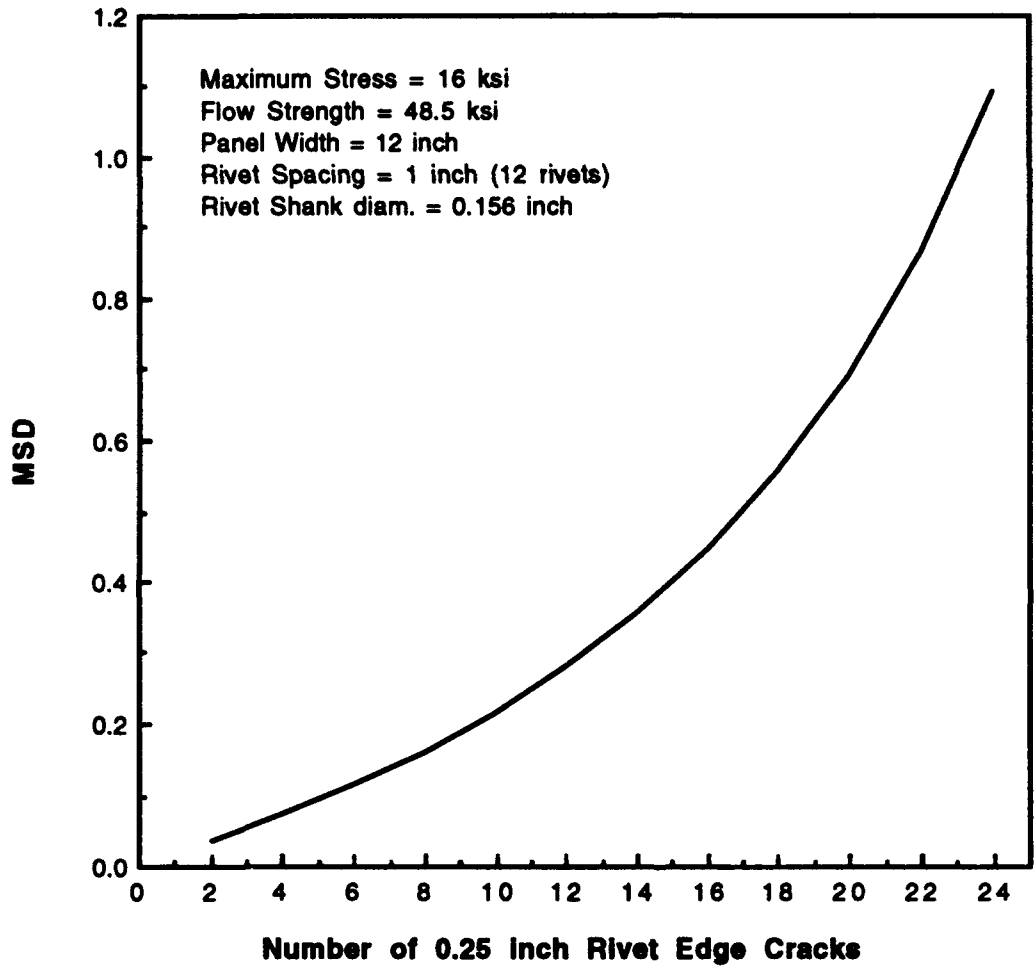
Figure D1: Relationship Between Number of Cracks and MSD According to the Definition (1)

Figure D1 shows an example plot of MSD vs. number of equal size cracks for the baseline specimen configuration.
