Evaluation of Nondestructive Inspection Techniques for Quality Control of Alumina-Ceramic Housing Components

Technical Report 1588
September 1993

**NAVAL COMMAND, CONTROL AND
OCEAN SURVEILLANCE CENTER
RDT&E DIVISION
San Diego, California 92152-5001**

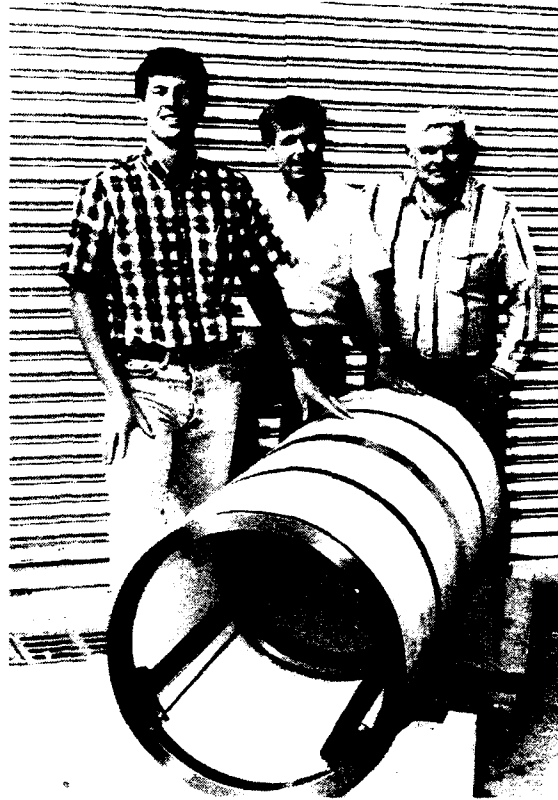
Figure 2. Photo of cylindrical hull section of 25-inch-diameter alumina-ceramic housing.

A typical deep submergence housing as designed at the Naval Command, Control and Ocean Surveillance Center (NCCOSC) RDT&E Division (NRaD) is shown in figures 1 and 2.* This housing consists of alumina-ceramic cylinders and hemispheres joined to each other by metallic end rings, typically machined from titanium or aluminum. The metallic end rings are epoxy-bonded to the ceramic components. Design details on typical NRaD designed housings may be found in references 2 and 3.

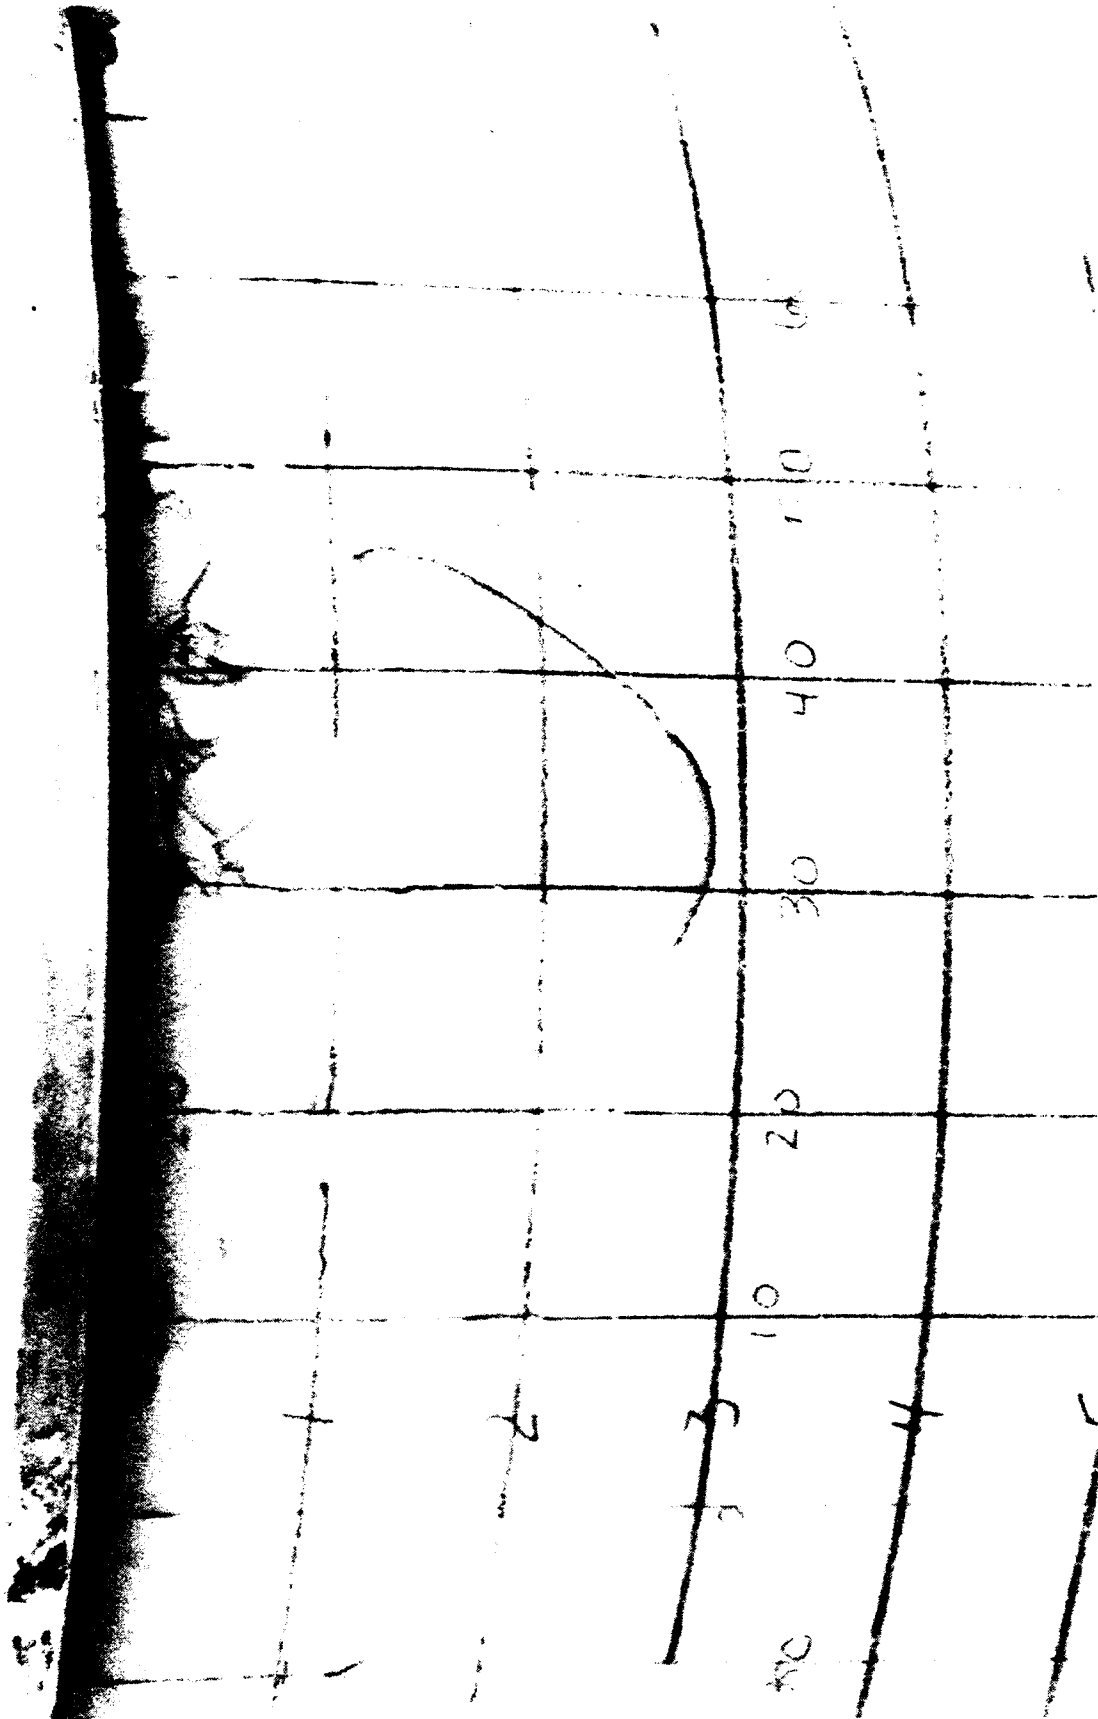
Figure 6. External spalling on alumina-ceramic cylinder (reference 13).

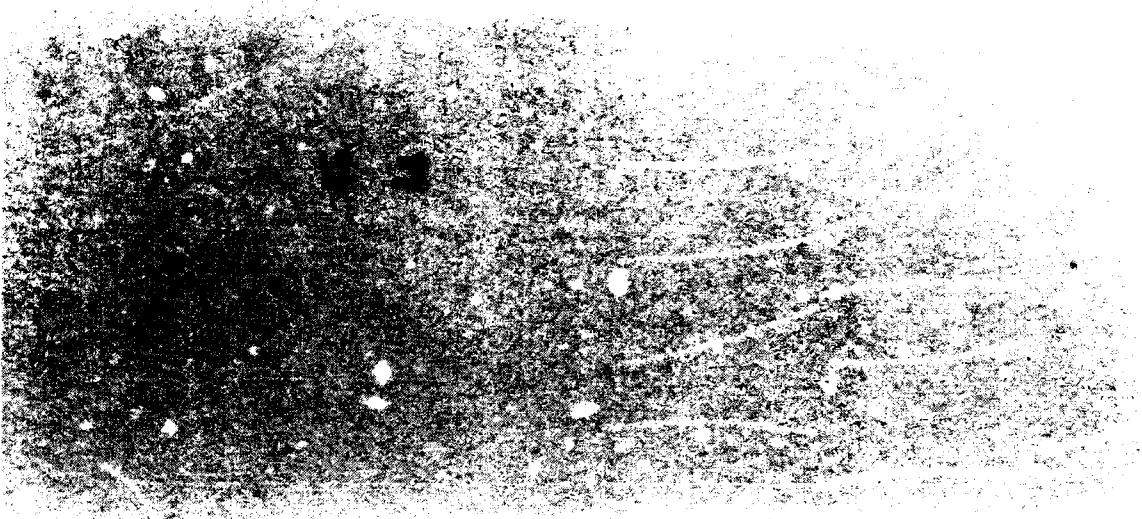
Figure 16. X-ray film radiograph of as-fired flat alumina tile (D2) containing 1-inch-long by 0.028-inch-diameter rod-shaped defects.

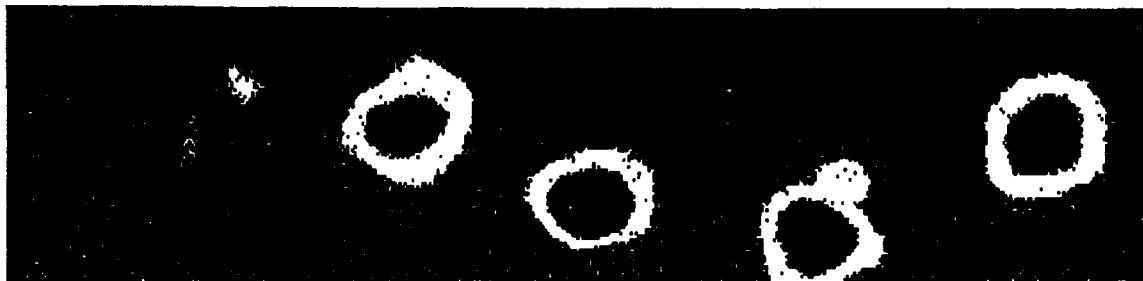
Figure 60. C-scan obtained by SAM of one column of defects found in as-fired curved ceramic specimen (G2) containing 0.105-inch-square by 0.005-inch-thick planar defects. The area shown represents a 0.5-inch by 2.25-inch area on the specimen.
