**PRELIMINARY ASSESSMENT REPORT  
U.S. ARMY RESERVE CENTER,  
MANITOWOC, WISCONSIN**

**FINAL REPORT**

**DECEMBER 1993**

**ECG, INC.  
8150 LEESBURG PIKE  
VIENNA, VIRGINIA 22182**

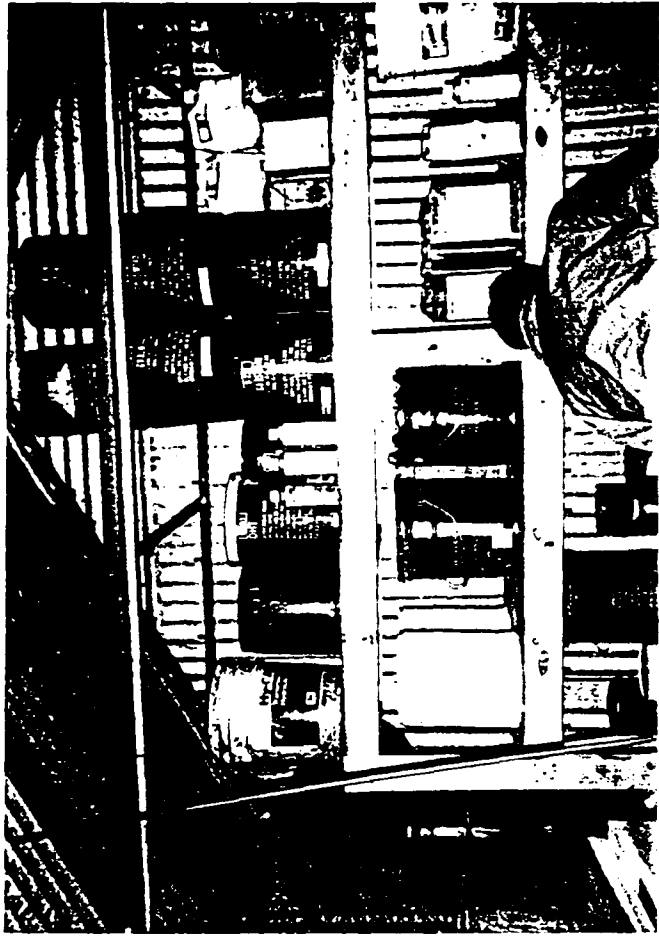
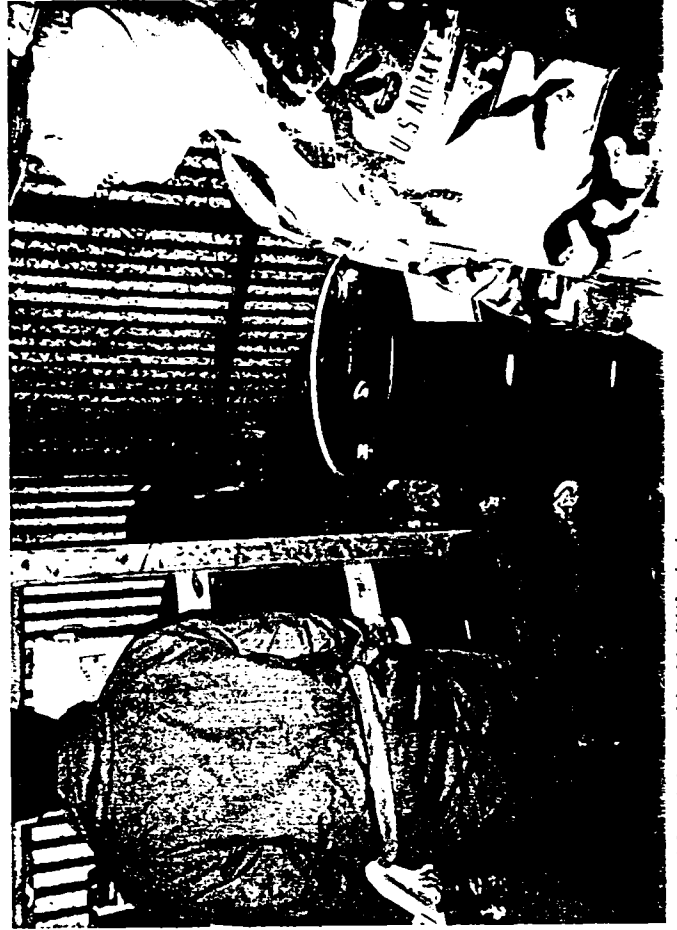
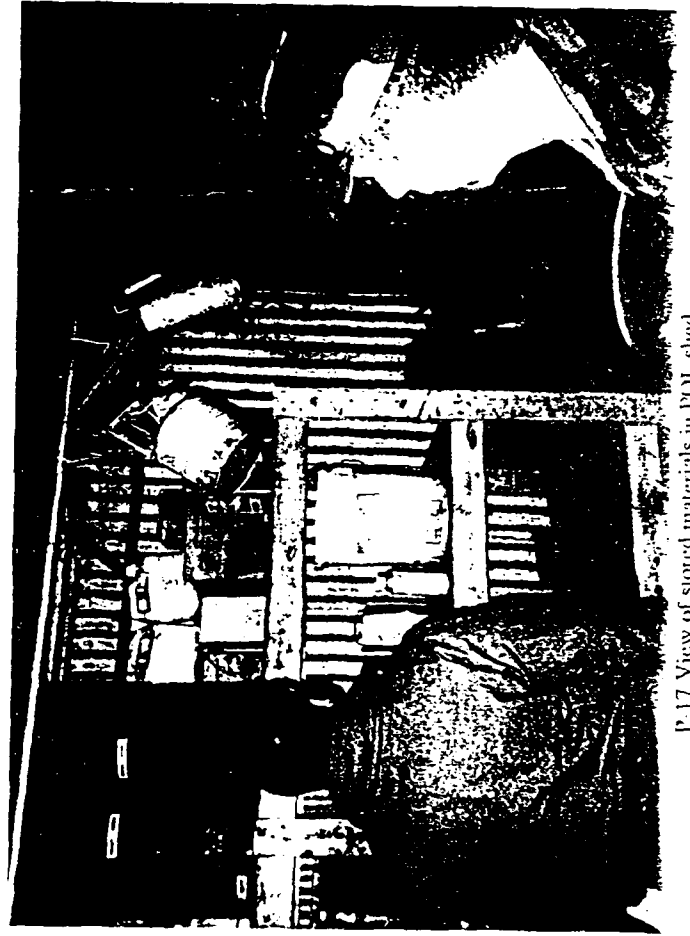
The POL shed was reported in the IIA to rest on a dirt substrate, i.e., without a paved foundation. MARC personnel have subsequently cleaned up this structure to reveal that it does sit atop a paved, bituminous floor. Currently, the floor still has a two to three inch blackened material covering, believed to be contaminated soil or sand. This shed still needs to be addressed and properly cleaned.

P-13 Material stored inside POL shed

P-14 Material stored inside POL shed

P-15 Empty cans and barrel inside POI shed

P-16 Empty cans and buckets inside POI shed

P-17 View of stored materials in POI shed

Action is now being taken on this shed. The Facility Management Officer for the 86th ARCOM noted, "An additional hazardous material/flammable storage shed has been ordered at time of the PA to replace the existing POL shed. The expected delivery date of this shed is December 28, 1993." <sup>8</sup>

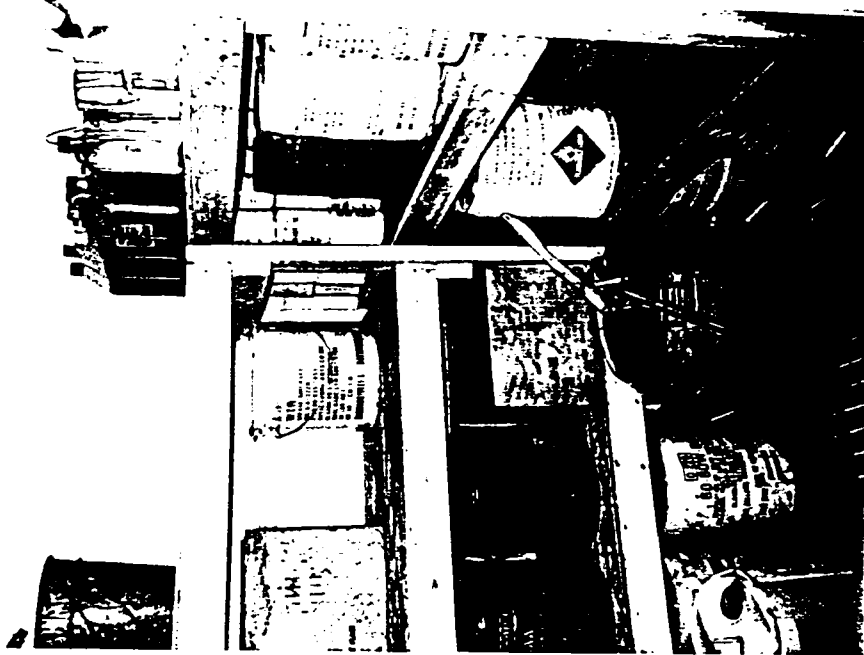
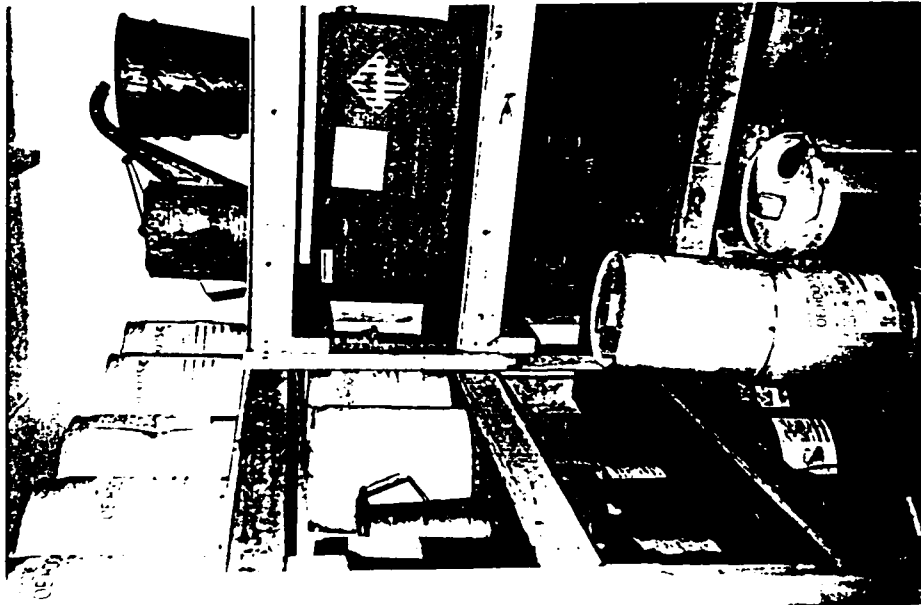
The flammable storage shed was acquired in 1991 for the purpose of storing petroleum products. The shed is to the west of the POL Storage Shed (see Section 3.7) and to the south of the Motor Vehicle Maintenance Building (see Section 3.11). The shed is an OSHA and RCRA approved flammable materials storage shed and contains brake fluid, enamels, transmission fluid, hydraulic fluid, greases, alcohol, lubricating oil, gear oil, and methanol. All containers appear to be in good condition with no apparent leaks. There is no evidence of spillage or leakage within the shed.

P-19 Right side inside flammable storage shed

P-18 Left side inside flammable storage shed

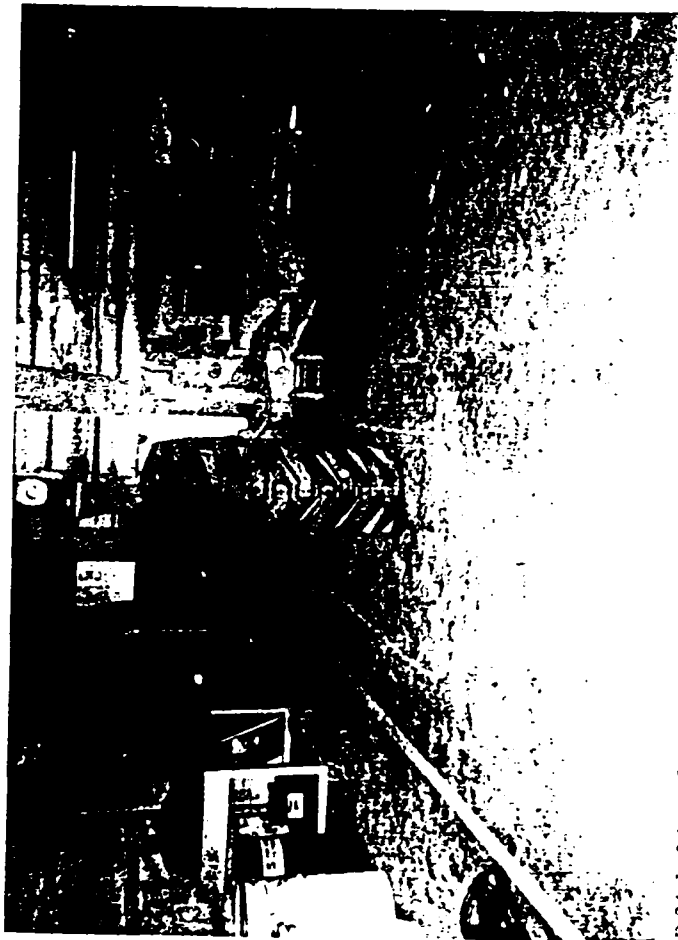
The motor vehicle maintenance building (referred to as the "Reserve Center shop") had contained a grease pit that was filled in and capped with cement in 1978. The IIA (Table 4-2, Item 4) considered the pit as a potential source of groundwater contamination. That report noted that the building design plans did not indicate a floor drain at the bottom. No further discussion or documentation of the grease pit was discovered during record searches and no current Center personnel had direct knowledge of the activities related to it.

P 24 Left bay of motor vehicle storage (maintenance shop); site of former grease  
(site 2) that has been filled and capped
