Coastal Studies in Support of the Sargent Beach, Texas, Erosion Control Project

by *Donald K. Stauble, Jon M. Hubertz,
Robin J. Hoban, Claire R. Livingston, Cheryl E. Pollock*
Coastal Engineering Research Center

Final report

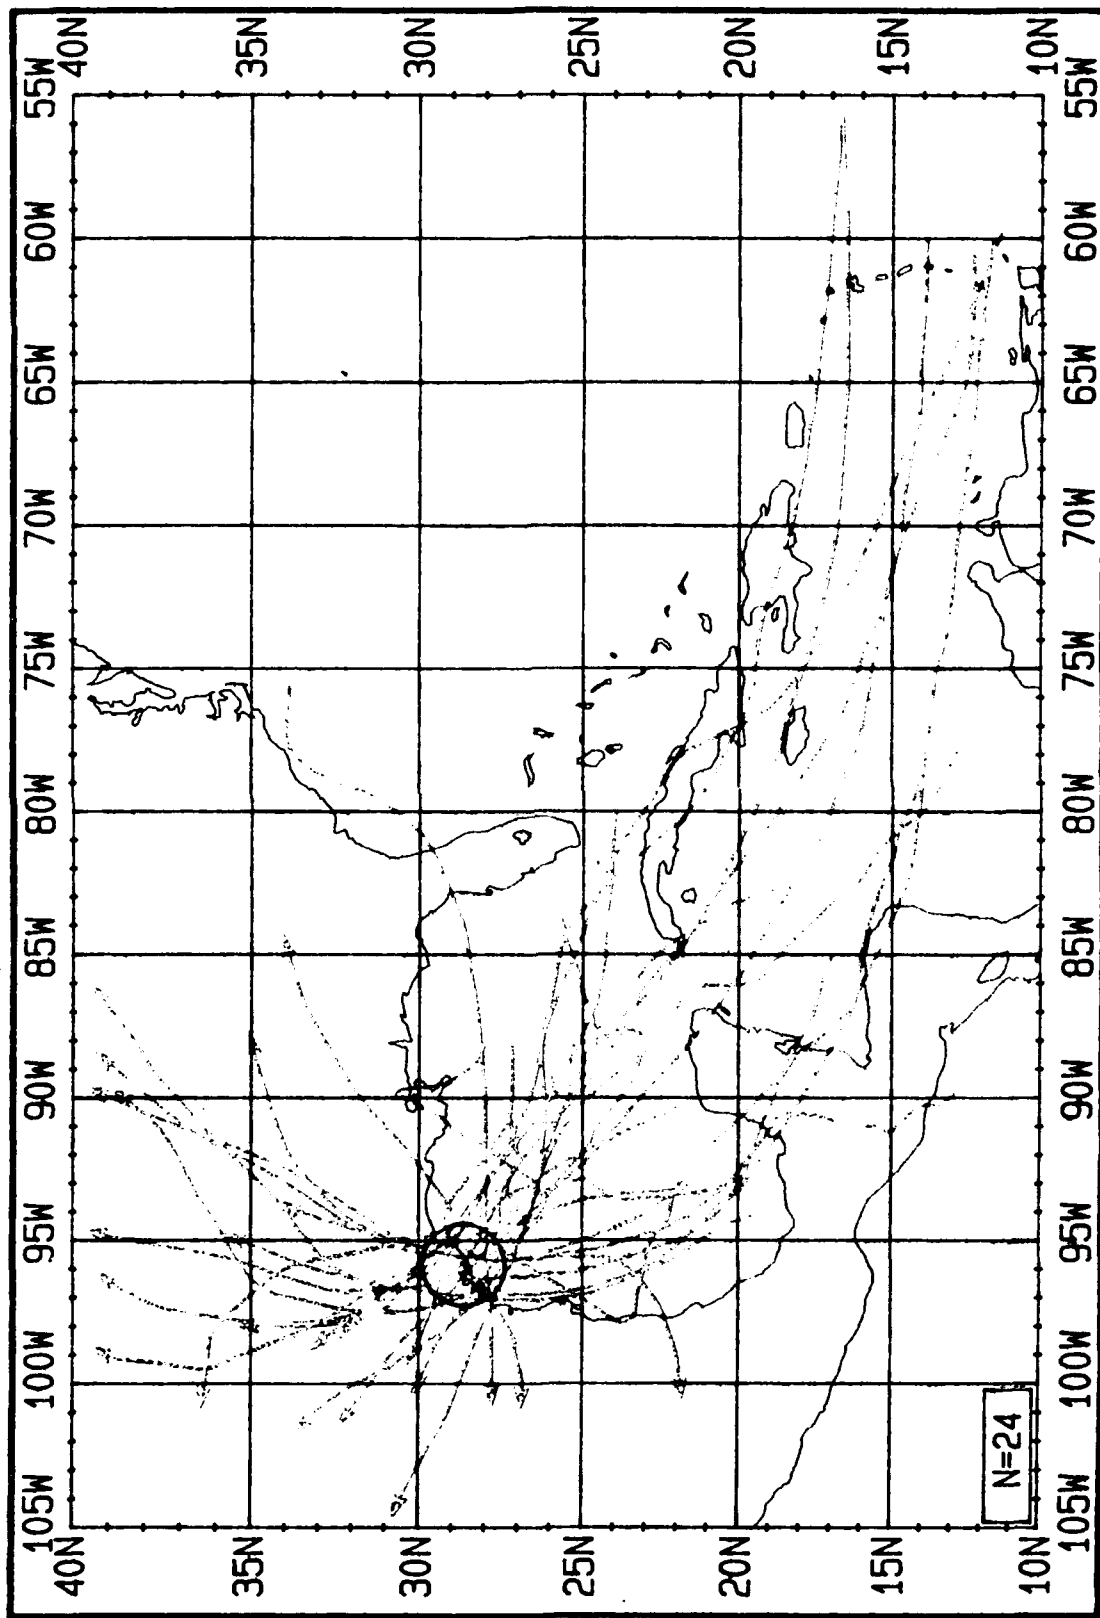
Figure 2. Tracks of hurricanes passing within 75 n.m. of Sargent Beach, TX: 1886-1990

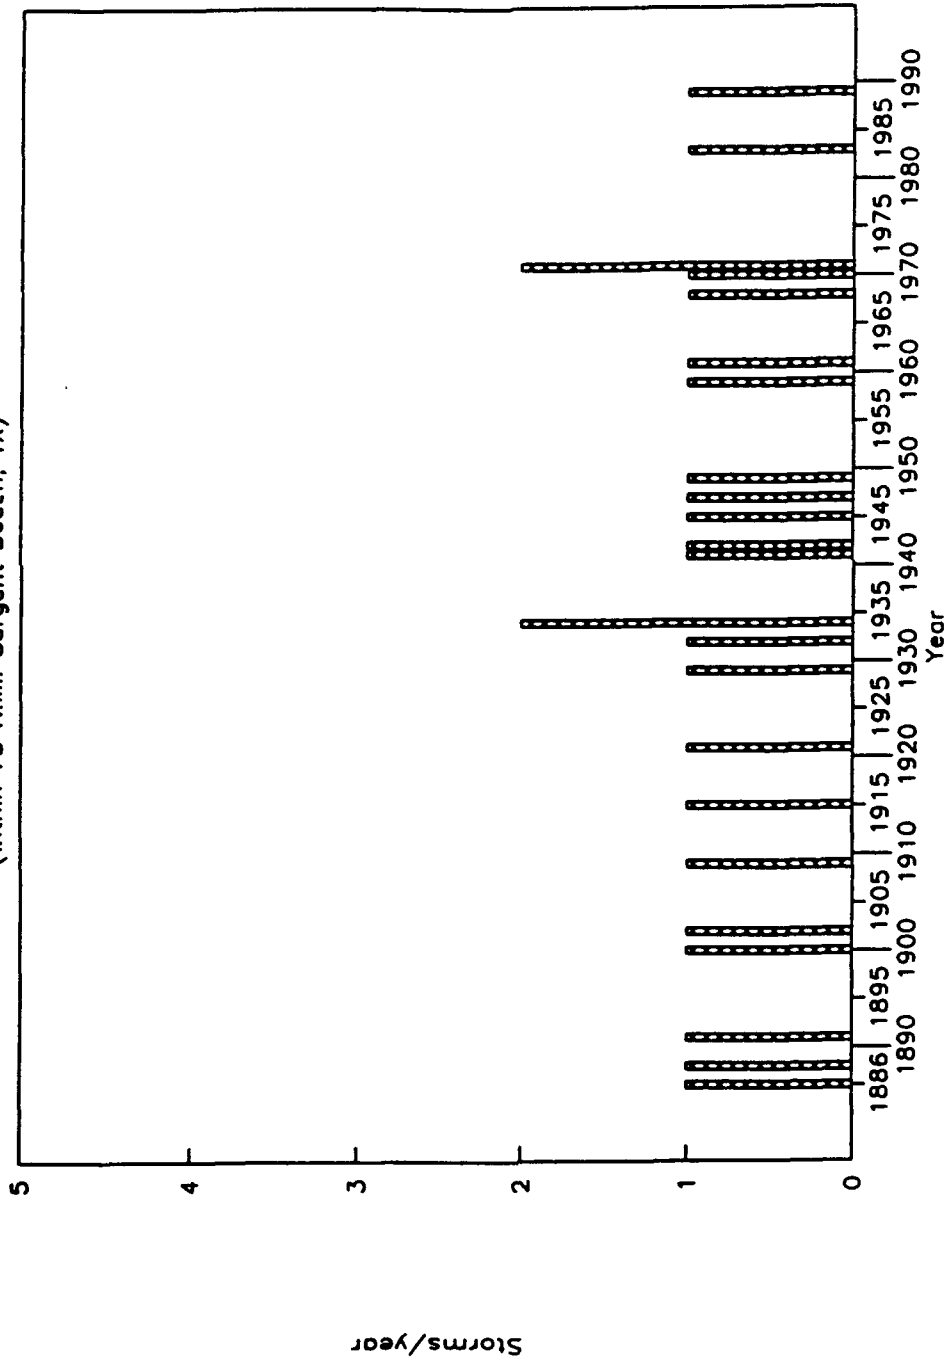
Figure 3. Occurrence of hurricanes by year

Storm Occurrence 1886-1990

(within 75 N.Mi. Sargent Beach, TX)

The paths of these storms are shown in Figure 2. Most of the paths, if slightly modified, had the potential to critically impact the site. If we include the past year 1990, there were 24 storms in 105 years which could potentially have affected Sargent Beach. Thus, on the average, there is the chance of 24/105 or 0.23 storms per year or approximately 1 storm every 4 years. These include all categories and all paths. Of course, storms do not occur with such regularity. The distribution of these storms in time is shown in Figure 3 for the period 1886 to 1990. From Figure 3, it is evident that there were periods of about 10 years without hurricanes and 2 years (1934 & 1971) when there were 2 in one year.

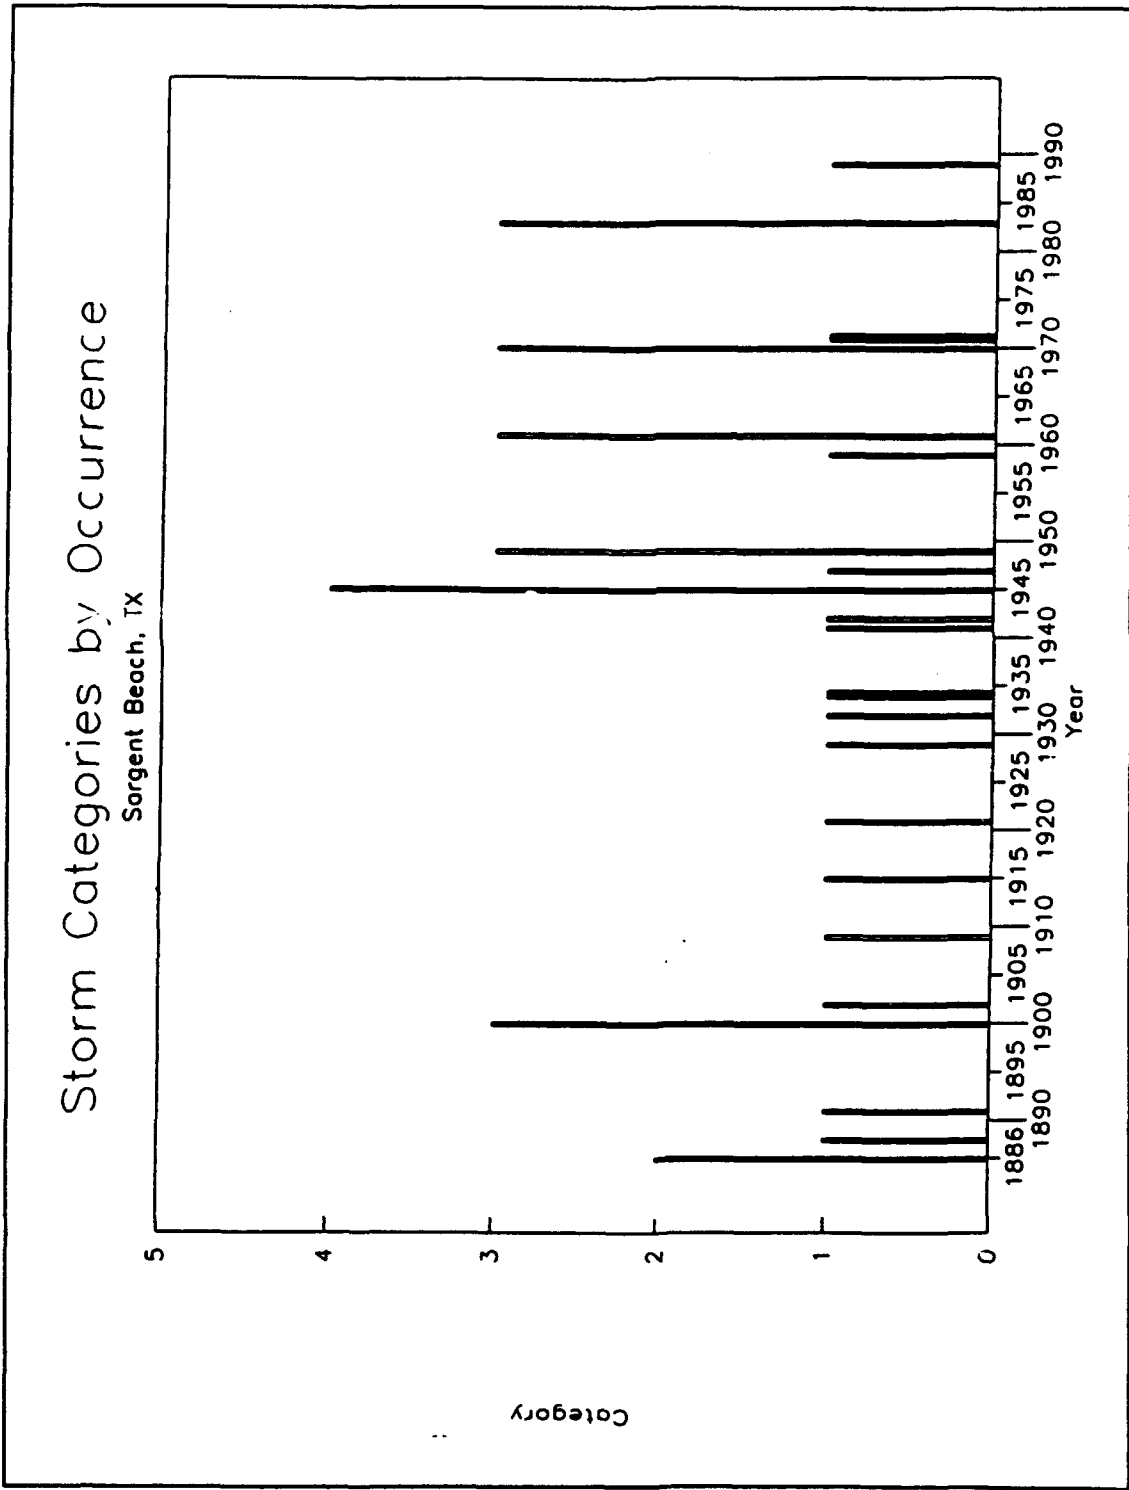
Figure 4. Categories of hurricanes by year

The distribution of these storms in time by category is shown in Figure 4. All categories, with the exception of 5 (the most severe), have occurred near the site. Most of the storms (17) are category 1, 1 of category 2, 5 of category 3, and 1 of category 4. There were 2 storms in the 1970's and 2 in the 1980's. If we project through the 1990's, we might expect 2-4 storms which could potentially affect the site. If so, this would average out to about 7 in 30 years as indicated by the historical data.

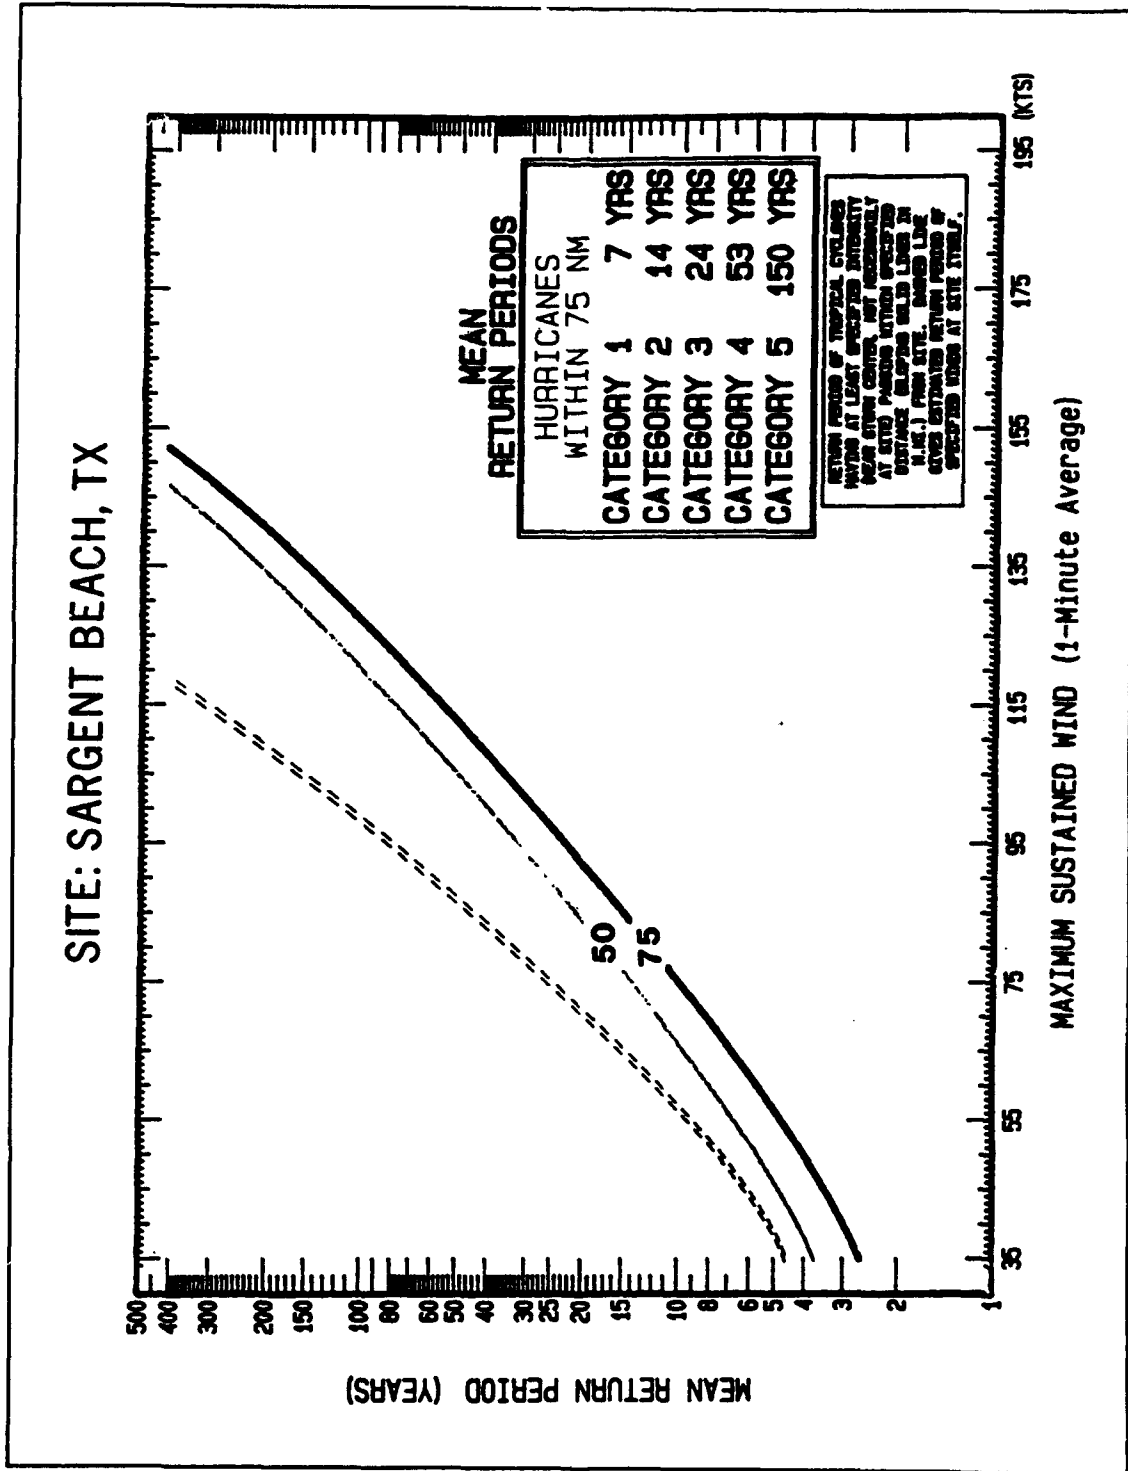
Figure 5. Mean return period versus maximum sustained wind speed

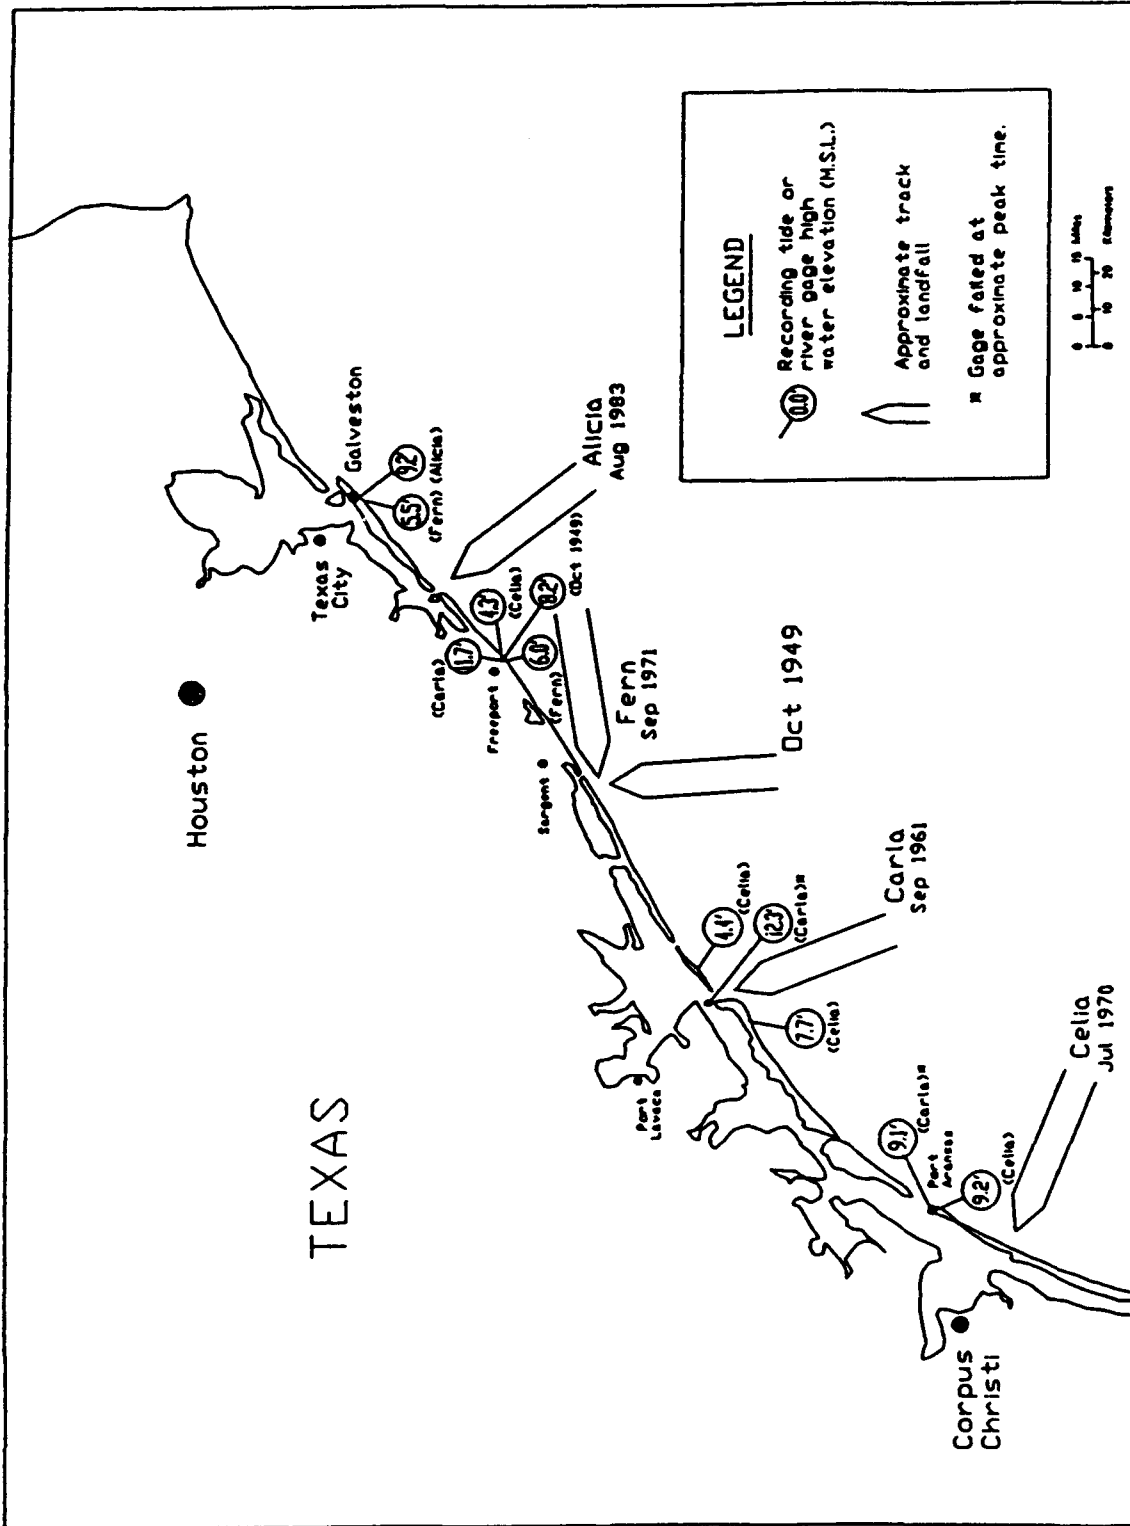
Figure 6. Measured water levels for hurricanes making landfall near Sargent Beach, TX

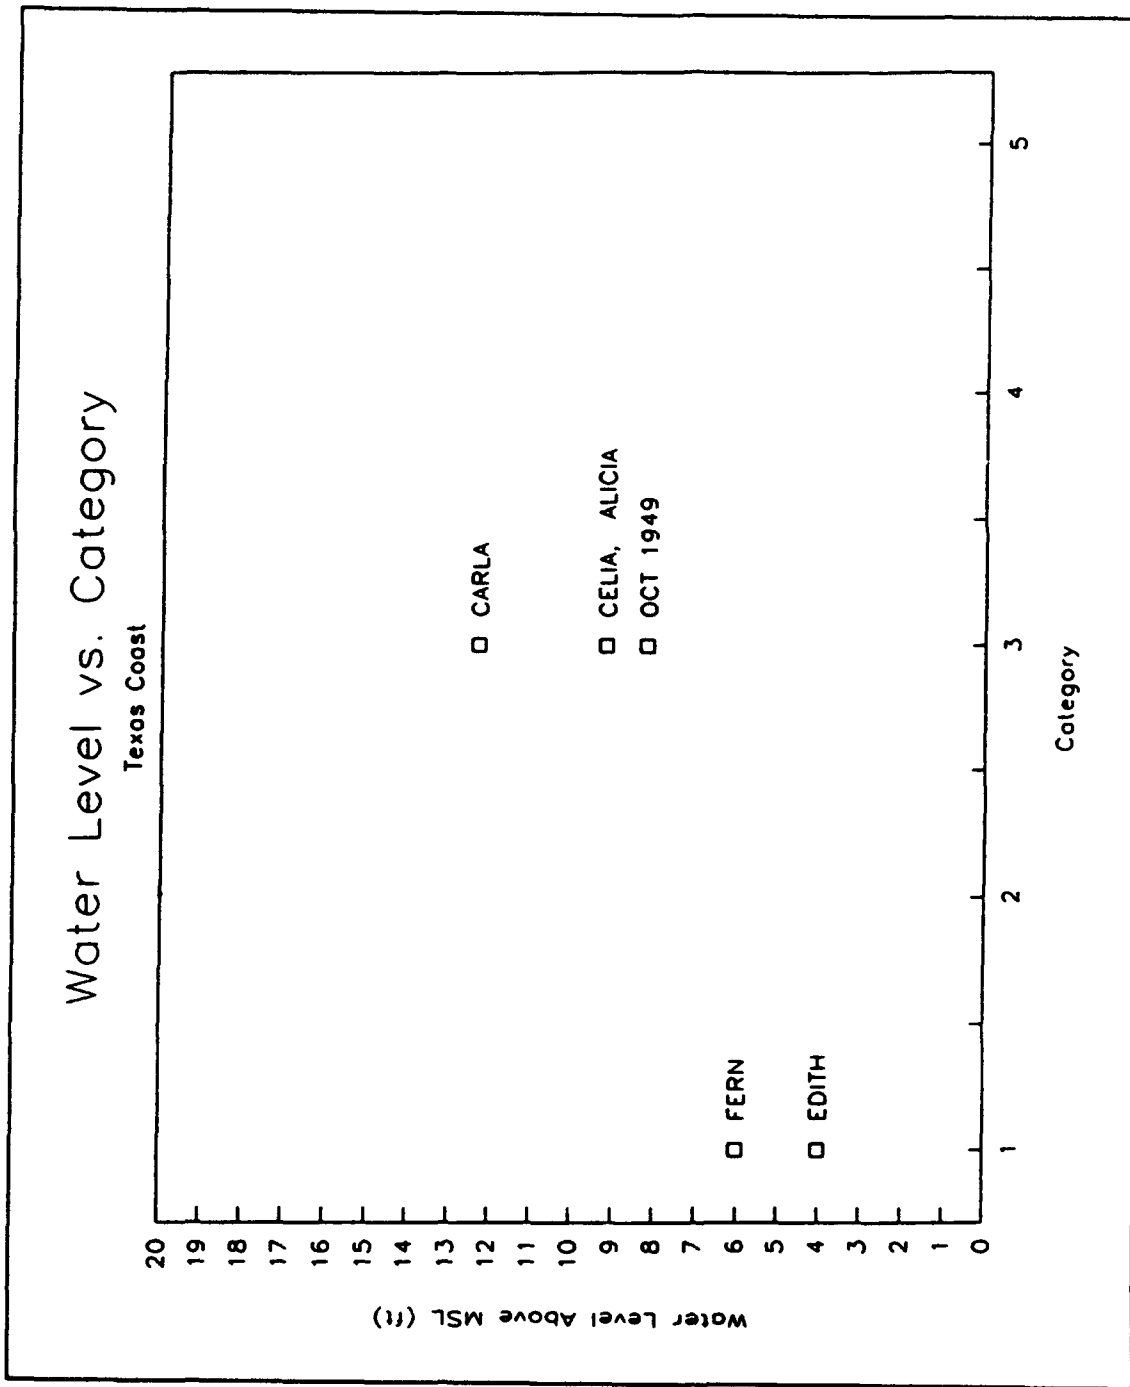
Figure 7. Water level versus storm category for hurricanes near Sargent Beach, TX

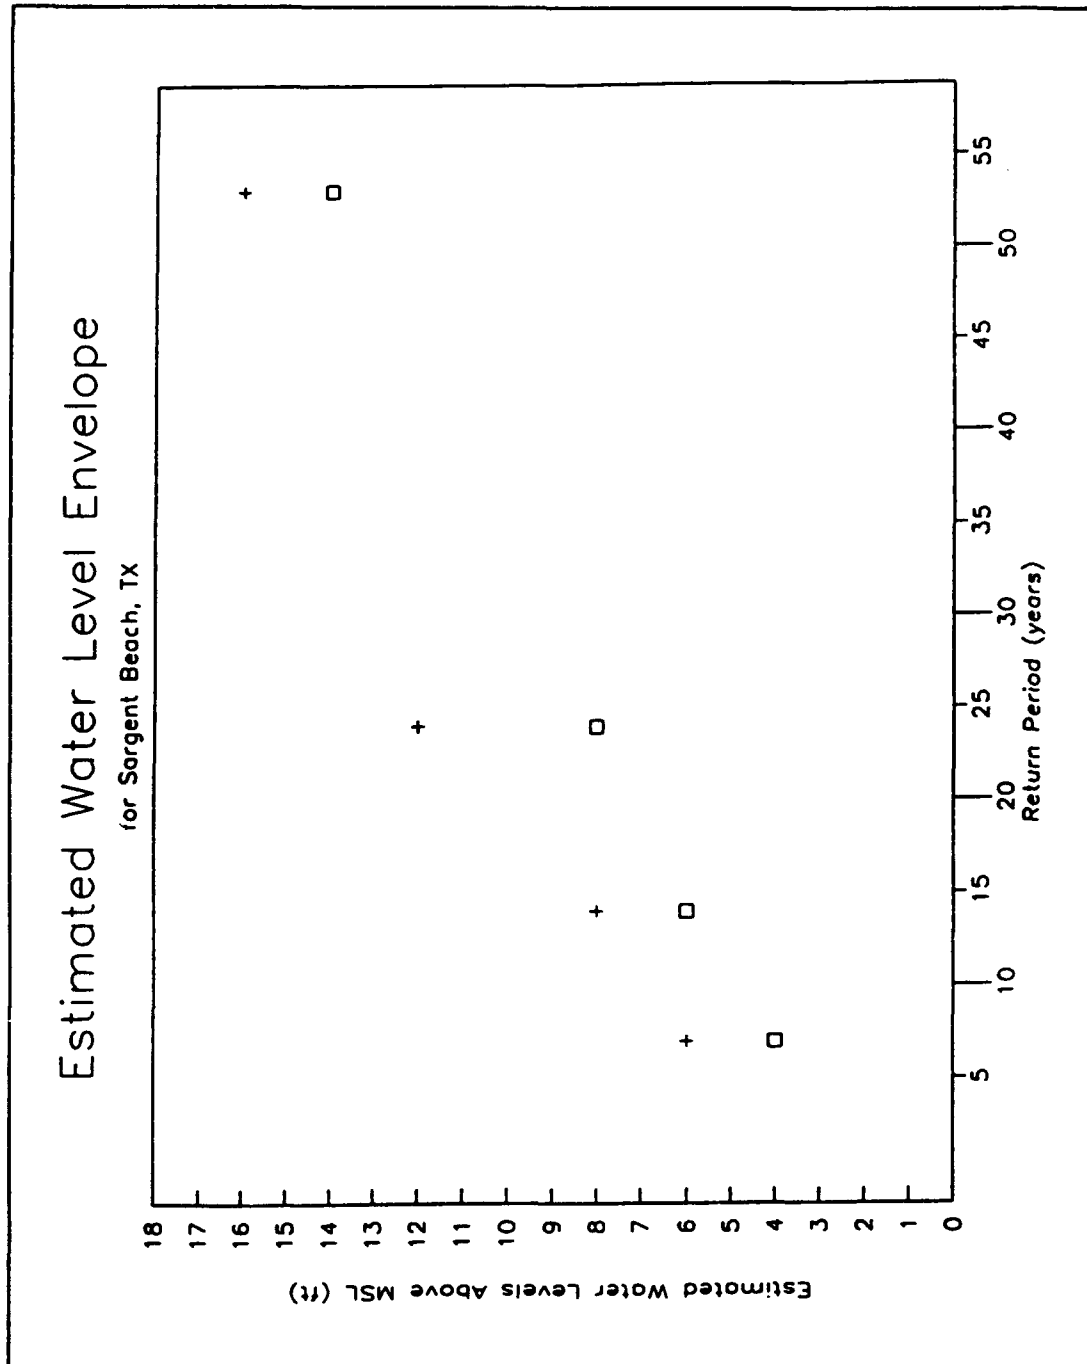
Figure 9. Estimated water-level envelope versus return periods for Sargent Beach, TX

If we assume the return periods associated with storms approaching within 75-n.m. are appropriate, then at Sargent Beach, one could expect total water levels of 4-6 ft above mean sea level to have a return period of about 7 years, 6-8 ft 14 years, 8-12 ft 24 years, and if we extrapolate 14-16 ft 53 years. This estimated water-level envelope and associated return periods are shown in Figure 9.

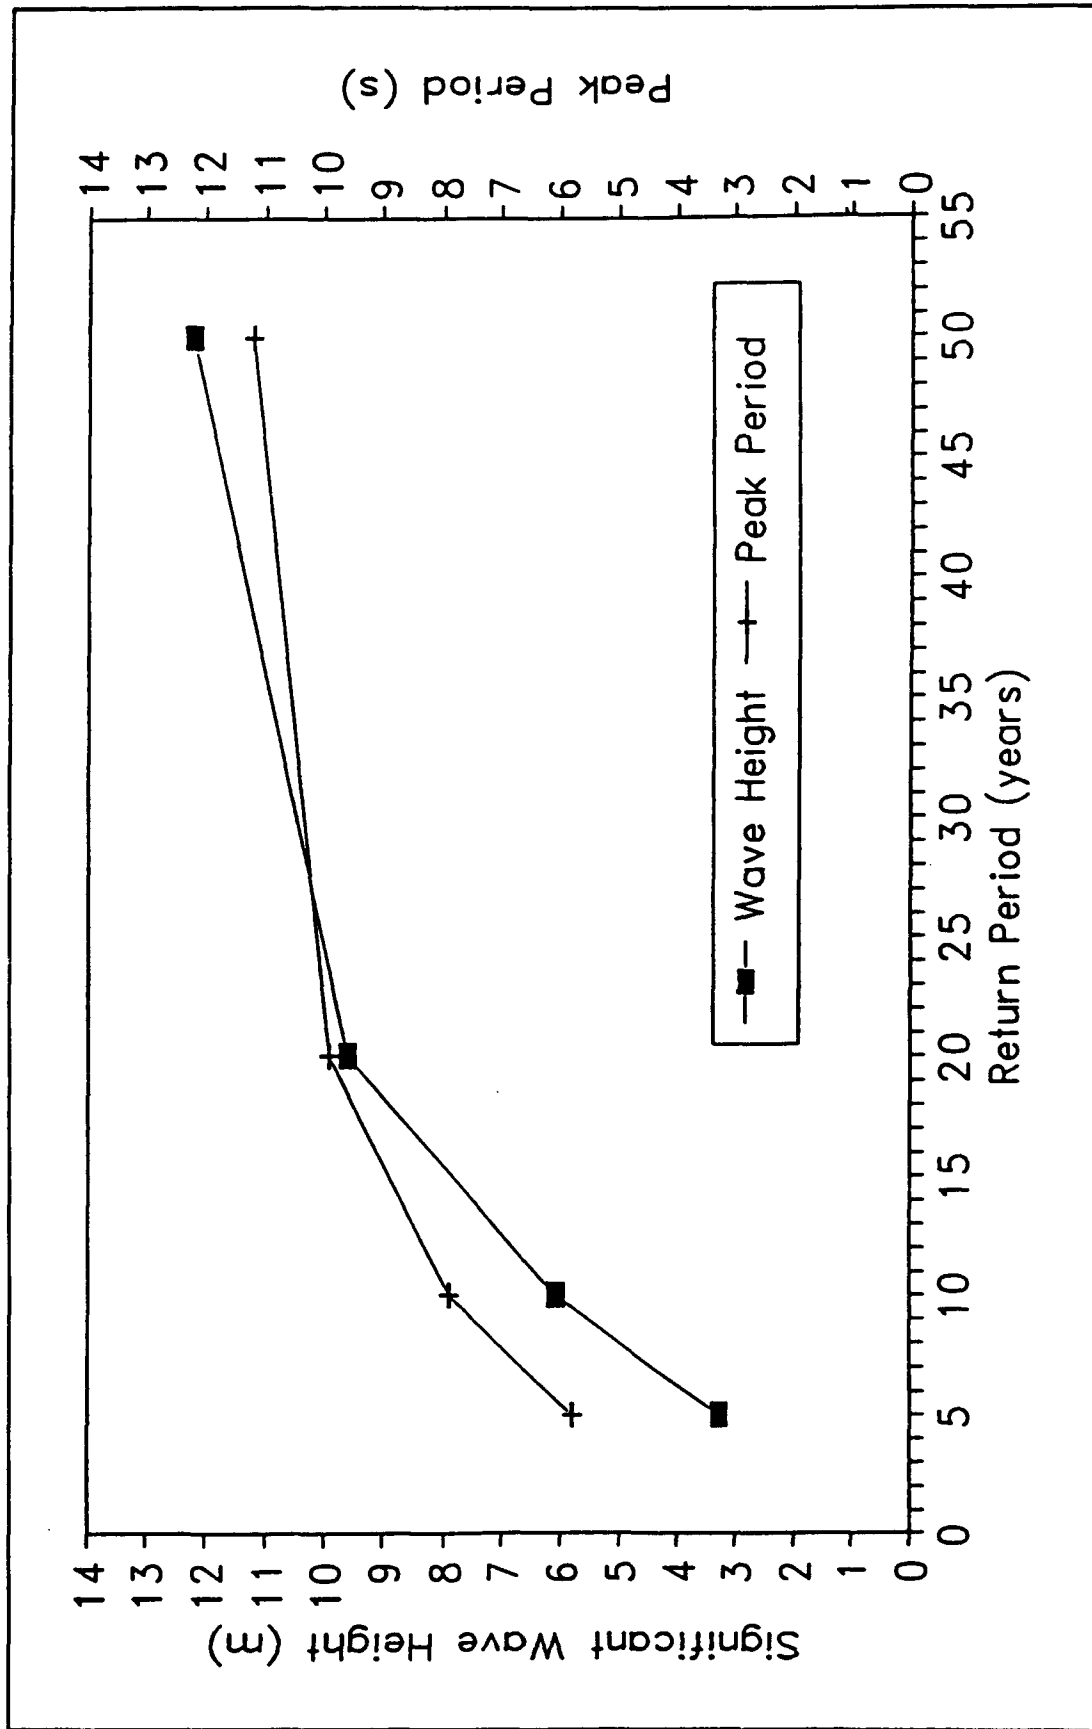
Figure 10. Wave heights and periods versus return periods for WIS Gulf station 9

Measured or observed wave conditions during hurricanes are more scarce than water level information. The best source of wave information near the site during hurricanes is contained in WIS Report 19 (Abel et. al. 1989) and the database on which the report is based. The revised values in the addendum to the report were used. Twenty-five hurricanes were simulated during the hindcast time period (1956-1975) all of which, except one, caused high wave energy at the hindcast station closest to the project site. This is station 9 located at 28.5 deg N, 95.5 deg W. This location is approximately 15 n.m. offshore in a depth of about 85 ft. These results were used to estimate return period wave heights and associated peak periods at this station. Estimates of the lower limit of the peak period for each wave height were obtained using Equation 15 from WIS Report 15 (Corson and Tracy 1985). These results are summarized in Figure 10.

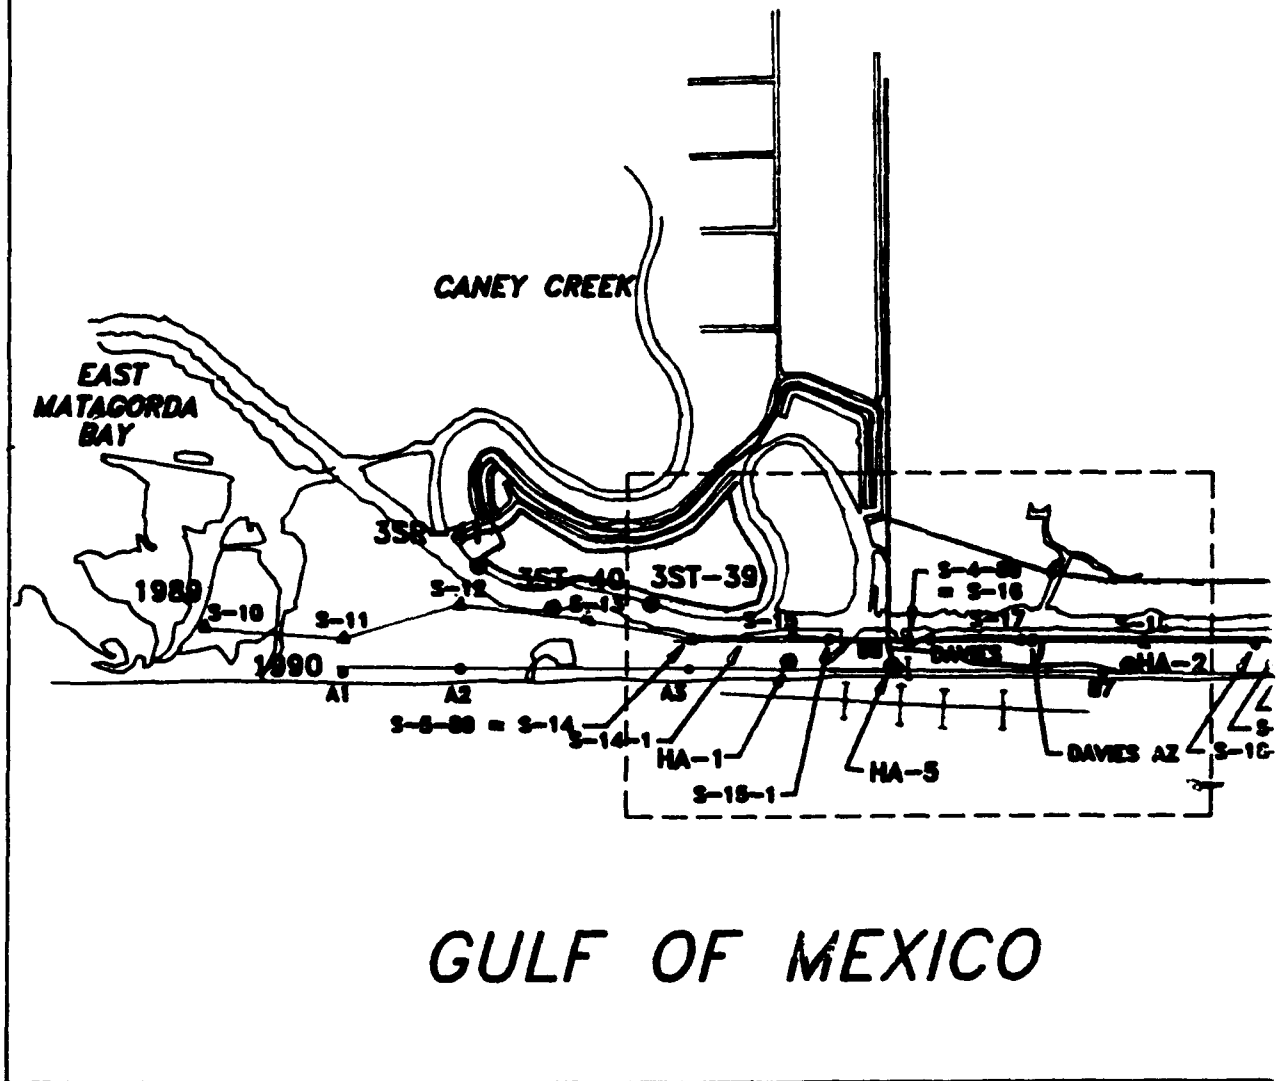
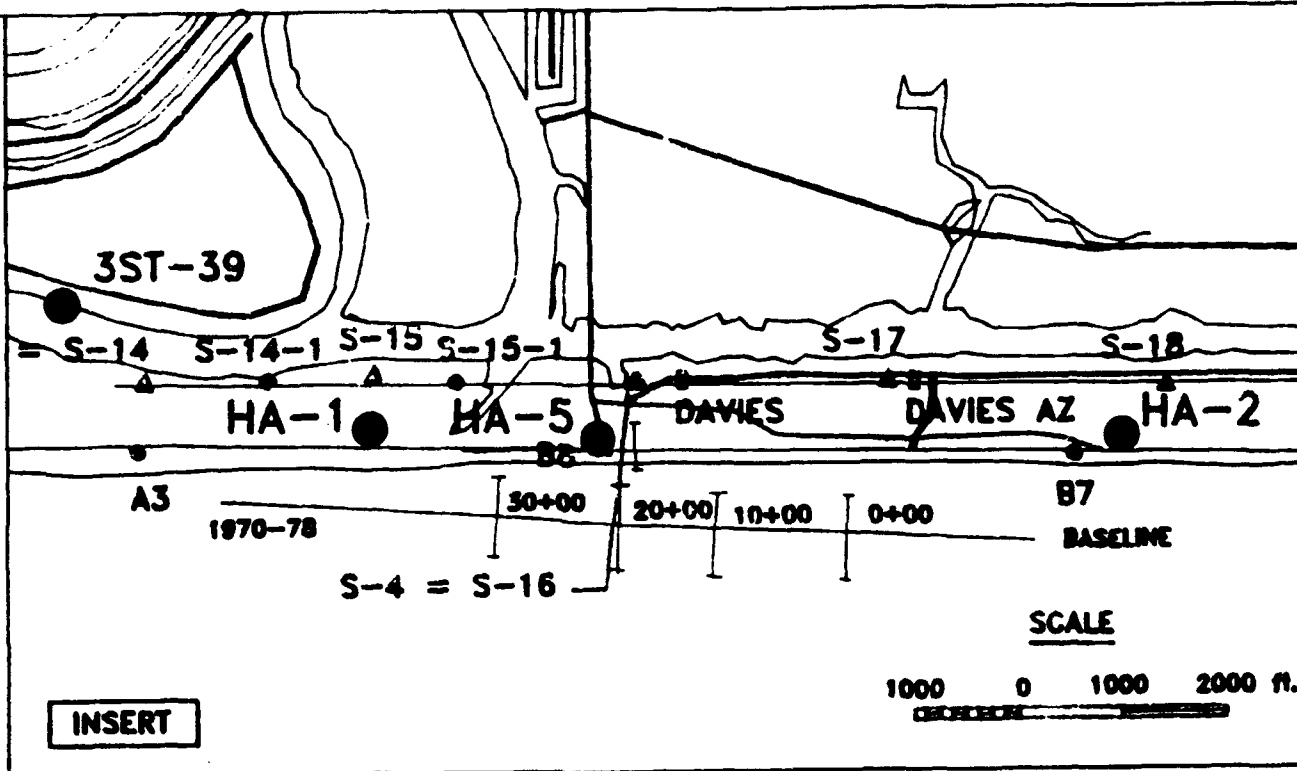
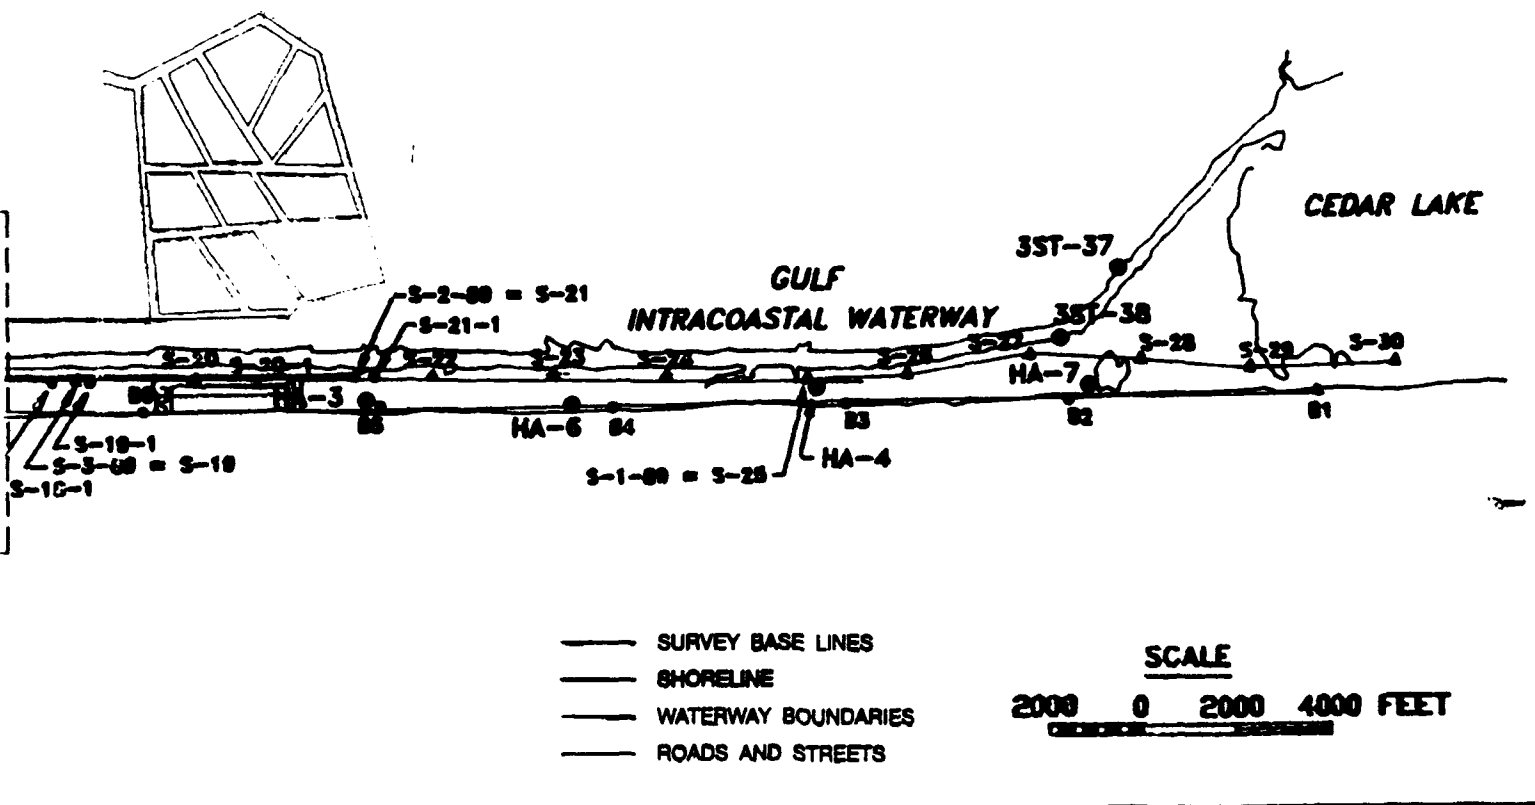
Figure 12. Detailed map of study area with past survey benchmark locations. Insert expands the built up a

it up area of Sargent Beach

Figure 35 shows both the 1937 and 1990 profile positions at approximately 50 years into the future, based on the life of the project at profile location S-17. Without any shore protection the shoreline would be 1,500 ft landward of the present position, using the average erosion rate of 30 ft/yr. Appendix C shows a similar type of analysis for profile locations S-13 southwest of McCabe's Cut, S-20 northeast of Charpiot's Cut, S-24 between Charpiot's Cut and Cedar Lakes, and S-28 near Cedar Lake (see Figure 12 for profile locations).

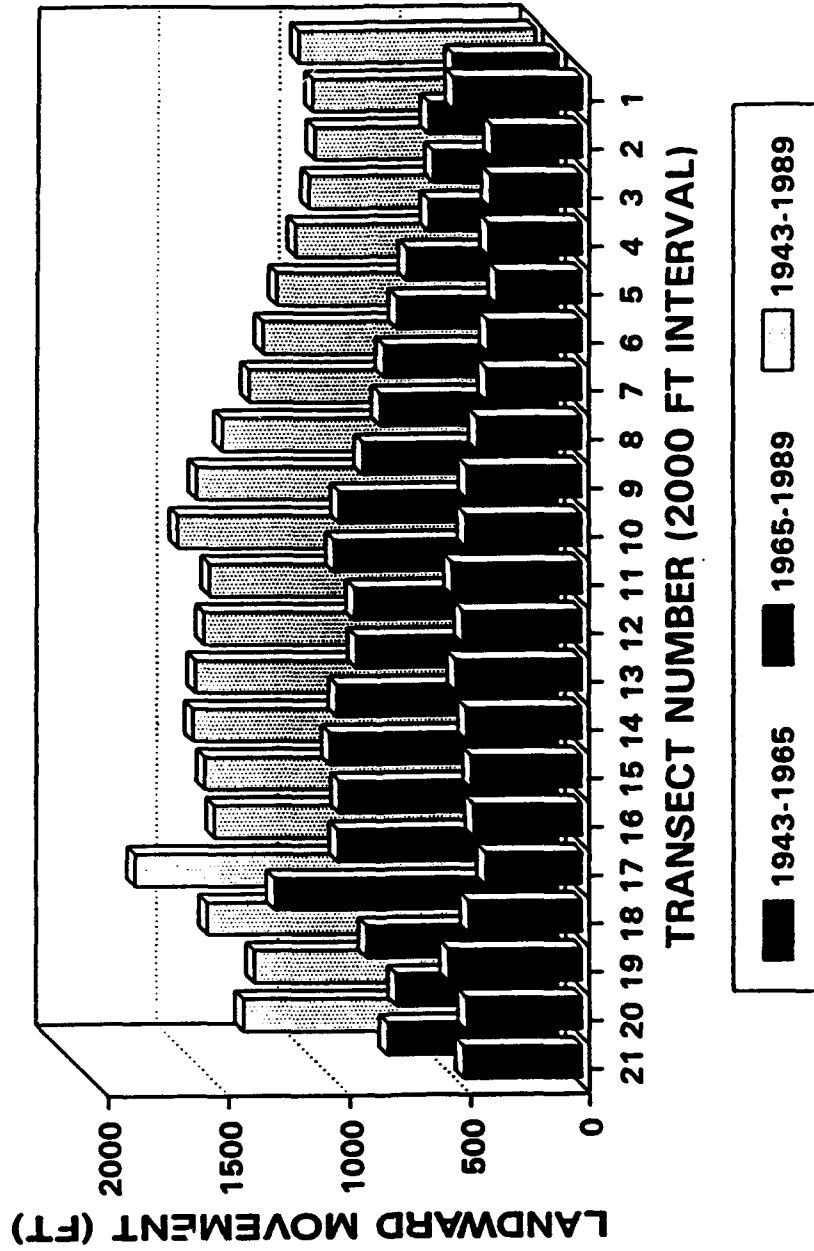
Figure 16. Maximum landward movement of the high-water line over the entire 46 year study period from 1943 to 1989, last 24 years from 1965 to 1989, and first 22 years from 1943 to 1965 for each transect

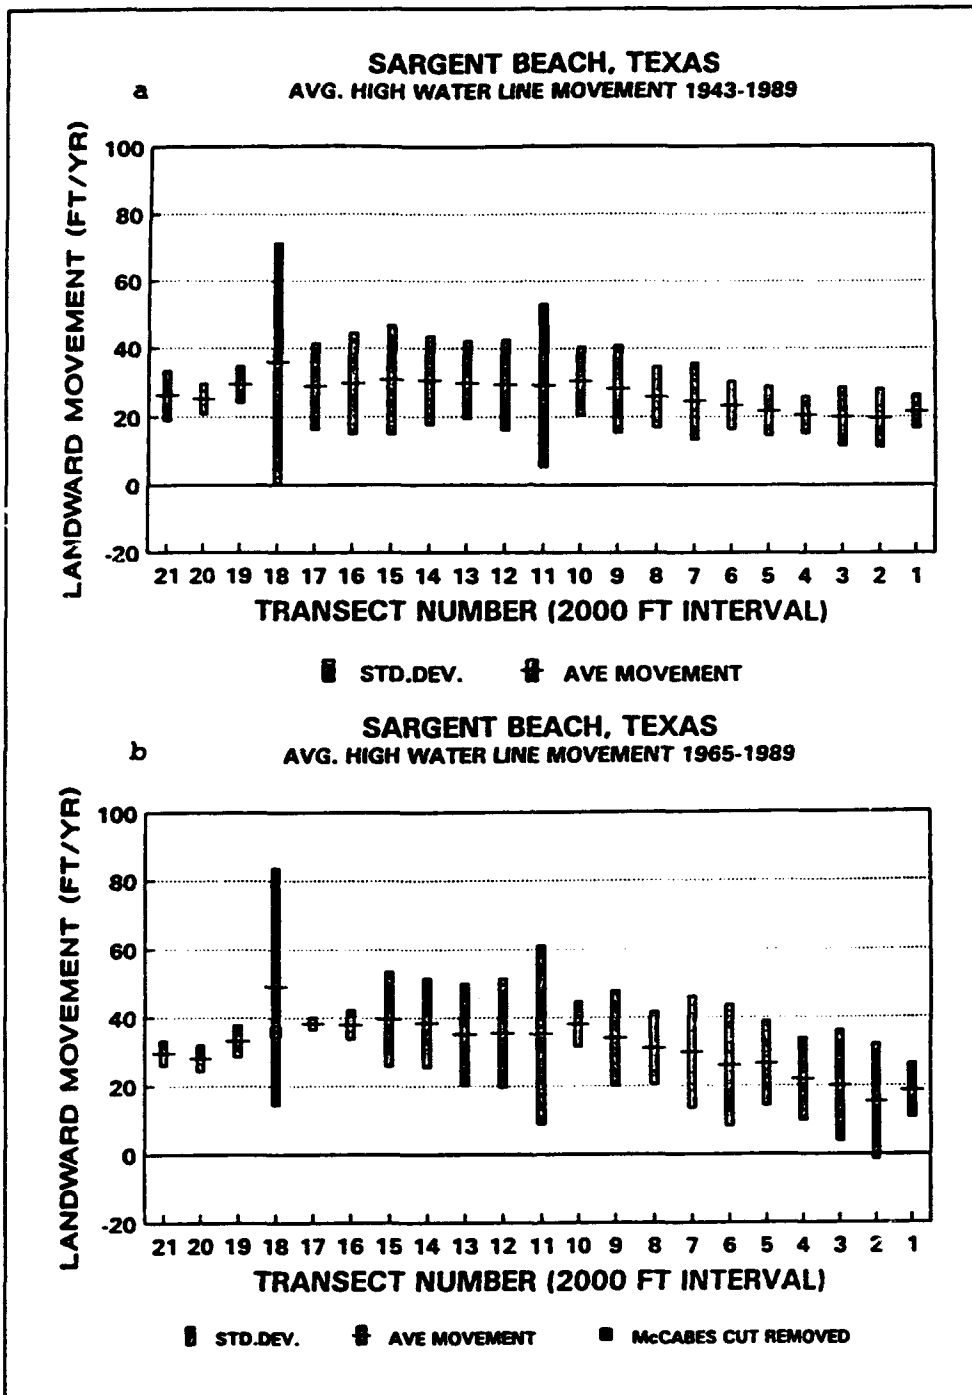
Figure 17. Average rate of high-water line movement over the (a) entire 46 year study, and (b) most recent 24 years for each of the transects. Averaging out the high variability of McCabe's Cut reduces the rate at station 18. Length of bars indicate standard deviation about mean for each transect

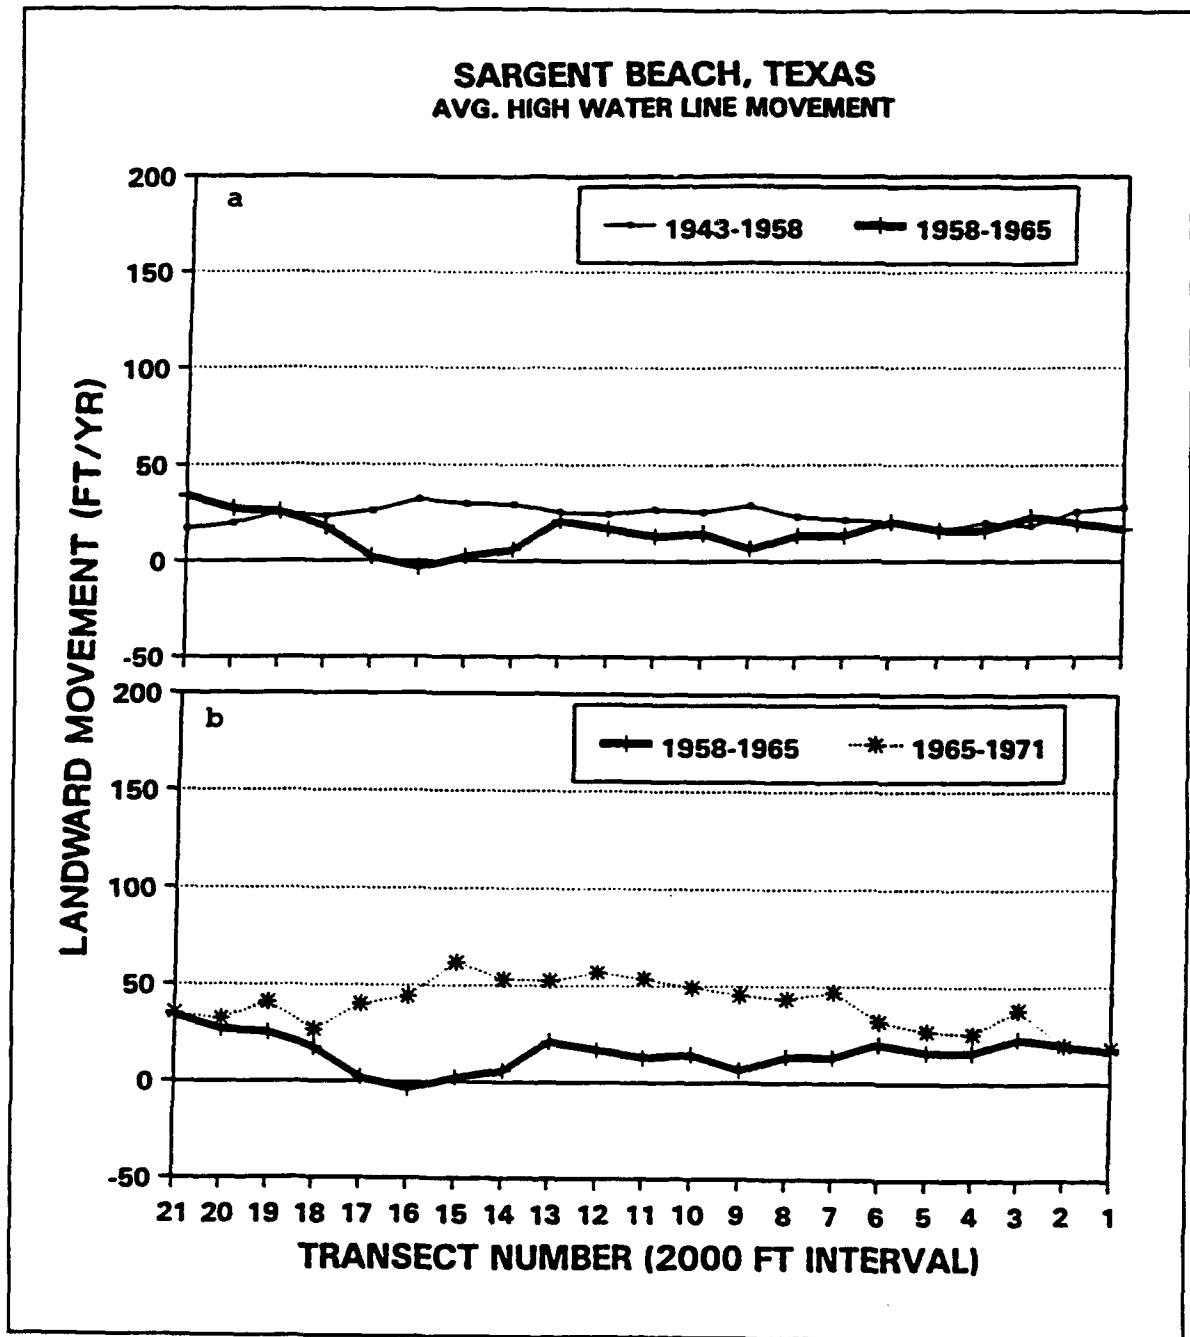
Figure 18. Average high-water line movement (a) from 1943-1958 and 1958-1965, (b) from 1958-1965 and 1965-1971
