Coastal Studies in Support of the Sargent Beach, Texas, Erosion Control Project

by *Donald K. Stauble, Jon M. Hubertz,
Robin J. Hoban, Claire R. Livingston, Cheryl E. Pollock*
Coastal Engineering Research Center

Final report

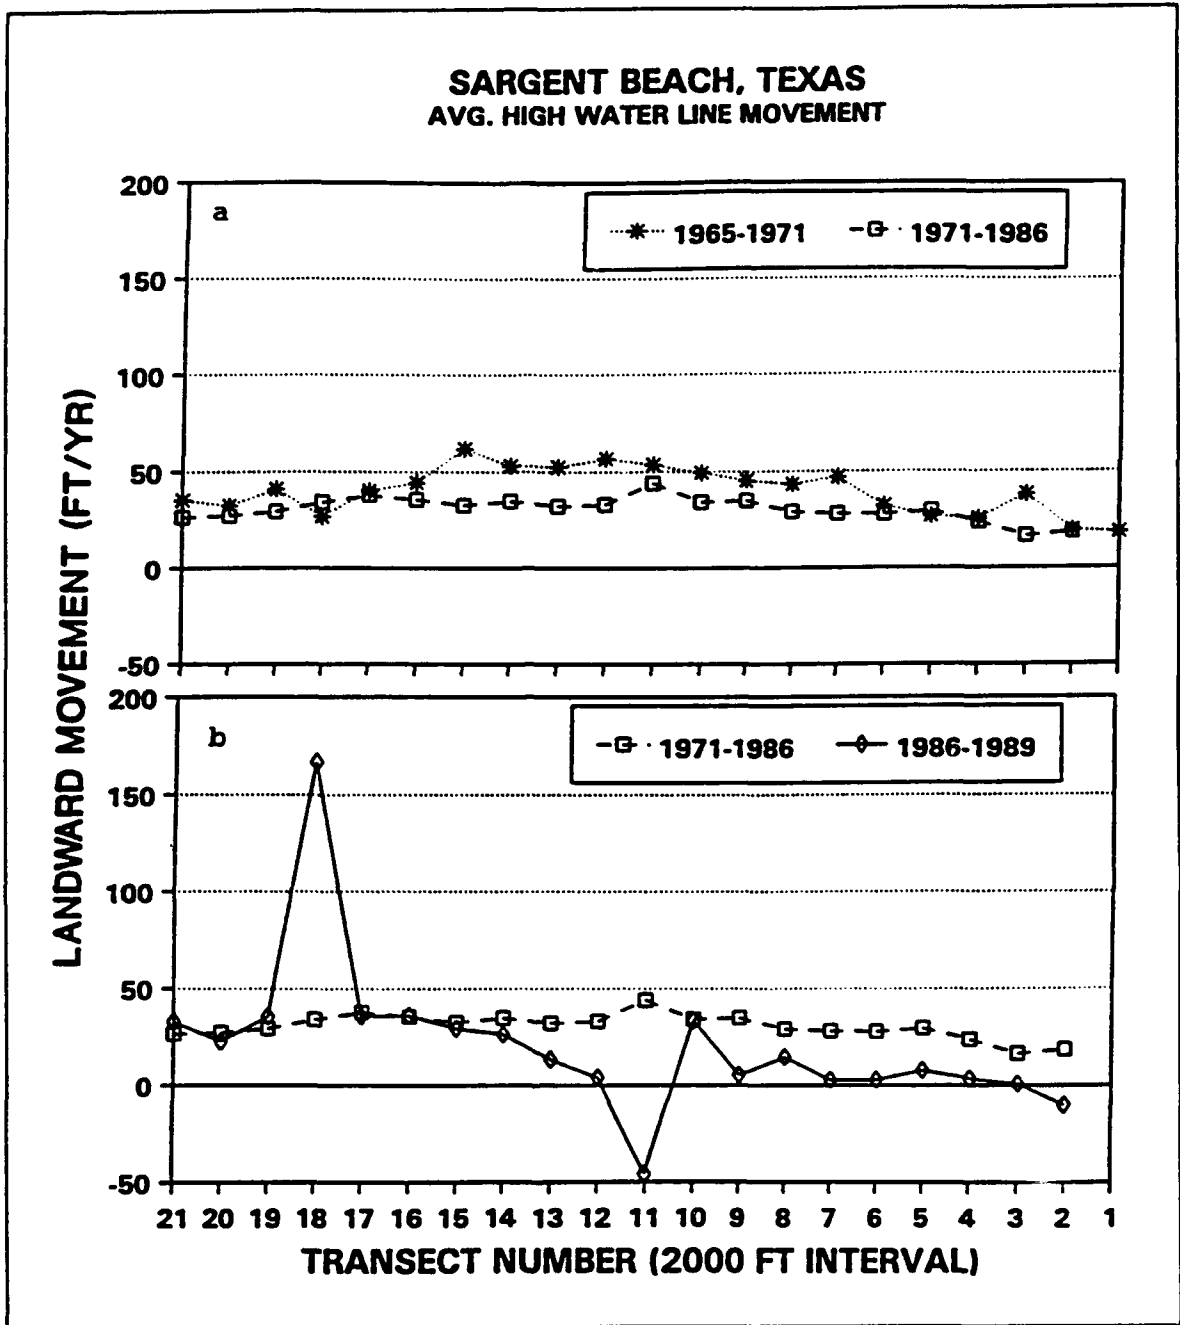
Figure 19. Average high-water line movement (a) from 1965-1971 and 1971-1986, (b) from 1971-1986 and 1986-1989

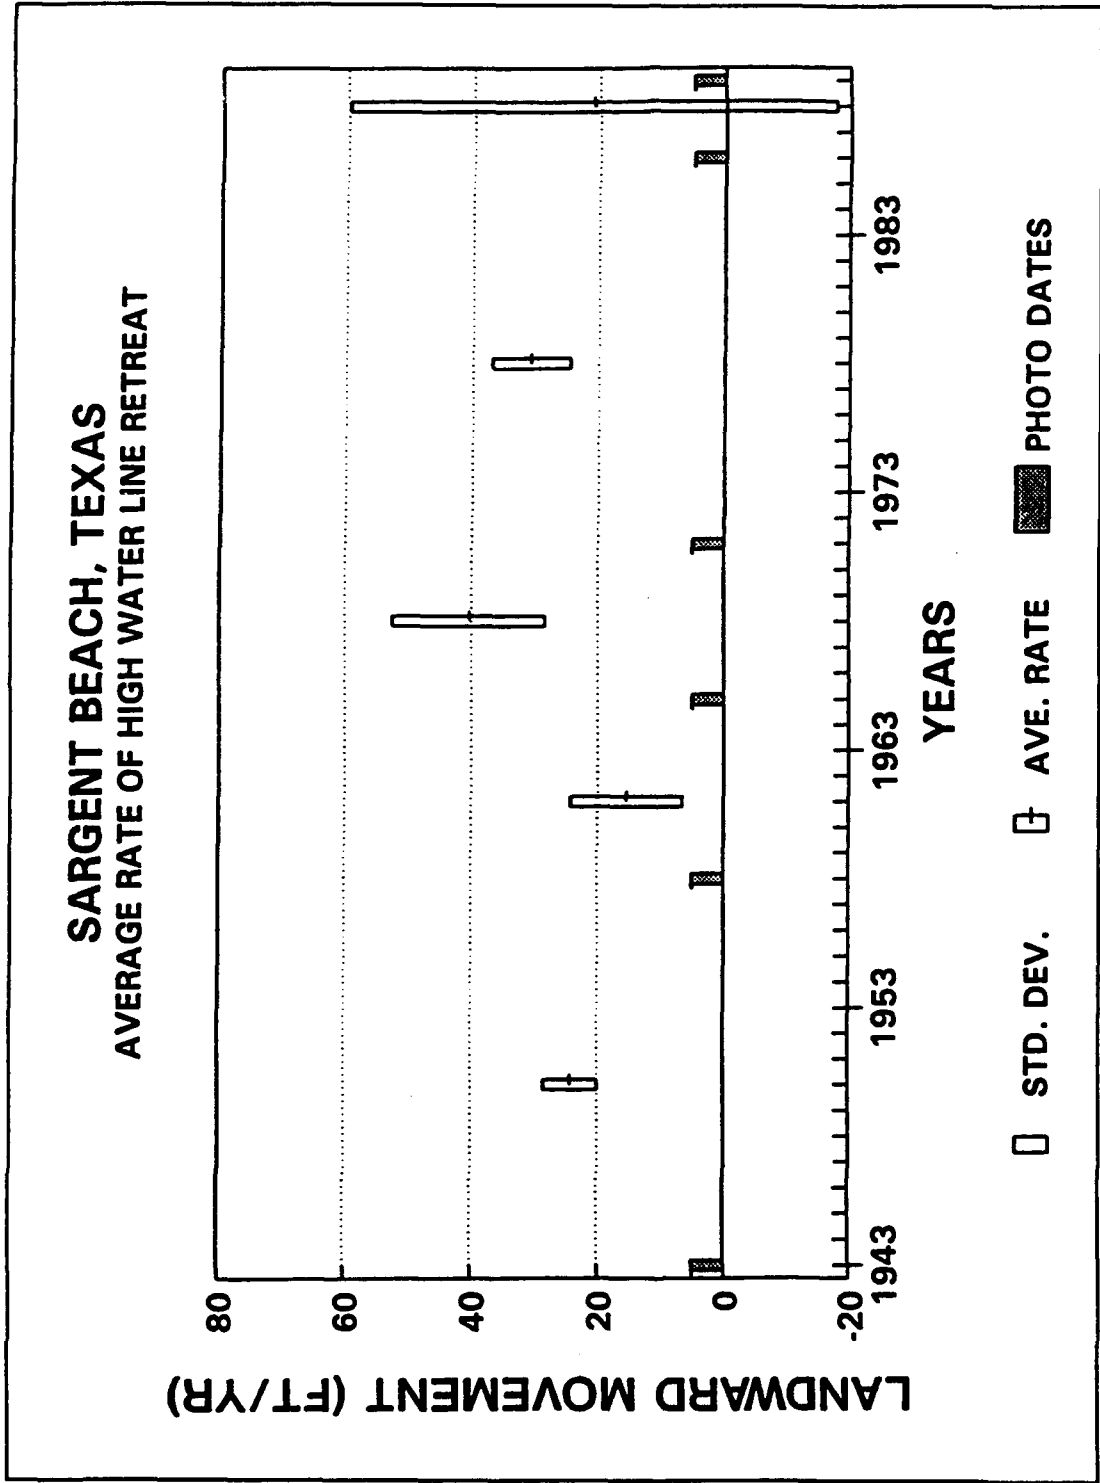
Figure 20. Average rate of high-water line erosion between each sampling period with standard deviation

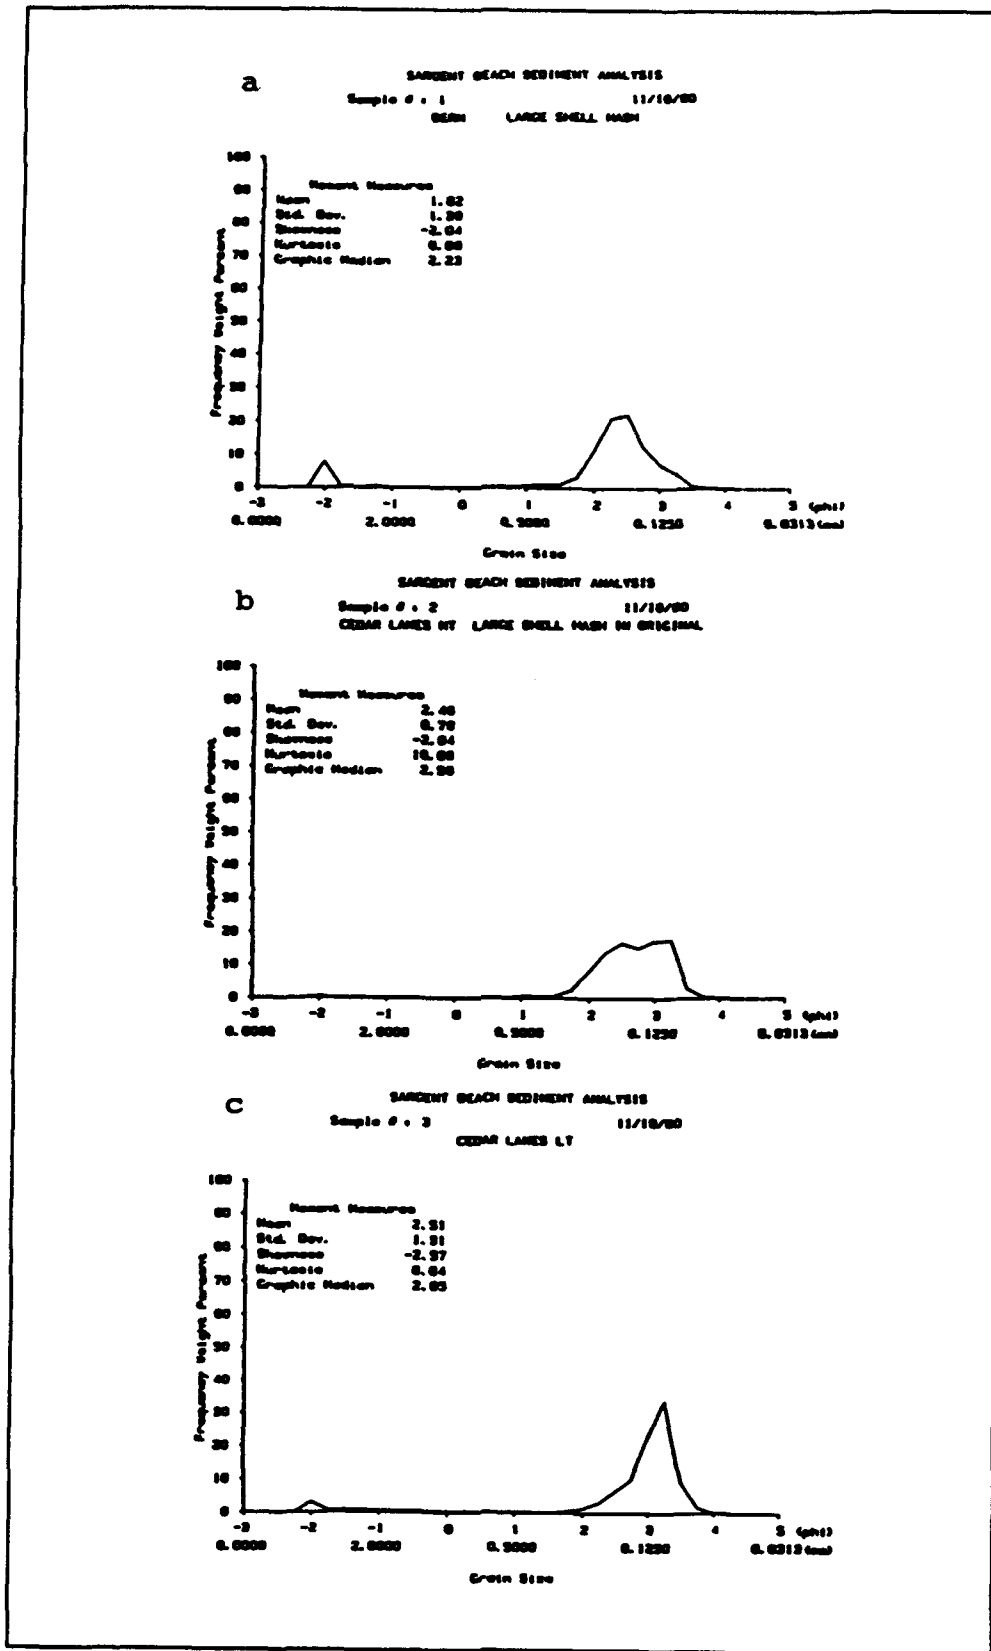
Figure 22. Surface sediment grain-size distributions of the Cedar Lake samples, (a) berm crest, (b) mid-tide, and (c) low tide

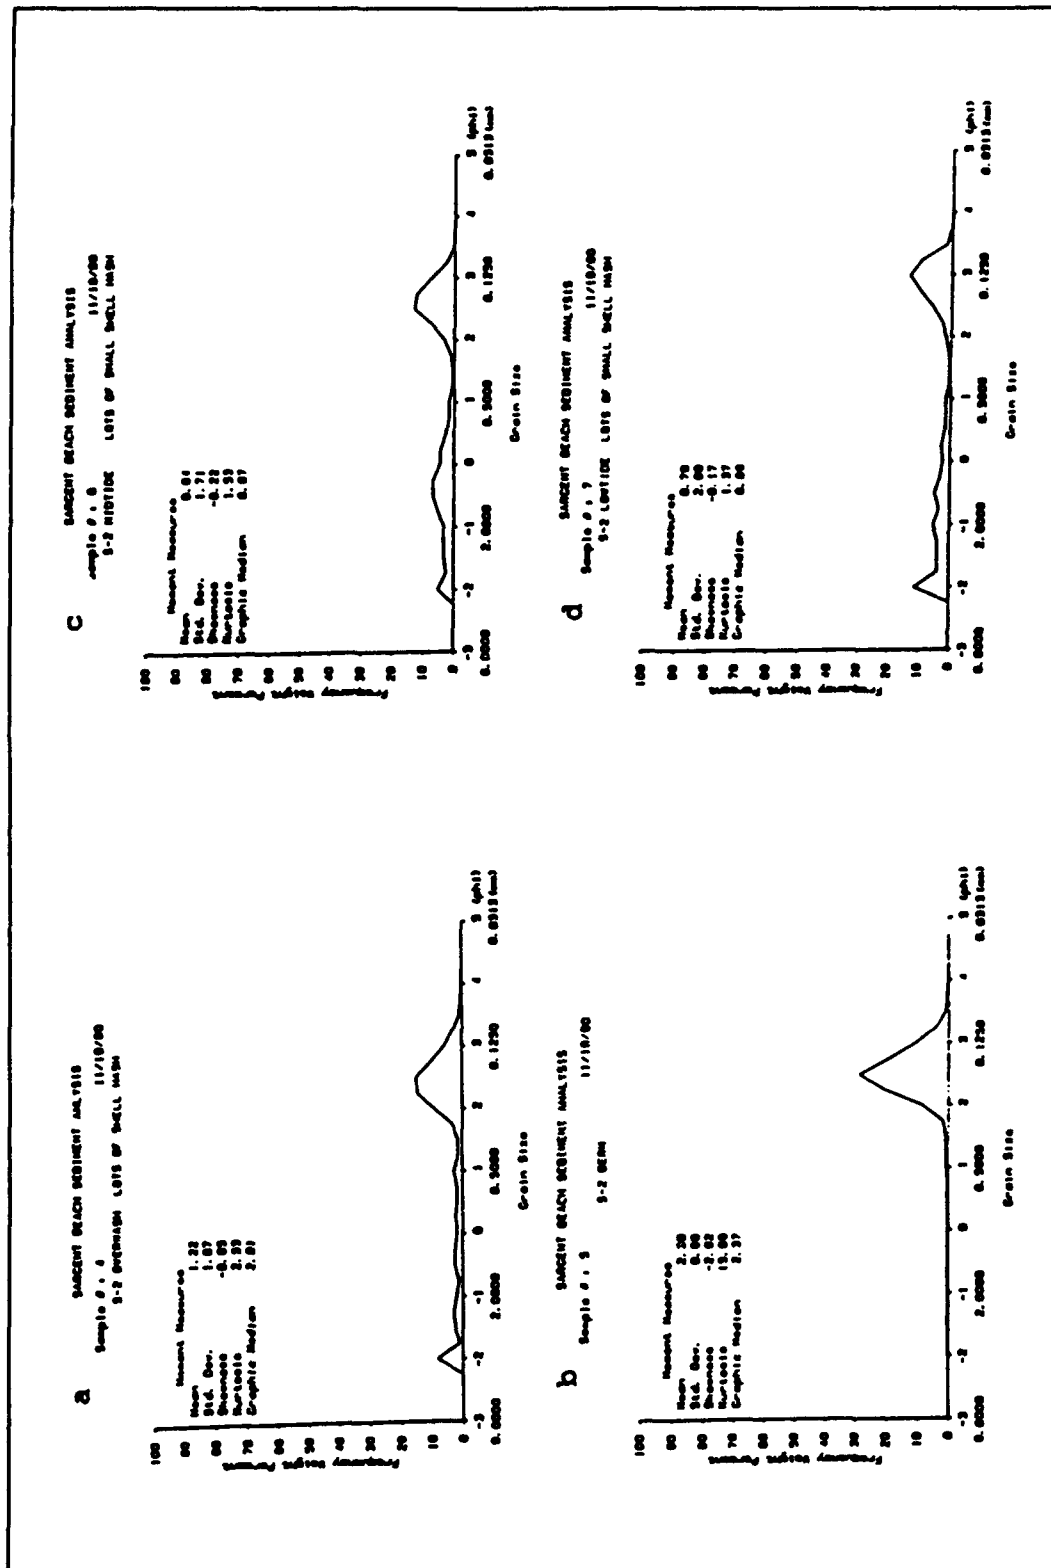
Figure 23. Surface sediment grain size distributions of the S-2 samples, (a) overwash, (b) berm crest, (c) mid-tide, and (d) low tide

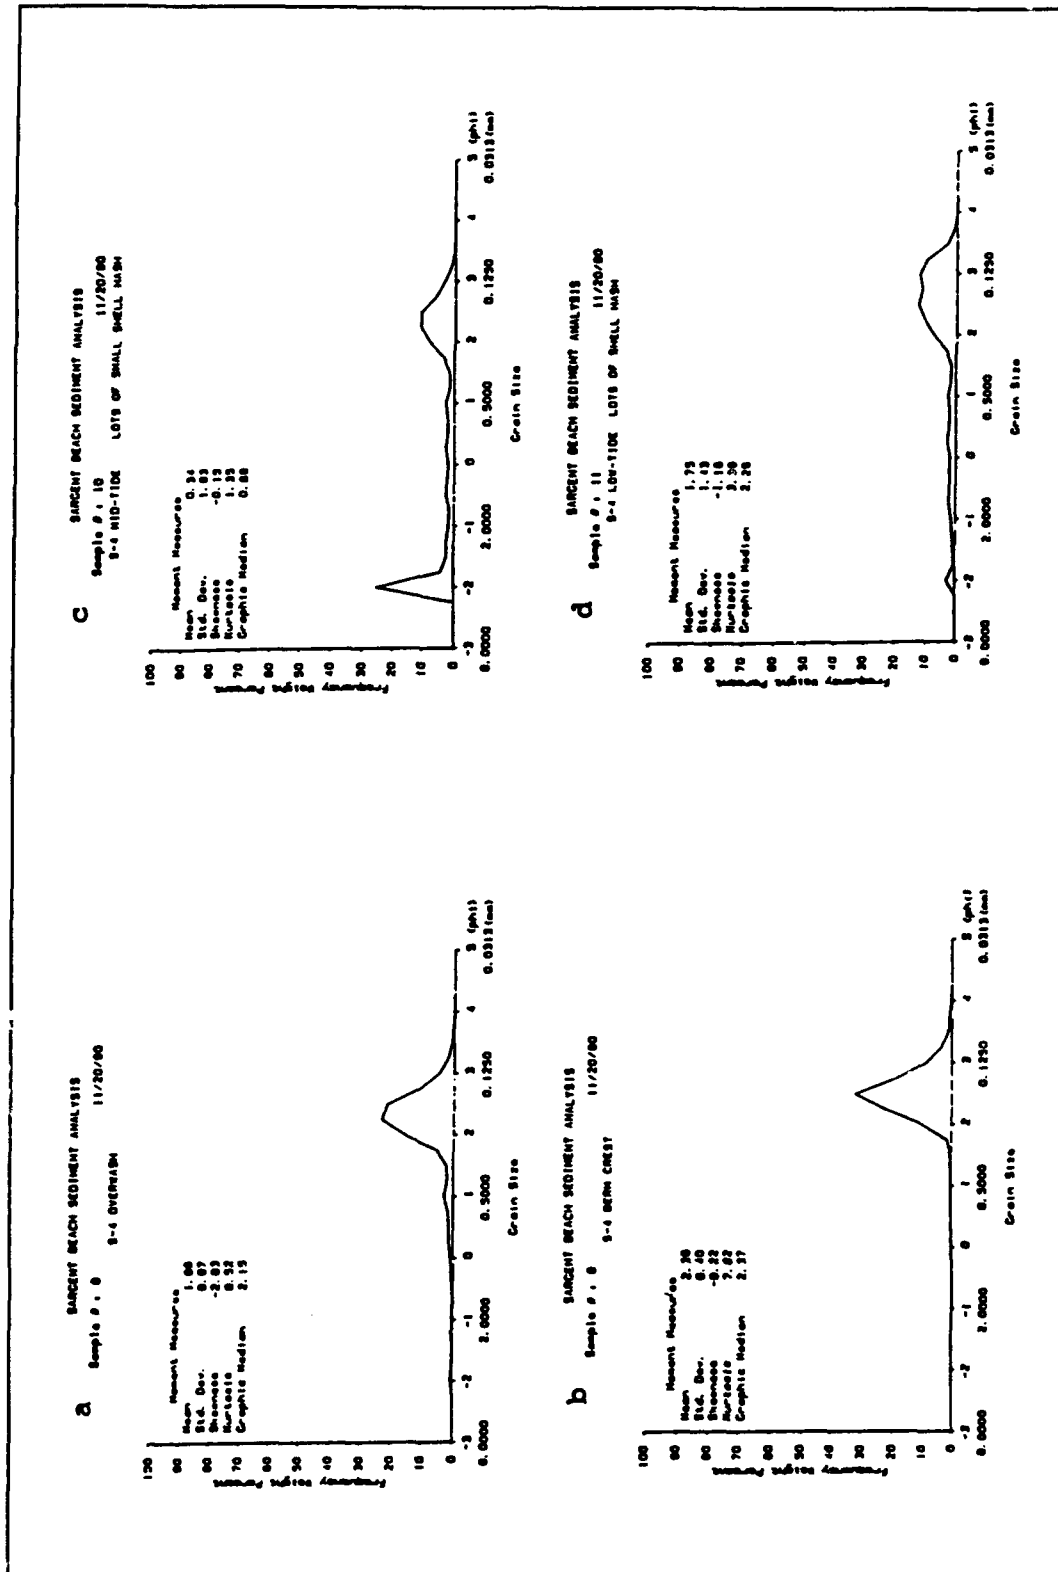
Figure 24. Surface sediment grain size distributions of the S-4 samples, (a) overwash, (b) berm crest, (c) mid-tide, and (d) low tide

The sediment grain size distributions of each surface grab sample (Figure 24) show a small amount of shell material on the overwash fan, little shell material at the berm crest and large amounts of small shell hash in the mid- and low tide areas. The low tide sand sample was collected from one of the pockets of sand between the clayey-silt terraces. Again the main sand peak was found around 0.21 mm (2.25 ϕ). The composite median for Transect S-4 was similar to Transect S-2, with a 0.22 mm (2.18 ϕ) value. The mean again reflected the coarse shell material component found on this transect with a value of 0.36 mm (1.48 ϕ), which is in the coarse sand range (Wentworth Classification).

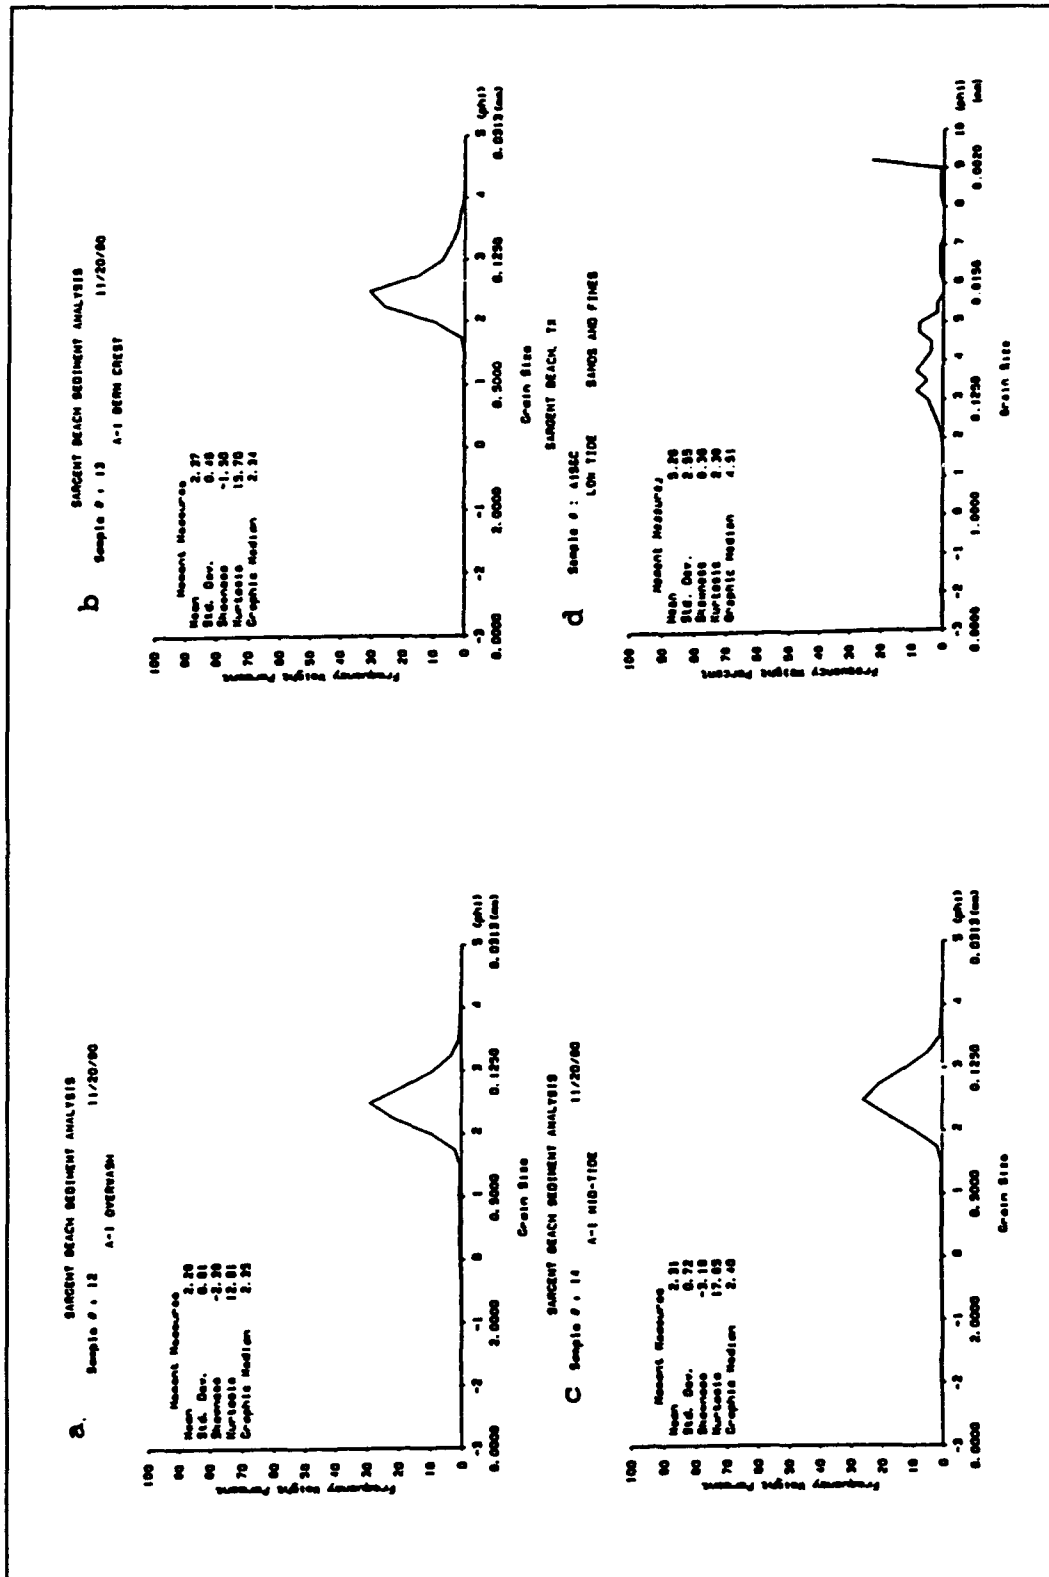
Figure 25. Surface sediment grain size distributions of the A-1 or S-11 samples, (a) overwash, (b) berm crest, (c) mid-tide, and (d) low tide. Note expanded size range on plot of low tide sample

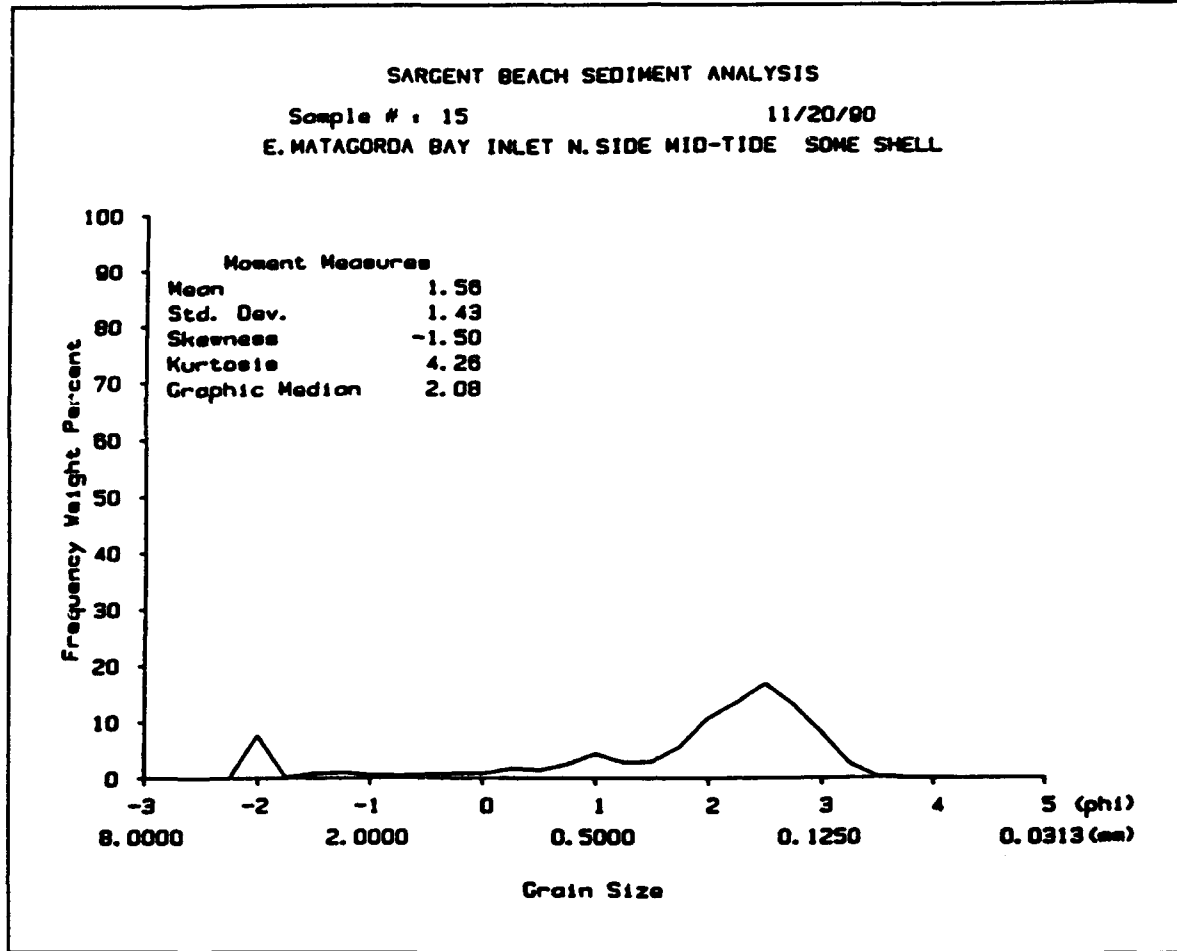
Figure 26. Surface sediment grain size distributions of the mid-tide at the northeast side of East Matagorda Bay Inlet

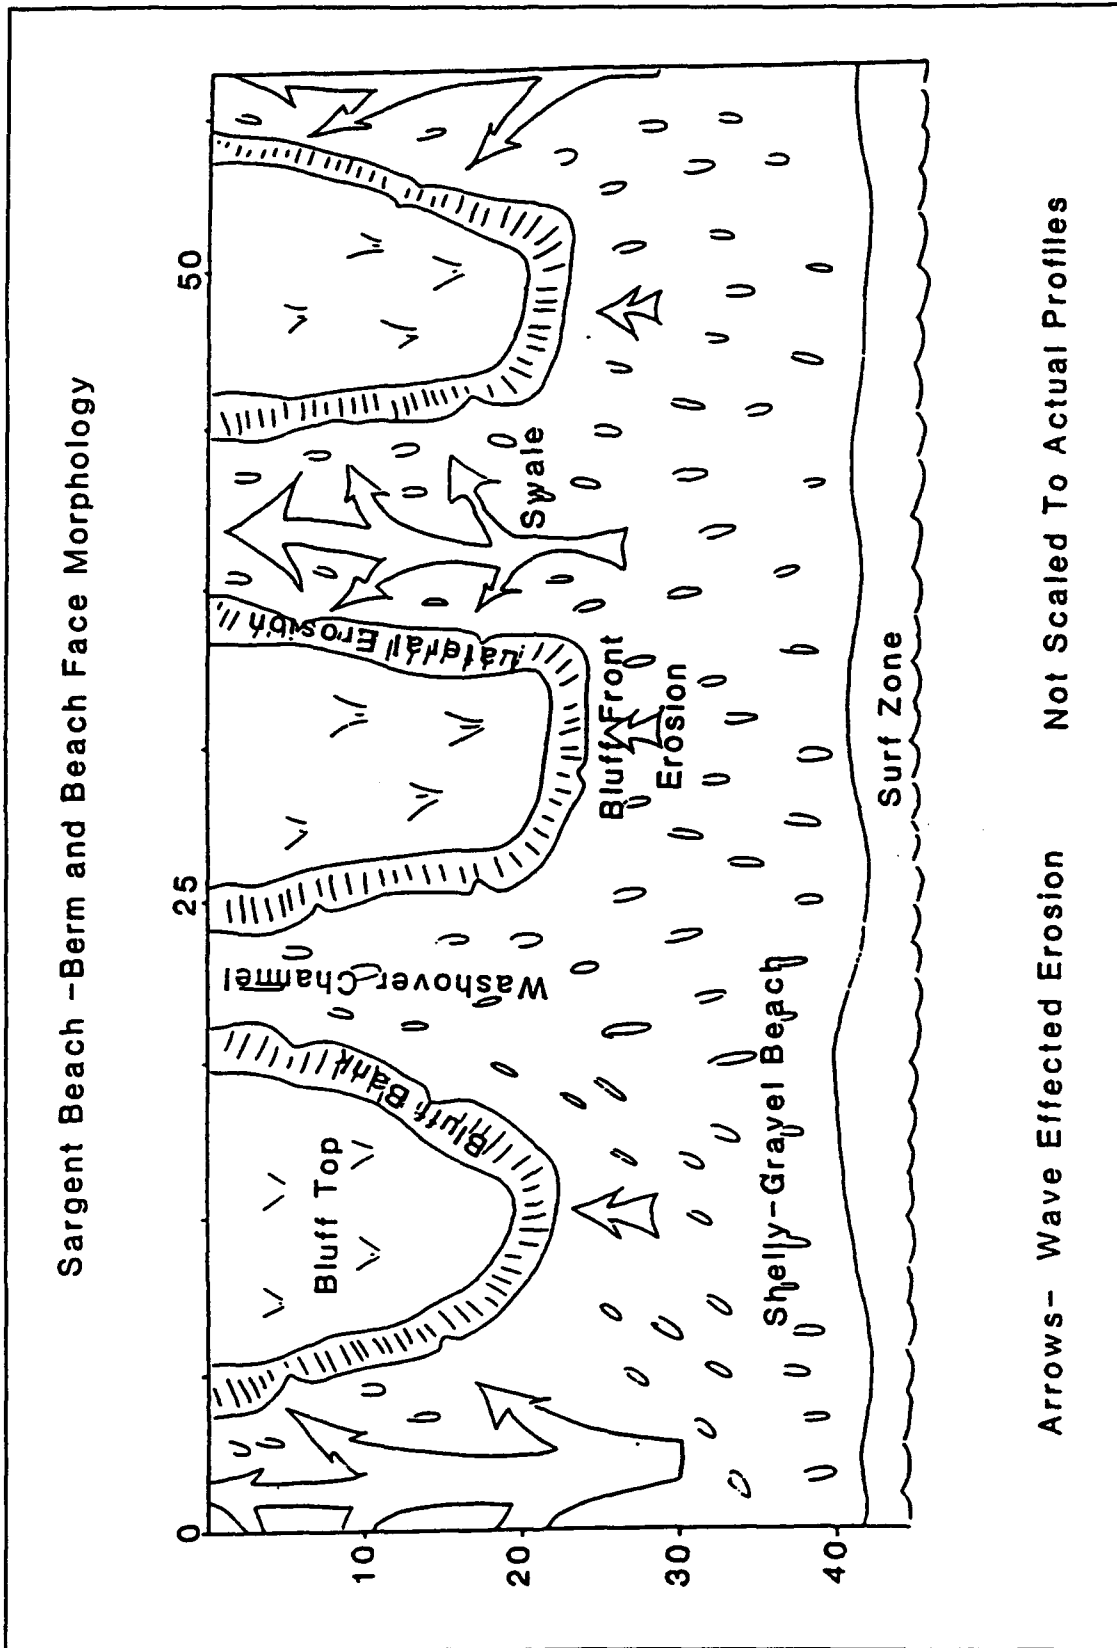
Figure 29. Diagram of the berm and beachface morphology at Sargent Beach. Low bluffs are separated by swales

On a sandy beach, erosion occurs predominantly at the beach face. At Sargent Beach the swales accelerate the beach erosion process. The swales cause more surface area of the finer grained bluffs to be exposed. During intensified wave attack, the swales concentrate the wave bore and intensify the erosive force of the shell gravel as it is hurled against the bluff walls (Figure 29). Through this process, the beach face is removed by lateral erosion.

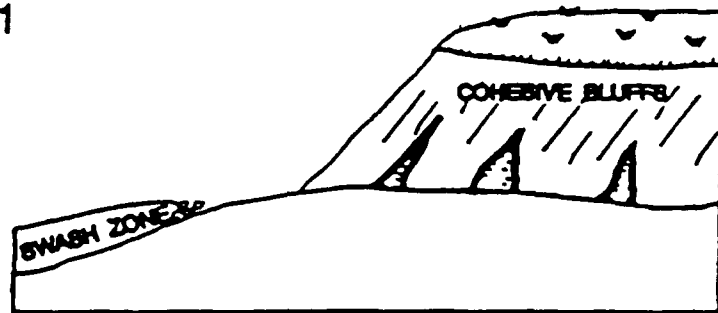
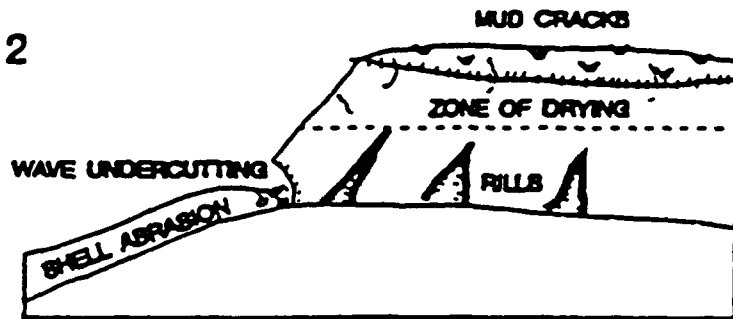
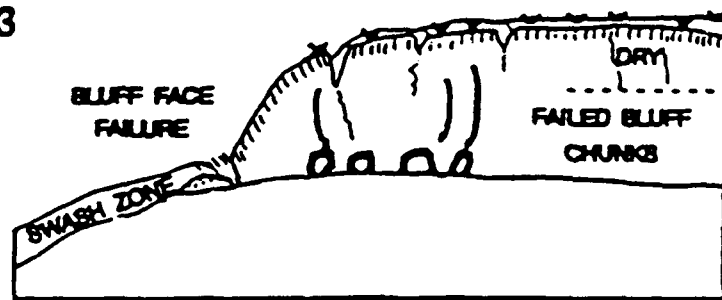
Figure 30. Scenario for bluff failure as at Sargent Beach

Abrasion of the lower section of the bluff by blasting it with sands and gravels causes undercutting (Figure 30). This phenomena was observed along the northern shore of western Lake Erie by Kilgour et al. (1976), where the overconsolidated bluffs were fronted by a narrow beach. Beach sands were incessantly worked against the bluff toe. Eventually, the bluff became undermined and a block of the consolidated sediments failed and fell to the beach. A similar phenomena probably occurs at Sargent Beach (Figure 30).

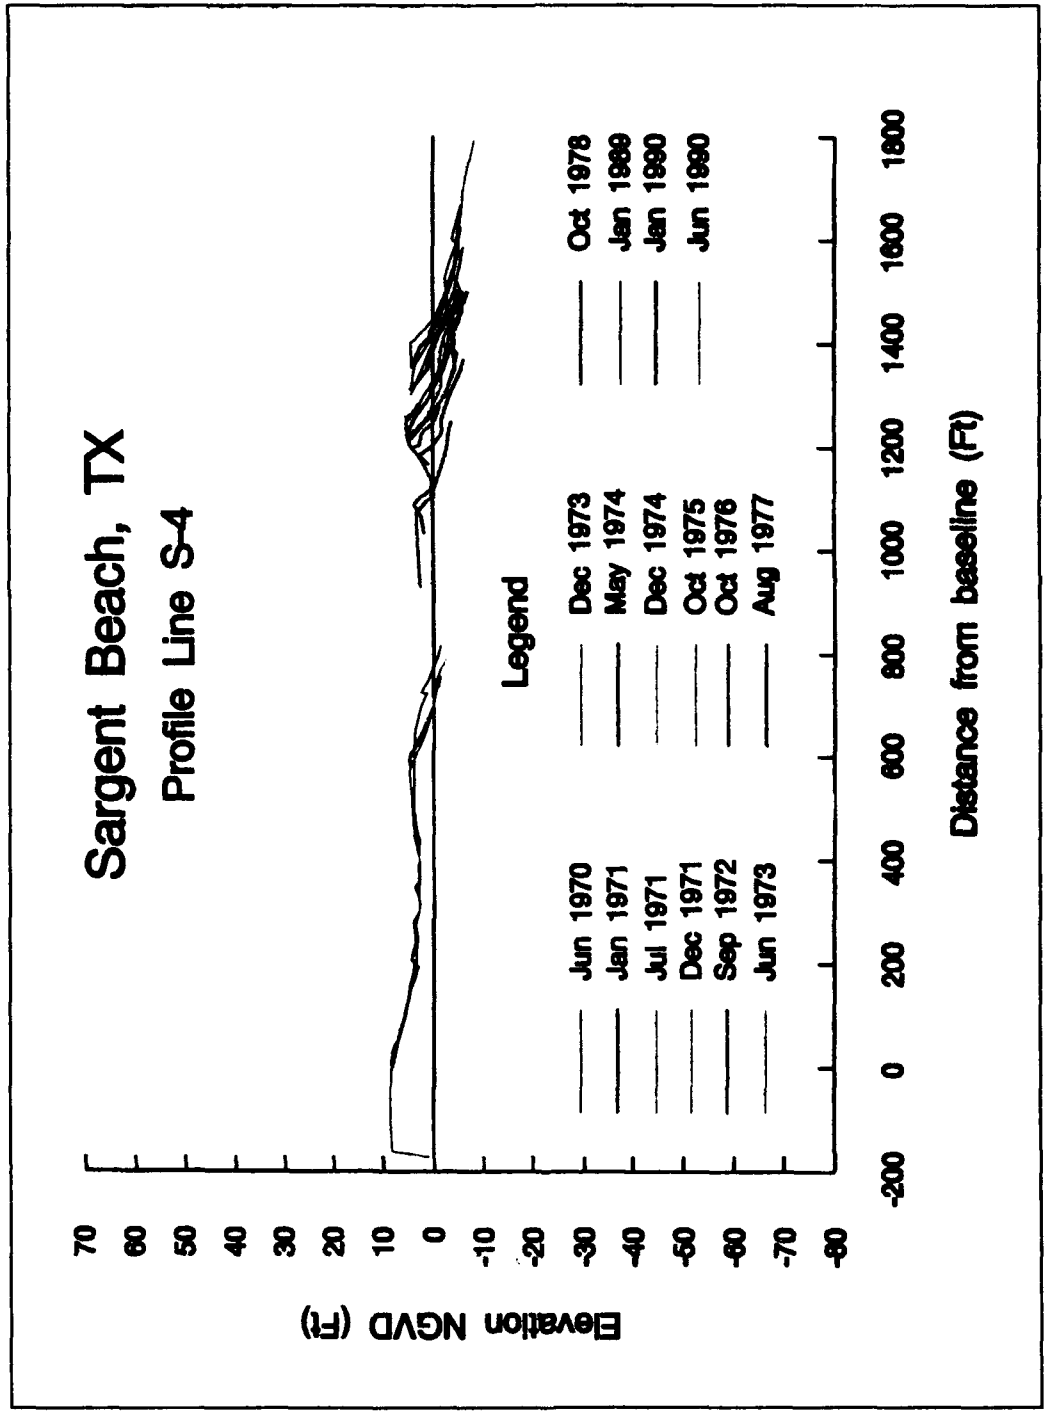
Figure 31. Landward retreat of wading depth profiles surveyed at S-4 from 1970 to 1990 (profile data supplied by Galveston District)

A review of the wading depth profiles from 1970 to 1990 at survey station S-4 just northeast of the highway FM 457 has shown the landward retreat of the shoreline (Figure 31). These were short profiles but all seemed to reach a similar depth in the most seaward portion of the profile. To examine the slope of the nearshore area, a series of long profiles were collected for this project ranging from 5,000 to 8,000 ft offshore. These long profiles show a gentle flat sloping profile. A bathymetric chart, done in 1937 by the then Coast and Geodetic Survey was digitized to compare the long-term change in the offshore slope. A comparison of the two long profiles along the S-17 transect (approximately 2000 ft northeast of S-4) are shown in Figure 32. This 53 year time spread illustrates the landward retreat of the entire profile. The 1937 profile extended offshore some 11,500 ft from the present survey baseline. The slope

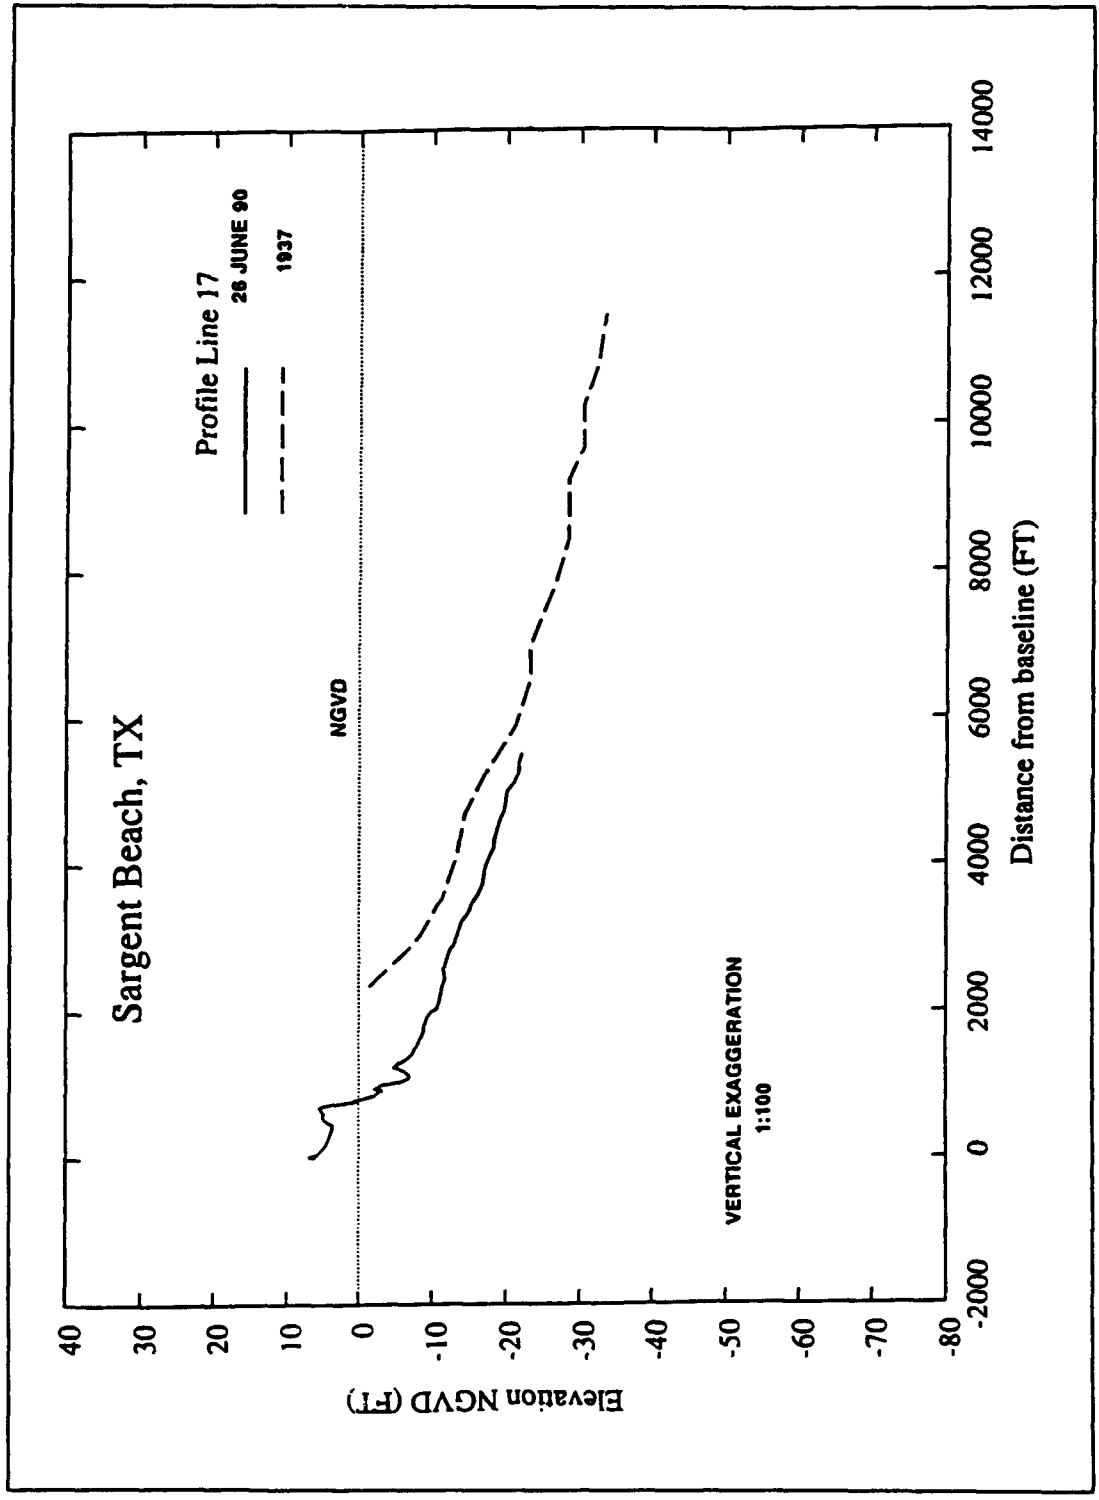
Figure 32. Landward retreat of the nearshore profile illustrated by the 1937 and 1990 profiles surveyed at S-17

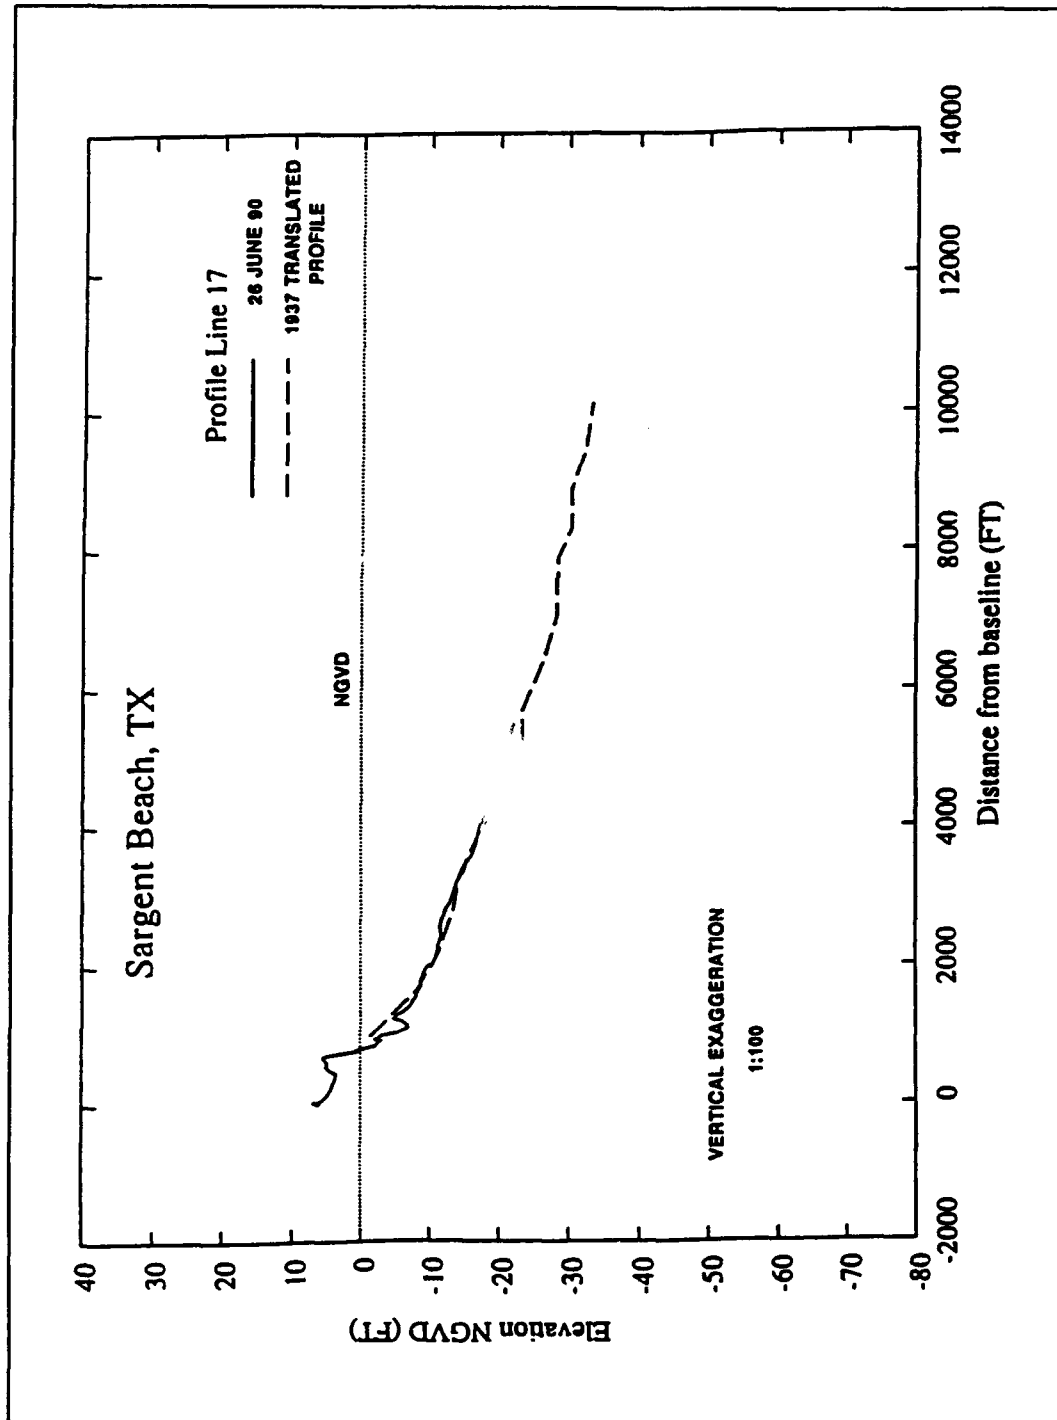
Figure 33. Superposition of 1937 nearshore profile over 1990 profile shows similar slope and overall profile shape over the 53-year span at profile S-17

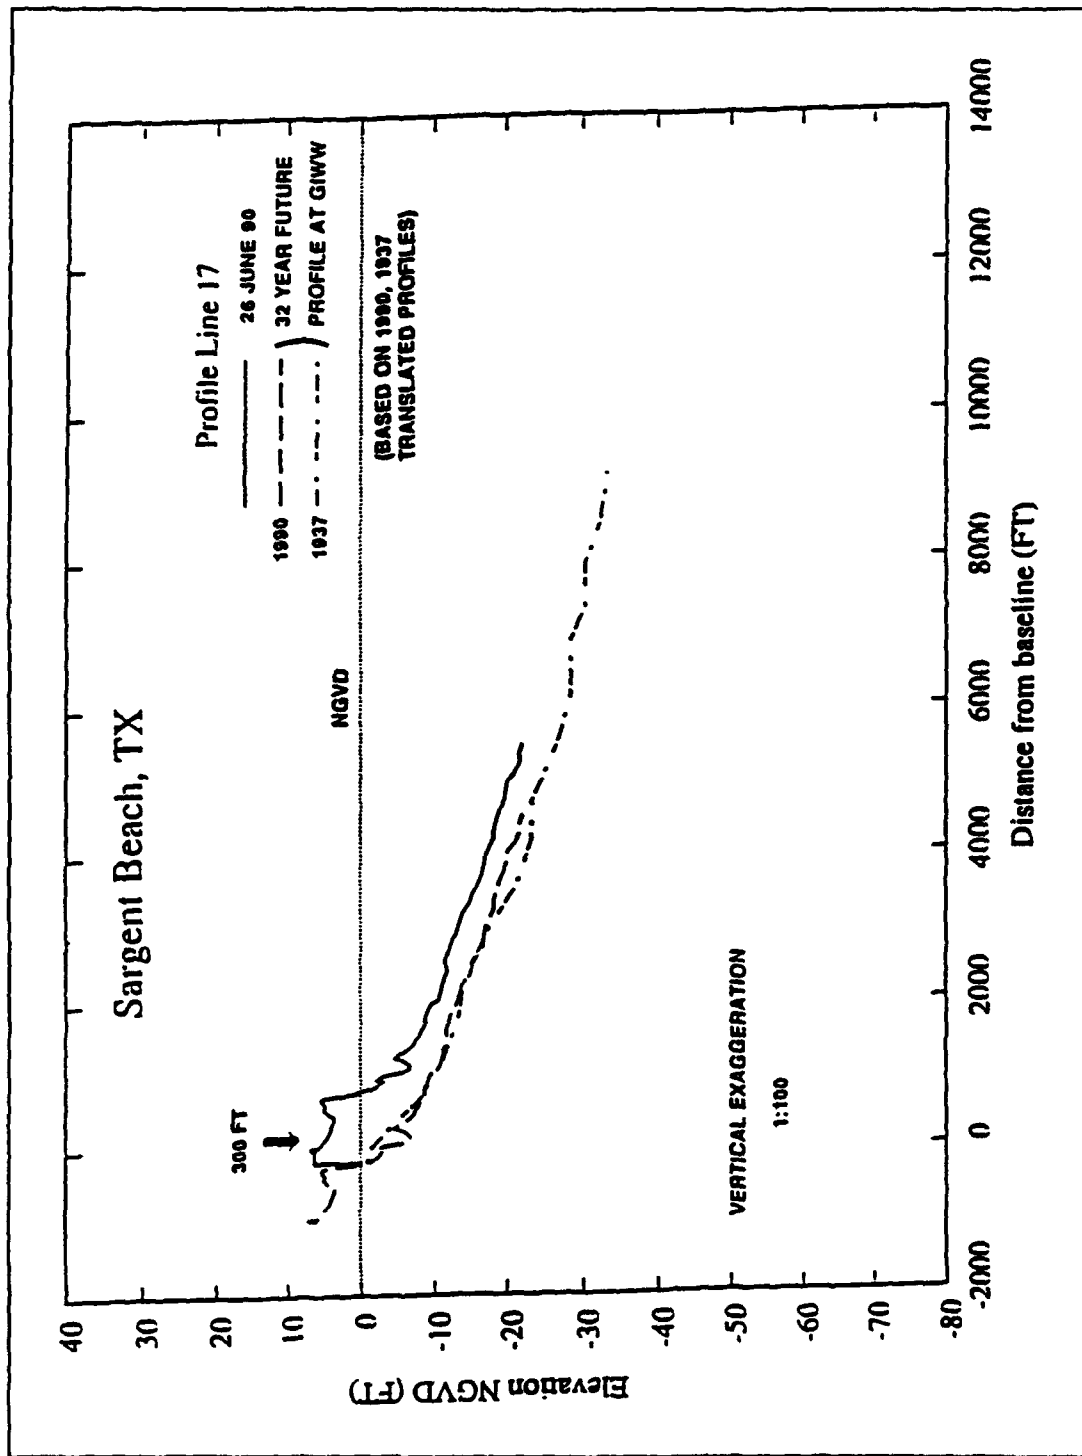
Figure 34. Translation of the 1937 and 1990 S-17 profiles landward to intersection with the GIWW. Calculated period of 32 years, based on an erosion rate of 30 ft/yr. Depth at translated profile at 300 ft present island width will be around -4 ft

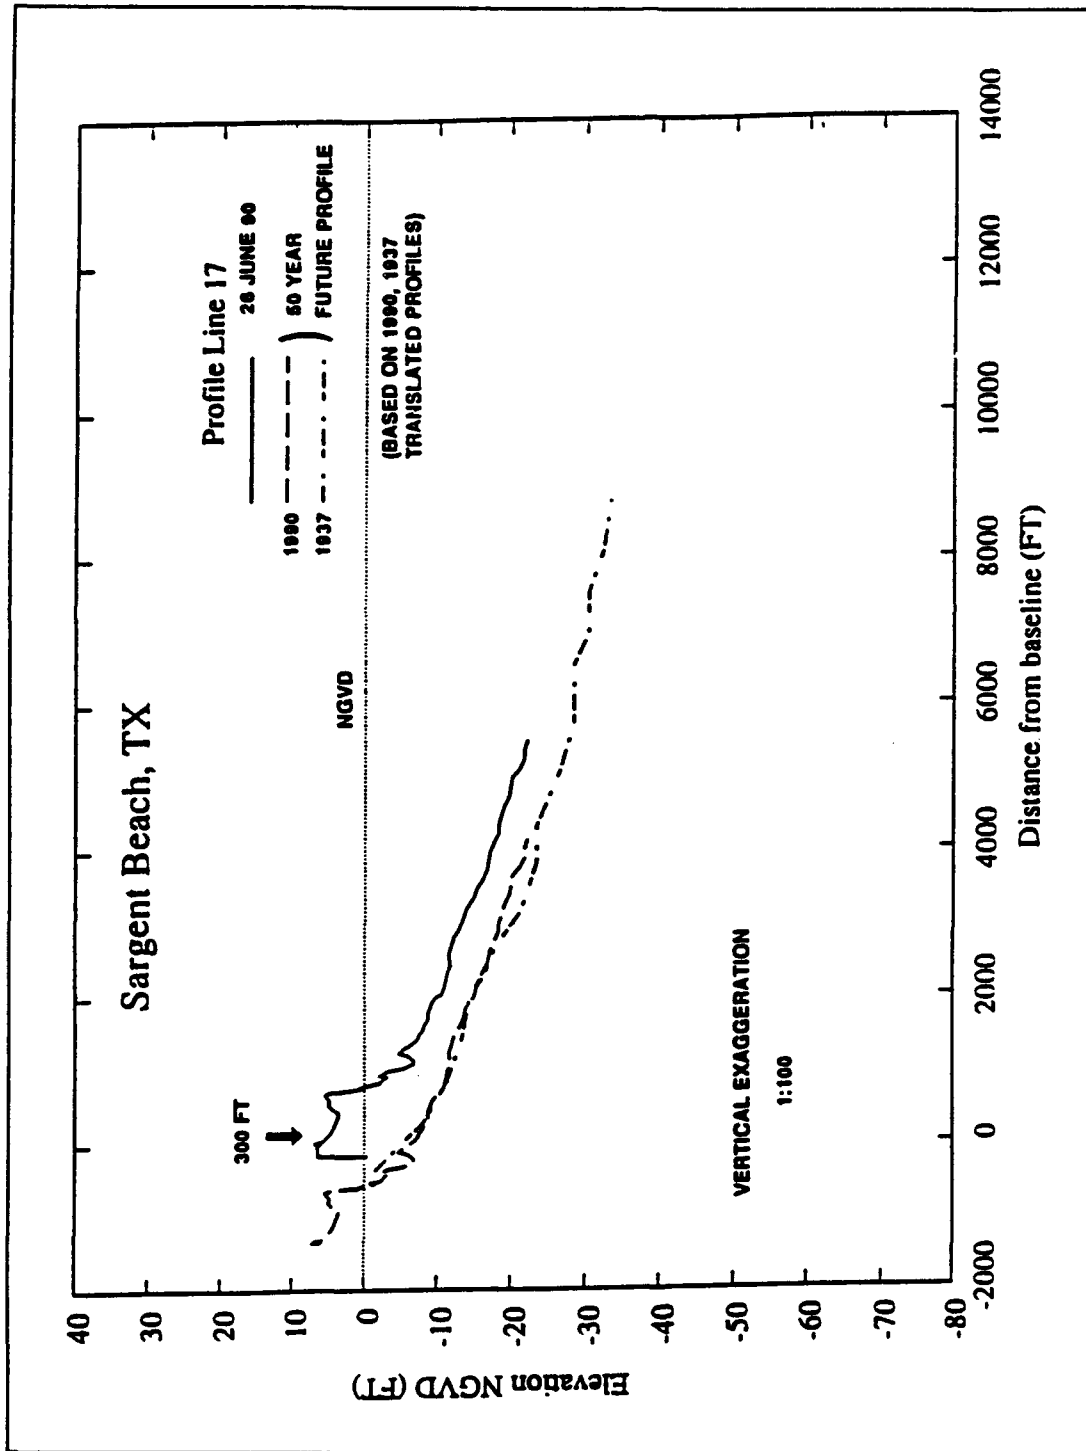
Figure 35. Translation of the 1937 and 1990 S-17 profiles landward to estimated position in 50 years, based on 30 ft/yr erosion rate. Depth at translated profile at 300 ft present island width will be around -8 ft
