Coastal Studies in Support of the Sargent Beach, Texas, Erosion Control Project

by *Donald K. Stauble, Jon M. Hubertz,
Robin J. Hoban, Claire R. Livingston, Cheryl E. Pollock*
Coastal Engineering Research Center

Final report

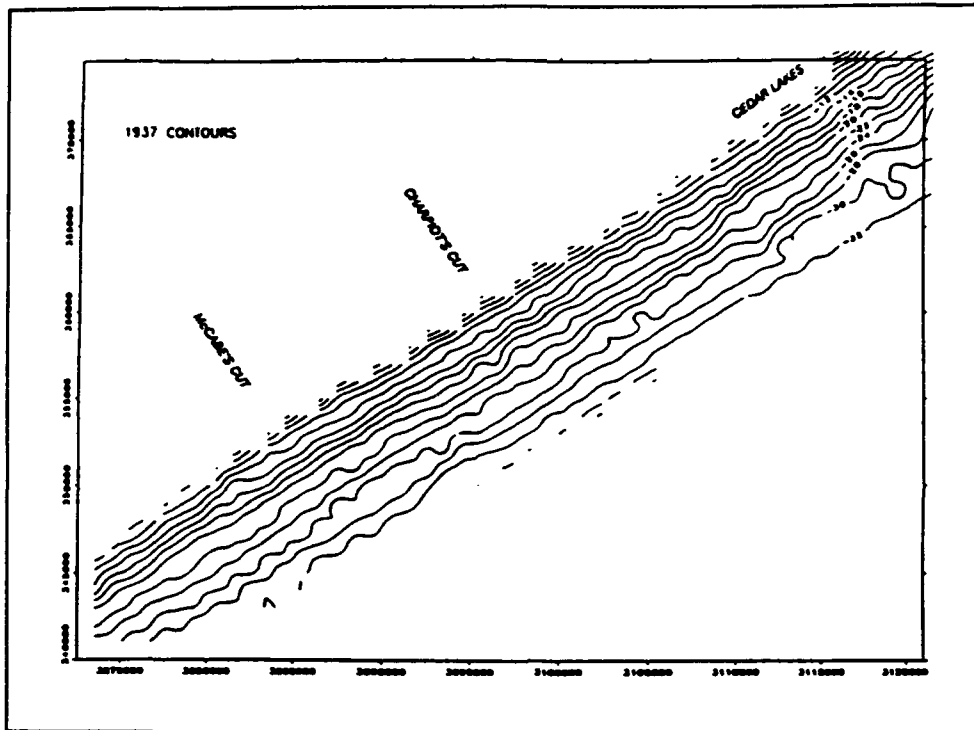
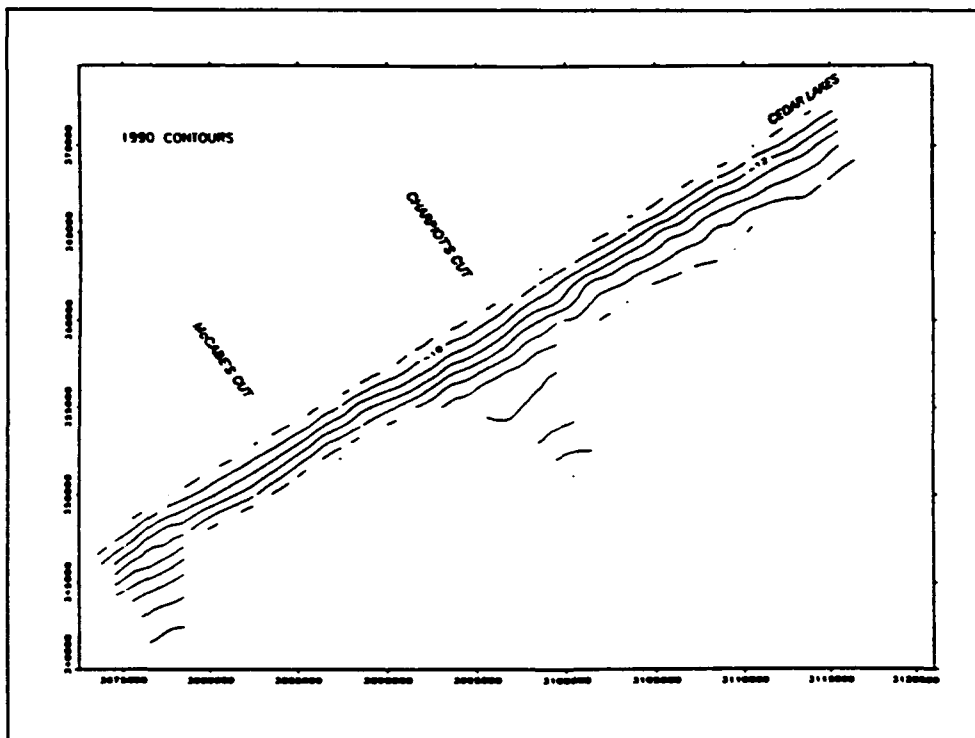
Figure 36. Nearshore bathymetry

a. From 1937 NOAA smooth sheet

b. From 1990 CERC survey

A plot of the nearshore bathymetry from the 1937 NOAA smooth sheets H-6314 (Bryan Beach to Choctaw Lake) and H-6315 (Choctaw Lake to Brown Cedar Lake) in Figure 36a shows that the nearshore area had nearly straight parallel contours gently sloping in the offshore direction. The 1990 nearshore bathymetry collected for this study by CERC also shows straight parallel contours (Figure 36b). A difference map was produced using the Contour Plotting Software package (CPS) which compared the 1937 and 1990 bathymetry. Figure 37 shows the accretion in green in the offshore area where sediment has been deposited over the 53 year period. In the northeast section in the vicinity of Cedar Lakes there is almost all accretion, possibly due to the erosion of the Brazos River Delta in recent years (Field et al. 1990). The nearshore area in the rest of the study area shows erosion in red, indicating that the shelf area Figure 32. Landward retreat of the nearshore profile illustrated by the 1937 and 1990 profiles surveyed at S-17 closest to the beach has eroded during this period. A small area of accretion can also be seen in the vicinity of McCabe's Cut where the inlet's ebb tidal delta probably was located. The general trend is one of erosion adjacent to the beach, with accretion some 3,000 to 4,000 ft offshore from the present shoreline.

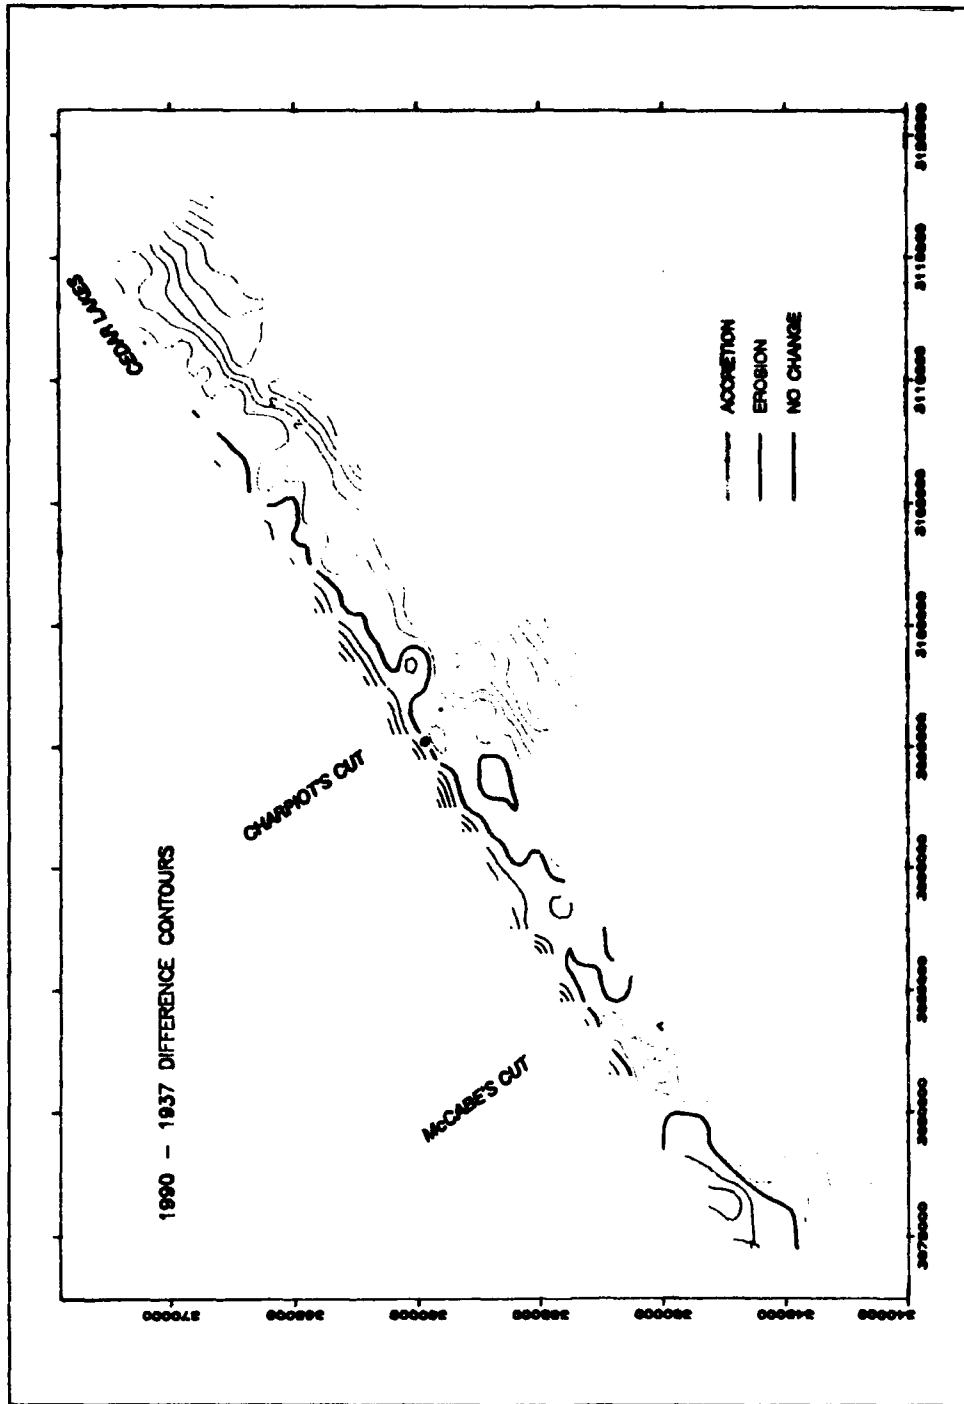
Figure 37. Difference map of 1937 and 1990 bathymetry off Sargent Beach showing accretion in the nearshore in the northeast portion of the study area. This accretion may be from erosion of the Brazos River Delta just around 10 miles (16 km) up drift. Erosion of the nearshore is seen for the remainder of the study area

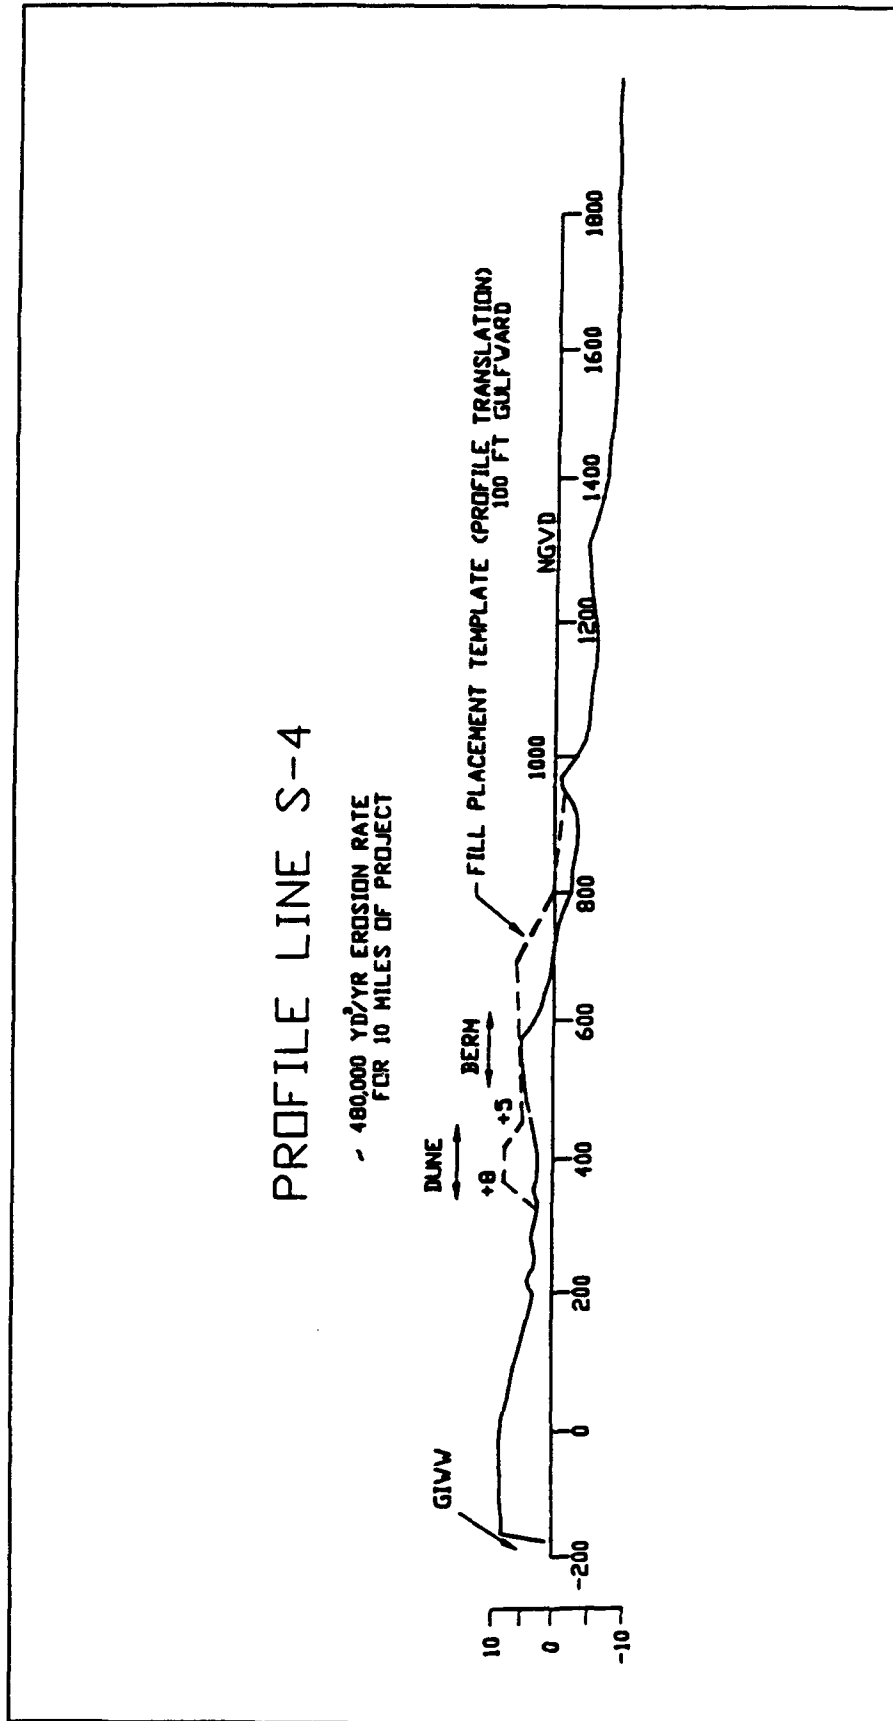
Figure 38. Design template based on typical profile (in vicinity of S-4 and S-17) for beach nourishment at Sargent Beach

To provide the required storm protection and prevent the erosion of the barrier island, a beach fill design template with a dune is suggested based on Hansen and Byrnes (1991) as the design template to provide the maximum protection. The design template contains a 50 foot wide "dune" in the back-shore area (Figure 38). This "dune" is really a mound of sand stockpiled to provide additional sand to counter expected erosion of the berm fill sand. The location of the dune was chosen at 600 ft gulfward of the GIWW to provide ample protection to the island. This is farther gulfward than the required 300-ft-wide island, but the greater width of island would provide more storm protection. The elevation of the dune was chosen at +8 ft NGVD, as this is the elevation of the dredge mounds on the back side of the island next to the GIWW. The +8 foot elevation may provide overtopping protection for up to a 15 year return period storm (Part II). Storm surge water levels above this will overtop the dune and penetrate landward, transporting the fill sand landward. The experience with Hurricane Hugo's impact on the South Carolina coast indicated that dunes greater than 15 ft high survived this 100 year return period storm and did provide protection to upland property, while lower dunes were eroded as overwash landward onto the back beach area (Stauble, et al. 1991). This storm can be considered an extreme event, and providing

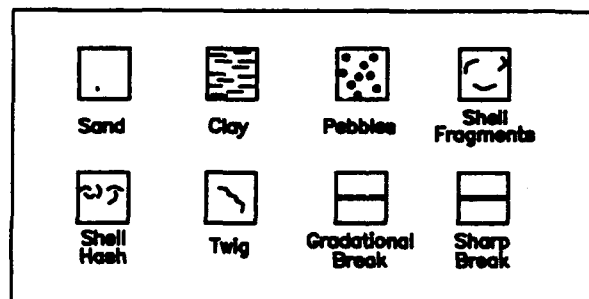
Legend of core logs

HA	Hand auger core
Al core	Aluminum core 3-in-diam
S4-1	Station 4, core number 1
C3	Cedar Lakes location, core number 3

Other data includes total length of core, descriptive location of core (eg. mid-tide), and occasional various inclusions.

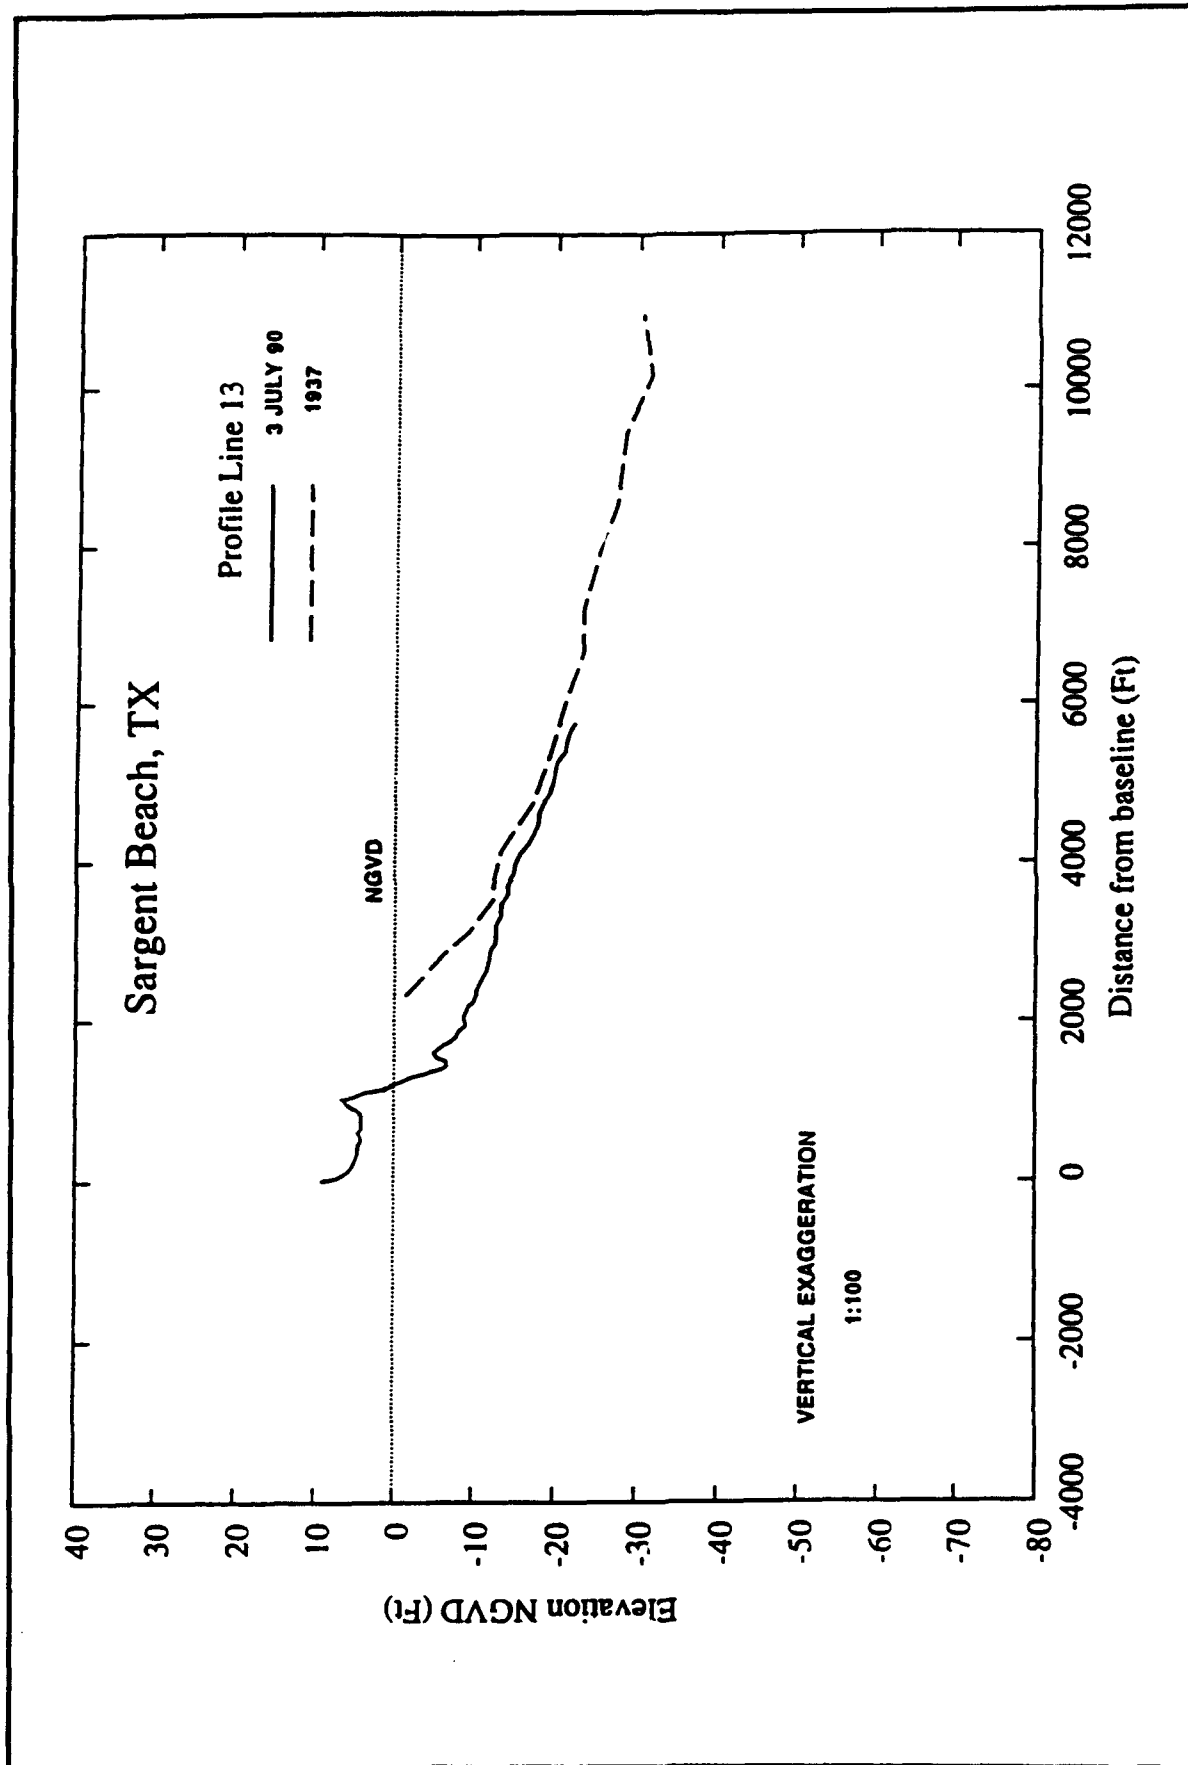
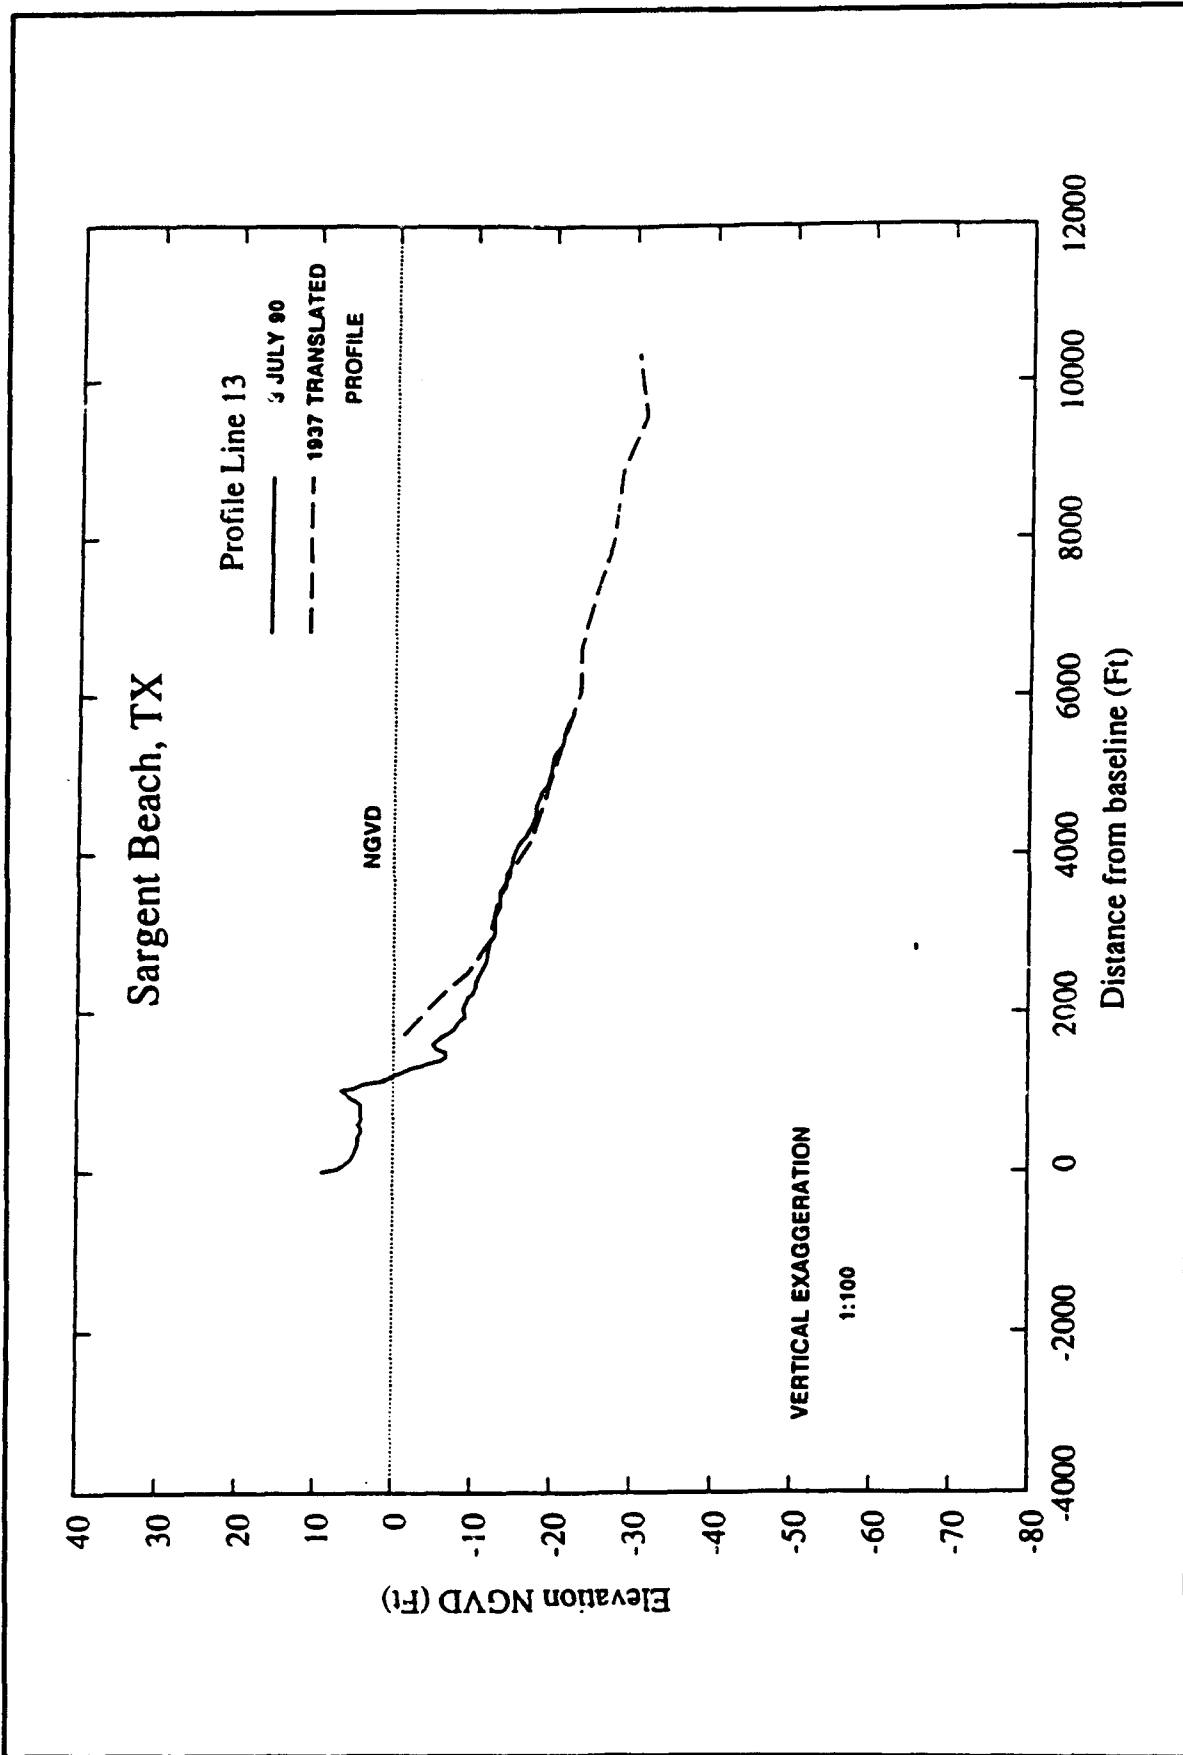
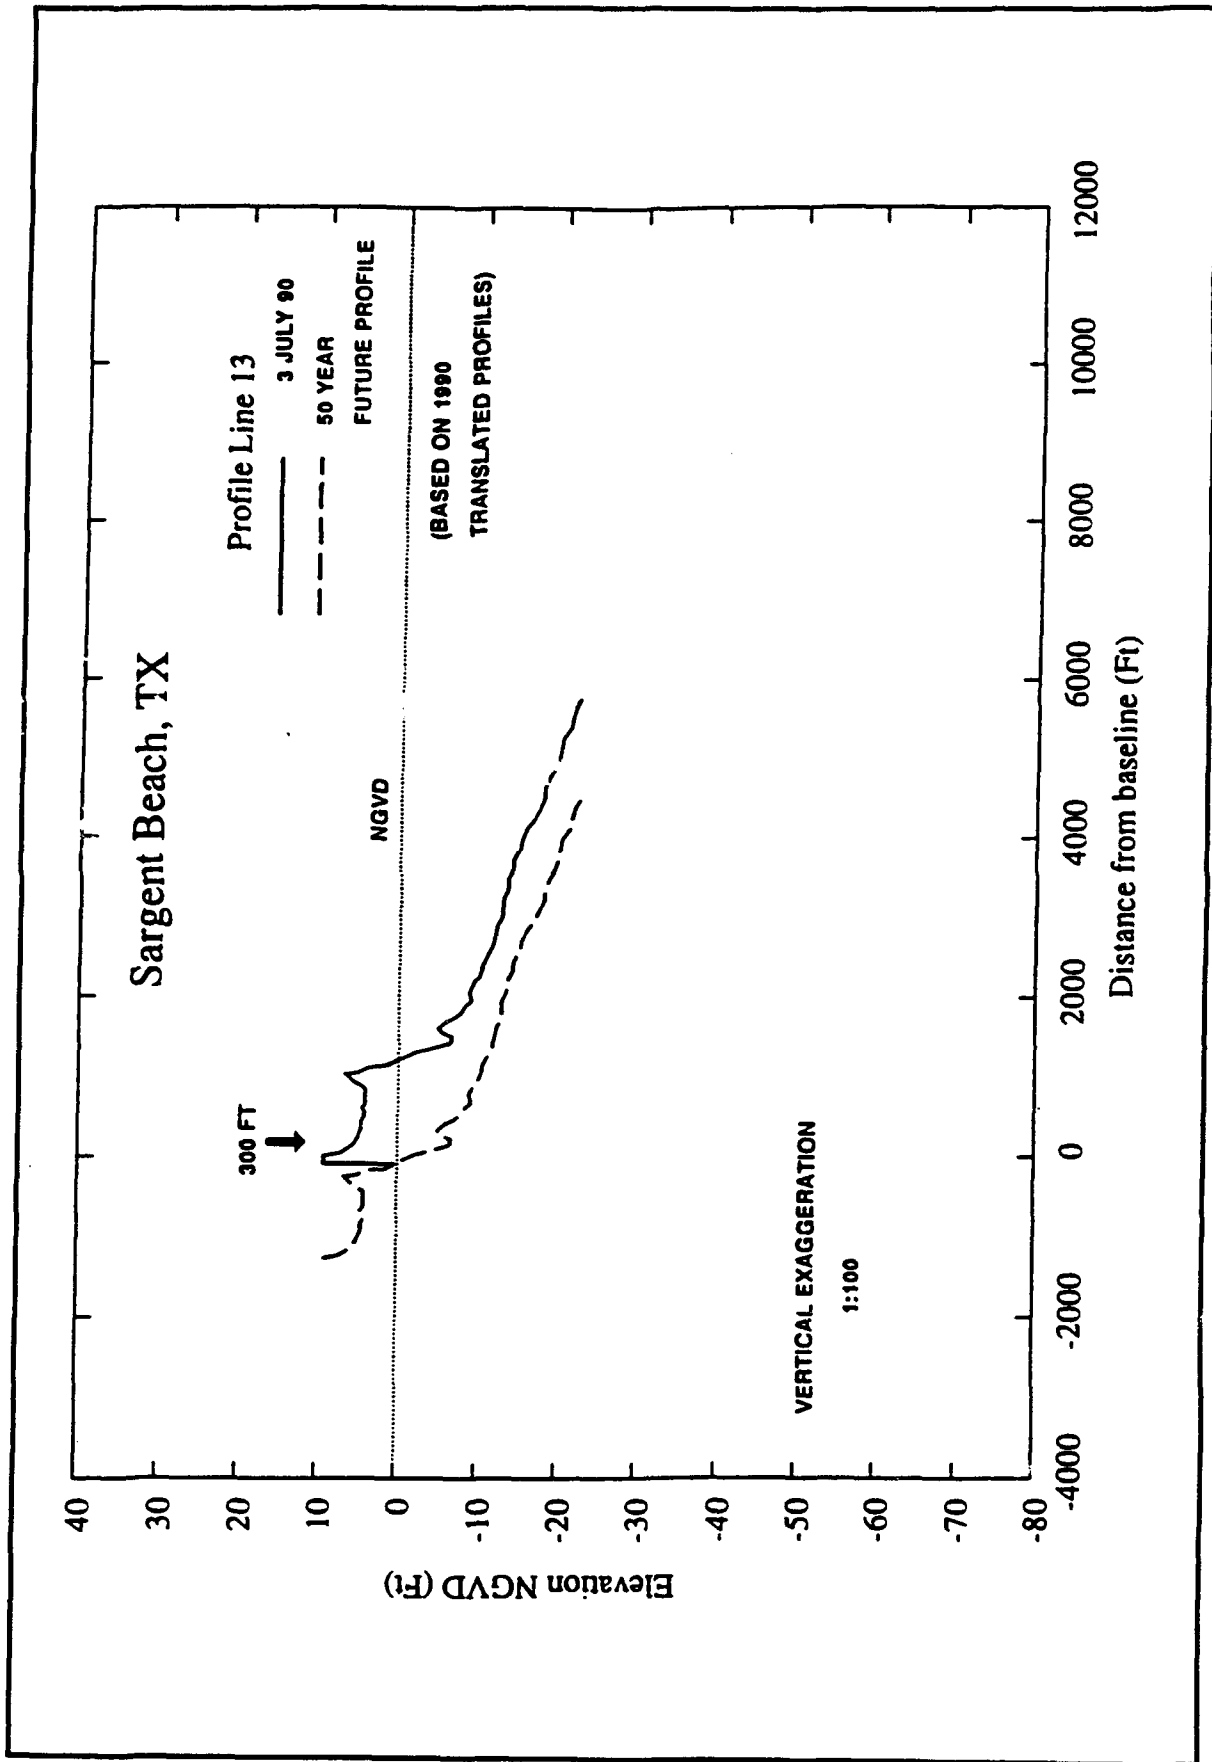
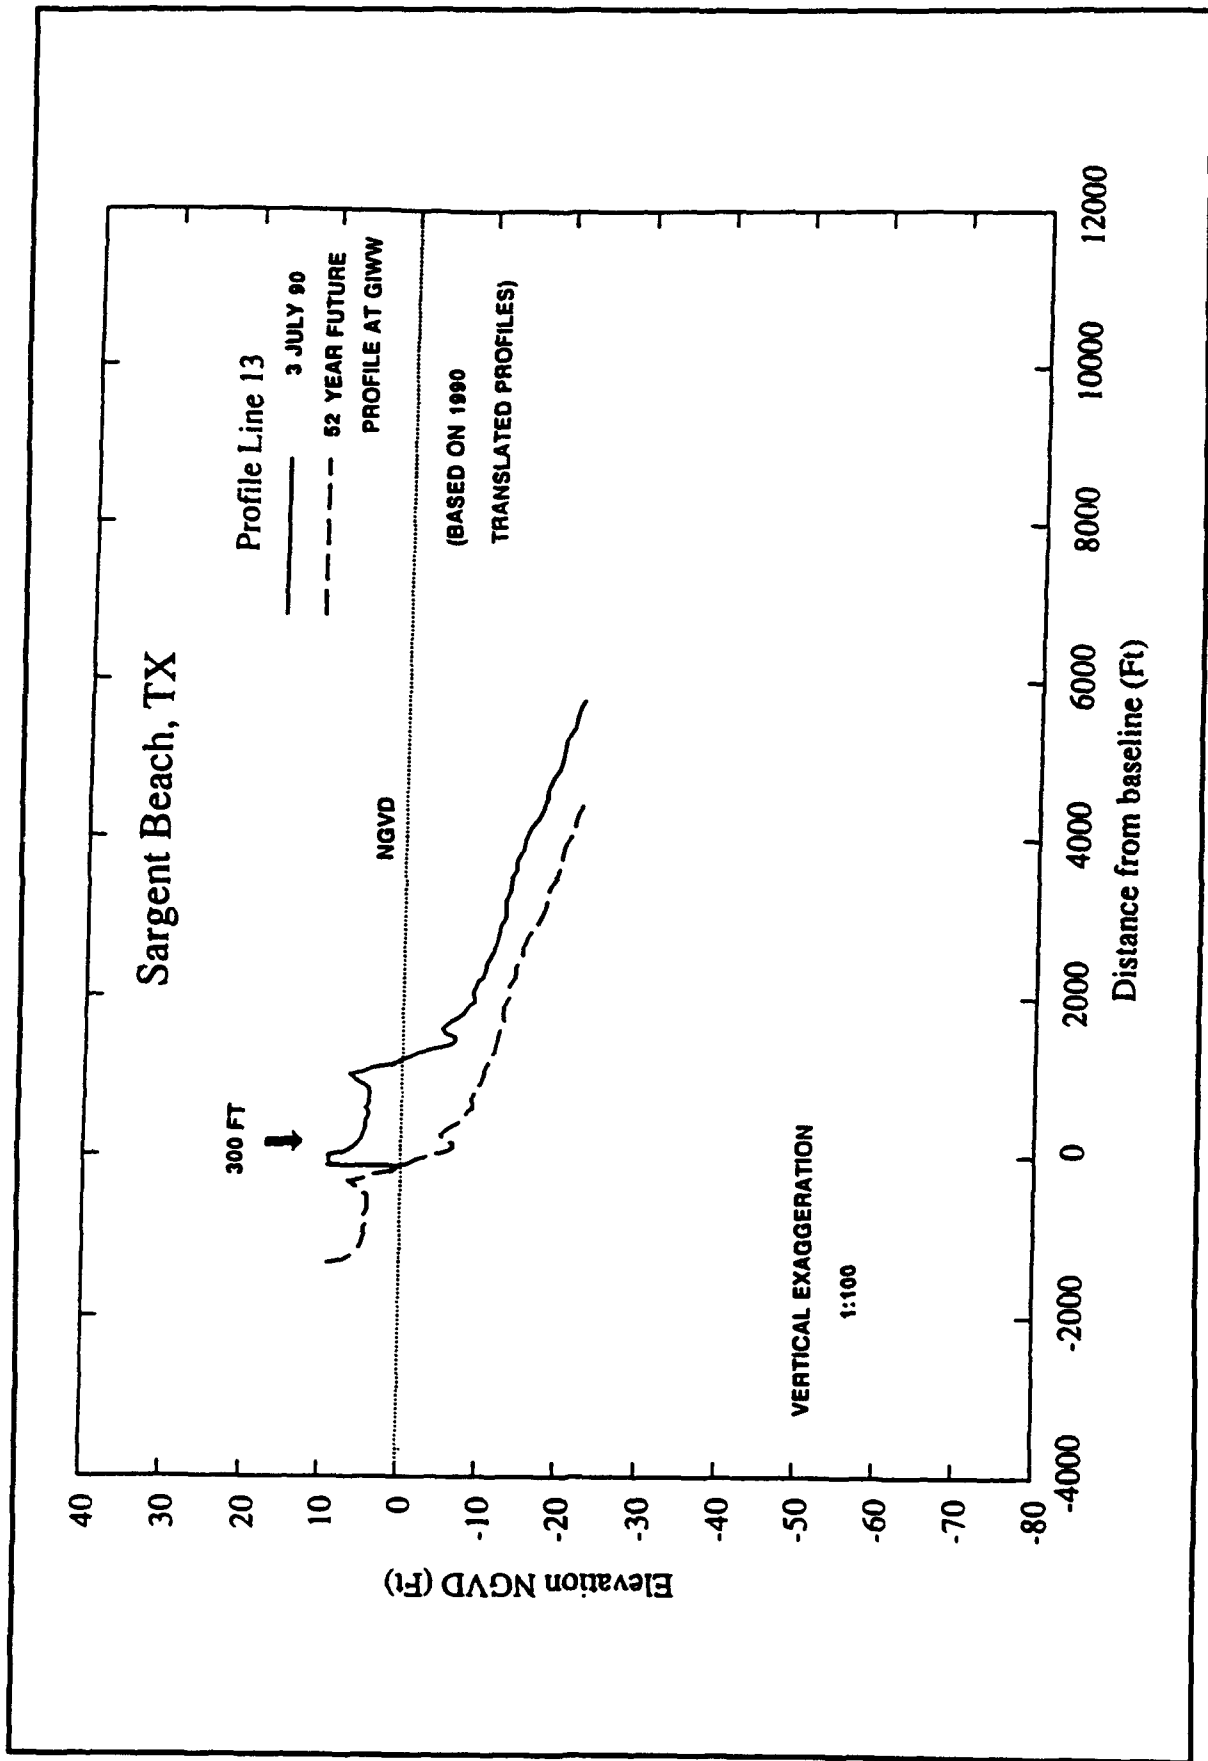
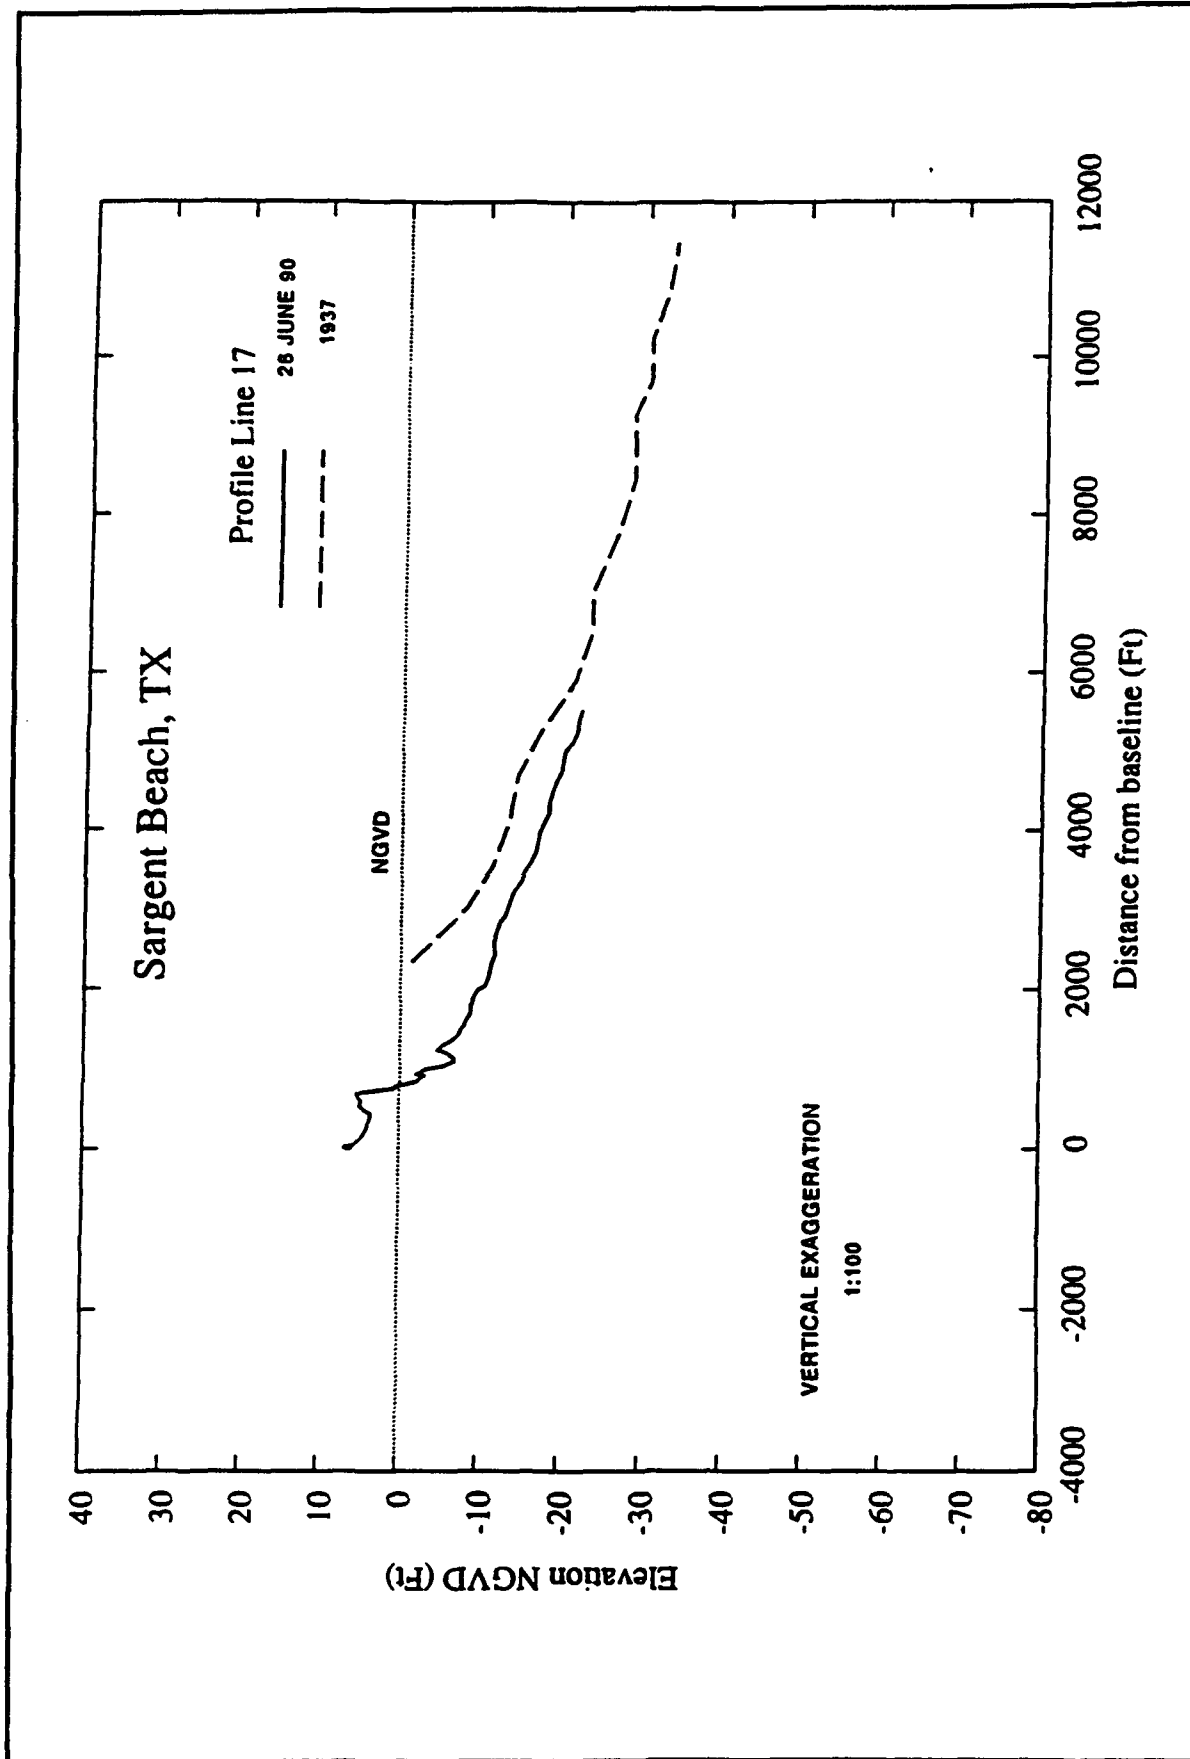
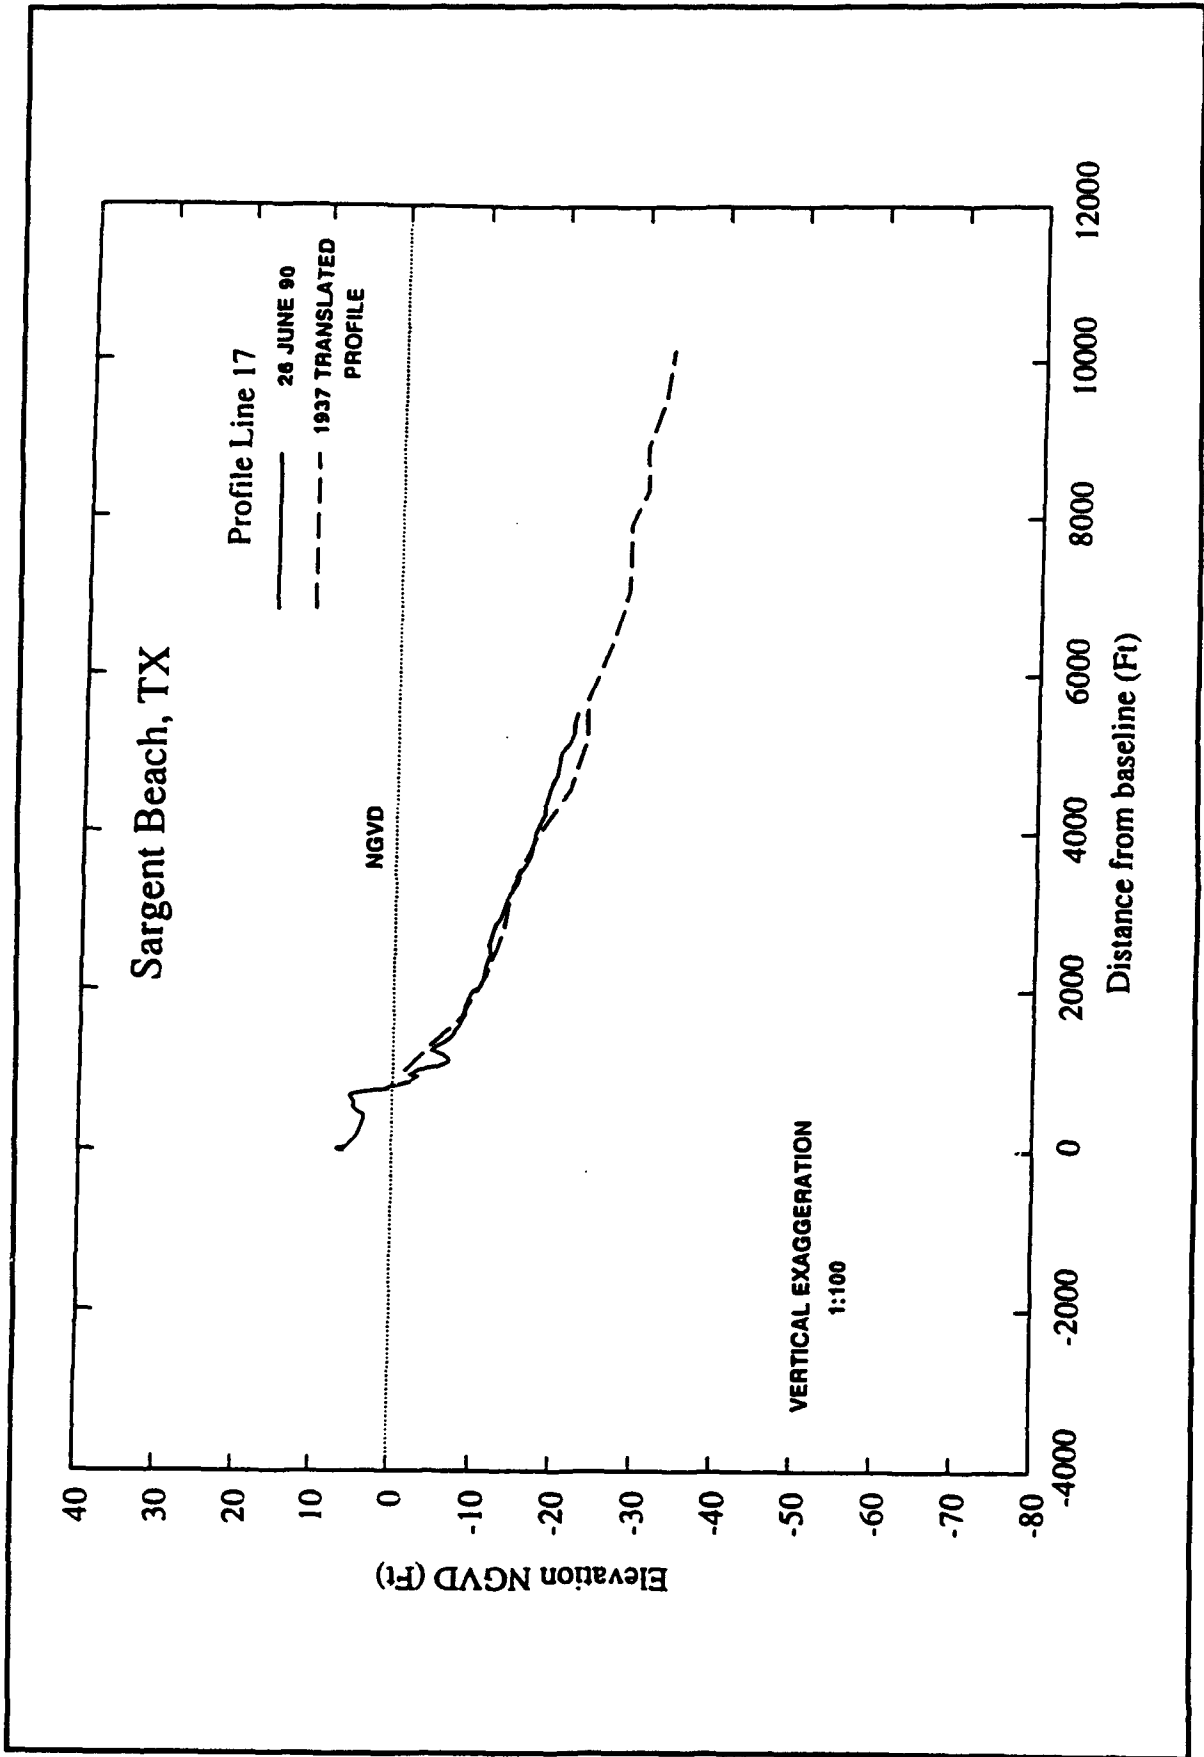
Comparison of 1937 and 1990 Profiles

Appendix C consists of profile position comparisons in various locations of the study area. The profile sites encompass S-13 southwest of McCabe's Cut, S-20 northeast of Charpiot's Cut, S-24 between Charpiot's Cut and Cedar Lakes, and S-28 near Cedar Lake. Comparison profile plots of 1937 and 1990, 1990 and a 1937 matched slope translation to 1990, 1990 and a projected future 1990 profile translated landward when the shoreline at the present rate of retreat (approximately 30 ft/yr) intersects the GIWW (Gulf Intracoastal Waterway) shoreline, and 1990 with a 50 year future profile translated from the 1990 profile based on the present rate of retreat are illustrated. A 300 ft mark is placed on the last two scenarios to indicate the desired width to maintain a barrier 300 ft seaward of the GIWW.
