USACERL Technical Report CRC-94/03  
March 1994

# Guidelines for Documenting Historic Military Structures

by  
Susan I. Encore, Dan Lapp, and Mira D. Metzinger

paraphrased for installation managers inexperienced in coordinating historic documentation. The four different levels of HABS documentation are explained. Examples of each are presented to give the manager a benchmark for evaluating documentation produced for his or her installation. The examples are extracted from HABS documentation of the historic Red Cross complex at Chanute Air Force Base, Rantoul, IL.

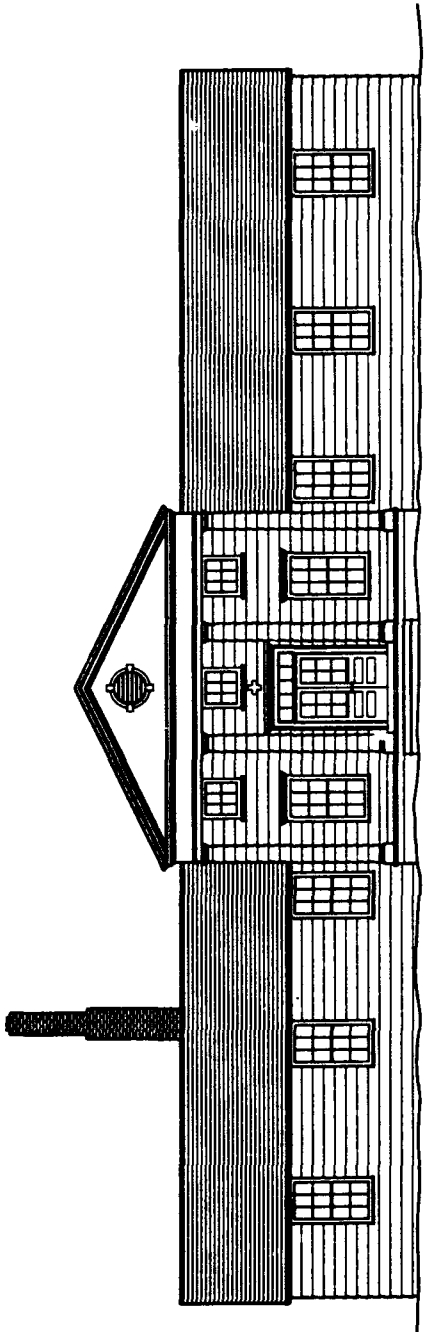
**EAST ELEVATION**

MATERIALS  
 SIDING—10" WOOD LAP SIDING  
 WINDOWS—6" x 8" DOUBLE HUNG  
 DOORS—1'-0" x 6'-0" COMMON BRICK

NOTE: OUTLETS, DOWNSPOUTS, WINDOW AIR CONDITIONERS, AND REMOVABLE SCREENS OMITTED FOR CLARITY

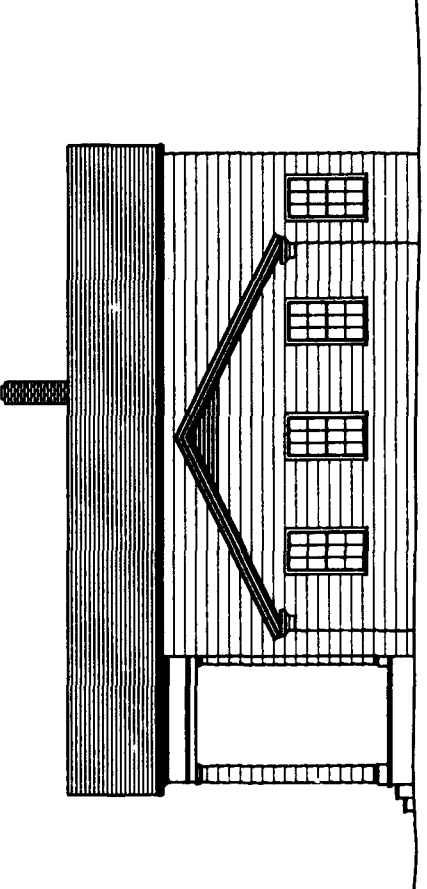
**NORTH ELEVATION**

MATERIALS  
 SIDING—10" WOOD LAP SIDING  
 WINDOWS—6" x 8" DOUBLE HUNG  
 DOORS—1'-0" x 6'-0" COMMON BRICK

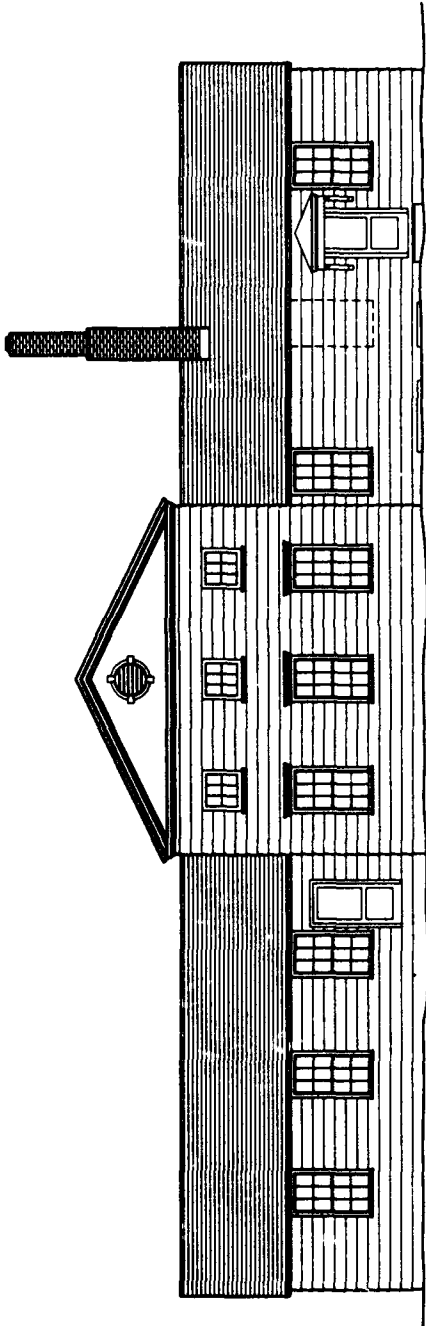
**WEST ELEVATION**

MATERIALS  
 SIDING-10" WOOD LAP SIDING  
 ROOF-THREE TAB ASPHALT SHINGLES  
 CHIMNEY-COMMON BRICK

NOTE: OUTLETS, DOWNSPOUTS, REMOVABLE SCREENS, WINDOW AIR CONDITIONER, TELEPHONE LEADS, AND HANDICAPPED RAMP OMITTED FOR CLARITY

The west elevation (Photo IL-1161-A-4, Drawing IL-1161-A, Sheet #4) is the least regular, for while it maintains the massing of the east elevation, the arrangement of openings is very different. Here the north wing is divided roughly into fourths by three typical windows. Abutting the southernmost window is a single door leading to the general office area. The main section of this elevation is identical to the east elevation (without the doors and the porch). The double doors have been replaced with a typical window, and the raking cornices have been removed from all the windows. The south wing is broken by two windows and a door, with the windows at either end of the wing and the door just south of the wing's center line. Before kitchen and bathroom remodeling in 1988, there was a window immediately to the north of the door (Drawing IL-1161-A, Sheet #4). Above the door is a small hip roofed portico, which fits between the top of the door and the eave (Photo IL-1161-A-8). The chimney is also located in this area, north of the wing's center line, and reaches a height of 13'-0" above the ridge.

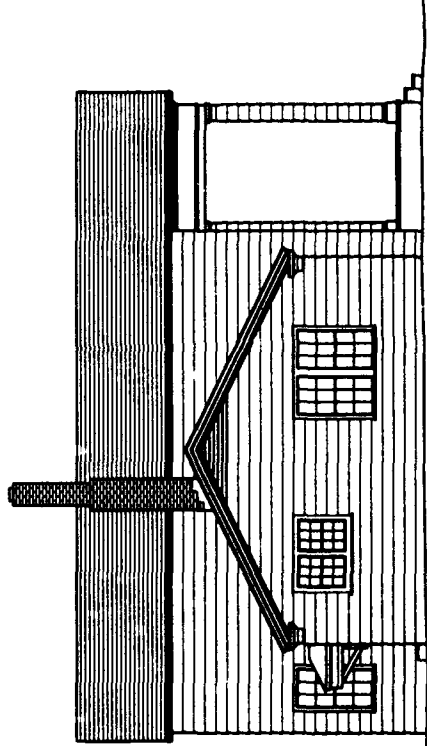
**SOUTH ELEVATION**

NOTE: OUTLETS, DOWNSPOUTS, REMOVABLE SCREENS, AND POWER LEADS OMITTED FOR CLARITY

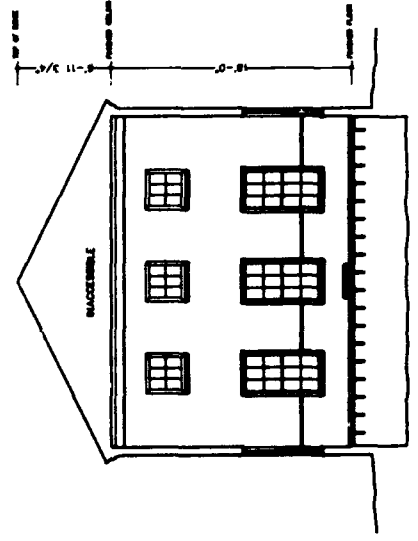
**SECTION A-A**  
 MATERIALS  
 FLOOR-2 1/4" OAK TONGUE AND GROOVE, CARPET  
 WALLS-PAINT ON PLASTER  
 CEILING-PAINT ON 16"X32" FIBER BOARD PANELS

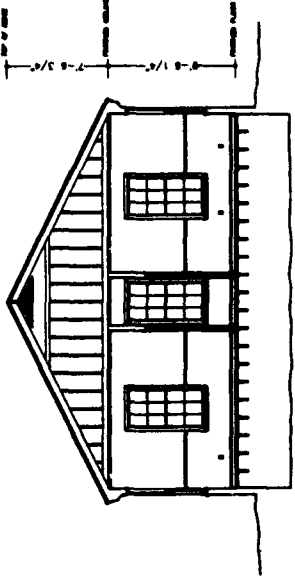
**SECTION B-B**  
 MATERIALS  
 FLOOR-2 1/4" OAK TONGUE AND GROOVE IN CORRIDOR,  
 CARPET IN OFFICES  
 WALLS-PAINT ON 16"X32" FIBER BOARD  
 CEILING-PAINT ON 16"X32" FIBER BOARD PANELS

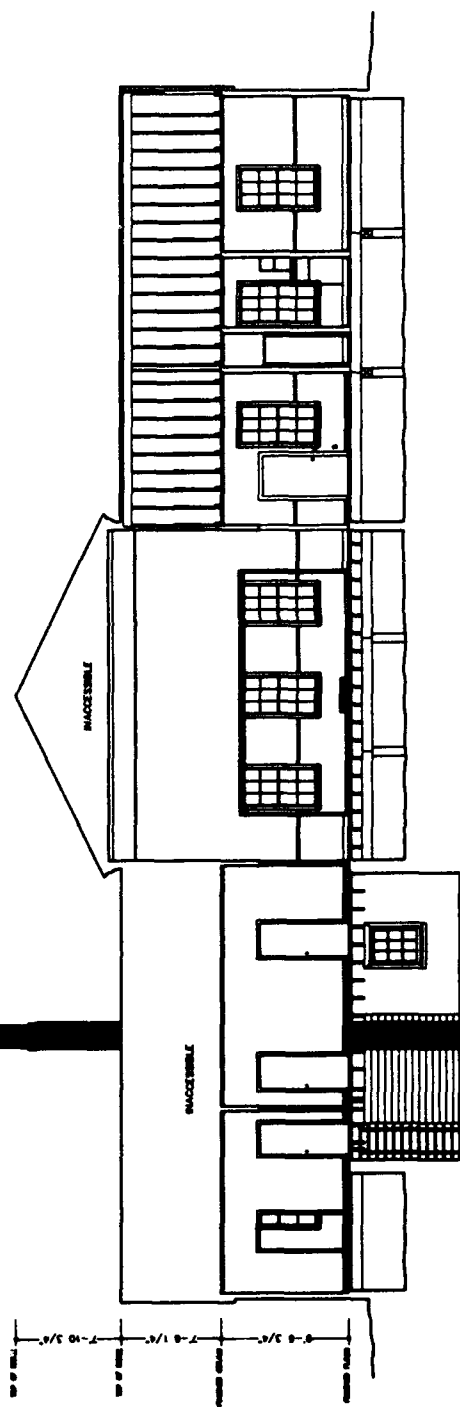
**SECTION C-C**  
 MATERIALS  
 FLOOR-2 1/4" OAK TONGUE AND GROOVE CORRIDOR  
 CARPET IN OFFICES  
 WALLS-PAINT ON PLASTER  
 CEILING-PAINT ON 16"X32" FIBER BOARD PANELS

NOTE: NORTH AND SOUTH WALLS HAVE ROSE PAPER AT OAK MOULD AND ARE NOT SHOWN IN ELEVATION

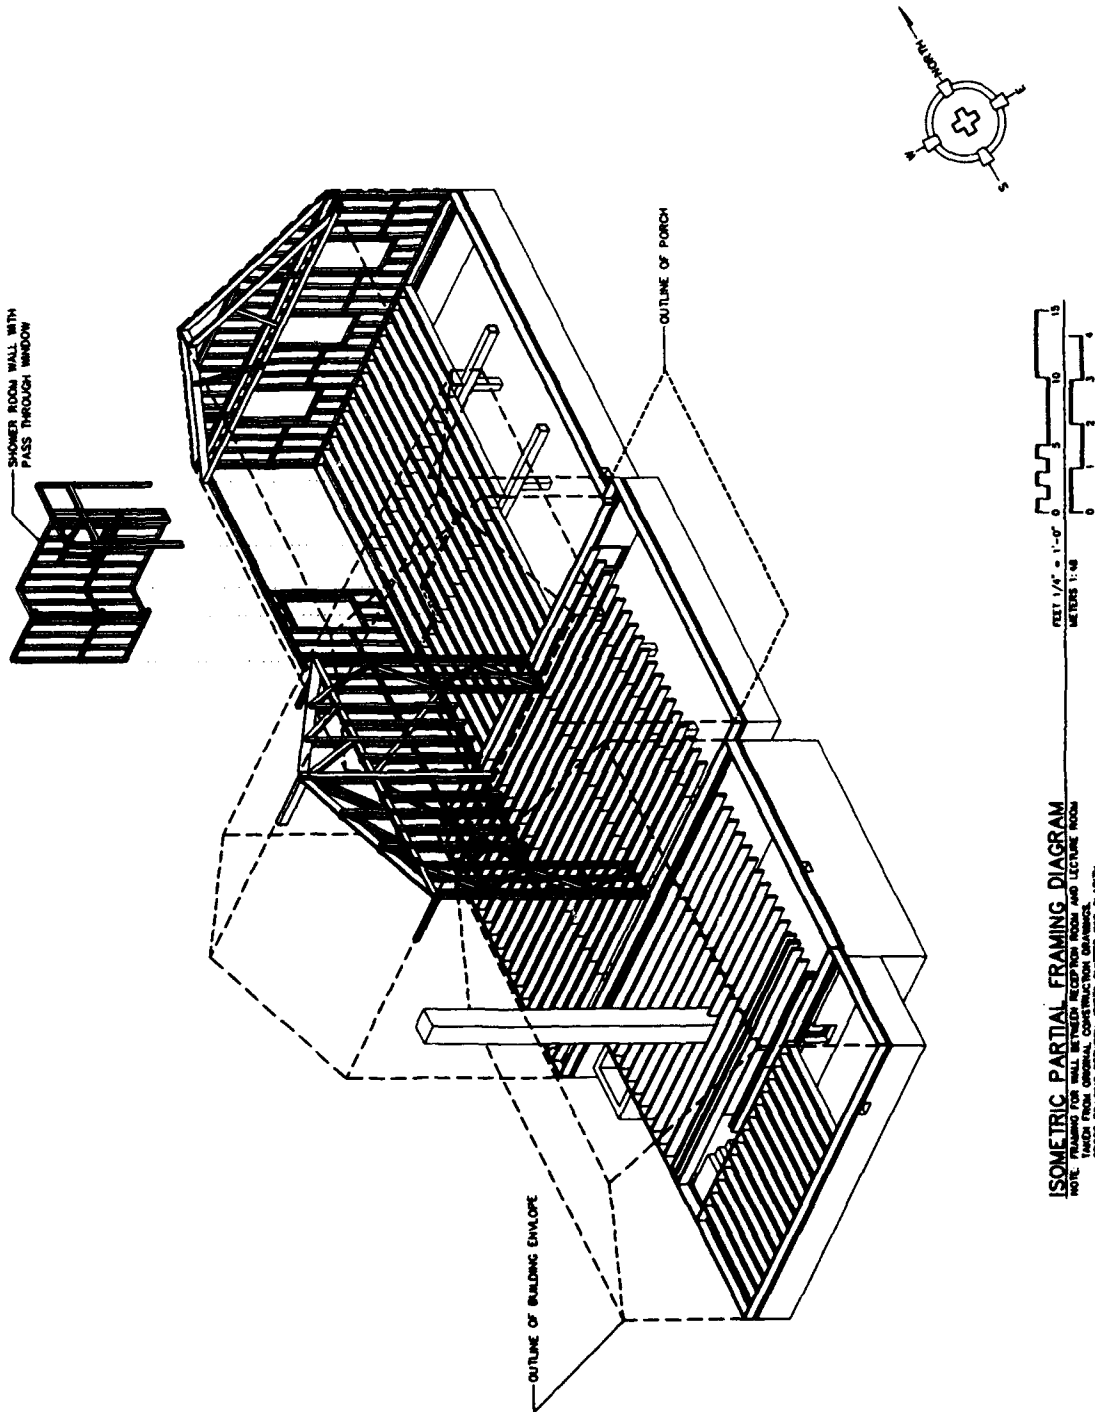
**ISOMETRIC PARTIAL FRAMING DIAGRAM**  
 NOTE: FRAMING FOR WALL BETWEEN RECEPTION ROOM AND LECTURE ROOM TAKEN FROM ORIGINAL CONSTRUCTION DRAWINGS. CROSS BRACING BETWEEN JOISTS OMITTED FOR CLARITY.

3. Wall Construction: The perimeter walls are platform construction using 2"x4" studs 2'-0" on center (Drawing IL-1161-A, Sheet #6). 1"x12" sheeting was used on the entire building and originally covered with a black felt vapor barrier and 1"x8" shiplap siding (now replaced with 1"x12" hard board siding). All corners are flashed with approximately 2" wide light gauge (18 Ga. or 20 Ga.) galvanized steel strips.

4. Structural System, Framing: The Red Cross Building uses platform frame construction (Drawing IL-1161-A, Sheet #6). The walls are typically framed from 2"x4" studs at 2'-0" on center. Windows are supported on a single 2"x4" at the sill with a double 2"x4" plate at the head. The platform is made of 2"x10" joists at 16" on center, supported on 6"x10" intermediate (sleeper) beams. In the north wing and the main area platforms, the floor joists span one-third of the area's length rather than the more standard ½ the width. The platform bears on ledges cast in the foundation walls, and is topped with 1" random width tongue and groove subflooring, laid diagonally, covered with ¾"x¾" oak tongue and groove finish flooring. The roof platform is 2"x10" rafters supported by a 1"x10' ridge board and a double 2"x4" plate at the perimeter. The deck is 1" random width sheathing covered with asphalt shingles. In order to provide the desired clear span in the reception and class rooms, and to bridge the 18'-0" door which opens the two rooms to each other, an elaborate built-up truss carries the roof loads to the foundation (Drawing IL-1161-A, Sheet #6). The truss acts as a shear wall tying the two wings together, and is built of a combination of 2"x4"s, 2"x6"s, and 2"x10"s.

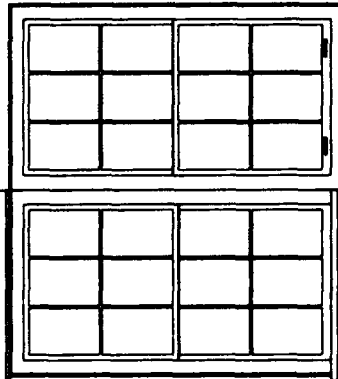
**WINDOW DETAIL**

DESCRIPTION  
INSIDE AND OUTSIDE ELEVATION OF THE DOUBLE WINDOWS OF THE MAIN BUILDING

b. Windows: The windows (Drawing IL-1161-A, Sheet #7) are primarily 6 over 6 double hung wood sash units that measure 3'-6"x6'-0". There is evidence that windows in the main area had raking cornices when the structure was built, but they have been removed. In 1988, the window in the apartment bath room was removed and filled in. The south end of the building is the only location where the double hung window pattern changes, and two major differences are found here as the units are hung in pairs, and one set varies in size from the typical sashes. The pair of windows on the southwest corner of the south end of the apartment are smaller than the other windows with each of the sashes measuring 2'-10"x4'-4"; the pattern of 6 over 6 lights is maintained. Like the original front doors, these windows are inconsistent with the 1943 COE drawing as the pairing of units is shown but no reduction in size is indicated. In the reception room and class room, 6 pane center pivot wood sashes, measuring 3'-0"x3'-0", were used at the second story level. There are six of these windows, three in each room, symmetrically arranged about the room's center line. The basement has a six pane wooden casement window located in a large well on the west side of the building which opens to the inside. At some time the window was rehung and the hinges were moved from the right side of the frame to the left side. Of note is the use of finish moldings around the inside of all the windows, as

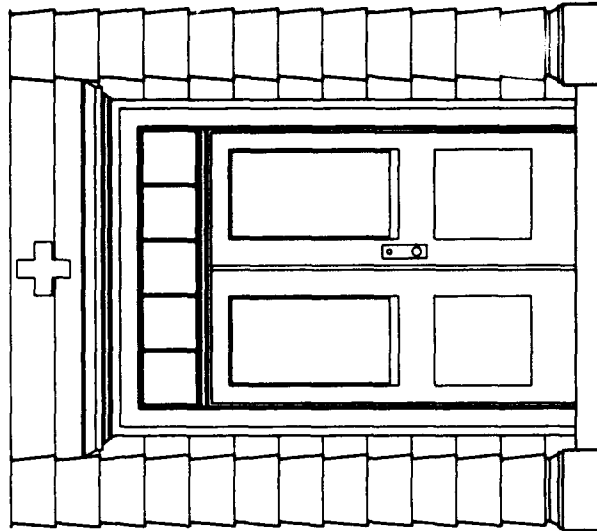
**FRONT DOOR DETAIL**

DESCRIPTION  
ELEVATION OF FRONT DOOR AND COLLARS  
NOTE: EAST ELEVATION DRAWING SHOWS STONE DOORS

area, and one for the apartment. The main entrance through the double doors has been modified as the five pane top-light and moderately elaborate cornice molding are all that remain of the original entry (Drawing IL-1161-A, Sheet #7). The building originally had doors with much larger nine pane lights (estimated at about 3'-0"x4'-0"). These doors were observed in a 1943 photo displayed at the time of our inspection, however, oddly enough the doors in the photo do not match the doors shown on the original elevation drawings. All other entrances to the building are single doors with one standard door used throughout. Measuring 2'-8"x6'-8", the door has a 1'-8"x3'-0" single pane light and a 1'-8"x1'-10" wainscot at the bottom. All have been fitted with screen doors; those leading to the reception room and the general office are wooden (probably not original), and the screen door on the apartment entrance is a modern metal unit.

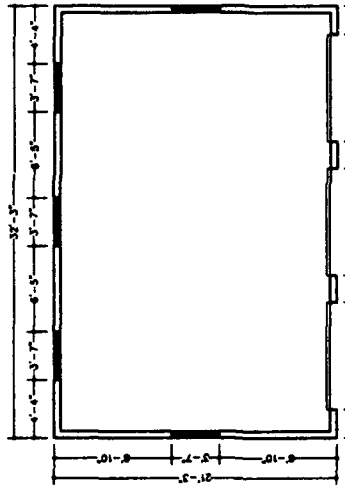
GARAGE FLOOR PLAN

FLOOR—CONCRETE  
 WALLS—STUD WALLS WITH 3/4" TONGUE AND GROOVE BOARDS, 10" LAP SINKS ON TOP  
 ROOF—THREE 7/8" ASPHALT SHINGLES

1. Overall Dimensions: The Garage measures 32'-3" wide and 21'-3" deep, and had a ridge height of 15' above grade. The north and south elevations are identical and each have a single centered nine pane window. The west elevation is composed of three symmetrically spaced identical nine pane windows, while the east elevation contains the three garage bay doors.
2. Foundations: The foundation is concrete slab on grade.
3. Walls: The Garage has stud walls with 5/4 tongue and groove boards. 10" lap siding has been placed on top.
4. Structural System, Framing: Light frame construction, with studs spaced 16" on center. Roof trusses consist of two rafters, one joist, and three posts.
5. Openings: Garage openings are composed of three wooden 8' overhead doors with wood battens and five lights each.
6. Roof: Medium pitch gable, three tab asphalt shingles.
