**Characterization of the Hydrogen  
Induced Cold Cracking  
Susceptibility at Simulated  
Weld Zones in HSLA-100 Steel**

**M. R. Stoudt  
R. E. Ricker**

U.S. DEPARTMENT OF COMMERCE  
Technology Administration  
National Institute of Standards  
and Technology  
Materials Science and Engineering Laboratory  
Metallurgy Division  
Gaithersburg, MD 20899

April 1994

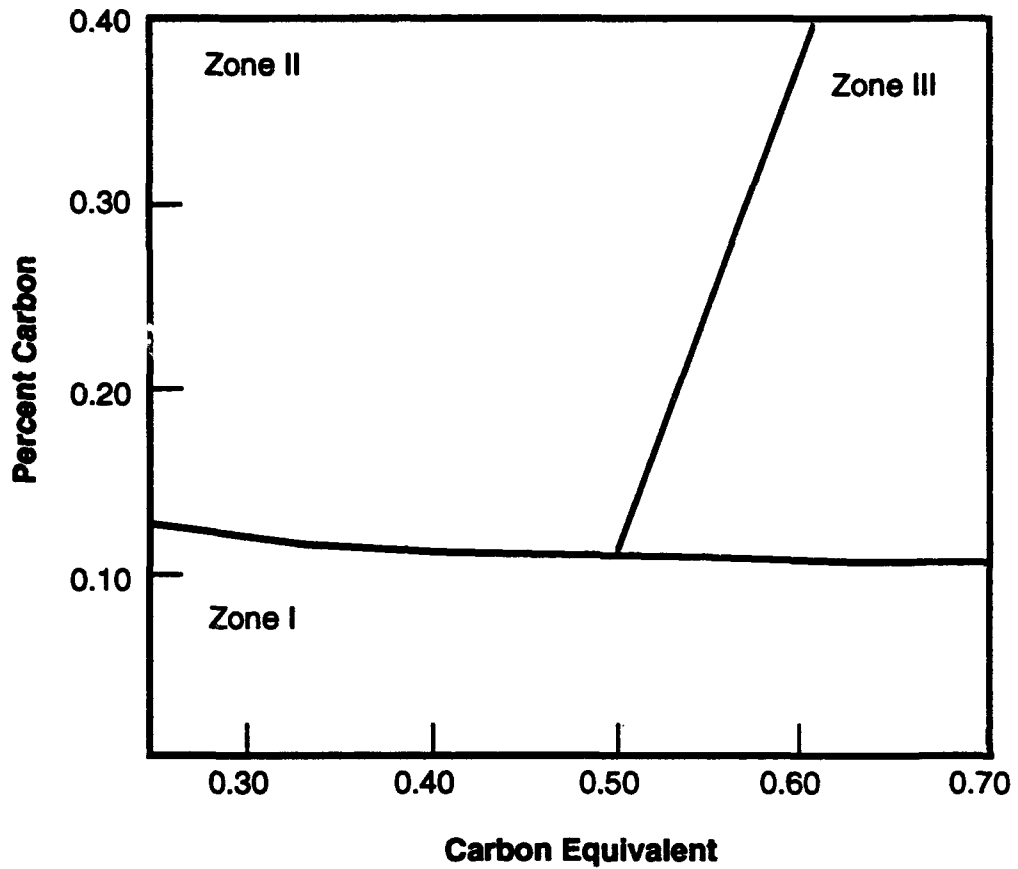
$$CE = C + \frac{Mn}{6} + \frac{Si}{7} + \frac{Ni}{55} + \frac{Cr}{5} + \frac{Mo}{4} + \frac{V}{5} + 1.3Nb$$

**Figure 1** The relationship between the actual carbon content, the carbon equivalent and the susceptibility to hydrogen induced cold cracking.<sup>9</sup>

Graville demonstrated that the cold cracking susceptibility of steels can be classified according to the composition and hardenability of the steel.<sup>9</sup> By plotting a slightly modified version of the standard relationship for the carbon equivalent against the actual carbon content of steels, Graville found three different regions of cold cracking behavior result as shown in Figure 1. In this figure, steels with compositions in Zone I contain very little carbon (<0.1%), exhibit little hardenability, and for most welding conditions, exhibit very little cold cracking. Zone II steels contain significant amounts of carbon, but contain only small quantities of the alloying elements which increase hardenability. As a result, the microstructures, hardness, and the cold cracking resistance of the HAZ's formed in these steels vary greatly with the welding conditions. Zone III steels contain significant quantities of both carbon (>0.1%) and alloying elements that increase hardenability. As a result, martensitic structures readily form during welding of these steels resulting in HAZ's which are susceptible to cold cracking. Therefore, welding of these steels require heat treatments and other special procedures which increase fabrication costs to avoid cold cracking.<sup>9,10</sup> The HY-100 alloy, presently used for ship fabrication, is a Zone III steel.

Examination of Figure 1 indicates that significant quantities of alloying elements can be added to a low carbon steel without increasing the cold cracking susceptibility. That is, it should be possible to create a steel which is strengthened with the alloying elements used in the carbon equivalent equation without increasing the susceptibility of the steel to cold cracking. HSLA-100 is designed to be a high strength steel with a Zone 1 composition and good resistance to cold cracking at welds.

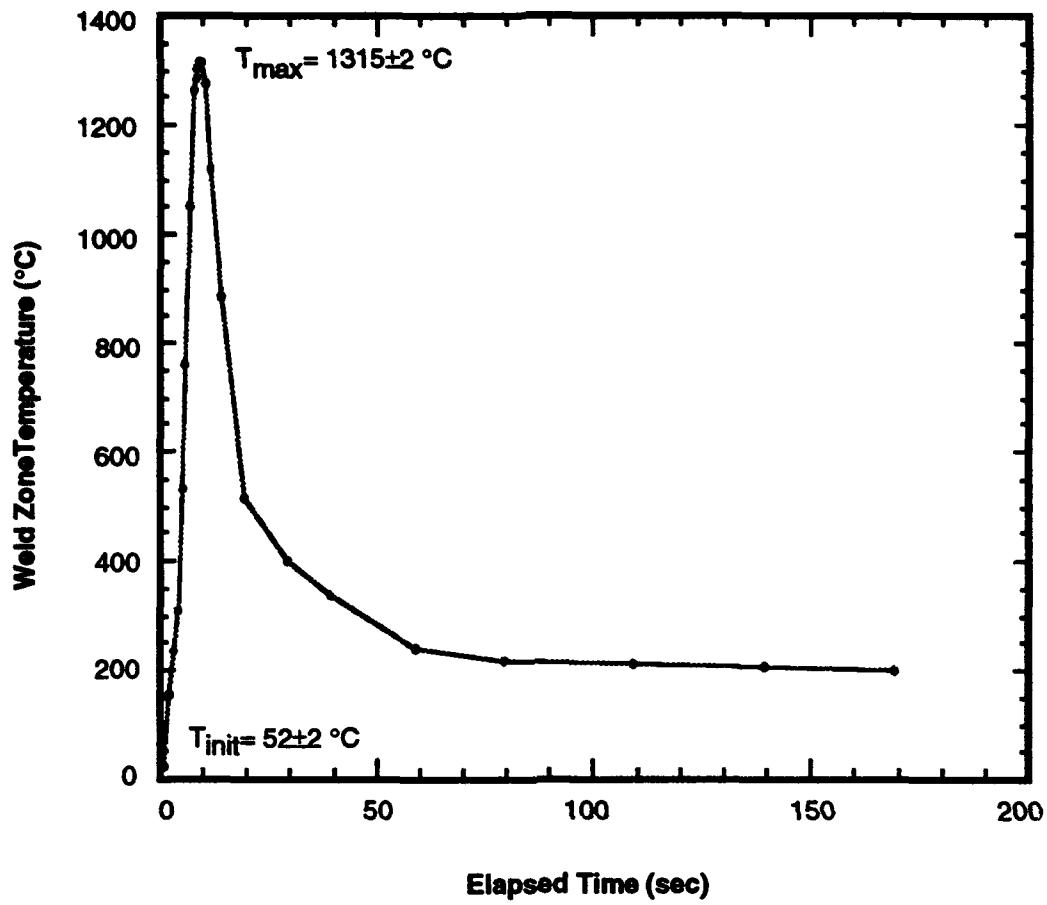
**Figure 2** The temperature-time command profile used to create the simulated heat affected zone resulting from a single welding pass.

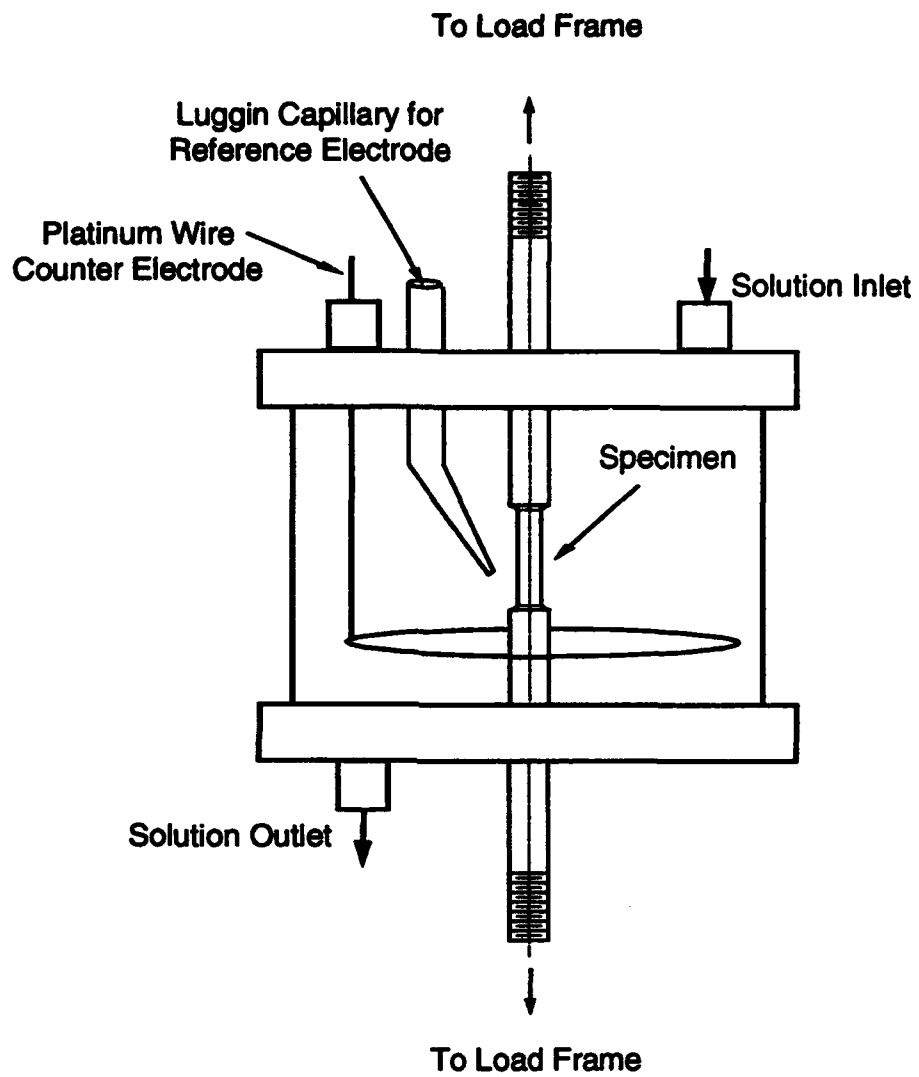
**Figure 3** A schematic diagram of the electrochemical cell used in the slow strain rate tests.

for the slow strain rate experiments is shown schematically in Figure 3. Approximately 1000 ml of solution was used for each test and the pH was measured before and after each test (ranging from 7.5 to 8.5 prior to testing, and from 6.0 to 9.5 after testing). For the constant potential (hydrogen fugacity) experiments, the potential of the sample was measured against a saturated calomel reference electrode ( $0 V_{SCE}=0.242 V_{NHE}$ ) and controlled with a commercial potentiostat. The mechanical tests were conducted using a computer controlled slow strain rate testing system which operated at a constant crosshead speed of  $0.0254 \mu\text{m}/\text{sec}$  ( $1 \times 10^{-6} \text{ in}/\text{sec}$ ). The computer system was configured to record applied load, crosshead displacement, elapsed time and either electrode potential or current depending on the particular experiment. Sample preparation for all of the tensile tests consisted of polishing the gauge section according to standard metallographic procedures. The remainder of the sample was coated with a stop-off lacquer to limit the surface area exposed to the environment. After failure, the samples were promptly removed from the cell, rinsed in flowing water and alcohol, dried and then stored in a vacuum desiccator until analyzed.

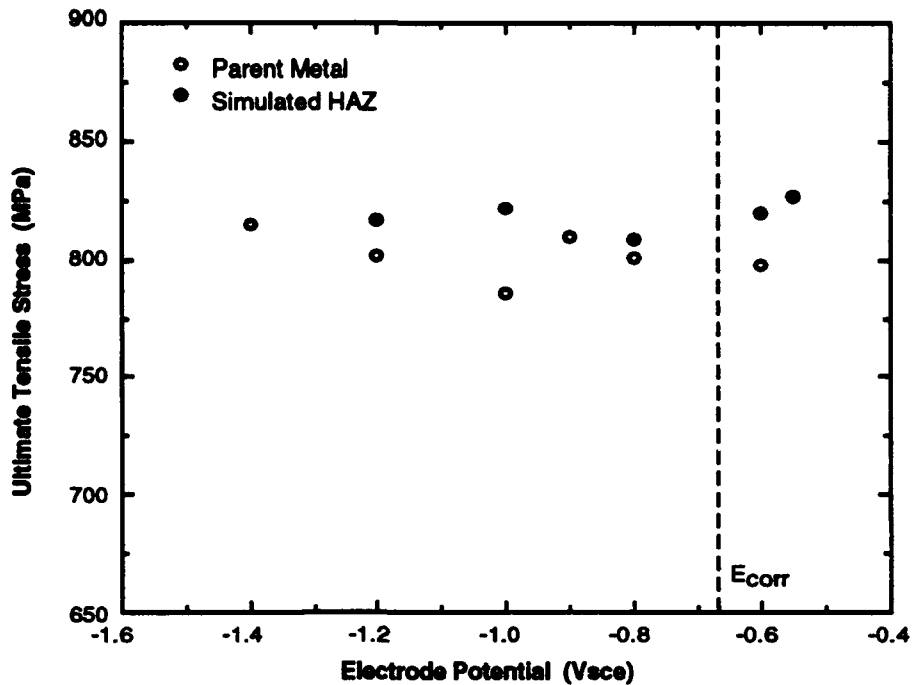
**Figure 4a** The ultimate tensile strength vs electrode potential for the HY-100 parent metal and simulated heat affected zone in recirculating ASTM artificial seawater.

The results of the slow strain rate tests are presented in Tables 3 through 6. The ultimate tensile strength data (UTS) are plotted against the sample potential for both the base metal and the simulated HAZ of the HY-100 alloy in Figure 4a. A similar plot for the HSLA-100 alloy is shown in Figure 4b. No discernable trend is present in the UTS data for the HY-100. However, a slight increase in the strength was observed with decreasing potential in the HSLA-100 data. The strain to failure data, also plotted as a function of electrode potential and heat treatment, show a decrease in ductility with decreasing electrode potential for both conditions of the HY-100 alloy (Figure 5a) and the HSLA-100 alloy (Figure 5b). The strain to failure data for the HY-100 base metal ranged from a maximum value of 10.5 percent to a minimum value of 6.5 percent and the simulated HAZ ranged from 7.38 to 4.75 percent over the same potential range. The HSLA-100 strain to failure data also showed a comparable trend ranging from 12.5 percent to 7.0 percent for the base metal and from 8.1 percent to 4.0 percent in the simulated HAZ over the same potential range. The best illustration of the influence of hydrogen fugacity on the cracking resistance of the two alloys lies in the reduction in area (RA) data. In Figure 6a, both conditions of the HY-100 show a decrease in RA with electrode potential. A similar trend is also shown by both conditions of the HSLA-100 (Figure 6b). Through the range of potentials between  $-0.800V_{scc}$  and  $-1.200V_{scc}$ , the base metal HY-100 showed a 35 percent decrease in the reduction in area data. A similar decrease in the RA data was observed in the simulated HAZ data. The reduction in the HSLA-100 data was comparable

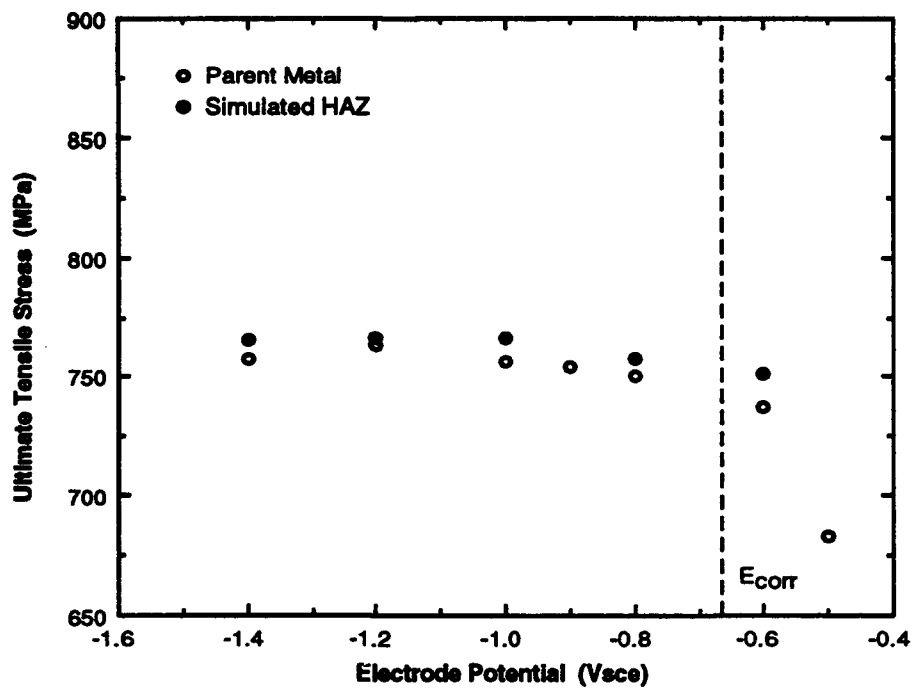
**Figure 4b** The ultimate tensile strength vs electrode potential for the HSLA-100 parent metal and simulated heat affected zone in recirculating ASTM artificial seawater.

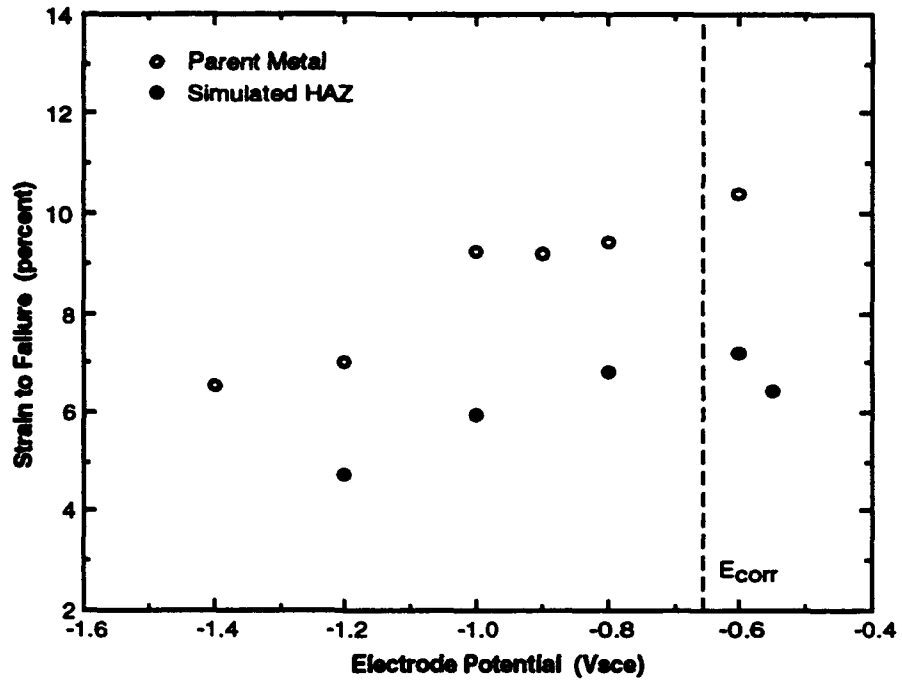
**Figure 5a** The strain to failure vs electrode potential for the HY-100 parent metal and simulated heat affected zone in recirculating ASTM artificial seawater.

The strain to failure and the reduction in area graphs of Figures 5 and 6 can be divided into three regions based on their curvature. First, over a range of potentials the ductility observed in artificial seawater approaches that observed in nitrogen. This region is identified as "Region I" in Figure 6. Some decrease is observed for increasing potentials in this range, but this is due to dissolution reducing the cross section of the samples. Second, a region is observed over which the ductility changes rapidly with decreasing potential which is labeled as "Region II" in Figure 6. Third, a region is observed over which the rate of decrease in ductility with potential begins to decrease as shown in the area identified as "Region III" in Figure 6.

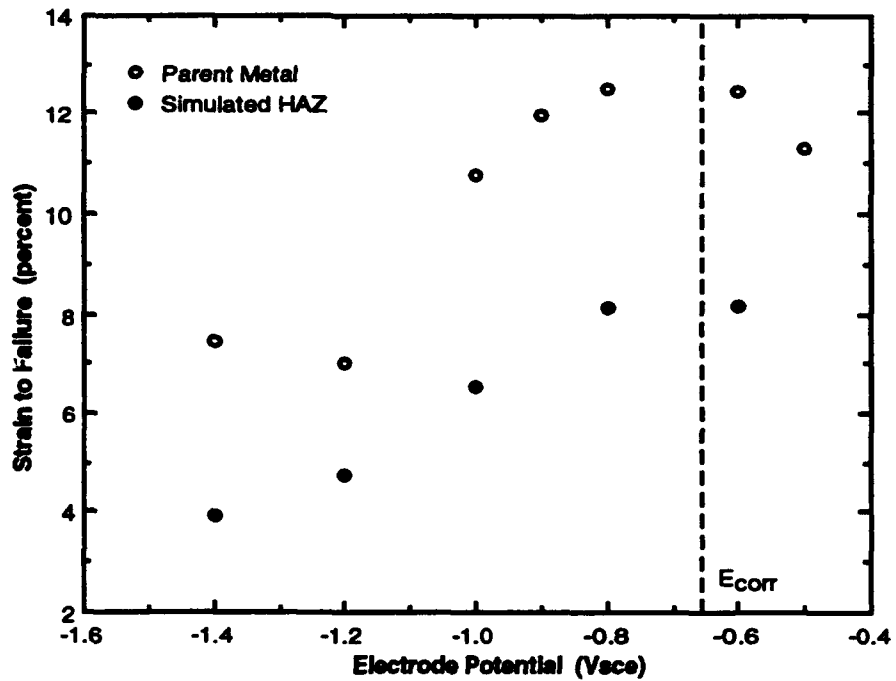
**Figure 5b** The strain to failure vs electrode potential for the HSLA-100 parent metal and simulated heat affected zone in recirculating ASTM artificial seawater.

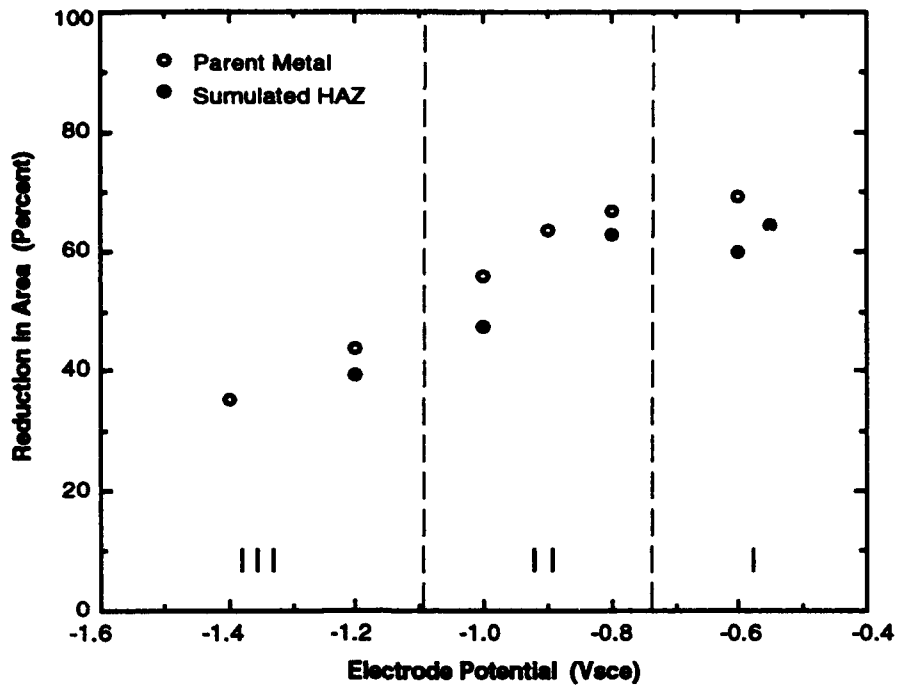
**Figure 6a** The reduction in area vs electrode potential for the HY-100 parent metal and simulated heat affected zone in recirculating ASTM artificial seawater.

The fractographic analysis was in agreement with the trends observed in the slow strain rate data. The features observed on the fracture surfaces from Region I in Figure 6 were exclusively ductile in nature and consisted entirely of microvoid coalescence (MVC) and related features. In Region III, the region of lowest ductility in Figure 6, the features did include brittle cracking and while cracking was observed, it appeared to consist entirely of transgranular-like features. Intergranular cracking has been observed in these alloys, generally along the prior austenite grain boundaries,<sup>11,12</sup> however, no features normally associated with cracking of this type were apparent on the surfaces of the fractures analyzed. The type of cracking observed on these fracture surfaces shall be referred to as transgranular cleavage-like (TCL) cracking. The features

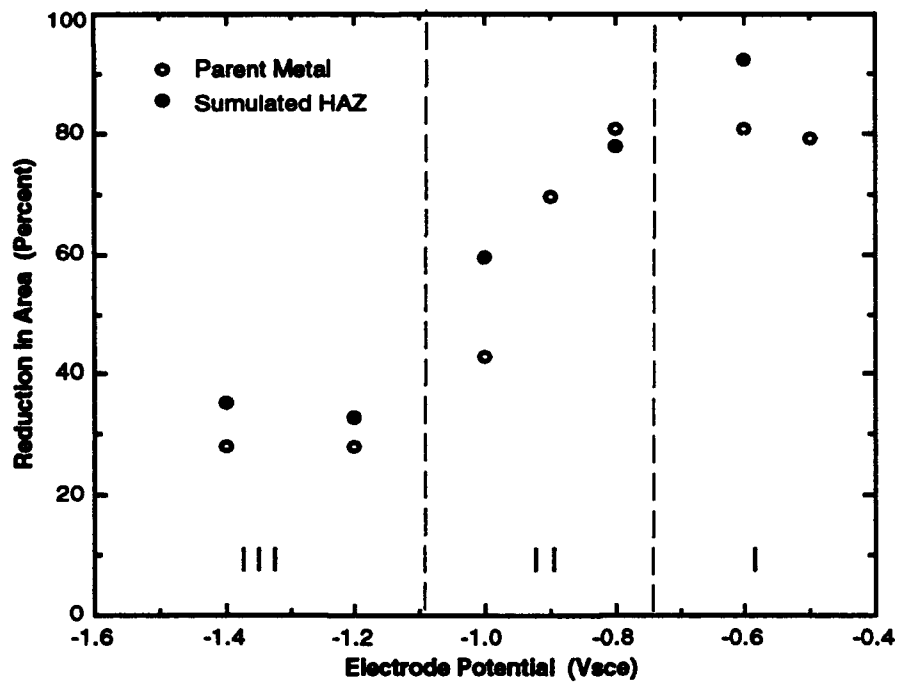
**Figure 6b** The reduction in area vs electrode potential for the HSLA-100 parent metal and simulated heat affected zone in recirculating ASTM artificial seawater.

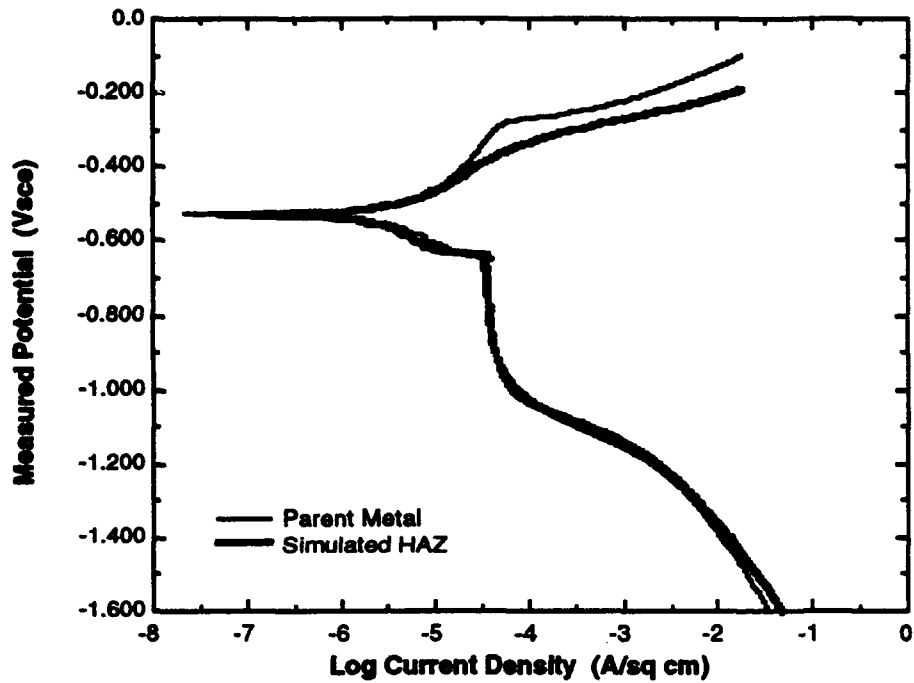
**Figure 7a** Potentiodynamic scan of the HY-100 parent metal and simulated heat affected zone in aerated ASTM artificial seawater at 1mv/sec scan rate.

The measured free corrosion potentials for both alloys and heat treatments in static, aerated and deaerated artificial seawater are given in Table 2. Neither alloy demonstrated any significant differences in the steady state potentials between the base metal and the simulated HAZ conditions. Only small differences between the behavior of the base metal and the HAZ for the two alloys were observed. As shown in Figure 7a, the behaviors of the base metal and the simulated HAZ in aerated seawater are essentially the same. The base metal showed a slightly lower anodic current as the potential approached the transpassive region and this feature was also observed in deaerated seawater, as shown in Figure 7b. This suppression of the anodic current may reflect some

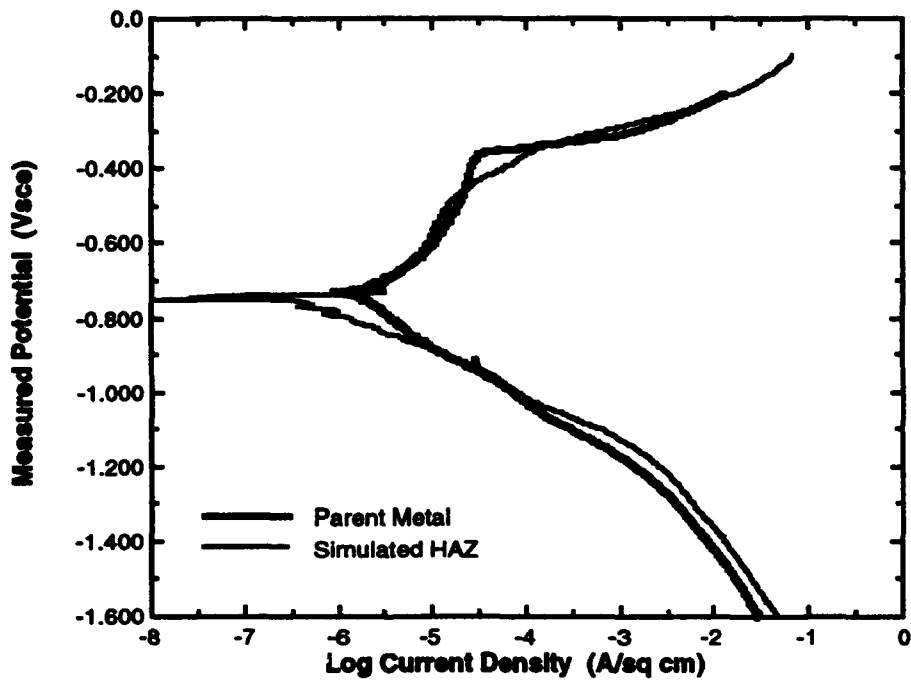
**Figure 7b** Potentiodynamic scan of the HY-100 parent metal and simulated heat affected zone in deaerated ASTM artificial seawater at 1mV/sec scan rate.

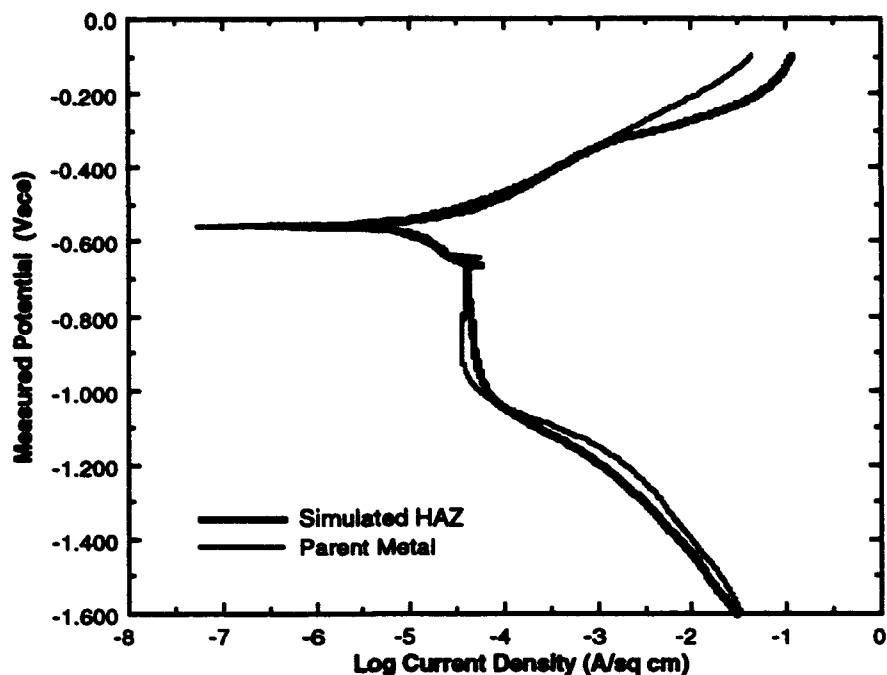
**Figure 8a** Potentiodynamic scan of the HSLA-100 parent metal and simulated heat affected zone in aerated ASTM artificial seawater at 1mV/sec scan rate.

change in the surface film, but more likely, it reflects a change in the homogeneity of the microstructure. The behavior of the base metal and the simulated HAZ of the HSLA-100, shown in Figure 8a, were also very similar in the aerated seawater. Like the HY-100, subtle differences were observed between the two heat treatments and the same was true in the deaerated seawater, as shown in Figure 8b. Figures 9a and 9b show the electrochemical behaviors of two base metals and the two simulated HAZs for the alloys and these plots show that only small differences between the alloys were observed.

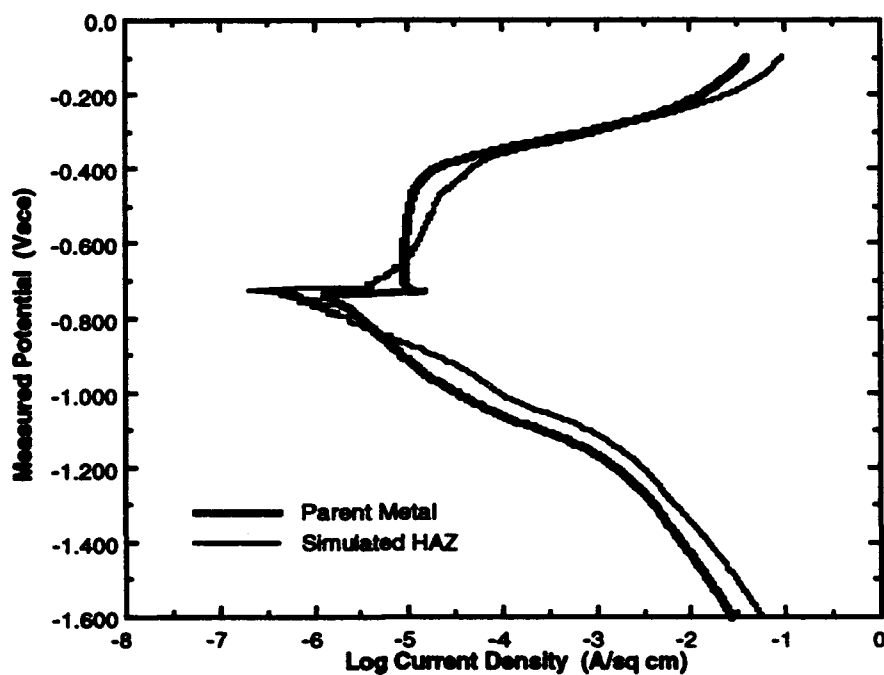
**Figure 8b** Potentiodynamic scan of the HSLA-100 parent metal and simulated heat affected zone in aerated ASTM artificial seawater at 1mV/sec scan rate.

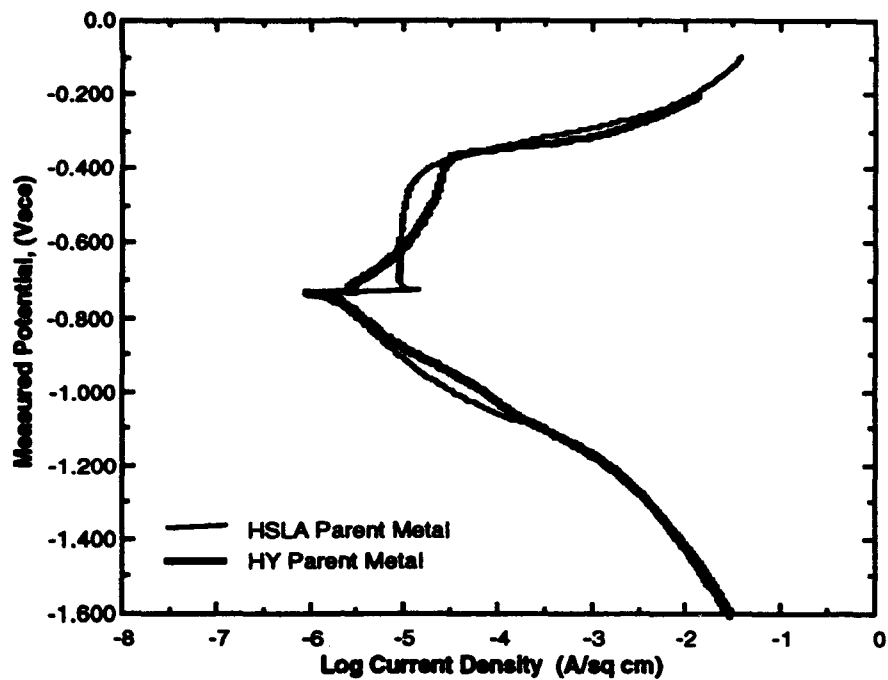
**Figure 9a** Comparison of the potentiodynamic scans for the HY-100 and the HSLA-100 parent metals in deaerated ASTM artificial seawater at 1mV/sec scan rate.

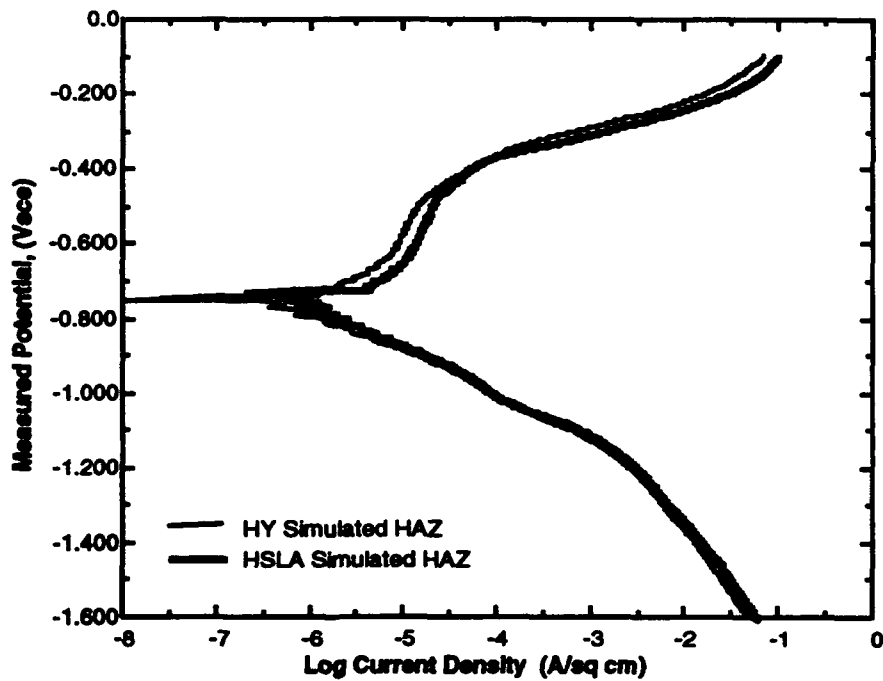
**Figure 9b** Comparison of the potentiodynamic scans for the HY-100 and the HSLA-100 simulated heat affected zones in deaerated ASTM artificial seawater at 1mV/sec scan rate.

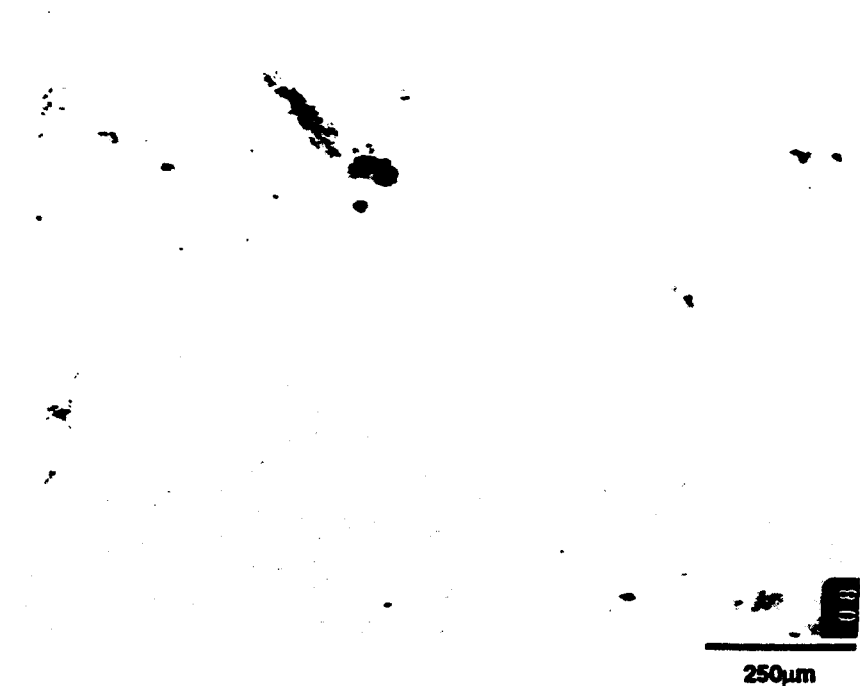
**Figure 10a**

As polished view of the HY-100 parent metal showing the size and distribution of the observed inclusions.

Quantitative metallography (QM) was performed on the base metal of the HY-100 and the HSLA-100 alloys to determine the size, shape and distribution of the inclusions present. Figures 10a and 10b are representative photomicrographs of the two alloys in the as polished condition and the results of the QM analysis are shown in Table 7. In general, the inclusions observed in the HY-100 alloy were larger in size, higher in number, and considerably less spherical than those observed in the HSLA-100 alloy.<sup>35</sup> The micrographs shown in Figure 11 represent the structures of the base metals of the alloys used in this analysis. The microstructure of the HY-100 base metal (Figure 11a) was identified as fine tempered lath martensite<sup>1</sup> and the HSLA-100 base metal (Figure 11b) was identified as coarse bainite with a random dispersion of incoherent niobium carbonitride precipitates.<sup>5,6</sup> The microstructure of the simulated HAZ in HY-100 varied greatly over the length of the HAZ whereas the microstructural variations in the HSLA-100 simulated HAZ varied little. Figures 12a and 12b show the

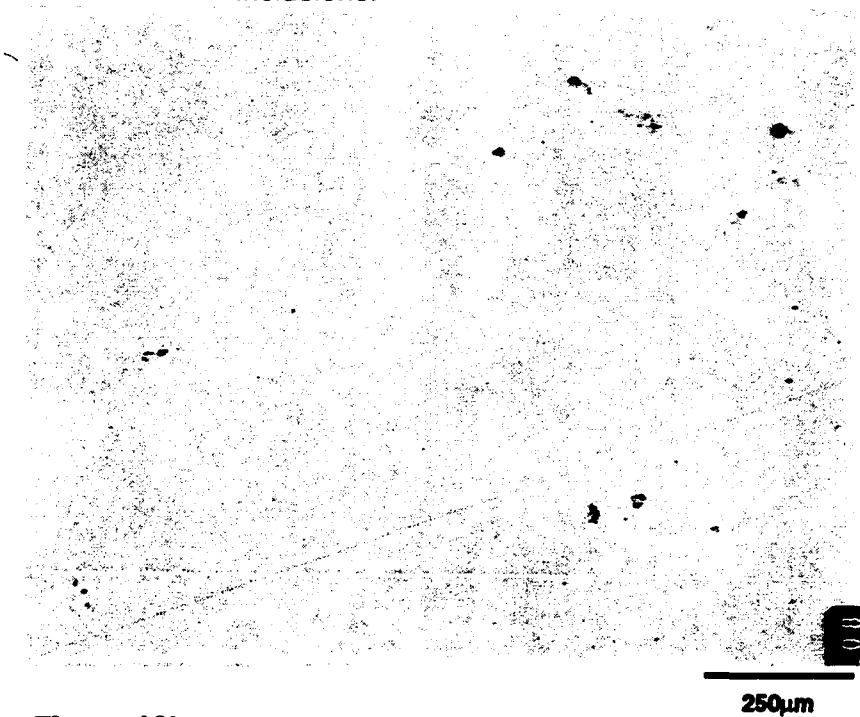
**Figure 10b**

As polished view of the HSLA-100 parent metal showing the size and distribution of the observed inclusions.

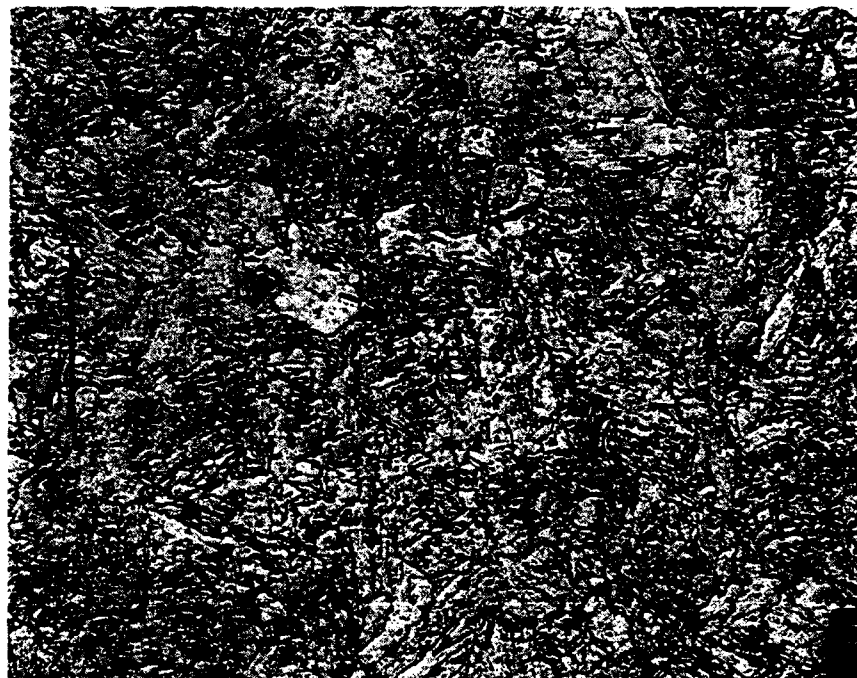
**Figure 11b** Optical micrograph of the HSLA-100 parent metal showing the bainitic structure and niobium carbonitride precipitates. (CLQ-1 etch)

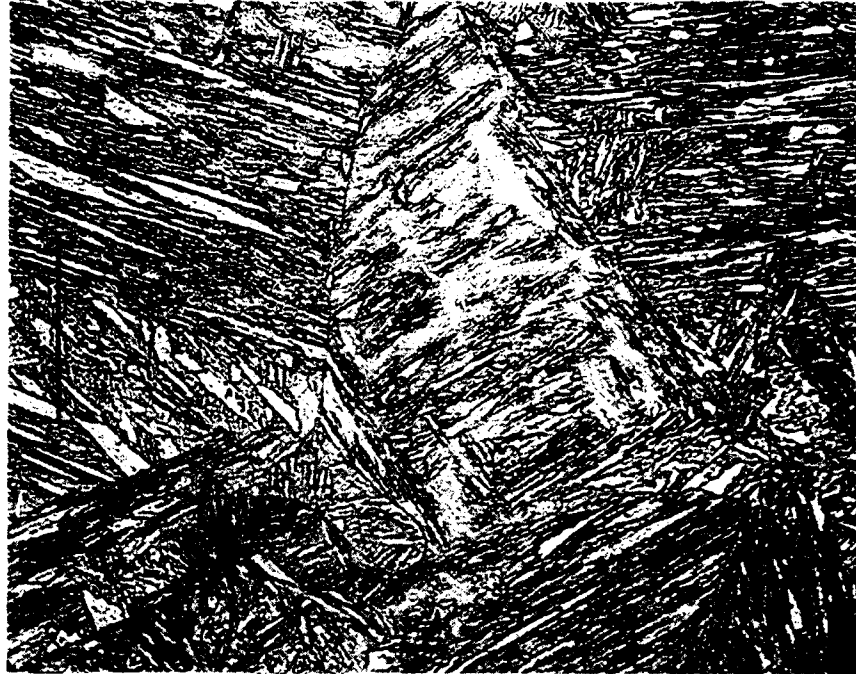
**Figure 12a** Optical micrograph of the HY-100 weld heat affected zone showing the greatest observed deviation from the parent metal microstructure. (CLQ-1 etch)

microstructures in the HY-100 and the HSLA-100 simulated HAZ's which deviated the greatest from the structure of the base metal.

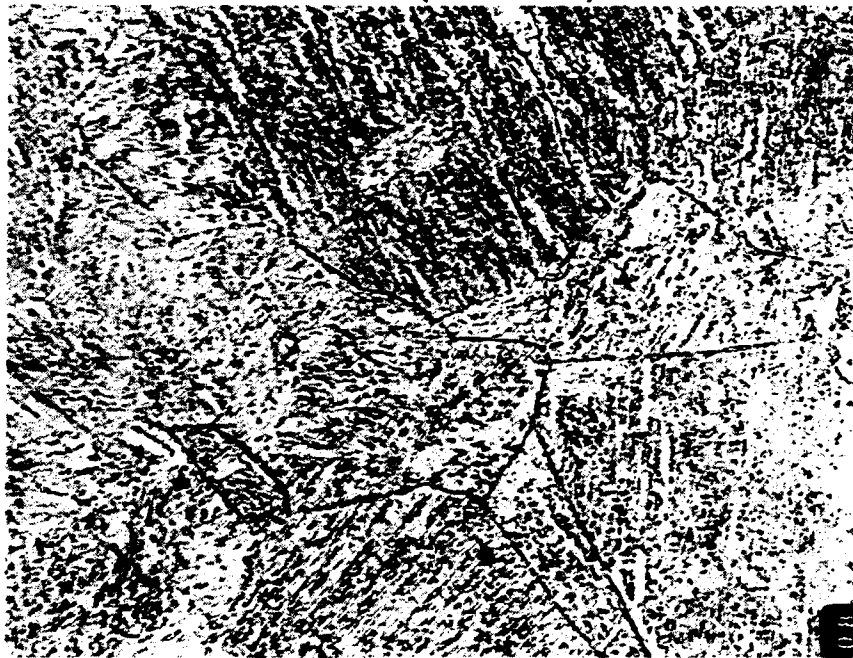
**Figure 12b** Optical micrograph of the HSLA-100 weld heat affected zone showing the greatest observed deviation from the parent metal microstructure. (CLQ-1 etch)

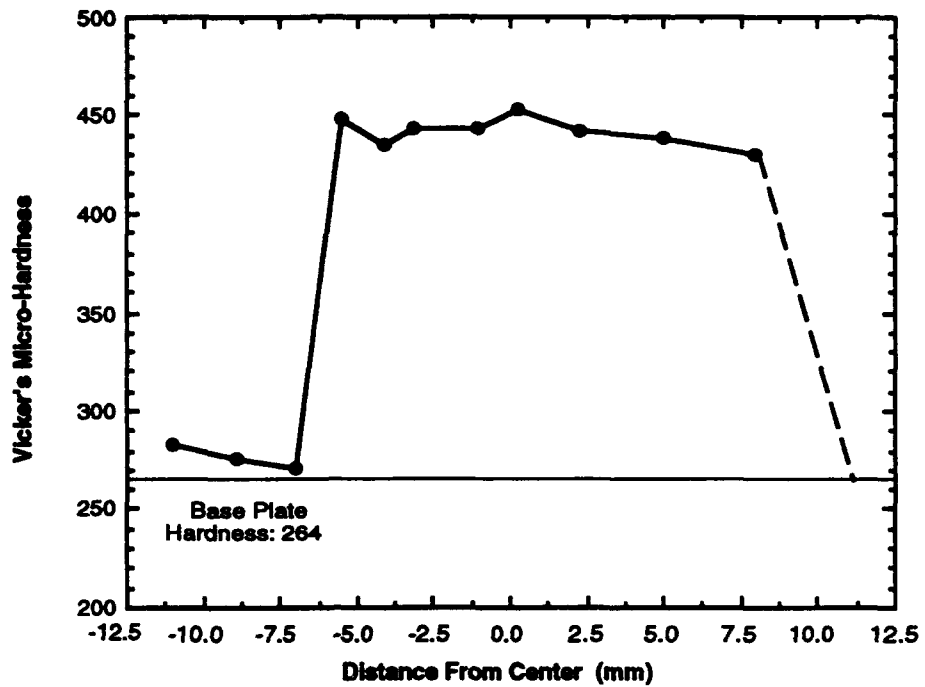
**Figure 13a** The variation in micro-hardness as measured from the center of the gauge section in a HY-100 simulated heat affected zone.

The variations in hardness as a function of distance from the center of the gauge section for both alloys are shown in Figures 13a and 13b. The HY-100 exhibited substantial changes in microhardness, ranging from approximately 264 VHN in the base metal to a maximum of 450 VHN in the simulated HAZ. The dashed lines in Figure 6 are extrapolations from the last measurements to the base metal hardness value and were included to illustrate the symmetry of the changes in observed in the hardness. The HSLA-100 exhibited microhardness values of approximately 270 VHN over the entire length of the base metal gauge section and increased to a maximum value of 320 VHN in the simulated HAZ.

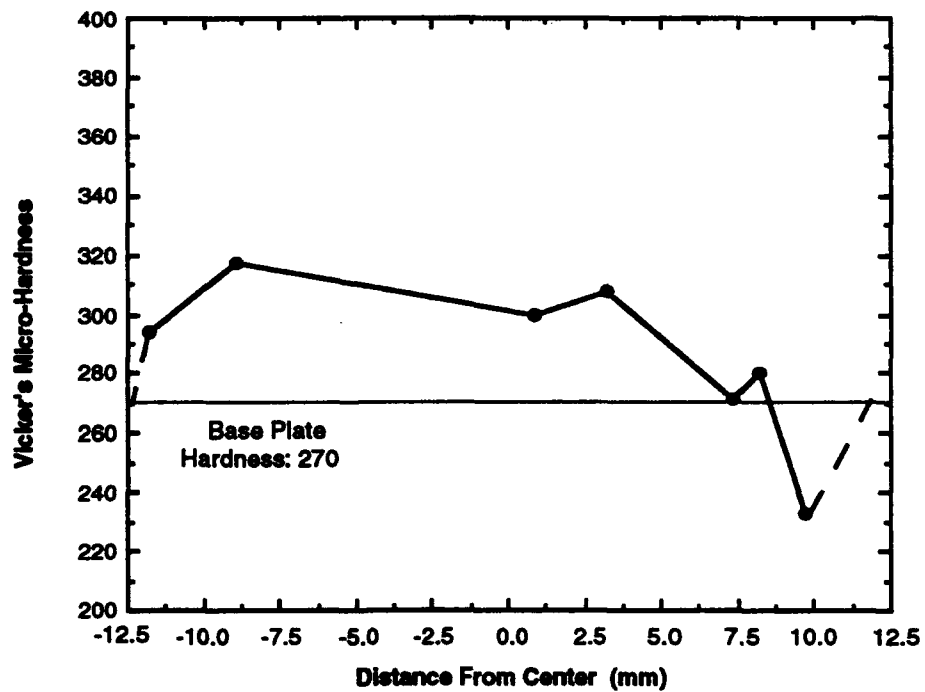
**Figure 13b** The variation in micro-hardness as measured from the center of the gauge section in a HSLA-100 simulated heat affected zone.

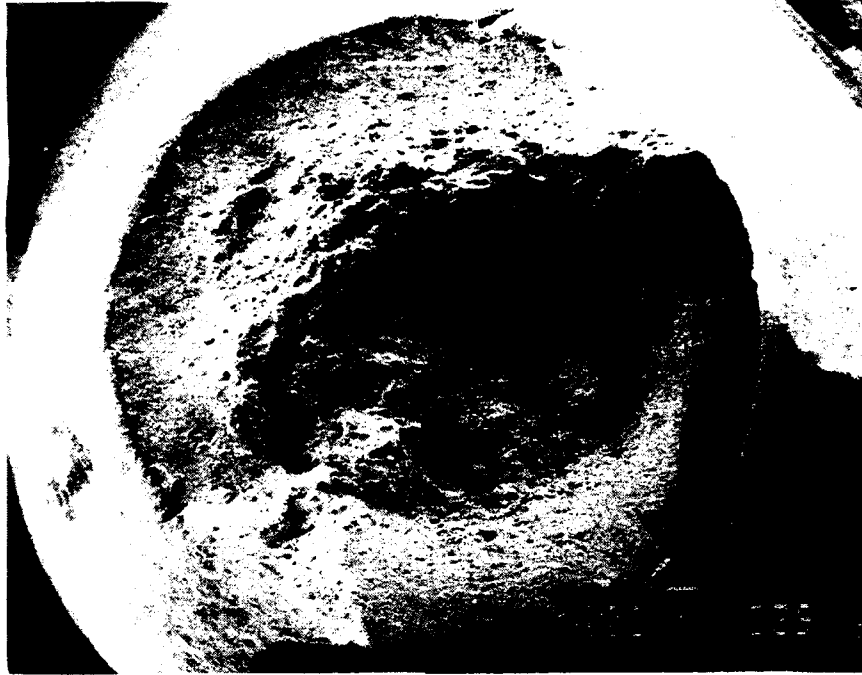
**Figure 14a** Low magnification scanning electron micrograph of the HY-100 heat affected zone showing the characteristic ductile behavior observed in the failures contained in Region I of Figure 6.

Figures 14 and 15 are representative scanning electron micrographs from the HAZ's tested at the potentials in Region I. Figure 14a, a low magnification overview of the fracture surface of the HY-100, depicts the general characteristics observed on all of the fractures in this region (i.e. MVC surrounded by a large region of shear). Figure 14b is a high magnification view of the MVC region. Figure 15a is a low magnification overview of a HSLA-100 simulated HAZ from Region I and again shows the characteristic shear and MVC of fractures at the potentials in this region. A higher magnification view of the MVC observed in this alloy is shown in Figure 15b. Overall, the microvoids observed on the surfaces of the samples tested at the potentials in Region I indicated a good retention of ductility in both alloys.

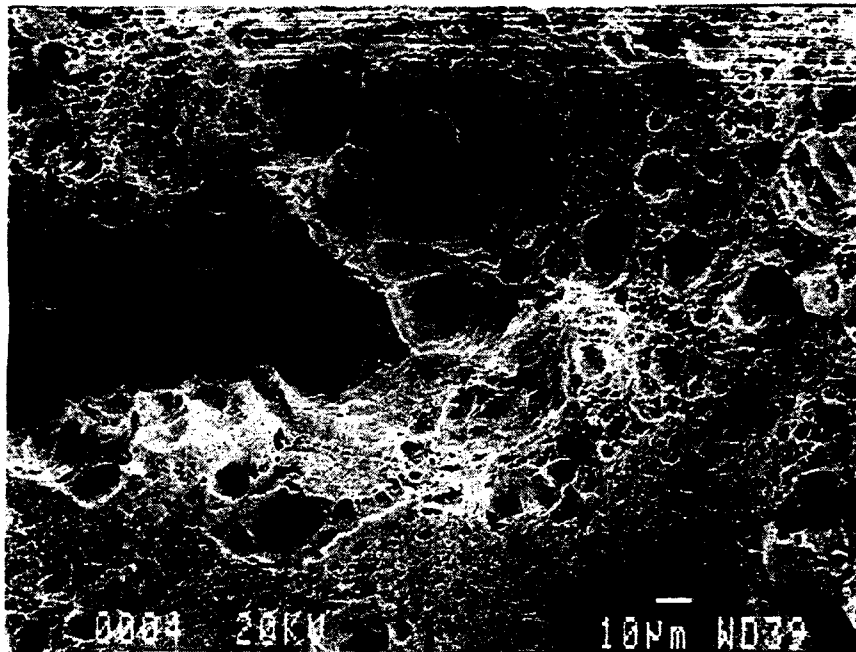
**Figure 14b** High magnification scanning electron micrograph from Figure 14a showing the general size and distribution of the observed microvoids.

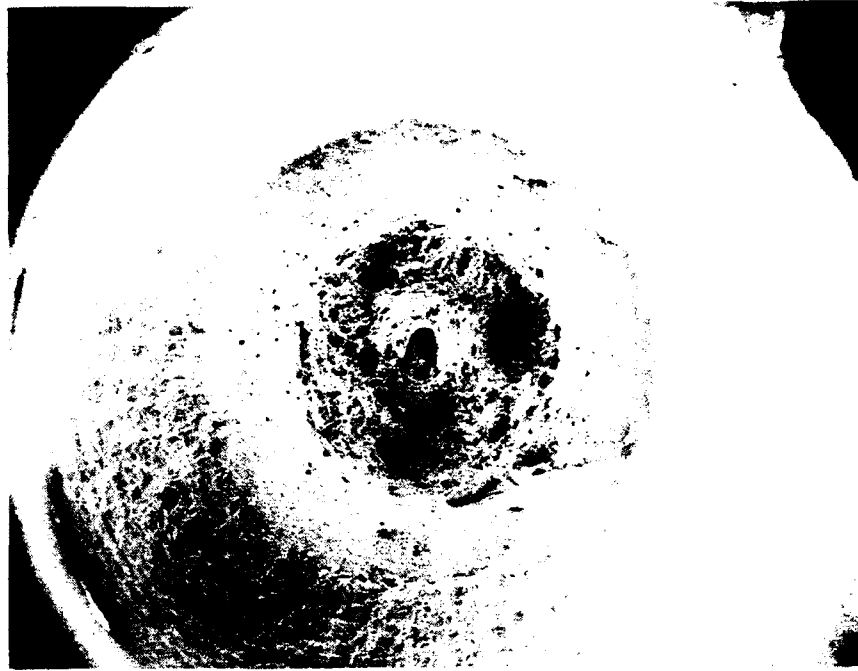
**Figure 15a** Low magnification scanning electron micrograph of the HSLA-100 heat affected zone showing the characteristic ductile behavior observed in the failures contained in Region I of Figure 6.

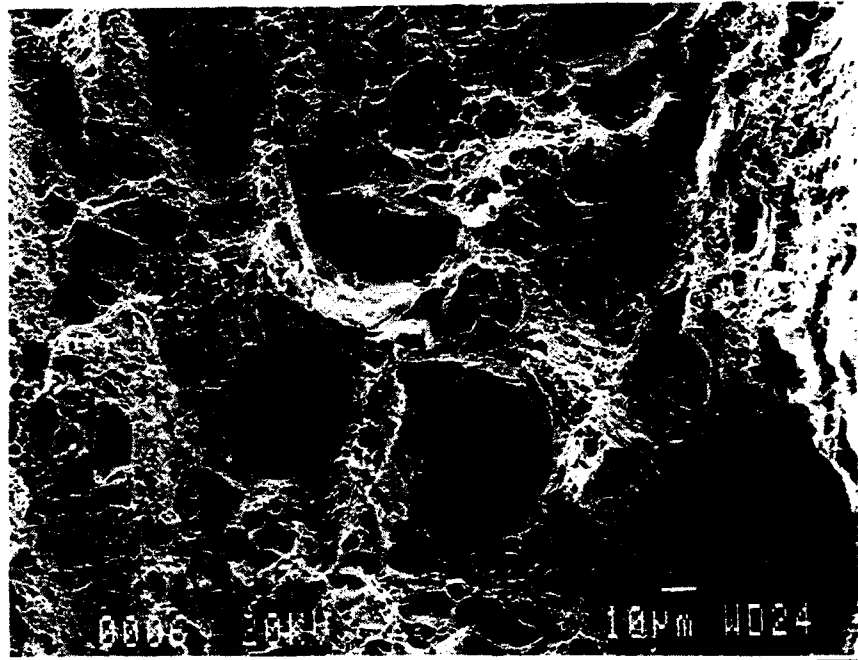
**Figure 15b** High magnification scanning electron micrograph from Figure 15a showing the general size and distribution of the observed microvoids.

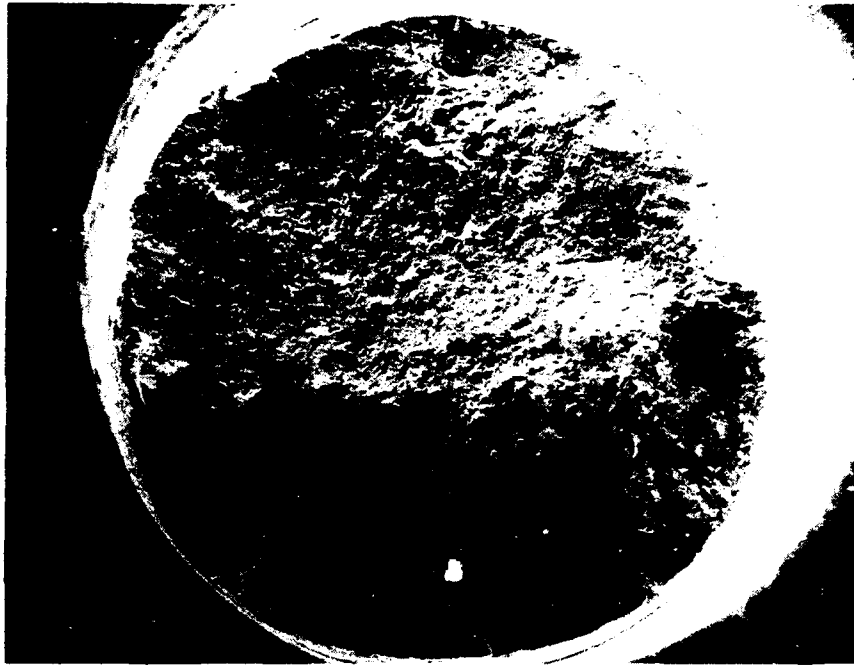
**Figure 16a** Low magnification scanning electron micrograph of the HY-100 heat affected zone showing the embrittled behavior observed in failures contained in Region III of Figure 6.

Figures 16 and 17, show fracture surfaces of simulated HAZ samples of the two alloys tested at a potential within Region III. Figure 16a is an overview of a representative HY-100 fracture surface. None of the features normally associated with ductile fracture are present in this figure. Instead, the fracture surface is composed primarily of large TCL regions with secondary transgranular cracks. Figure 16b depicts the cracking observed in the HY-100 throughout this region. Figure 17a is a similar low magnification view of the HSLA 100 sample tested at a potential in Region III. Again, TCL cracking was observed, but this type of cracking was observed only near the edge of the fracture surface. The majority of the features on the HSLA-100 fracture surfaces in Region III was MVC. In Figure 17b, a high magnification view of the cracking observed and a transition

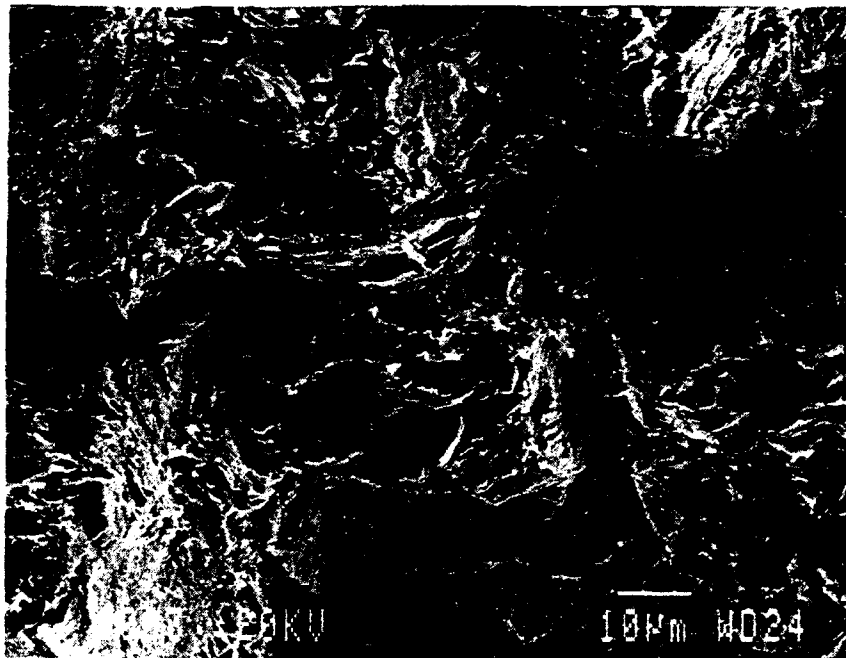
**Figure 16b** High magnification scanning electron micrograph from Figure 16a showing the nature of the transgranular cleavage-like cracking observed.
