**Characterization of the Hydrogen  
Induced Cold Cracking  
Susceptibility at Simulated  
Weld Zones in HSLA-100 Steel**

**M. R. Stoudt  
R. E. Ricker**

U.S. DEPARTMENT OF COMMERCE  
Technology Administration  
National Institute of Standards  
and Technology  
Materials Science and Engineering Laboratory  
Metallurgy Division  
Gaithersburg, MD 20899

April 1994

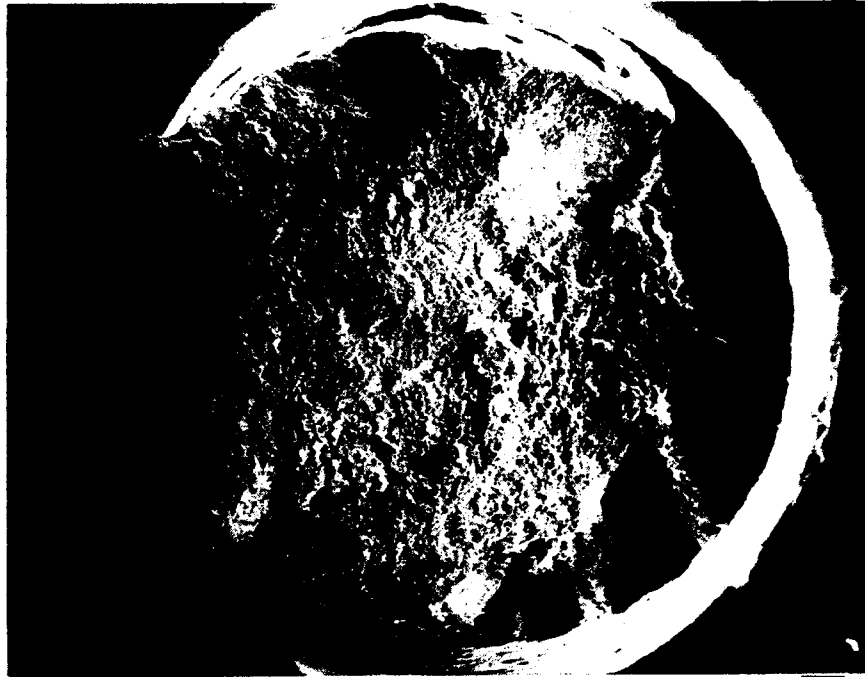
**Figure 17a** Low magnification scanning electron micrograph of the HSLA-100 heat affected zone showing the behavior observed in failures contained in Region III of Figure 6.

Figures 16 and 17, show fracture surfaces of simulated HAZ samples of the two alloys tested at a potential within Region III. Figure 16a is an overview of a representative HY-100 fracture surface. None of the features normally associated with ductile fracture are present in this figure. Instead, the fracture surface is composed primarily of large TCL regions with secondary transgranular cracks. Figure 16b depicts the cracking observed in the HY-100 throughout this region. Figure 17a is a similar low magnification view of the HSLA 100 sample tested at a potential in Region III. Again, TCL cracking was observed, but this type of cracking was observed only near the edge of the fracture surface. The majority of the features on the HSLA-100 fracture surfaces in Region III was MVC. In Figure 17b, a high magnification view of the cracking observed and a transition

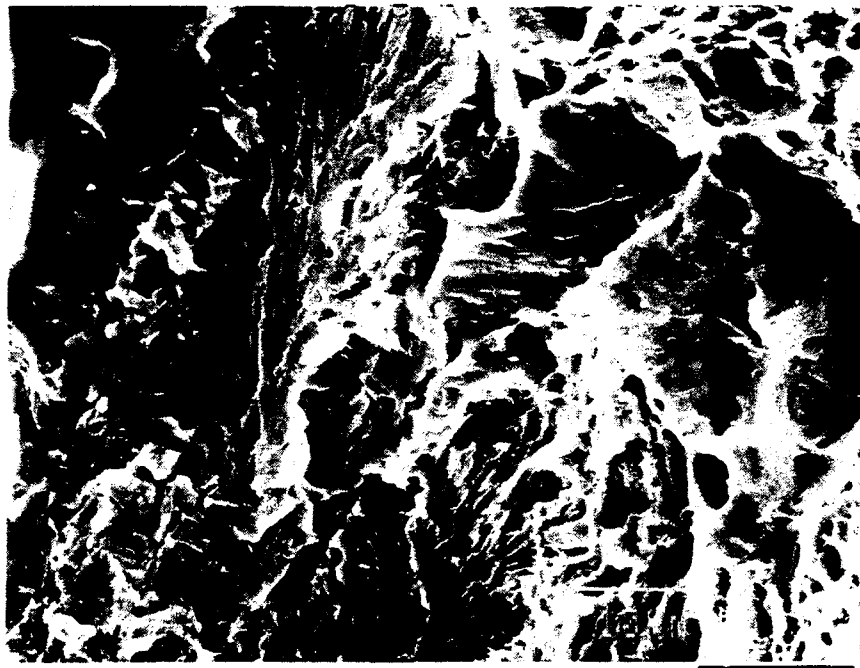
**Figure 17b** High magnification scanning electron micrograph from Figure 17a showing the nature of the transgranular cleavage-like cracking observed.

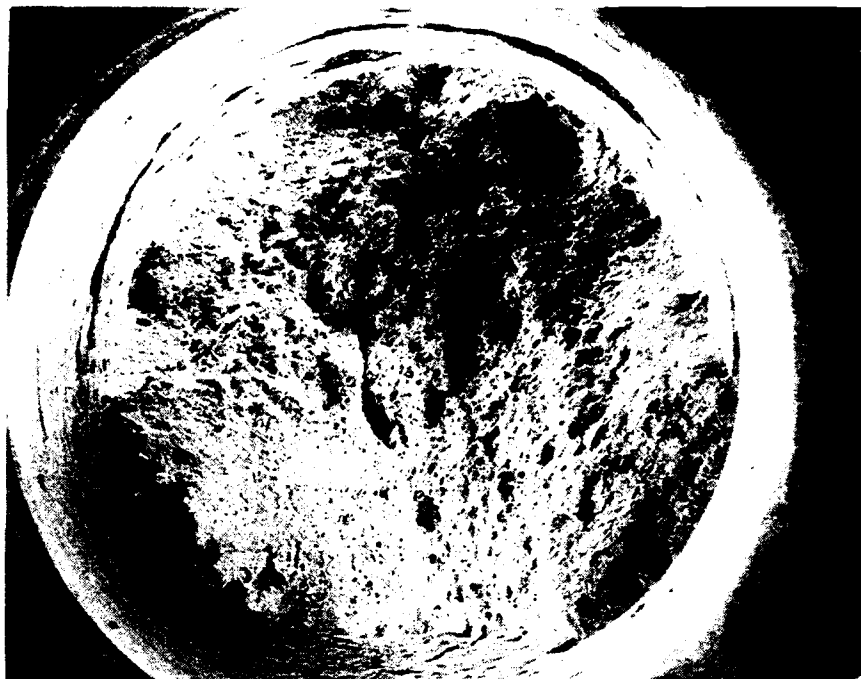
**Figure 18** Low magnification scanning electron micrograph of the HY-100 heat affected zone showing the mixed mode behavior observed in failures contained in Region II of Figure 6. 100  $\mu\text{m}$

observed in Region II, the transition region between Regions I and III in Figure 6, were generally a mixture of the two types of fracture: MVC and TCL.

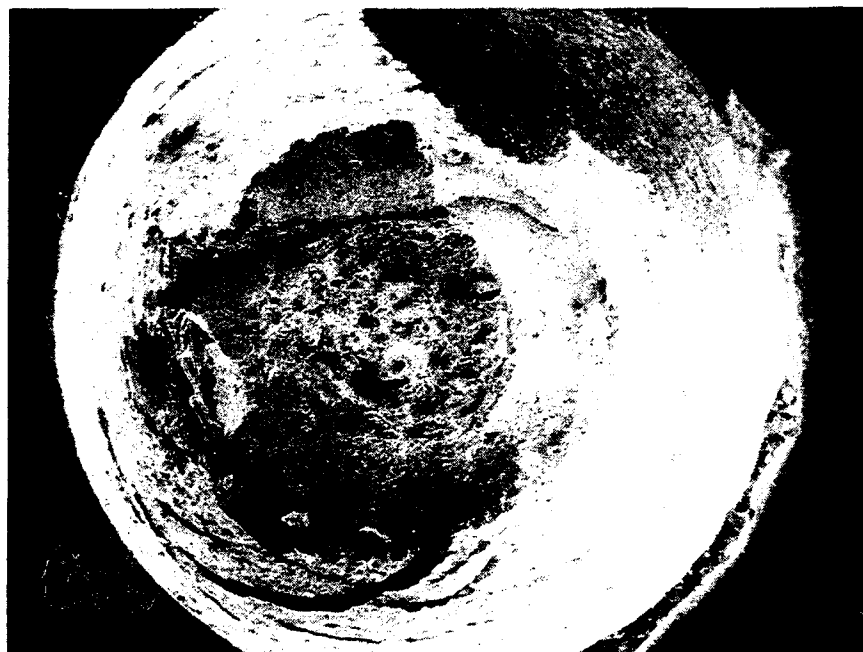
**Figure 19** Low magnification scanning electron micrograph of the HSLA-100 heat affected zone showing the mixed mode behavior observed in failures contained in Region II of Figure 6. 100  $\mu\text{m}$

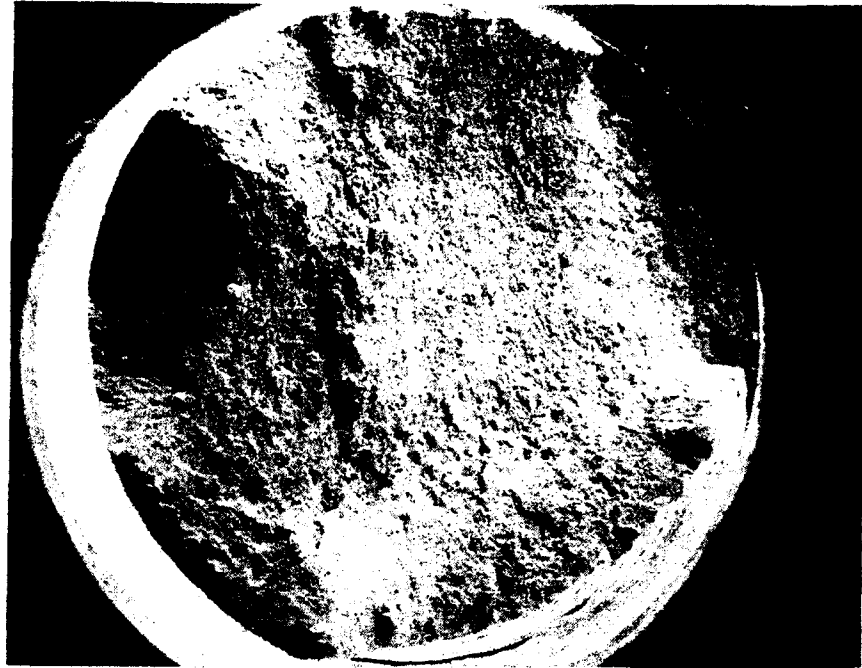
**Figure 20a** Low magnification scanning electron micrograph of the HY-100 parent metal showing the embrittled behavior observed in failures contained in Region III of Figure 6.

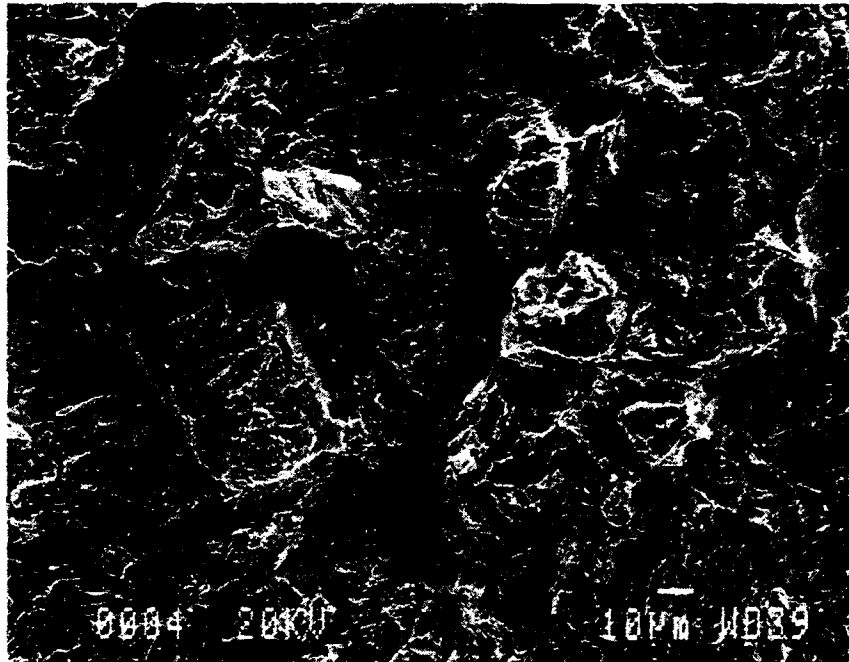
**Figure 21b** High magnification scanning electron micrograph from Figure 21a showing the nature of the transgranular cleavage-like cracking observed.
