SAND94-0308 • UC-722

**Impact Testing of the H1224A
Shipping/Storage Container**

H1224A weapons containers have been used for years by the Departments of Energy and Defense to transport and store W78 warhead midsections. Although designed to protect these midsections only in low-energy handling drop and impact accidents, a recent transportation risk assessment effort has identified a need to evaluate the container's ability to protect weapons in higher-energy environments. Four impact tests were performed on H1224A containers with W78 Mod 6c mass mockup midsections inside, onto an essentially unyielding target. Dynamic acceleration and strain levels were recorded during the side-on and end-on impacts, each at 12.2 m/s (40 ft/s) and 38.1 m/s (125 ft/s). Measured peak accelerations experienced by the midsections during lower velocity impacts ranged from 250 to 600 Gs for the end-on impact and 350 to 600 Gs for the side-on impact. Measured peak accelerations of the midsections during the higher velocity impacts ranged from 3,000 to 10,000 Gs for the end-on impact and 8,000 to 10,000 Gs for the side-on impact. Deformations in the H1224A container ranged from minimal to severe bucklin

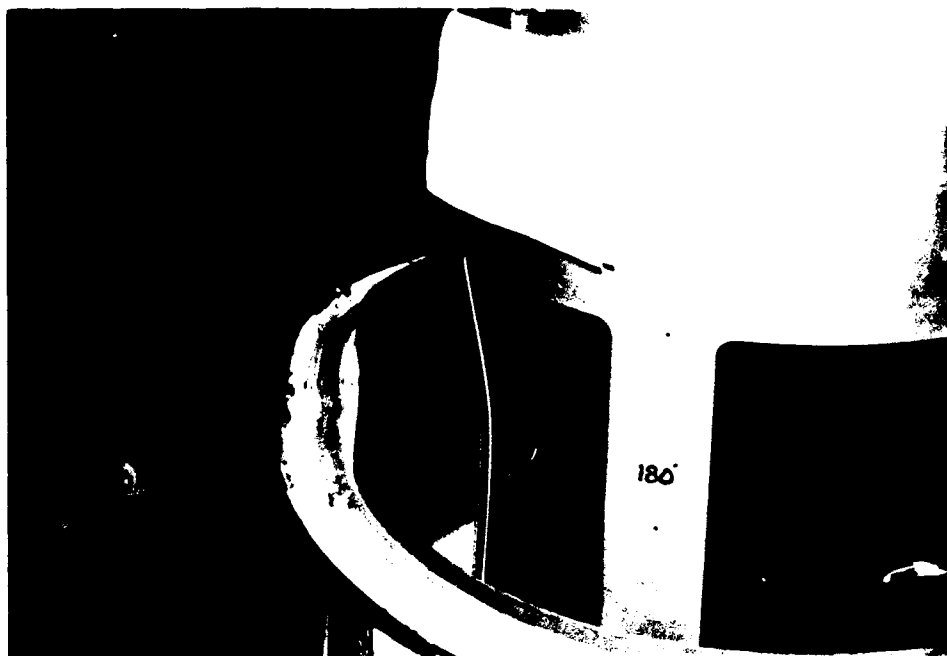
Figure 5.2.4 HLV inner container bending

Inside the container, the inner container diameter was decreased at its midsection slightly, as shown in Figure 5.2.4, due to contact with the outer shell during impact. The bending moment through the RV midsection due to support only at its ends during the side-on impact caused slight fracture of the carbon phenolic aeroshell at its midpoint and fore end (0° circumferentially), as shown in Figures 5.2.6a and 5.2.6b. The rapid loading of the RV after the flexible foam "bottomed out" caused bolts on the fore-most fore end weight plate to shear, as shown in Figure 5.2.7. No deformation was visible on the fore plate and aft cover. Container and RV deformations for the HLV impact test are quantified in Tables E 2.1, E 2.2, and E 2.3 of Appendix E, from measurement locations specified in Figures 3.6, 3.7, and 3.8.

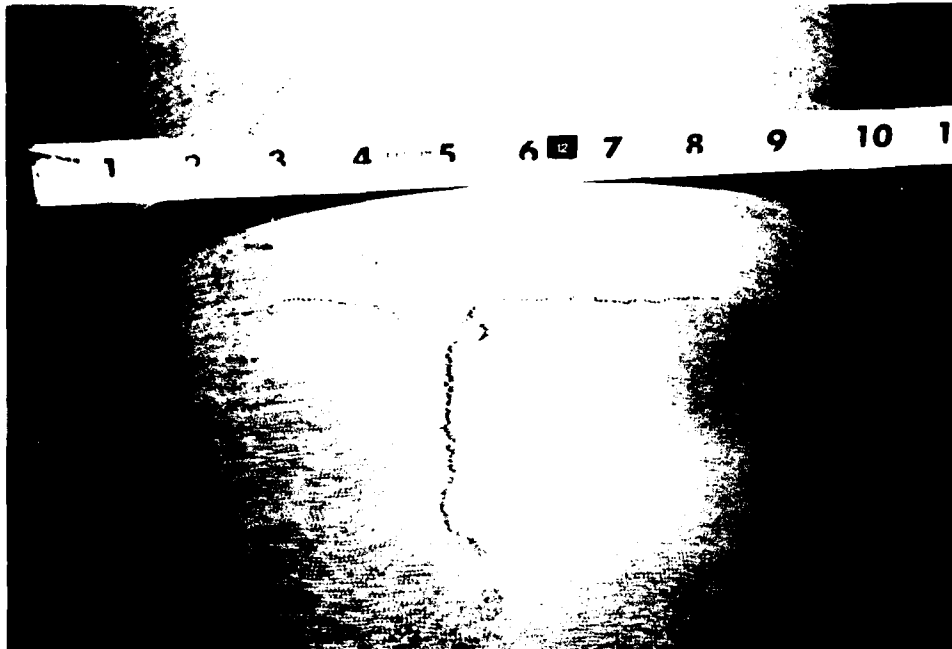
Figure 5.2.6a HLV Mk12a Mod6c cracking

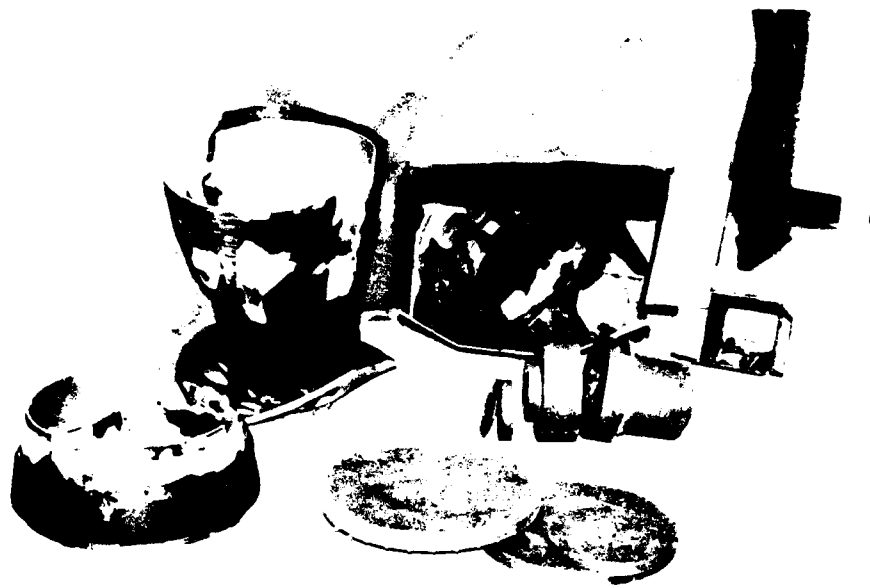
Figure 5.3.5 Mk12a Mod6c aeroshell fracture and weight plate detachment

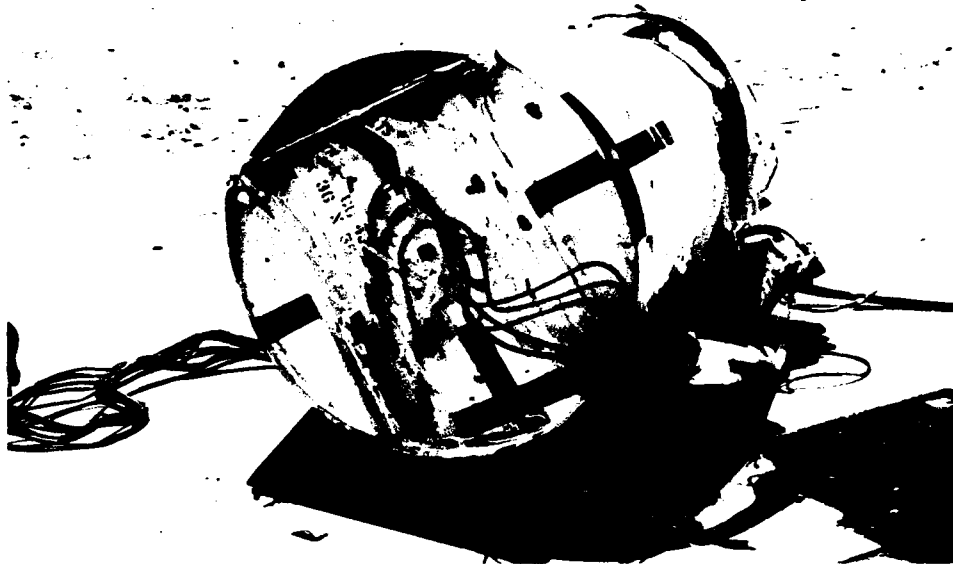
Figure 5.4.2b HHV H1224A post-test deformation

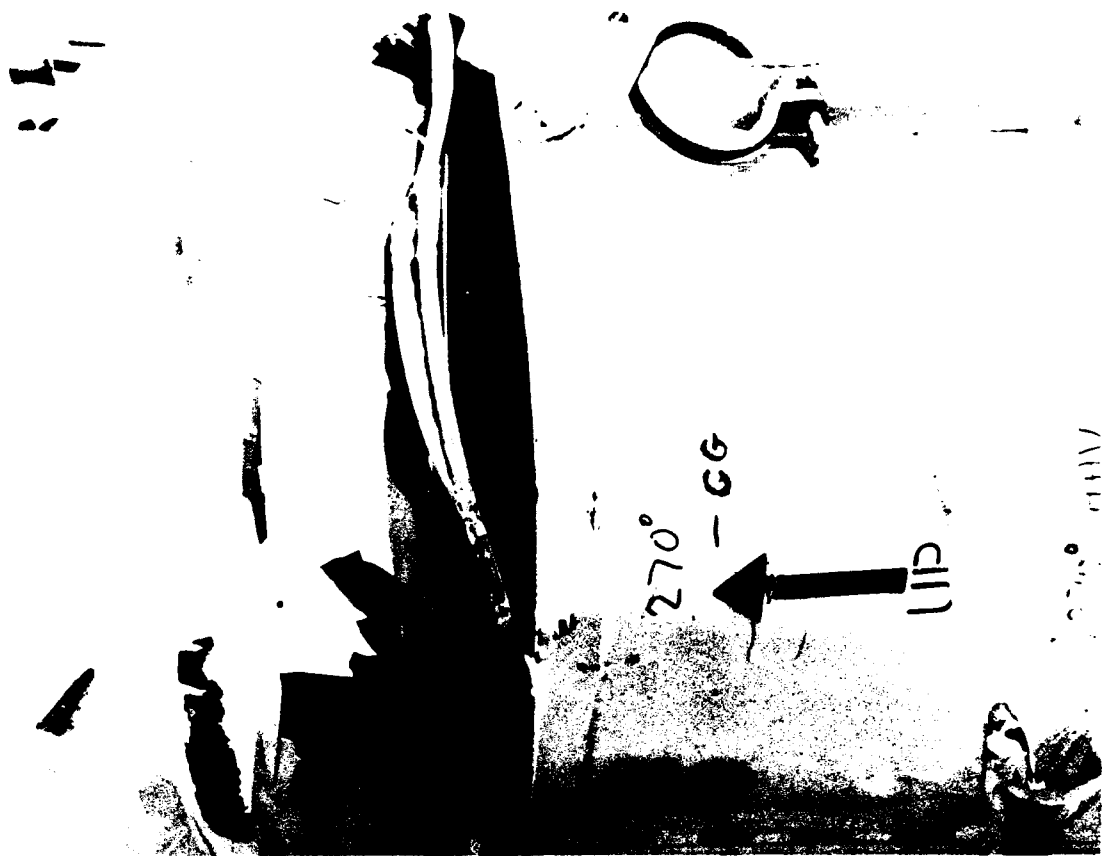
Figure 5.4.2c HHV H1224A post-test deformation

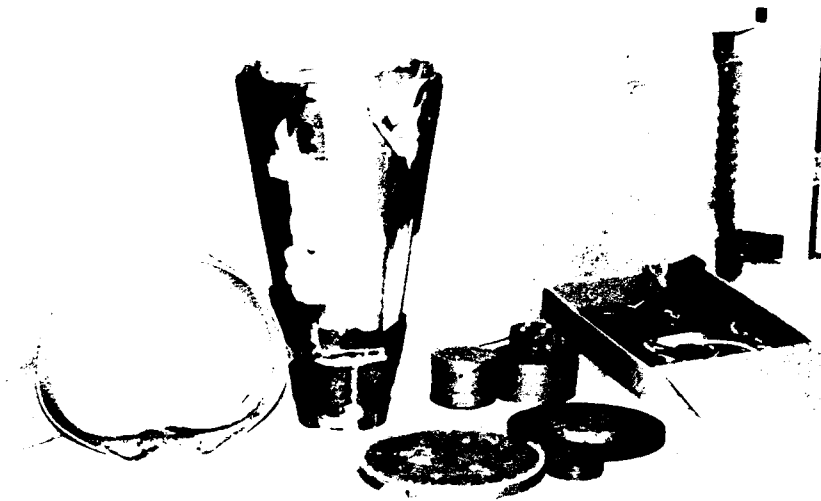
Figure 5.4.6 HHV Mk12a Mod6c aeroshell fracture and detached weight plates

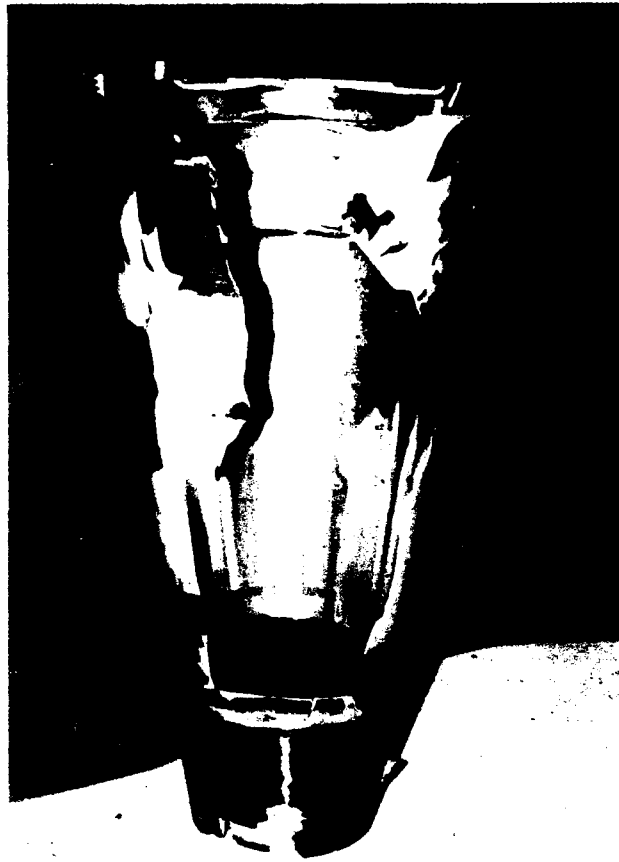
Figure 5.4.7 HHV RV carbon phenolic aeroshell fracture
