TECHNICAL REPORT ARCCB-TR-94013

QUALIFICATION OF M256 BREECBLOCK REPAIR PROCEDURE

MARCH 1994

<p>US ARMY ARMAMENT RESEARCH, DEVELOPMENT AND ENGINEERING CENTER CLOSE COMBAT ARMAMENTS CENTER BENÉT LABORATORIES WATERVLIET, N.Y. 12189-4050</p>	
--	--	--

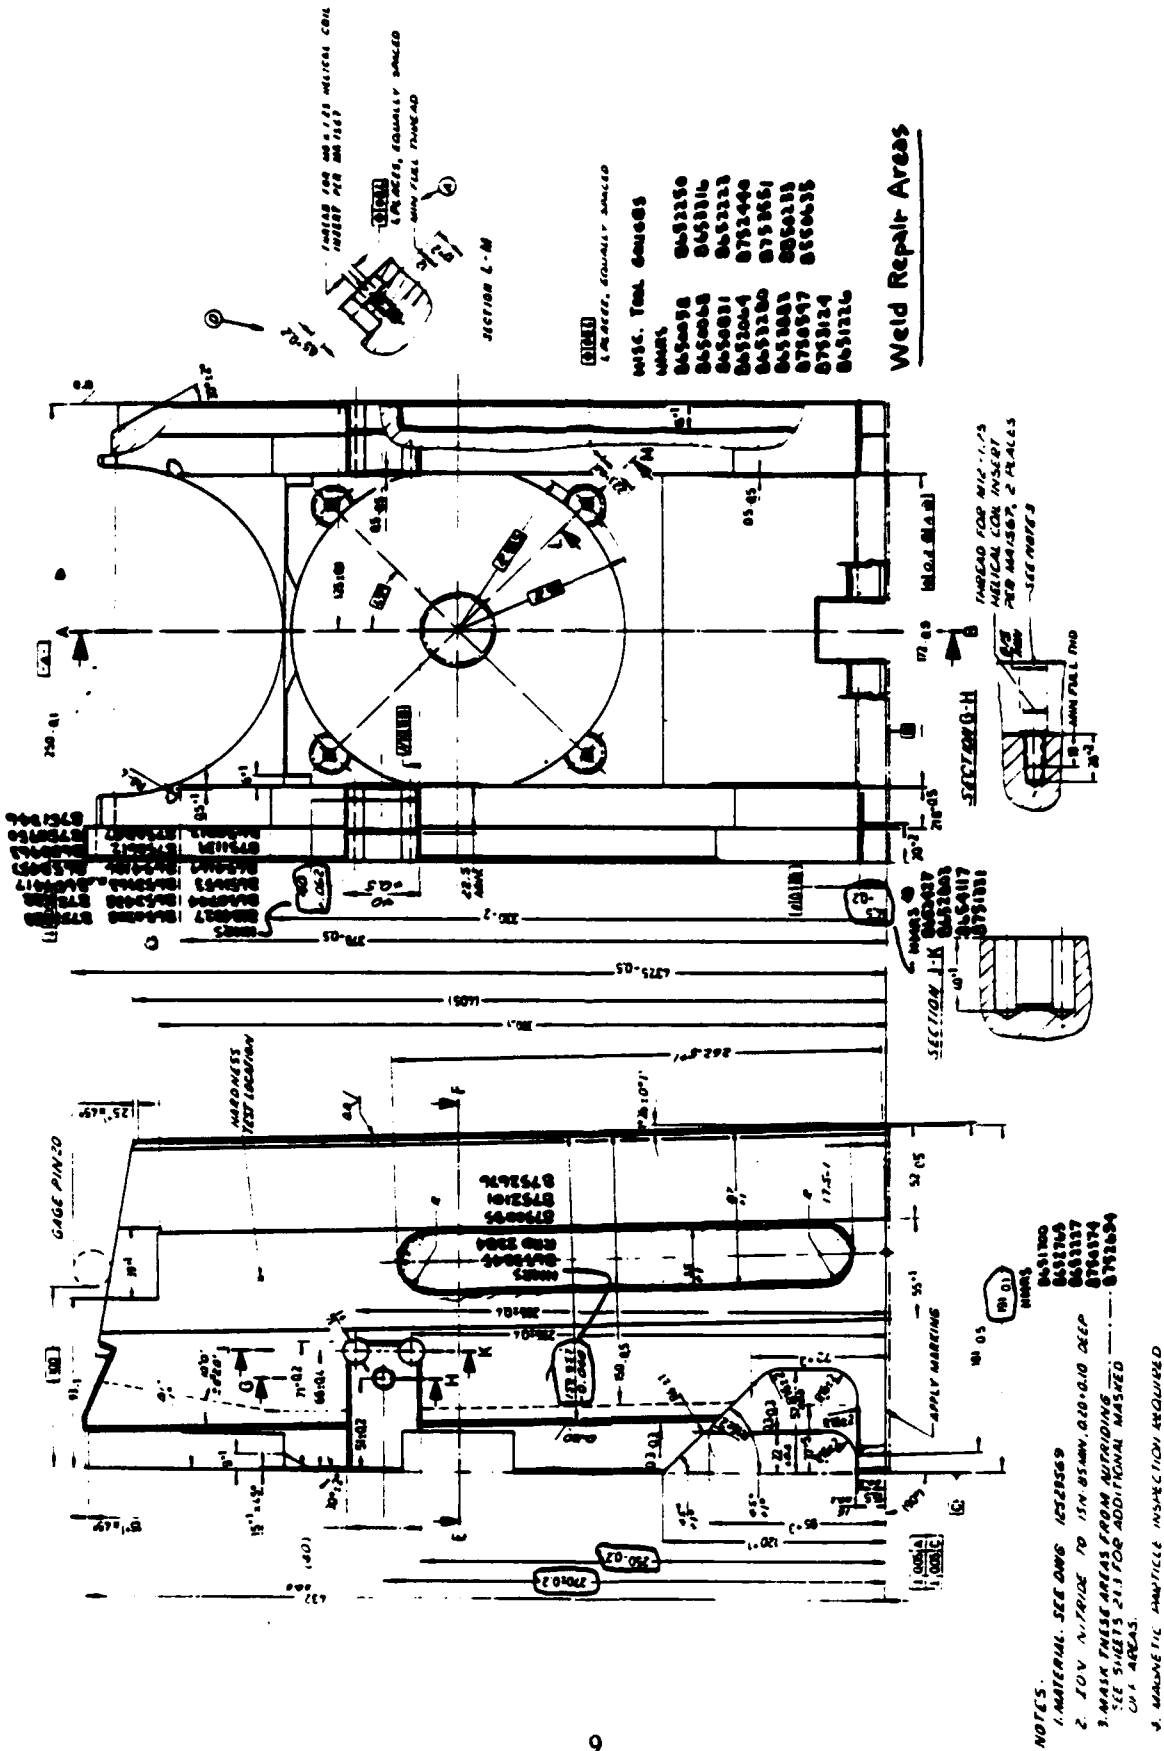
Figure 2. Location of nonconformances that resulted in weld repair development.

Regularly-occurring machining-induced defects affect both functional and nonfunctional surfaces; the features accounting for the majority of defects are highlighted in Figures 2, 3, and 4. A test specimen of M256 breechblock material was provided to the Process Engineering Branch of Benet's Engineering Support Division for application of different weld filler metals. These weld filler metals were specially selected for their ultra-high strength in the as-cast condition; their properties are described in Tables 3 through 7. The specimen was then subjected to a metallurgical analysis to identify any potential difficulties with the process and select the best

A preliminary weld repair procedure was created (SARWV Weld Repair Procedure No. 35, Appendix A), which requires weld application and remachining prior to ion nitriding. The maximum depth of weld permitted is 4.76 mm (3/16 inch). Two M256 breechblocks were selected to simulate tool gouges and other defects that represent 90 percent of the nonconforming material conditions reported. As a result, breechblock shop numbers 1419 and 2814 were machined, welded, remachined, and subsequently ion nitrided. These breechblocks were subsequently shipped to the New Mexico Institute of Mining Technology, TERA Group, Socorro, New Mexico, where they were installed in cannon assemblies and fired. Figures 5 through 8 show the appearance of breechblock shop number 1419 after weld repair and after finish machining in the areas of concern.
