Community Environmental Response
Facilitation Act (CERFA) Report

Fort Benjamin Harrison
Indiana

Final Report

**U.S. Army Environmental
Center (USAEC)
Aberdeen Proving Ground, MD**

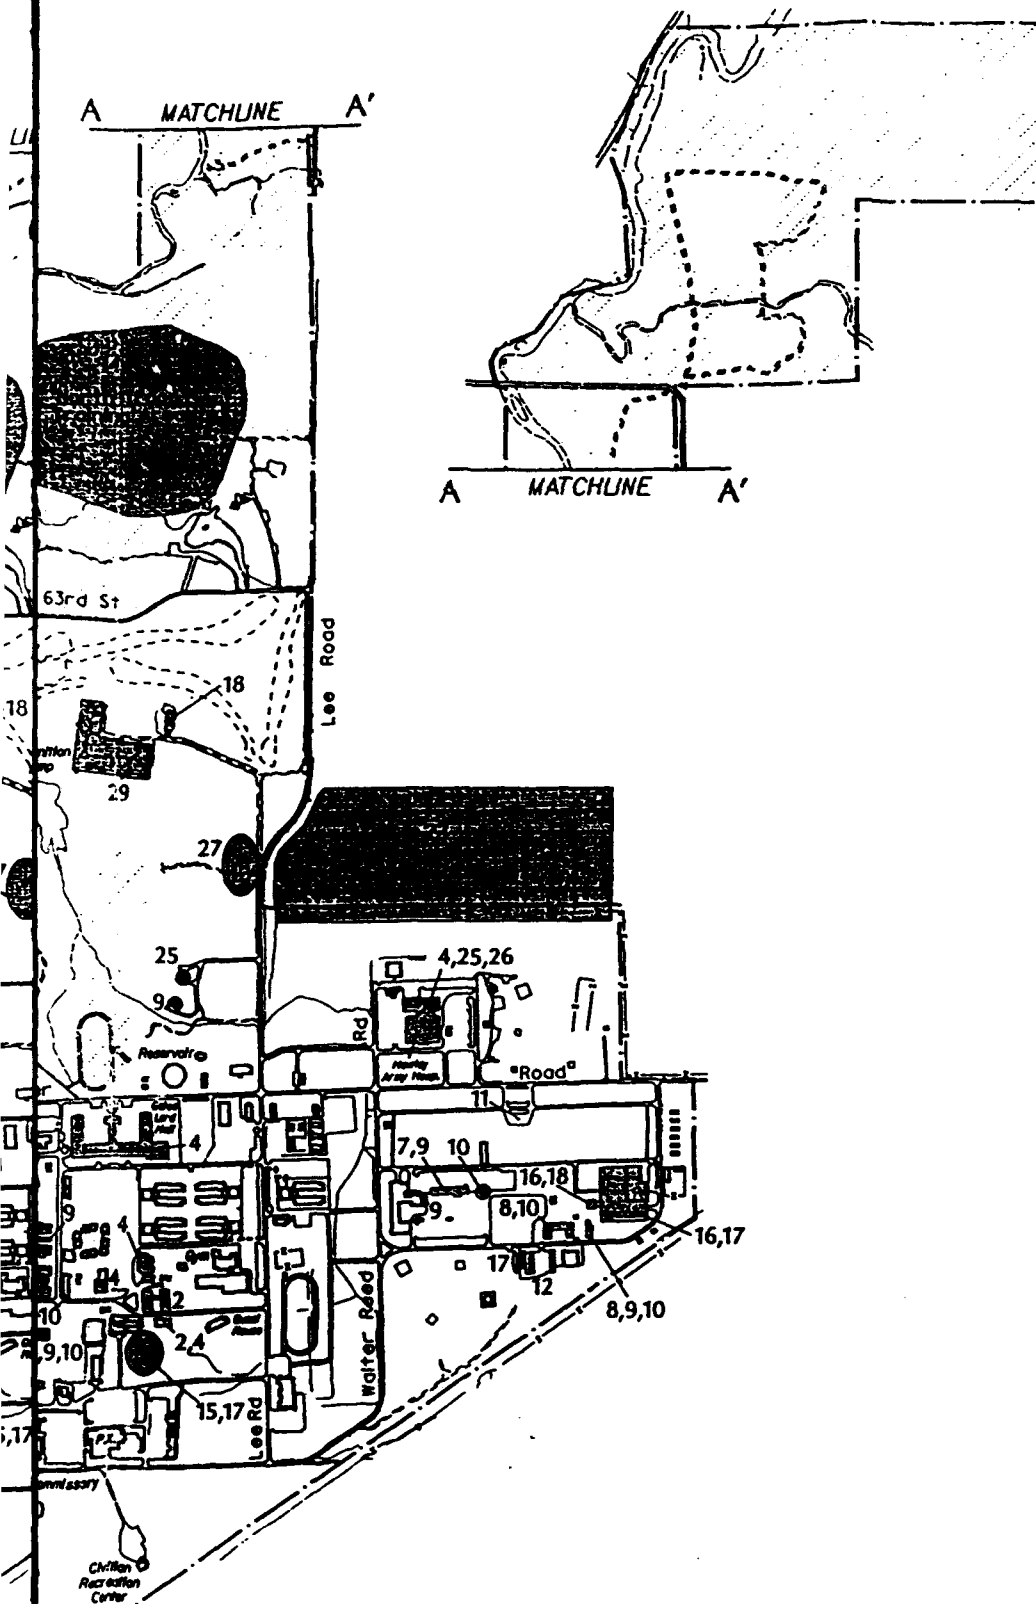
Figure 4.1
Areas Requiring
Environmental Evaluation

Areas requiring environmental evaluation (AREEs) at FBH were identified in the 1992 Enhanced PA, the 1990 USATHAMA Property Report, and the 1987 USAEHA report. Thirty-six AREEs, and their potential to contribute to contamination at FBH, were designated based upon evaluation of these and other existing documentation and on the site visit conducted during the investigation for the Enhanced PA. Past site conditions and management practices were evaluated on the basis of readily available records and the recollections of people interviewed. Possible sources of contamination were identified, and recommendations were made for a follow-up investigation. Table 4.1-1 lists all AREEs by number; the locations are shown in Figure 4-1. Facility-wide AREEs (such as asbestos and lead) are not shown due to their extensive nature.

1. DPCA Field Printing Shop
2. TASS Devices Shop
3. Graphics Shop
4. Photographic Processing Area
5. Weapons Cleaning Area
6. Carpentry Shop
7. Maintenance Shop
8. Former Maintenance Area
9. Wash Rack, Grease Rack, or Oil/Water Separator
10. Maintenance Area Drum Storage / PCL Waste Storage
11. Fueling Station
12. DIS Engineering Building
13. Water Treatment Operations
14. Firing Range/Training Area (not all shown on Flgs. 5-1, ES-1)
15. Former Drum/Waste Storage Area
16. DRMO Hazardous Waste Storage Area
17. PCB-Containing Waste Storage Area
18. Pesticide Mixing and Storage Area
19. Buried Drums (Lithium Bromide Solution)

20. Former Sewage Treatment Plant (not all shown)
21. Underground Storage Tank (not shown)
22. Aboveground Storage Tank (not shown)
23. Former Sanitary Landfill (East)
24. Former Sanitary Landfill (West)
25. Former Incinerator
26. Hospital and/or Clinic
27. Fire Training Area
28. Spill Area (not shown)
29. Ammunition Storage Area
30. Former Coal Storage Yard
31. Asbestos (not shown)
32. Pesticide Usage (not shown)
33. Former Coal Storage Area (not shown)
34. Radon (not shown)
35. Boiler Blowdown (not shown)
36. Transformer (not shown)

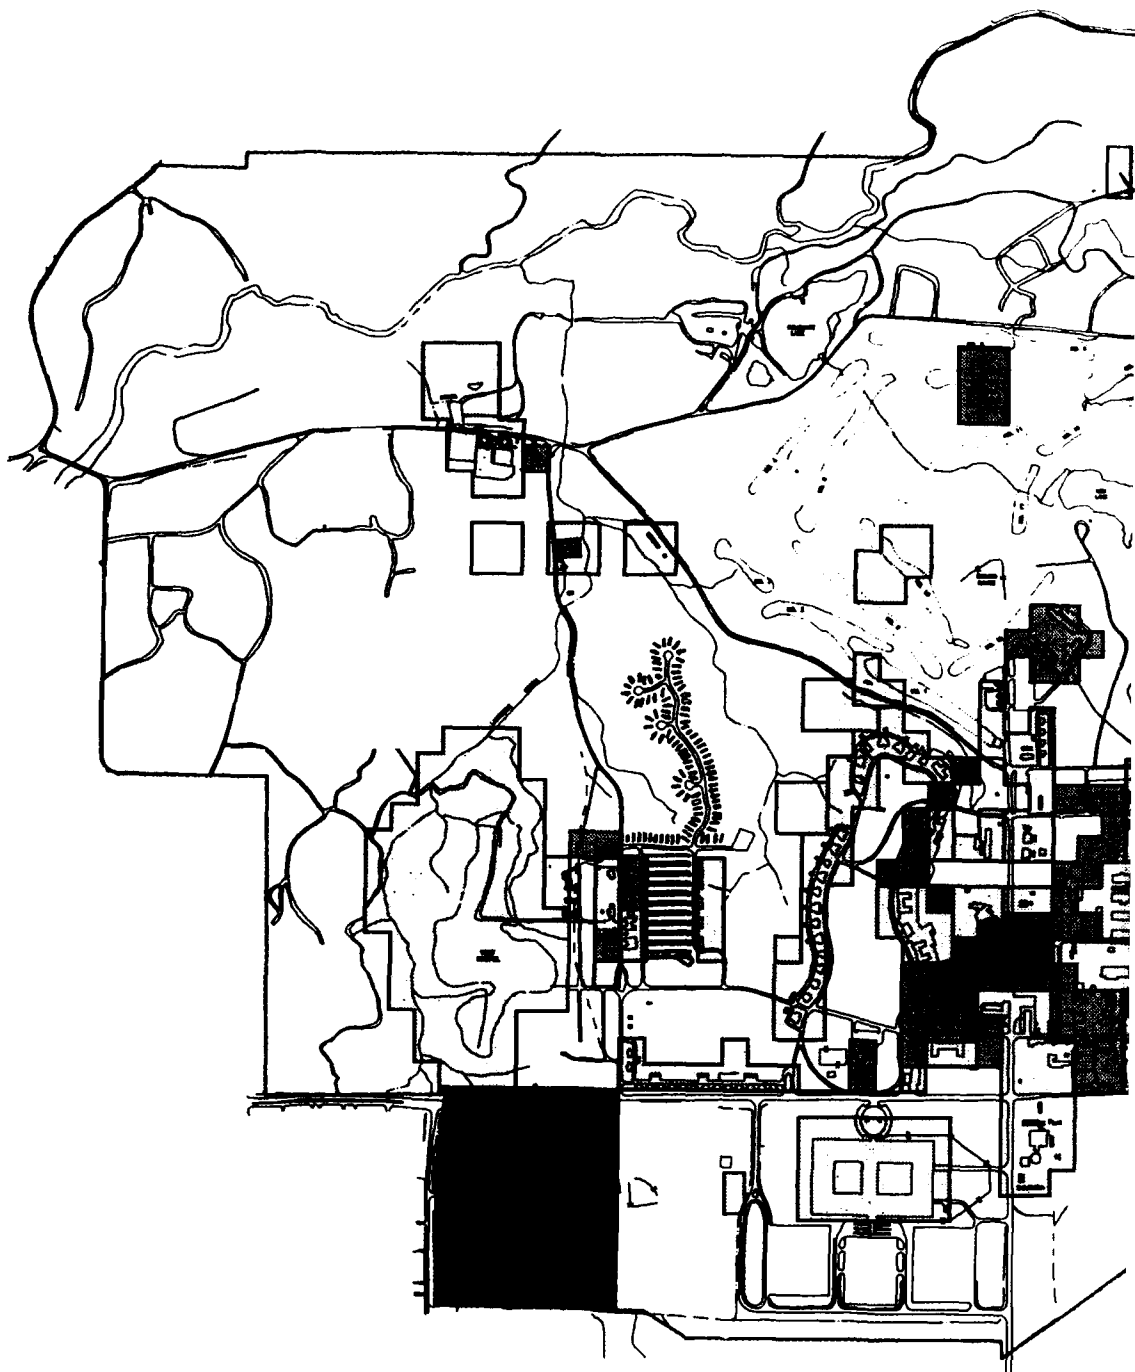
5.3 Summary CERFA Map

Figure 5-3 summarizes the breakdown of the FBH property according to the criteria for parcel identification under CERFA. This map is identical to Figure 5-1 but presents only the CERFA designations and shading for each parcel; none of the backup environmental data have been included.
