**Community Environmental Response  
Facilitation Act (CERFA) Report  
Army Materials Technology Laboratory  
Watertown, MA**

ENVIRONMENTAL RESOURCES MANAGEMENT, INC.  
855 Springdale Drive  
Exton, PA 19341

11 APRIL 1994

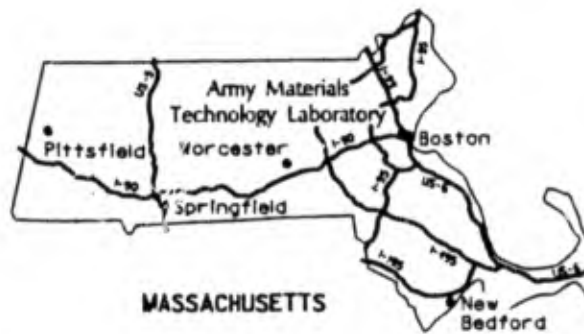
Figure 1.3-2  
 Topographic Profile  
 Army Materials Technology Laboratory  
 Watertown, Massachusetts

Overburden deposits consist of (in ascending order) basal glacial till directly overlying bedrock, silty clay with some fine sand and gravel, interlayered outwash deposits of sand and gravel with some fine materials, and finally, more recent deposits and fill near the surface.

Previous investigations indicate that regional ground water flows away from topographic high areas toward the Charles River. Generally, ground water flows south-southeast. For shallow ground water, flow velocity varies from 0.3 ft/day to 1.8 ft/day. Depth to ground water varies from five feet along the southeastern boundary to approximately 30 feet along the eastern boundary, where the ground surface reaches its maximum elevation and coarse-grained deposits allow rapid soil drainage.

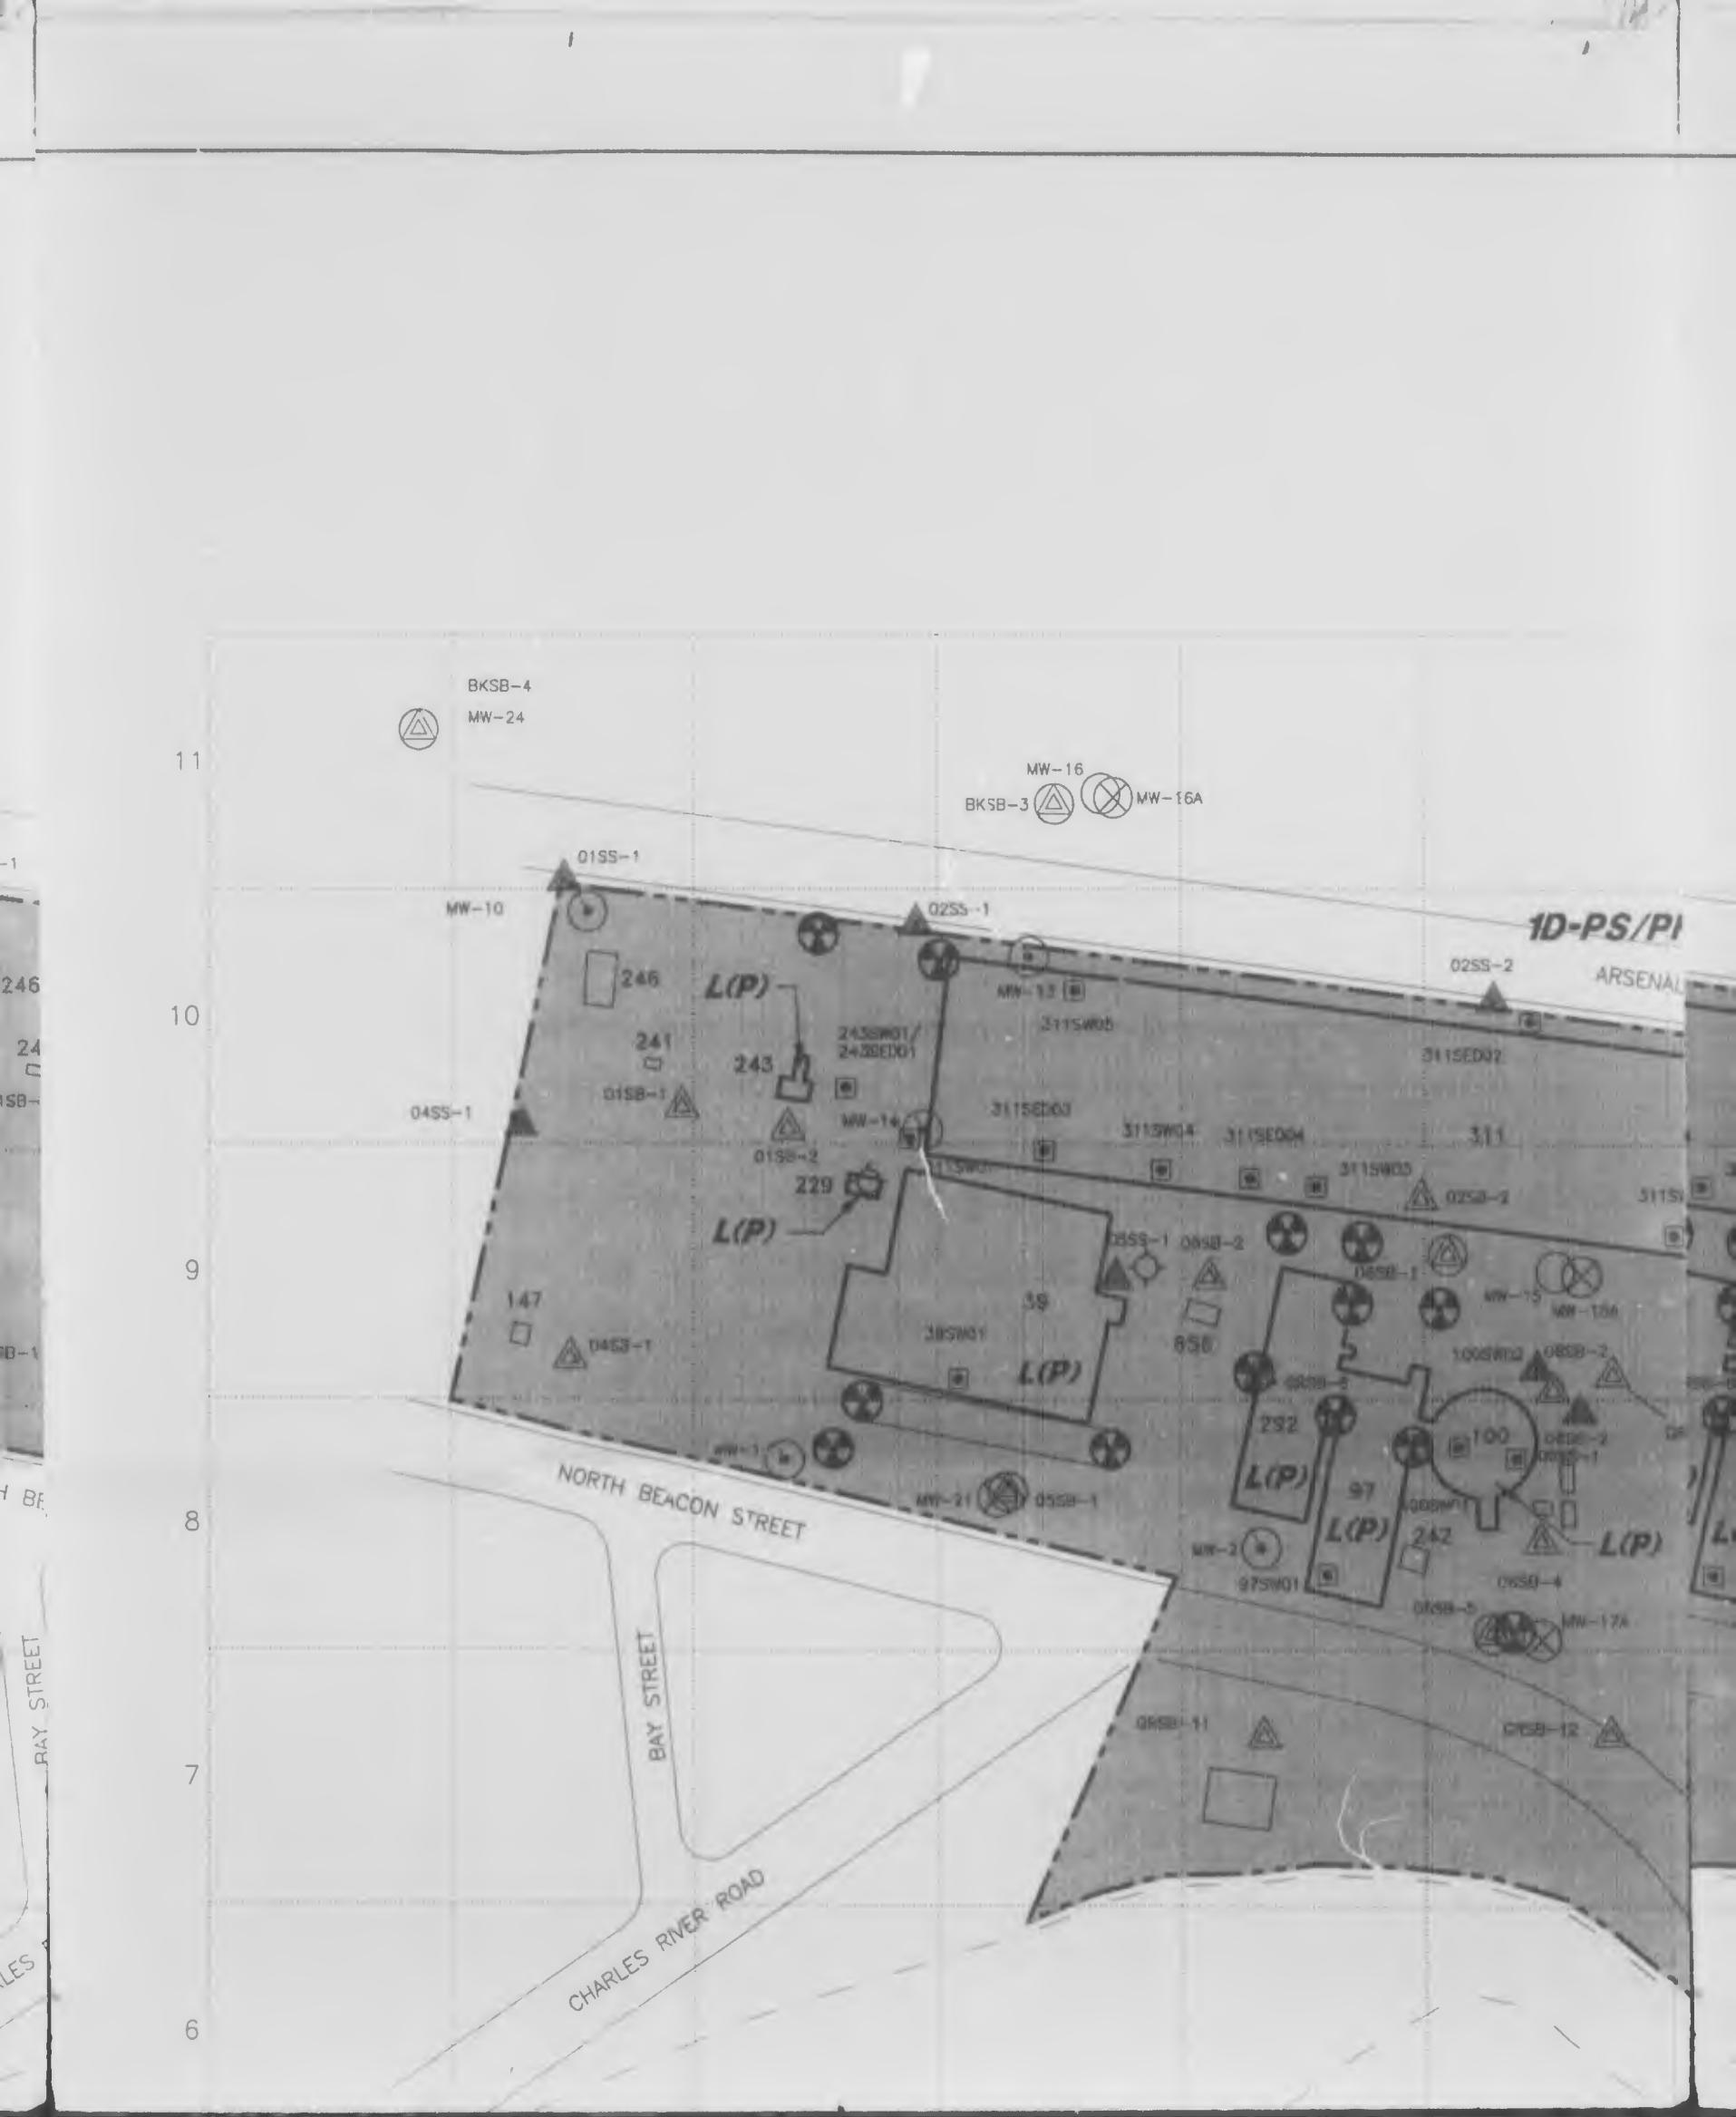
**1D-PS/PR/HS/HR/A/L/L(P)/R**

43SW03 (OIL SAMPLE FROM 2000 TON PRESS)

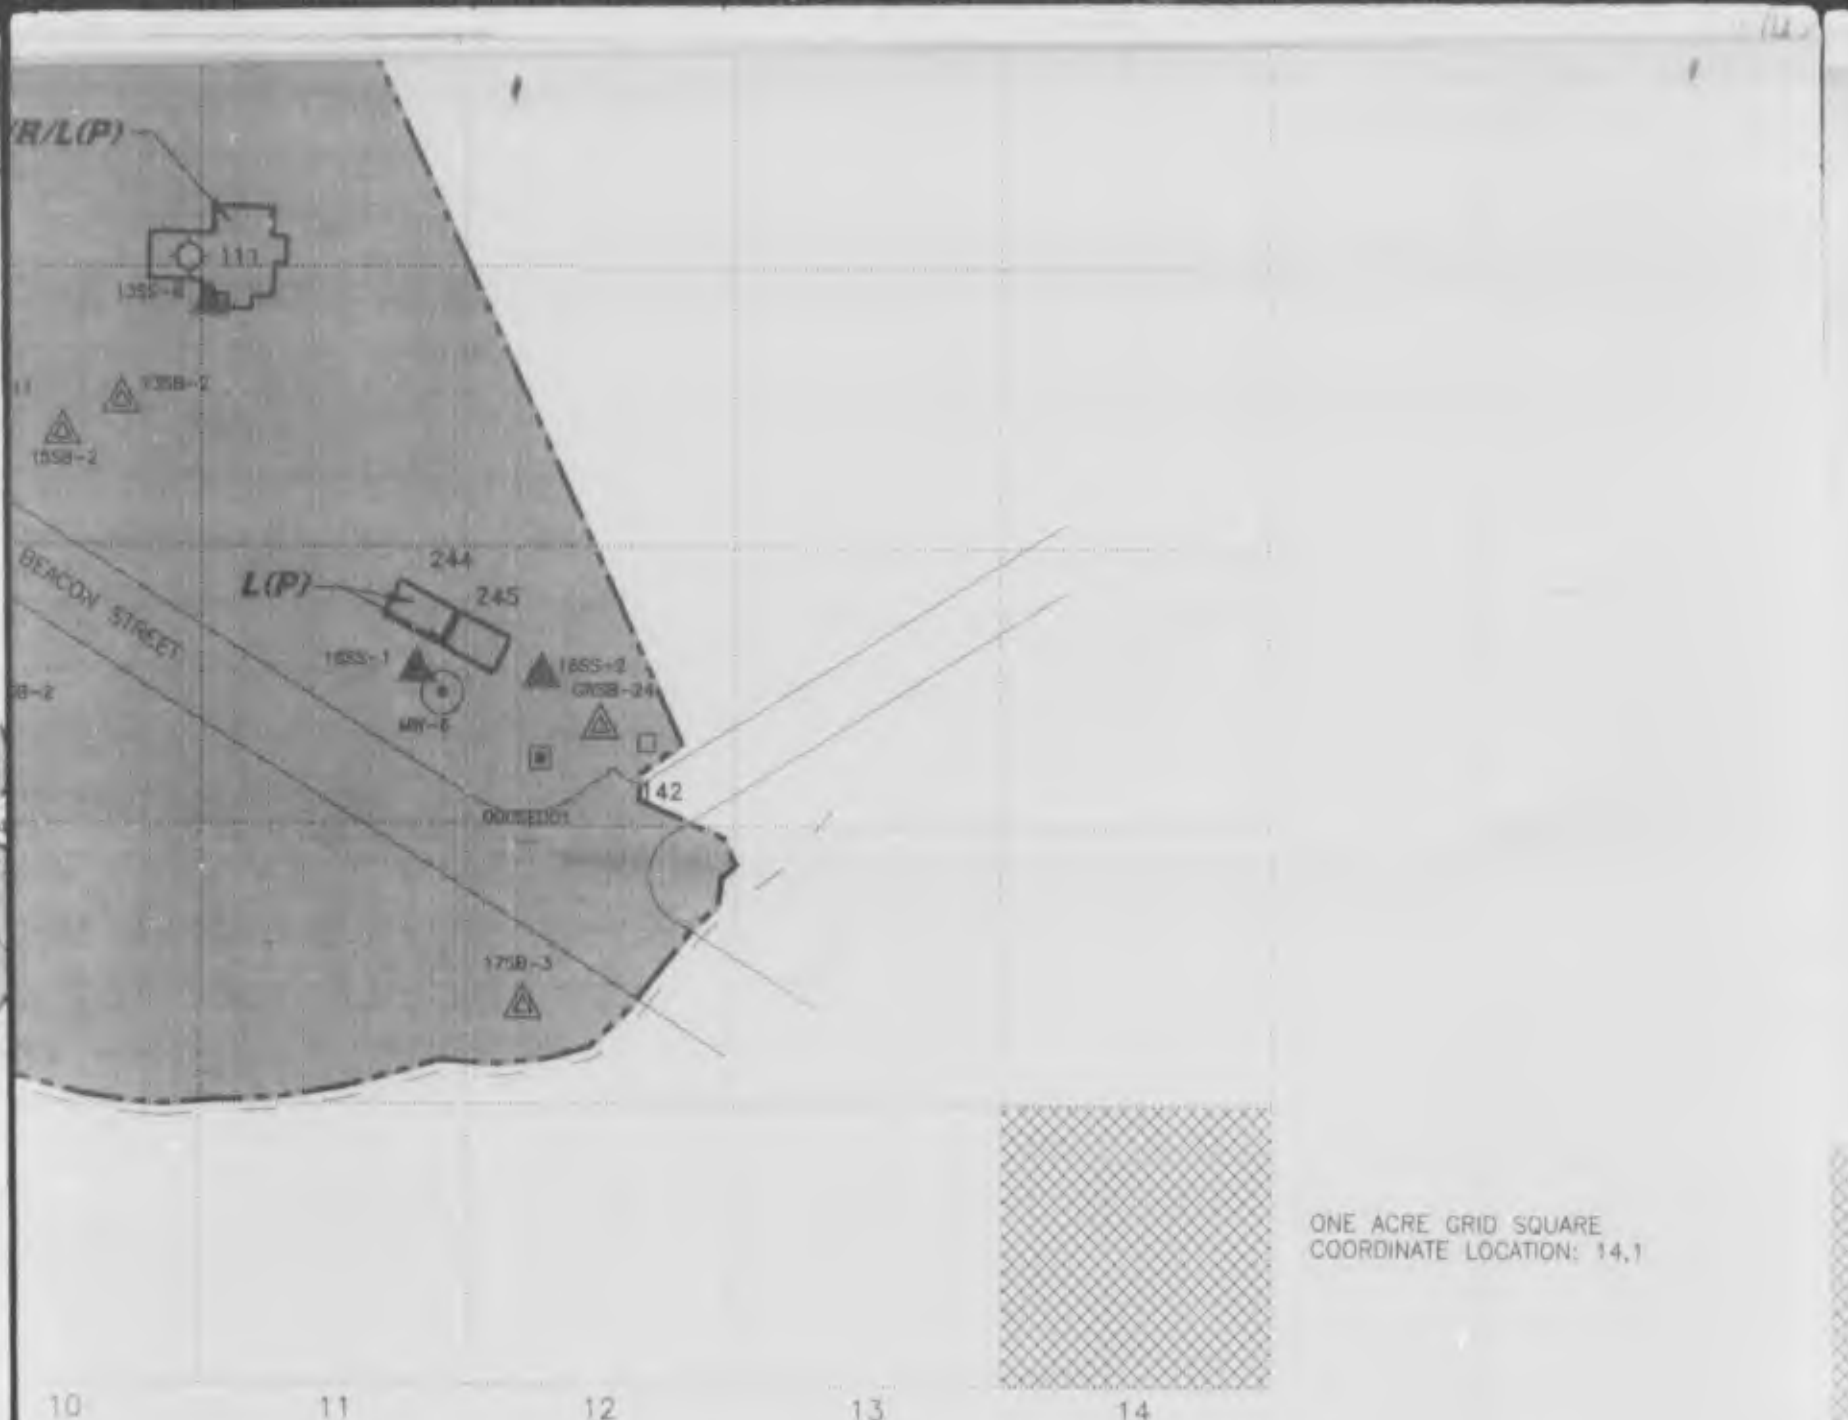
**Figure 5.3-1**  
**CERFA Parcel Designations**  
**Army Materials**  
**Technology Laboratory (AMTL)**  
**Watertown, Massachusetts**

Figure 5.3-1 summarizes the breakdown of AMTL according to the criteria for parcel identification under CERFA.
