**Community Environmental Response
Facilitation Act (CERFA) Report
Tacony Warehouse
Philadelphia, PA**

11 APRIL 1994

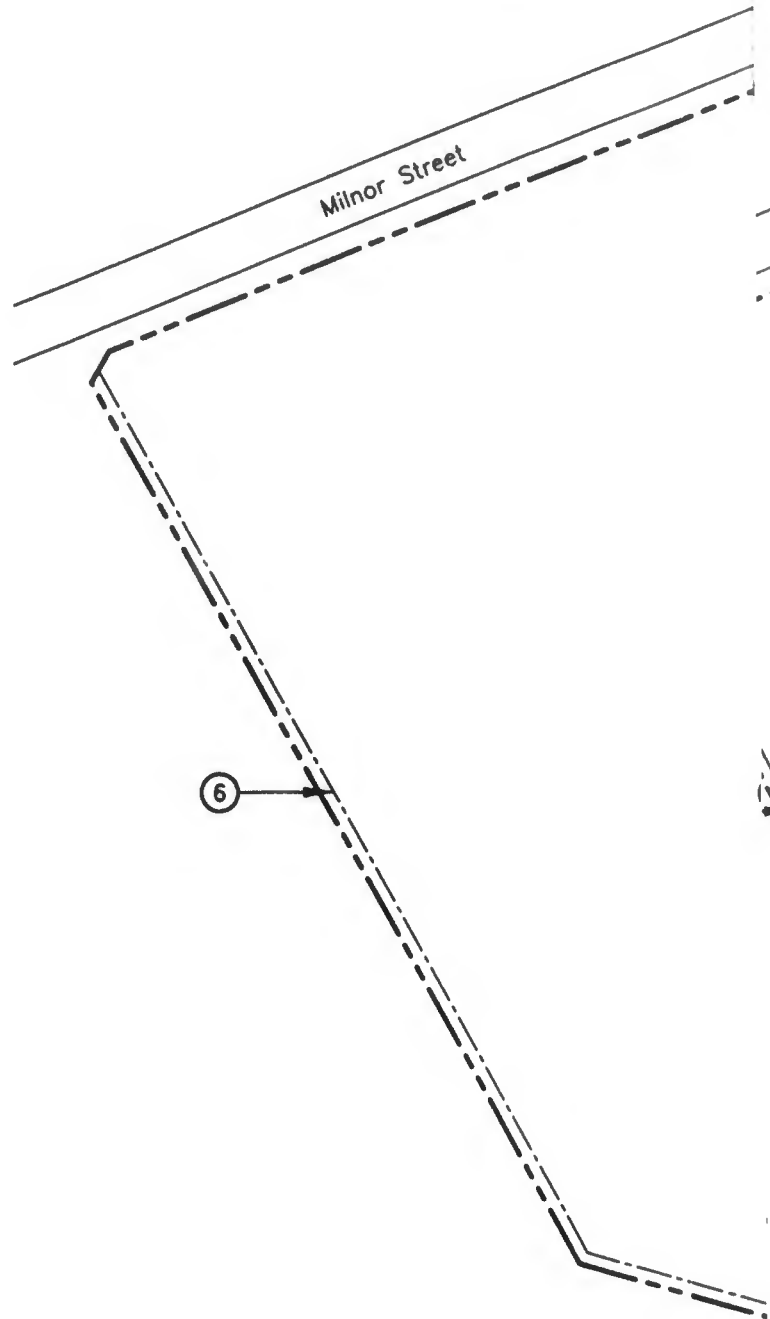
Figure 5.2-1
Tract Map
Tacony Warehouse
Philadelphia, Penns)

ERM conducted a review of tract maps and transfer documents to identify the prior property owners of the BRAC portion of Tacony Warehouse at the time of its transfer to the Army. The purpose of this review was to collect additional information concerning the property's prior use and environmental condition at the time of its transfer to the Army. Based on this review, no additional information was collected. Previous ownership and the dates of transfer to the Army are indicated on Figure 5.2-1.

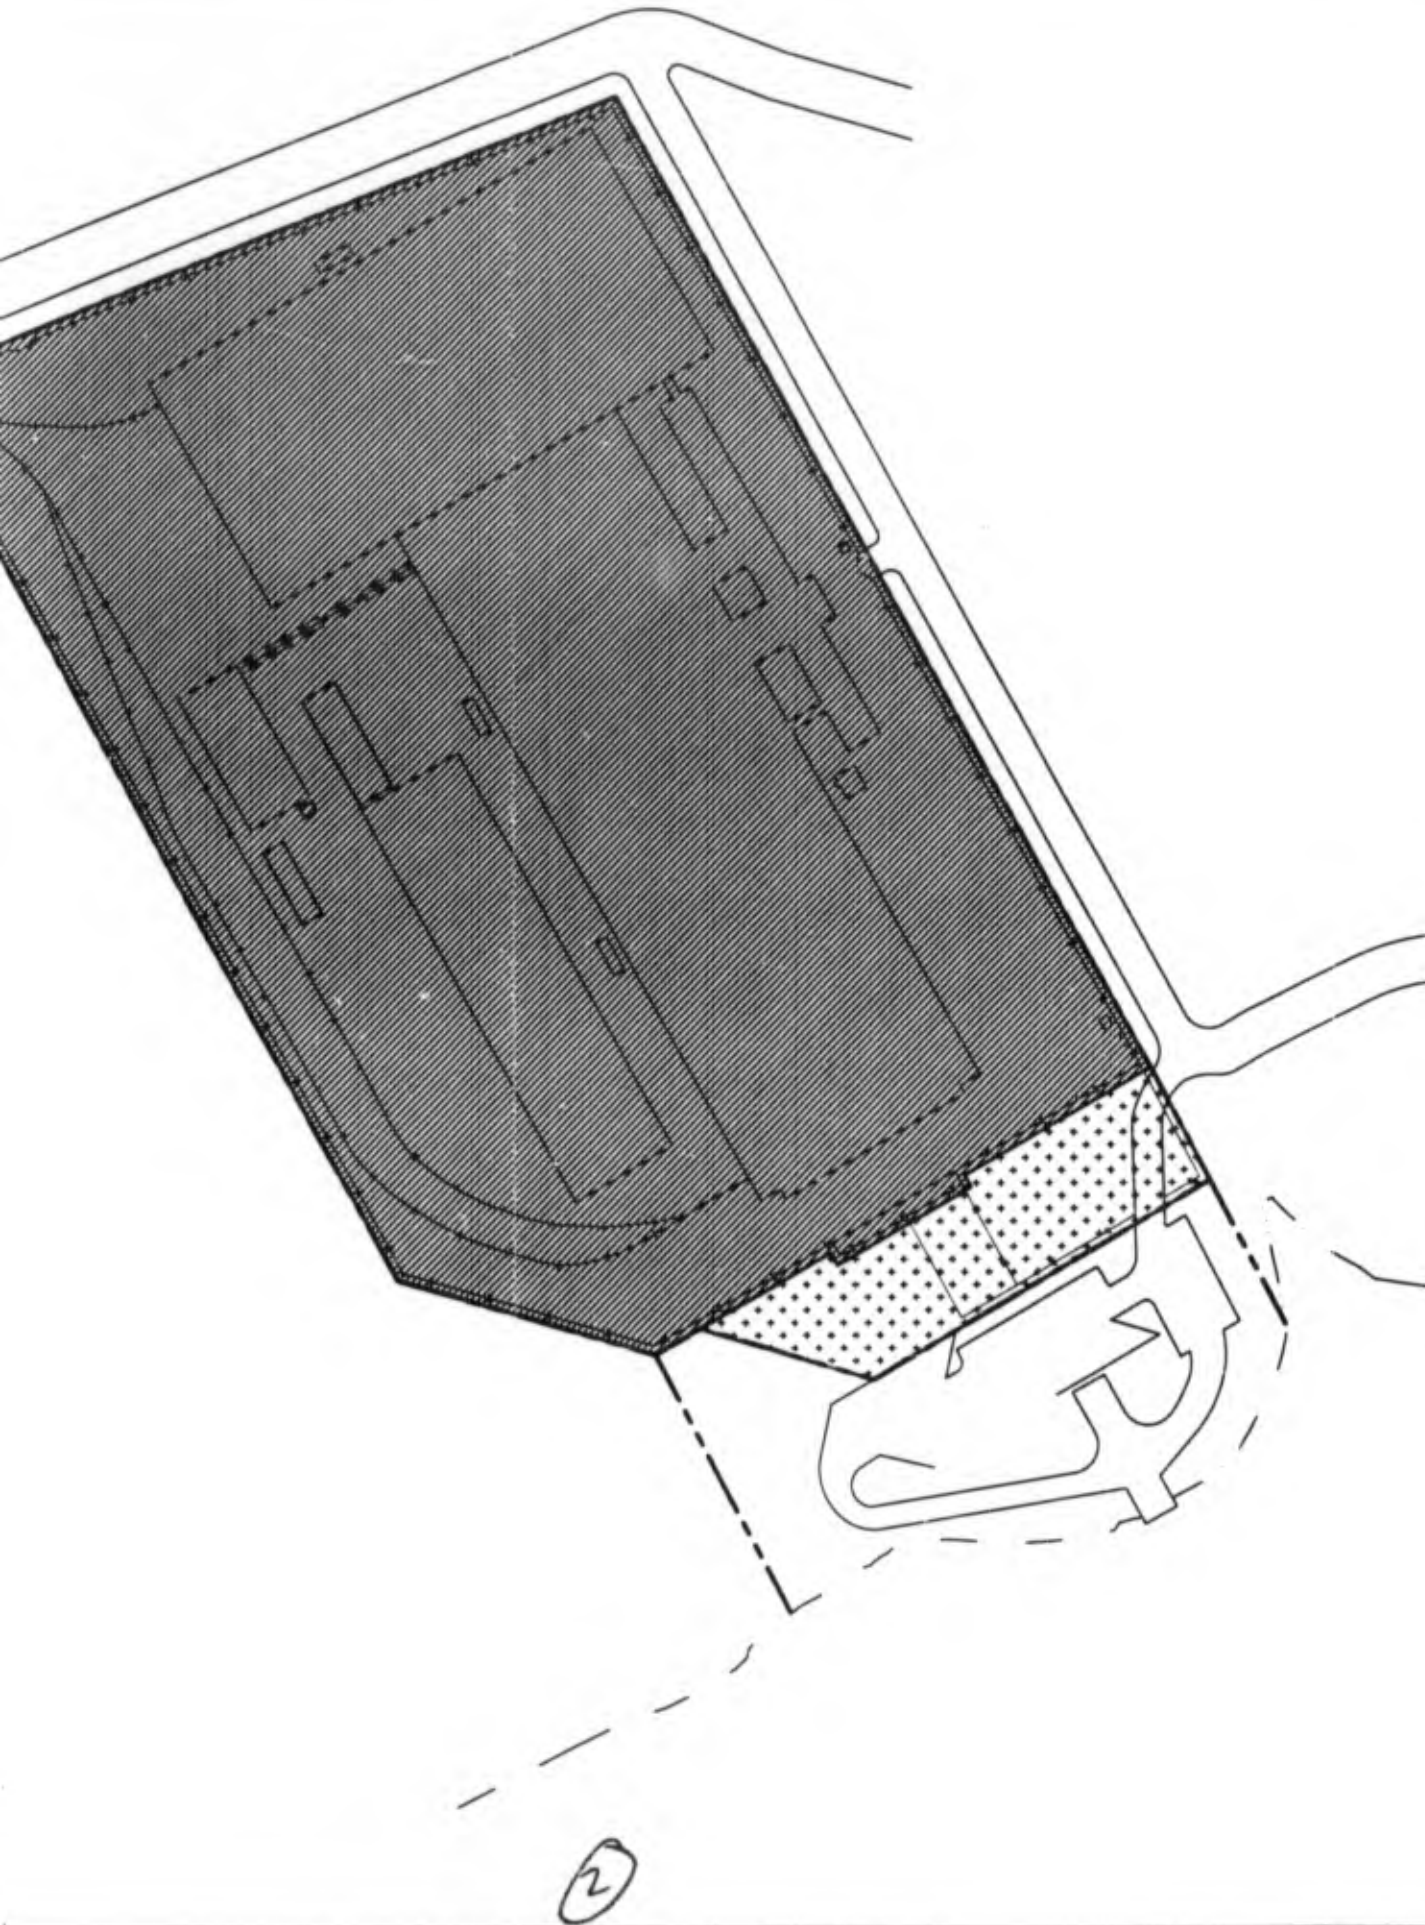
**Figure 5.3-1
CERFA Parcel Designations
Tacony Warehouse
Philadelphia, Pennsylvania**

Where CERFA Disqualified Parcels and CERFA Qualified Parcels have coincided, the overlapped area has been designated CERFA Disqualified. Labels for any such overlapped parcels also indicate the presence of the qualifying hazards. CERFA Excluded Parcels have been excluded from this investigation of contaminant locations and therefore have no overlapping CERFA Disqualified Parcels or CERFA Qualified Parcels. Structures within CERFA Disqualified Parcels that contain qualifying safety hazards are designated with the applicable qualifying label, where map scale permits this level of detail.
