APPAREL ADVANCED MANUFACTURING TECHNOLOGY  
DEMONSTRATION

ADDENDUM TO FINAL TECHNICAL REPORT  
( IMPLEMENTATION: INDUSTRIAL APPLICATION )

In-Process Quality Control in Apparel Production:  
Sewing Defects

Georgia Institute of Technology  
School of Textile & Fiber Engineering

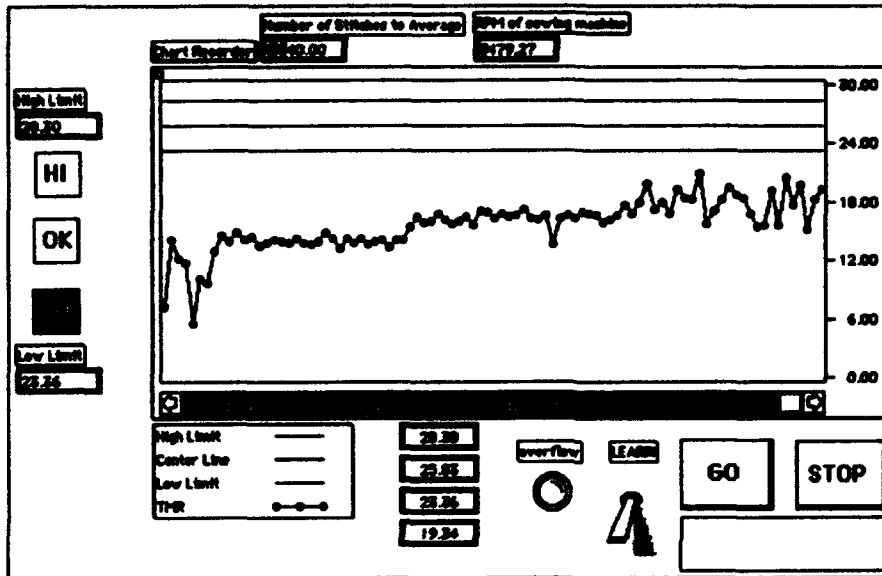
Figure 1. Coats Sewability Test Results

Figure 1. shows that the poor thread yields a highly variable thread consumption in the groups of stitches. The TMR values are variable for reasons that are not certain at this time. Speculation is that thread uniformity in mass per unit length over the short term and finish variation over the short term are probable causes. Coats is anxious to follow up with commercial versions of the defect detector when such might become available.

Results of the work with Coats American were consistent and are represented in the data of Figure 1. following on the next page.

The people at Coats American also offered their assistance with sewing thread should a particular research need arise in the Georgia Tech Apparel Lab. This device appears to be responsive to a need that has existed for a long while. A go - nogo test of sewability can be added to the other quality tests as part of normal production testing. It may help in the resolution of sources of the inconsistency as well. Three threads are shown in the figure. Two acceptable and the last unacceptable.

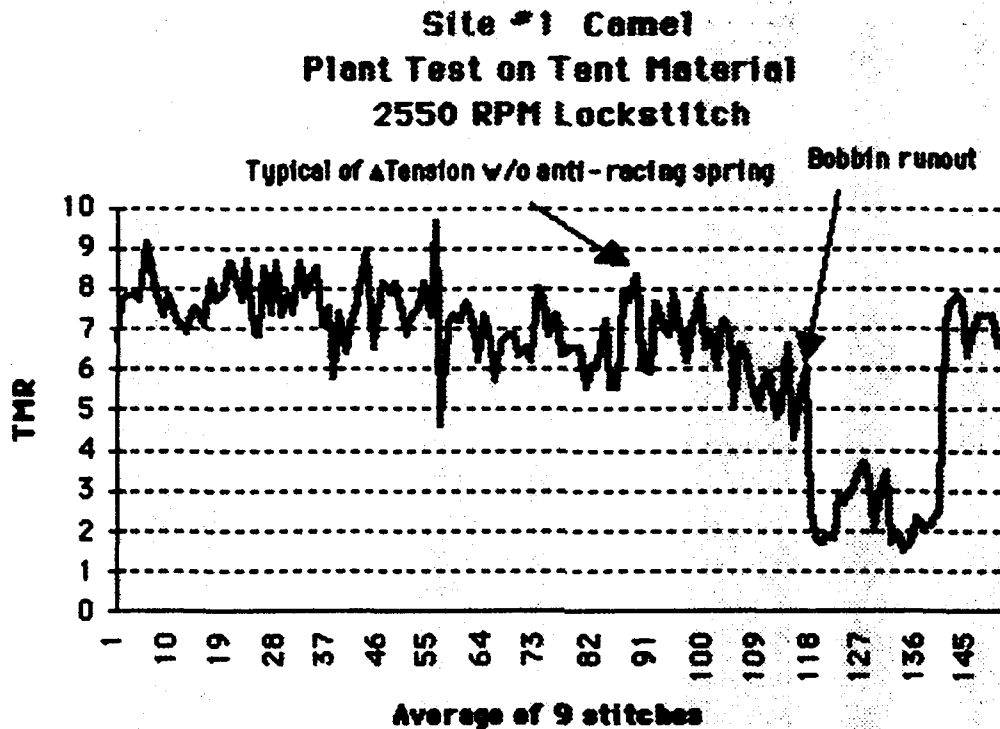
Figure 2. Camel Mfg. Bobbin Runout Data

This figure illustrates a phenomenon that has been observed in the lab as well as at the Camel site. The long lockstitch seams stress the bobbin reserves of thread. Bobbin thread runout is a common occurrence that requires operator diligence to respond with as little wasted seaming as possible. The figure shows a reduction in **TMR** prior to total loss of bobbin thread. This is assumed to be caused by low tension in the bobbin thread allowing the top thread to pull up higher in the seam. The bobbin may have already unwound at this point. Finally, the top thread finds no bobbin thread to hold it in the seam, thus eliminating the interlocking loop in the seam. The **TMR** value remaining reflects the thread usage caused by the feed dogs advancing the fabric and pulling top thread along the top of the fabric. With appropriate limits, bobbin runout could be detected. Bobbin thread runout has always been detectable with no difficulty.

Generally, there were no unusual occurrences technically during this visit. When the bobbin ran out, there was immediate reaction. When the seam failed to fold properly, there was a low limit signal due to the reduced thread consumption in the seam. This is illustrated in Figure 2. following.

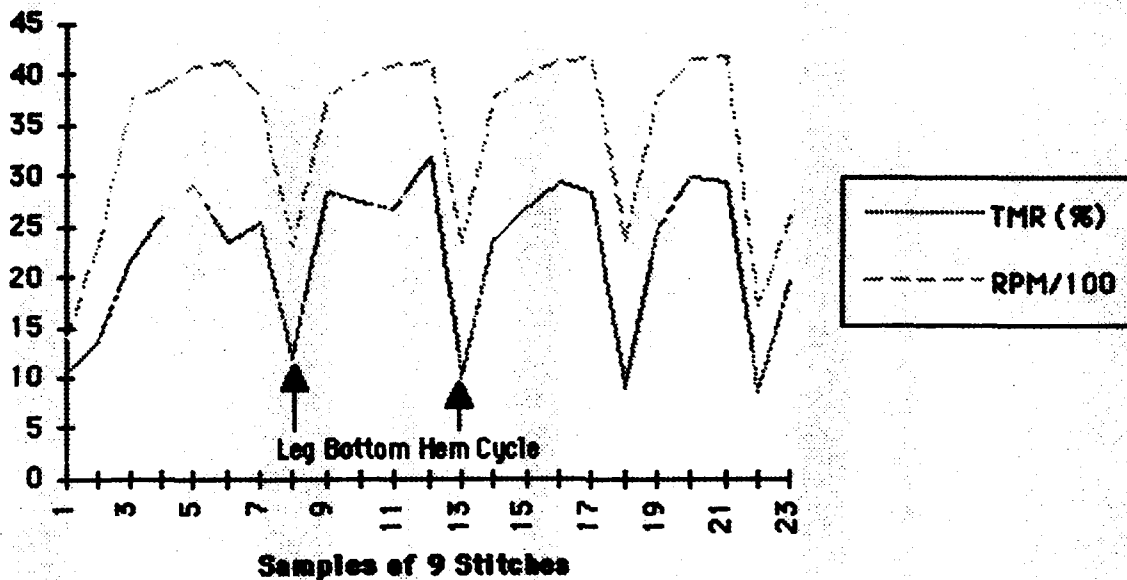
Figure 3. Data from Levi Plant Visit

This particular machine also had worn bearings and loose parts such that vibration was much higher than average. The smooth nature of the data in Fig. 3 belies the true nature of the raw data. The group averages were of 20 raw data points. The goal was to have reasonable four sigma limits (not the entire span of the graph.) Also, we noted that the value of **TMR** was higher than we had ever measured in any previous test. This observation suggests that the top thread was not following the usual path in the fabric. Mr. Milsaps agreed that this machine was an unfair test bed and a secondary choice with controllable speed was identified. The data from previous tests was presented to the Levi's group so that they could see the successes which have been seen elsewhere. By this time the shift was coming to an end as was our trip. The return to this plant at some time in the future is a strong desire of the research team.

The set-up of this demonstration took an unusually long time because of recurring irregularity in the **TMR** trace. Mechanics worked on the machine and replaced a broken part. Nevertheless, the inconsistencies continued. Now it appears that we were working with worn feed dogs that allowed fabric slip (affecting net **TMR**) and stitch to stitch variation. There may have been thread problems compounding the issue. Data was collected with a group size of twenty. This reduced the variance such that a partially effective demonstration could be made. This consumed some five hours of plant time.

Figure 3. following comes from the Levi's site visit.

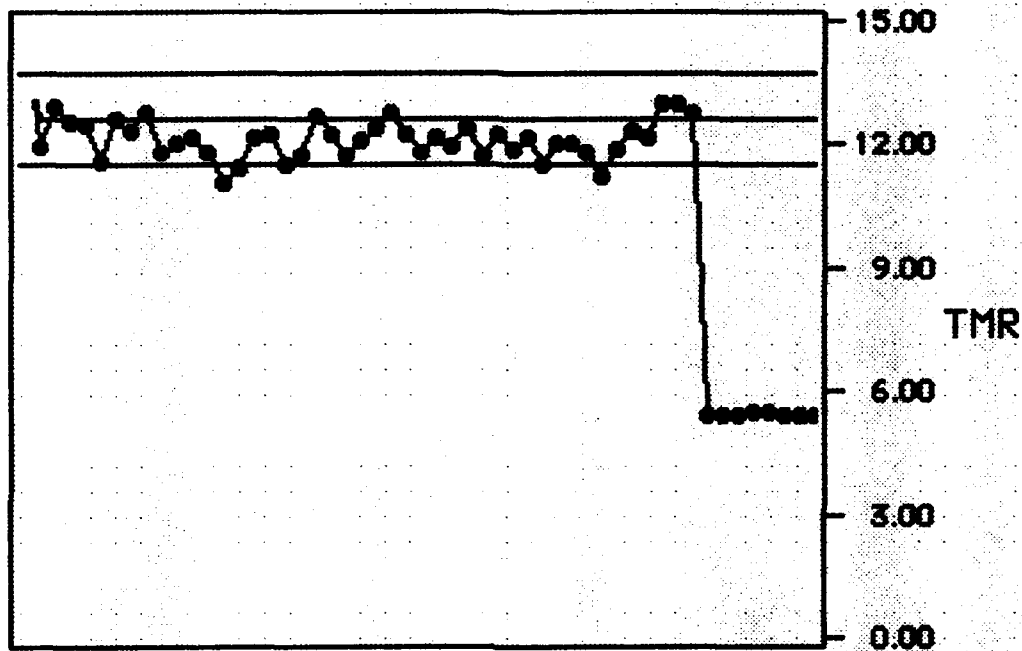
Figure 4. Typical Appearance of Wrap-up Condition

Every simulated wrap-up was detected. This clearly would be useful on an automated sewing line. While the interest was there to proceed immediately, the question was asked if the detector could be expanded to sample both the top thread and the bottom thread at the same time. The response to that question is that the current microprocessor is at its limit on accomplishing the tasks of its program in the time available. To sample more threads would require greater speed. The Russell staff was interested in this line of attack being followed by the Georgia Tech group.

After setting up the demonstration gear, the test was conducted by passing the bottom thread through a hand held guide and walking away from the machine while it was sewing. This simulated continuous withdrawal of bottom thread during the sewing process as happens when wrap-up occurs. The result was a clearly detectable loss of TMR caused by the fact that no pulse from the Eltex unit occurred during the machine cycle. Therefore, TMR dropped to zero. This is a very easily detectible condition and was spotted every time that it occurred.

Data from this part of the Russell visit is typified by the "borrowed" data which is given in Figure 4.

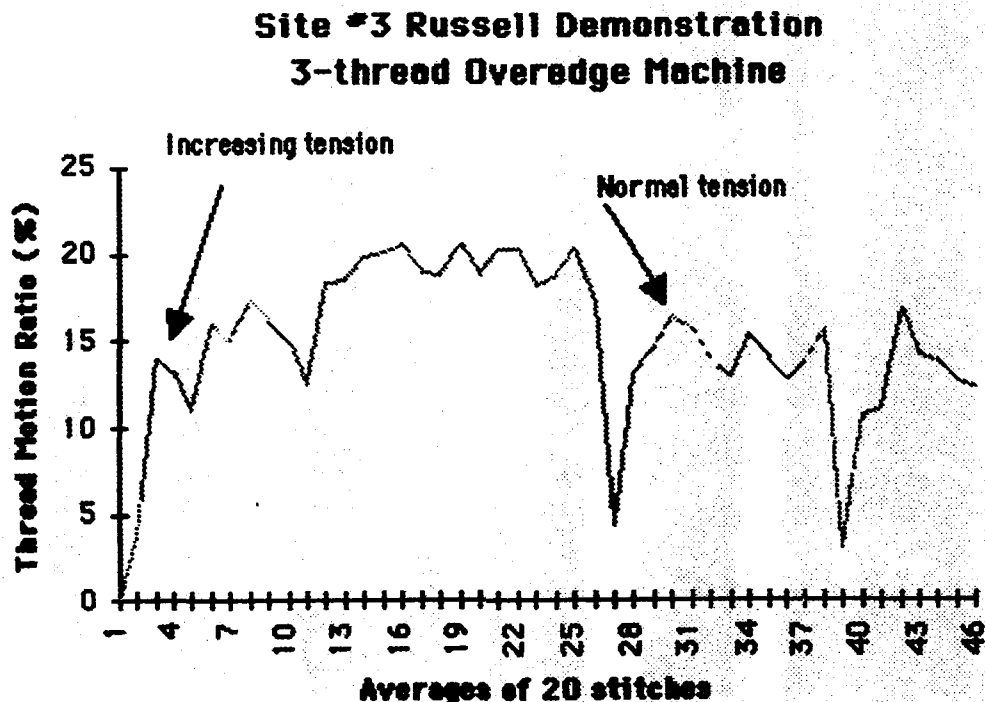
Figure 5. Overedge Tension Variations

Tension changes were clearly observable as changes in TMR. Some tests were made to see if changes in tension

The overedger is a three thread sewing machine. It passes two threads over the edge of the garment and uses one additional thread to complete the so called "delta", whose balance is quite important to first quality seams. The tests included determining what could be found about loss of thread and thread tension imbalance which might lead to imbalance of the "delta". Figure 5. illustrates the overedge data.

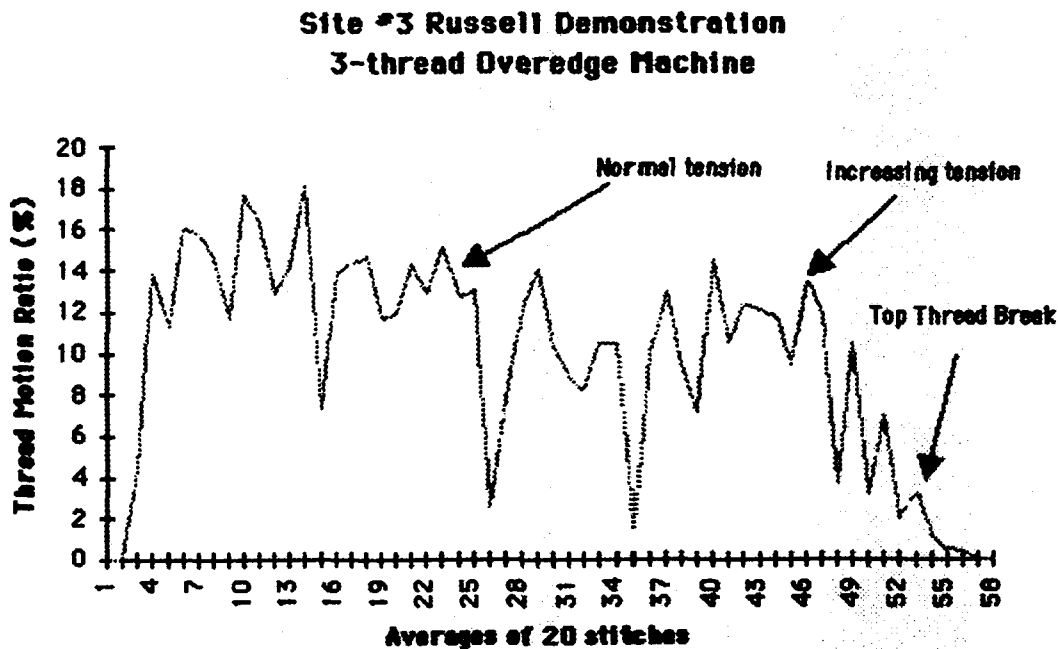
Figure 6. Top Thread Break

The need for multiple thread monitoring is especially apparent in automated processes where a break in one of the three threads should result in a clear change. The tests showed that thread breaks probably would be detected, but individual monitoring would bring this probability up to a certainty.

on a second or third of the threads could be seen in the thread being sampled. While small variations followed changes in any thread (probably due to the balance of the "delta" being off set), there was a clear need to monitor each thread to be certain that the machine was running properly. Figure 6. gives additional information on the tests, namely a thread break.

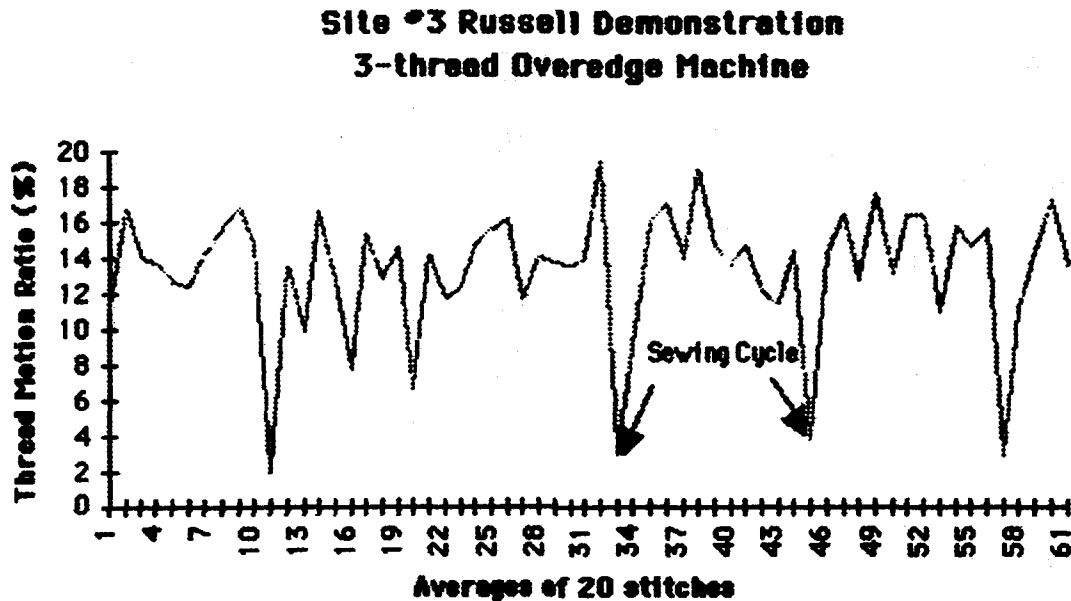
Figure 7. Normal Stitches with Needle Thread

Machine stops and length of cycle are additional measurable quantities. On all three threads of the overedge stitch sewing head, there was clear indication of a thread break when it occurred. Thread tension change when significant enough to change the balance of the "delta", also produced an out of limit condition on the detector.

reasonably. Figure 7. shows 20 stitch groupings as part of an effort to smooth the data.
