INVESTIGATION OF TENSION-COMPRESSION
FATIGUE BEHAVIOR OF A UNIDIRECTIONAL
METAL MATRIX COMPOSITE AT ELEVATED
TEMPERATURE

THESIS

Darren L. Kraabel, 2nd Lieutenant, USAF

AFIT/GAE/ENY/94D-6

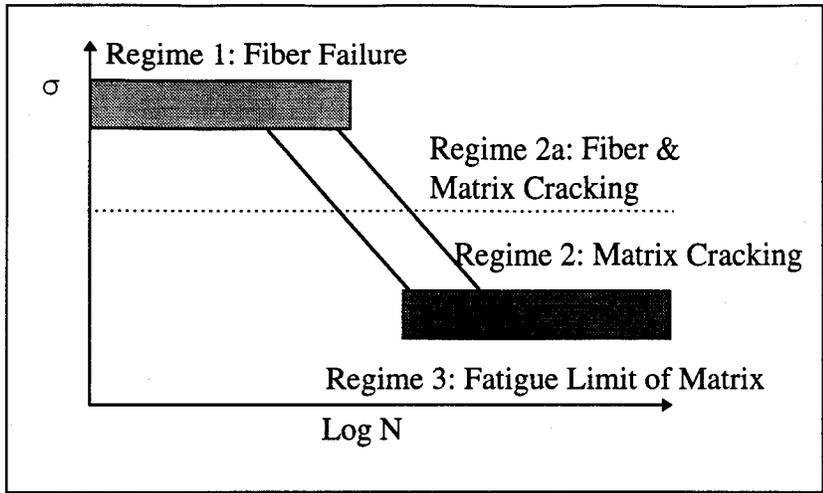
Figure 3. Boyum's Model for Regimes of Cross-Ply Laminate S-N Curve

For composite materials, fatigue life diagrams are often broken into regimes consisting of varying failure mechanisms. Following Taljera's approach (38), many researchers have broken the fatigue life of a MMC into three distinct regimes: Regime 1, 2 and 3. Specifically, Majumdar and Lerch have separated the S-N curve for the unidirectional SCS-6/Ti-15-3 laminate, tested in tension-tension at an R-ratio of 0.1, into Regime 1, which is dominated by fiber failure, Regime 2, which is dominated by matrix failure, and Regime 3, which consists of specimens that did not fail and fall below the fatigue limit of the material (21). Between these regimes, the authors found the failure modes to be complex, consisting of combinations of failure modes. Boyum, who tested a cross-ply laminate under tension-compression conditions, elaborated upon Taljera's approach by breaking Regime 2 into two separate qualitative regimes, Regime 2a and Regime 2 (4). In Regime 2a, the higher range of applied stress, failure was caused by a combination of fiber and matrix cracking while Regime 2 consisted solely of matrix cracking. Boyum's regimes are shown in Figure 3.

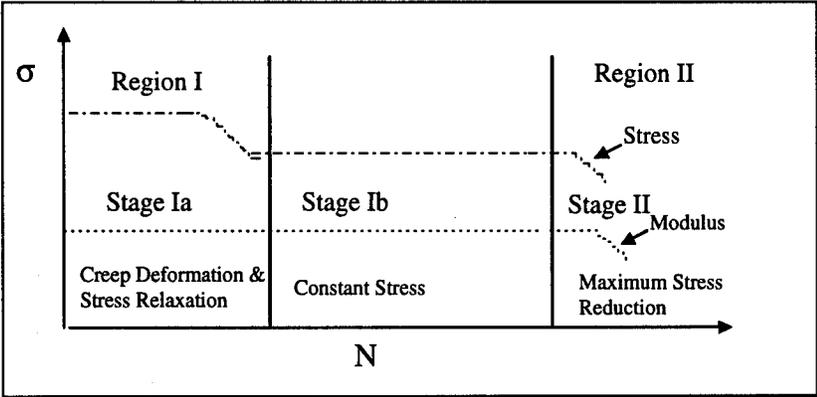
Figure 4. Sanders' Model for Regimes of [0]₈ Laminate

The macroscopic response of a composite can also be separated into regions defining various behavior. Sanders analyzed fatigue life data for strain-controlled fatigue by breaking the σ - ϵ response over time into two stages (32). Stage I is dominated by matrix creep and can be broken into two sub-stages, Ia and Ib. Stage Ia consists of creep deformation of the matrix resulting in a relaxation of the lamina stress. Stage Ib represents the region where the maximum applied stress remains constant. Stage II is defined by a reduction in the maximum stress. These stages are schematically shown in Figure 4.

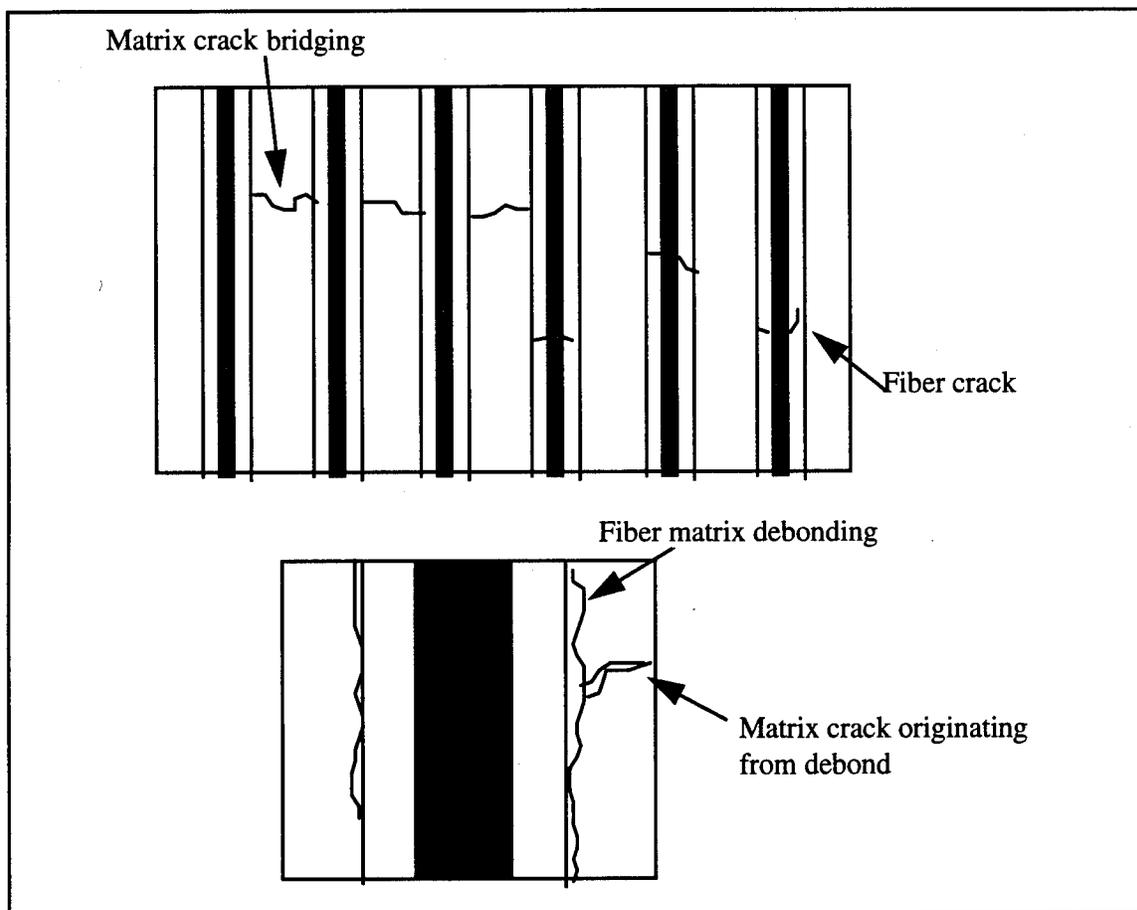
Figure 5. Damage Mechanisms

Micro-mechanical analysis in the current study is broken into two separate groups, damage and plasticity. Damage mechanisms include matrix cracks, fiber breaks, and fiber-matrix debonding. Plasticity includes slip band formation, crack nucleation and fatigue striations, which are similar to slip bands. The type of damage in each specimen is dependent upon the applied stress level. Figure 5 illustrates the damage mechanisms as they pertain to a unidirectional laminate.

Damage is defined by the creation of new free surfaces from fiber and matrix crack growth. Cracks may originate within the fiber and matrix itself or they may originate from fiber-matrix interfaces. Fiber cracks may cause debonding between the fiber and matrix. This debonding prevents the fibers from transferring any load to the

matrix. Debonding may also occur from low interface strength caused by poor material processing. Debonding of this nature provides numerous crack initiation sites within the matrix. The two types of debonding are important in determining what causes failure. Extreme necking around fibers shows a great deal of debonding which is caused by fiber overload, i.e. fiber cracks. Debonding that shows less necking indicates destruction of the fiber-matrix interface due to low interface strength. Matrix cracks are likely to originate from this region whereas fiber cracks may be nonexistent.

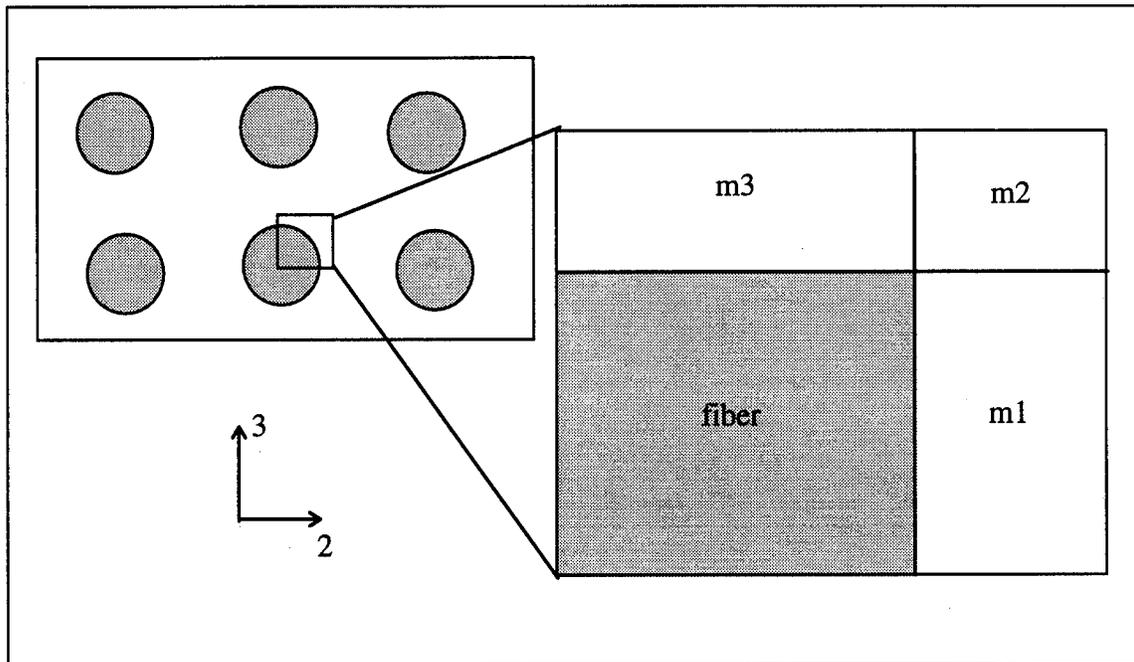
Figure 6. Representative Unit Cell

tenet that classical laminated plate (CLP) theory assumptions on the strain variation apply to the non-linear laminate formulation. It also incorporates a unified viscoplastic theory for the inelastic matrix behavior. This theory is based on combining plastic and viscoplastic strain into a single term. The advantages of this model over others is that it more closely models laminates containing off-axis plies. All calculations are made using the unit cell as illustrated in Figure 6. This cell models one quarter of the fiber and surrounding matrix, employing symmetry and equivalent boundary conditions.

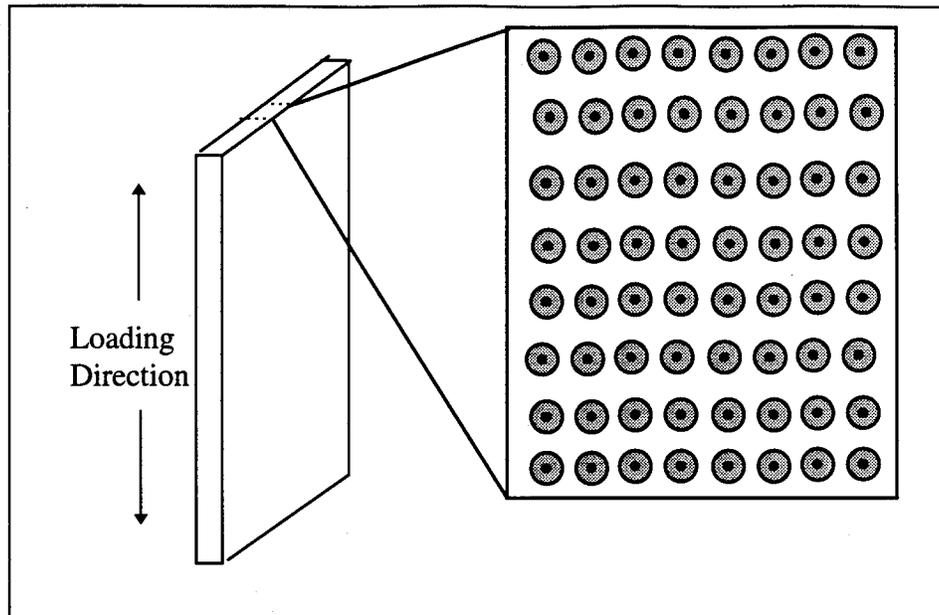
Figure 7. Unidirectional Metal Matrix Composite [0]₈

Fiber	Matrix
E (GPa)	400	82
α (10^{-6} mm/mm/C)	4.9	10
ν	0.25	0.36
σ_{ult} (MPa)	3550	865
σ_{ys} (MPa)	-	865

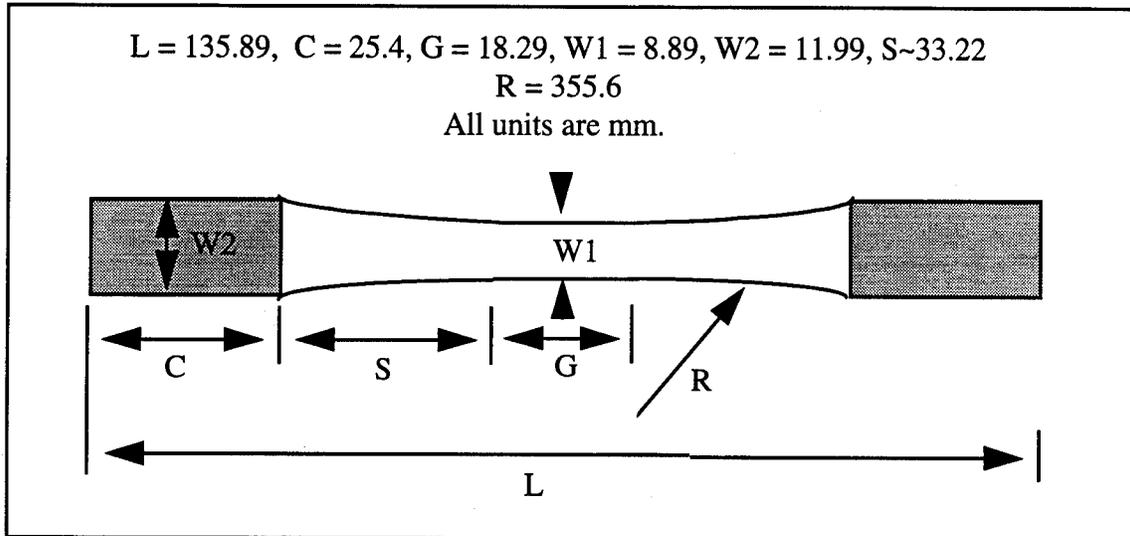
Figure 8. Dogbone Specimen Geometry

than 31.75 cm would produce a small enough shear stress. A conservative radius of 35.56 cm was used to further reduce the shear stress in the shoulder region. Consistent failures within the gage length indicate that the specimen design works well for fatigue testing. Thus, the specimen design used for this study is identical to the one used by Majumdar and Newaz. The specimen geometry is shown in Figure 8.

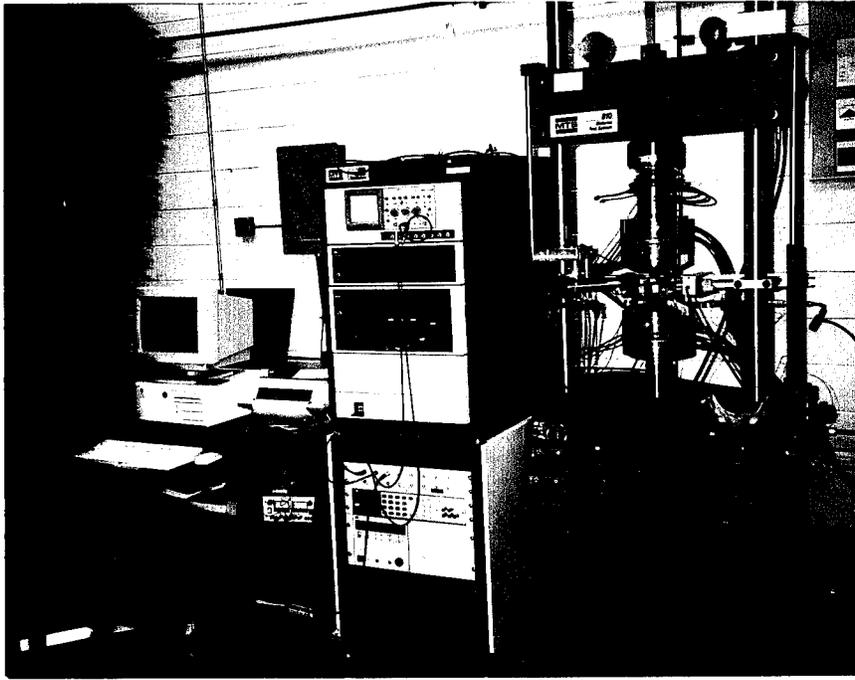
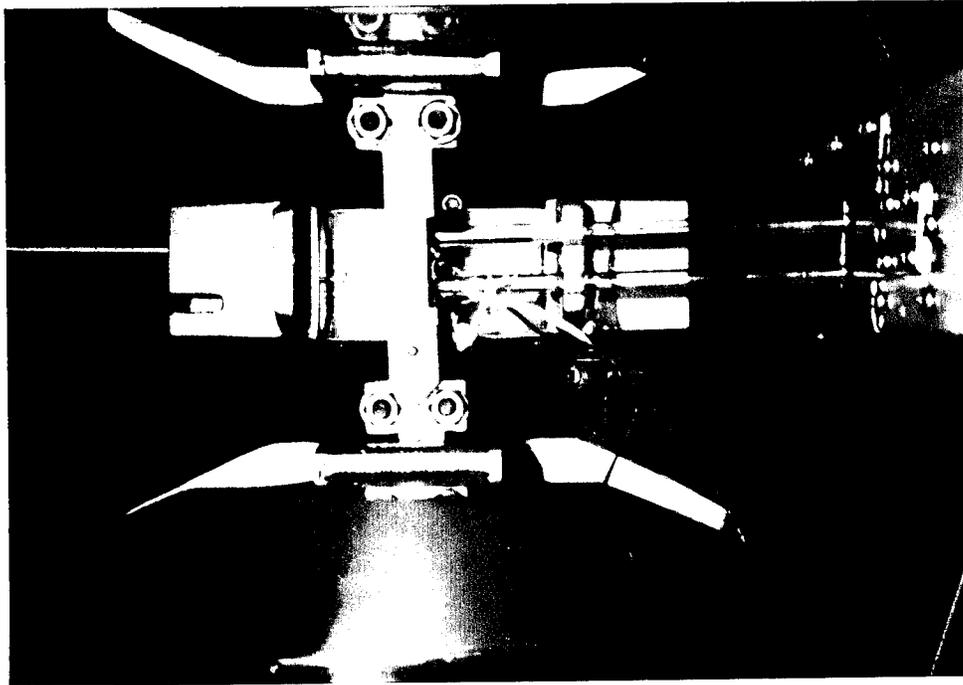
Figure 9. Test Setup

The data acquisition system can also be controlled in the program. The user may specify a cycle interval at the end of which data is to be taken. The data is written to a file in the computer with the cycle number as the filename and the extension “.dat”. Approximately 500 pairs of data are taken during the cycle. Also, every time data is taken, the maximum and minimum stress and strain, modulus, and temperature for the corresponding cycle are written to a file called “minmax.dat”.

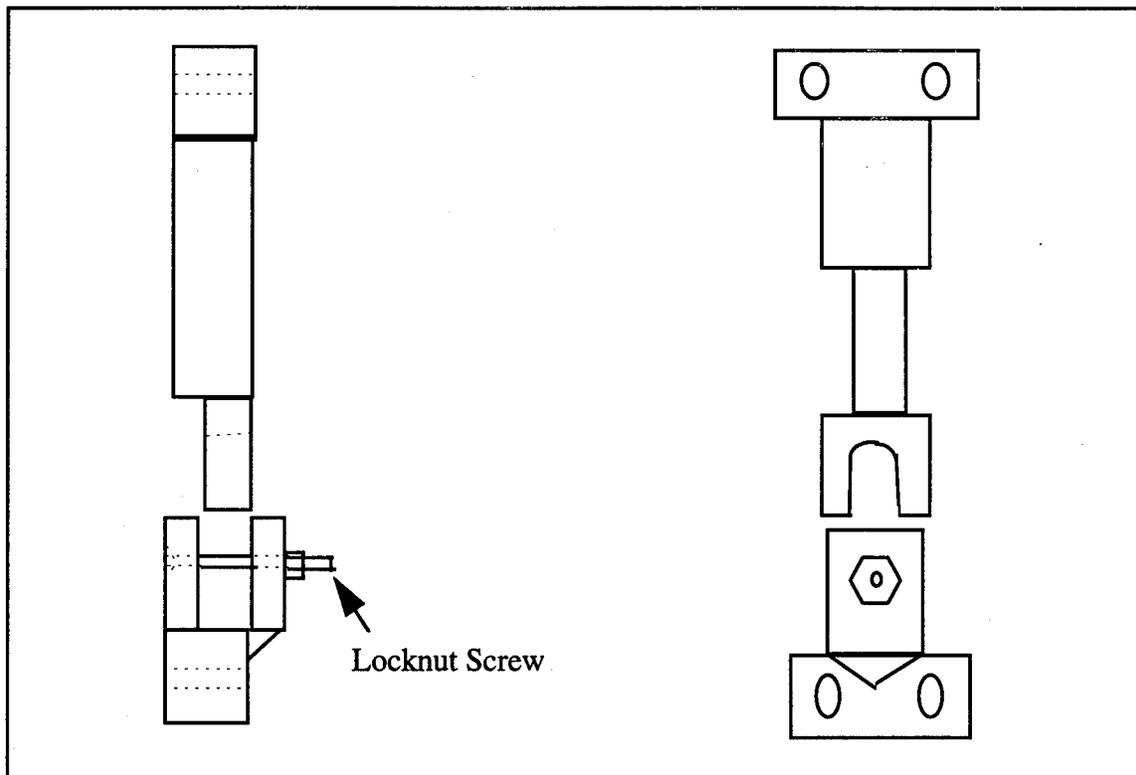
Figure 10. Buckling Guide Modifications

The guide, as designed by Boyum, would not fit the dogbone specimen used for this study. Also, initial testing indicated that the diameter of the locknut screws was too small to withstand the large forces generated by buckling of the specimen during high stress tests. Thus, the overall length of the guide was shortened and the smaller half modified to withstand the increased loads. The modifications consisted of providing additional support to the locknut screw as shown in Figure 10.

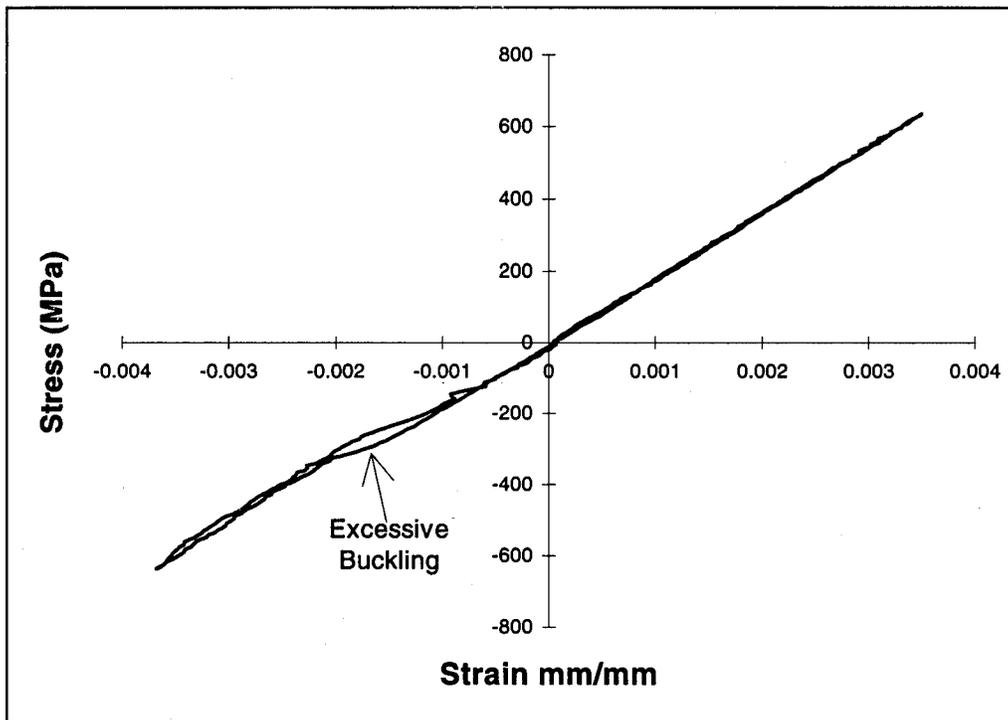
Figure 11. Excessive Buckling

were then mounted perpendicular to the test stand grips using a small level. Once mounted, the specimen temperature was raised to 427 °C over a period of 40-45 minutes. When the temperature had reached equilibrium the thermal strain was measured. The initial cycle was controlled by hand to determine the initial modulus and to check for excessive buckling. Excessive buckling was observed by a cusp in the compression region as shown in Figure 11. To correct this situation, the specimen was realigned with the buckling guide. Additionally, the guide and specimen were realigned in the test stand.

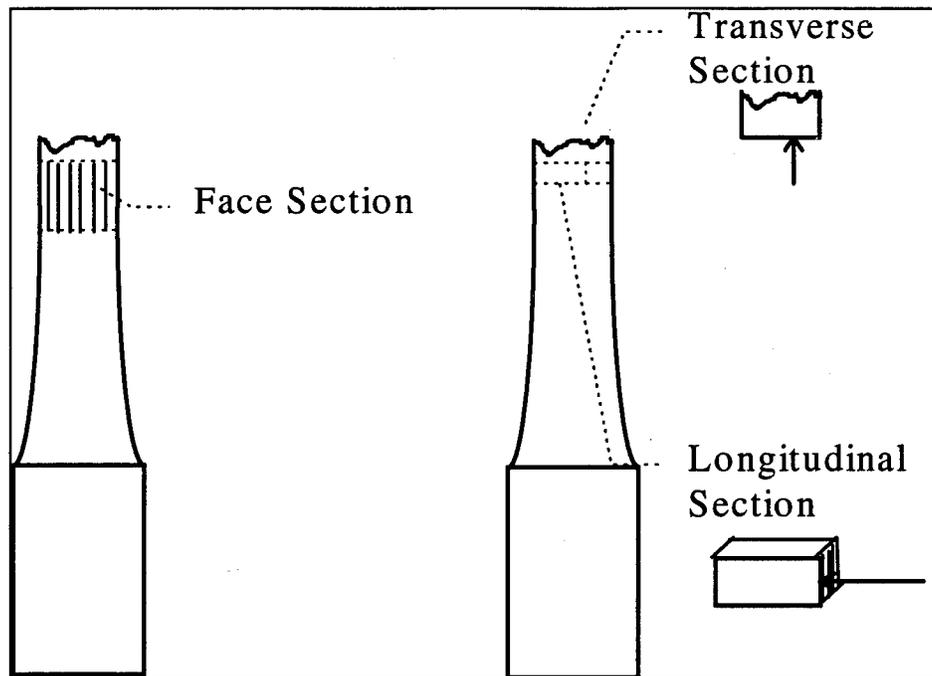
Figure 12. Specimen Sectioning

1 μm solution Vibromet and polished for approximately 24 hours. The specimens are then moved to a 1/2 μm solution Virbomet for approximately 8 hours. Lastly, the specimens are placed in a mastermet solution Vibromet for 20 minutes.

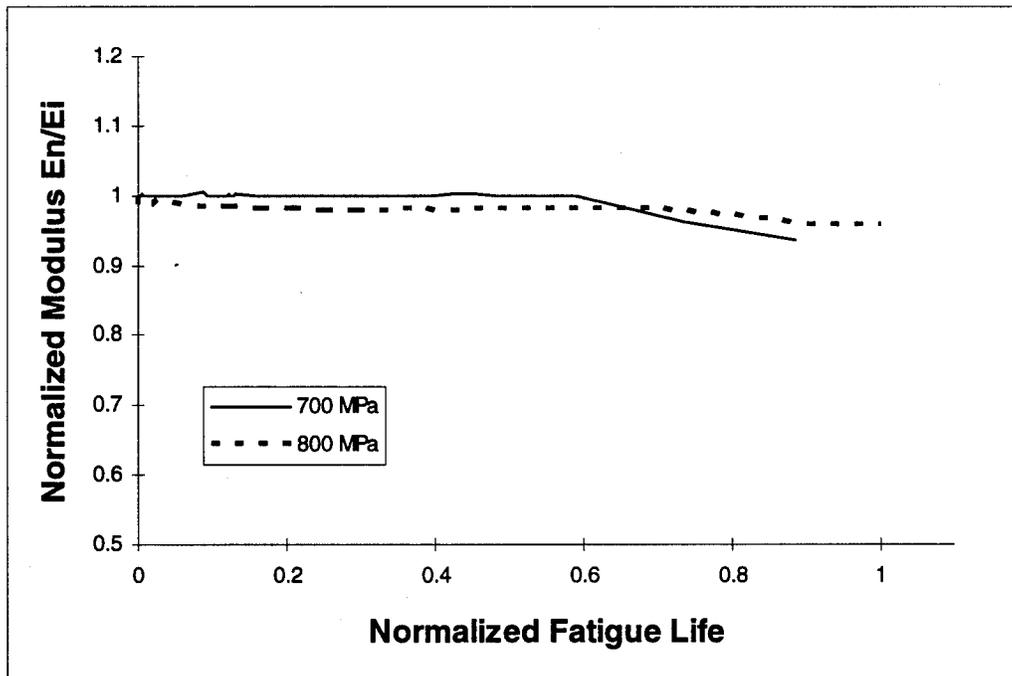
Figure 14. Group 1 Normalized Modulus Trends

Trends in the modulus during cycling are extremely helpful in determining the initiation of damage and the rate of damage progression throughout the fatigue life of the specimen. Generally, any degradation in the modulus indicates damage. Figure 14 shows the trends in the normalized modulus for all tests in Group 1. The normalized modulus is calculated by dividing the current modulus by the initial modulus. Likewise, the normalized fatigue life is calculated by dividing the current cycle by the number of cycles at failure.

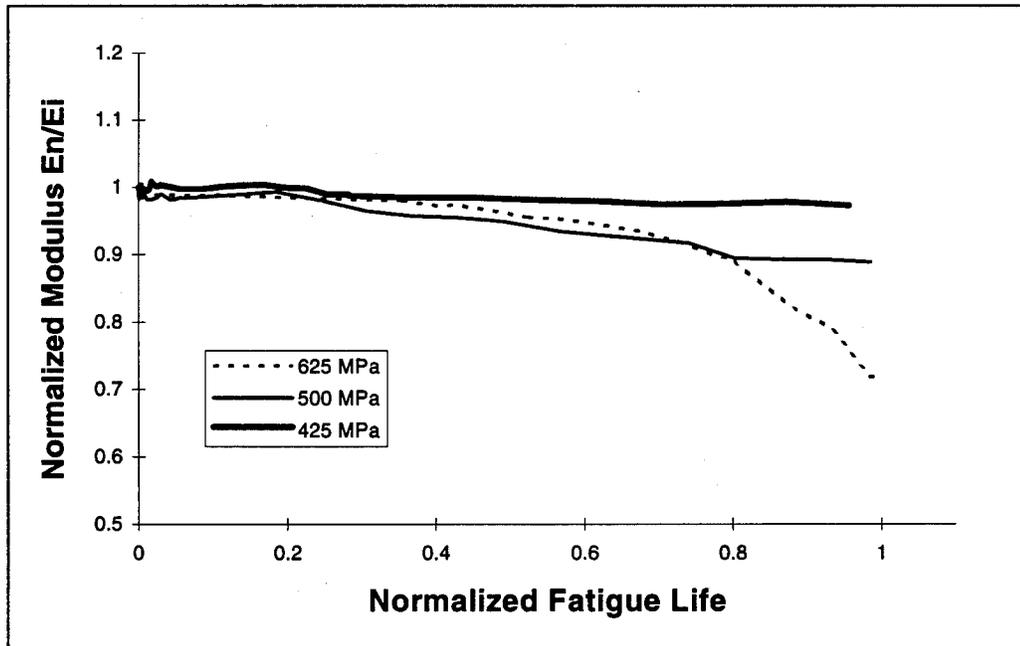
Figure 16. Group 2 Normalized Modulus Trends

Figure 16 shows the modulus trends for those specimens in Group 2. Upon initial inspection, the 425 MPa specimen shows a trend similar to that seen in Group 1, but microscopic evaluation and further macroscopic analysis show that this specimen exhibits behavior consistent with other specimens in Group 2. Whereas the modulus remained constant for approximately 60% of the fatigue life in Group 1, modulus degradation began after as little as 20-40% of the fatigue life in Group 2. Percentage of fatigue life should not be confused with actual cycle number. Simple calculations show that the modulus degradation in Group 2 began at later cycle counts than in Group 1, even though the corresponding fatigue life percentage is less for Group 2. Although modulus degradation at 425 MPa is not obvious in Figure 16, a plot of the actual modulus versus cycle count in Figure 17 shows a more dramatic reduction.

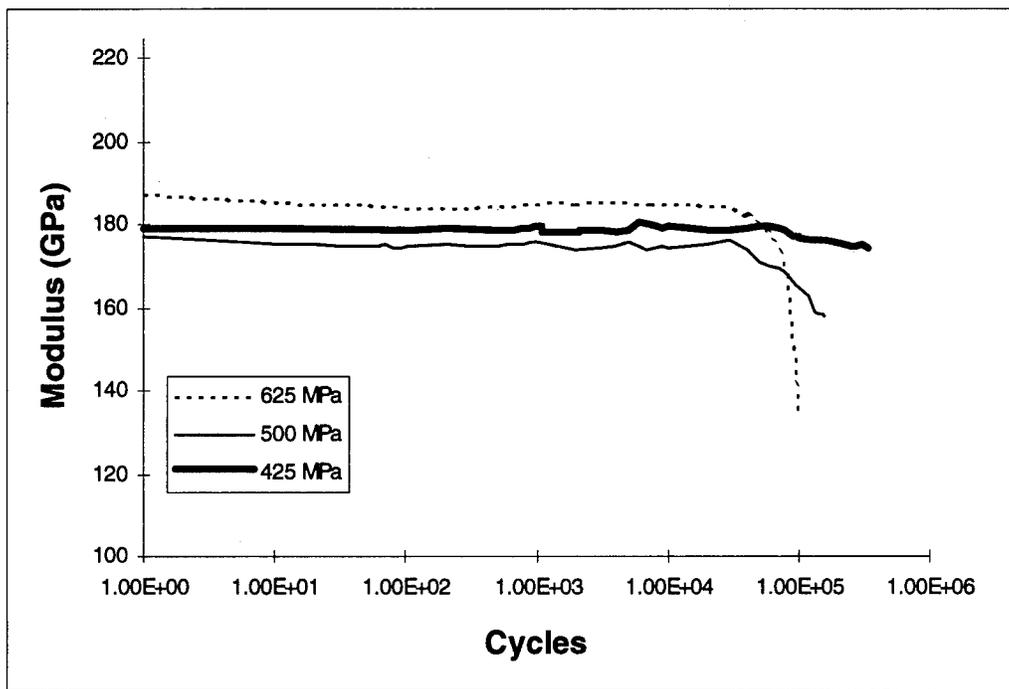
Figure 17. Group 2 Modulus Trends

The amount of modulus degradation in Group 2 also varies with the applied stress, as shown in Figure 17. As the applied stress increases, the amount of modulus degradation increases. This indicates that more matrix cracking occurs at higher stresses. Microscopy will show that the crack density increased with the increasing stress in Group 2.

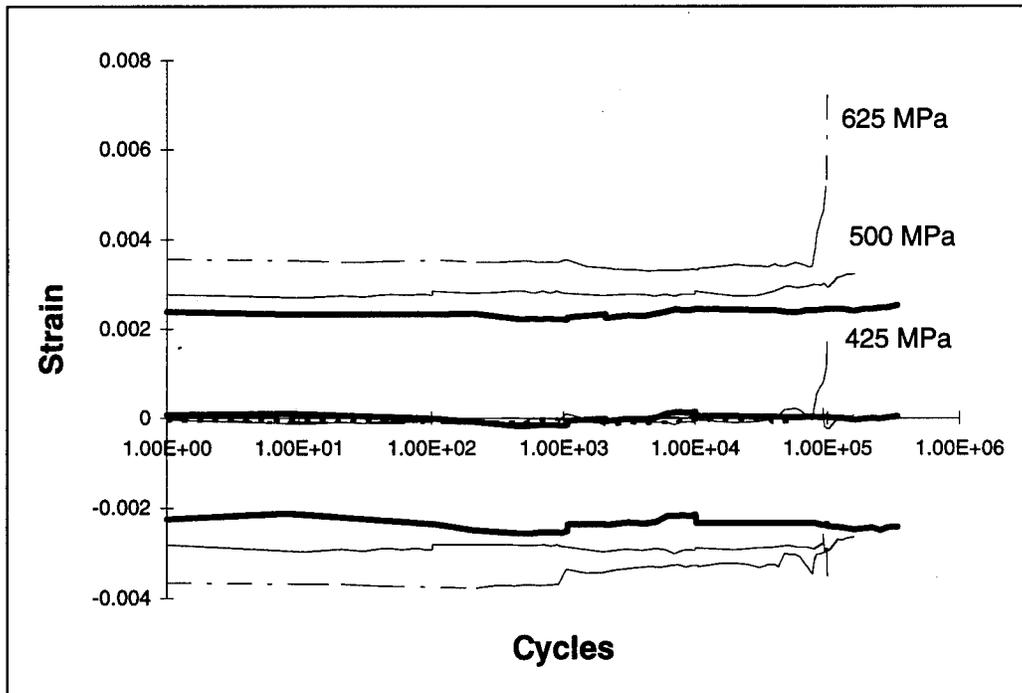
Figure 18. Group 2 Strain Trends

reduction was observed in the specimen cycled at 425 MPa, thereby explaining the lack of increase in maximum strain near the end of the fatigue life. Also, the decrease in modulus causes an increase in the strain range. This relationship can be shown by comparing the change in modulus versus the change in strain range as shown in Figure 19 where modulus and strain range data for the 625 MPa fatigue test are plotted against the fatigue life. The increase in strain range is caused by an increase in the tensile strain while compressive strain remains constant. To better illustrate the rise in strain range caused by an increase in the tensile strain, it is helpful to look at the stress-strain response.

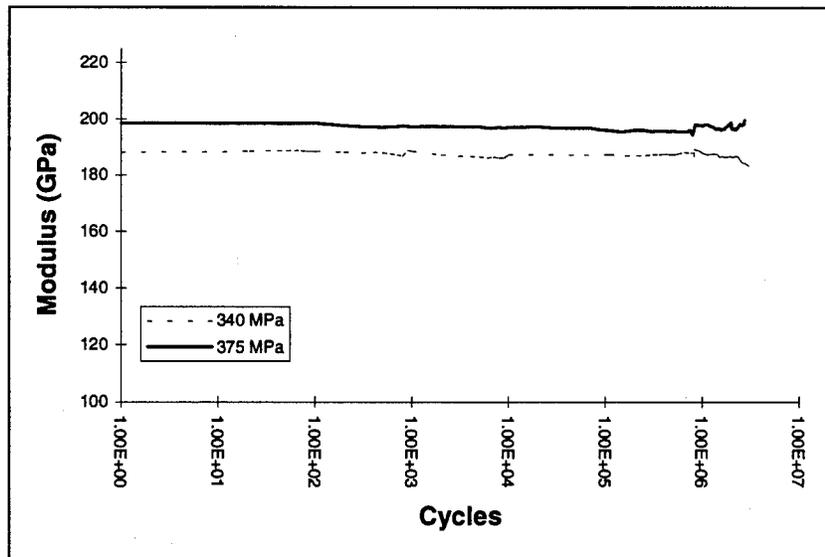
Figure 21. Modulus vs Fatigue Life for Group 3 Tests

Figure 21 shows the modulus trends for specimens in Group 3. The modulus remained constant throughout the test showing no indication of damage. Edge replicas showed some fiber cracking after 100,000 cycles and their number did not increase with subsequent cycles, but as mentioned before, this is not indicative of the rest of the specimen. Edge replicas also showed that some matrix cracking developed from the debonding between the fibers and the matrix where the fibers had already cracked. Also, once matrix cracks were detected in edge replicas, they did not increase in number or size. Analysis of the modulus trends indicates that the existing matrix cracks had no effect on the material stiffness and probably did not progress throughout the laminate.

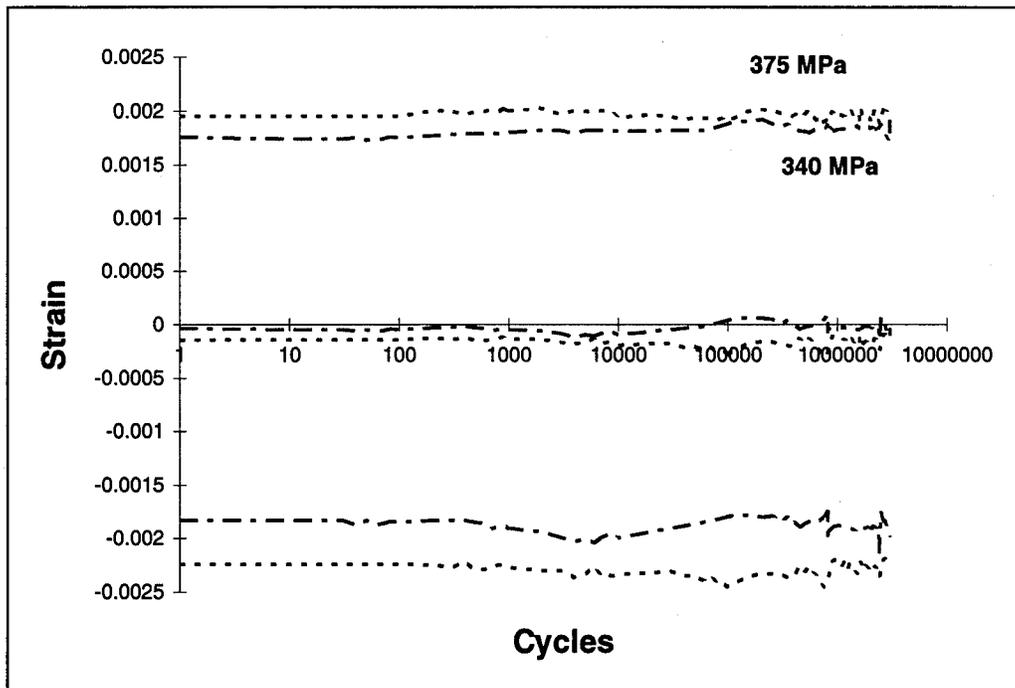
Figure 22. Group 3 Strain Trends

Figure 22 shows the strain trends for Group 3. Once again the trends show no evidence of creep. Also, since there was no change in modulus, there is no increase in maximum strain or strain range. Thus, it appears that damage observed in edge replicas has not progressed throughout the composite and that these specimens were cycled below the fatigue limit of the matrix material.

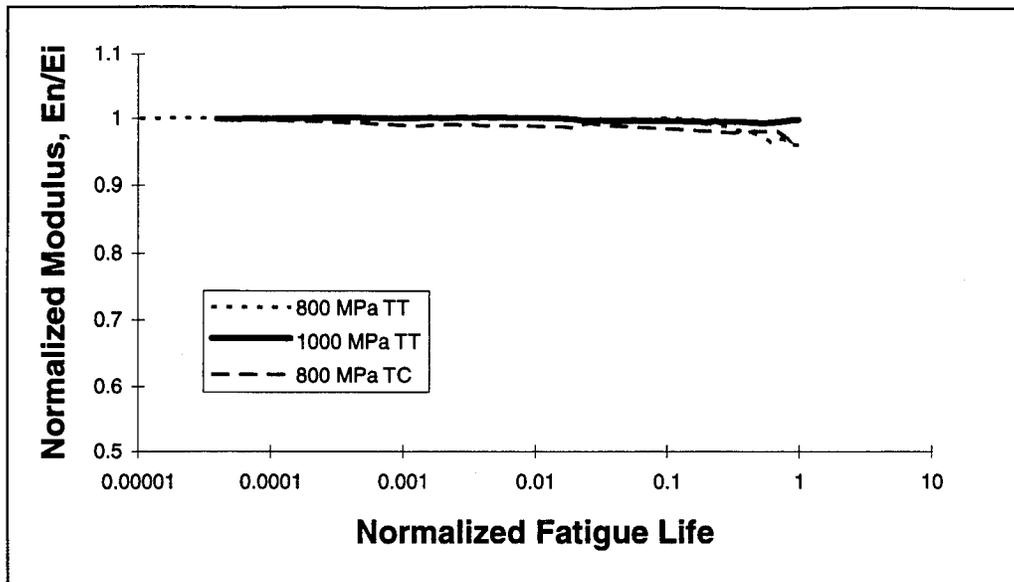
Figure 23. Normalized Modulus vs Fatigue Life

Also shown in Figure 23 is the modulus trend for the fully-reversed specimen cycled at 800 MPa. Modulus degradation under tension-tension fatigue occurred over a small number of cycles, spanning only over the end of the fatigue life, while tension-compression fatigue produced damage much earlier in the fatigue life. Once again, the percentage of fatigue life where damage initiates should not be confused with actual cycle number. Strain trends will show that damage initiated at approximately the same cycle count for both loading conditions but progressed at greatly different rates through the composite.

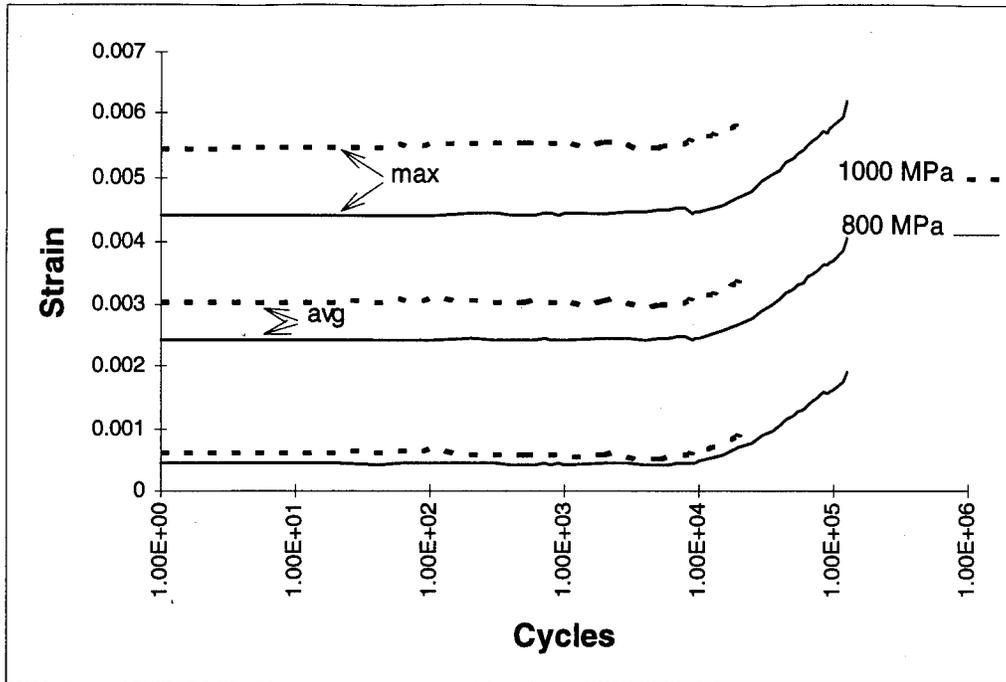
Figure 24. Max, Min and Avg strain, TT HT

The maximum and minimum strain trends are once again important in identifying creep behavior. Figure 24 shows the strain trends for the tension-tension tests conducted in this study. The initiation of damage is seen as a pronounced rise in both maximum and minimum strains at the end of the fatigue life. Unlike the strain trends in tension-compression loading, those for tension-tension loading show evidence of creep behavior. As shown in Figure 25, the maximum and minimum strains begin to rise after approximately 10,000 cycles. To determine whether this increase is a result of damage or creep, the modulus and strain range must be analyzed. Figure 26 shows that the modulus and strain range remain constant for more than 20,000 cycles indicating that the increase in strain between 10,000 and 20,000 cycles is a result of creep and not damage.

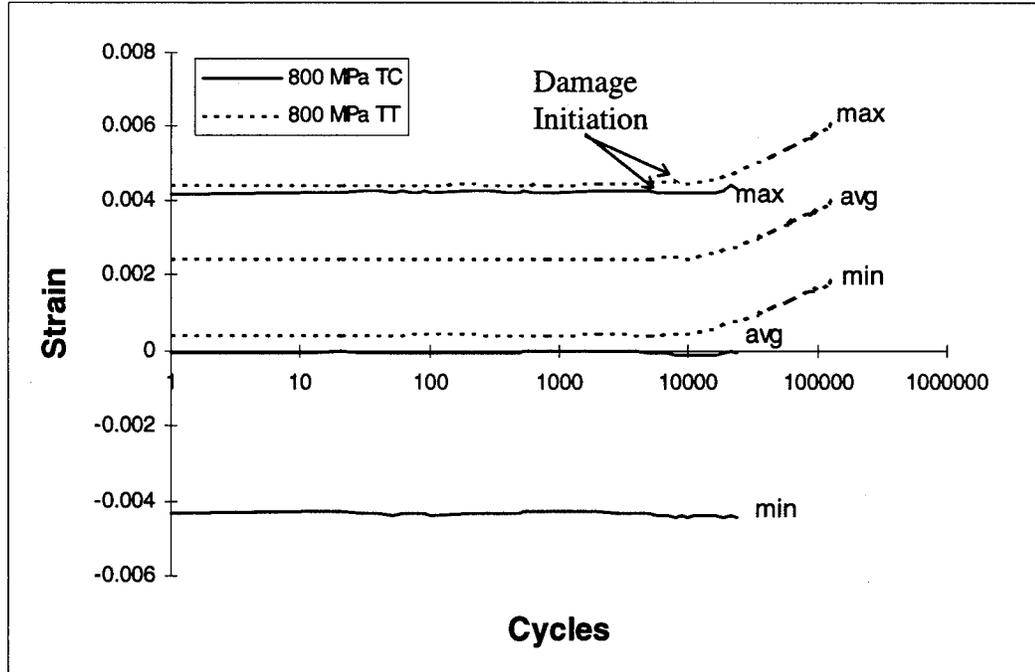
Figure 27. TT vs. TC Strain Trends, 427 ° C

Figure 27 plots the maximum strains for fatigue tests conducted at 800 MPa in both tension-tension and tension-compression loading conditions. Although damage initiated at approximately the same cycle count, the number of cycles to failure is much greater under tension-tension fatigue. Thus, once damage occurred under tension-compression fatigue, it progressed faster through the composite than under tension-tension fatigue.

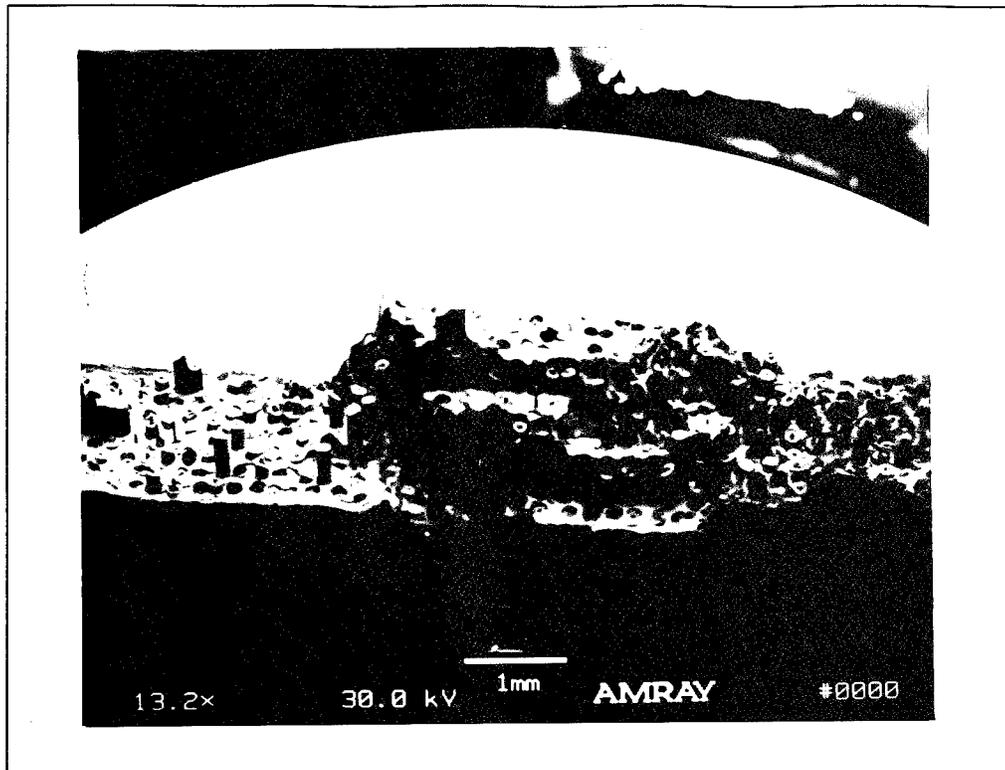
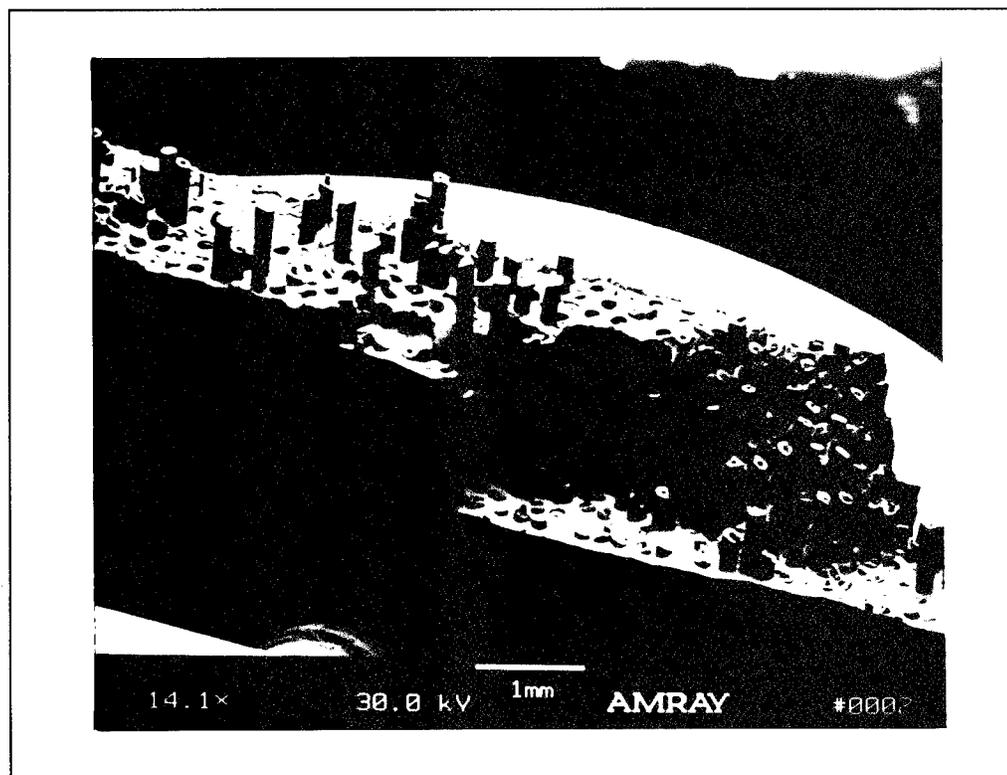
Figure 31 shows many levels of flat area while Figure 28 shows a single level. This indicates that many cracks were progressing through the composite at low stress. As the stress level increases, one crack tends to dominate resulting in a single level of flat fracture surface area.

Figure 28. Fracture Surface at 800 MPa, TC HT

Figure 31. Fracture Surface at 425 MPa, TC HT

While all specimens show some flat area where the fibers remain intact, there also exists an area of fiber pull-out in each case where extensive matrix necking has occurred. Figure 32 shows extensive fiber-matrix debonding in the necked portion of the 800 MPa fracture surface. A closer examination of necked region of the 800 MPa specimen shows ductile void coalescence which is seen as dimples in Figure 33. This indicates that the fibers failed first followed by matrix failure caused by overload in tension. The overload resulted from a smaller amount of fibers carrying the same applied stress. The fibers in the necked region were carrying all the load since the other fibers had already fractured behind the advancing matrix crack tip.

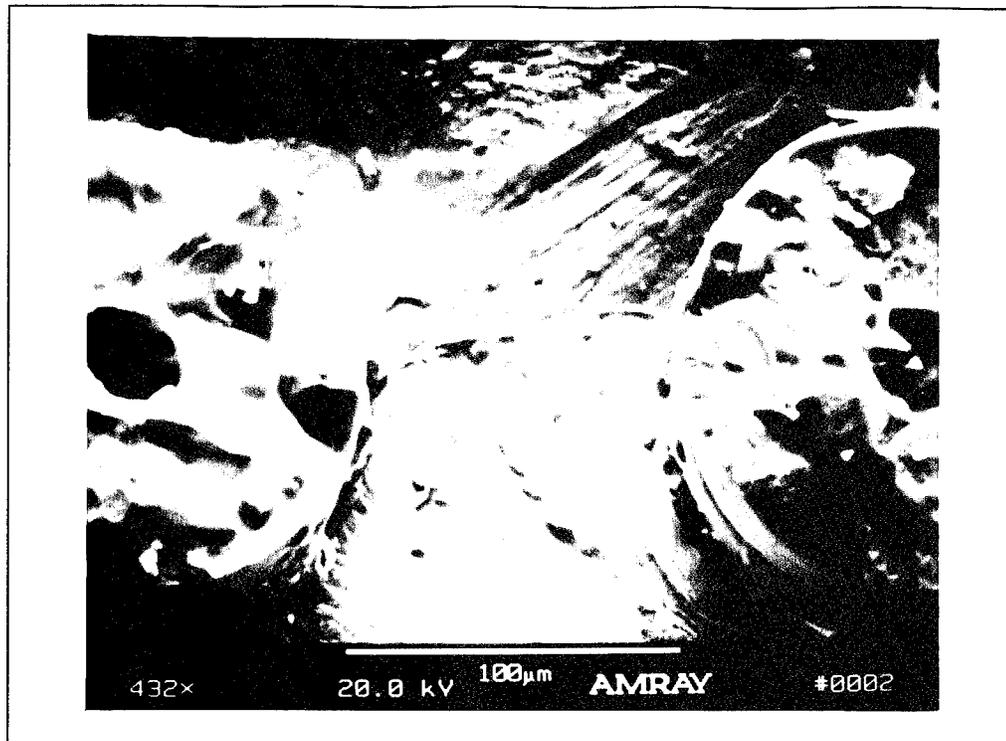
Figure 34. Fatigue Striations, Intact Fibers, 700 MPa, TC HT

Examination of the flat portions of the fracture surface provide strong evidence of matrix fatigue crack growth caused by cycling. Figure 34 shows the flat area of the fracture surface at 700 MPa. It consists mainly of fibers that have remained intact. The fibers that appear to have pulled out of the matrix material in the flat region of the fracture surface are caused by random fiber failure as the matrix crack progresses throughout the specimen. Additionally, very little fiber-matrix debonding has occurred. Closer examination yields the presence of fatigue striations in the matrix caused by fatigue cracking. The striations grow parallel to the direction of the crack growth. In Figure 34, cracks can be seen growing from a few different directions.

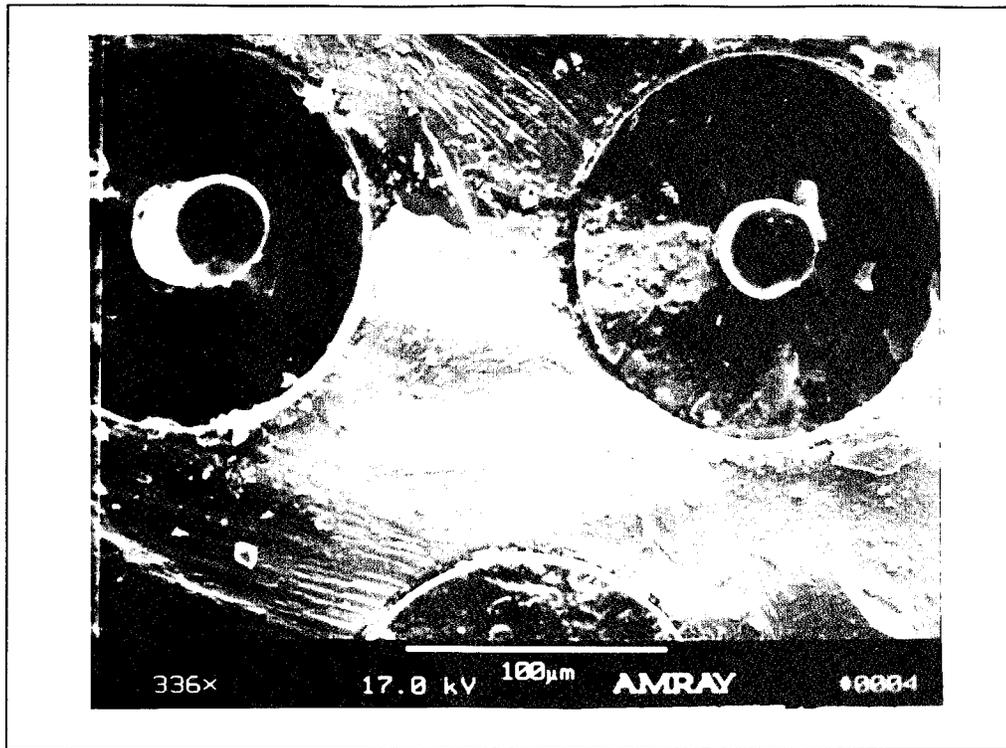
Figure 35. Fatigue Striations, 425 MPa, TC HT

Whereas fatigue striations are present at 700 MPa, they are also found at lower stresses including the specimen cycled at 425 MPa. Recalling that as the surfaces at 800, 700, and 625 MPa contained areas of matrix necking and fiber pull-out, the surface of the 425 MPa specimen is completely flat. All the fibers appear to be intact with little or no fiber-matrix debonding. Initially it may appear that a different failure mechanism is occurring at lower stresses but the presence of fatigue striations, shown in Figure 35, across the entire surface describe numerous matrix cracks growing from different directions. Thus, failure is dominated by matrix cracking at low stresses as well as higher stresses. The progression of matrix cracking, however, requires the previously described group separation. Specimen sectioning clearly illustrates the difference in matrix crack growth between groups 1 and 2.

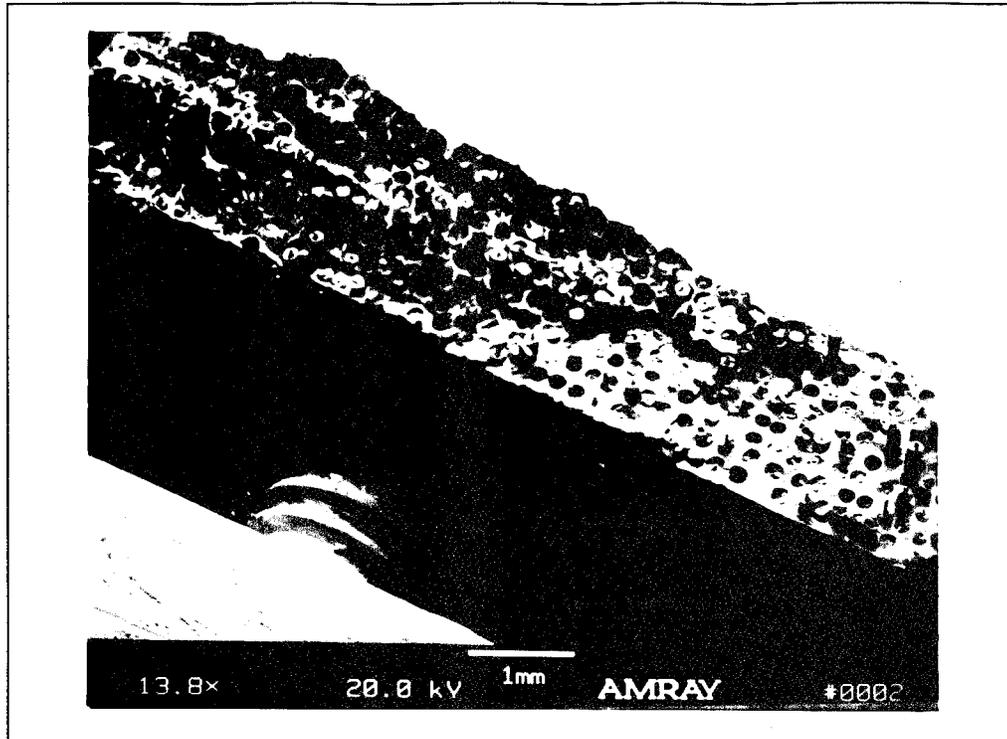
Figure 36. Fracture Surface, 800 MPa, TT HT

The examination of the micro-mechanical behavior of tension-tension fatigue loading was limited to the specimen cycled at 800 MPa since it was the only one used for comparison of failure mechanisms. The fracture surface shown in Figure 36 consisted of a small flat portion and a much larger, uneven area where fibers pulled out of the matrix. This is similar to the fracture surface at 800 MPa under tension-compression loading conditions. The flat region indicated matrix cracking while the uneven region once again indicated failure by tensile overload. The only difference between tension-tension and tension-compression loading is the amount of flat area. For the tension-tension loading case, the flat region is much smaller indicating that more of the surface was dominated by fiber pull-out.

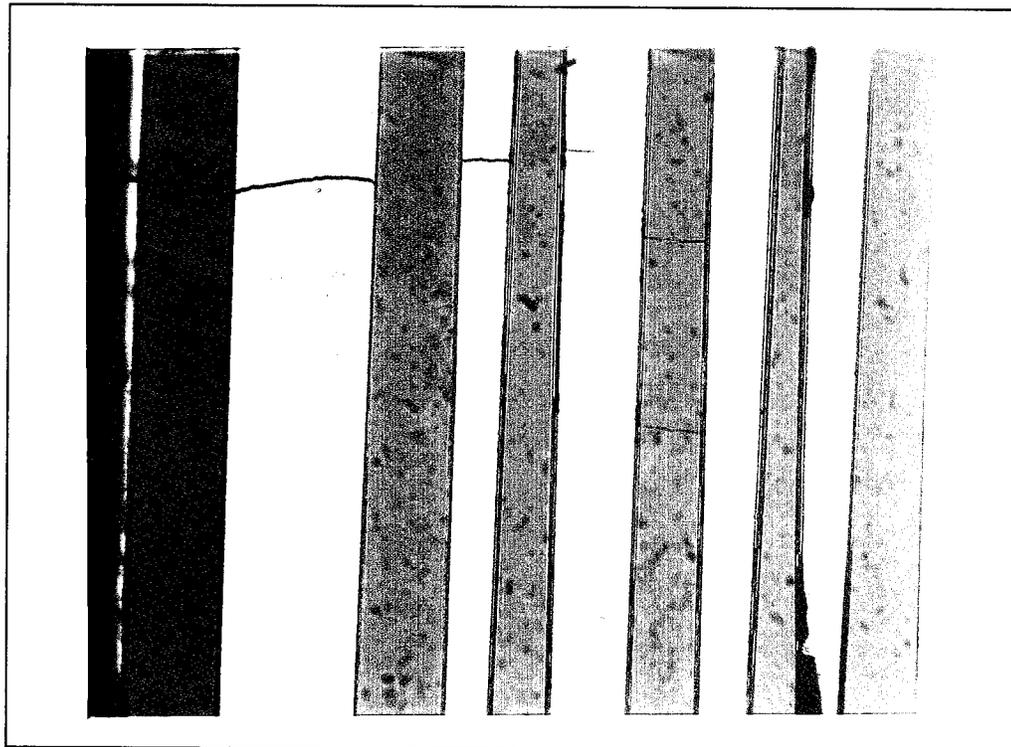
Figure 37. Matrix and fiber cracking, 800 MPa, TC HT

density of matrix cracks at 700 MPa is roughly the same as that observed at 800 MPa. Thus, in Group 1, damage consists of minimal matrix cracking and even less fiber cracking. It should also be noted that even though fiber bridging did occur, the number of fibers bridged by the matrix crack is minimal when compared with that observed in Group 2. The lack of fiber bridging in these specimens suggests that as matrix cracks developed, one of these cracks became dominant. As the dominant crack propagated through the composite, the additional stress carried by the fibers exceeded the fiber's ultimate strength causing them to fail directly behind the advancing crack tip. Thus, crack propagation is rapid and does not allow the other matrix cracks to mature.
