INVESTIGATION OF TENSION-COMPRESSION
FATIGUE BEHAVIOR OF A UNIDIRECTIONAL
METAL MATRIX COMPOSITE AT ELEVATED
TEMPERATURE

THESIS

Darren L. Kraabel, 2nd Lieutenant, USAF

AFIT/GAE/ENY/94D-6

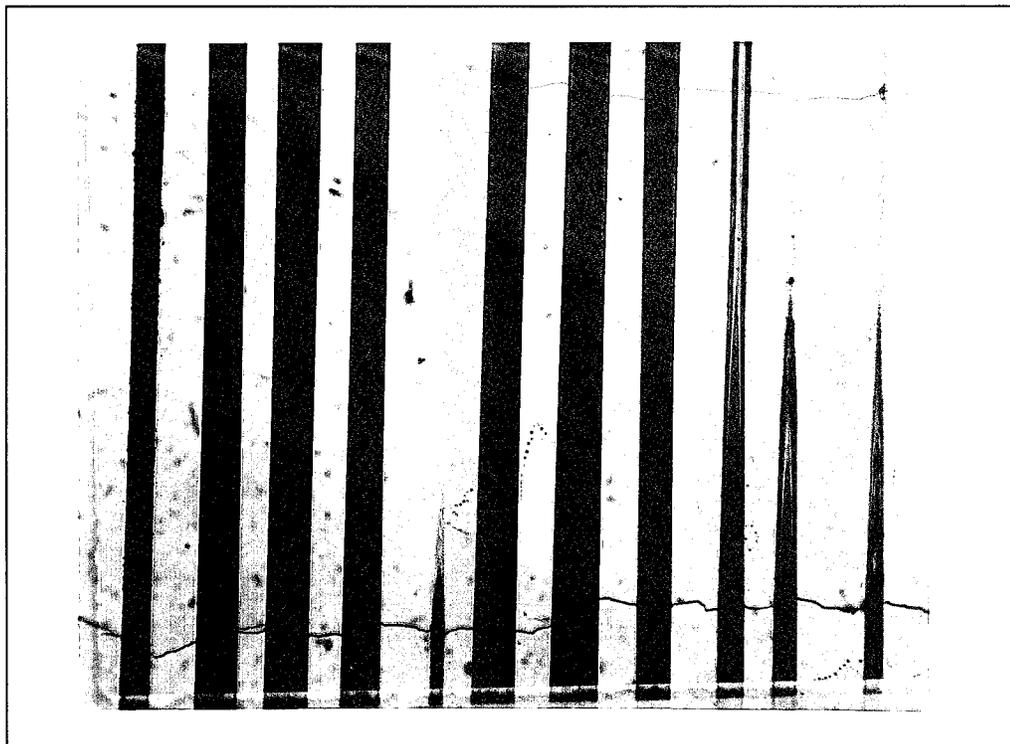
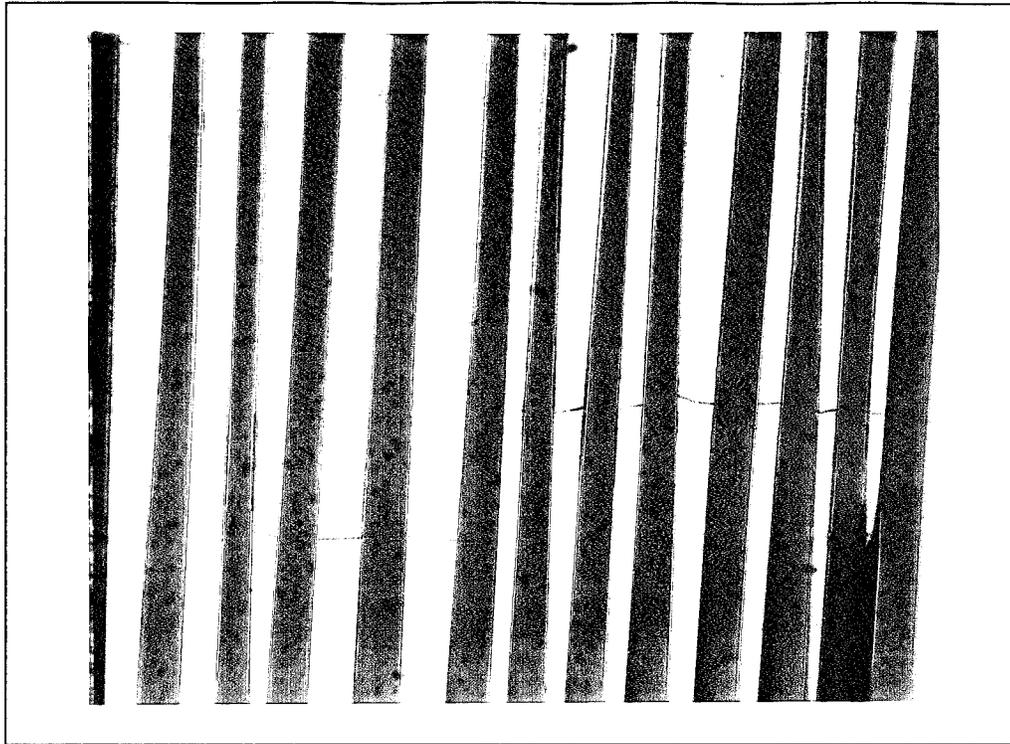
The damage observed in Group 2 consists of matrix cracking and extensive fiber bridging. As shown in Figures 38-40, the matrix cracks all grow across many lines of fibers without causing fiber failure. This phenomenon, called fiber bridging, was also noted by Sanders in matrix dominated failure modes (33). As cracks grow, they encounter fibers which are much stronger than the matrix in which the cracks are growing. The fiber-matrix interface is relatively weak and rather than progress through the fibers, the cracks progress around them, often causing fiber-matrix debonding. Also seen in Figure 40 are molyweave. Since the molyweave act like precipitates in an alloy, they are strong crack initiation sites. In this specimen, however, cracks did not originate from the molyweave.

Figure 38. 625 MPa Fiber Bridging

Figure 39. 500 MPa Fiber Bridging, TC HT

Figure 40. 425 MPa Fiber Bridging and Molyweave

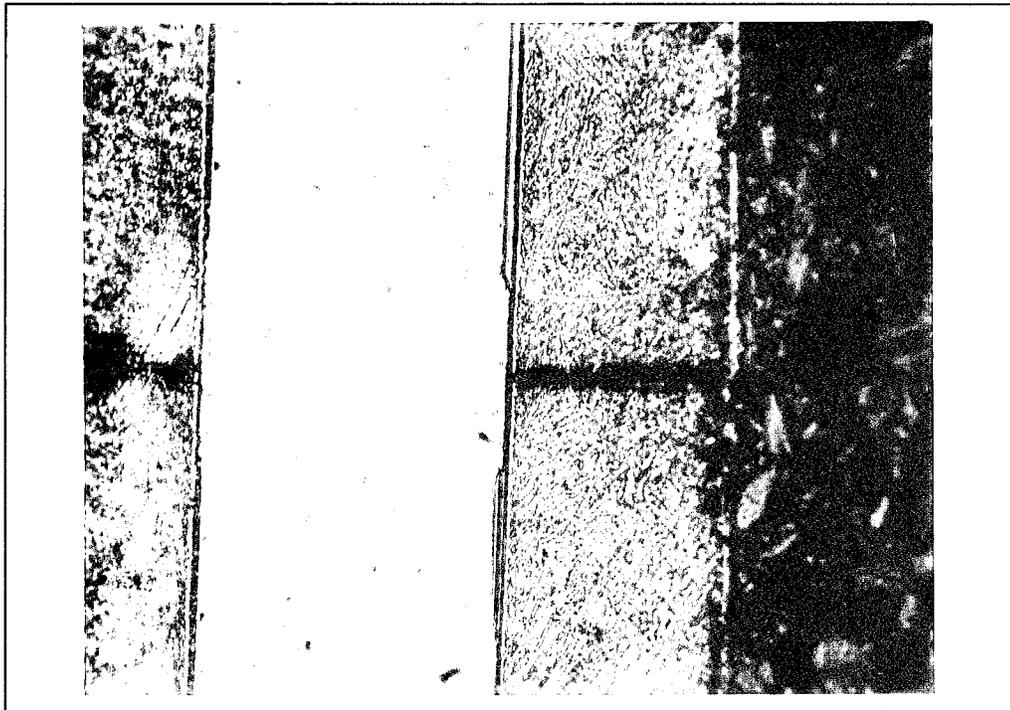
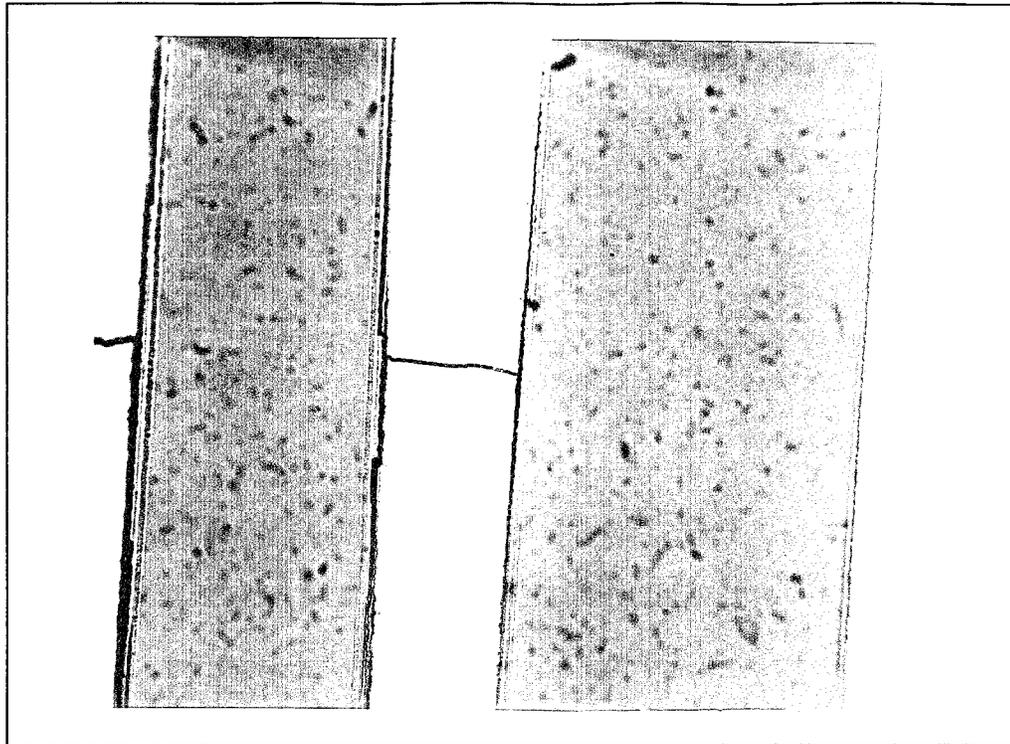
Crack initiation sites were not limited to any particular region of the test specimens. While some cracks initiated on the edge of the specimen, Figure 41, others originated in the middle, Figure 42. This indicates that while the specimen edges are important crack nucleation sites, fatigue cracks can still develop within the material, far from the edge. Cracks that developed within the material initiated from fiber-matrix interface failure, as shown in Figure 42, caused either by other cracks that had bridged the fibers or by interface defects.

Figure 41. Edge Crack Initiation, 625 MPa, TC HT

Figure 42. Crack Initiation Within Specimen, 500 MPa, TC HT

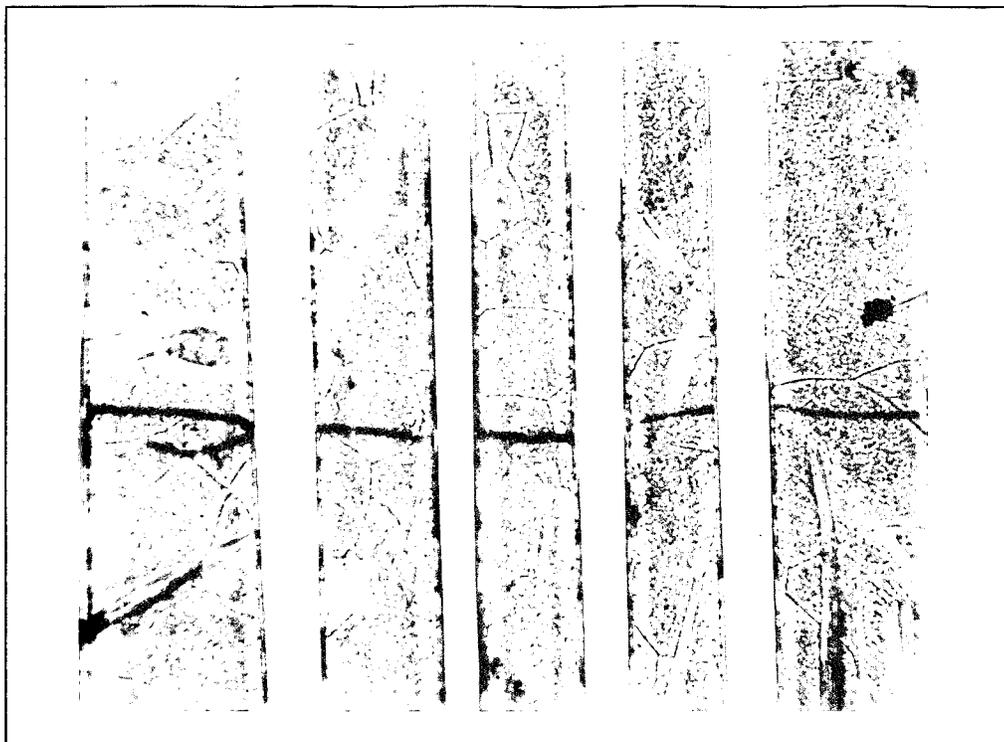
Figure 43. Transgranular crack growth, 425 MPa, TC HT

As can be seen from the sectioned samples, no fiber fracture was observed in Group 2. Evidence of matrix cracking was observed in all specimens, both on the fracture surface and in the sectioned samples. The necked regions of the fracture surfaces can now be explained by tensile overload while the flat areas contain strong evidence of fatigue crack growth.

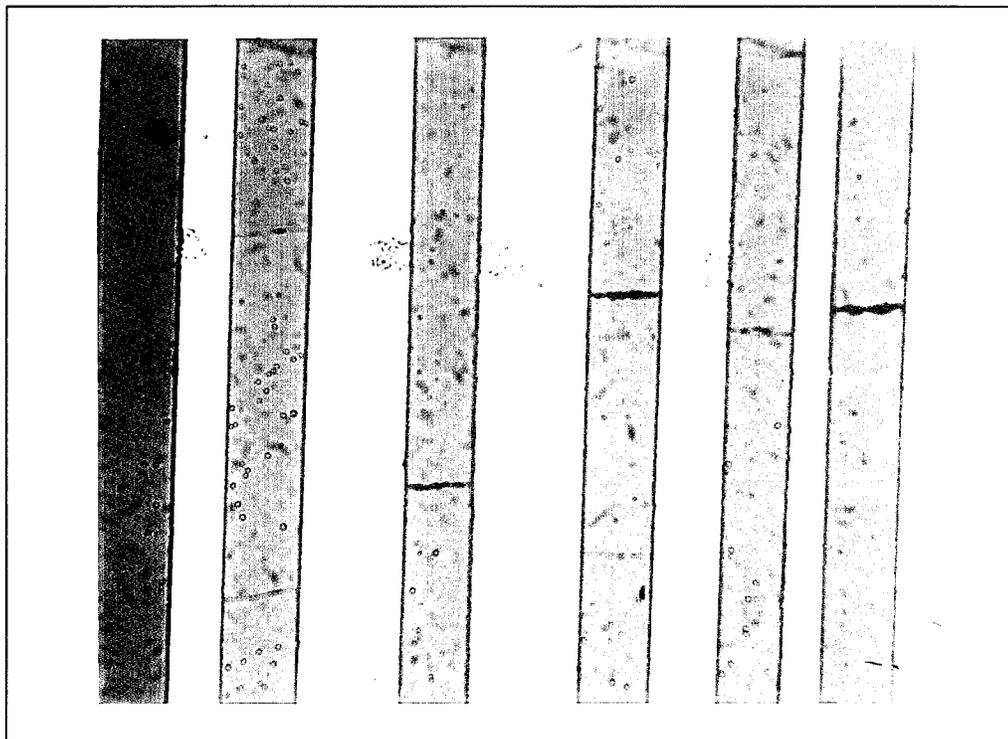
Figure 46. Fiber fracture, 800 MPa, TT HT

combined with the flat portion of the fracture surface suggest that the specimen failed under a combination of failure mechanisms which include both fiber and matrix fracture. Matrix creep observed in the strain trends previously discussed offers an explanation for fiber cracking. Majumdar and Newaz (24) have suggested that matrix creep results in a drop in matrix stress, forcing the fibers to carry more load, hence causing fiber cracks.

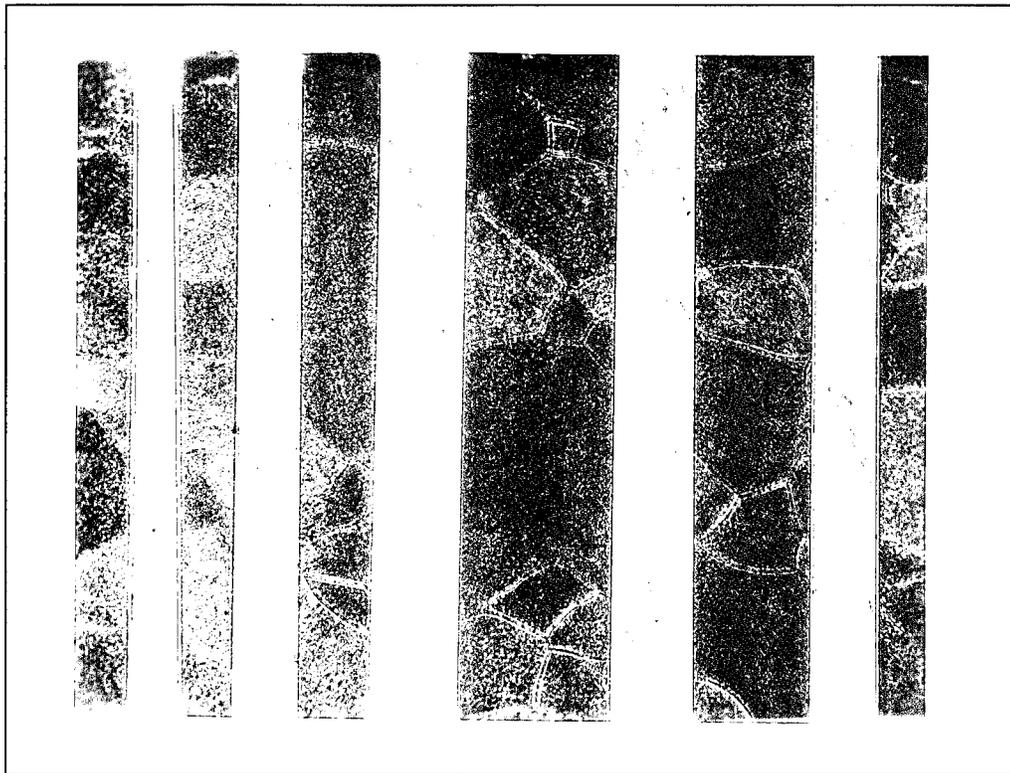
Figure 47. Etched Face Specimen, 800 MPa

corresponding to 800 MPa falls well below that limit. Also, a micro-mechanical analysis in Appendix A shows that the matrix stresses at 800 MPa are far below the proportional limit of the matrix material. Therefore, to obtain matrix plasticity, the laminate must be cycled above 0.55% maximum strain regardless of the loading type, e.g. tension-tension vs. tension-compression.

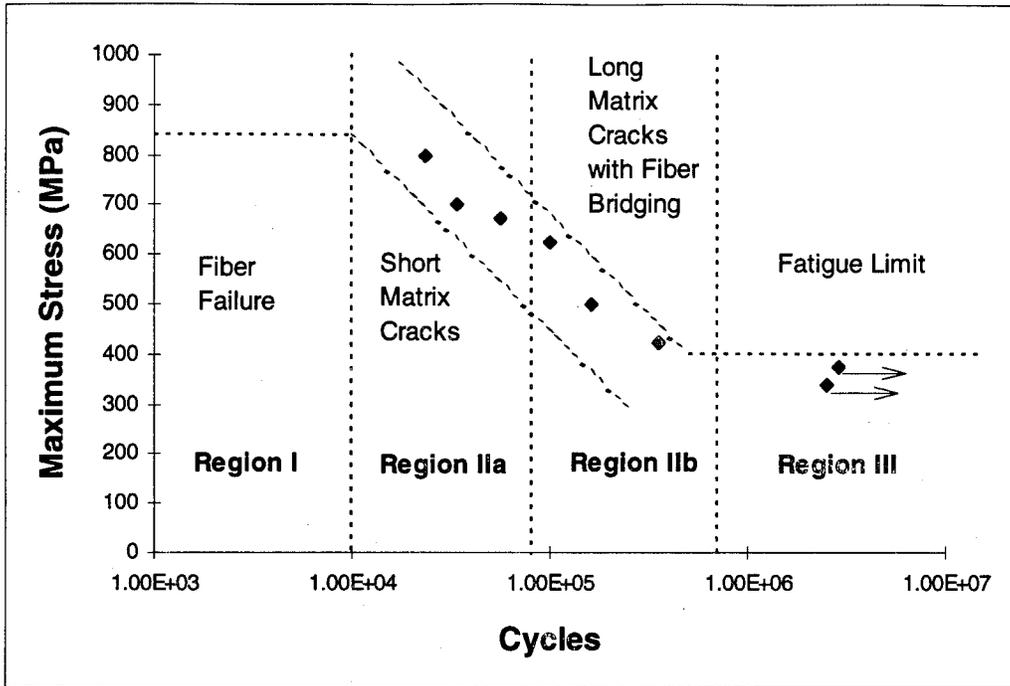
Figure 48. $[0]_8$ Tension-Compression Fatigue Life Curve

Specimens in Group 3 fall within this region.

This investigation shows that the fatigue life diagram for the unidirectional metal matrix composite studied can be broken up into three regions based on the observed failure mechanisms. Region I is dominated by fiber failure with very little matrix cracking. Region II contains matrix cracking, fiber bridging and minimal fiber cracking. Region III contains specimens that fall below the fatigue limit of the matrix material resulting in fatigue lives greater than one million cycles.
