FATIGUE BEHAVIOR OF A CROSS-PLY  
CERAMIC MATRIX COMPOSITE SUBJECTED TO  
TENSION-TENSION CYCLING WITH HOLD TIME

THESIS

Scott A. Grant  
Captain, USAF  
AFIT/GAE/ENY/94D-16

Master of Science in Aeronautical Engineering

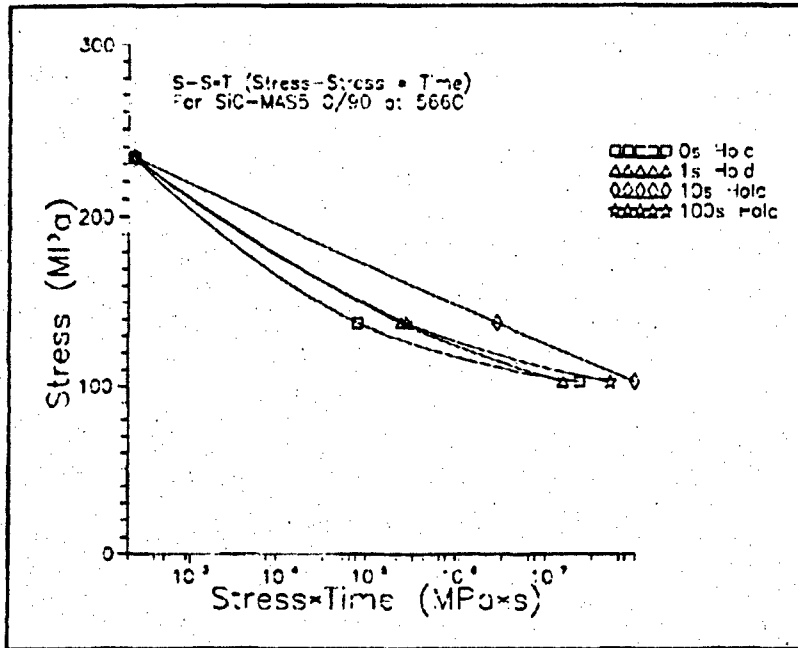
Figure 12. S-S\*T Curves for 566°C.

The data from the pure stress rupture test [3] does not fall on the S-T curve for two reasons. First, the failure of the material must be a function of both the cycling *and* environmental temperature. One mechanism will dominate over the other as the temperature and loading wave-form vary. Second, the rate of oxidation in most materials is not constant. In the absence of flaking, the oxide provides a protective layer that inhibits further oxidation.

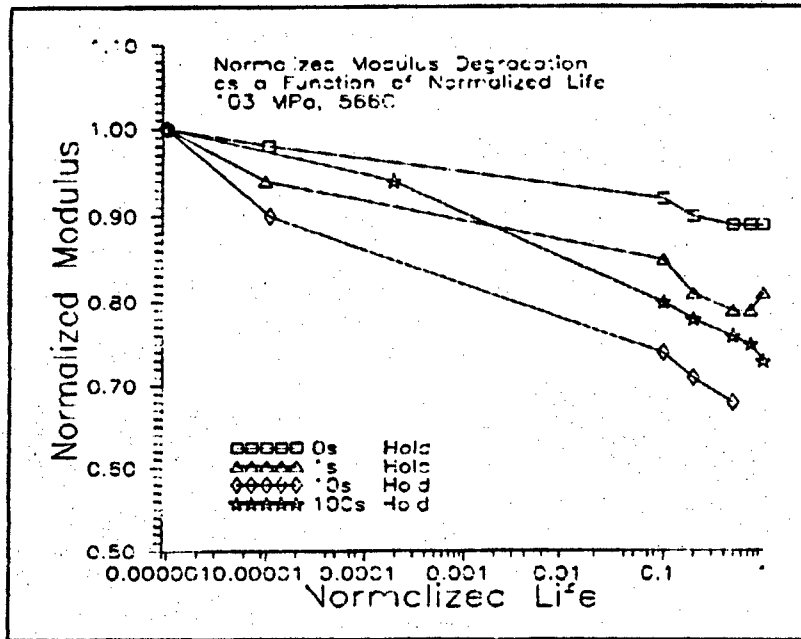
Figure 21. Normalized Modulus Degradation/Life for 566°C, 103 MPa.

At 566°C, the 103 MPa tests show a definite dependence on hold time as shown in Figure 21. In general, as the hold time increases, the extent of modulus

degradation also increases. At failure, the normalized moduli for this combination of stress and temperature vary between 0.7 and 0.9. When the stress is increased to 138 MPa, the normalized modulus stabilizes to approximately 0.6 after the first few cycles as shown in Figure 22.

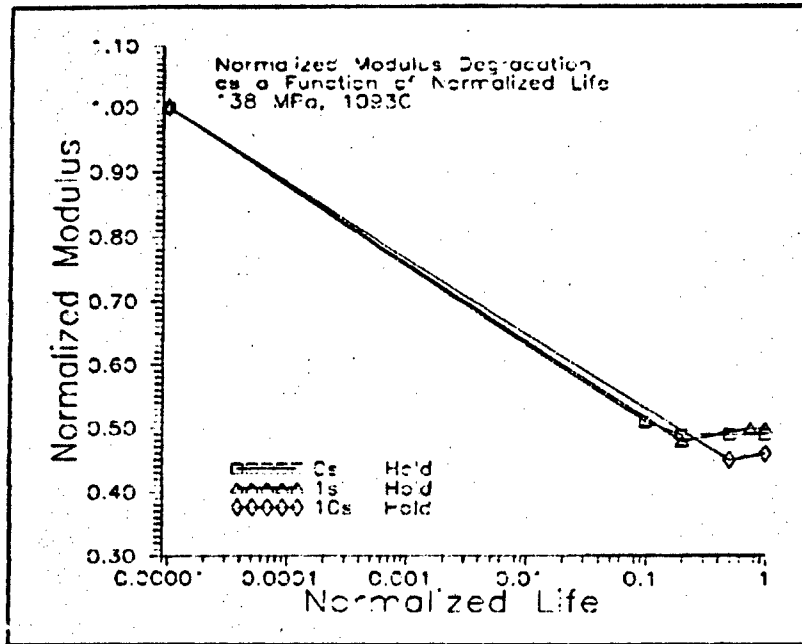
Figure 24. Normalized Modulus Degradation/Life at 1093°C, 138 MPa.

on the hold time. Figure 24 illustrates the trends at this combination of temperature and stress.

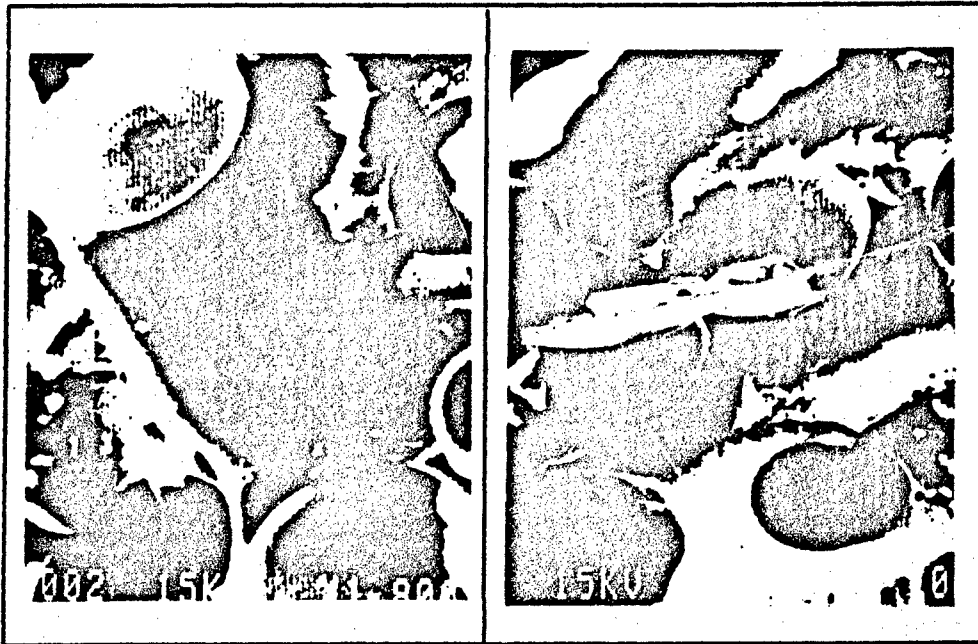
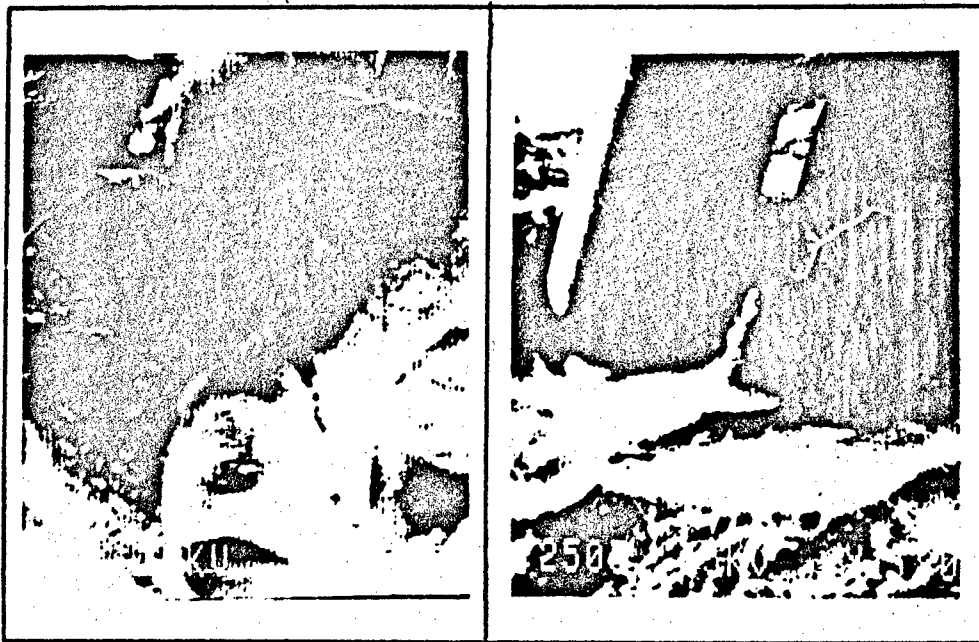
It was found that all fibers examined from the 566°C tests contained little or no evidence of oxidation. Only the 138 MPa tests showed any evidence of damage from the environment. Figures 68 to 71 illustrate the condition of the fibers at the surface in order of increasing hold time for the edge and center of each case.
