CHARACTERIZATION OF FATIGUE BEHAVIOR
OF 2-D WOVEN FABRIC REINFORCED
CERAMIC MATRIX COMPOSITE
AT ELEVATED TEMPERATURE

THESIS

AFIT/GAE/ENY/94D-15

DEPARTMENT OF THE AIR FORCE
AIR UNIVERSITY
AIR FORCE INSTITUTE OF TECHNOLOGY

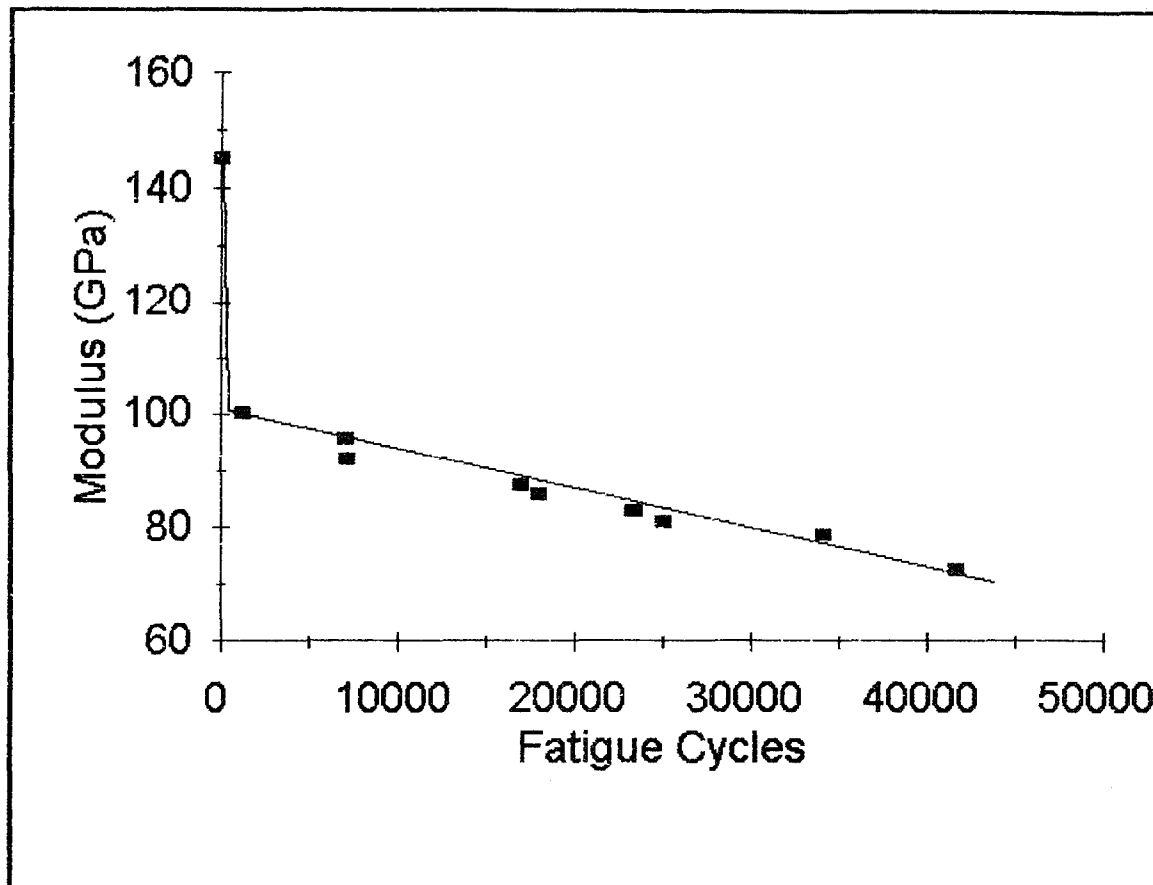
Figure 4-18 120 MPa Unnotched Modulus Reduction

Figure 4-18 shows the modulus reduction over the life of the test. Note the 21% loss of modulus from 145 GPa in the linear region of the first cycle to an average value of 115 GPa exhibited during the cycling of the test. A low magnification micrograph of the fracture surface is shown in Figure 4-19.

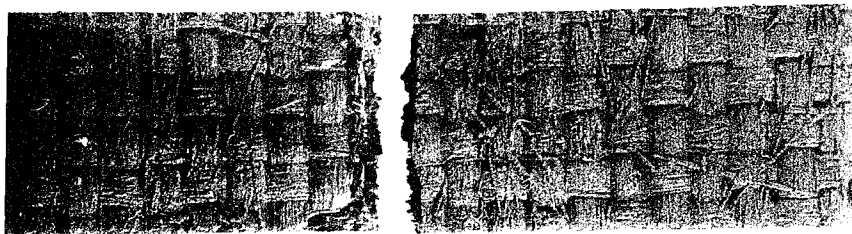
Figure 4-20 Fracture Surface, 110 MPa Unnotched Test, 7X

The lowest stress level of unnotched fatigue test was the 110 MPa test. It cycled 259,249 times before failure. A magnified optical micrograph of the fracture surface is presented in Figure 4-20. This specimen was the only unnotched specimen which had the failure in the center of the gage length.
