Technical Report SL-94-24
November 1994

**US Army Corps
of Engineers**
Waterways Experiment
Station

Shear Reinforcement in Deep Slabs

by *Stanley C. Woodson*

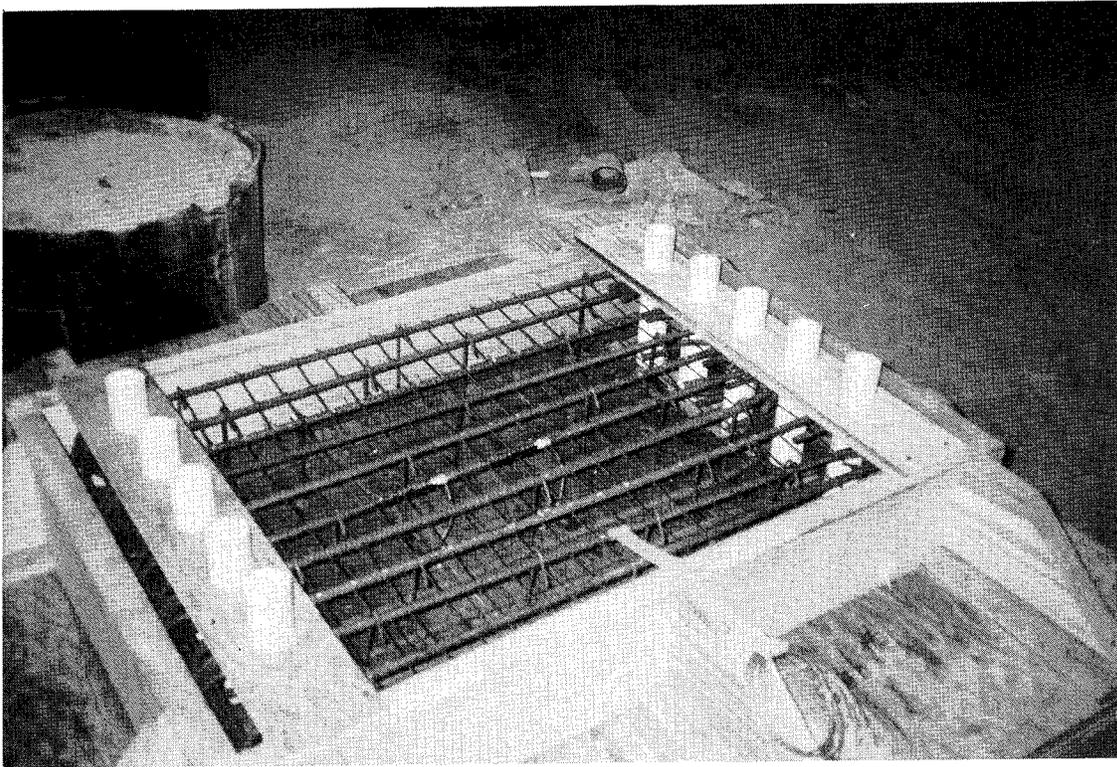
Figure 15. Slab No. 1 Prior to Concrete Placement

The slabs were constructed in the laboratory with much care to ensure quality construction with minimal error in reinforcement placement. Figures 15 through 27 are photographs of slabs no. 1 through 13 prior to the placement of concrete. Figure 28 is a close-up view of the lacing in slab no. 3, and Figure 29 is the close-up view of the stirrups in slab no. 7.

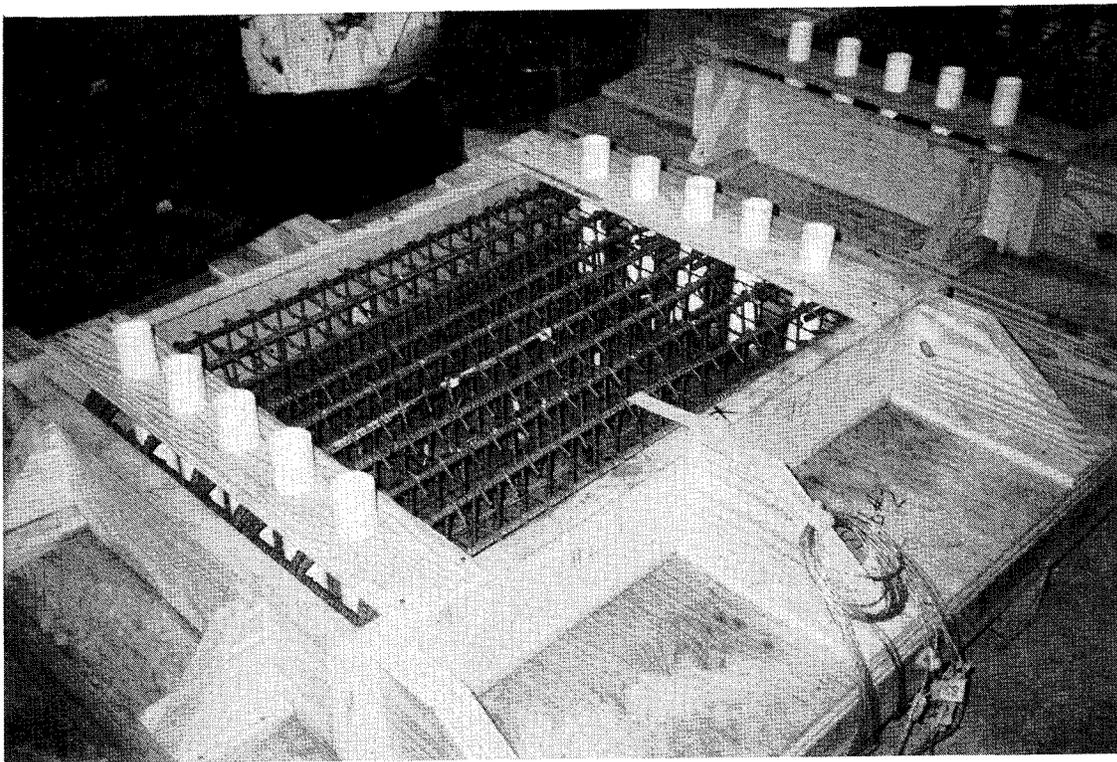
Figure 16. Slab No. 2 Prior to Concrete Placement

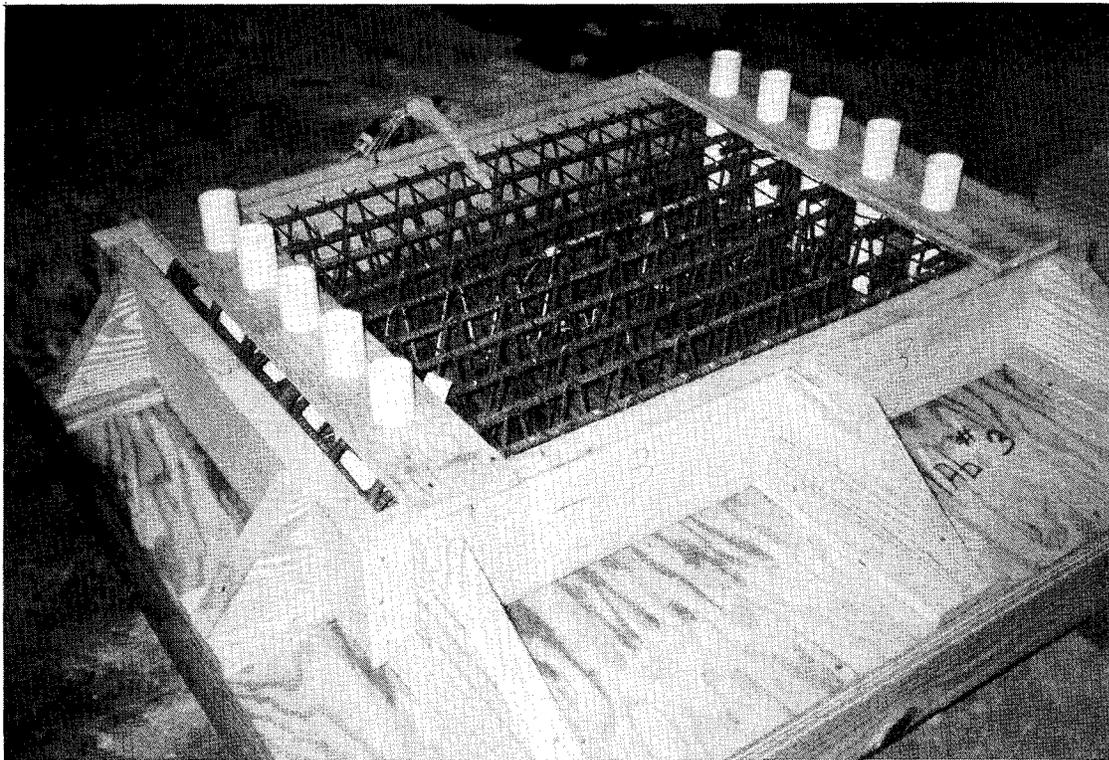
Figure 17. Slab No. 3 Prior to Concrete Placement

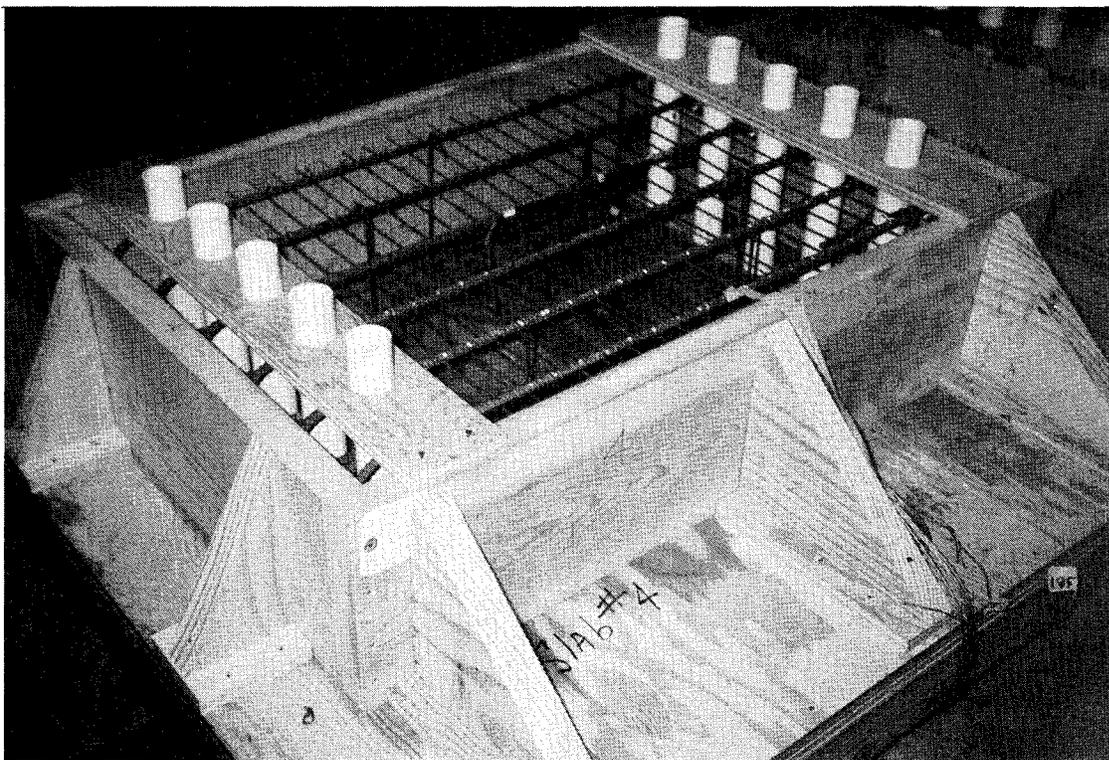
Figure 18. Slab No. 4 Prior to Concrete Placement

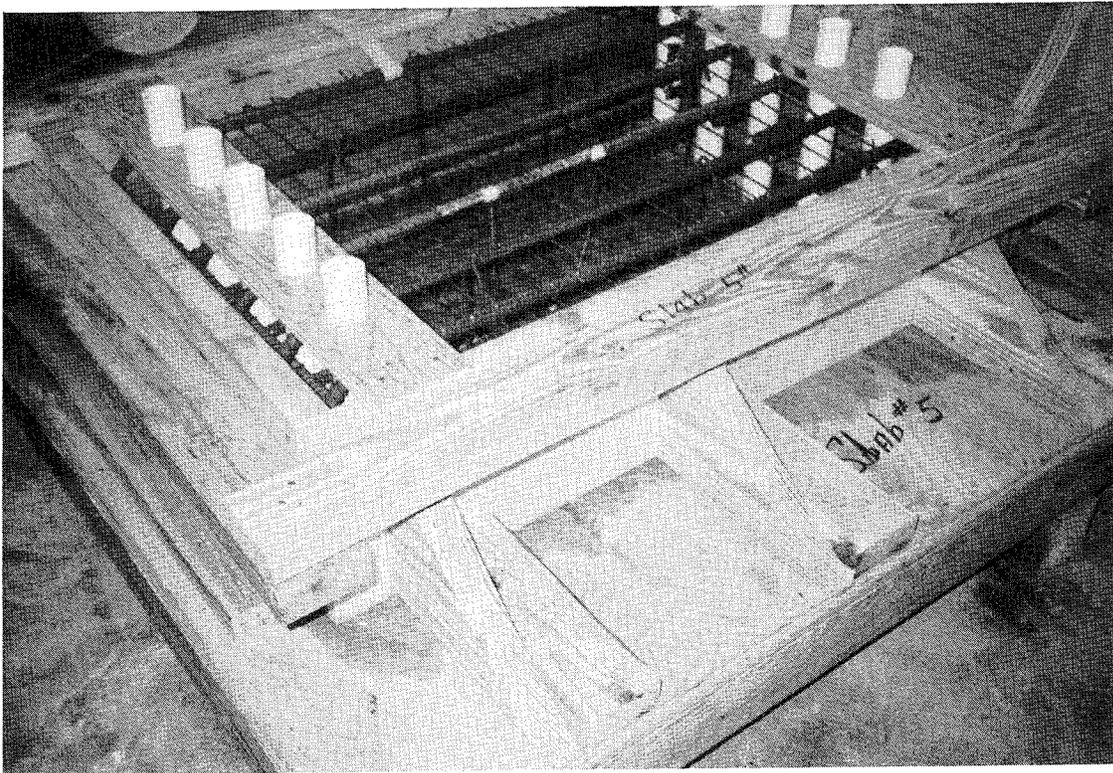
Figure 19. Slab No. 5 Prior to Concrete Placement

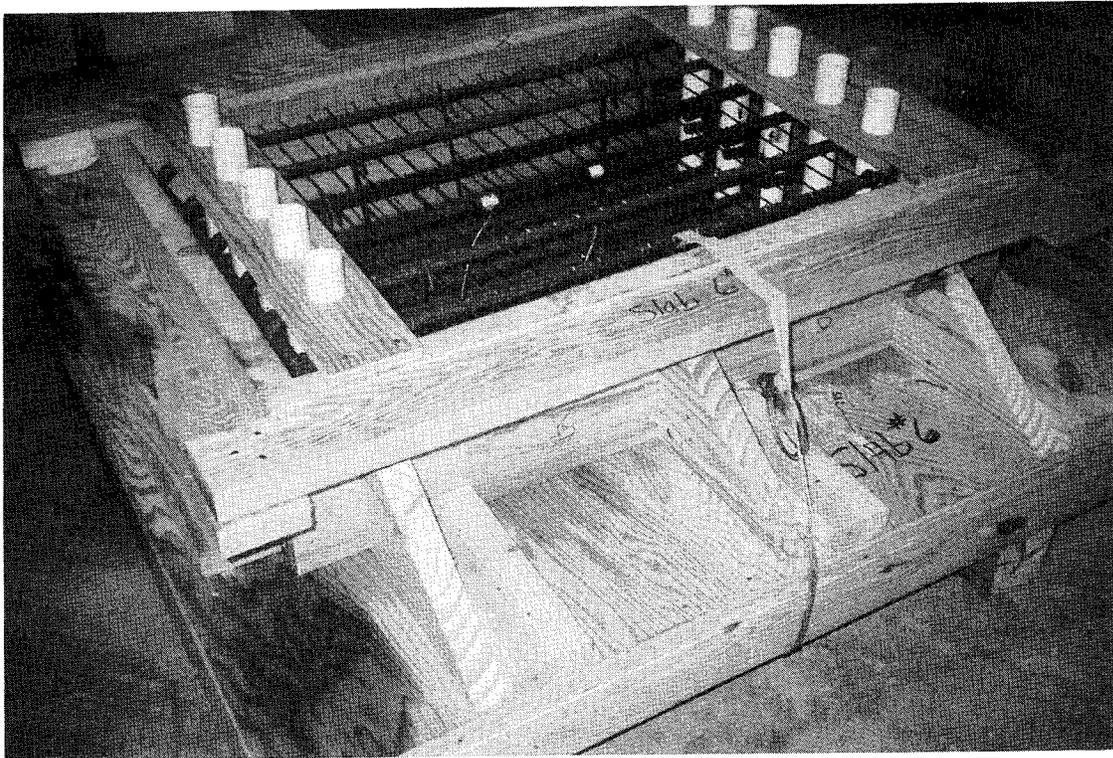
Figure 20. Slab No. 6 Prior to Concrete Placement

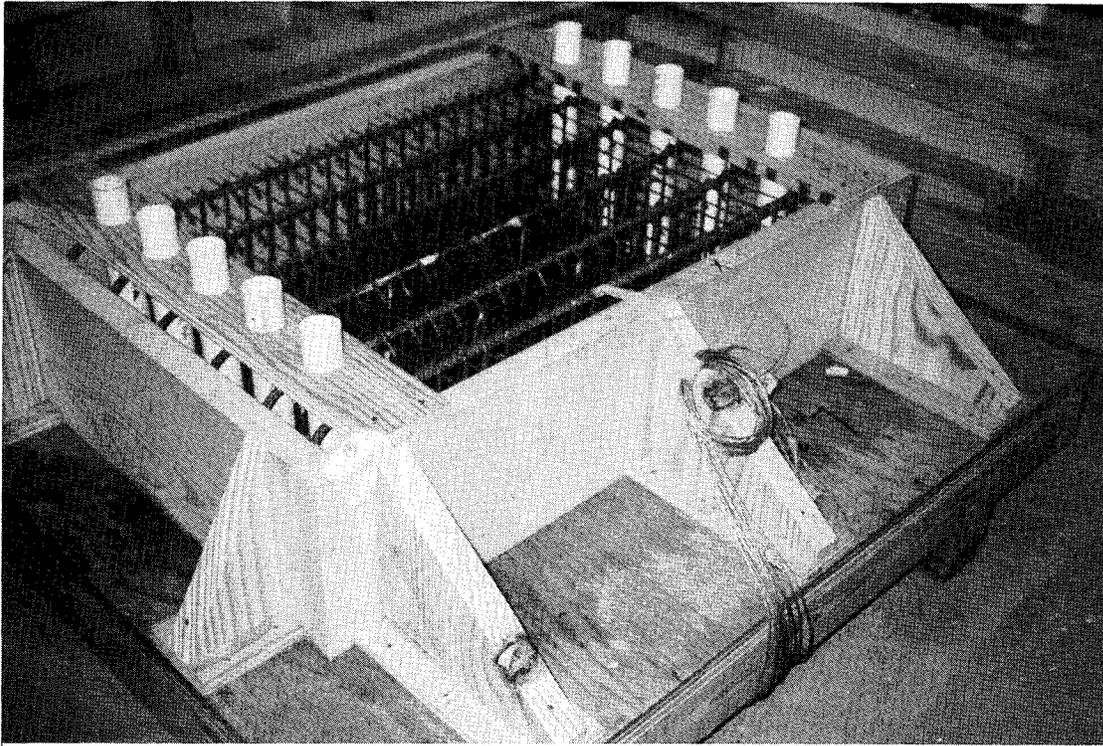
Figure 21. Slab No. 7 Prior to Concrete Placement

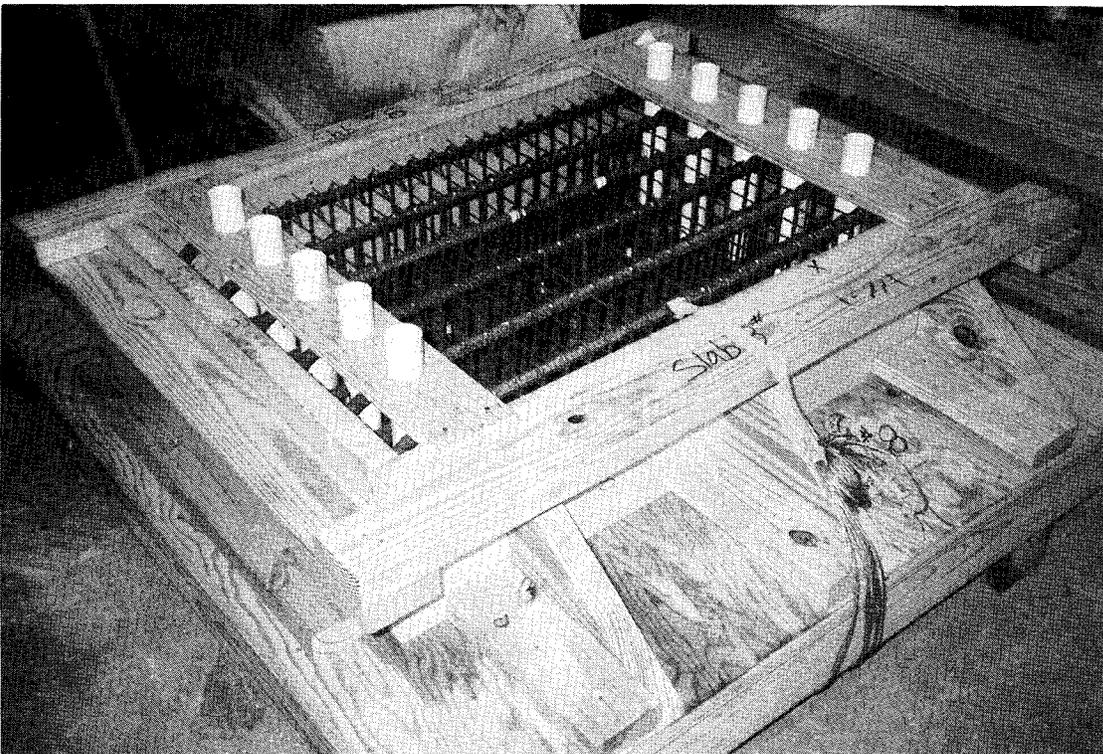
Figure 22. Slab No. 8 Prior to Concrete Placement

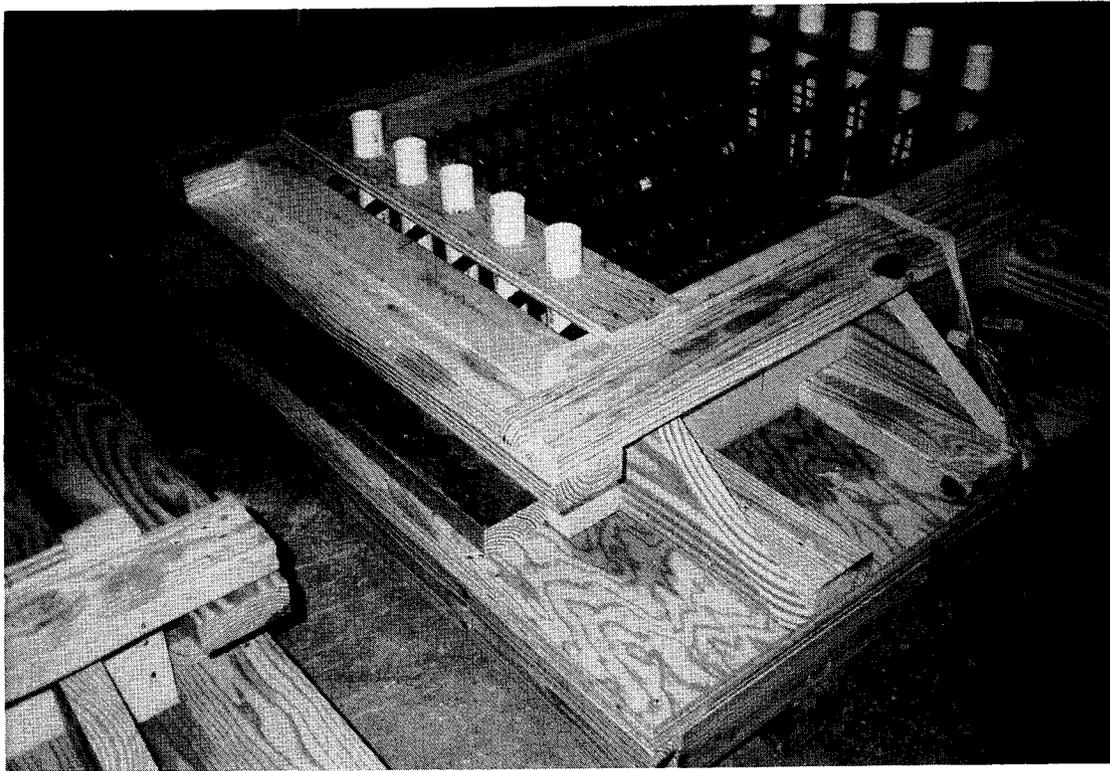
Figure 23. Slab No. 9 Prior to Concrete Placement

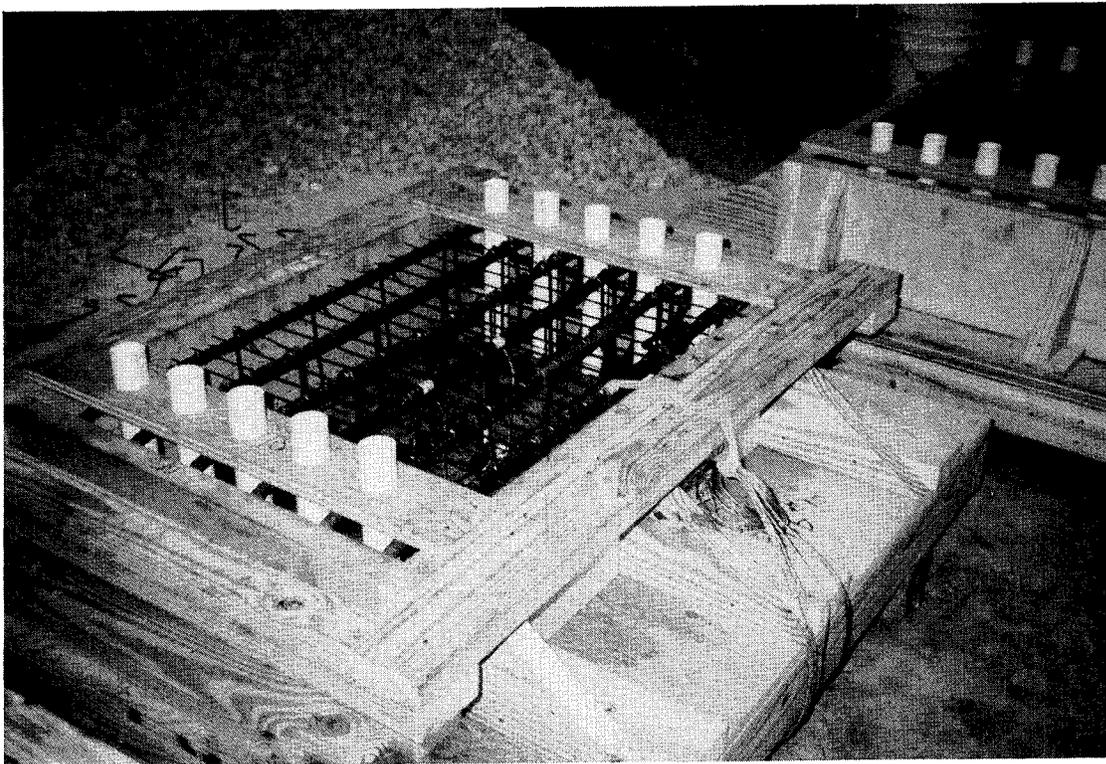
Figure 24. Slab No. 10 Prior to Concrete Placement

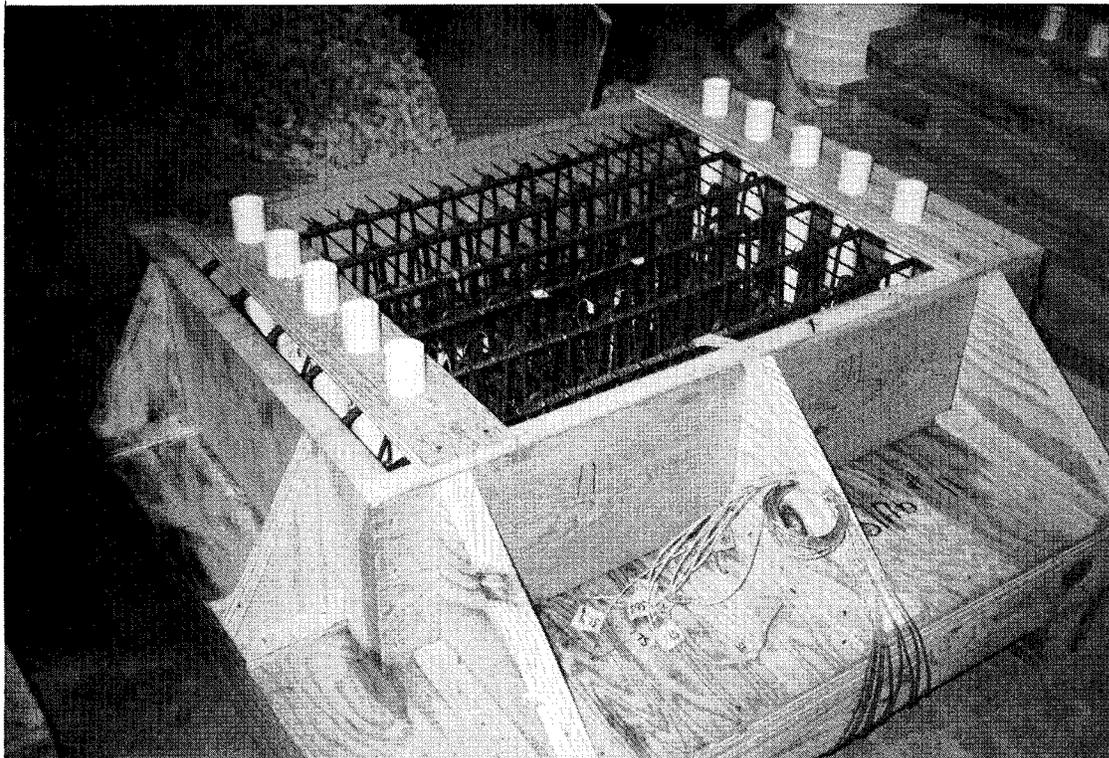
Figure 25. Slab No. 11 Prior to Concrete Placement

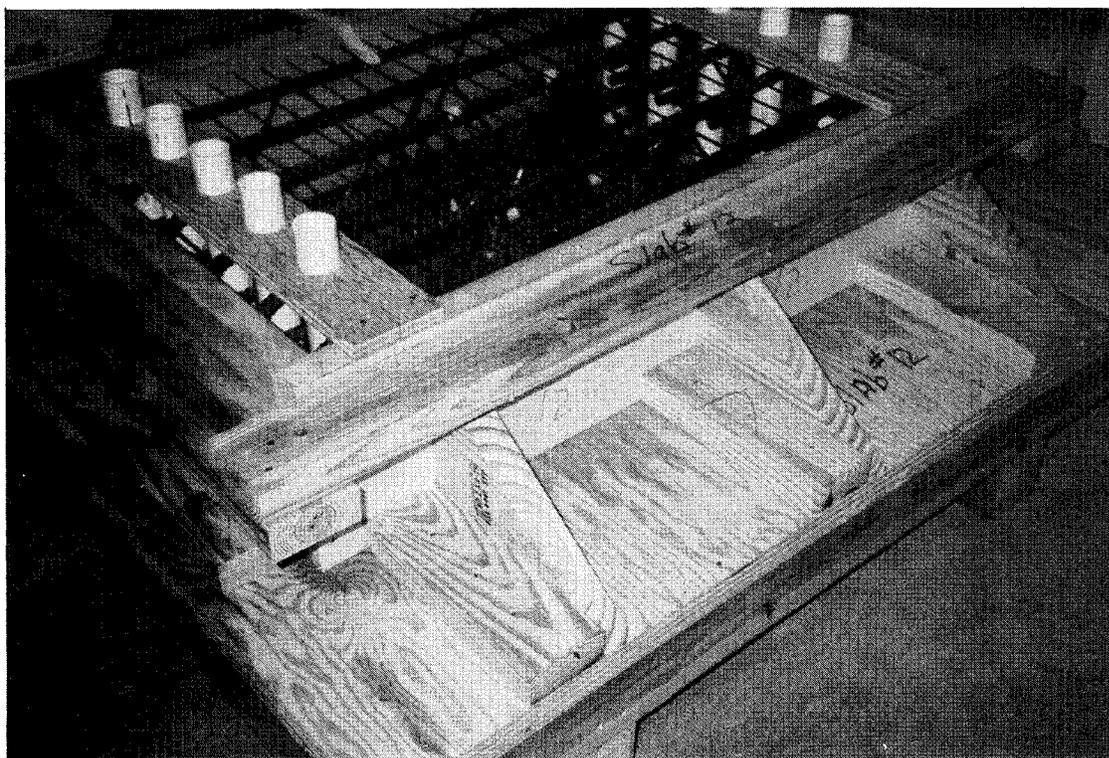
Figure 26. Slab No. 12 Prior to Concrete Placement

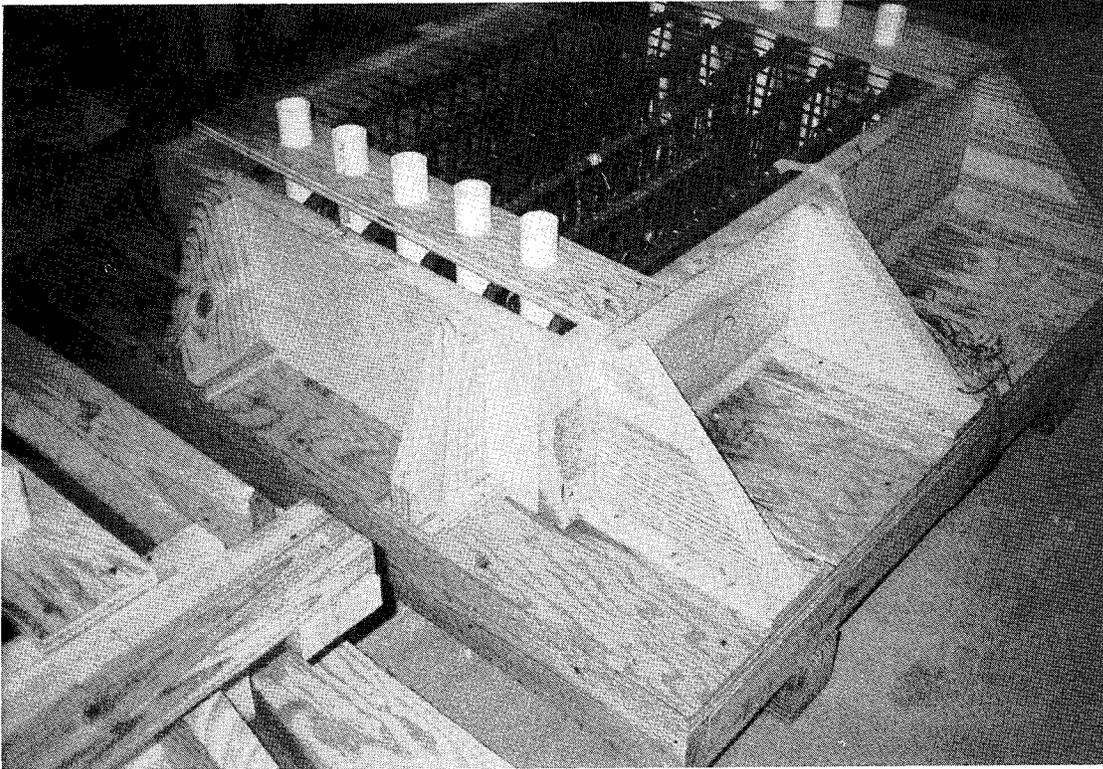
Figure 27. Slab No. 13 Prior to Concrete Placement

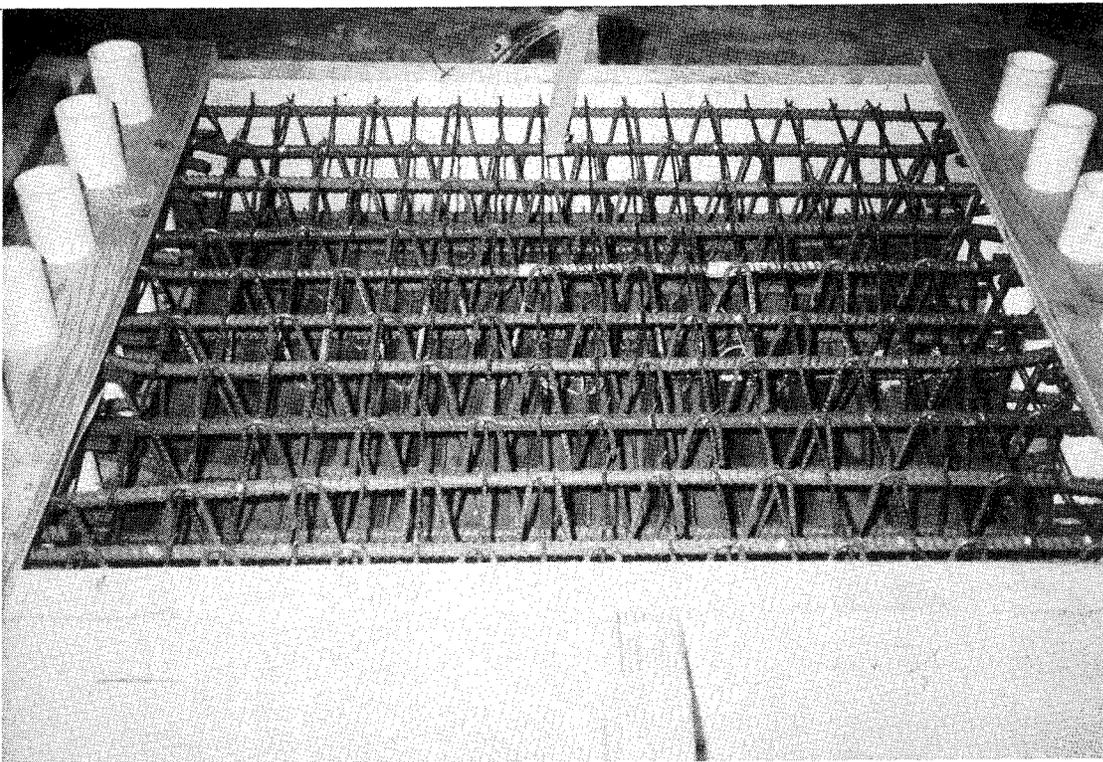
Figure 28. Close-up View of Lacing in Slab No. 3

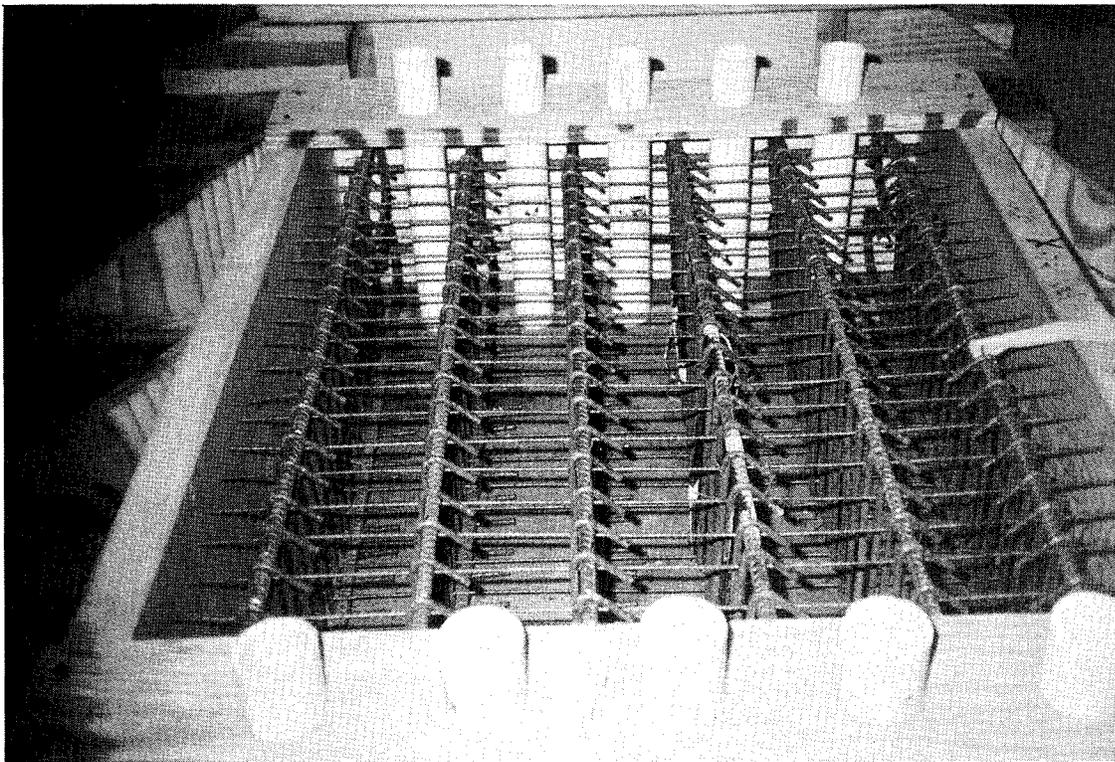
Figure 29. Close-up View of Stirrups in Slab No. 7

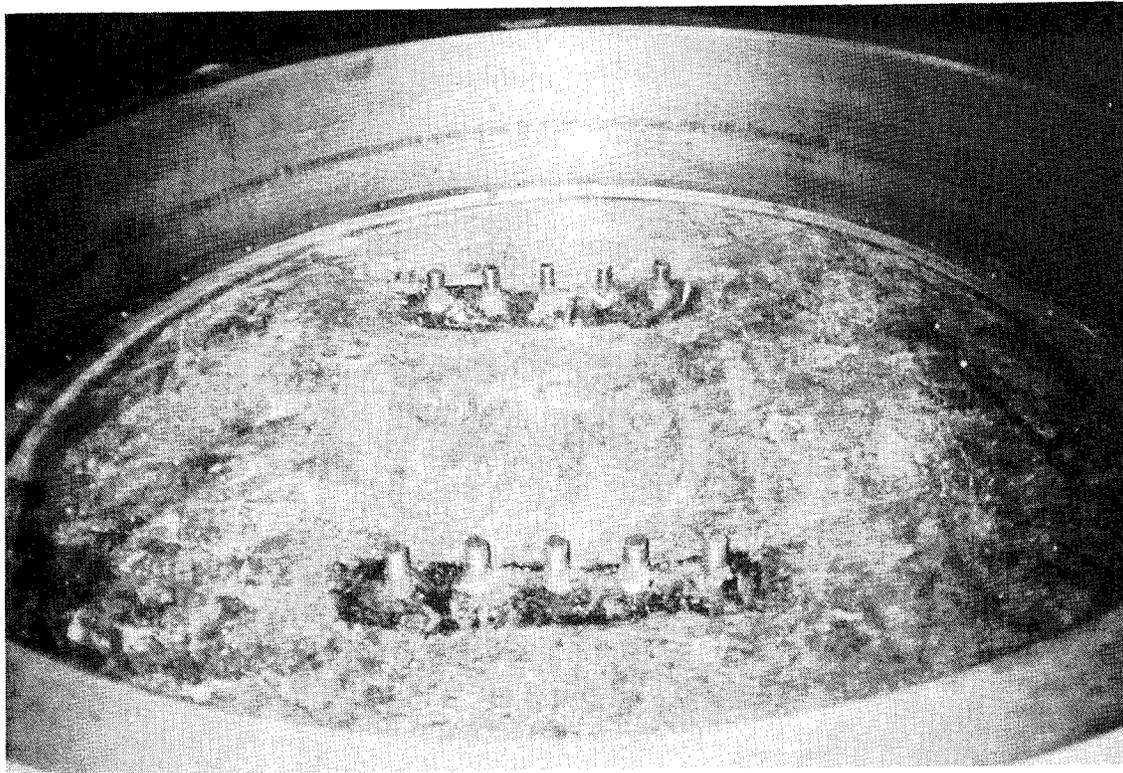
Figure 36. Membrane Covering Slab

The 6-foot diameter static test chamber was used to slowly load the slabs with water pressure. Huff (1969) presented a detailed description of the test device. Preparations for the experiments began with the reaction structure being placed inside the test chamber and surrounded with compacted sand. In general, the reaction structure consisted of a steel/concrete box without a top. Bolts for clamping the slabs protruded upward from the two sides. The reaction structure had a removable door to allow access to the space beneath the slab specimen, particularly for instrumentation requirements. Placement of a 36- by 24-inch slab in the reaction structure allowed 6 inches of the slab at each end to be clamped by a steel plate that was bolted into position, thereby leaving a 24- by 24-inch one-way restrained slab to be loaded with uniform pressure. After a slab was placed on the reaction structure, the wire leads from the instrumentation gages and transducers were connected. After placing the removable door into position, the sand backfill was completed on the door side of the reaction structure. A 1/8-inch-thick fiber-reinforced neoprene rubber membrane and a 1/8-inch-thick unreinforced neoprene rubber membrane were placed over the slab as shown in Figure 36, and 1/2- by 6- by 24-inch steel plates were bolted into position at each support. Prior to the bolting of the plates, a waterproofing putty was placed between the membrane and the steel plates to seal gaps around the bolts in order to prevent a loss of water pressure during the experiment. The chamber's lid was lowered into position (Figure 37), and the chamber was rolled inside the large reaction structure. A time of approximately 18 minutes was required to fill the bonnet indicated when the bonnet had been filled. At that time, the waterline valve was again closed to allow closing of the relief plug. The waterline valve was once again opened slowly, inducing a slowly increasing load to the slab's surface as the lid of the chamber was pushed upward and against the large reaction structure (shown in the background of Figure 37). A gasoline-powered pump was connected to the waterline to facilitate water pressure loading since the commercial line pressure was not great enough to reach ultimate resistance of the slab in any of the experiments. Monitoring of the pressure gages and deflection gages indicated the behavior of the slab during the experiment and enabled this author to make decision for experiment termination by closing the waterline valve. The loading was controlled at a slowly changing rate, resulting in a load application time of several minutes. Following experiment termination, measurements and photographs of the slab were taken after removal of the neoprene membrane. Finally, the damaged slab was removed and the reaction structure was prepared for another slab.

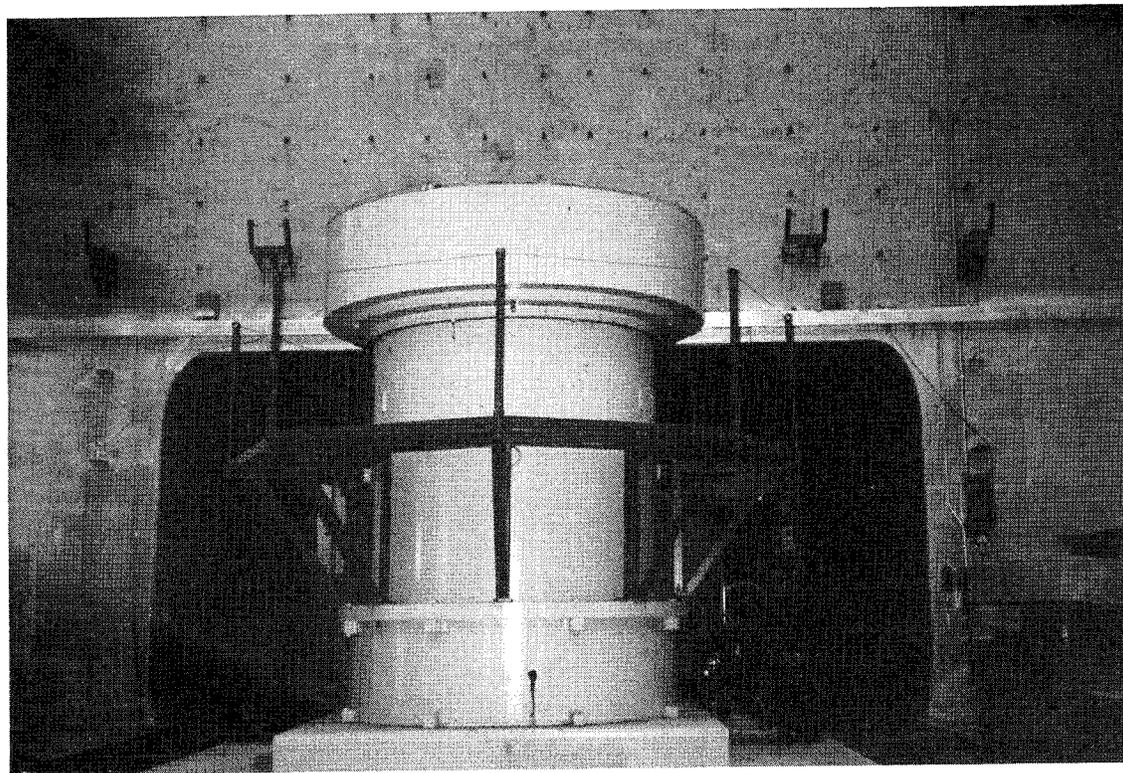
Figure 37. Test Chamber Ready to Roll Inside Large Reaction Structure

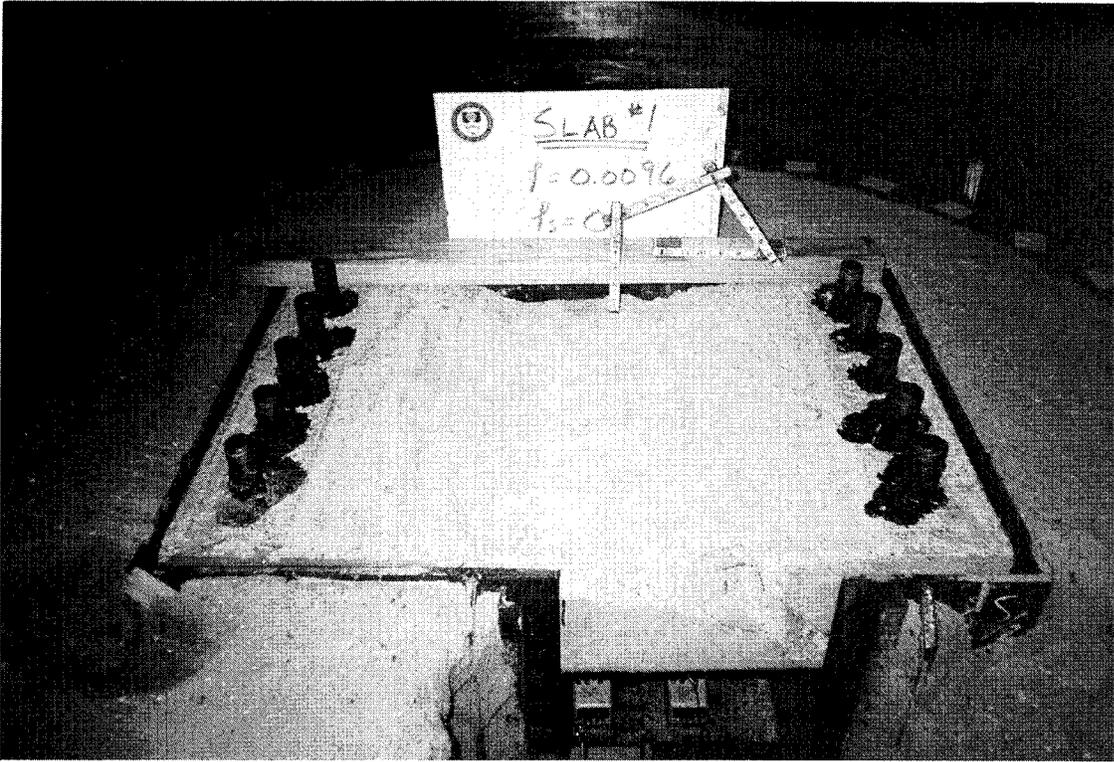
Figure 38. Posttest View of Slab No. 1

Posttest measurements and inspection provided a data check and damage assessment of each slab prior to removal from the reaction structure. Figures 38 through 50 show the posttest condition of each slab. Except for slab no. 4, Figures 38 through 50 show the slab immediately after removal of the neoprene membrane. For slab no. 4, Figure 41 shows the slab after removal from the reaction structure. Slab no. 4 was only slightly damaged and, therefore, could be safely removed from the reaction structure prior to photography. Figure 41 provides a better view of the side crack pattern than was allowed while the slab remained in the reaction structure.

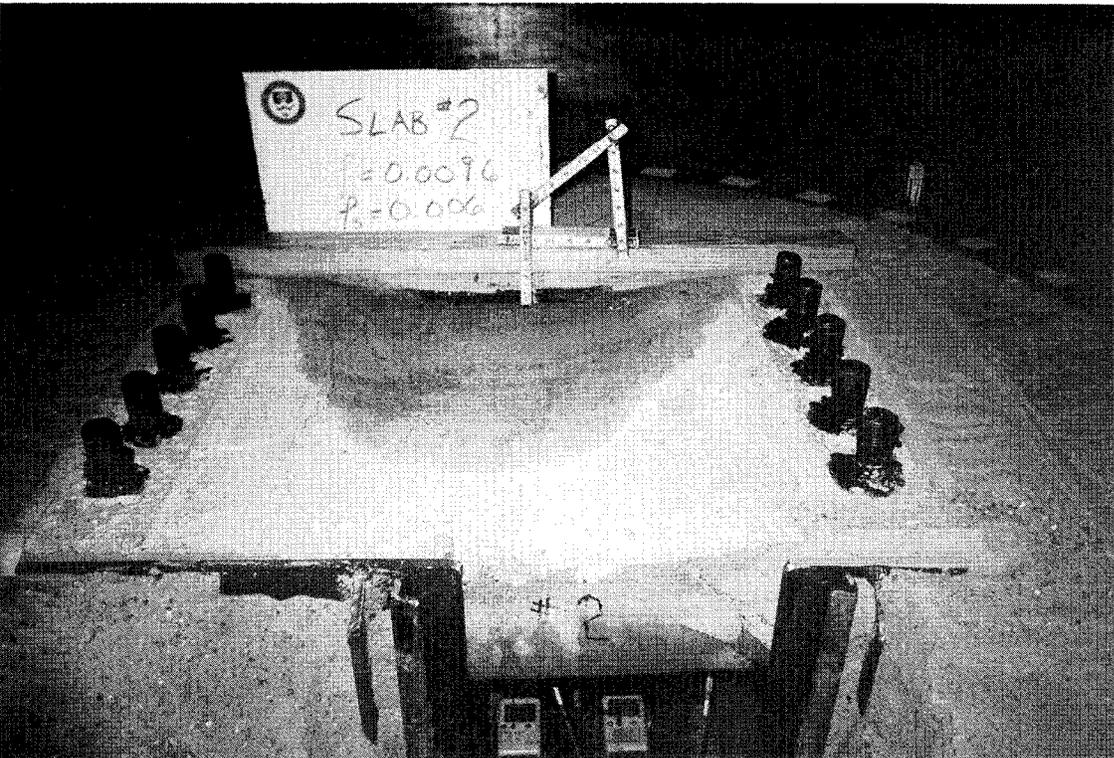
Figure 39. Posttest View of Slab No. 2

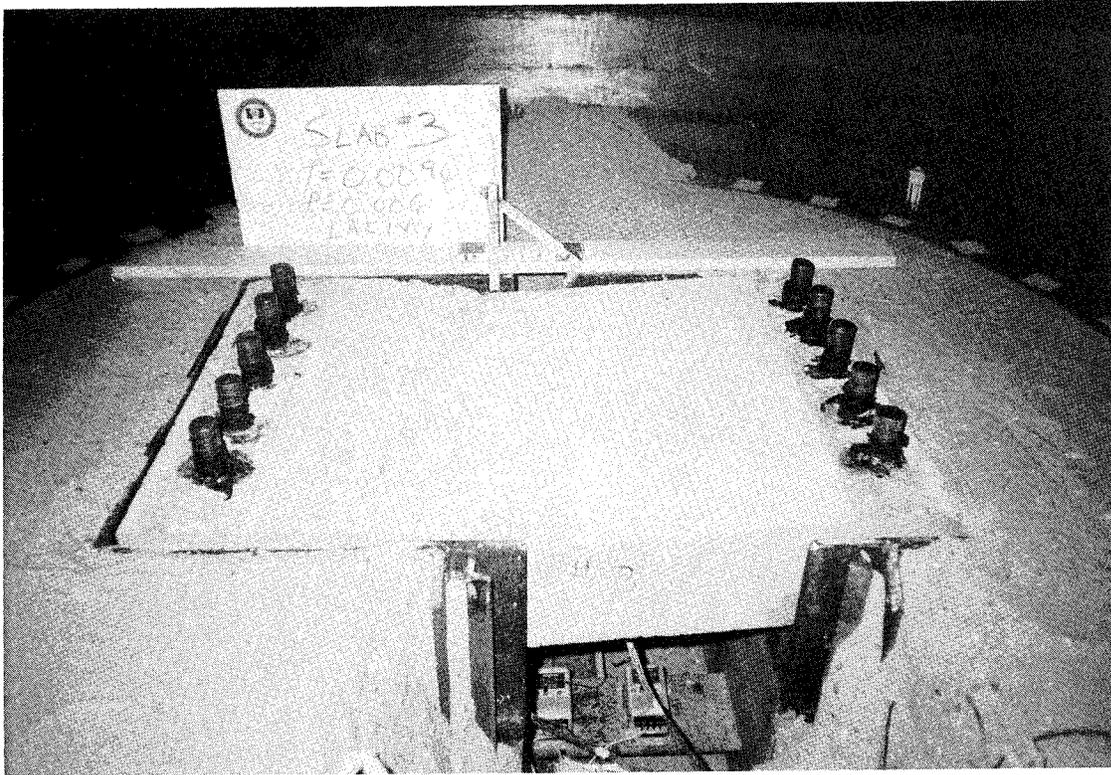
Figure 40. Posttest View of Slab No. 3

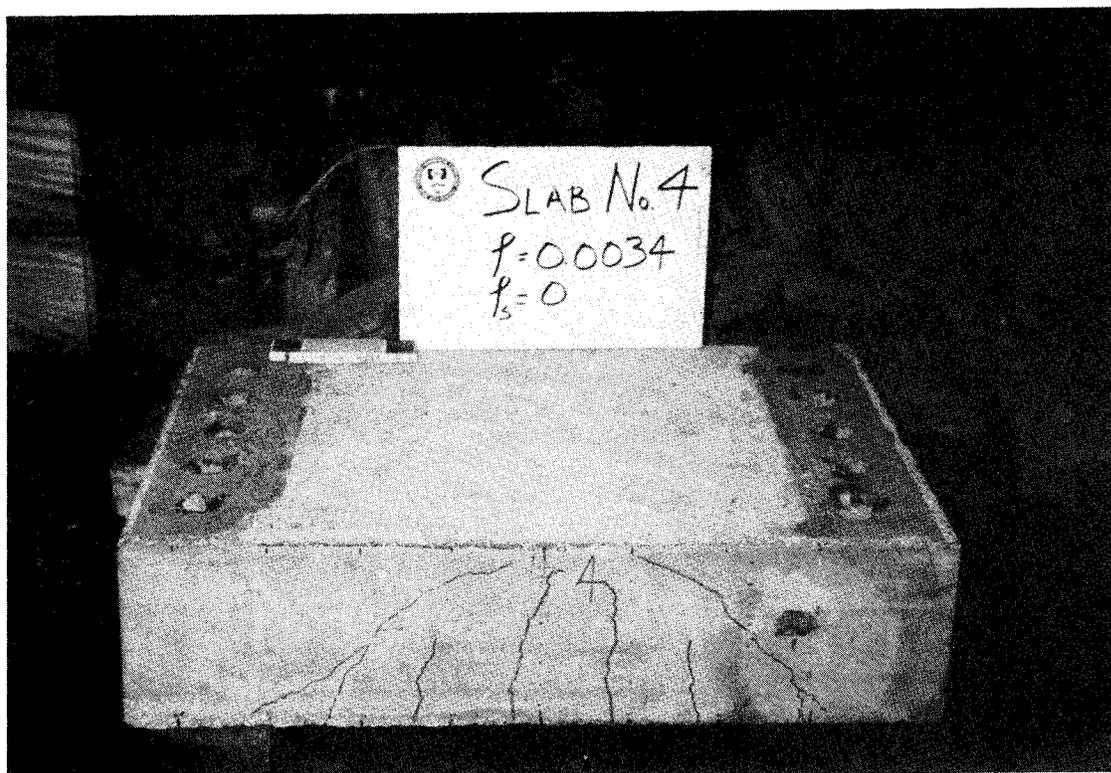
Figure 41. Posttest View of Slab No. 4

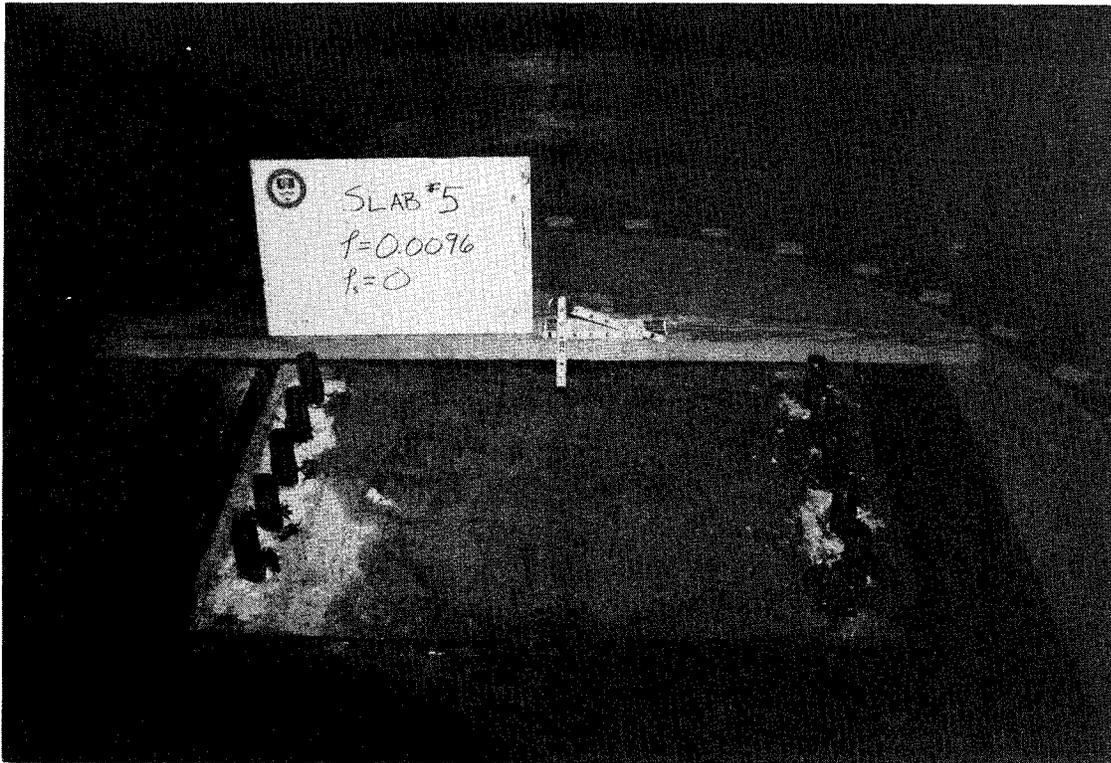
Figure 42. Posttest View of Slab No. 5

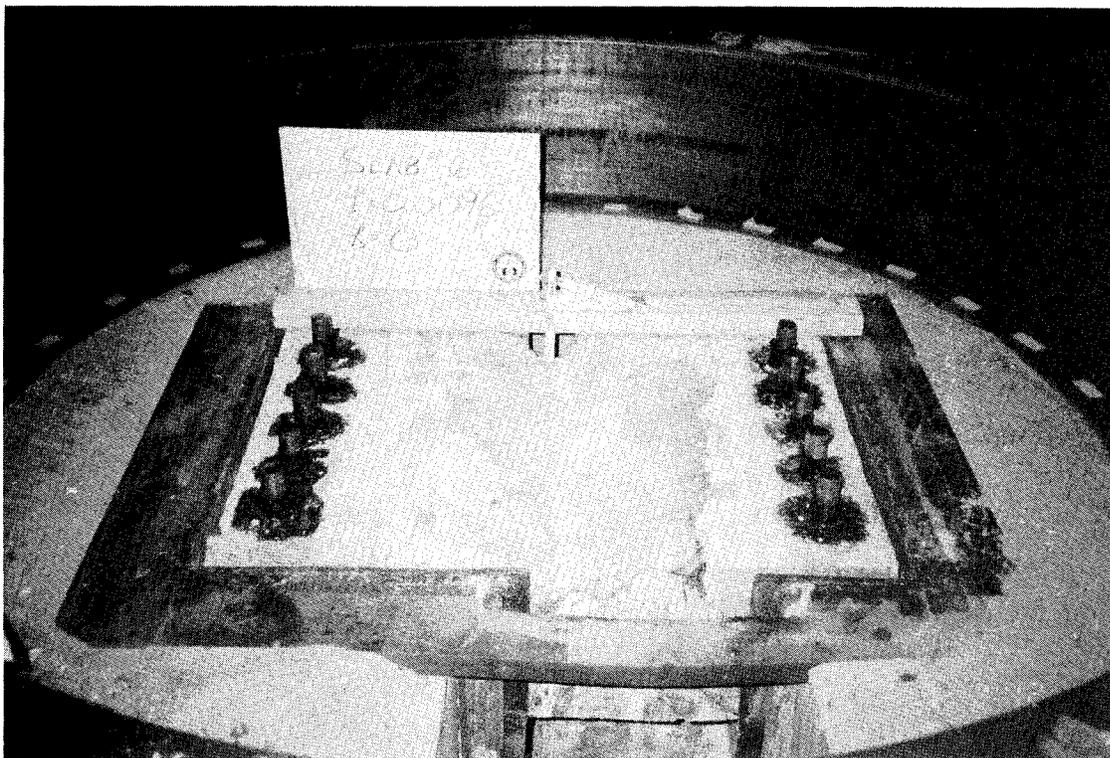
Figure 43. Posttest View of Slab No. 6

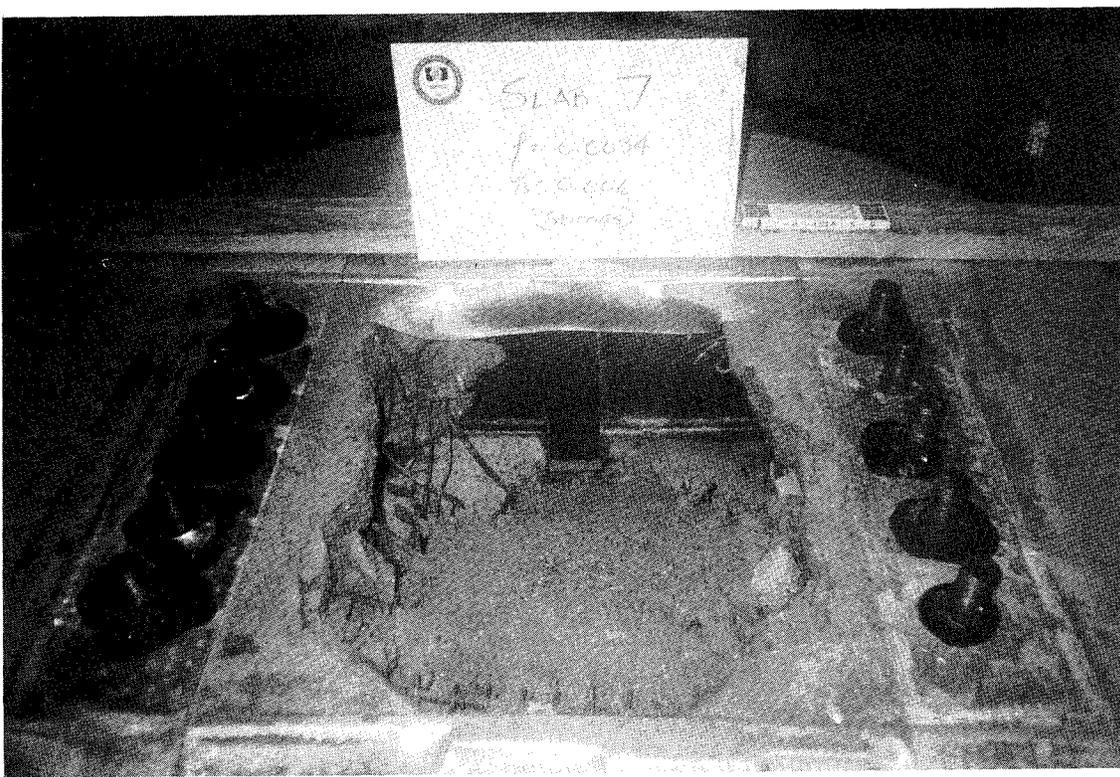
Figure 44. Posttest View of Slab No. 7

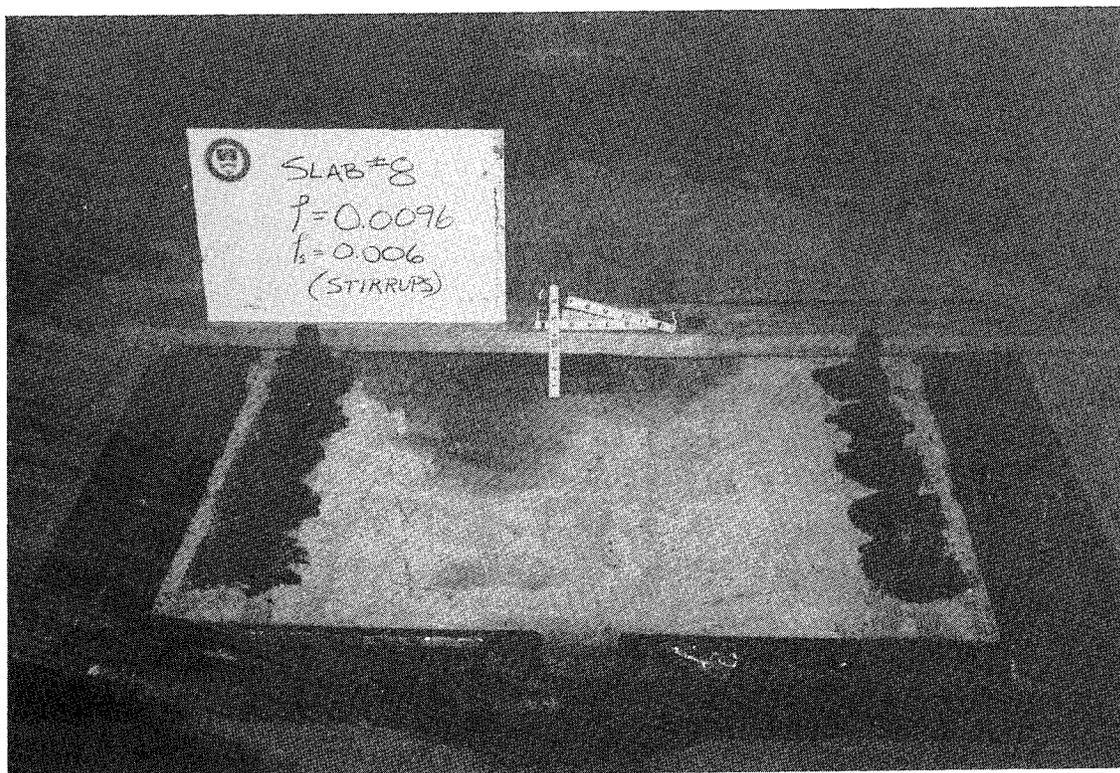
Figure 45. Posttest View of Slab No. 8
