Technical Report SL-94-24
November 1994

**US Army Corps
of Engineers**
Waterways Experiment
Station

Shear Reinforcement in Deep Slabs

by *Stanley C. Woodson*

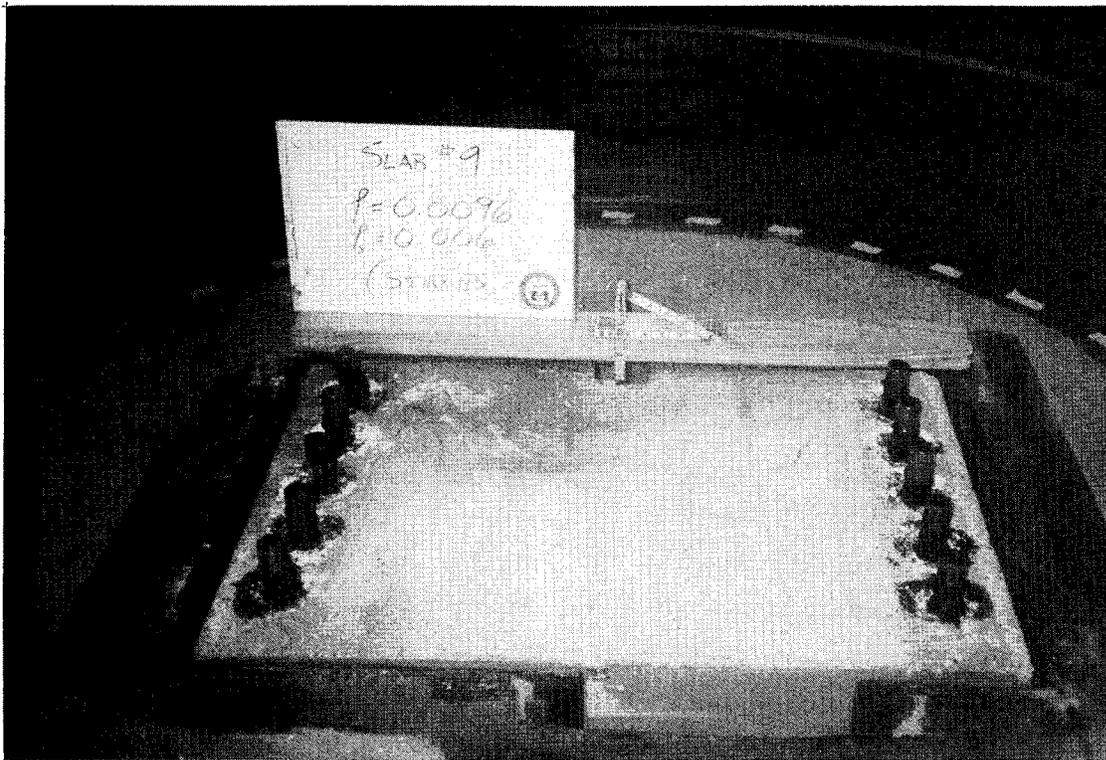
Figure 46. Posttest View of Slab No. 9

Posttest measurements and inspection provided a data check and damage assessment of each slab prior to removal from the reaction structure. Figures 38 through 50 show the posttest condition of each slab. Except for slab no. 4, Figures 38 through 50 show the slab immediately after removal of the neoprene membrane. For slab no. 4, Figure 41 shows the slab after removal from the reaction structure. Slab no. 4 was only slightly damaged and, therefore, could be safely removed from the reaction structure prior to photography. Figure 41 provides a better view of the side crack pattern than was allowed while the slab remained in the reaction structure.

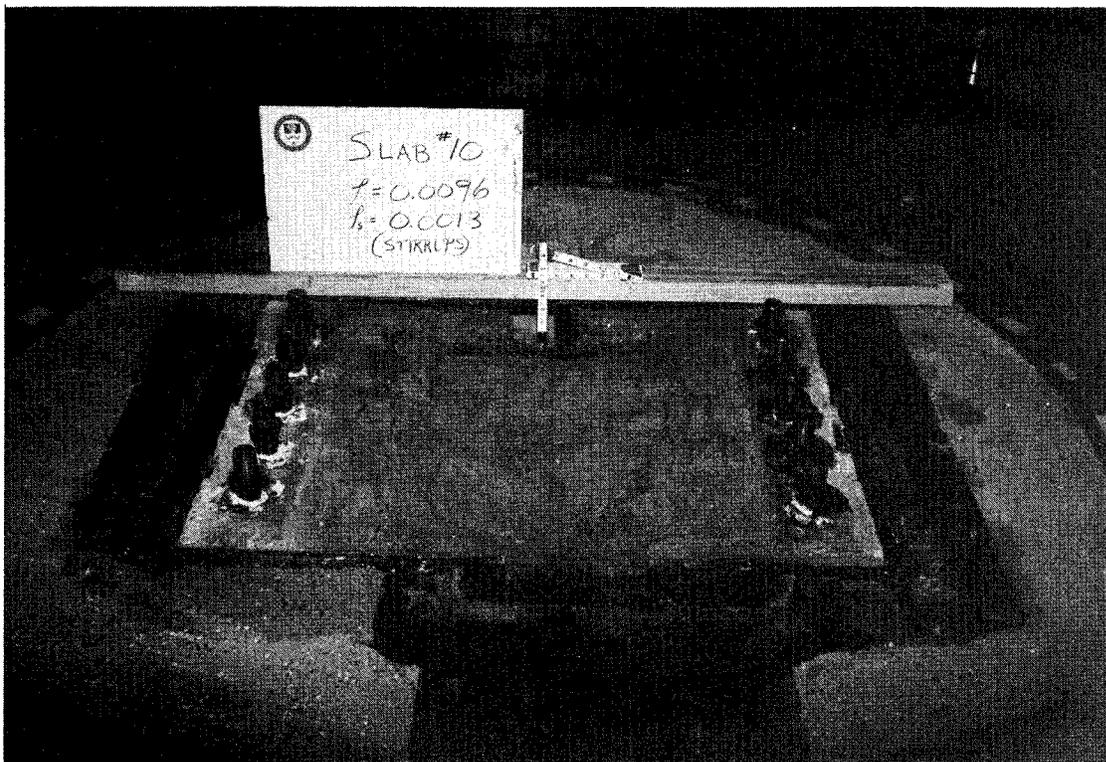
Figure 47. Posttest View of Slab No. 10

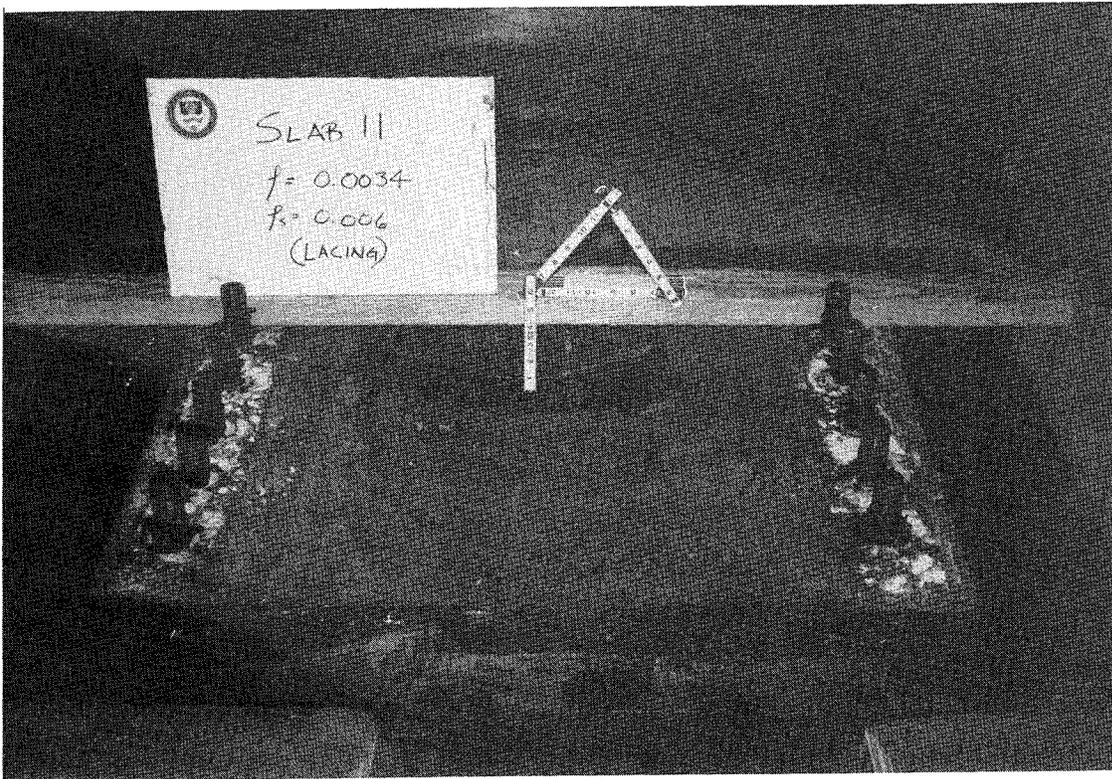
Figure 48. Posttest View of Slab No. 11

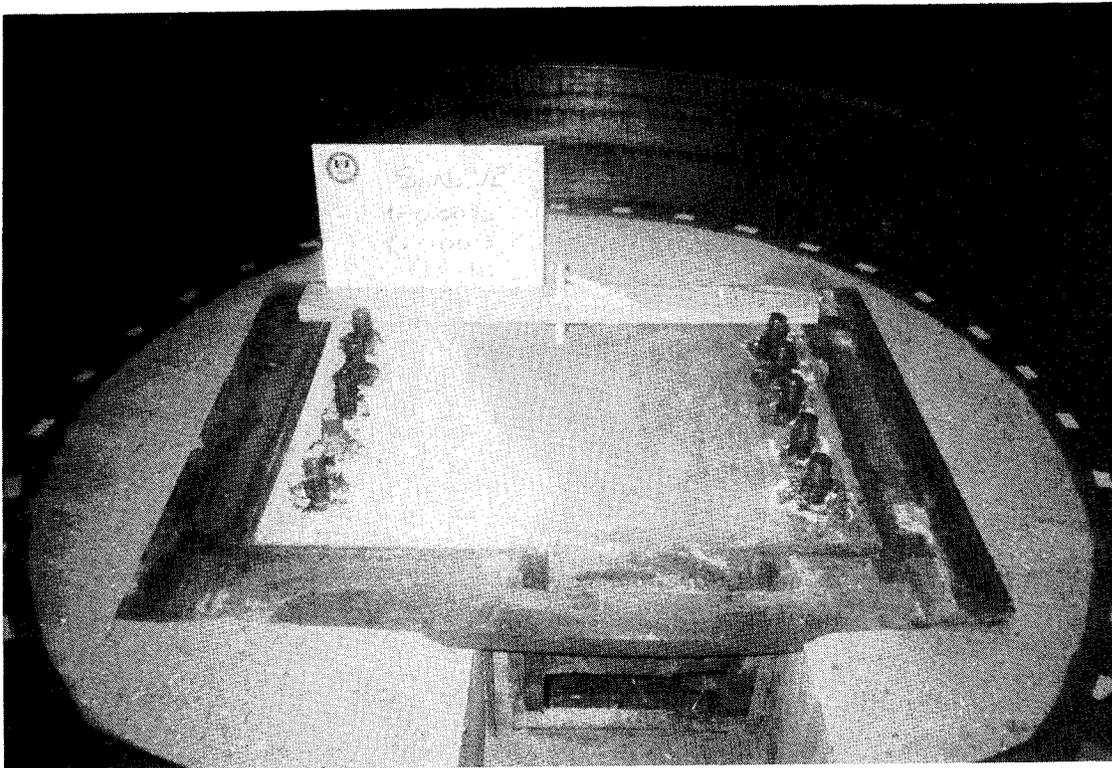
Figure 49. Posttest View of Slab No. 12

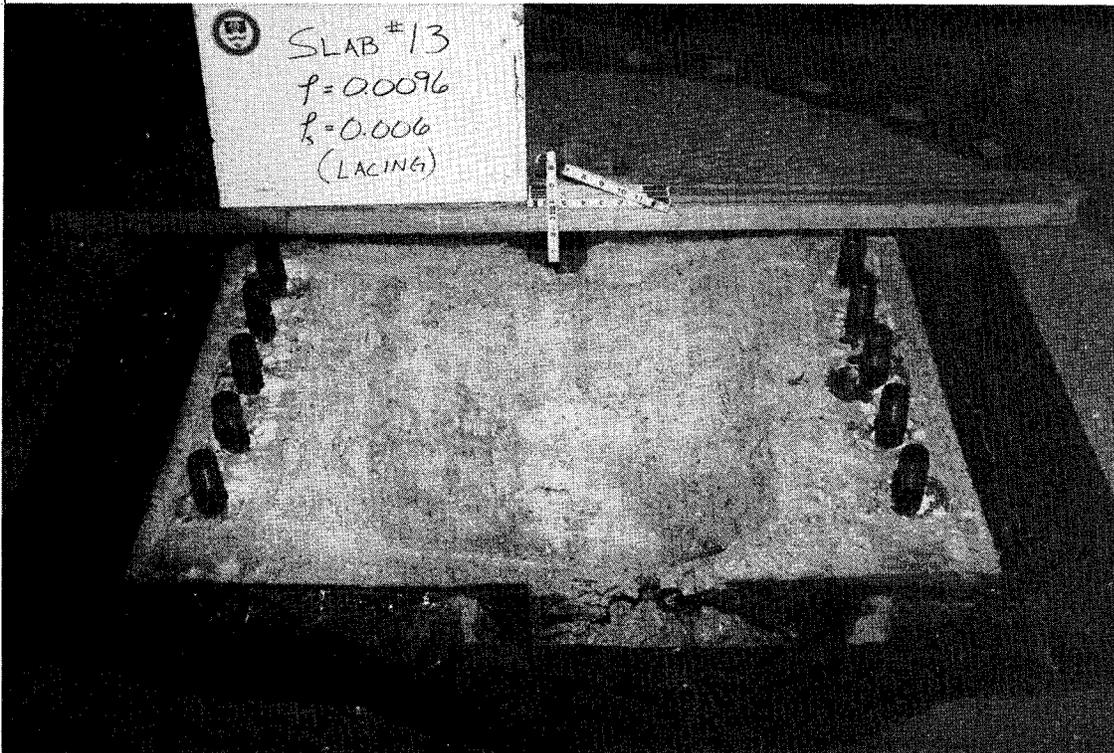
Figure 50. Posttest View of Slab No. 13

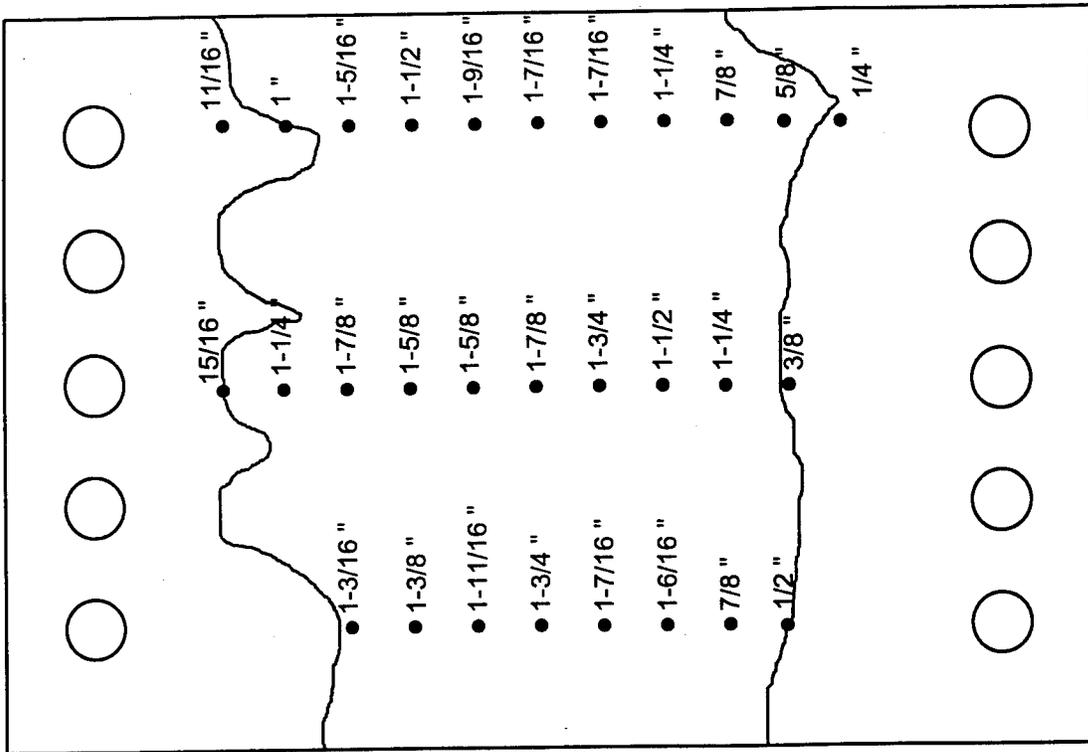
Figure 62. Posttest Deflection Survey for Slab No. 5

Figures 60 through 69 present the posttest deflection survey data. In these figures, permanent deflections measured on the top (loading) surfaces of the slabs are given at numerous locations. Additionally the locations of major

cracks are drawn. The circles shown in the figures represent the locations of the bolt holes; thus, a 24-by-36-in slab is shown in each figure. The clear span for each slab was 24 inches. Slabs no. 4 and 7 are not included in the deflection survey figures since slab no. 4 was not loaded to significant damage and slab no. 7 incurred catastrophic damage.

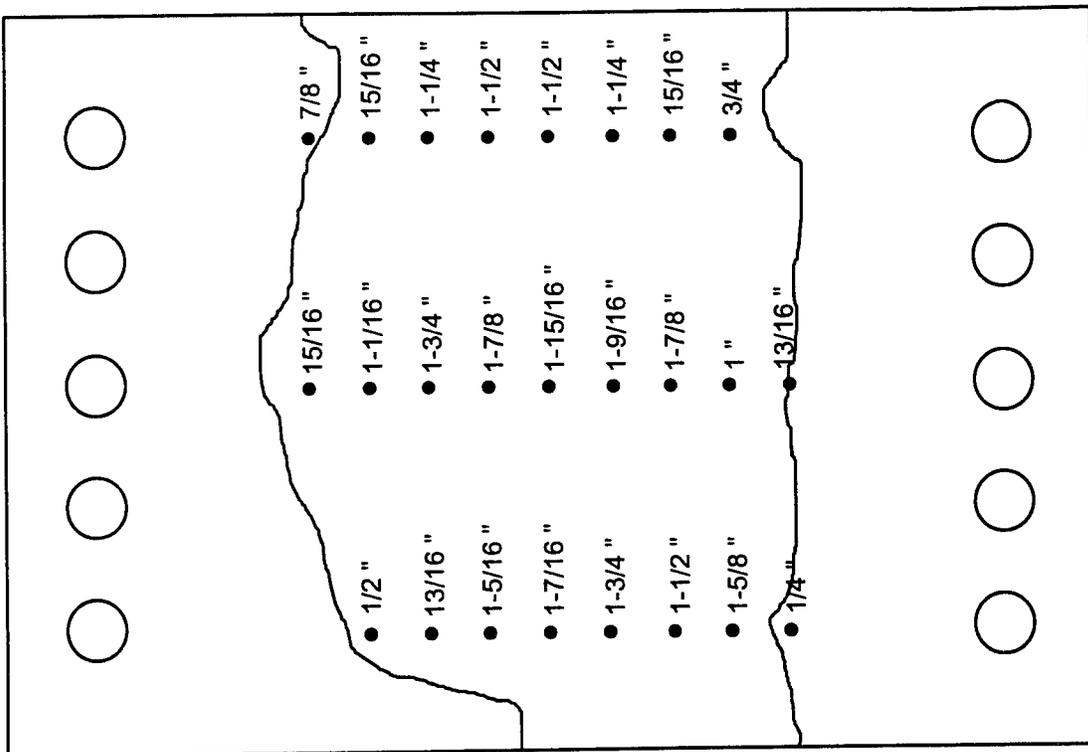
Figure 63. Posttest Deflection Survey for Slab No. 6

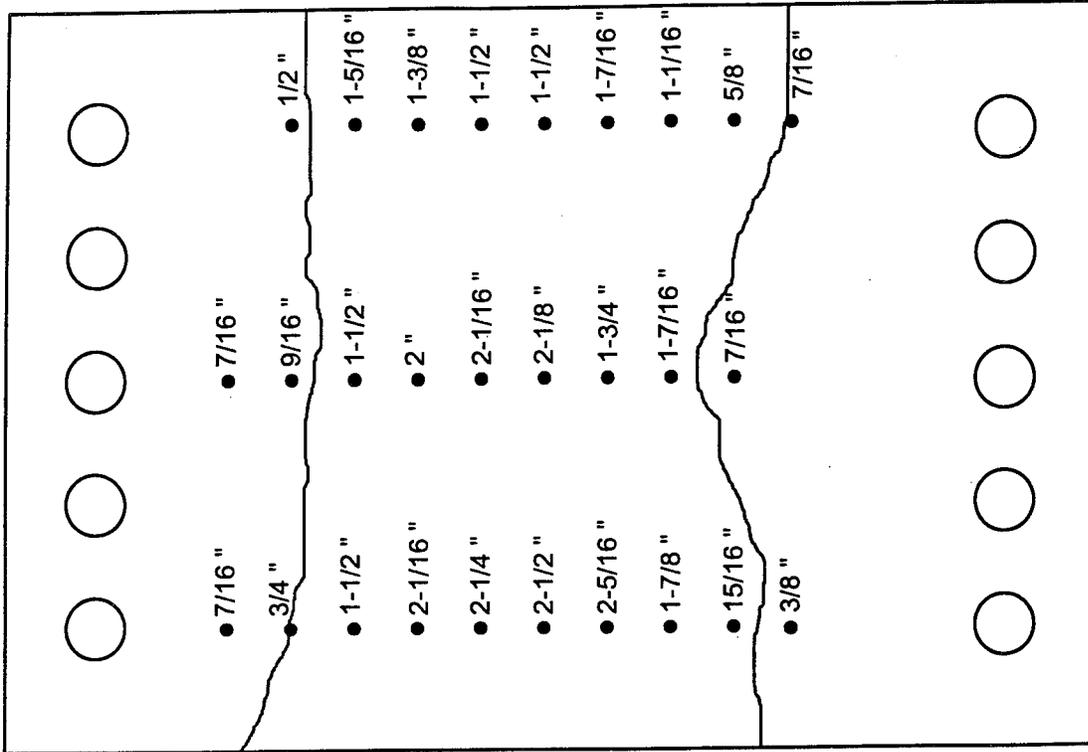
Figure 64. Posttest Deflection Survey for Slab No. 8

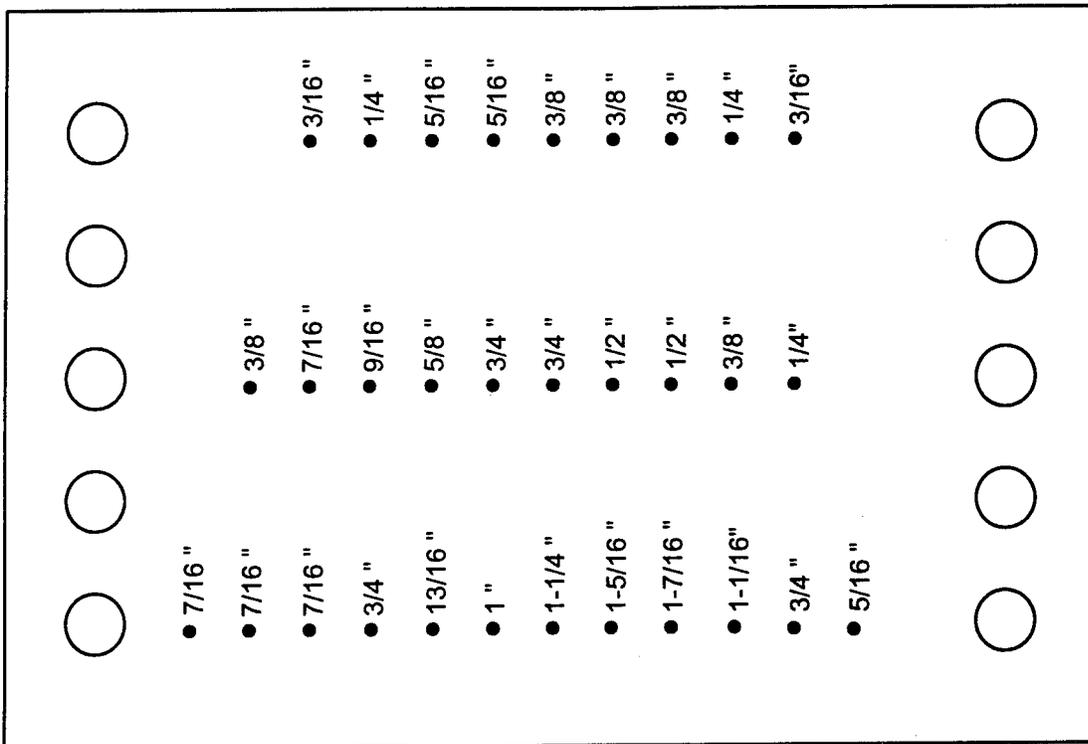
Figure 65. Posttest Deflection Survey for Slab No. 9

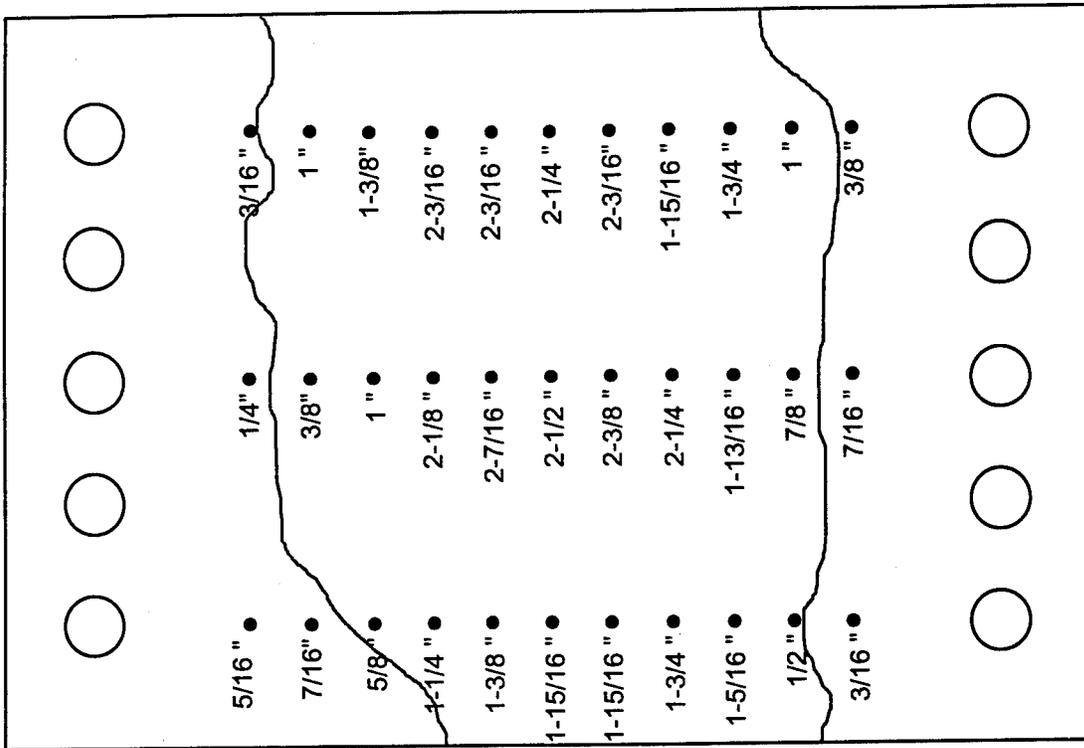
Figure 66. Posttest Deflection Survey for Slab No. 10

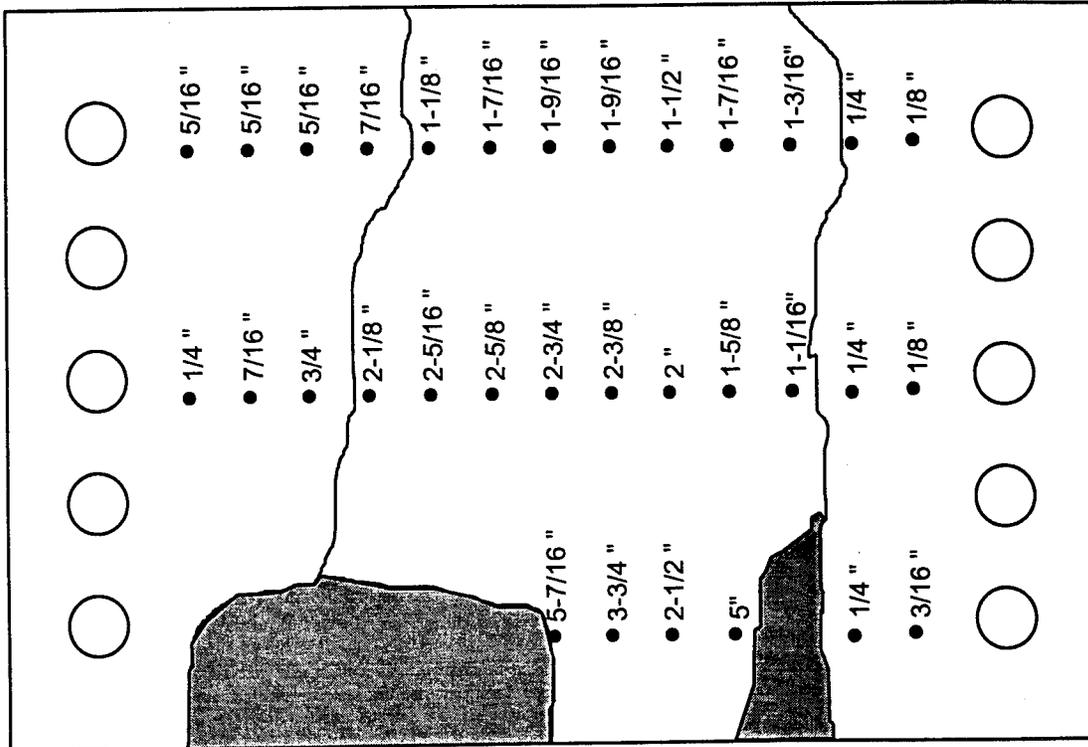
Figure 67. Posttest Deflection Survey for Slab No. 11

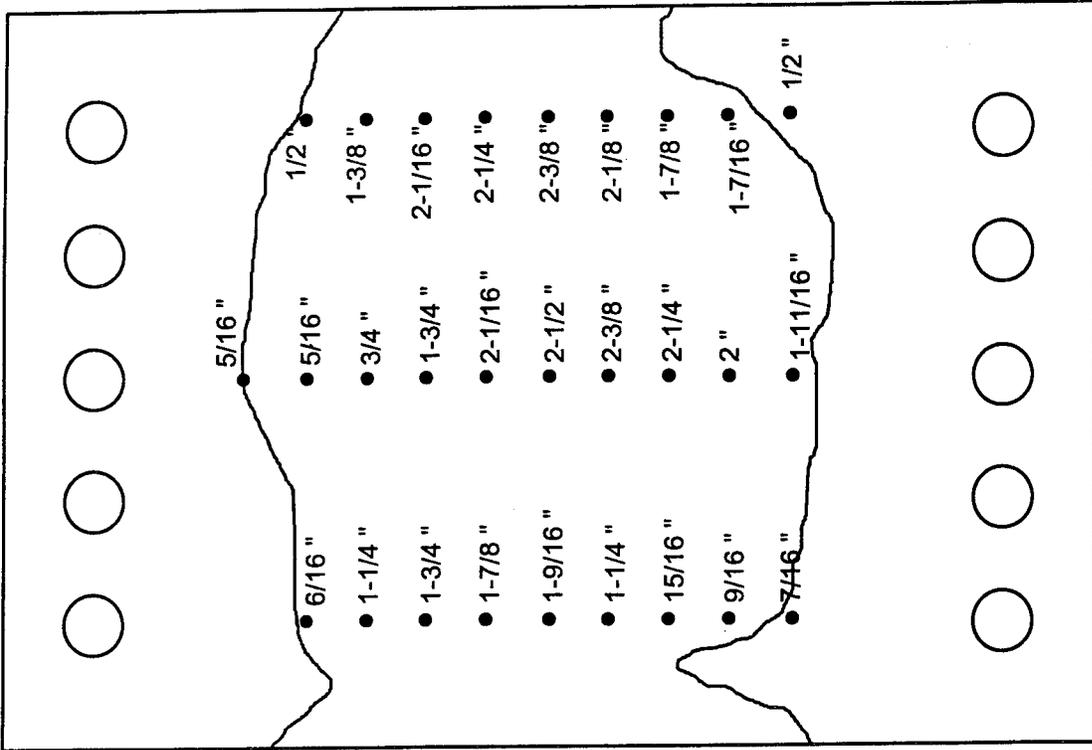
Figure 68. Posttest Deflection Survey for Slab No. 12

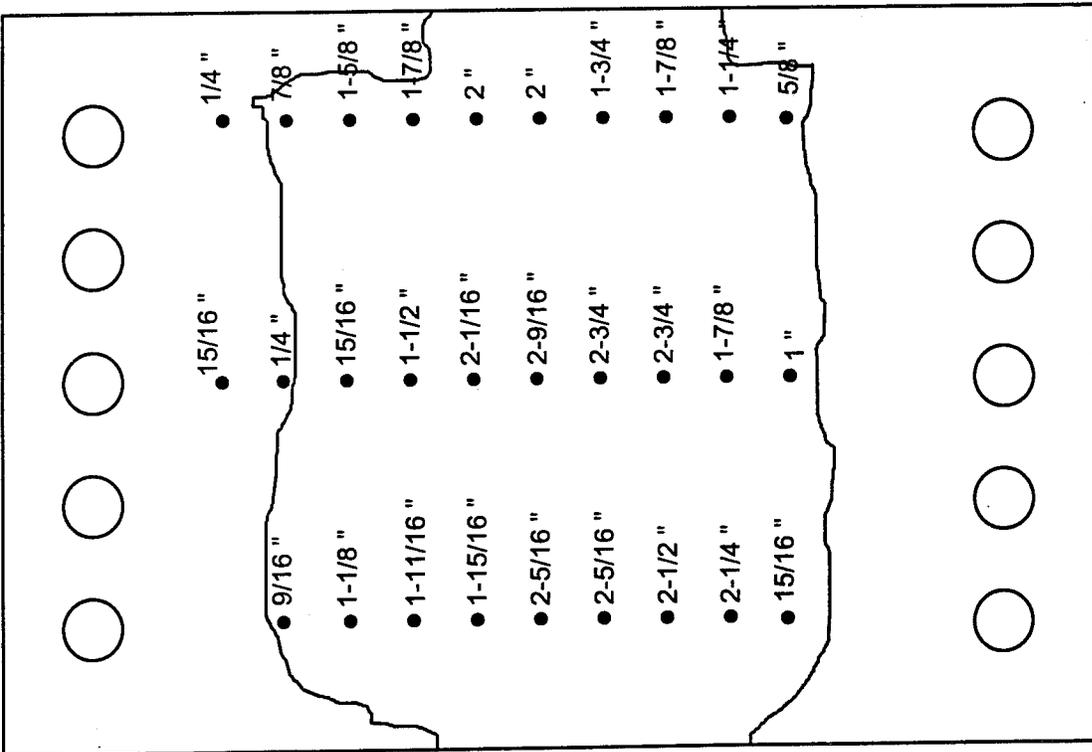
Figure 69. Posttest Deflection Survey for Slab No. 13

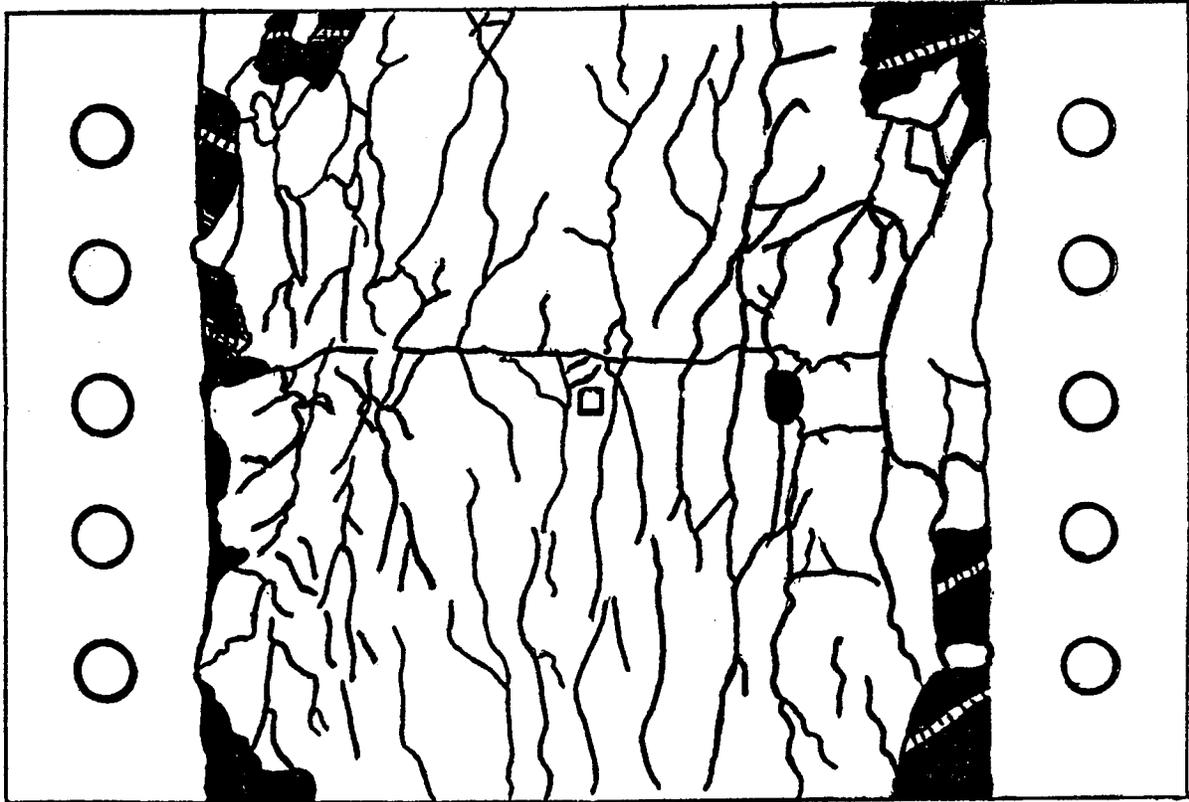
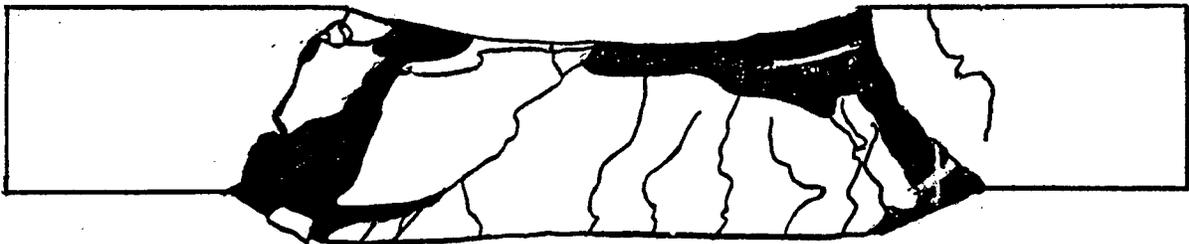
a. Bottom View

b. Side View

Figure 70. Sketch of Damage for Slab No. 1

Figures 70 through 80 are artist sketches of the bottom and side posttest views of the slabs. Sketches are not included for slabs no. 7 and 11 since they were damaged too heavily for a meaningful drawing. Figures 60 through 80 are useful for the reader that wants to carefully evaluate the response of the slabs. In this report, the figures will not be discussed in detail, but rather are used to support the observations and conclusions drawn from the instrumentation data and damage photographs.

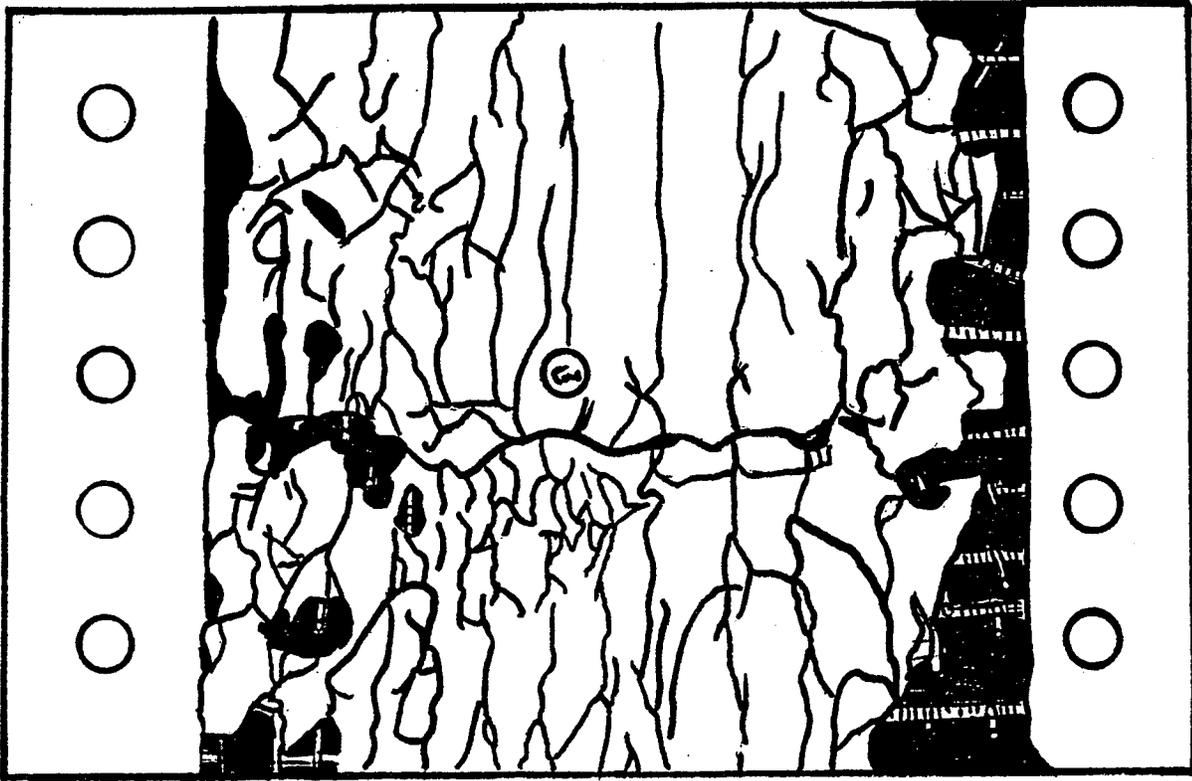
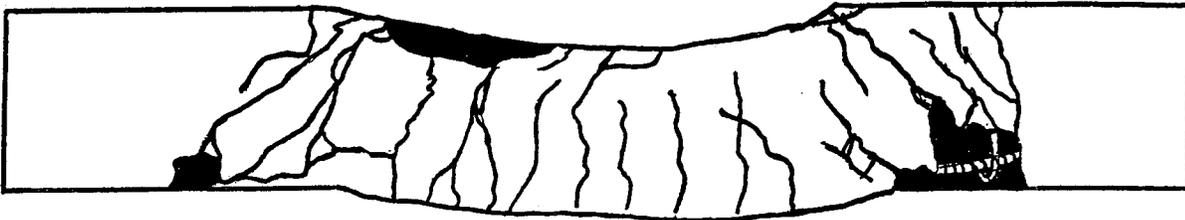
a. Bottom View

b. Side View

Figure 71. Sketch of Damage for Slab No. 2

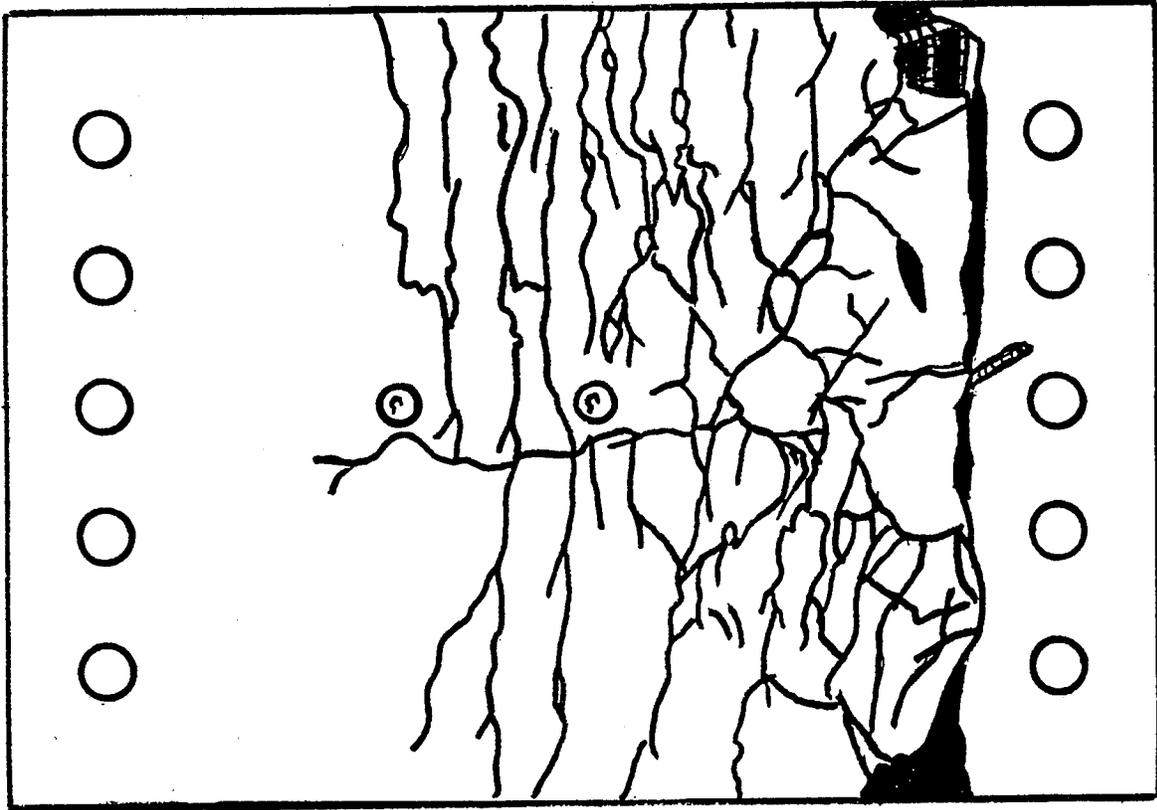
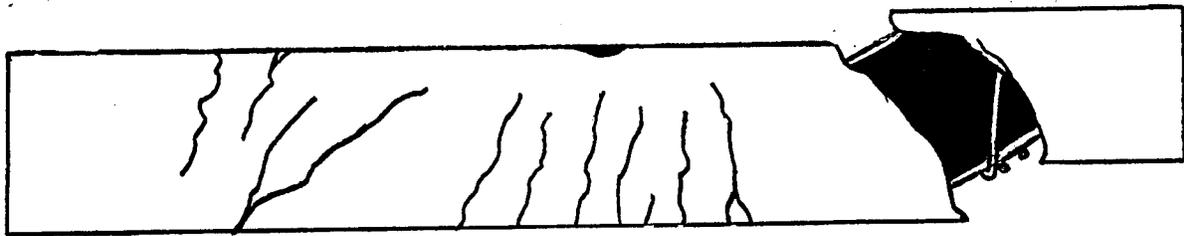
a. Bottom View

b. Side View

Figure 72. Sketch of Damage for Slab No. 3

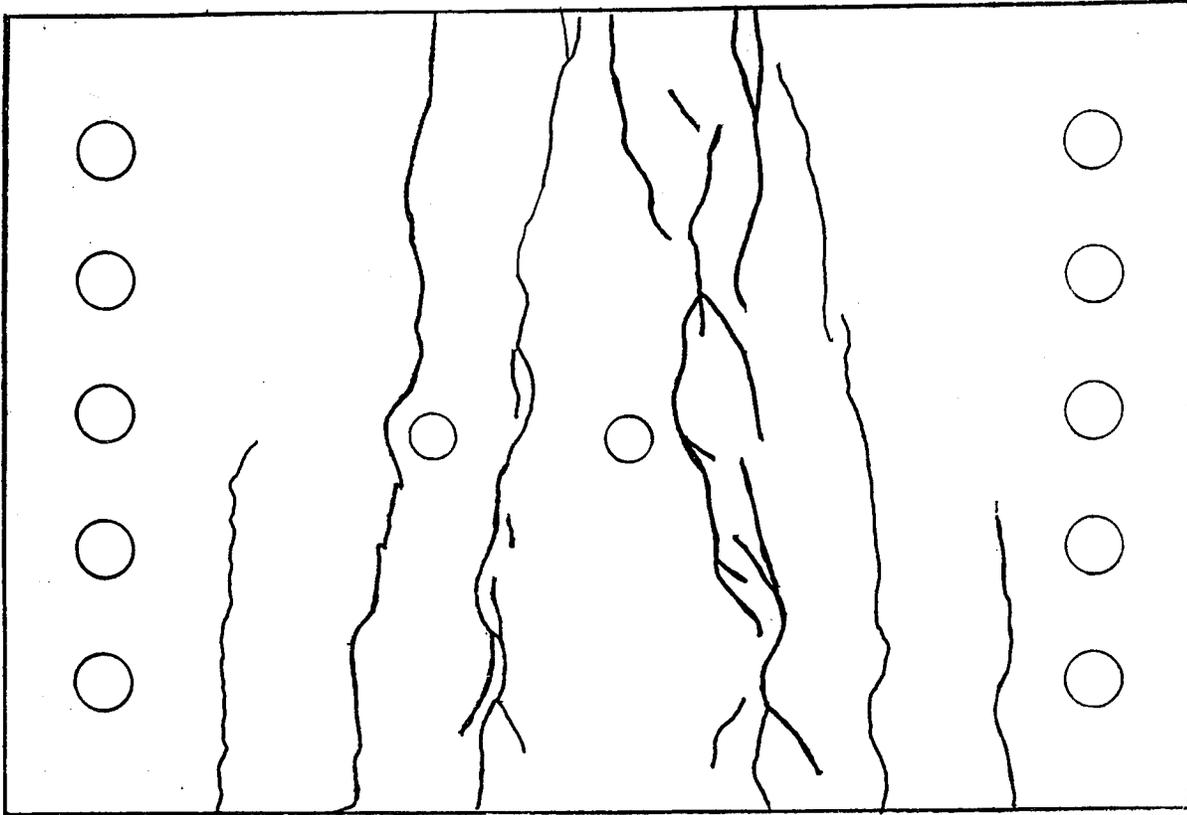
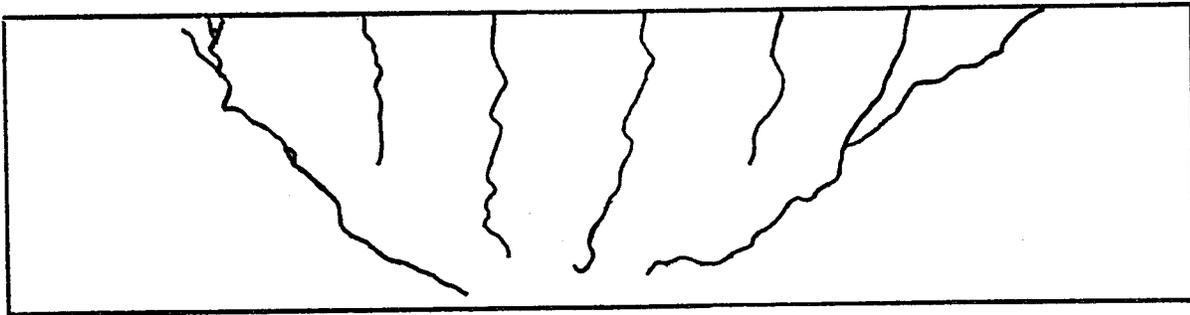
a. Bottom View

b. Side View

Figure 73. Sketch of Damage for Slab No. 4

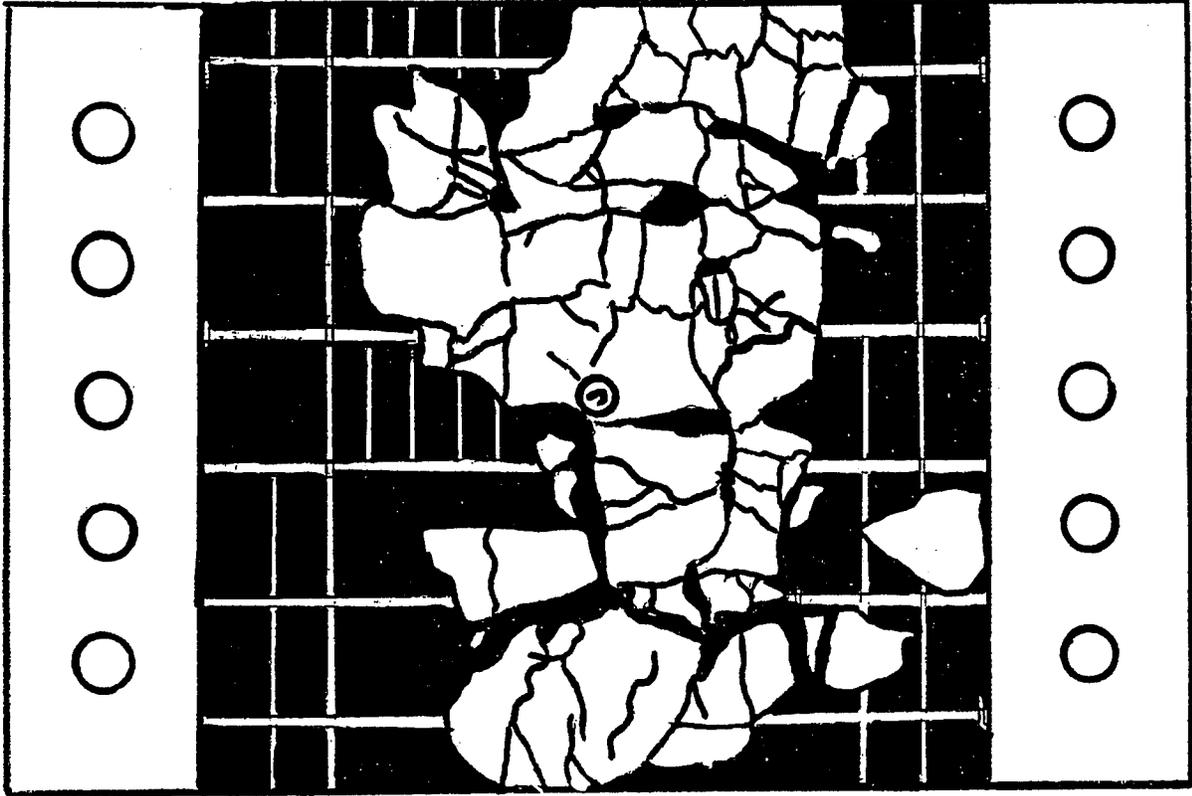
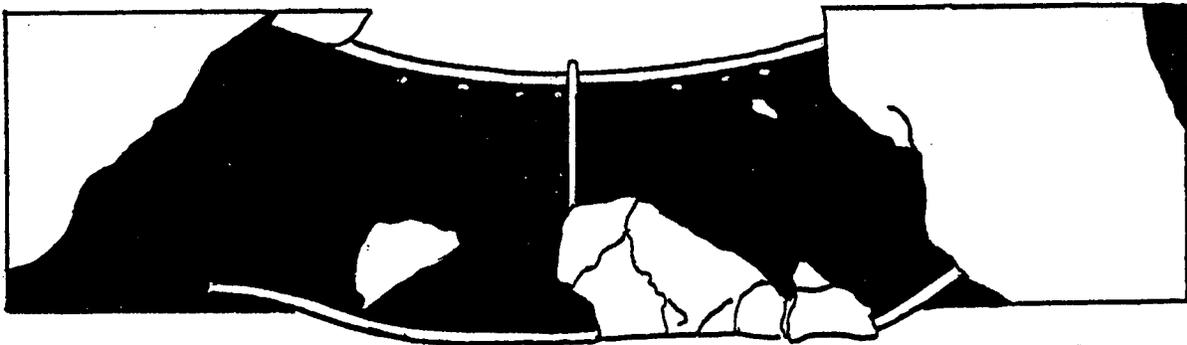
a. Bottom View

b. Side View

Figure 74. Sketch of Damage for Slab No. 5

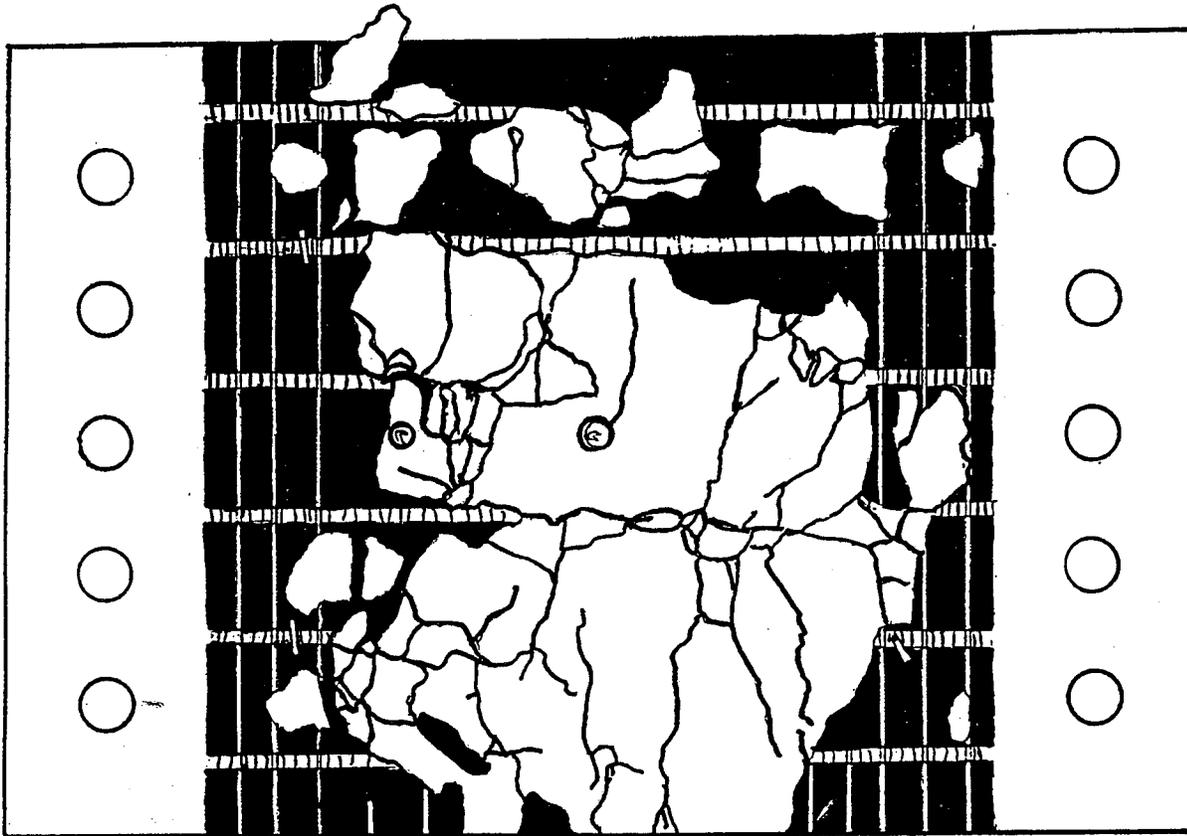
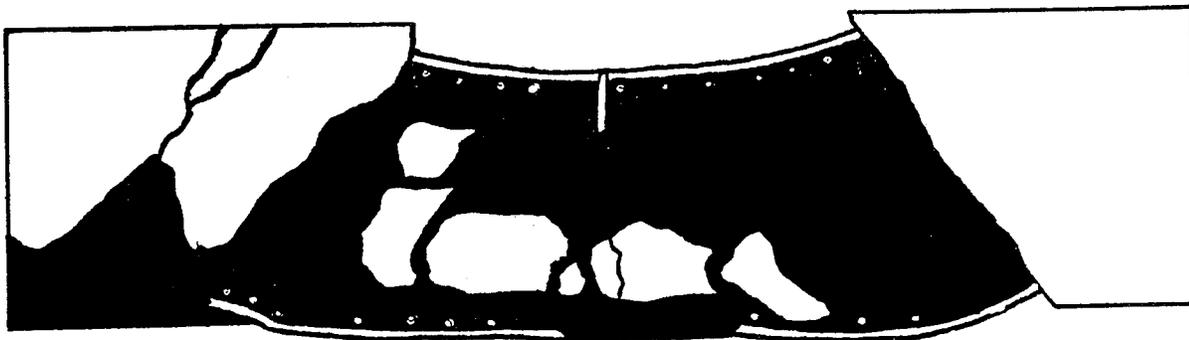
a. Bottom View

b. Side View

Figure 75. Sketch of Damage for Slab No. 6

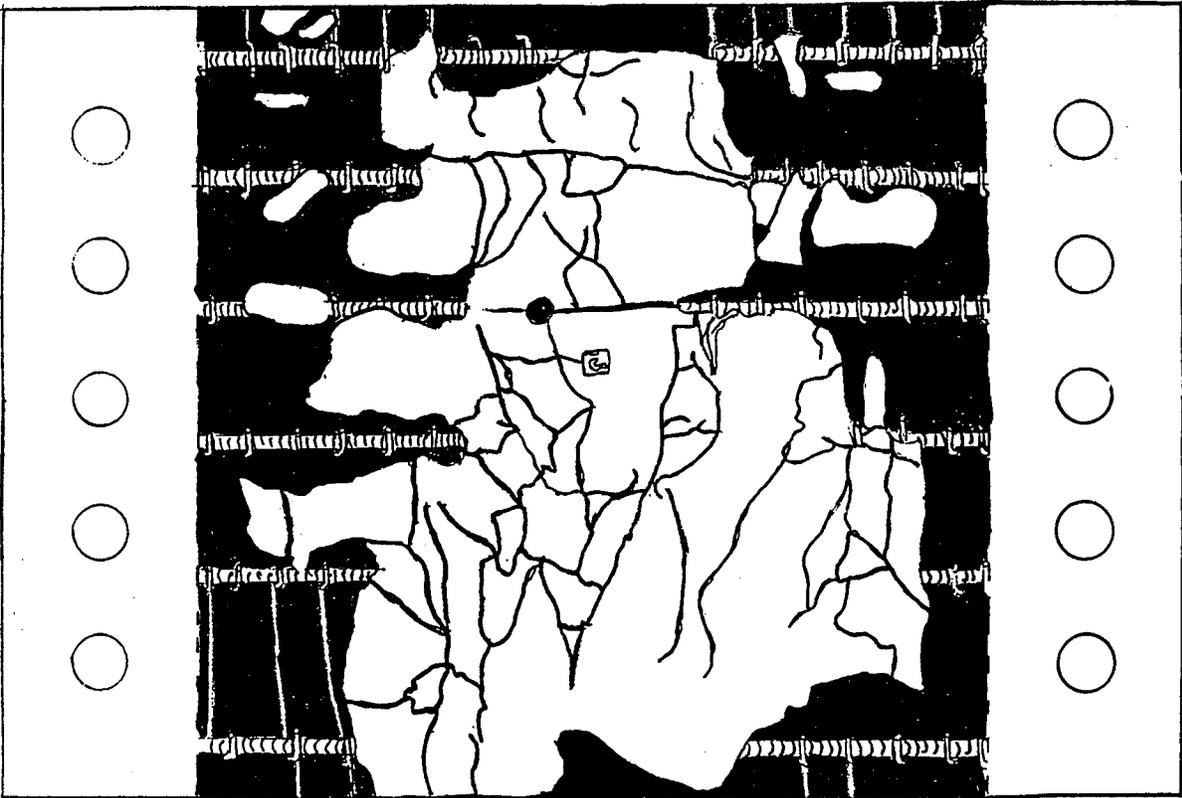
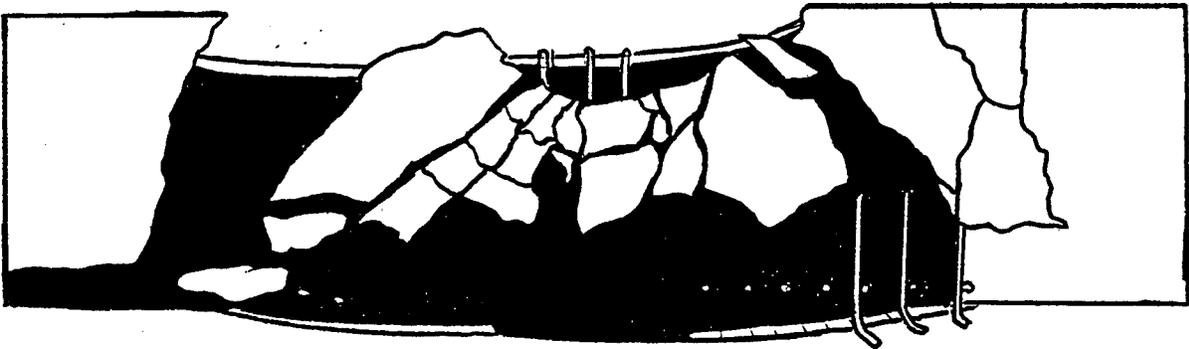
a. Bottom View

b. Side View

Figure 76. Sketch of Damage for Slab No. 8

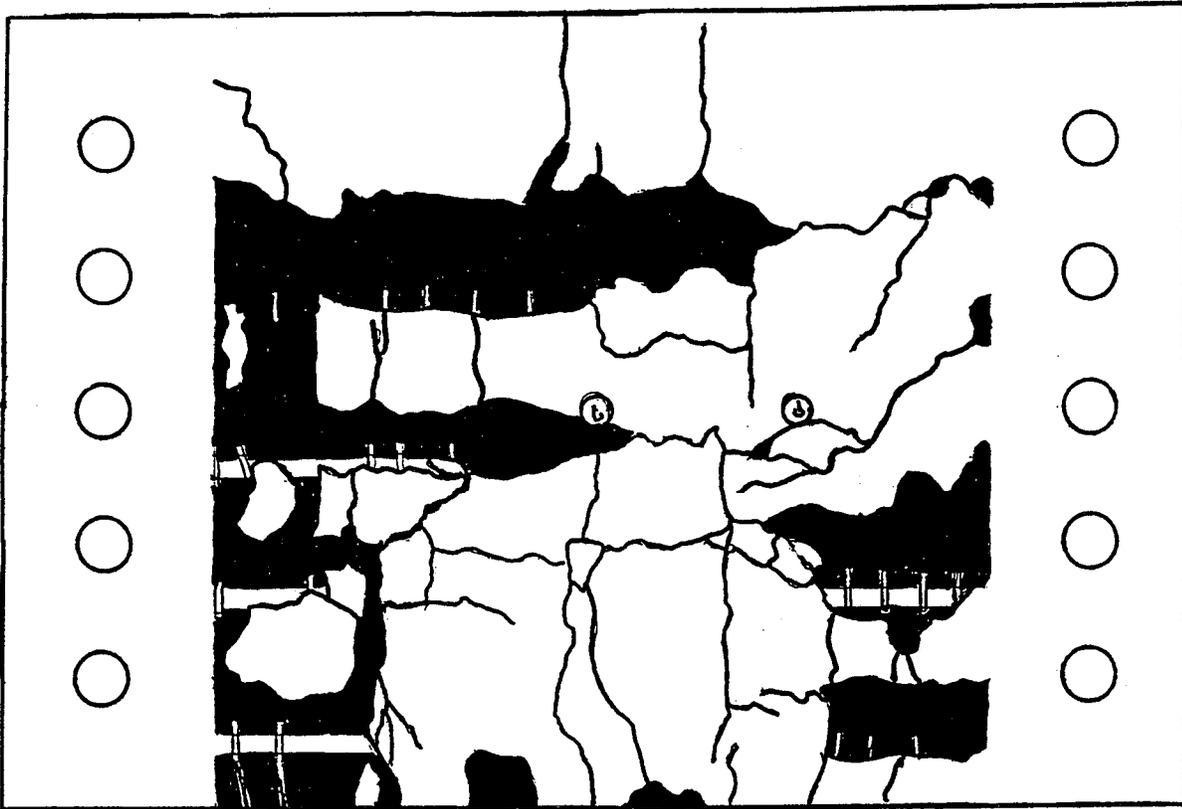
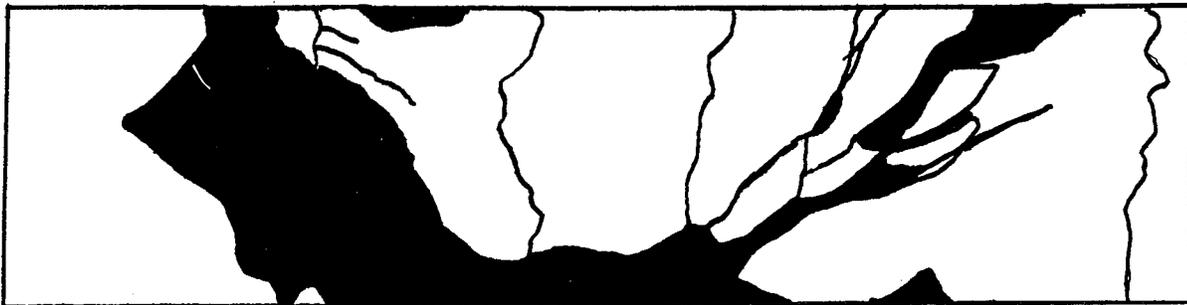
a. Bottom View

b. Side View

Figure 77. Sketch of Damage for Slab No. 9
