Technical Report SL-94-24
November 1994

**US Army Corps
of Engineers**
Waterways Experiment
Station

Shear Reinforcement in Deep Slabs

by *Stanley C. Woodson*

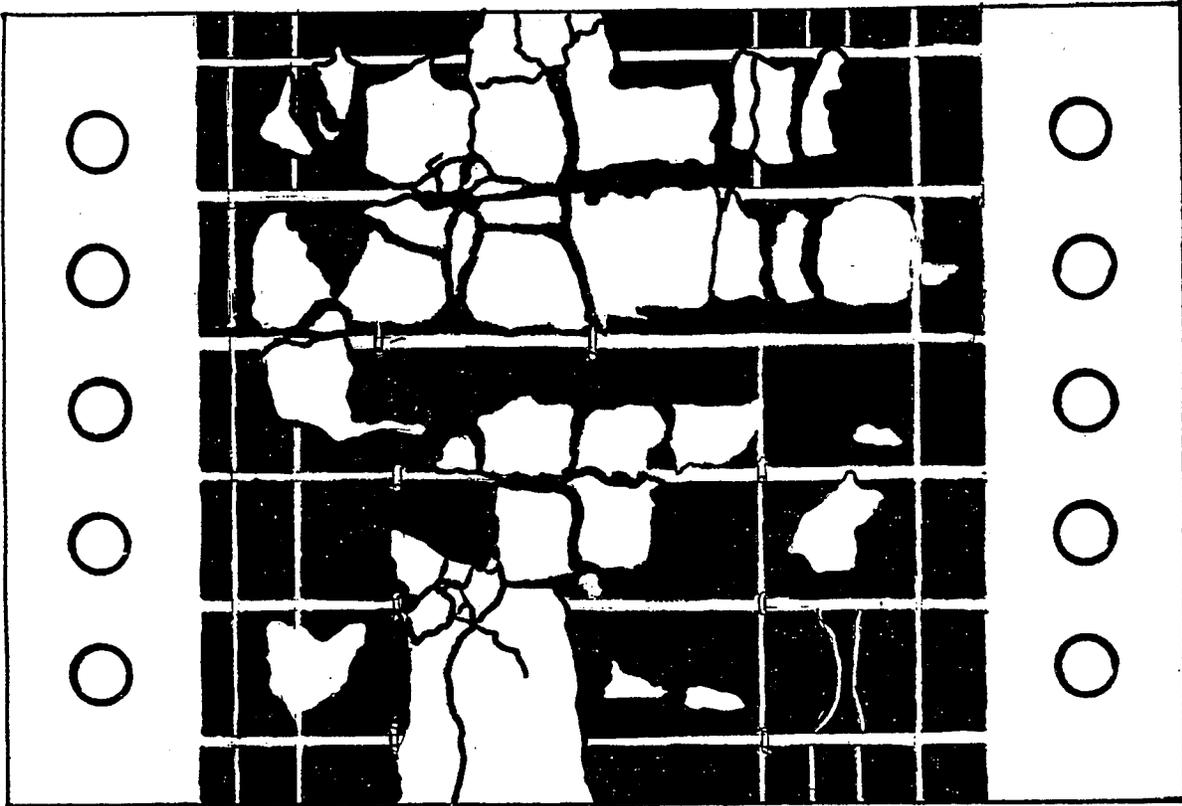
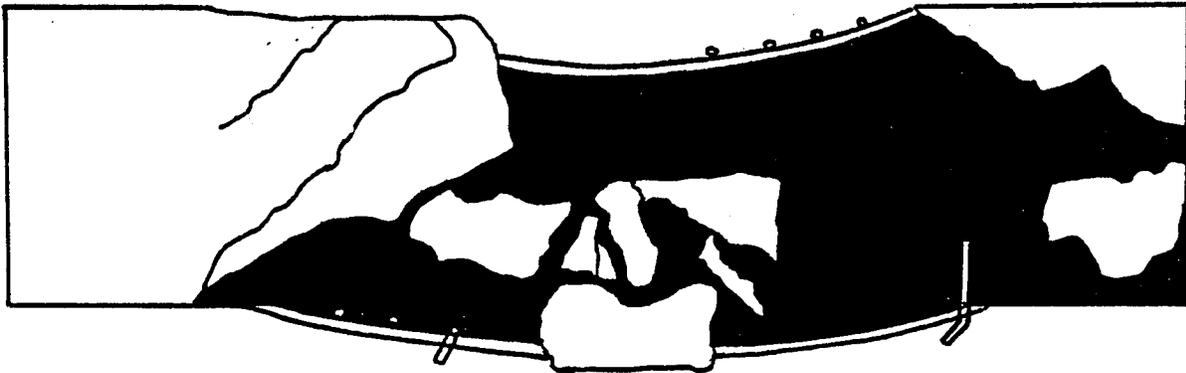
a. Bottom View

b. Side View

Figure 78. Sketch of Damage for Slab No. 10

Figures 70 through 80 are artist sketches of the bottom and side posttest views of the slabs. Sketches are not included for slabs no. 7 and 11 since they were damaged too heavily for a meaningful drawing. Figures 60 through 80 are useful for the reader that wants to carefully evaluate the response of the slabs. In this report, the figures will not be discussed in detail, but rather are used to support the observations and conclusions drawn from the instrumentation data and damage photographs.

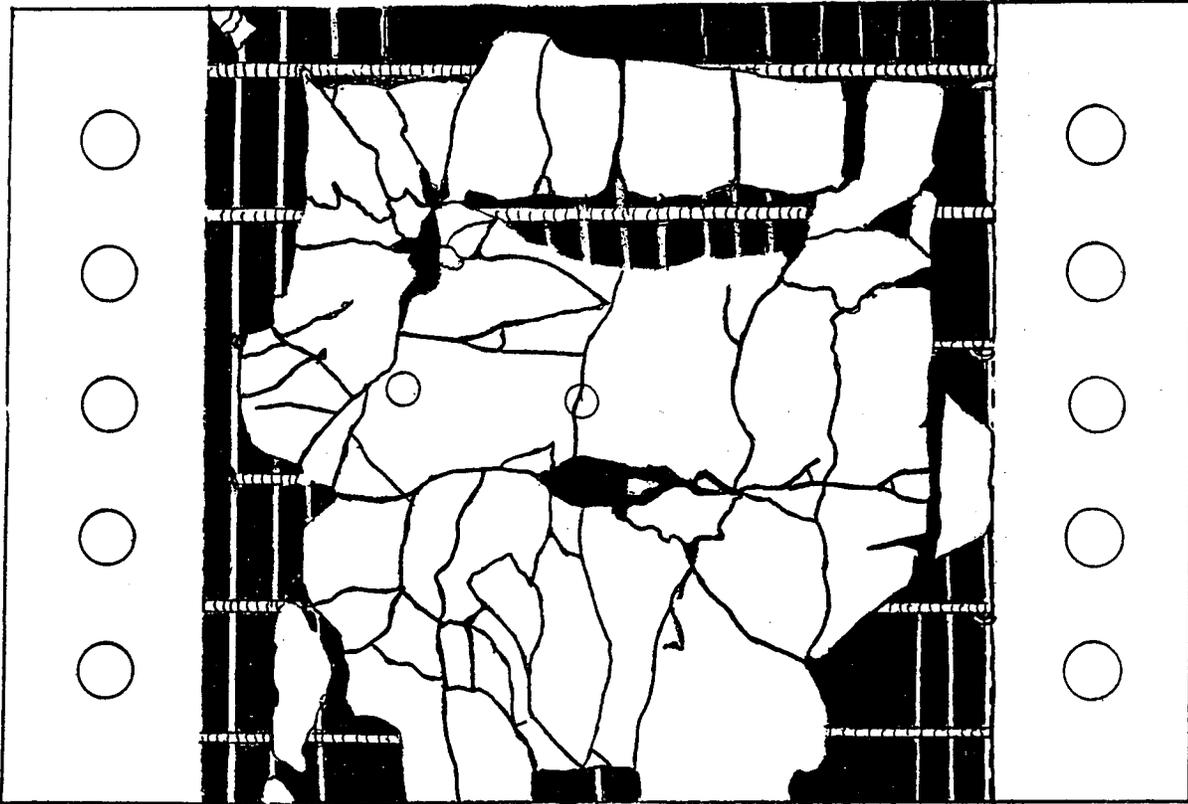
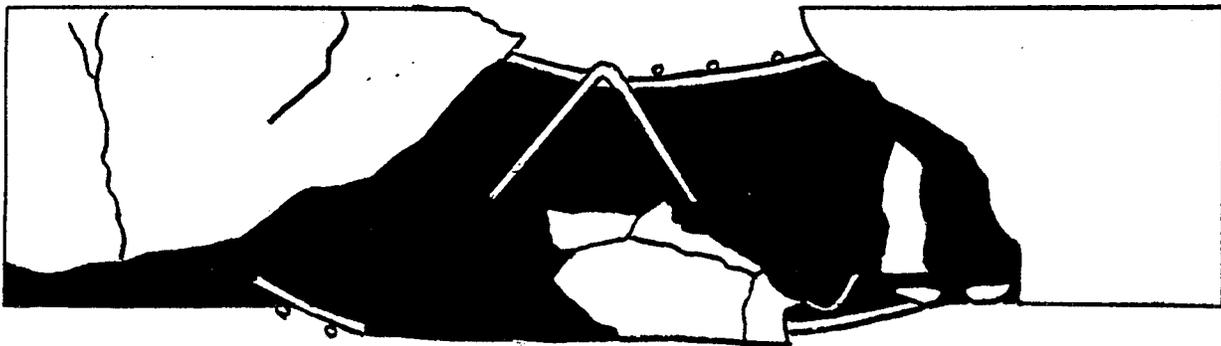
a. Bottom View

b. Side View

Figure 79. Sketch of Damage for Slab No. 12

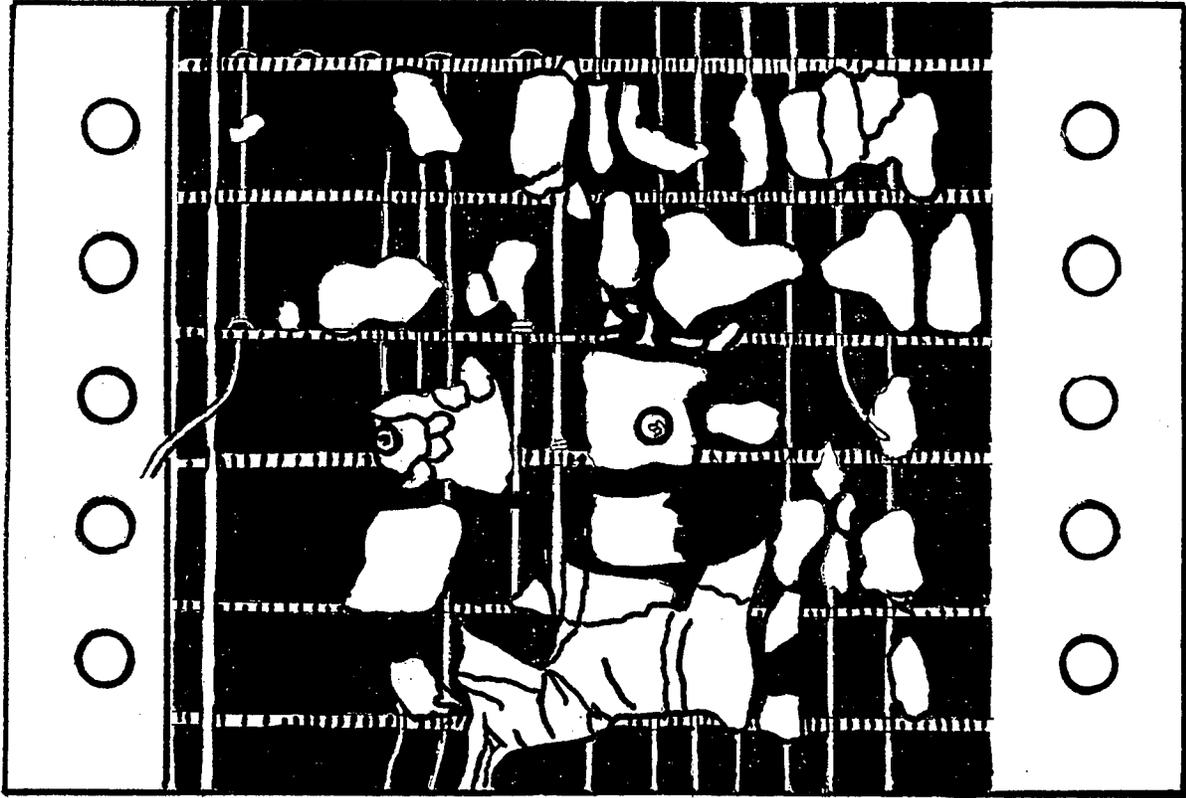
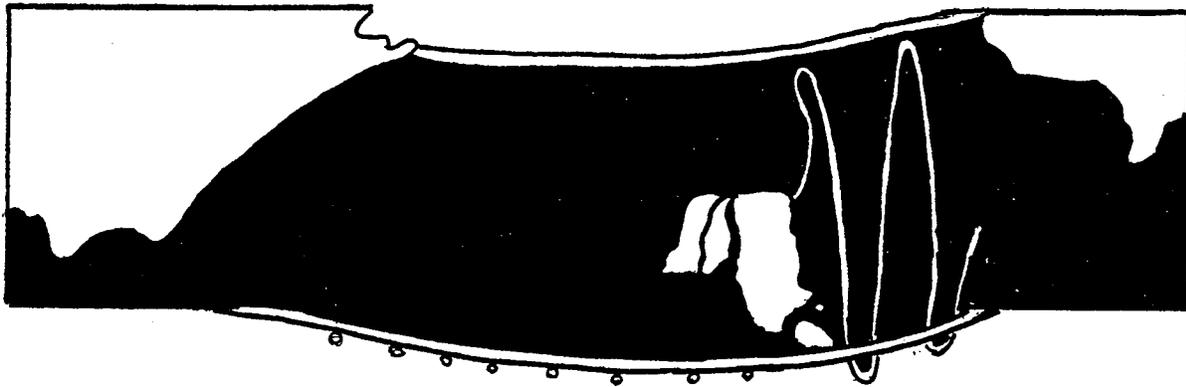
a. Bottom View

b. Side View

Figure 80. Sketch of Damage for Slab No. 13
