DOT/FAA/CT-94/120

Evaluation of Retro-Reflective Beads in Airport Pavement Markings

Final Report

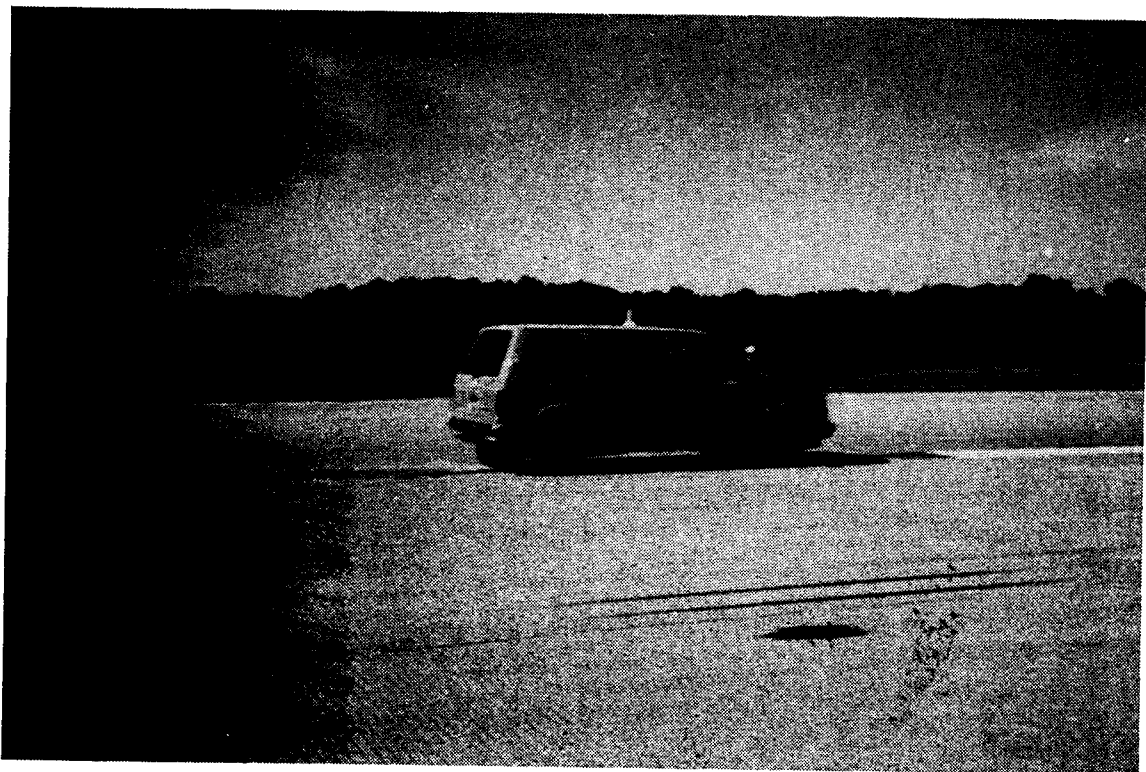
FIGURE A-44. FRICTION TESTING AT PITTSBURGH

Friction testing was conducted at two of the three selected airports. The Atlantic City and Pittsburgh airports possessed the friction testing equipment to collect the skid resistance data necessary for this test. Data were collected initially upon application and quarterly using the RFT Friction Test vehicle. Refer to figure A-44 for a depiction of the vehicle in operation.

Friction data obtained from the various materials indicated that certain marking materials exhibit positive friction benefits as compared with others. A reduction in friction readings would indicate that the abrasiveness of the material had degraded. Refer to figures A-45 and A-46 for the materials tested and friction data for the Atlantic City and Pittsburgh airports. In general the friction readings for the two beaded stripes (#6 & #7) were equivalent or better than those for the unbeaded materials. At the Pittsburgh test site the ambient pavement

friction was determined to be 0.75 mu. The #6 and #7 stripes (with beads and silica) provided average friction readings of 0.55 and 0.56 mu, slightly lower than that of the unbeaded #5 stripe with the silica additive, but well above that of the older existing paint markings (0.2 mu) and the minimum maintenance level of 0.41 (at 60 mph) as specified in the FAA Advisory Circular 150/5320-12B, Measurement, Construction, and Maintenance of Skid-Resistant Airport Pavement Surfaces⁶.
