# Ice Jam Flood Assessment for the St. John River Basin, Aroostook County, Maine

Special Report 95-15

**US Army Corps  
of Engineers**

Cold Regions Research &  
Engineering Laboratory

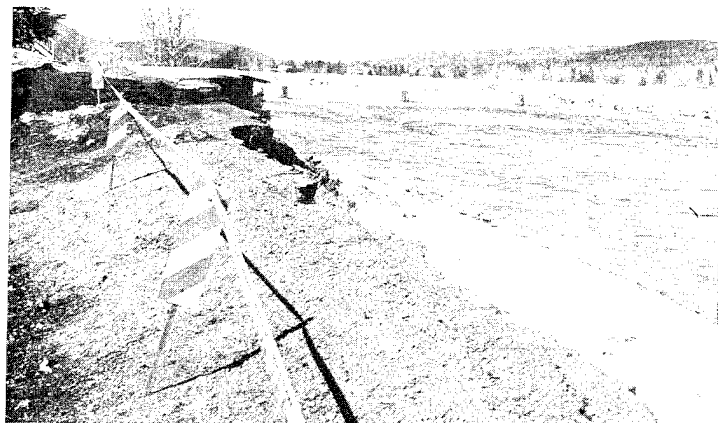
*a. Bridge and road section destroyed.*

**Figure 1. Ice jam damage in the town of Allagash, Maine, April 1991.**

(1973–1992) (Table 1). Most recently, in the spring of 1991, devastating ice jam floods on the St. John River caused damage estimated at \$14,000,000. On 9 and 10 April 1991, the two bridges in the village of Dickey, located in the town of Allagash, 1000 ft of state highway and 11 houses were destroyed (Fig. 1) and an additional 22 houses were damaged. On 13–14 April, ice jam floods on the Aroostook River caused damage to shoreline, roads, 16 houses in the town of Fort Fairfield and properties in the village of Crouseville located in the town of Washburn.

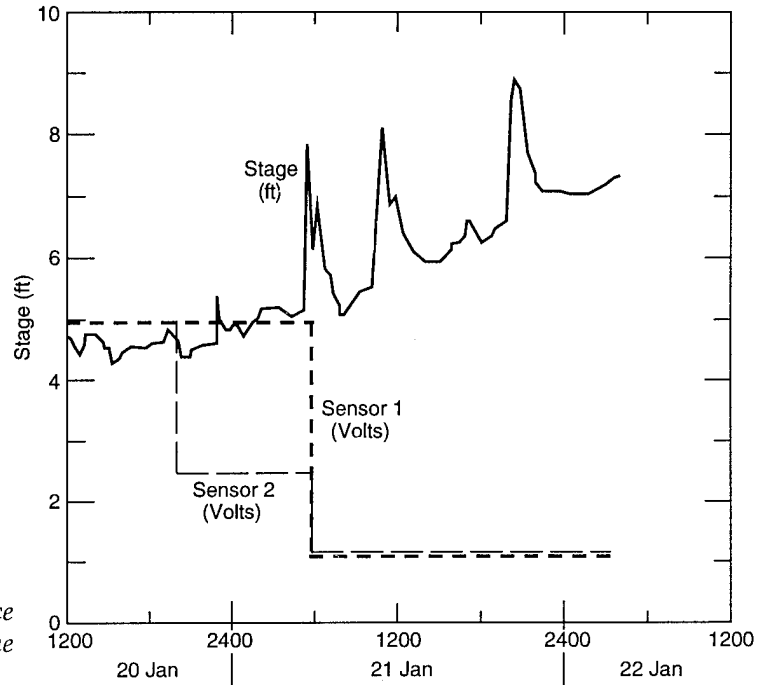
Figure 5. Comparison of signals from ice motion detector and stage gage at Nine Mile.

the other 175 ft. This difference in length was introduced to account for the possibility that the ice may not break up simultaneously across the whole river width. We also felt that two pairs of wires per detector would improve their reliability, since there is always the possibility that one pair may be damaged by chafing of the protective insulation because of minor ice motion, or other causes.

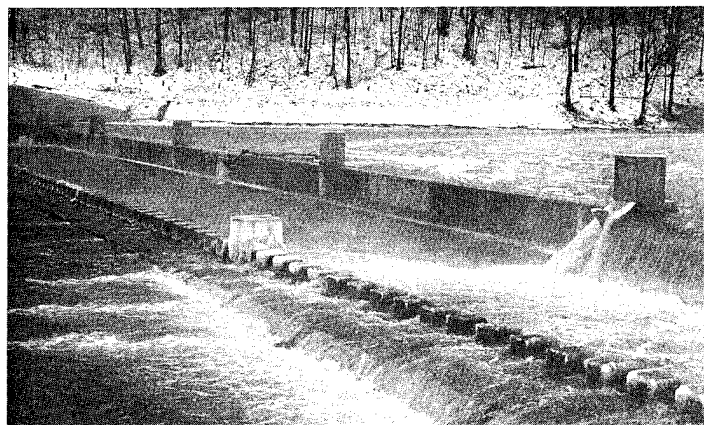
b. Oil Creek ICS in operation.

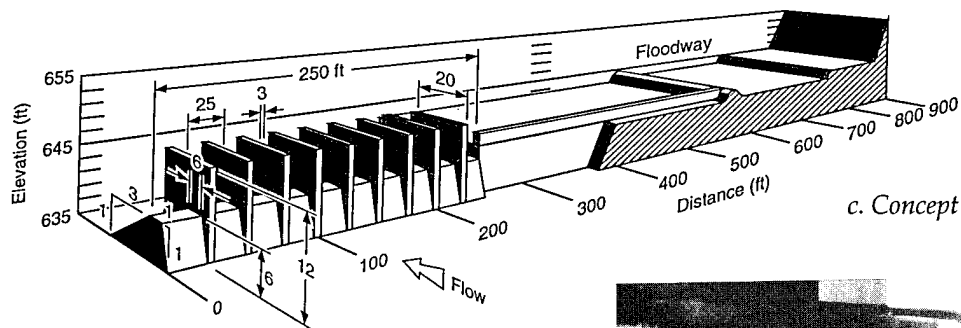
c. Concept of Cazenovia Creek ICS.

around an existing ice jam site, thereby reducing the water level behind the jam and consequent flooding. It, therefore, also reduces the water pressure head exerted on the jam, and delays jam failure. A bypass channel can be used alone, as was proposed at Port Jarvis, New York, or in conjunction with an ice control structure (e.g., Cazenovia Creek structure, Fig. 6c and d).

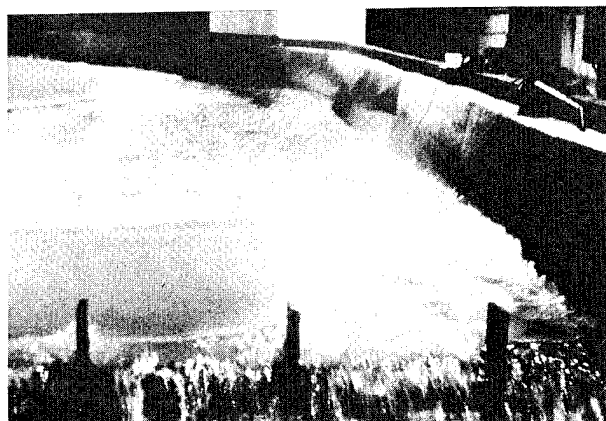
d. Hydraulic model of Cazenovia Creek ICS.

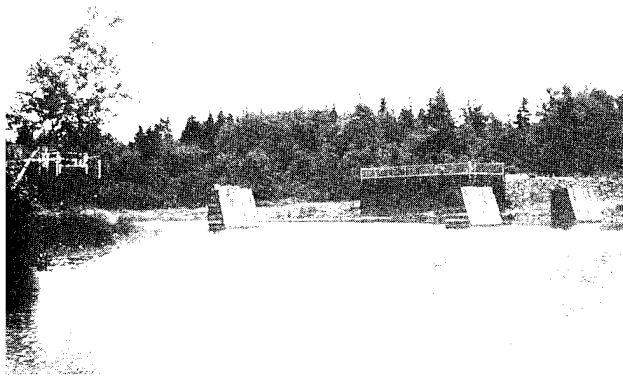
Figure 7. Example of rock-filled crib, Cherryfield, Maine.

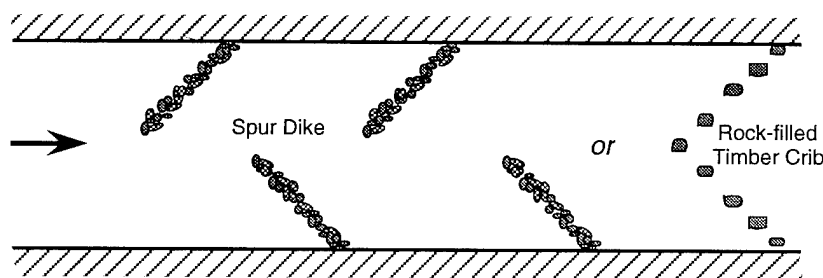
Figure 8. Spur dikes and rock-filled timber cribs for ice control.

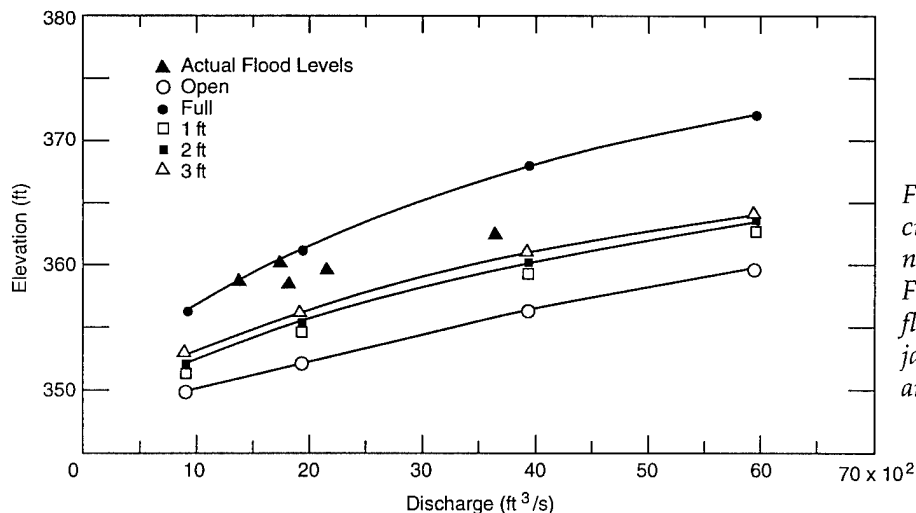
Figure 12. Ice-affected rating curves of the Aroostook River, near Limestone Road bridge, Fort Fairfield. Shown are the flood levels reached during ice jams in 1932, 1936, 1940, 1973 and 1976.

developed for river station 402+84, which corresponds to the Limestone Road bridge. The curves represent open water, ice-covered and ice-jammed conditions in order of increasing stage. The figure shows the calculated ice-affected water levels for discharges up to a 25-year open water flood (60,000 ft<sup>3</sup>/s). It is unlikely, however, that an ice cover would remain intact for discharges much greater than 10,000 ft<sup>3</sup>/s or that a jam would remain stable for discharges as large as a 5-year open water flood (43,000 ft<sup>3</sup>/s). For the major ice-related floods reviewed in Table 3, peak stages for all but one were reached at discharges of no more than 23,000 ft<sup>3</sup>/s. The remaining flood, in 1976, had a discharge on the order of 37,000 ft<sup>3</sup>/s. A 2-year flood is on the order of 31,000 ft<sup>3</sup>/s. Prior to reaching a 5-year recurrence interval discharge, it is likely that any ice jam would release, and water levels would return to open water levels. Thus, the true rating curve would likely follow the curve for an ice cover of appropriate thickness up to a discharge

of 10,000 to 15,000 ft<sup>3</sup>/s, and would then increase to levels no greater than the equilibrium jam curve (depending on ice conditions and supply).

Figure 12 shows an ice-affected rating curve

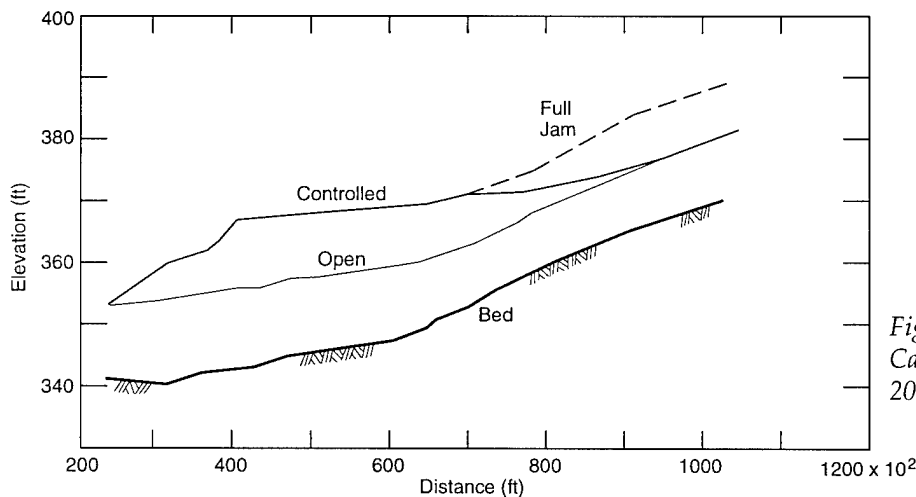
Figure 13. Possible effect of the Caribou dam as an ICS ( $Q = 20,000$  ft<sup>3</sup>/s;  $h_i = 28$  in.).

would be limited to that ice present in the river between Fort Fairfield and the dam. The HEC-2 program with ice option was run for this case, for the same discharge of 20,000 ft<sup>3</sup>/s and with the additional assumption, supported by the field measurements and the calculations in Table 2, that the ice thickness averaged 28 in. The results of the computations are presented in Figure 13. With ice supply limited by the dam, we found that the jam should extend up to station 680, approximately, and that the jam backwater should merge with the open water surface profile at about station 950. Therefore, improvements to the dam to ensure that it acts as an ice-control structure would not be sufficient to alleviate ice jam flooding at Fort Fairfield. Additional mitigation means, upstream of Fort Fairfield and below the dam, would be required.

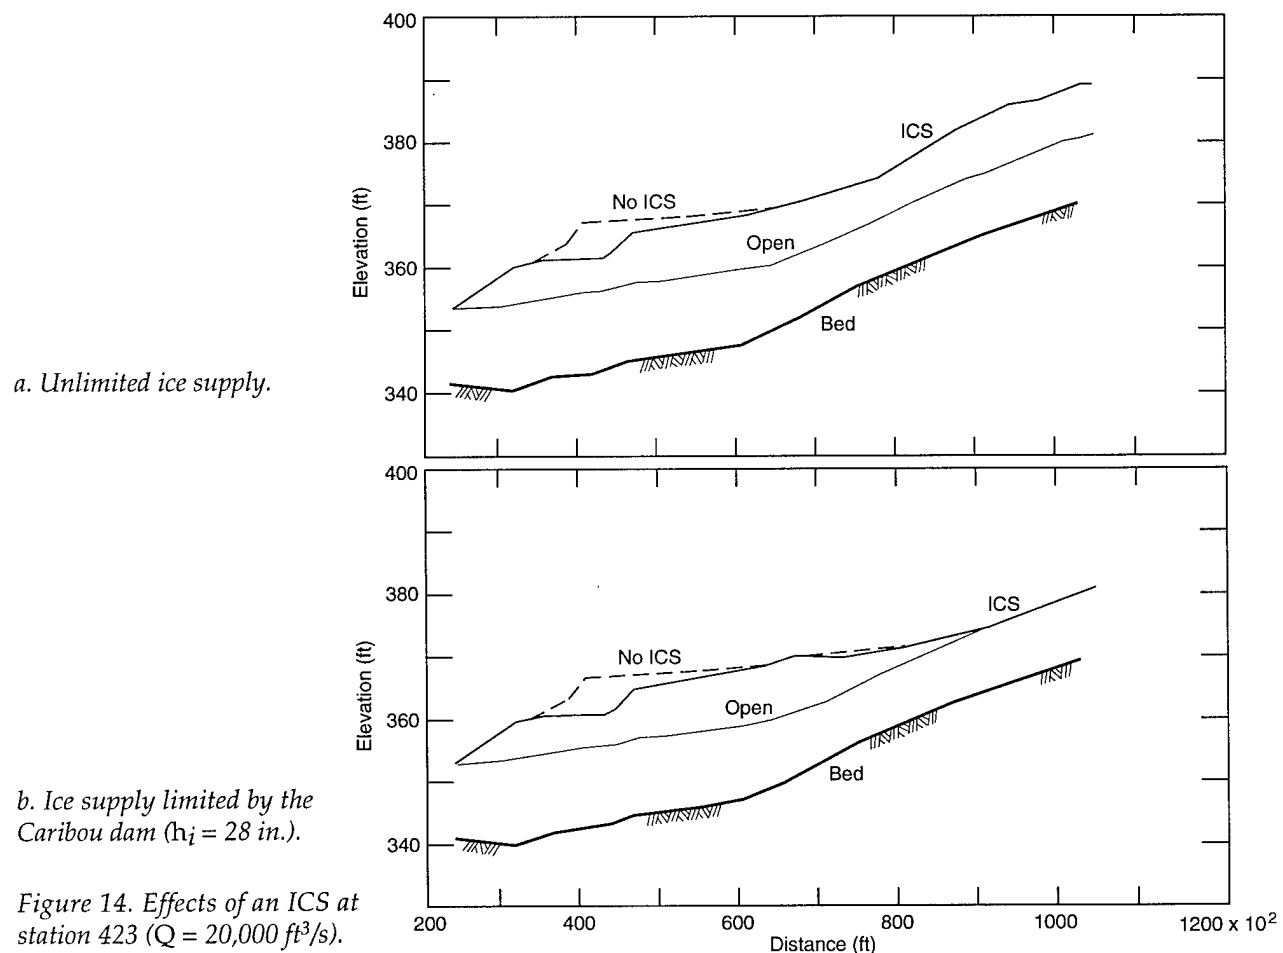
Figure 14a shows the effect of constructing an ICS at station 423+00, approximately 2000 ft upstream from the Limestone Road bridge for the case of unlimited ice supply. Figure 14b shows the effect of the same ICS when the ice supply is limited by the Caribou dam and for an ice thickness of 28 in. Both figures show that the water level is reduced by as much as 6 ft between about stations 330 and 423. Upstream of the ICS

the water level is initially reduced by about 2 ft, but at about station 630 it goes back to the level without the ICS.

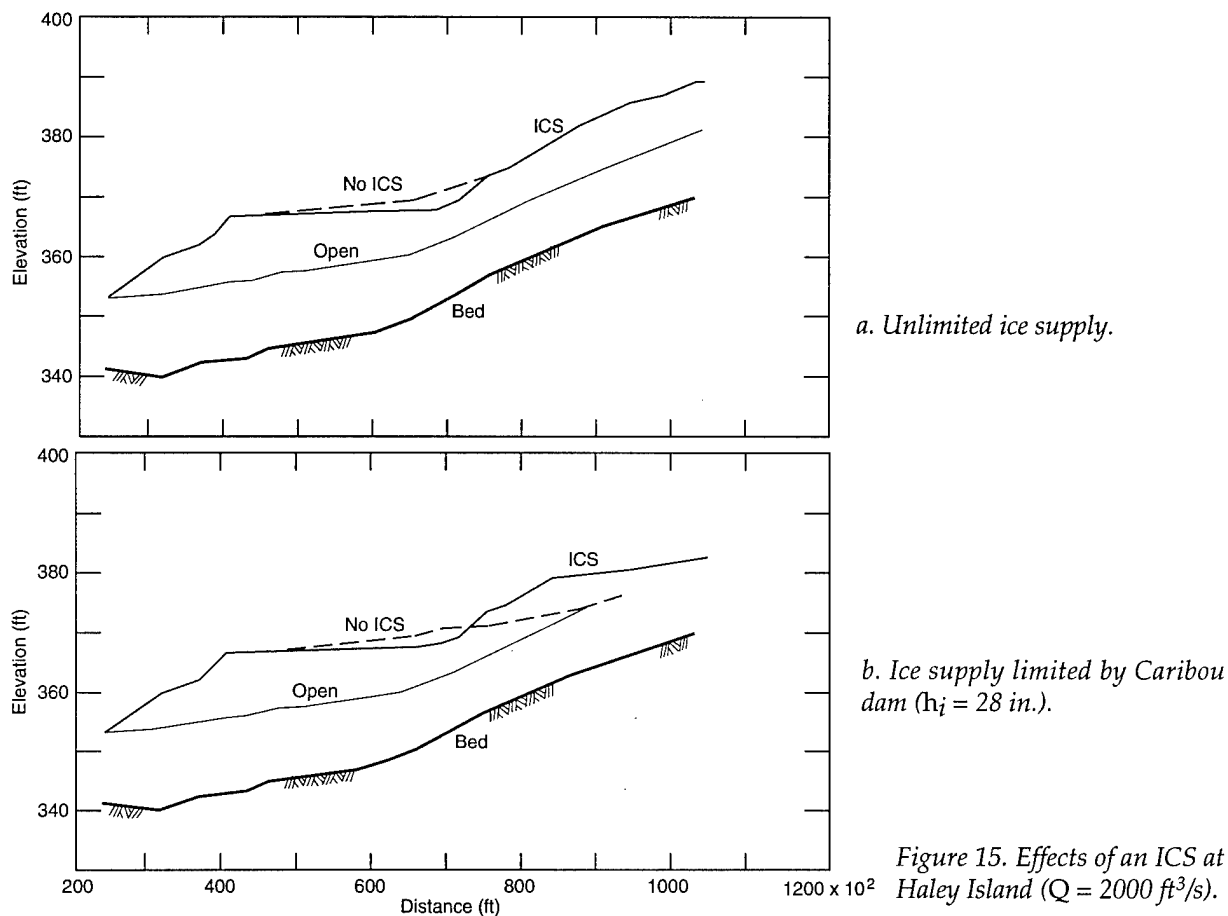
The effects of an ICS at station 656 in the vicinity of Haley Island are shown in Figure 15 for the two cases of unlimited ice supply and ice supply limited by the Caribou dam. The figures show no discernible effect of the ICS on the water level below station 500, and a maximum drop of about 3 ft in the water level at the ICS location. For the case of unlimited ice supply, the water level upstream of the ICS goes back to the full jam value at about station 740. On the other hand, if the Caribou dam indeed limits the downstream ice supply, the ICS at Haley Island leads to an increase in upstream water level (Fig. 15b) because it retains all the ice between Haley Island and the dam.
