USACERL Special Report 95/05
June 1995

John Martin's Home?: Historical and Archaeological Investigations of Site 9Mu56, Murray County, Georgia

Cultural Resources Consulting Division
South Carolina Institute of Archaeology and Anthropology
University of South Carolina

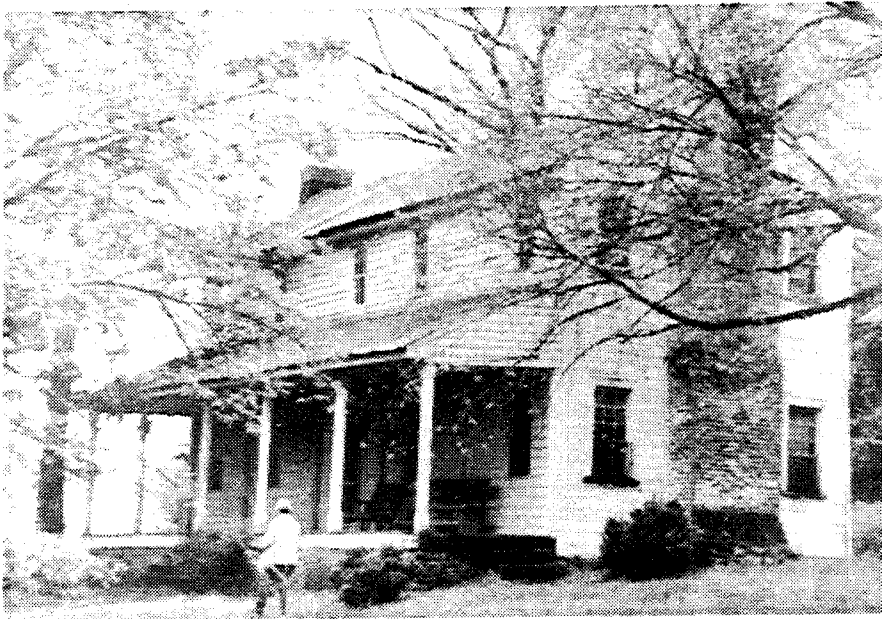
Figure 2.6 Pre-1969 Photograph of the Front of the Structure at 9Mu56 Looking Southwest (Courtesy of Robert Davis).

The Martin house was of frame construction with a rock foundation (Figures 2.6, 2.7, 2.8, 2.9). A two-story I-plan, it had two rooms flanking a central hall on each floor with a cantilevered staircase in the center of the house. Brick chimneys at either end of the house provided a fireplace to each room. A federal agent described the house in 1837 as "frame dwelling house 36 x 33, 2 stories high, 3 brick chimneys, 5 fireplaces, 128 light (window panes) windows, good floors, and doors all well finished, worth \$4,000.00" (Davis 1990:61). Curiously, the 1968 appraisal of lot number 401 describes the dwelling house at 9Mu56 as 18 x 46 feet (Pryor 1969). The reason for the size discrepancy is unknown. The discrepancy in the width, 33 feet in 1837 and 18 feet in 1968, can be explained in that the nineteenth century description included porches, while the 1968 appraisal obviously did not. However, why the length of the house was recorded as 36

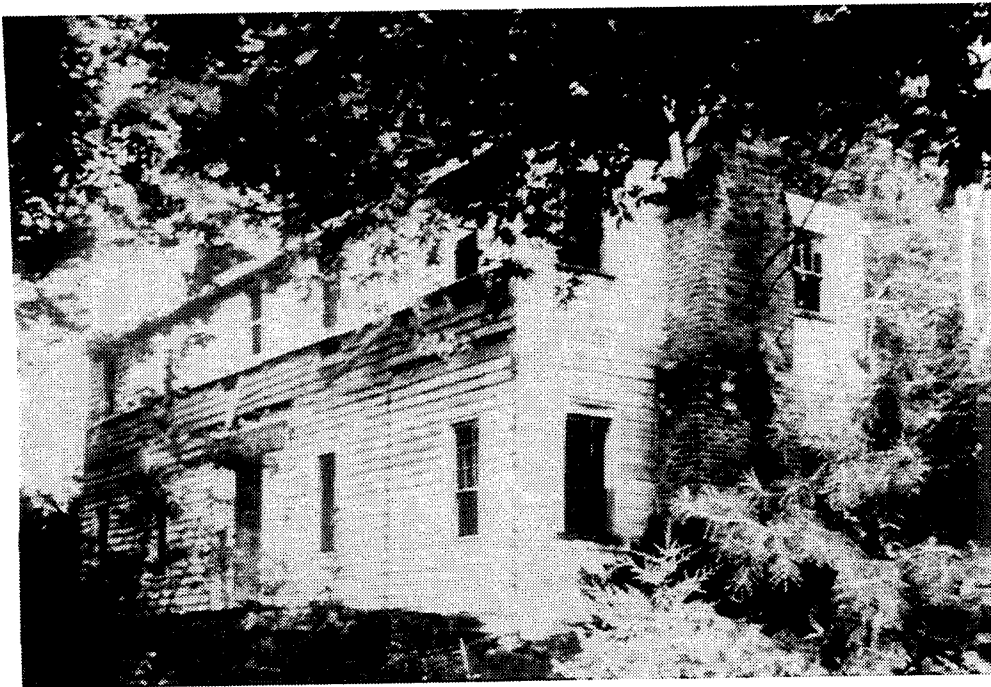
Figure 2.7 Photograph of the Structure at 9Mu56 Before Removal Looking Southwest (Courtesy of Joe Blackmon, U.S. Army Corps of Engineers).

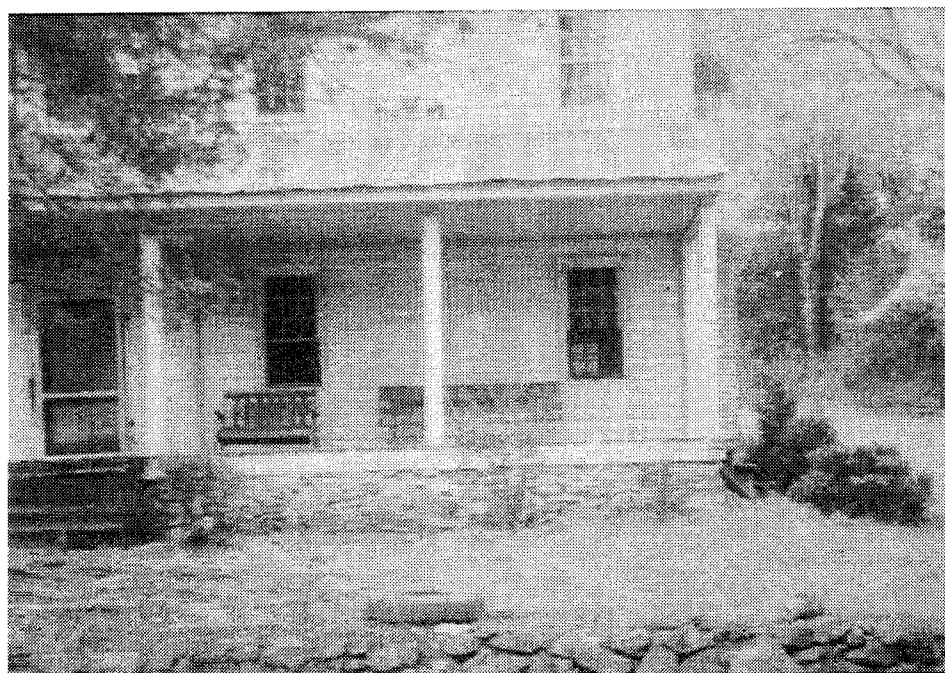
Figure 2.9 Pre-1969 Photograph of the Front of the Structure at 9Mu56 Looking West (Courtesy of Jim Nolan).
