**Community Environmental Response  
Facilitation Act (CERFA) Report  
Vint Hill Farms Station  
Warrenton, Virginia**

May 1994

**COMMUNITY ENVIRONMENTAL RESPONSE FACILITATION  
ACT (CERFA) REPORT  
VINT HILL FARMS STATION  
WARRENTON, VIRGINIA**

**USAEC Contract DAAA15-91-D-0017  
Delivery Order 006**

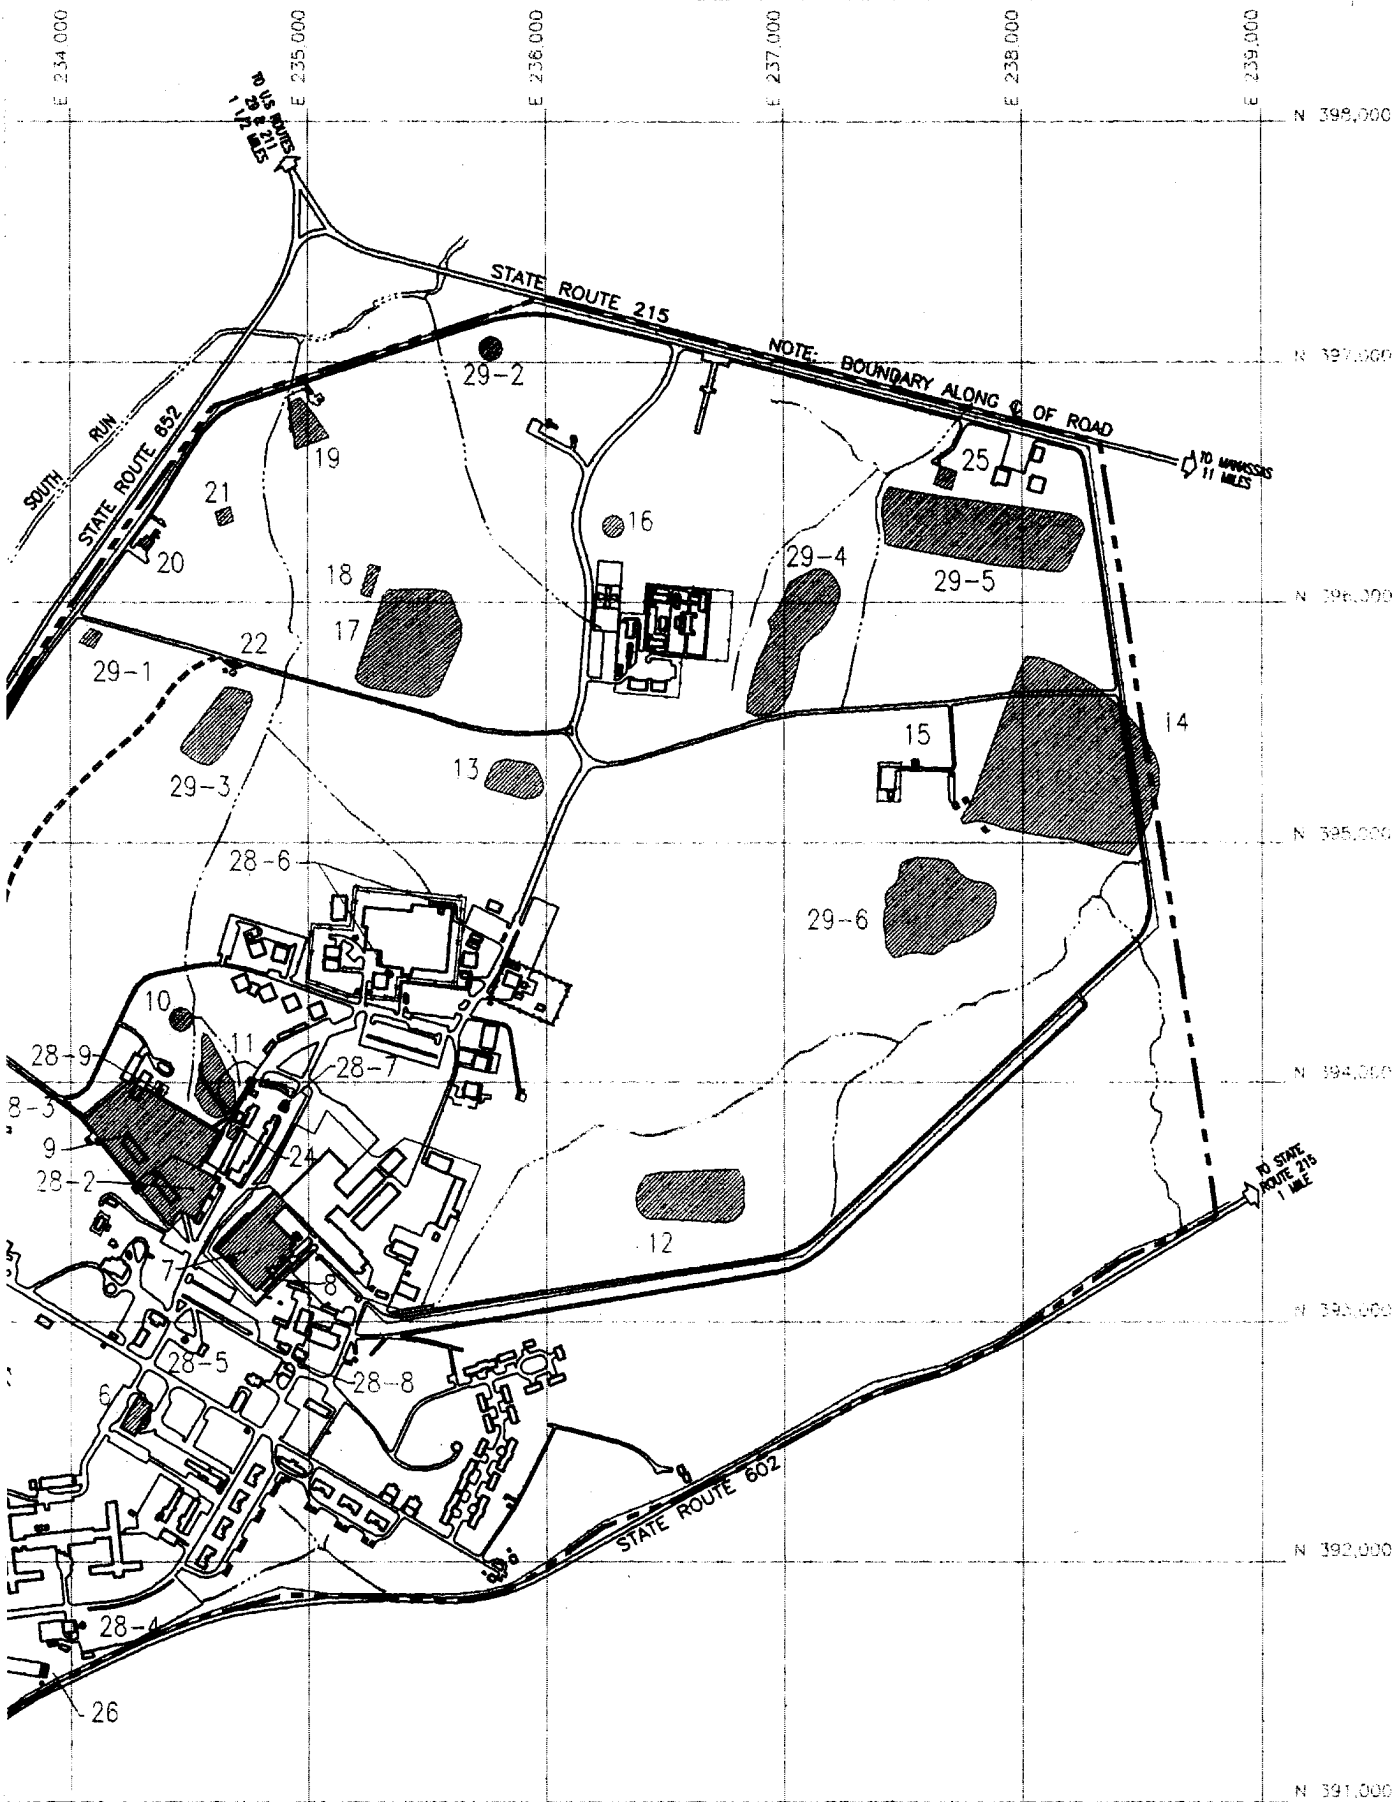
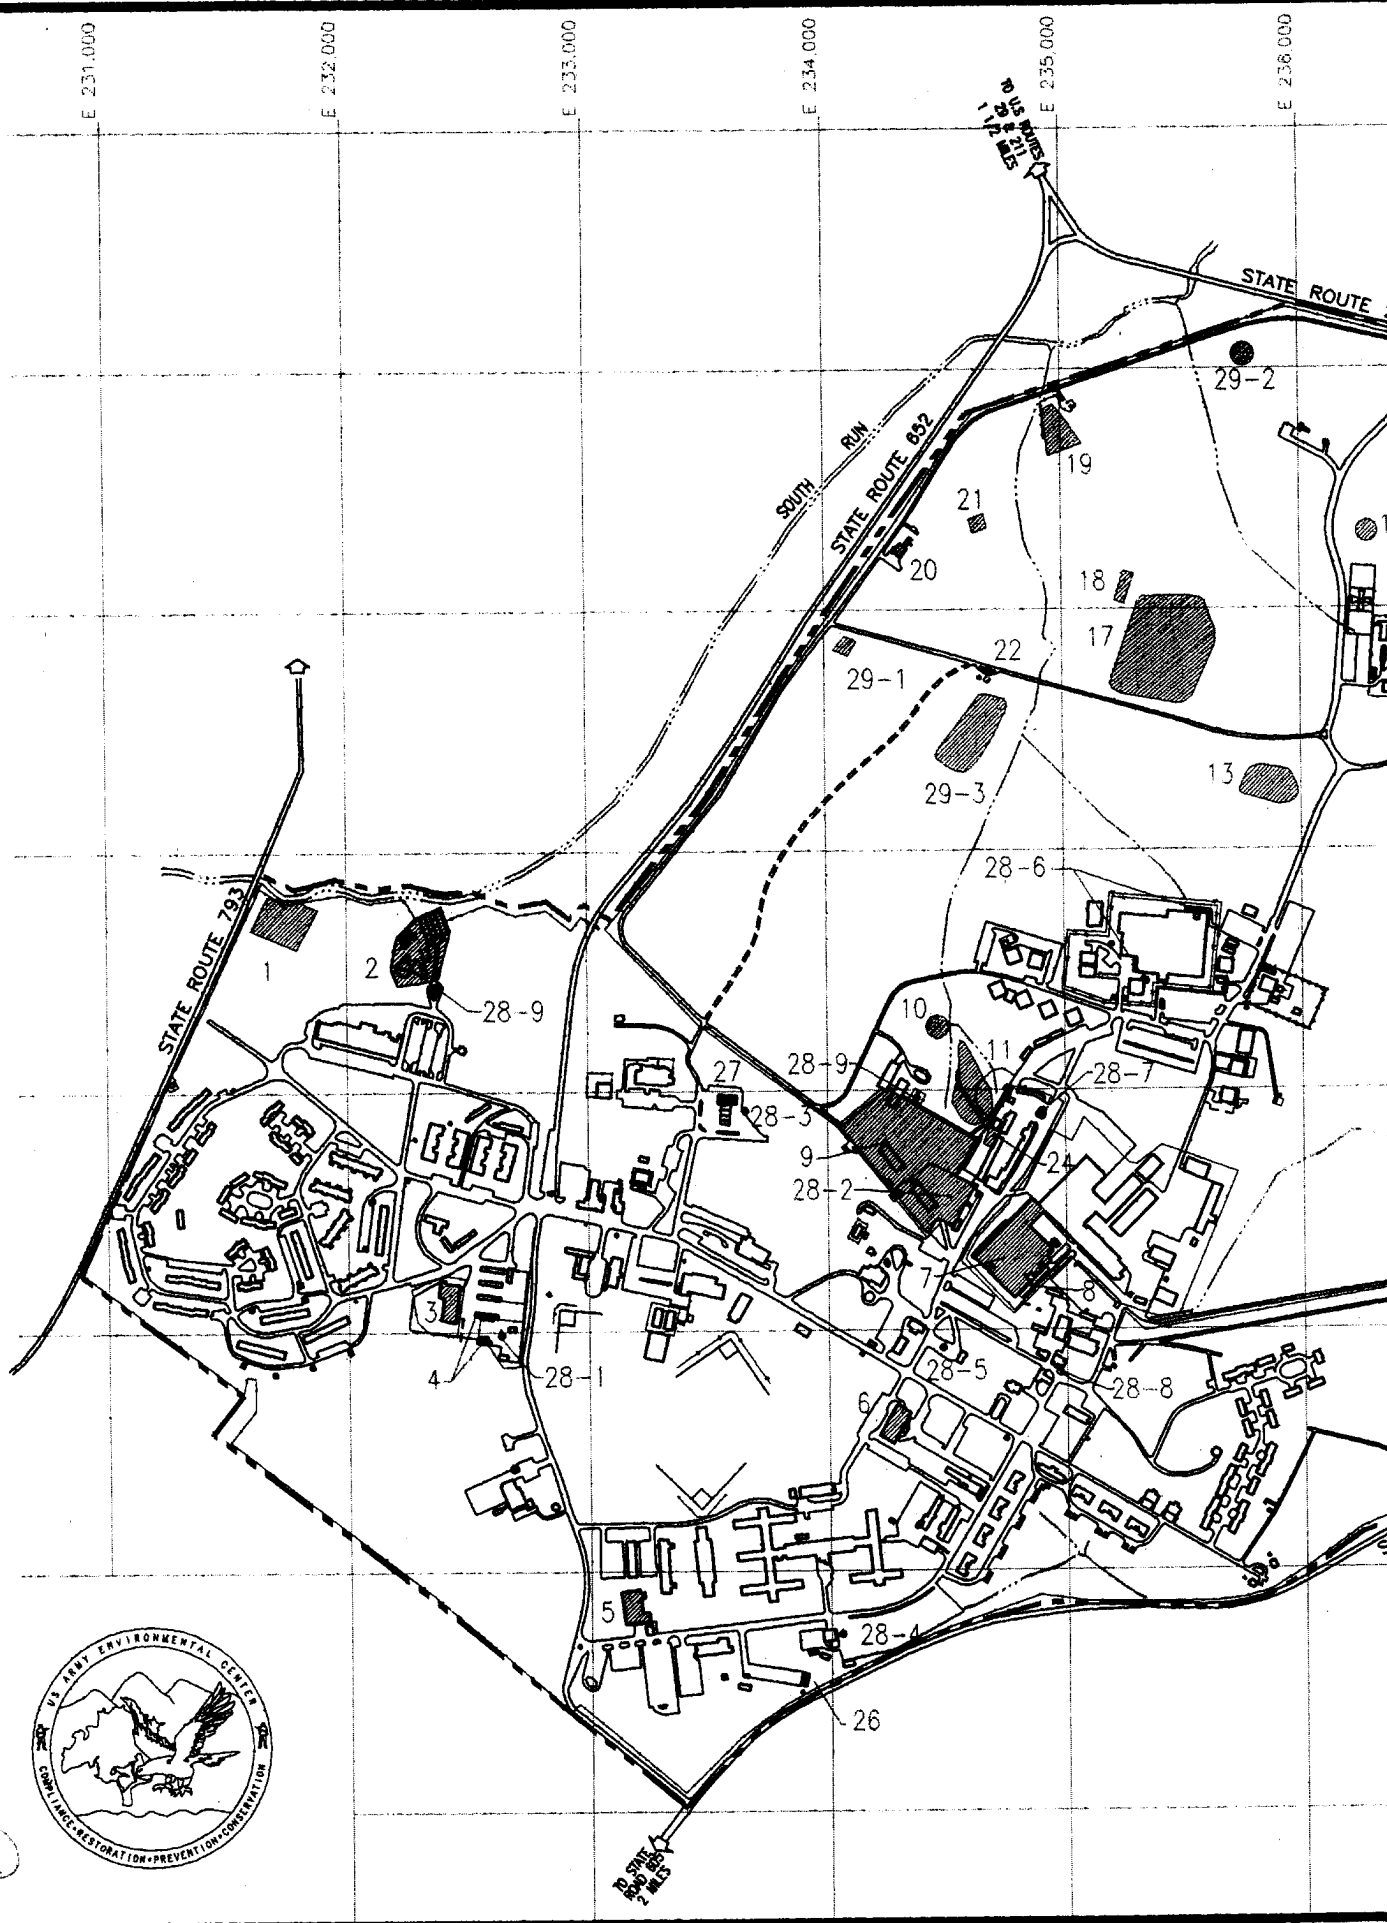
Scienc	
GI	
Figure: 4-1	Project: 01-01

# AREEs LOCATIONS
