**COMMUNITY ENVIRONMENTAL RESPONSE  
FACILITATION ACT REPORT  
FOR TOOEE ARMY DEPOT - NORTH AREA  
TOOELE, UTAH**

**USAEC Contract DAAA15-93-D-0006  
Delivery Order 001**

**October 5, 1994**

### FINAL COMMUNITY ENVIRONMENTAL RESPONSE FACILITATION ACT REPORT FOR TOOEELE ARMY DEPOT - NORTH AREA TOOELE, UTAH

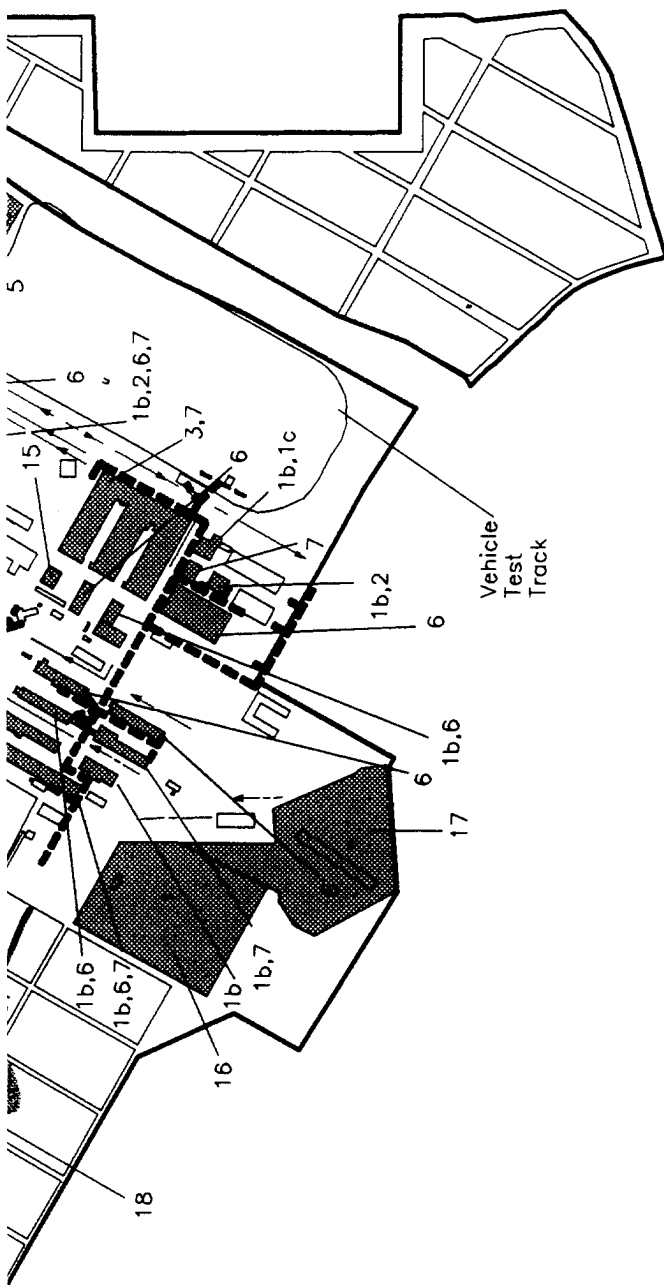
AREE Number	Description	AREE Number	Description
1a.	SWMU 49: Old Wastewater Distribution System - Current Stormwater Sewer System	9.	SWMU 36: Industrial Wastewater Treatment Plant (IWWP)
1b.	SWMU 49: Old Wastewater Distribution System - Old Connections to the New Wastewater System	10.	Asbestos*
1c.	SWMU 49: Radiator Repair Facility	11.	PCB-Containing Transformers*

2.	SWMU 47: Boiler Plant Blowdown Water	12.	Underground Storage Tanks*
3.	SWMU 50: Compressor Condensate Drain	13.	Above Ground Storage Tanks*
4.	SWMU 51: Chromic Acid/Alodine Drying Beds	14.	SWMU 52: Drain Field and Disposal Trenches*

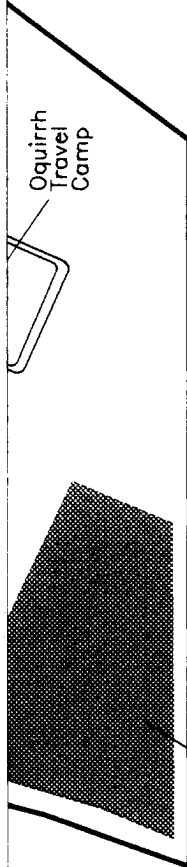
NOTE: This figure includes AREE 12 underground storage tanks and AREE 13 above ground storage tanks. The installation inventory of tanks is organized by building number. As such, shading of the buildings associated with the tanks was avoided to eliminate confusion concerning the extent of the AREE.

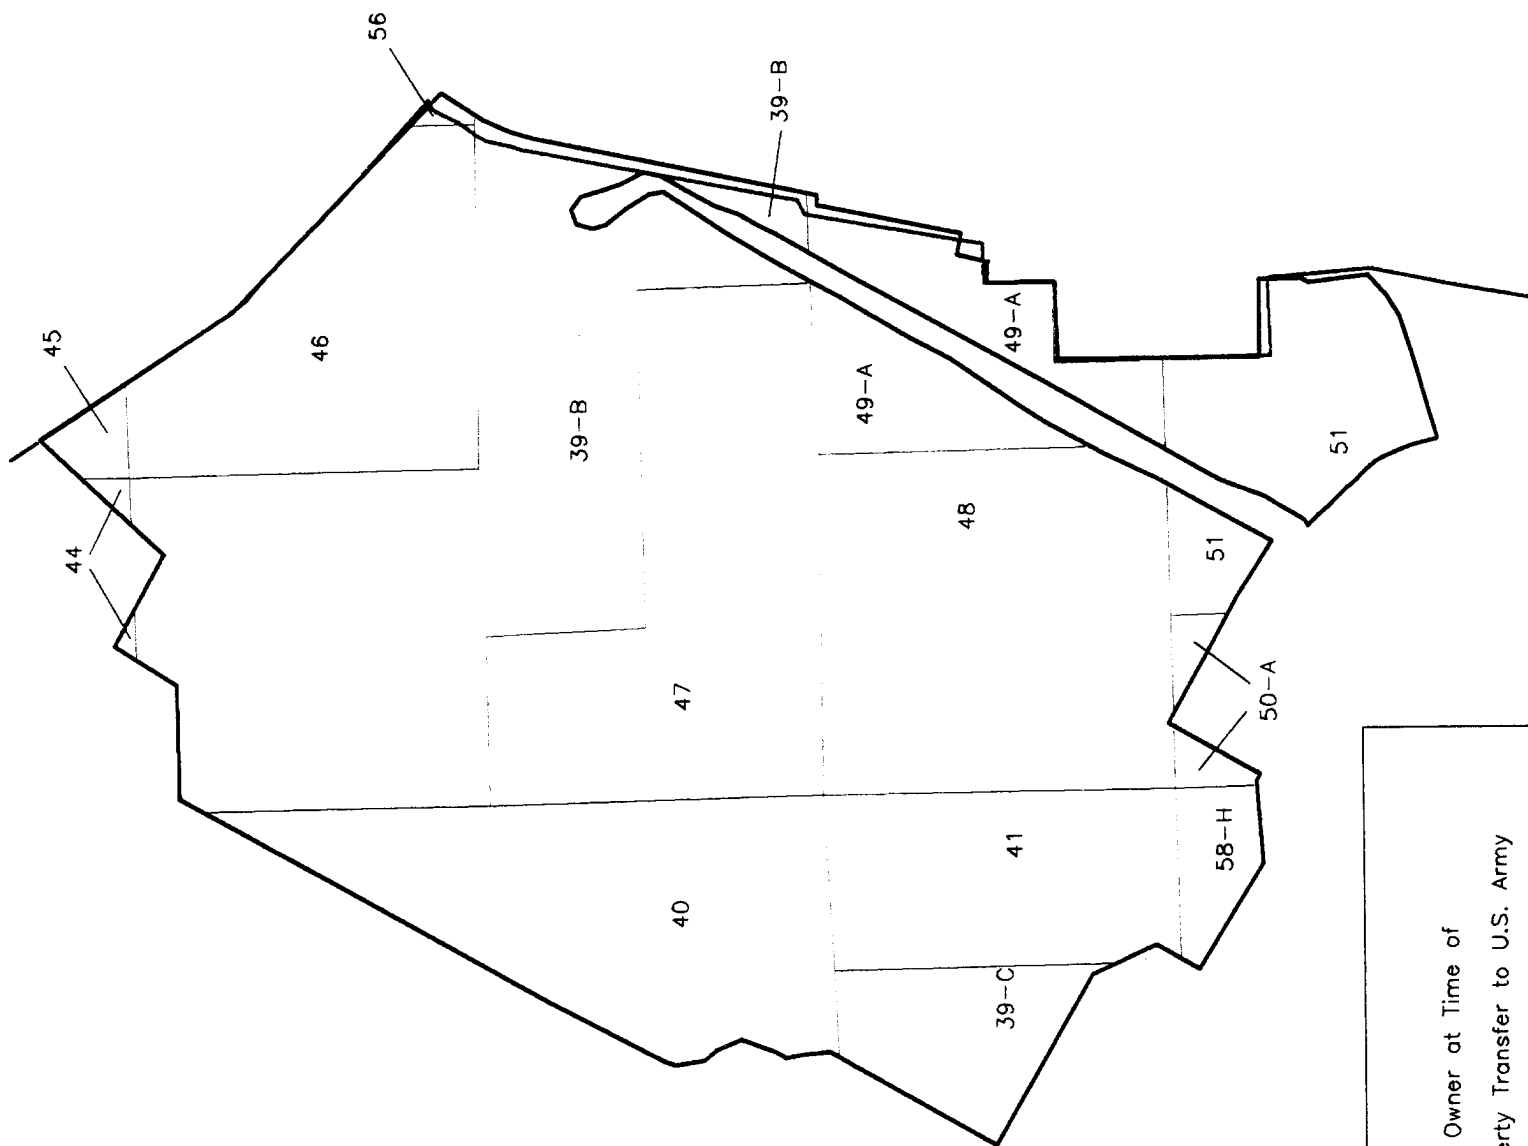
Tract Designation	Land Owner at Time of Property Transfer to U.S. Army
-------------------	--

Tract Designation	Land Owner at Time of Property Transfer to U.S. Army
B	Housing and Home Finance Agency
C	Federal Works Agency
39-B	Peter Clegg and Ida L. Clegg
39-C	Peter Clegg and Ida L. Clegg
40	Peter Clegg and Ida L. Clegg
41	George L. Tate and Alice R. Tate
44	James D. James, et al.
45	Francois J. Spitters and Geritje Spitters
46	Frank Penovich
47	Margaret Outcalt and William B. Outcalt
48	Fred Arthur Bonham and Nellie Elizabeth Savage
49-A	Howard J. Clegg and Zella O. Clegg
50-A	William H. Bryan and Emily L. Bryan
50-B	William H. Bryan and Emily L. Bryan
51	James A. Hogle and Mary C. Hogle
53	Willard G. Atkin and W. Frank Atkin
54-B	Annie M. Atkin
56	Stana Urich
57	Annie A. Gillespie
58-H	State of Utah
58-L	State of Utah
62	W. Frank Atkin, et al.

AGEISS conducted a review of tract maps and transfer documents provided by the U.S. Army Corps of Engineers to identify the prior property owners of the BRAC portion of TEAD-N at the time of its transfer to the Army. The purpose of this review was to collect additional information concerning the property's prior use and environmental condition at the time of its transfer to the Army. No information indicating that environmentally significant operations were associated with prior BRAC parcel land use was noted during this review. Previous ownership and the dates of transfer to the Army are indicated on Figure 5-1.
