Reef Breakwater Wave-Attenuation and Stability Tests, Burns Waterway Harbor, Indiana

by *Robert D. Carver, Brenda J. Wright*

Final report

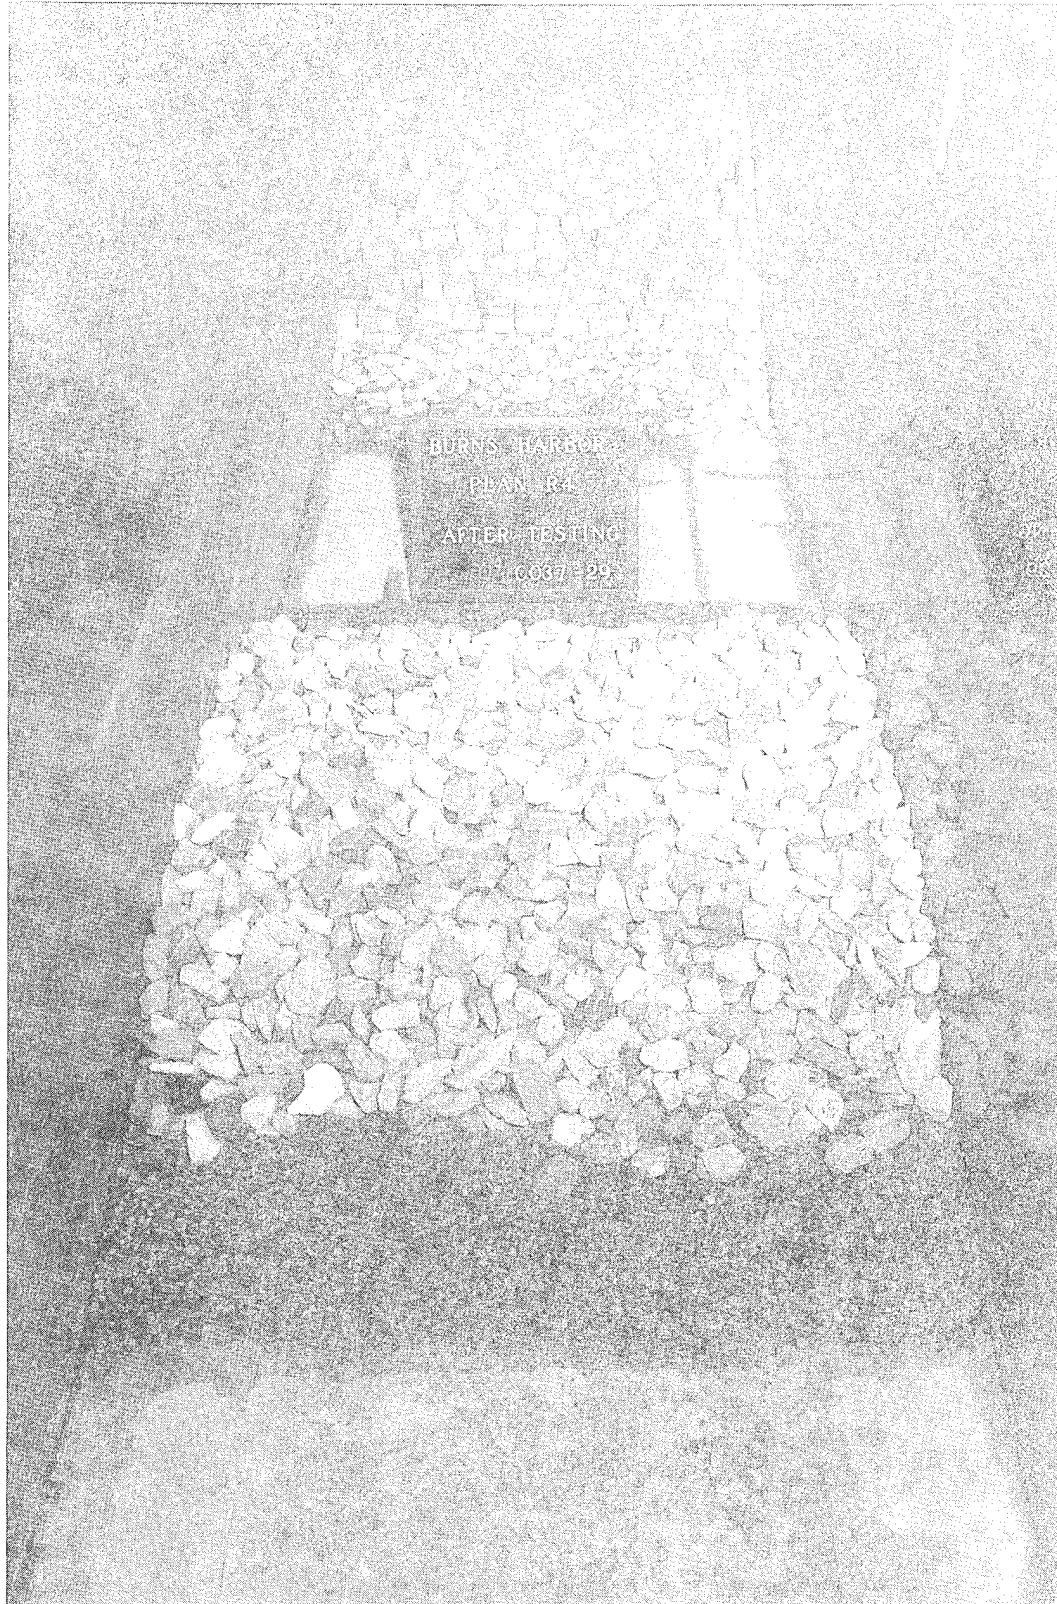
Photo 12. Lakeside view of Plan R4 (existing breakwater in background) after wave attack

Photo 13. End view of Plan R4 after wave attack

Photo 14. End view of existing breakwater as protected by Plan R4

As expected and shown in Figure 15, Plan R4 produced transmission results very similar to Plan R3. The 1- to 5-ton stone used to armor the reef showed more movement than the 3- to 5-ton stone used in Plan R3 (Photos 12 and 13); however, this movement amounted to only about 3 to 4 percent of the original stone volume and was considered acceptable. One lakeside and three harbor-side armor units were displaced from the existing breakwater (Photo 14).
