NASA CR-132645

# BORON/ALUMINUM SKINS FOR THE DC-10 AFT PYLON

FINAL REPORT

McDonnell Douglas Corporation  
Douglas Aircraft Company  
3855 Lakewood Blvd  
Long Beach, California 90846

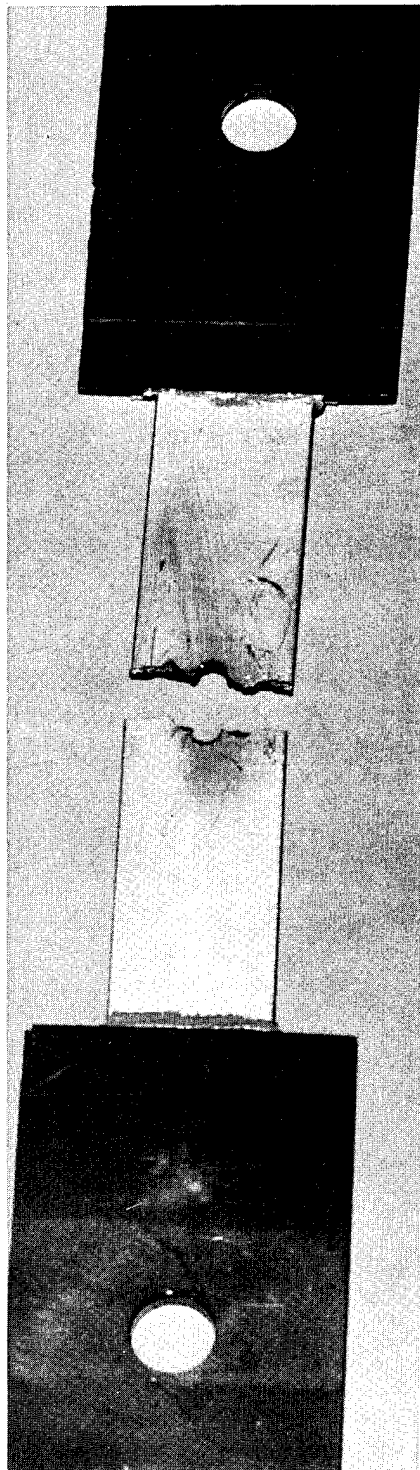
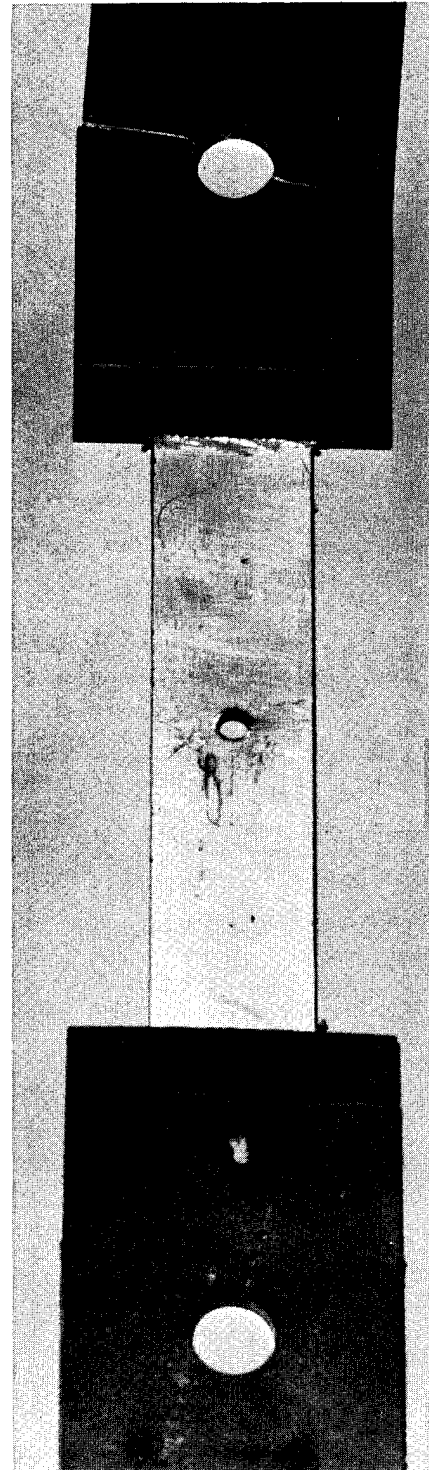
Figure 77 Failed Fatigue Specimen

#3 Failed at 2,362,000 Cycles

#4 Failed in Grip
