-- 1 - AD NUMBER: D432682
 -- 5 - CORPORATE AUTHOR: BOEING CO SEATTLE WA BOEING MARINE SYSTEMS
 -- 6 - UNCLASSIFIED TITLE: DEVELOPMENT OF AN ADVANCED COMPOSITE
 -- HYDROFOIL FLAP,
 -- 9 - DESCRIPTIVE NOTE: FINAL REPORT,
 --10 - PERSONAL AUTHORS: OKEN,S. ;
 --11 - REPORT DATE: , 1979
 --12 - PAGINATION: 138P
 --14 - REPORT NUMBER: D321-51319-1
 --15 - CONTRACT NUMBER: N00024-76-C-4233
 --20 - REPORT CLASSIFICATION: UNCLASSIFIED
 --22 - LIMITATIONS (ALPHA): APPROVED FOR PUBLIC RELEASE; DISTRIBUTION
 -- UNLIMITED. AVAILABILITY: NAVAL SUPPLY SYSTEMS COMMAND, WASHINGTON,
 -- D. C. 20362.
 --33 - LIMITATION CODES: 1 24

FIGURE		PAGE
1-1	PATROL CRAFT HYDROFOIL (PCH-1) COMPOSITE FLAP	10
3-1a	COMPOSITE FLAP PCH-1 ASSEMBLY (5-9865-1 SHEET 1)	26
3-1b	COMPOSITE FLAP PCH-1 ASSEMBLY (5-9865-1 SHEET 2)	27
3-2	NASTRAN MODEL OF PCH FLAP	28
3-3	PREDICTED FLAP DEFLECTIONS AT THE TRAILING EDGE	29
3-4	FLAP CONTOUR DEFORMATIONS DUE TO PRESSURE AT F.S. 54	30
3-5	CRITICAL STRESS AREAS OF THE COMPOSITE FLAP	31
3-6	FLAP WEIGHT COMPARISONS	32
4-1	TENSION-TENSION FATIGUE TEST SETUP	37
4-2	TENSION-TENSION FATIGUE PROPERTIES (NO HOLE)	38
4-3	TENSION FATIGUE FAILED SPECIMEN	39
4-4	TENSION-TENSION FATIGUE PROPERT

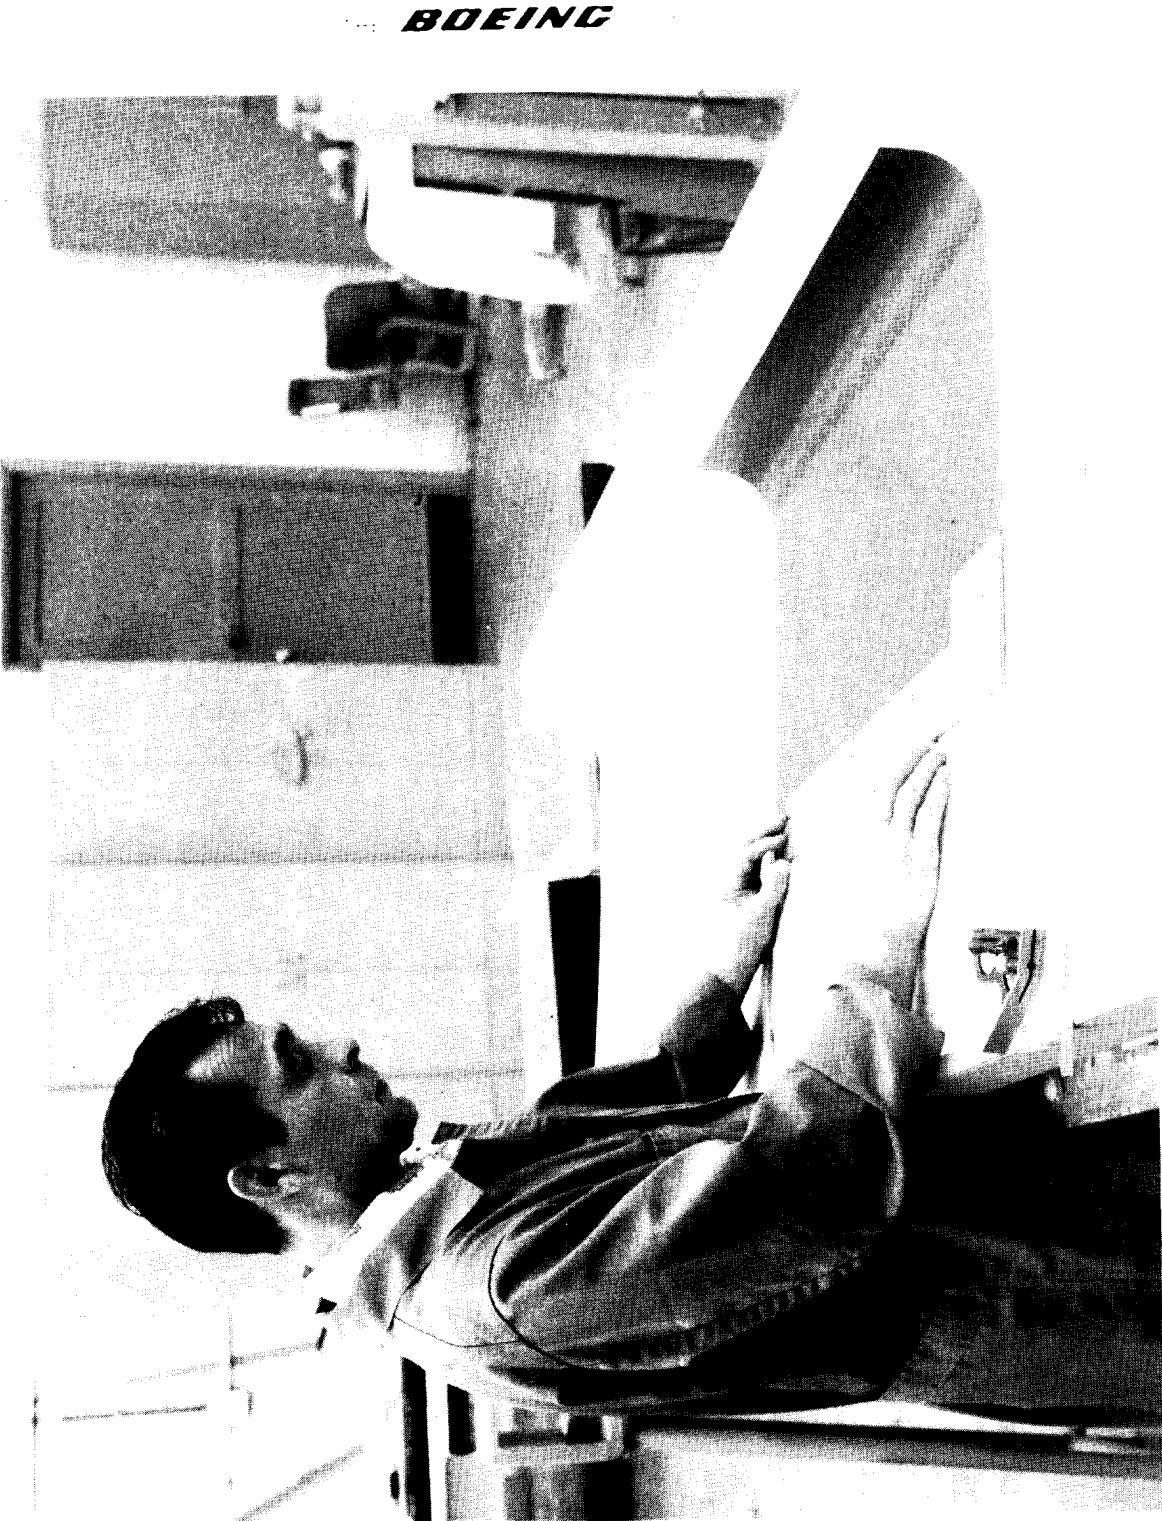
FIGURE 5-4 COMPOSITE COVER LAYUP

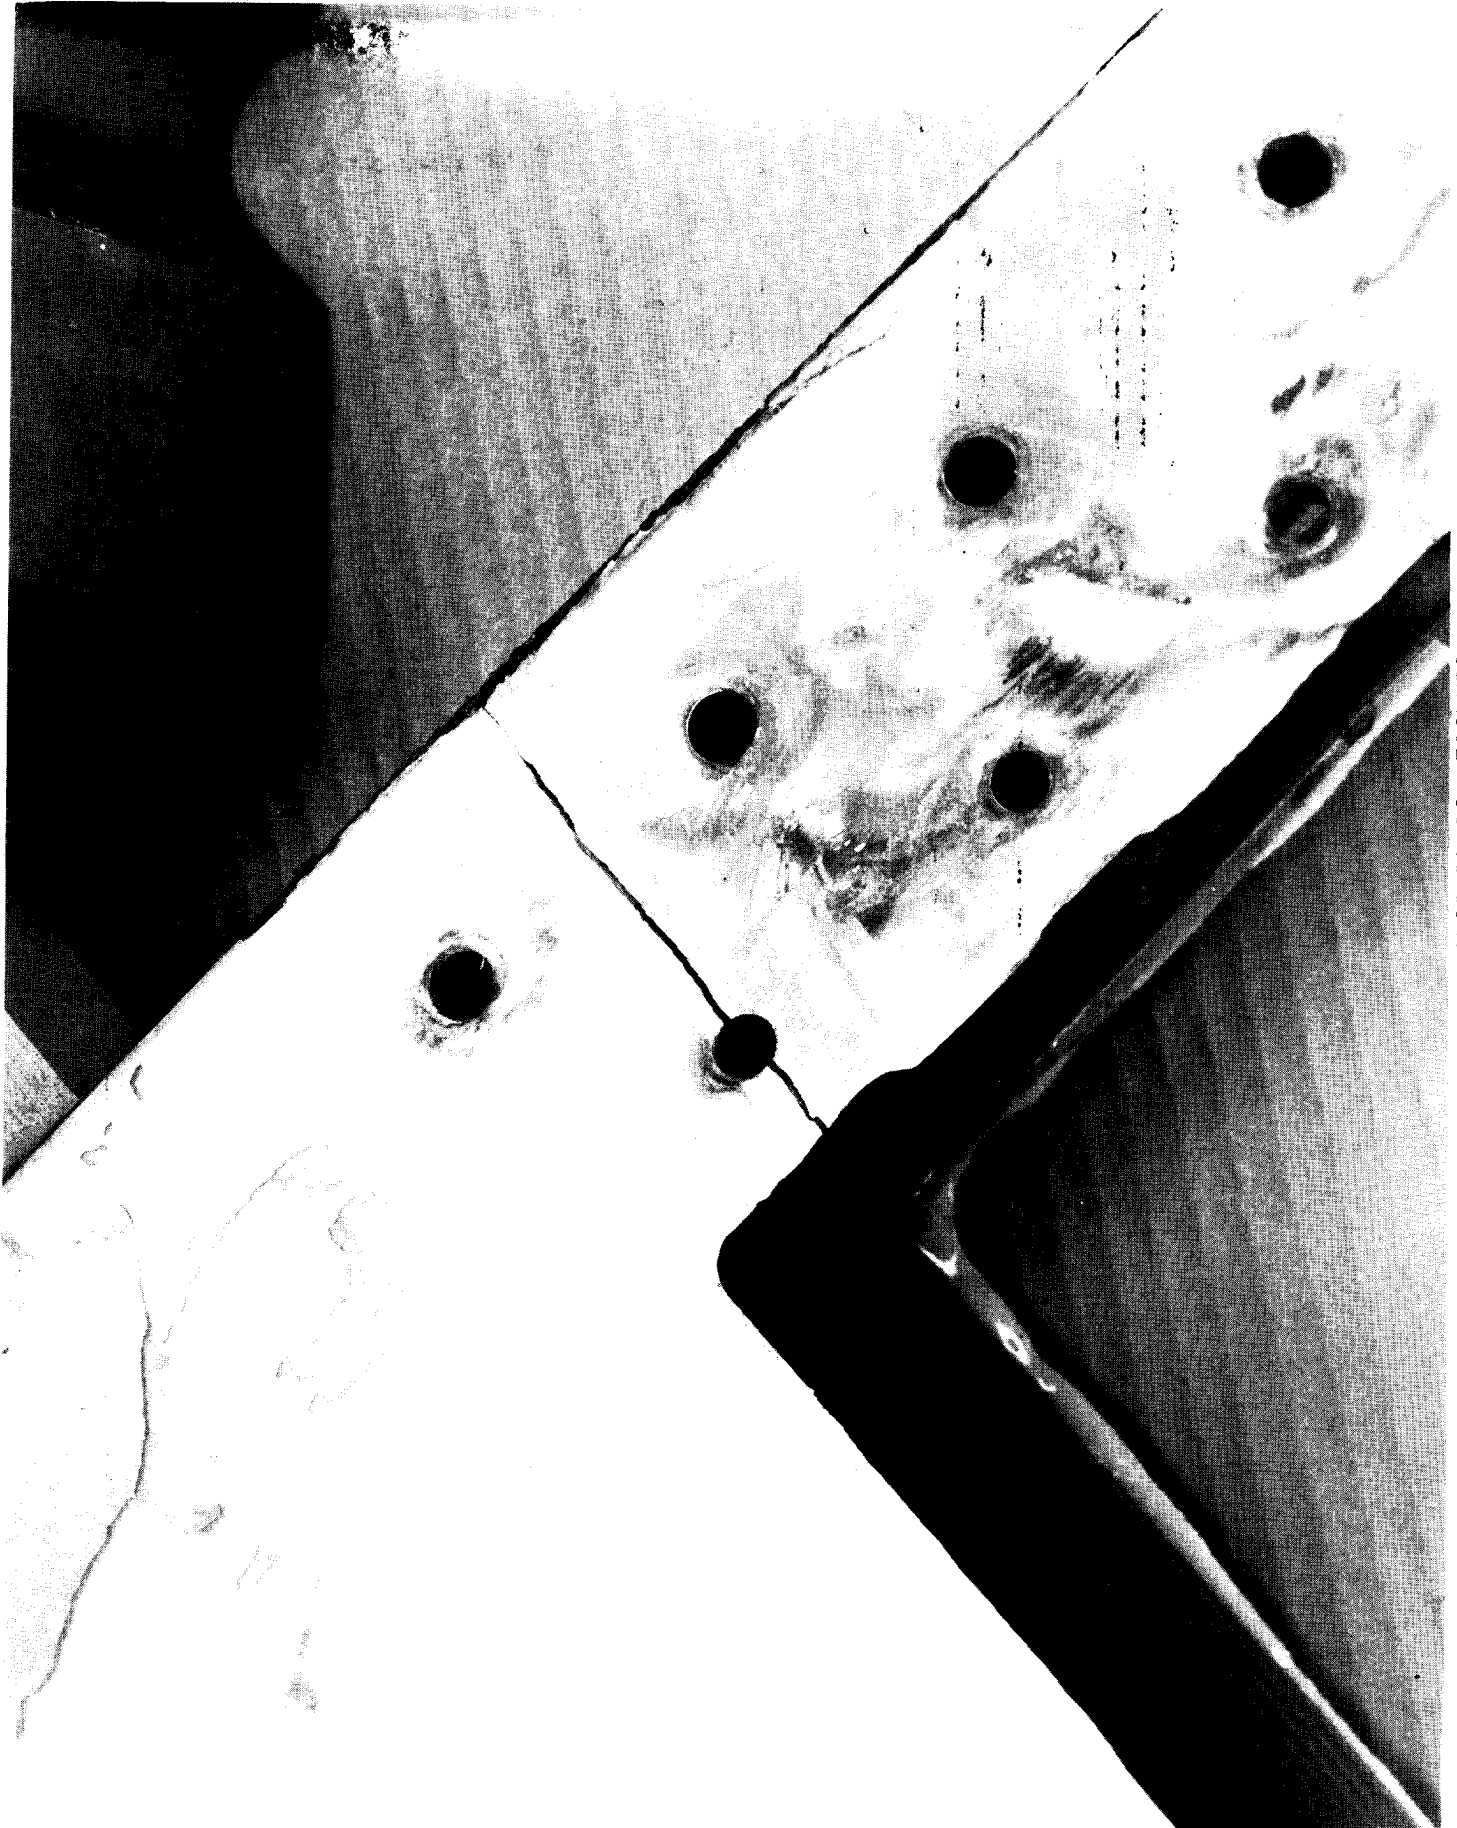
FIGURE 5-9 TITANIUM CLOSURE RIB FAILURE

The primary failure consisted of the fracture of the titanium closure rib. It was preceded by a bond failure along the nose of the flap which drastically changed the load paths to the composite covers. The resulting loads produced high bending stresses in the closure rib causing it to fail. Subsequent analysis and examination of the detail parts strongly backed this sequence of failure events.

between the covers and the titanium spar and crank assembly had to be pried apart with a screwdriver, indicating very good adherence. The area in the nose of the flap showed some voids and a lack of bond. It was theorized that threaded attachments installed prior to the cure cycle caused the covers to hang-up and prevented positive pressure in these areas. The failure in the titanium closure rib did not extend through its full depth. It occurred on the tension side of the rib through a bolt hole, as shown in Figure 5-9.
