BEHAVIOR OF DAMAGED GRAPHITE/EPOXY LAMINATES  
UNDER COMPRESSION LOADING

NASA Contractor Report 159293

## FINAL REPORT

**BRUCE A. BYERS**  
BOEING COMMERCIAL AIRPLANE COMPANY  
P.O. BOX 3707, SEATTLE, WA 98124

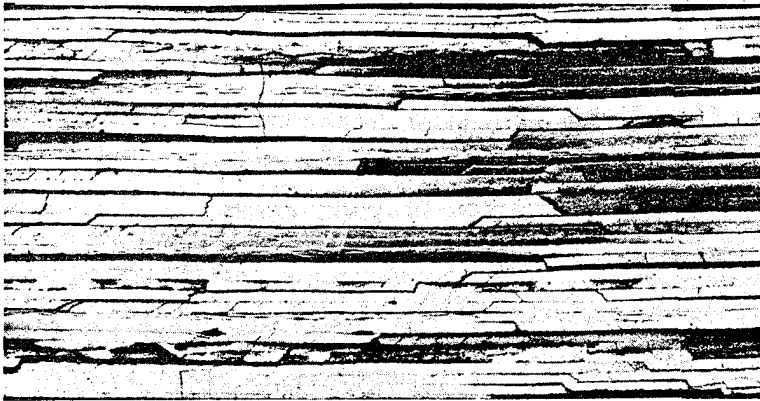
Figure 11. Comparison of Fracture Modes Following Low-Velocity Impact

- T300/5208
  - Impact = 15.8J (140 in-lb)
  - Delamination
  - Transverse cracks
  - Internally shattered

- T300/BP907
  - Impact = 31.6J (280 in-lb)
  - Delamination
  - Fiber fracture
  - Transverse cracks

- T300/P1700
  - Impact = 15.8J (140 in-lb)
  - No damage under impactor
  - Transverse cracks

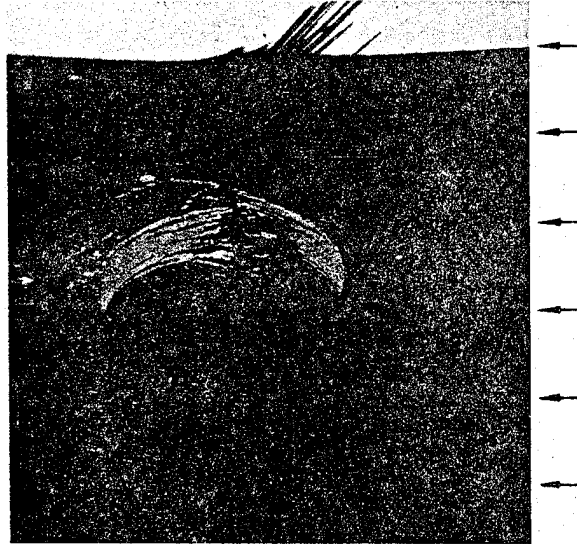
Figure 14. Failure Mode Comparison of Circular-Hole Specimens

T300/5208  
 $\epsilon_{ULT} = 5300 \mu\text{cm}/\text{cm}$

- Failure modes:
  - Delamination
  - Brooming
  - Transverse splitting

T300/BP907  
 $\epsilon_{ULT} = 5630 \mu\text{cm}/\text{cm}$

- Failure modes:
  - Some delamination
  - Shear

- $\pm 45$ -deg dominated laminate
- Hole diameter = 2.54 cm (1.0 in)

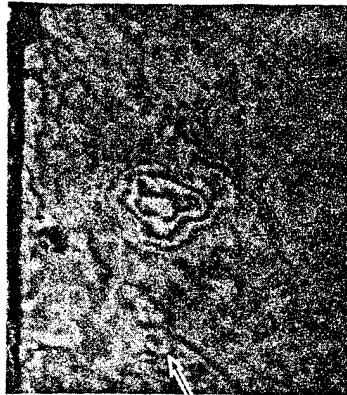
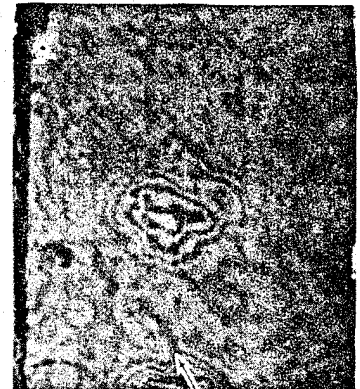
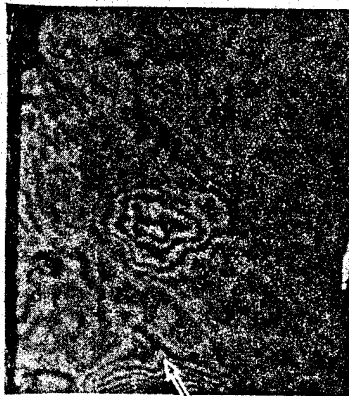
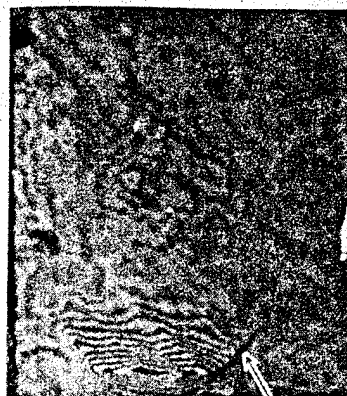
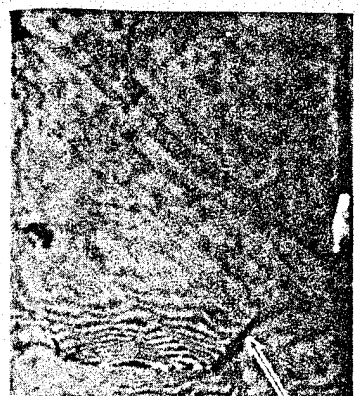
N = 1000\*  
Initial delamination  
3.81-cm (1.5-in)  
diameter, 4 plies deep

N = 13 000\*  
New damage nucleation

N = 15 000\*  
Damage growth

N = 19 000\*  
Damage growth

N = 26 000\*  
Delamination growth  
plus cracking

N = 28 000\*  
Appearance close to  
failure

\*Strain range = -6000 to -600  $\mu\text{cm}/\text{cm}$

During an attempt to monitor delamination growth in a T300/BP907 specimen with the same simulated delamination size and position, an interesting feature developed. Figure 28 is a series of moiré fringe photographs for this specimen. At the cyclic compression strain level of -6500 to -650  $\mu\text{cm}/\text{cm}$ , the region over the delamination buckles on every cycle; however, with an increasing number of cycles, delamination growth initiates in a region away from the specimen edges and initial delamination position. NDI scans prior to testing gave no indication of damage at this location. This behavior was atypical of the simulated delamination cyclic compression tests. Cyclic compression lives for all the simulated delamination tests are summarized in Table 11.
