NASA TN D-6599

ANALYSIS OF SURVEYOR III TELEVISION CABLE AFTER RESIDENCE ON THE MOON

by Frederick C. Gross and John J. Park

*Goddard Space Flight Center
Greenbelt, Md. 20771*

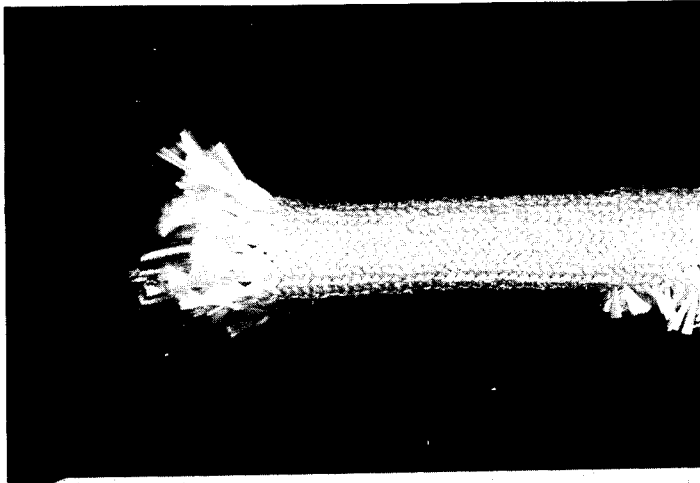
Figure 1—Surveyor cable, glass fabric covering over nineteen insulated wires. (1.5X)

The Surveyor cable, as was mentioned previously, consisted of a glass fabric sleeve over 19 insulated wires (Figure 1). The fabric itself appeared to be a dirty gray, darker than the TAT sample. Some small particles, presumably lunar dust, were noted on the fabric (Figure 2); these particles were neither large nor very numerous. In addition, it was noted that the TAT sample also had loose pieces of metal or dirt in its fabric sleeve. However, the Surveyor sample had more particles and was darker.

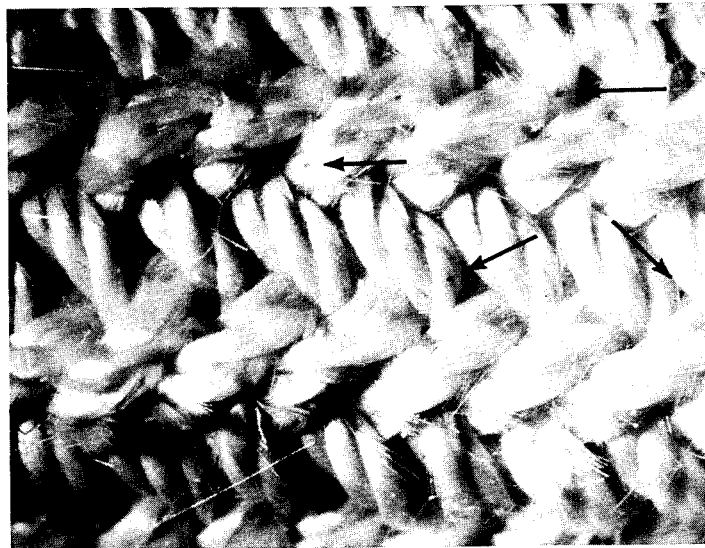
Figure 2—Enlarged view of woven glass fabric; black particles are believed to be lunar dust. (20X)

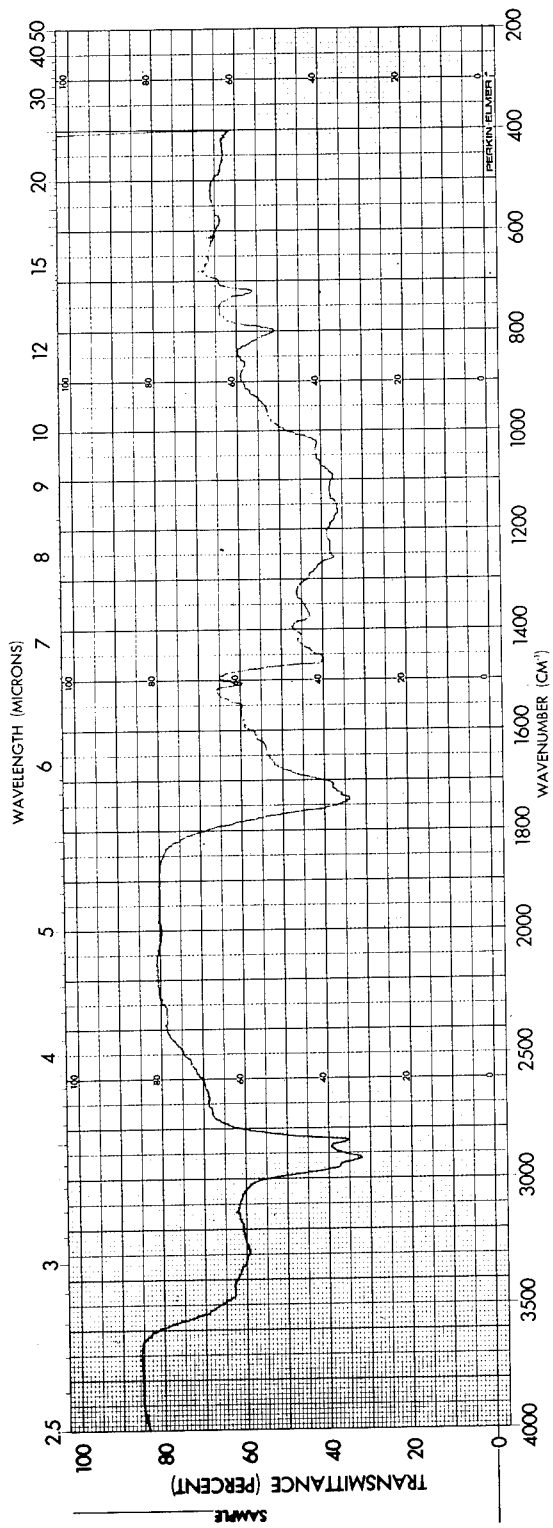
Figure 3(a)—Reproduction of spectrum of chloroform extract from TAT glass fabric. [The SI equivalent of the micron (μ) is the micrometer (μm); $1 \mu = 1 \mu\text{m}$.]

Samples of fabric were extracted with boiling chloroform. The chloroform was evaporated, and the weights of the extracts were determined. The comparison of these results was positive: The TAT sample had a 0.32-percent residue, and the Surveyor sample had a 0.21-percent residue. The residues were dissolved again, and their infrared spectra were obtained. The spectrum of the TAT sample [Figure 3(a)] showed mostly aliphatic esters and other carbonyl-containing compounds such as fatty acids. The spectrum of the Surveyor sample [Figure 3(b)] was a more clearly defined pattern of aliphatic esters, which indicated that some volatilization of the lower-boiling constituents might have occurred in the space vacuum.

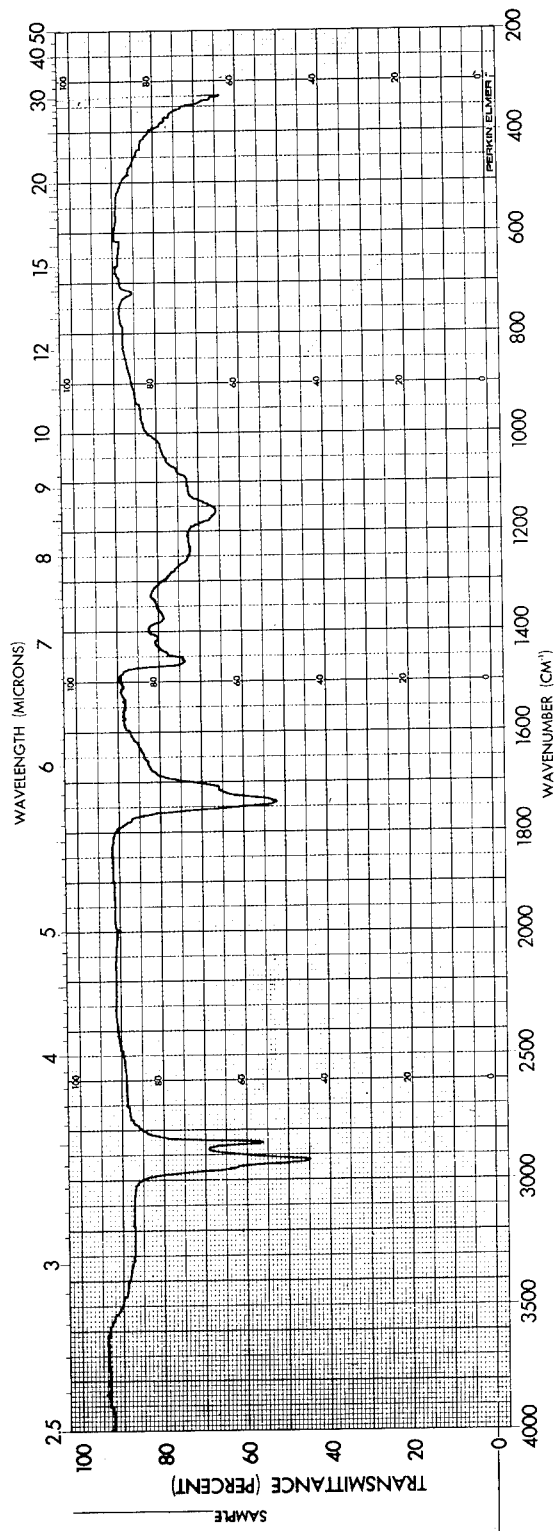
Figure 3(b)—Reproduction of spectrum of chloroform extract from Surveyor glass fabric. [The SI equivalent of the micron (μ) is the micrometer (μm); $1 \mu = 1 \mu\text{m}$.]

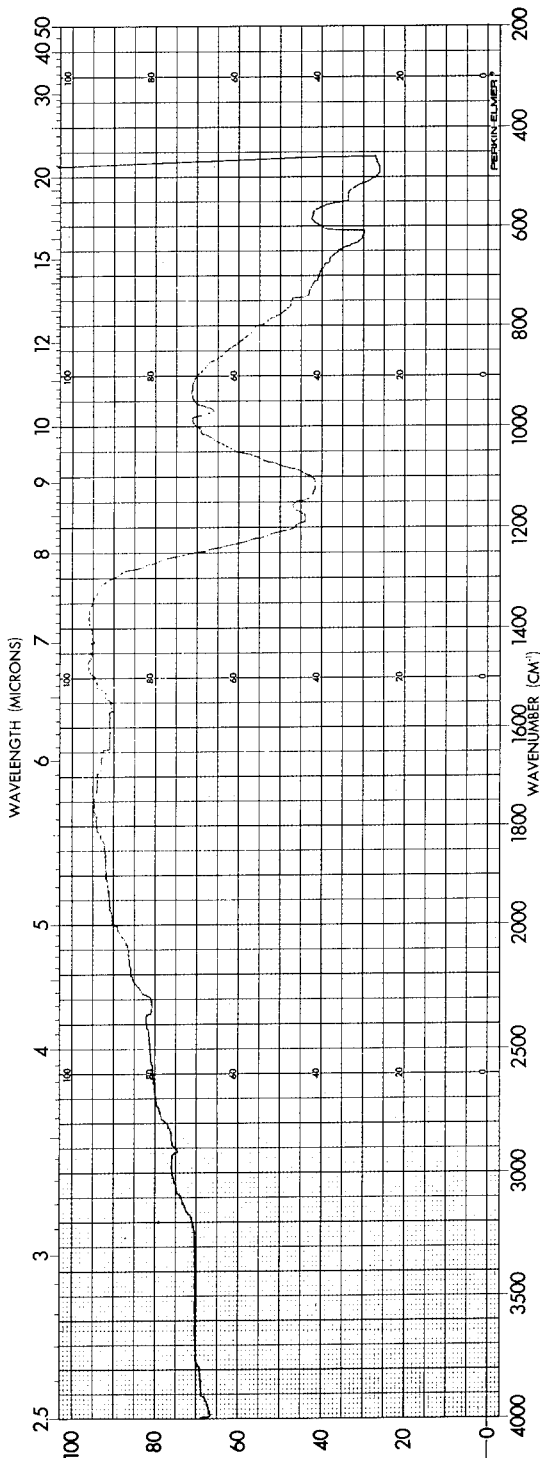
Figure 4(a)—Reproduction of ATR-IR chart of TAT Teflon insulation. [The SI equivalent of the micron (μ) is the micrometer (μm); $1 \mu = 1 \mu\text{m}$.]

Dissolution of the outer polyimide layer by a 15-percent hot potassium-hydroxide solution was carried out. The underlying Teflon layer of the Surveyor sample showed some small areas of slight discoloration. The ATR-IR patterns yielded some slight differences in the region of 800 to 500 cm^{-1} , though it would be difficult to assign positive significance to these because of the normal variations of the test [Figures 4(a) and 4(b)]. The bands in the region of 2900 cm^{-1} in Figure 4(b) are considered to be a residual contaminant on the infrared reflectance crystal.

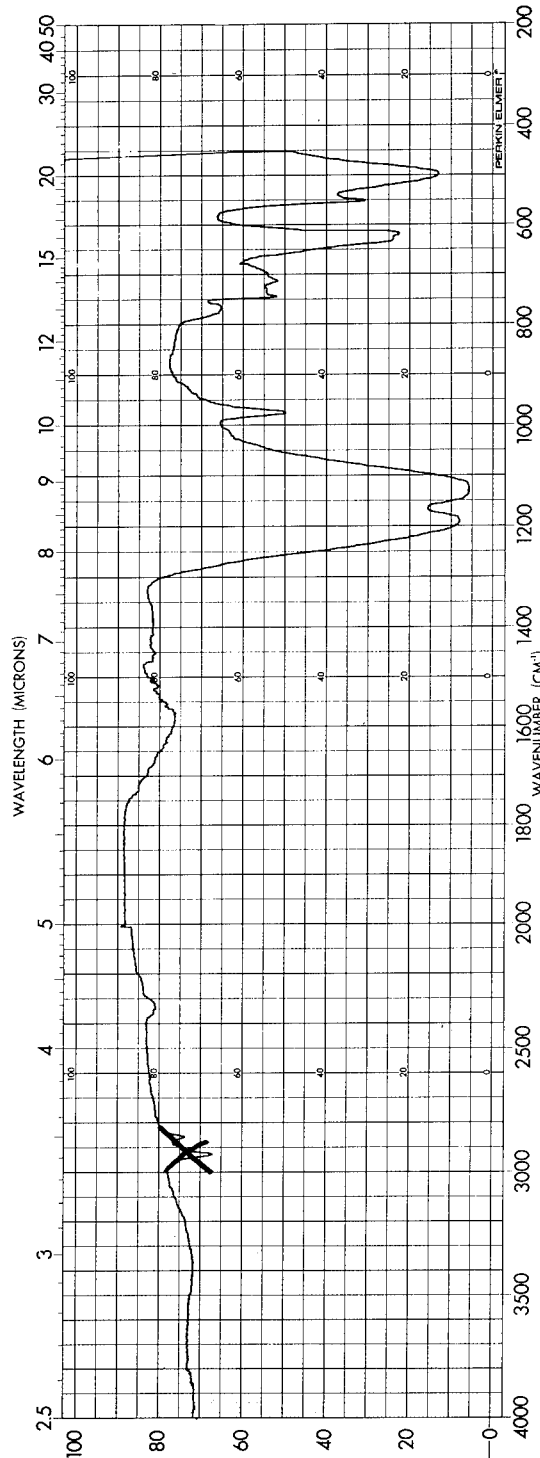
Figure 4(b)—Reproduction of ATR-IR chart of Surveyor Teflon insulation. [The SI equivalent of the micron (μ) is the micrometer (μm); $1 \mu = 1 \mu\text{m}$.]

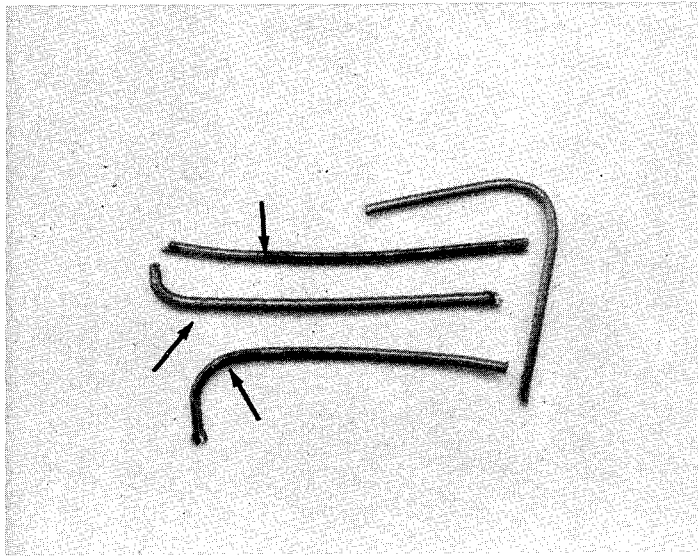
Certain portions of at least two Surveyor wires showed black areas (Figure 6). It was determined that these areas were under the insulation rather than on the surface. These areas were examined in an electron microprobe analyzer. These results showed primarily silver and copper, but also sulfur and iron; the sulfur was associated with the silver rather than with the iron. The X-ray diffraction pattern identified the black areas as silver sulfide, Ag_2S . There were also occasional areas on the wires that were determined to be high in copper and sulfur, possibly copper sulfate, $CuSO_4$. It must be assumed that the sulfide corrosion was on the wires before the trip to the moon, though it should be pointed out that no such areas were observed on any of the TAT wires.

Figure 6—Surveyor wires showing corrosion on three separate wires; fourth wire with large bend is from TAT.
