NASA Contract Report CR-168023

COMPRESSION AND COMPRESSION FATIGUE TESTING OF COMPOSITE LAMINATES

T. R. Porter

Boeing Military Airplane Company
P.O. Box 3707
Seattle, Washington 98124

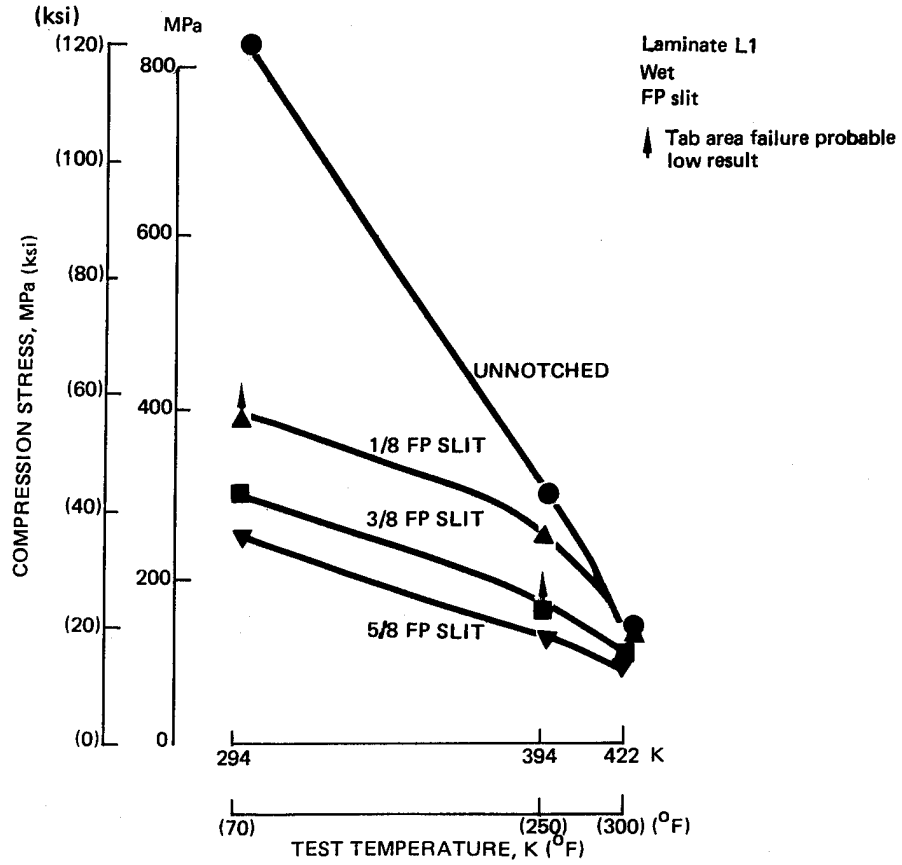
Figure 15. Effect of Test Temperature on the Dry-Compression Fracture Strength

These temperature effects are illustrated for dry and wet laminates in figures 15 and 16 for the through slits (FP) and figure 17 for the half penetration (HP) slit. As shown in figure 17, elevated temperature can reduce the notch effect for tension-loaded HP slits leading to an increase in fracture strength. Under compression loading, however, the elevated-temperature dry and the elevated-temperature wet specimens display a significant reduction in strength.
