USAATCOM TR 95-D-8

ADVANCED ROTOR BLADE EROSION PROTECTION SYSTEM

KAMAN AEROSPACE CORPORATION BLOOMFIELD, CT 06002-0002

Final Report

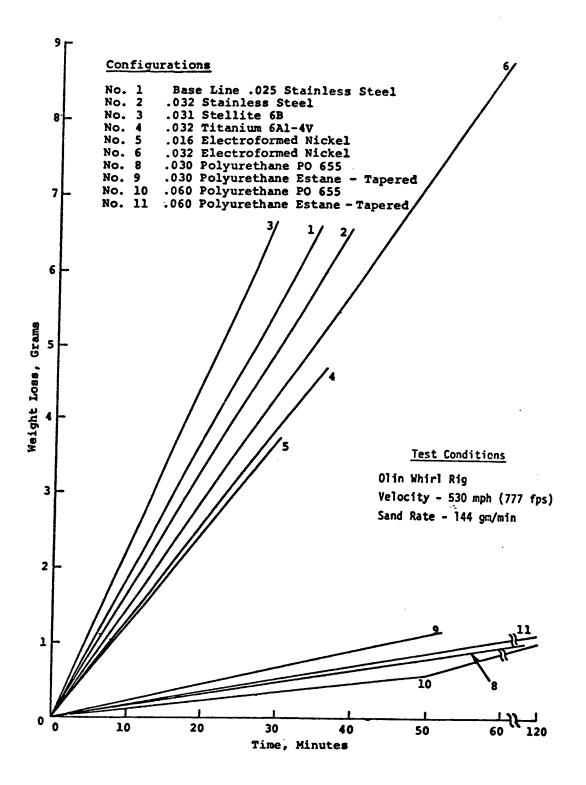
Figure 1, Sand Erosion Wear Rate, Comparative Summary. (From Ref. 1)

Army data shows that the metal erosion guards employed on the B-540 metal main rotor blades for the AH-1 Cobra helicopter exhibited low flight time between replacement as a result of sand erosion⁽²⁾. The elastomeric erosion guard originally developed for the K747 composite main rotor blade for the same helicopter performed to the Army's specified sand and rain erosion resistance requirements⁽³⁾. It was fabricated from Estane 82-083-1828, a thermoplastic polyurethane material supplied by B.F. Goodrich. Although satisfactory from the standpoint of sand and rain erosion performance, it proved to be undesirably vulnerable to foreign object impact damage during in-ground-effect (IGE) and operational nap-of-the-earth (NOE) maneuvers. As a result of this experience, an erosion guard with improved resistance to impact was developed⁽⁴⁾. It was fabricated from P0655, a thermosetting polyurethane material supplied by Custom Urethane Elastomers, Inc. (CUE Inc.) formerly Fluorocarbon Inc.

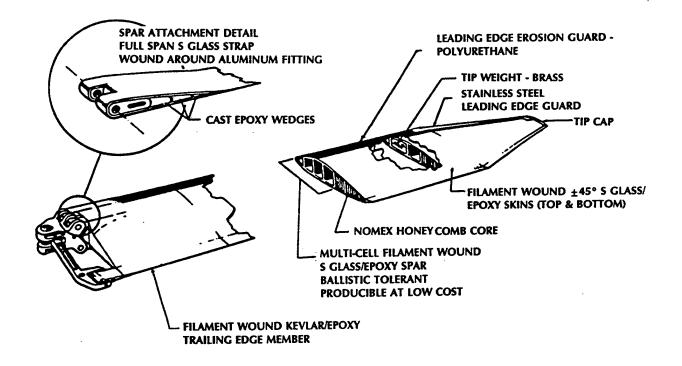
Figure 2. K747 Blade Configuration.

The current K747 blade configuration has a 43.5-inch-long, stainless steel, leading edge guard covering the outboard end of the PO655 guard as shown in Figure 2. Its purpose is to enhance rain and impact resistance. Conversely, its resistance to sand erosion is much worse as evidenced by the sand erosion wear rates shown in Figure 1 for stainless steel versus polyurethane. During extensive desert operations, the blades can be modified in the field and flown without the stainless steel guards. After the guard is removed, six stainless steel shields are installed with new self-locking screws as shown in Figure 23. These shields are elongated countersunk washers that cover attachment cutouts in the PO655 guard. The cutouts are through holes which allow the shields to seat directly against the attachment posts bonded in the blade. A process was developed whereby most of the attachment holes were cut in the experimental erosion guards using a 76-inch OD hole saw during prebond dry-fit operations. K747 blades that have the stainless steel erosion guard so removed are called field-modified. This configuration was chosen for the test blades so erosion effects would appear sooner. They were 3-scale balanced to match field-modified production blades.

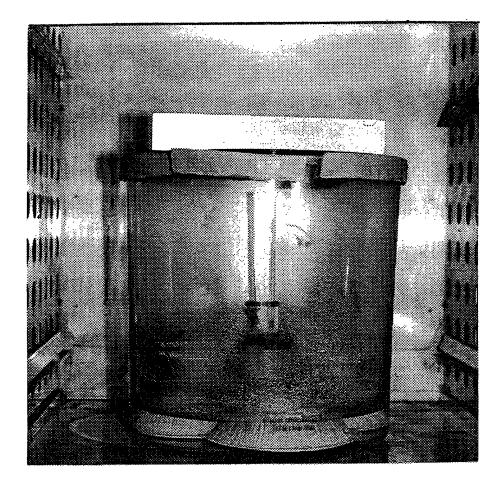
Figure 3. Apparatus Used for Hydrolysis Testing.

All 62 materials were tested for possible degradation in a hot-wet environment. The temperature/humidity levels of the MIL-STD-810E humidity test were increased to a constant 82°C (180°F)/95-100% relative humidity to identify materials which may eventually degrade by the molecular chain scission mechanism of hydrolysis. Due to the large number of samples tested, four separate groups were run. Figure 3 shows the apparatus used for this test. About an inch of distilled water was placed in the bottom of a large plastic container. Samples were placed in small aluminum dishes and stacked on racks. The container was then covered and sealed except for a small opening to relieve pressure. The semi-sealed container was placed in an air circulating oven which was maintained at 82°C (180°F). Materials were visually inspected and tested for durometer hardness prior to exposure and periodically throughout the exposure cycle. The failure mode of most of the materials was a fairly rapid drop in the hardness value within the first several hundred hours of exposure followed by an eventual melting of the material. Several of the materials became brittle and developed cracks. The neoprene samples, 21 and T6, did not melt or crack but swelled irreversibly, especially the thin sample T6. Even after being removed from the test environment and allowed to dry, the samples remained swollen to such a degree that they were considered undesirable. The results of the hydrolysis tests are summarized in Table 1 and described in greater detail in Table 2.

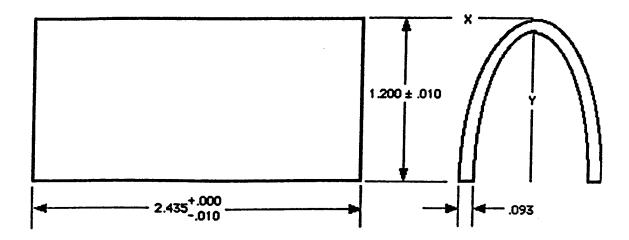
a. Glass-Epoxy

Figure 4. Leading Edge Airfoil Substrates.

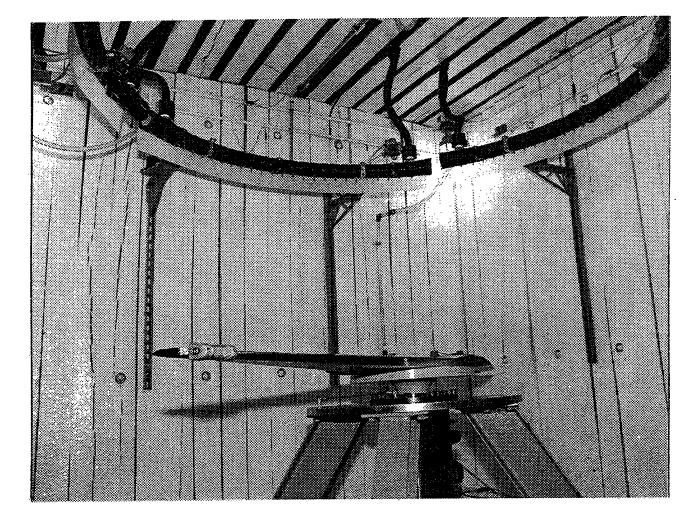
Figure 5. Specimen Attached to Rotor Blade of UDRI Rain Erosion Test Rig.

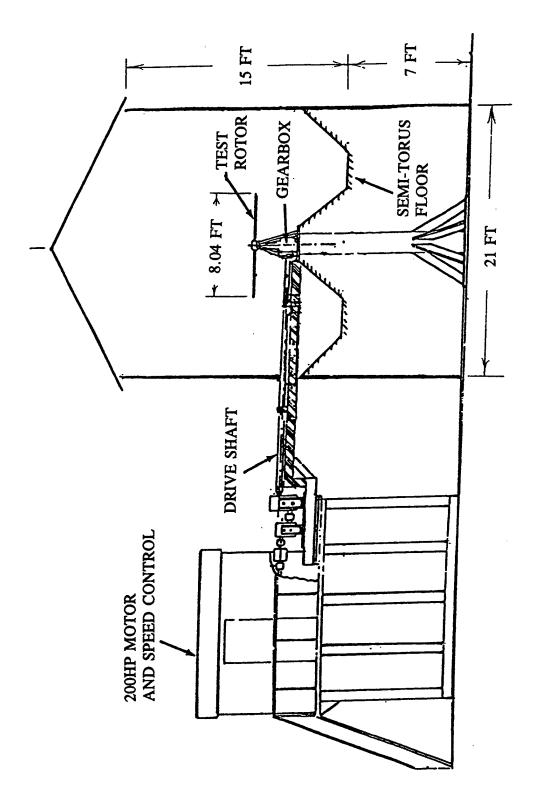
Figure 6. Kaman Whirling Arm Sand Erosion and Impact Test Facility.

The 8.04 foot diameter test rotor is housed in a circular enclosure, 21 feet in diameter and 15 feet high. See Figure 6. This conforms to the rotor-to-enclosure size ratio recommended in the QTP. The facility employs a 200 hp, 1800 rpm motor which is connected to a hydraulic speed reducer. The output is fed into two intermediate gearboxes, through appropriate shafting and into a tail rotor gearbox to satisfy the required maximum output shaft speed of up to 1900 rpm. Although the test coupon speed of 733 fps requires only 1750 rpm, the as-designed capability provides for sufficient margin to ensure meeting the rpm requirements independent of power requirements. The center of the test enclosure contains a vertical steel mast and pedestal with a horizontally mounted rotor assembly. The rotor gearbox contains a pitch change mechanism to allow presetting and/or varying of the specimen angle of attack during the dynamic phases of testing. A semi-torus shaped floor was installed to encourage circulation of sand particles during testing.

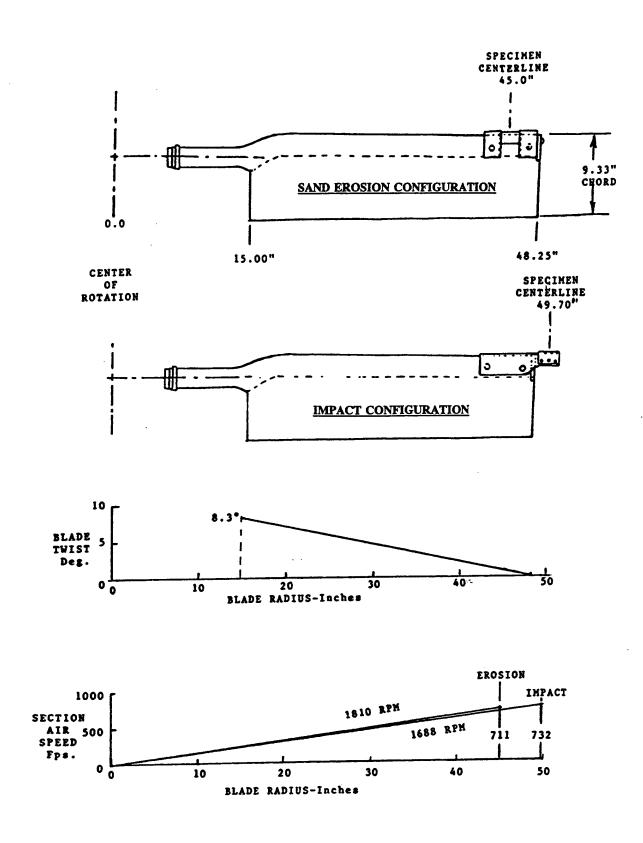
Figure 9. Erosion and Impact Blade Configurations.

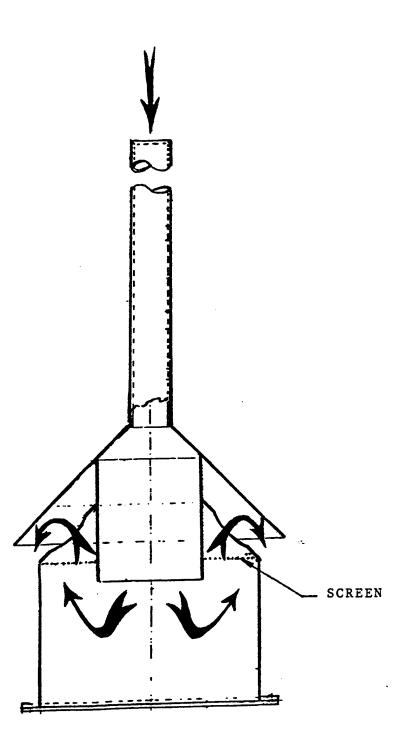
Figure 11. Sand Collector.

Table 6 shows the results of the sand erosion tests. Sample weight loss and the weight of sand collected over the 10-minute test period were determined. Sample No. 4 was run several times to insure consistency during the testing. The sand to air density was calculated as described above and was found to be reasonably consistent. There is, however, some variation and this was taken into account when making comparisons. A normalized weight loss column is included where the weight loss was divided by the sand to air density. To further simplify the results, the samples were compared using the material currently in use on the K747 blade as the baseline material. Therefore, the normalized weight loss for Samples No. 4A and 4B was divided by the normalized weight loss obtained for each material. Using that basis, the larger the number, the better the material can resist sand erosion. Table 7 lists the materials ranked in order of their comparison ratio number.

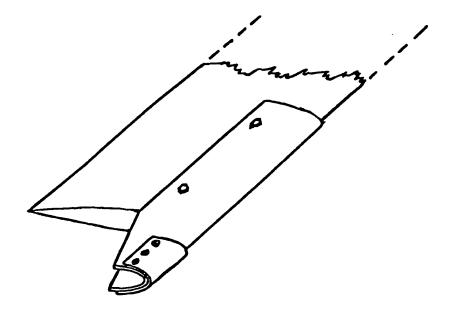
Figure 12. Attachment Arrangement for Impact Tests.

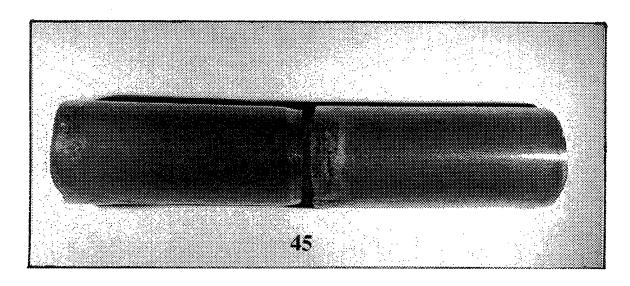
a. Rain erosion specimens after 1060 minutes.

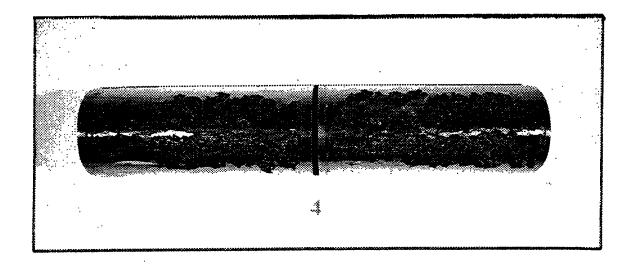
a. Rain erosion specimens. Failed after 240 minutes.

Sample T3U, which is the identical urethane formulation of molded sample 45, also exhibited excellent rain erosion results. After 240 minutes, the specimens were unblemished and would likely survive much longer. Solar radiation resistance was excellent as described above. Sand erosion, although almost six times better than sample 4 in erosion wear rate, was found to be unacceptable. After only 10 minutes of testing, small splits had developed and one had opened down to the substrate. Subsequently it filled with sand and began to lift from the

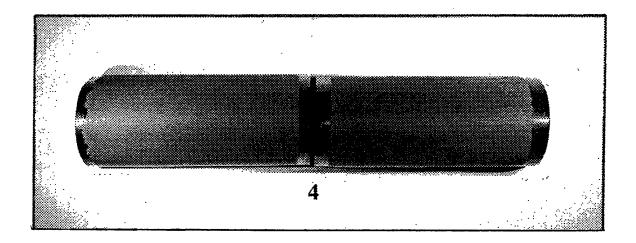
b. Sand erosion specimens.

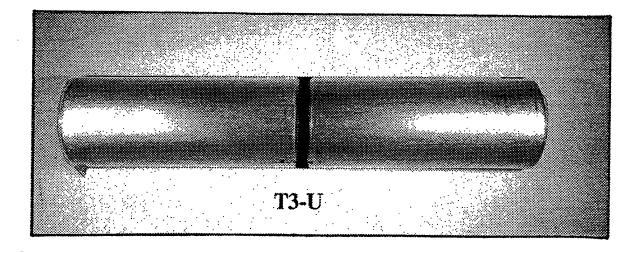
a. Rain erosion specimens. No failure after 240 minutes.

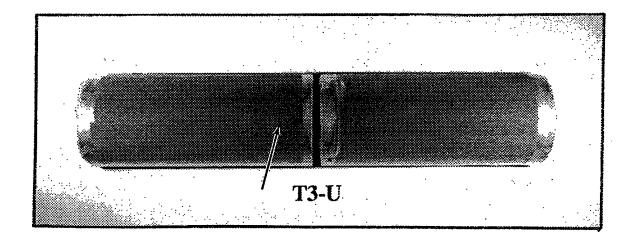
b. Sand erosion specimens. Arrow indicates split in tape.

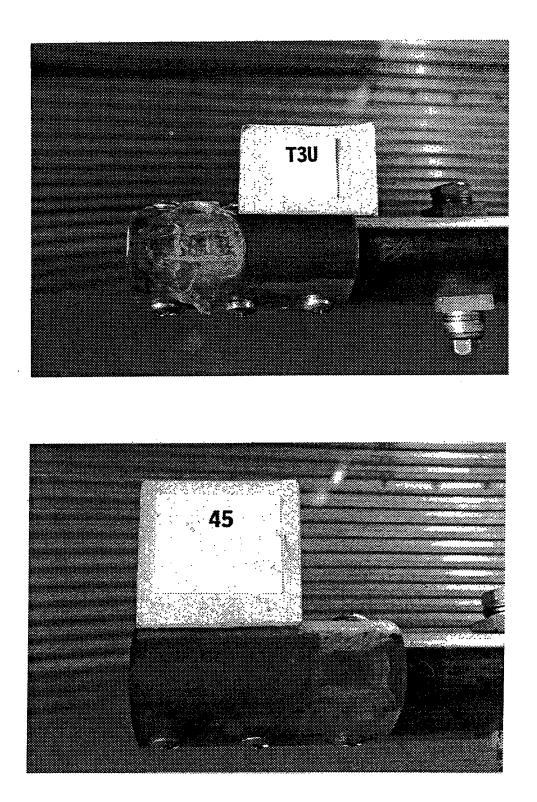
Figure 17. Samples T3U and 45 After 7/8 In. Dowel Impact.

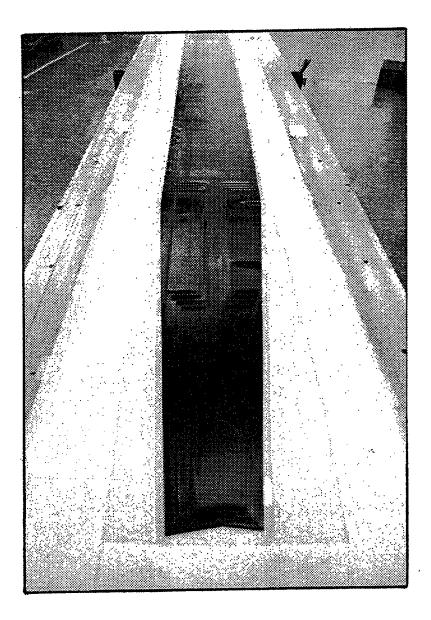
Figure 19. Layup of Plies for NPE 2916 Erosion Guard Before Vacuum-bagging.

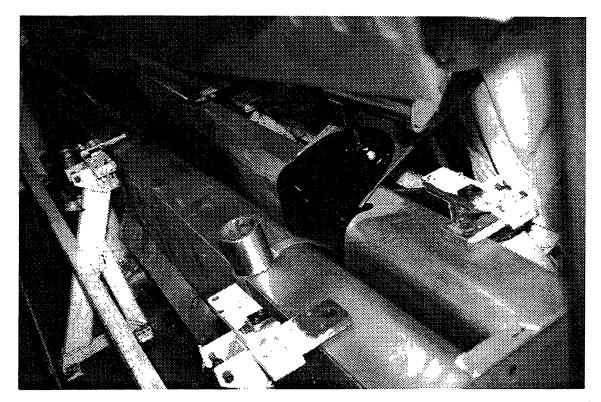
Figure 20. Casting 535330A into Tip End of Mold Cavity. Note Brass Shim at Station 246 Lower Surface.

A second attempt was made by the author and CUE personnel. A standard production PO655 erosion guard had been allowed to stay overnight in the heated and closed mold. Upon its removal from the mold, a hole at station 246 lower surface and rips at stations 176 lower surface and 142 upper surface were observed. These were above the trim line and presented no problems. CUE personnel said that, based on their previous trials, if the guard had been fabricated from 535330A instead of PO655, the rips would have progressed past the trim line, making it unacceptable. Thickness measurements of the guard upper and lower surfaces at those stations suggested that the male plug apparently shifts upon tool closure toward the sides of the female tool where the hole and rips occur. To offset this tool shifting, three 0.010 in. thick brass shim strips ending 2 inches above the trim line were positioned on the lower female tool at the stations described above. Figure 20 shows the shim at station 246 lower surface.

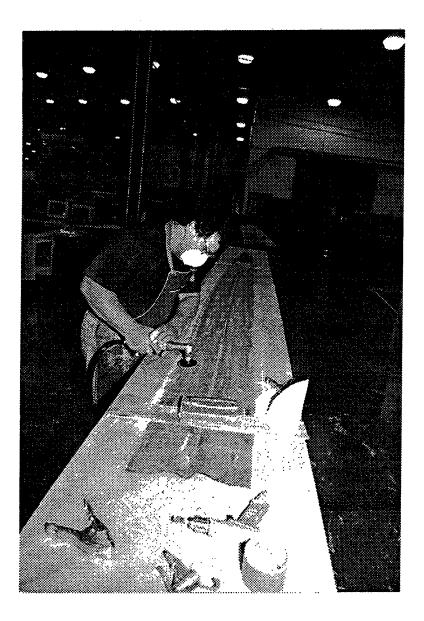
Figure 21. Scuffing Internal Surface of 535330A Erosion Guard in Preparation for Bonding.

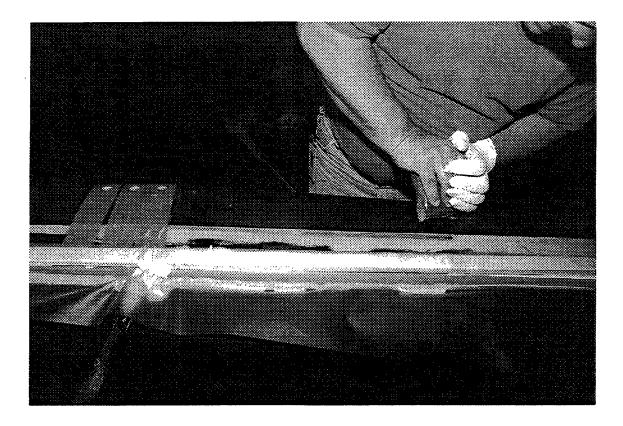
Figure 22. Squeegeeing Excess Adhesive from Bondline during Vacuum Bag Bond Operation.

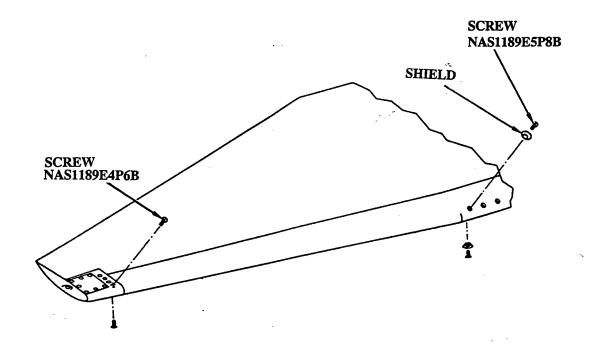
Figure 23. Installation of the Shields.

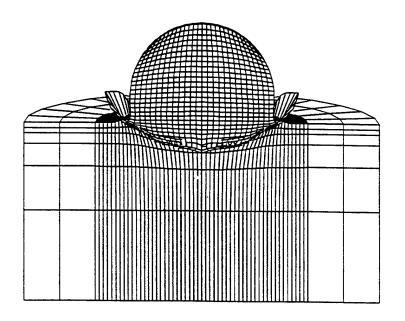
a. Normal impact condition at 2 μ s.

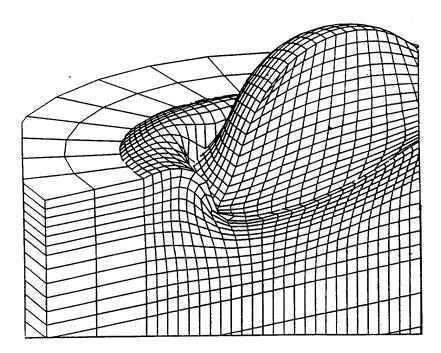
- b. A 45° oblique impact condition at 5 μ s. The waterdrop impact is from left to right.
- Figure 2.1. Finite element representations for a 2 mm waterdrop impacting at 1000 fps on a polymeric layer.

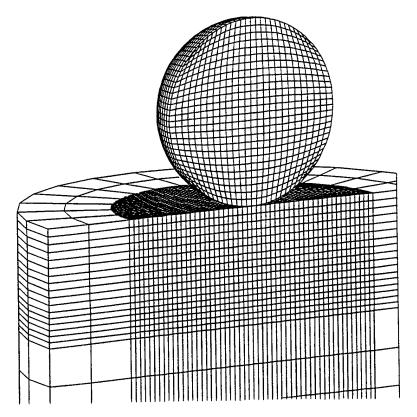
Figure 2.2 Finite element grid configuration for the waterdrop impact simulation.

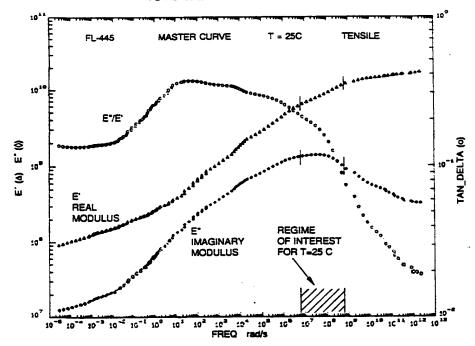
Figure 3.1 Linear viscoelastic properties over an extended frequency range for a polyurethane material (FL-445). These results are for very small strains.

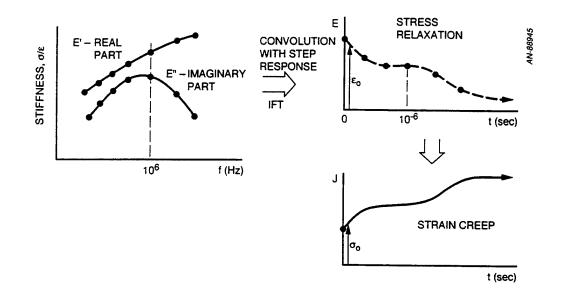
Figure 3.2 Construction of impulse material response for the computational modeling utilizing linear cyclic stiffness data.

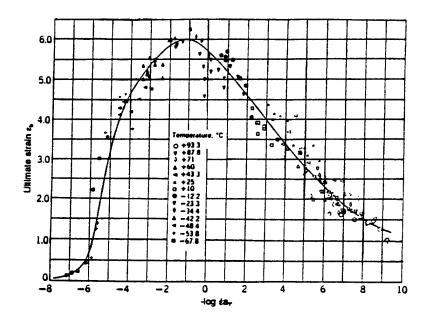
Figure 3.3 Tensile Strain at break plotted against the logarithm of strain rate reduced to - 10°C for a cross-linked styrene-butadiene rubber at 14 temperatures.

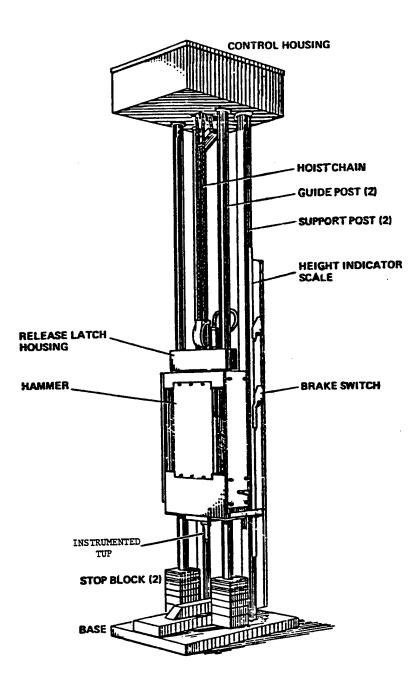
Figure 3.5 Schematic of drop weight system.

Within GRC's DYNATUP[®] Products Group are impact testing experts for plastics and composites using a family of instrumented drop weight systems (an example of this equipment is shown in Figure 3.5. A modified drop tower arrangement can use a cantilever beam actuator shown schematically in Figure 3.6 to measure the tensile strength in the test specimen. The maximum realizable strain rate is about $7 \times 10^3 \text{ s}^{-1}$ for the current fixture.

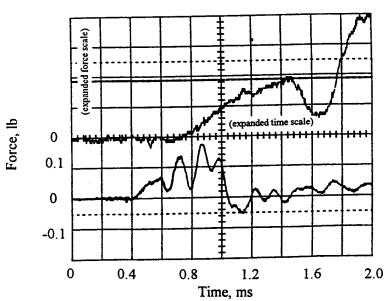
Figure 4.7 Load/time trace for evaluation of the stresses in polyurethane Material 17, Run 12-1. (Refer to Appendix A). The upper trace provides an expanded scale of the forces during the loading phase.

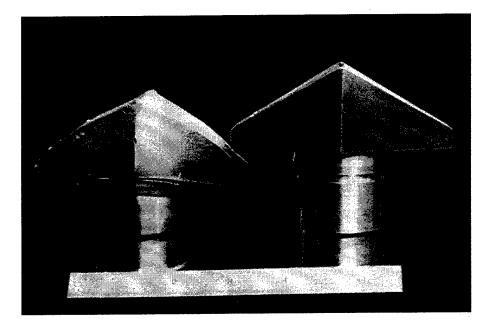
a. Pre-and posttest flyer plates and sabots used in 16000 in/in/s strain rate tests.

A flyer plate also had to be designed which would not fracture during the loading cycle. The impact event at projectile velocities in the vicinity of 2000 fps is fairly violent. The major limitation on the maximum velocity that can be used reliability in the polymeric impact tests is the onset of fracture in the flyer plate. This was a critical limitation until the flyer plate shape

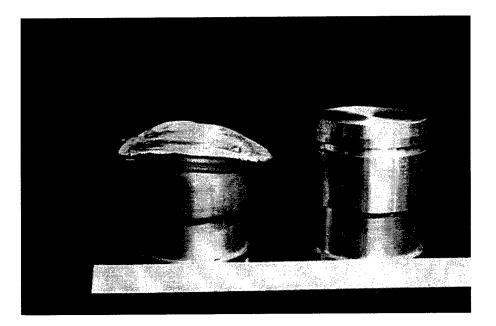
b. Deformation of 220 g aluminum projectile after 1800 fps impact.

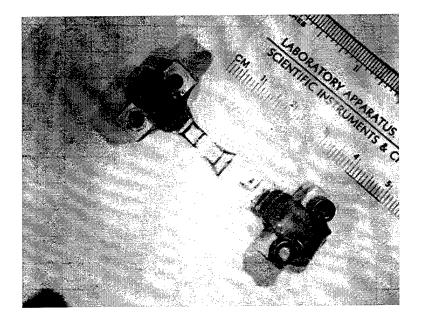
Figure 4.9. Failed polyurethane specimen with successful mounting arrangement.

Static tests using a Tinius Olsen Universal Test Machine were used to determine strain to failure at low strain rates and to experiment with various gripping techniques. The very simple, inexpensive mounting technique which was devised for attaching the polyurethane specimen to the flyer plate was used in these tests which were a further check on whether any specimen pull out was taking place. Quasistatic tension tests have produced true strains to failure of 500 to 800 percent in the candidate materials.

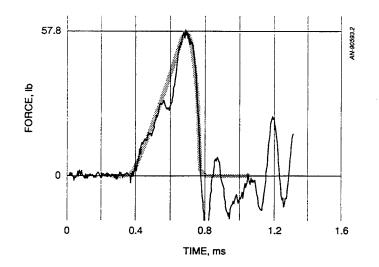
Figure 5.5. Force/Time History for Material 45 (Run 1-12a).

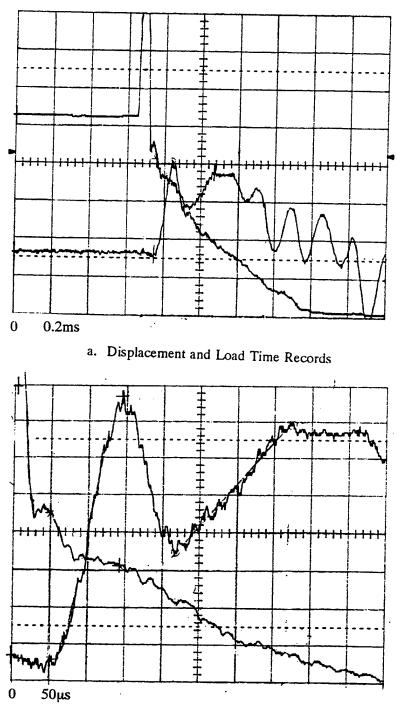
b. Expanded Load Trace

Figure A1. Run No. 1-7a for Material 4 Impacted at 1100 fps.

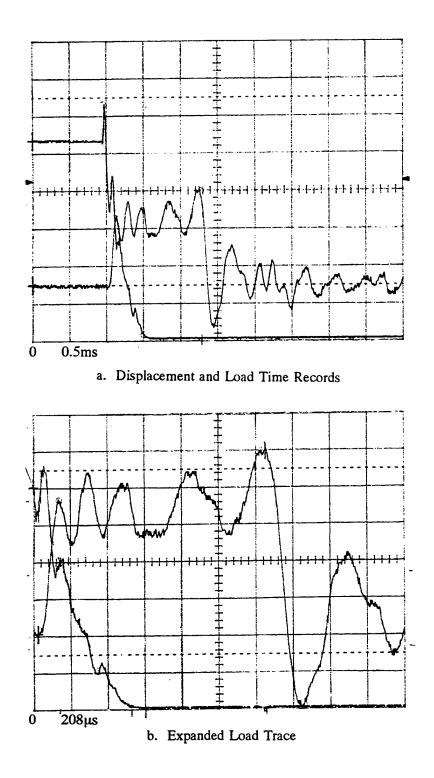
Figure A2. Run No. 1-7b for Material 4 Impacted at 510 fps.

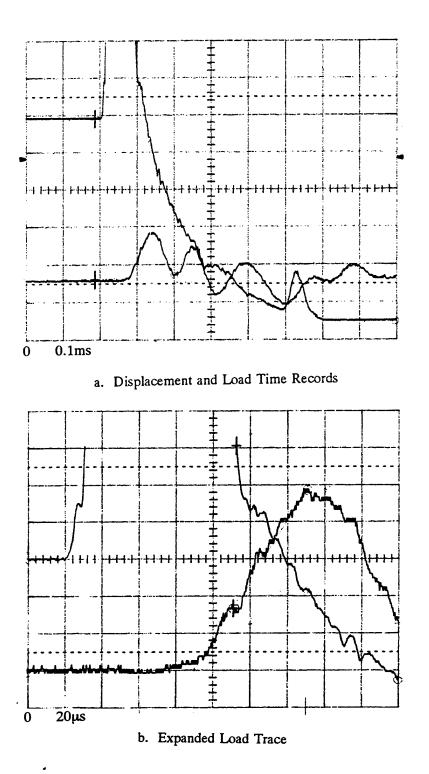
Figure A4. Run No. 12-9 for Material No. 11 Impacted at 1100 fps.

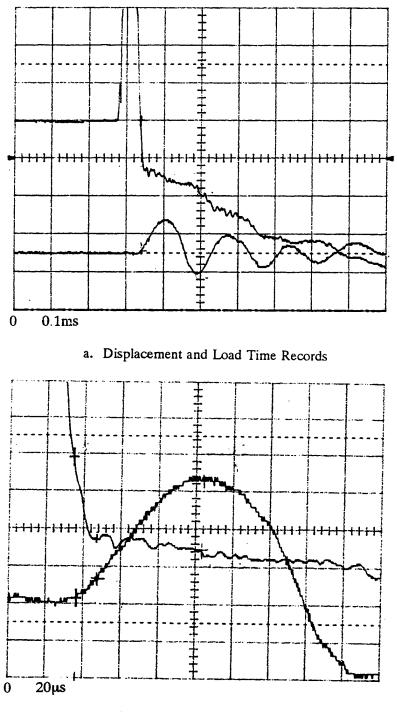
Figure A5. Run No. 1-6 for Material 11 Impacted at 1100 fps.

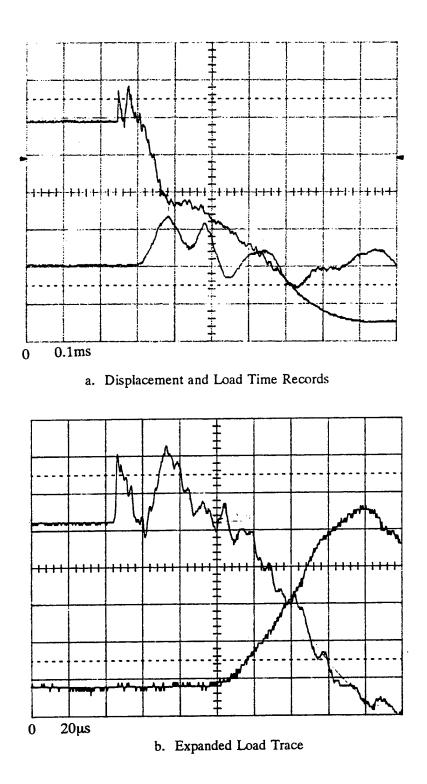
Figure A6. Run No. 12-8b for Material No 11 Impacted at 875 fps.

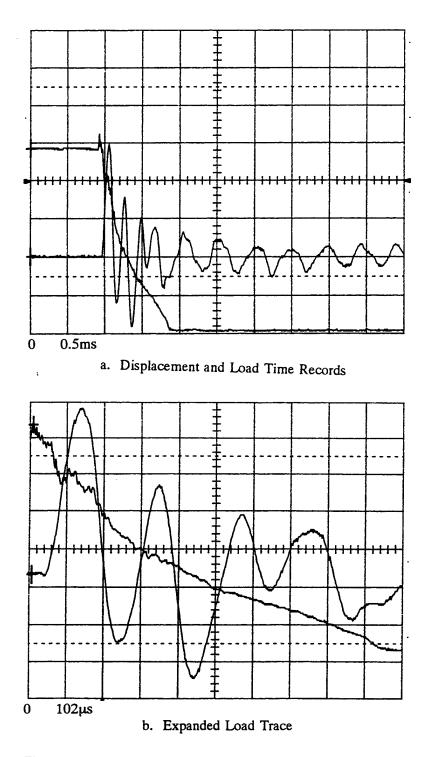
Figure A7. Run No. 2-16 for Material 11 Impacted at 310 fps.

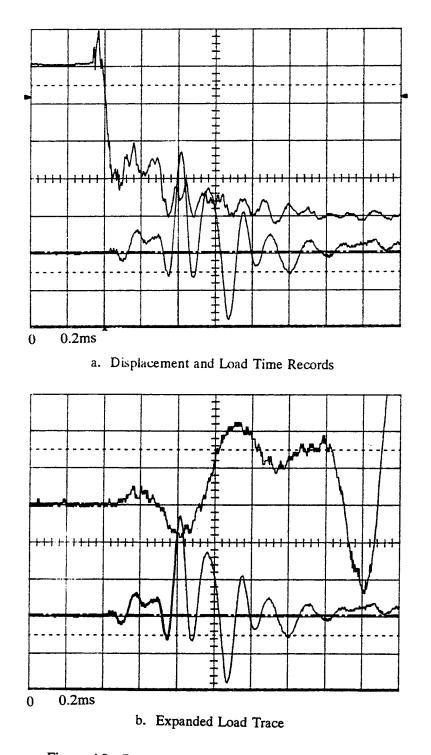
Figure A8. Run No. 12-2 for Material 17 Impacted at 1100 fps.

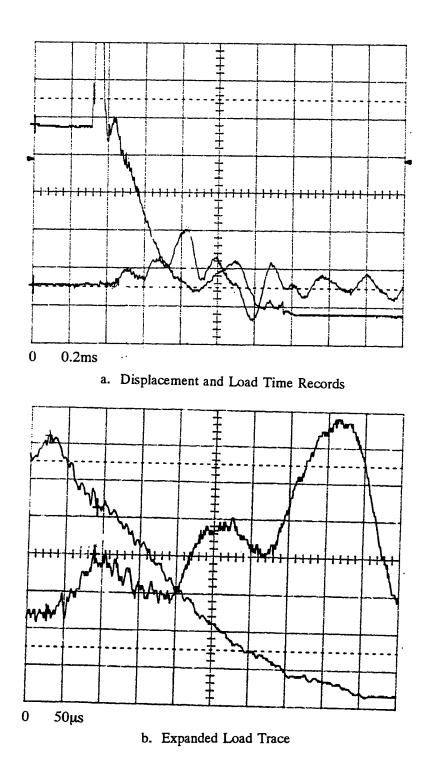
Figure A9. Run No. 12-31 for Material 17 Impacted at 1100 fps.

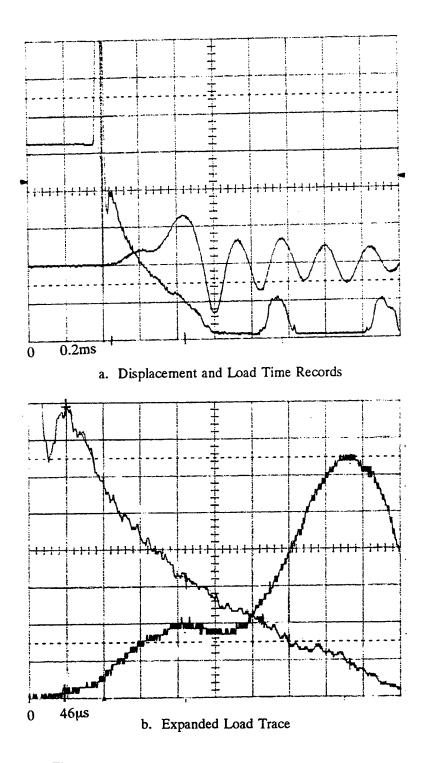
Figure A10. Run No. 1-14a for Material 17 Impacted at 1100 fps.

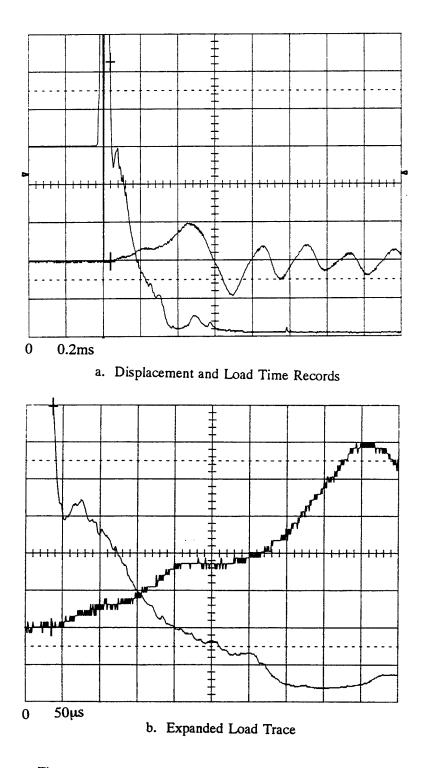
Figure A11. Run No. 1-14b for Material 17 Impacted at 1100 fps.

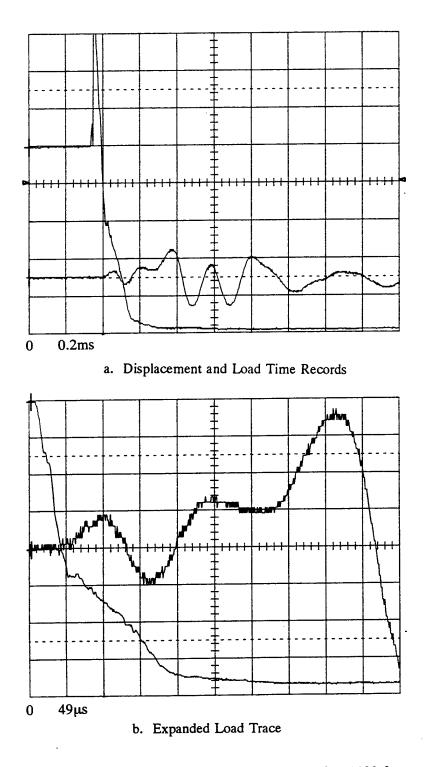
Figure A12. Run No. 1-15 for Material 17 Impacted at 1100 fps.

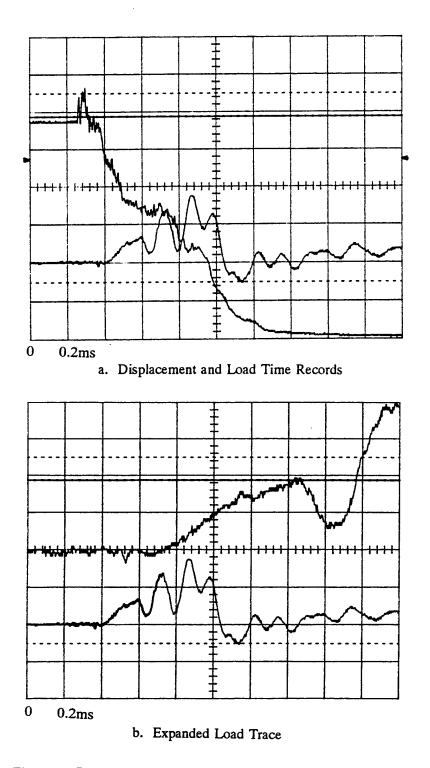
Figure A17. Run No. 12-1 for Material 17 Impacted at 875 fps.

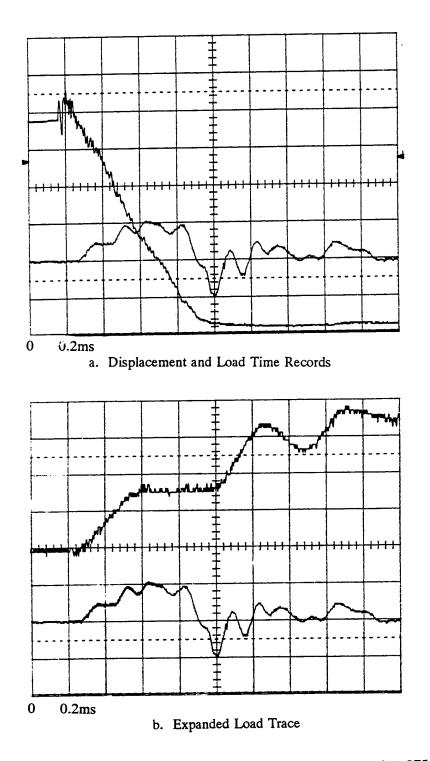
Figure A18. Run No. 12-8a for Material 17 Impacted at 875 fps.

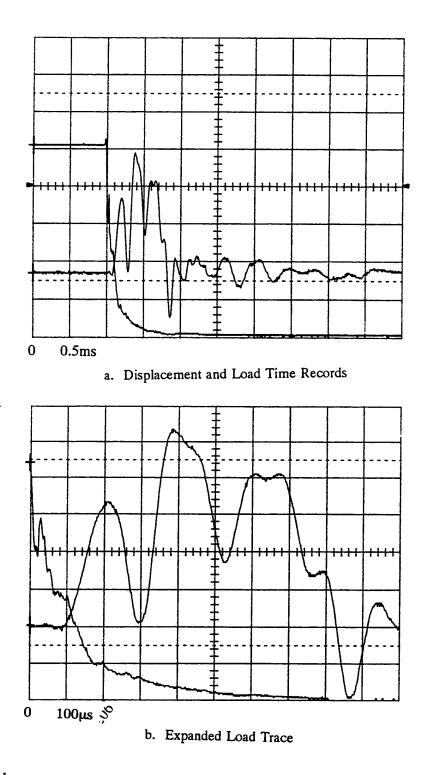
Figure A19. Run No. 2-11 for Material 17 Impacted at 310 fps.

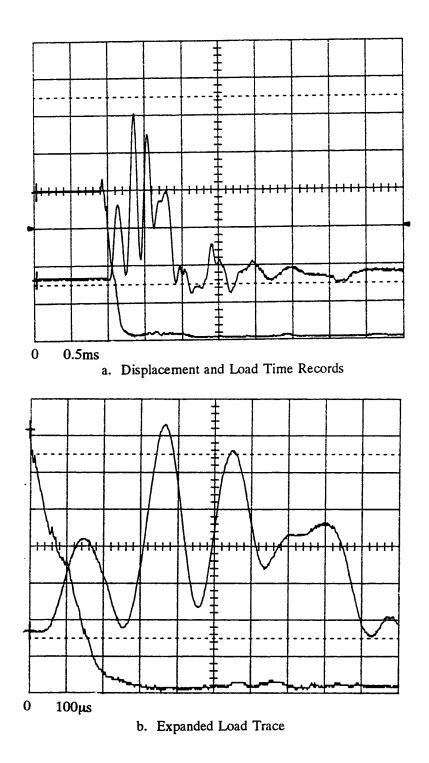
Figure A20. Run No. 2-15 for Material 17 Impacted at 310 fps.

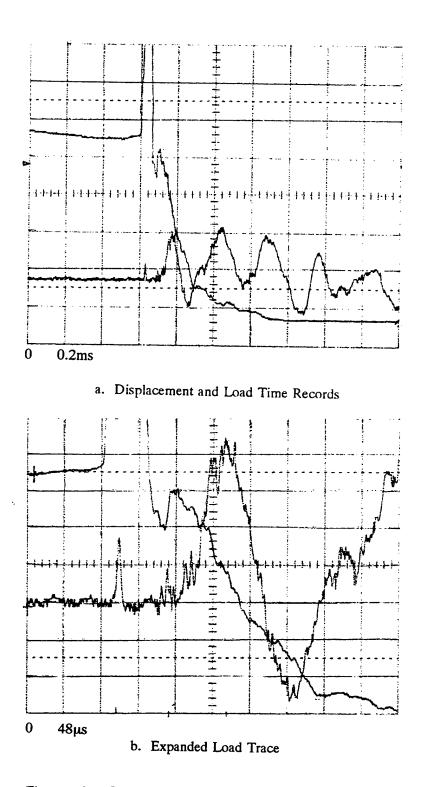
Figure A21. Run No. 12-22 for Material 44 Impacted at 1100 fps.

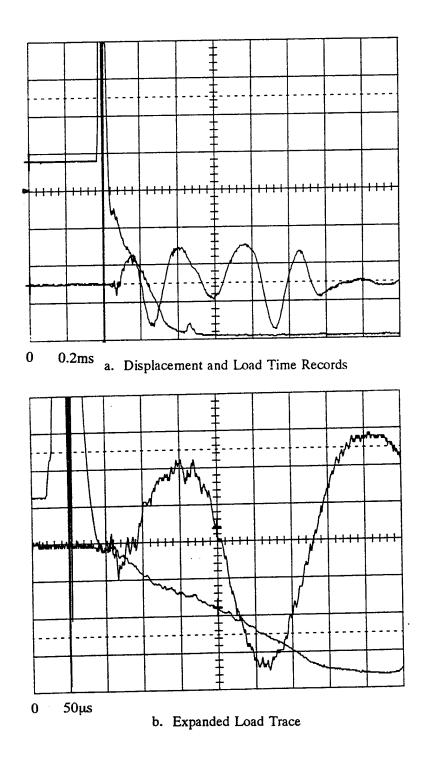
Figure A22. Run No. 1-18 for Material 44 Impacted at 1100 fps.

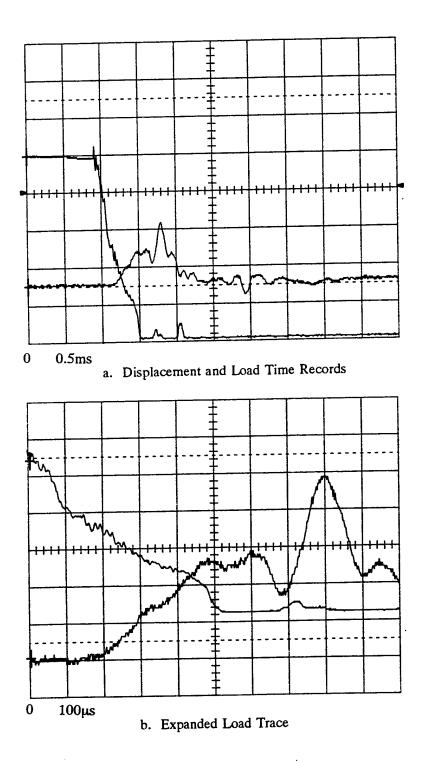
Figure A24. Run No. 1-19b for Material 44 Impacted at 310 fps.

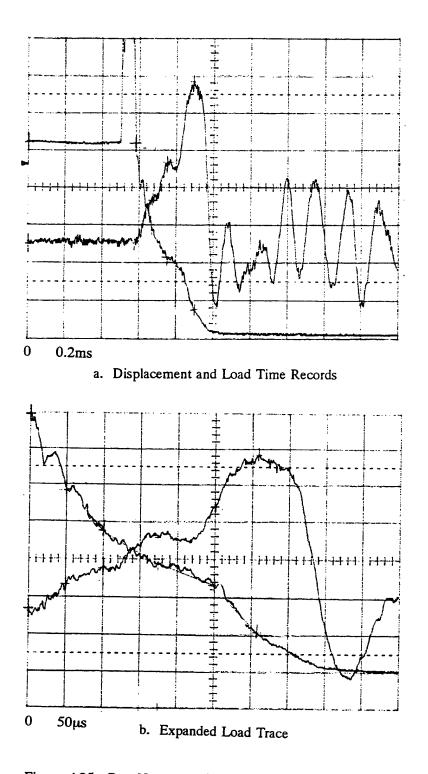
Figure A25. Run No. 1-12a for Material 45 Impacted at 1100 fps.

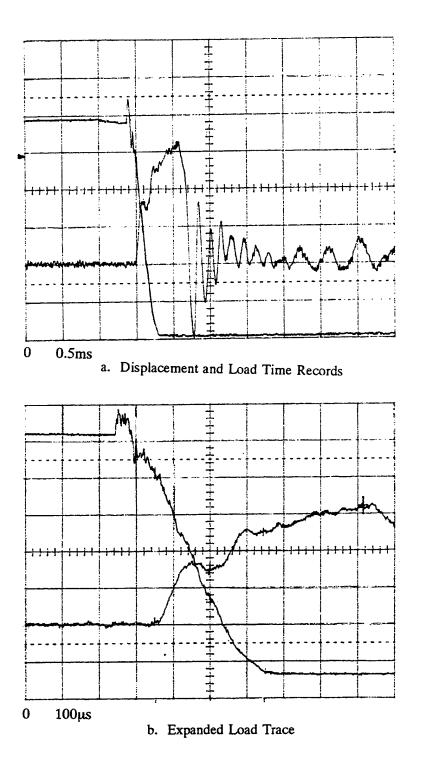
Figure A26. Run No. 1-12b for Material 45 Impacted at 570 fps.

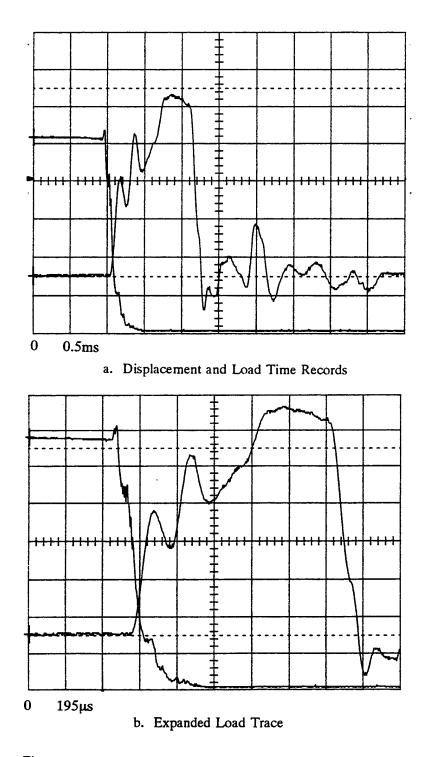
Figure A27. Run No. 2-12 for Material 45 Impacted at 310 fps.

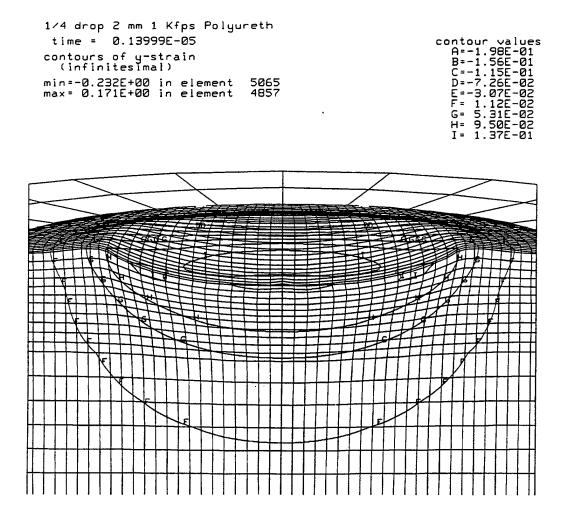
Figure B5. Circumferential strain distribution for Simulation 1 at 1.4 μ s.

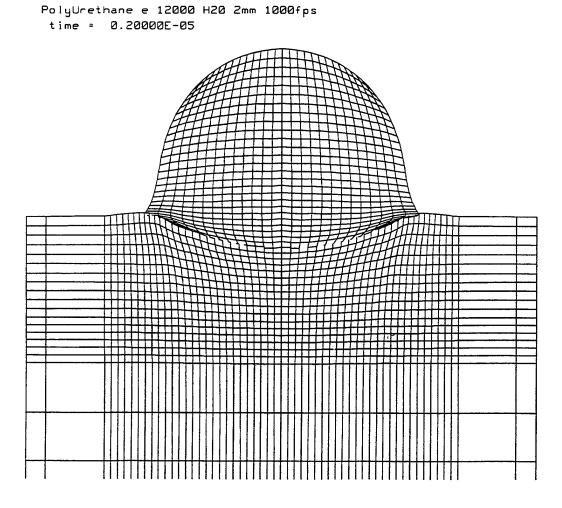
Figure B7. Waterdrop and polyurethane layer grid configuration for Simulation 2 at 2.0 μ s.

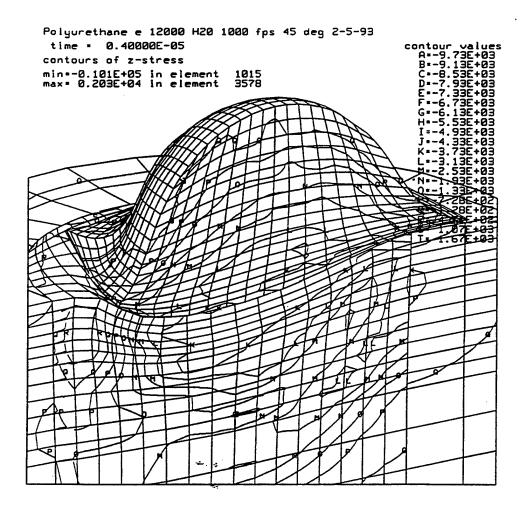
Figure B32. Axial stress distribution for Simulation 5 at 4.0 µs.

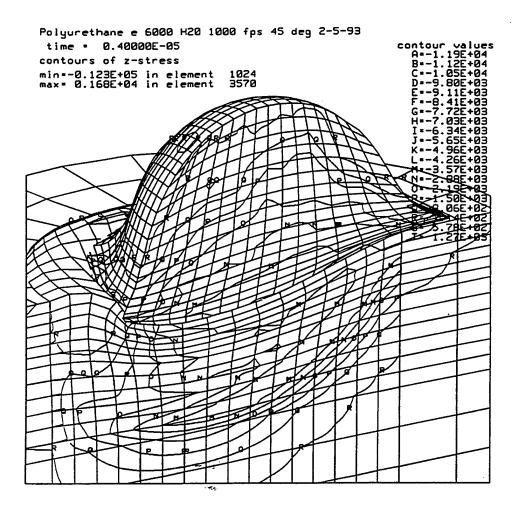
Figure B35. Axial stress distribution for Simulation 6 at 4.0 μ s.

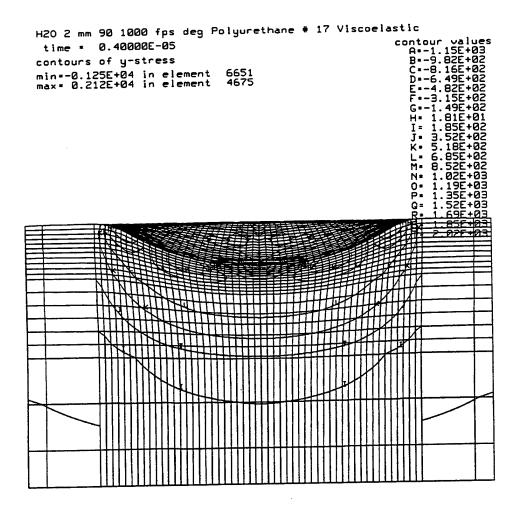
Figure B56. Circumferential stress distribution for Simulation 9 at 4.0 μ s.

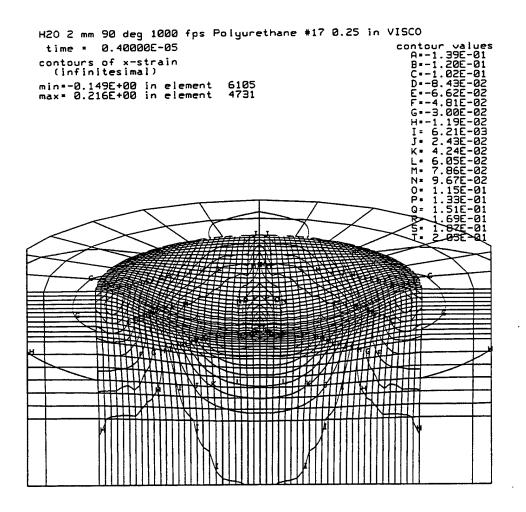
Figure B63. Radial strain distribution for Simulation 10 at 4.0 $\mu s.$

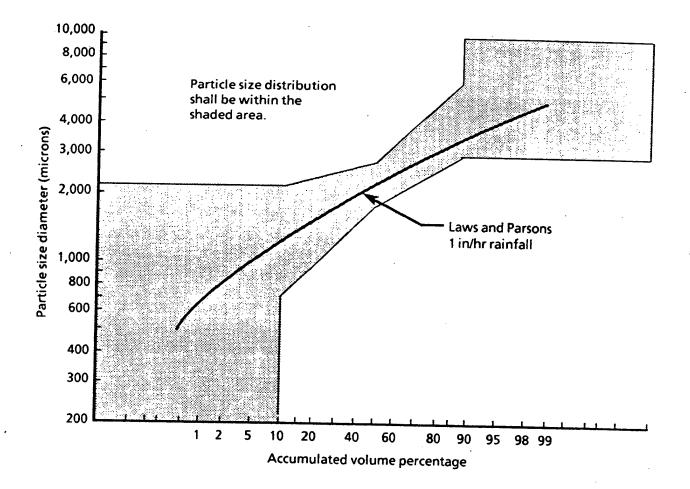
Figure F-1. Particle size distribution for rainfall.

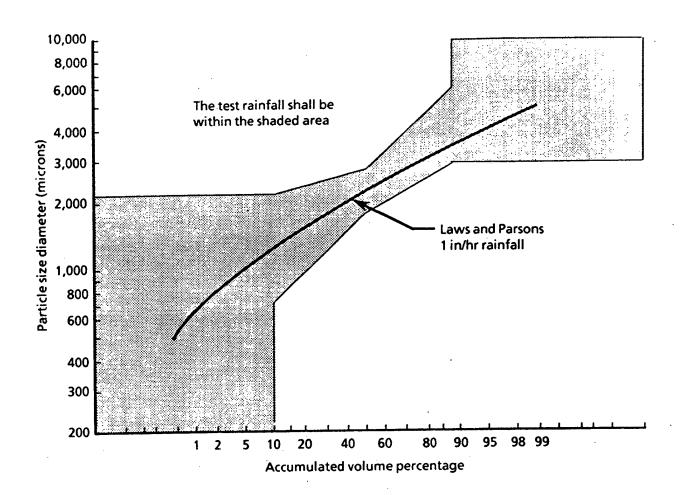
Figure G-1. Allowable particle size distribution for test.

The ideal test intensity is 1 in/hr. However, accelerated testing of up to 4 in/hr is acceptable. Qualification will assume the wear rate is directly proportional to intensity (i.e., 1 hour at 4 in/hr equals 4 hours at 1 in/hr). By using this proportionality relationship, testing at 1 in/hr may be used to qualify for the requirements of $\frac{1}{2}$ in/hr rainfall intensity. Evaluation of test time at different intensities shall be based on the average of all readings taken during the test. However, the maximum intensity shall not exceed 4 in/hr and the minimum shall not be less than $\frac{1}{2}$ in/hr while maintaining the required particle size distribution. Also, the minimum and maximum shall not be more than 1 in/hr from the average (e.g., avg = 1 in/hr, $min \ge \frac{1}{2}$ in/hr and $max \le 2$ in/hr; or if avg = 3.5, $min \ge 2.5$ in/hr and $max \le 4$ in/hr).
