DOT/FAA/AR-95/110

# Fiber Reinforced Structures for Small Turbine Engine Fragment Containment (Phase II)

July 1996

Final Report

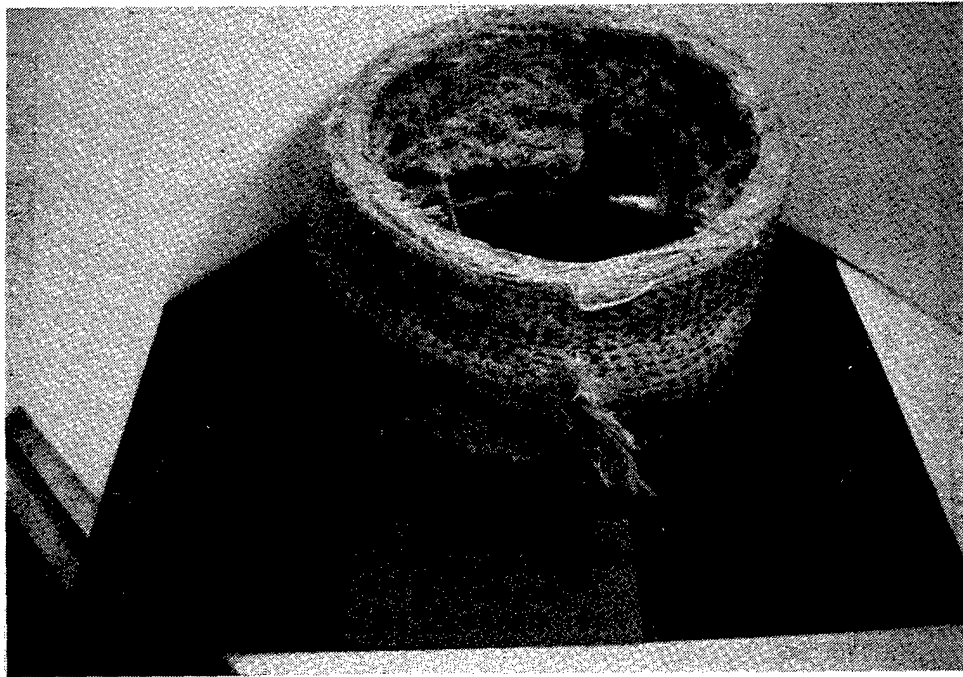
FIGURE 52. POSTTEST PHOTO OF SPIN TEST STRUCTURE 5 SHOWING BLADE EXIT POINT. DISK FRAGMENTS WERE STUCK IN THE RING AFTER THE TEST

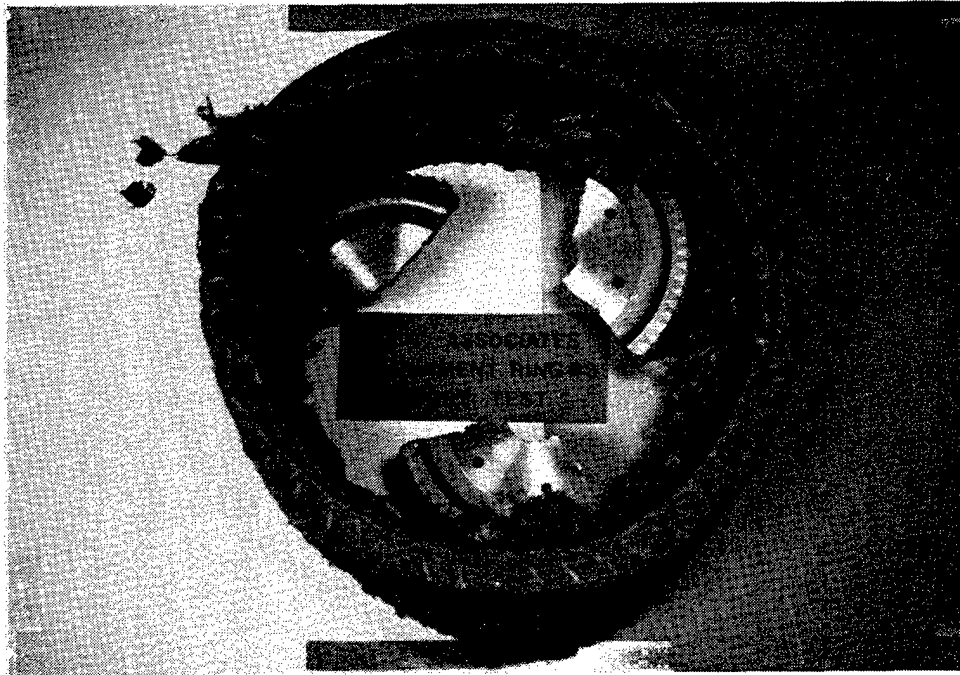
FIGURE 60. PBO RING AFTER TEST

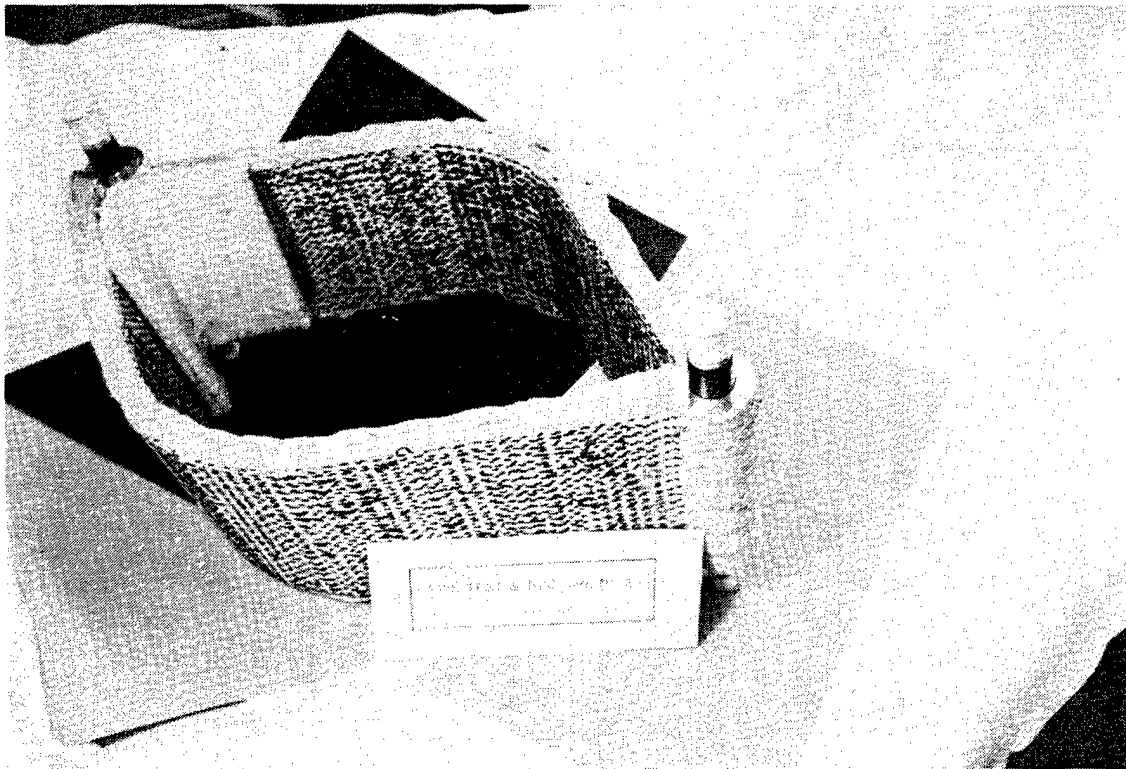
FIGURE 66. FINISHED AND ASSEMBLED SPIN TEST STRUCTURE 10. PINS AT THE JOINTS ARE UNIDIRECTIONAL KEVLAR IN A THIN THIN-WALLED, 1.25-IN OD ALUMINUM TUBE. THE JOINT PROTECTIVE SHIELD IS A 30-PLY DRY LAMINATE ATTACHED WITH VELCRO®.
