An Analysis of Possible Microbiologically Influenced Crevice Corrosion of 316 Stainless Steel in a Seawater Environment

MASTER OF SCIENCE IN OCEANOGRAPHIC ENGINEERING
at the
MASSACHUSETTS INSTITUTE OF TECHNOLOGY
and the
WOODS HOLE OCEANOGRAPHIC INSTITUTION

SEPTEMBER 1996

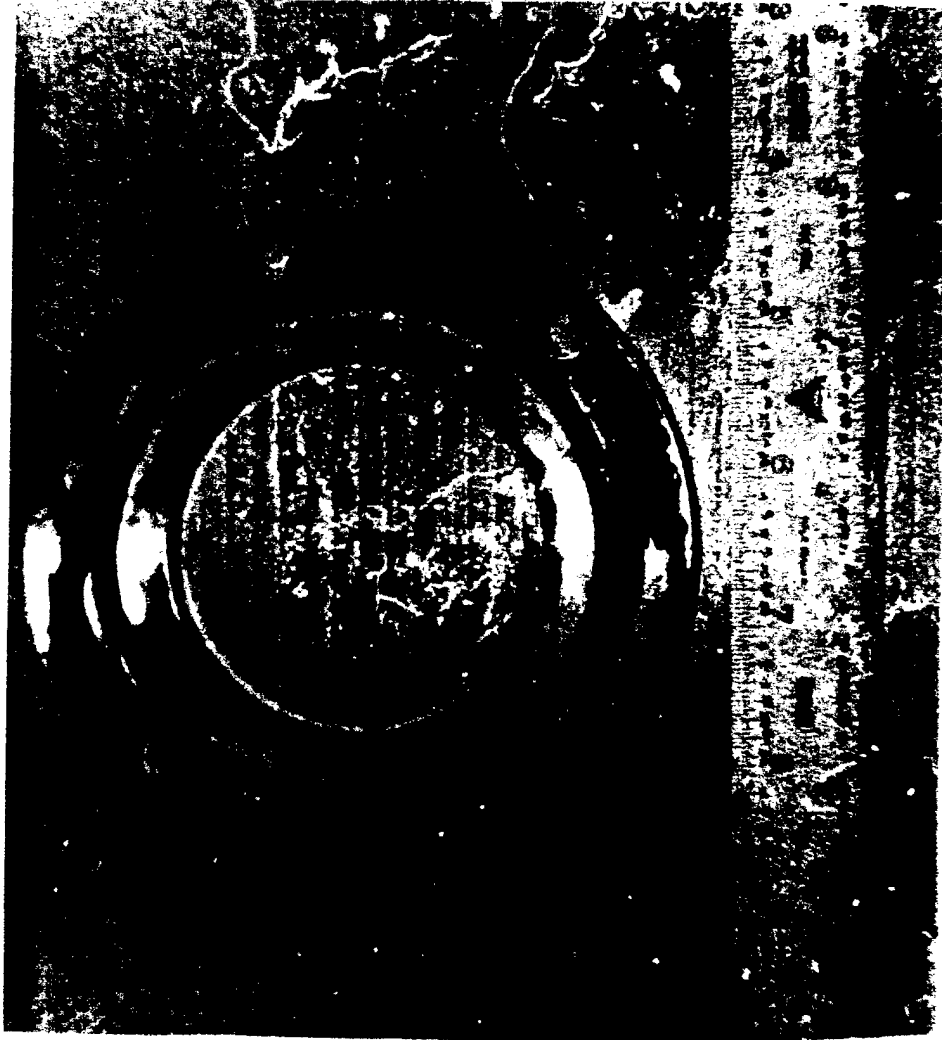
Figure 1-1: Corrosion-Damaged Specimen #1 (O-ring grooved side)

experiment which exhibited this rapid and severe crevice corrosion. These components were 316 Stainless Steel space rings which were used to join two pressure housings on a large fixed instrument. The components were produced on an end-mill in the machine shop at the Woods Hole Oceanographic Institution and given a smooth surface finish. Each has six holes through which fasteners passed and an O-ring groove milled into one side. Outer diameter is 4.5 inches, inner diameter is 3.5 inches, and thickness is 3/8 inches. Figures 1-1 and 1-2 are photographs of one of these corrosion-damaged components, while figure 1-3 is a line drawing of the vorticity instrument suspended within its tripodal frame for deployment on the sea bottom. The location of the two rings in the pressure housing is indicated by the arrow. The rings were separated from the rest of the instrument by spacers composed of Delren plastic.

The particular components which were analyzed by me were utilized in an instrument deployed on 11 July 1994 at 48° 23.55' N latitude 124° 31.91' W longitude in 130 meters of water off the coast of the state of Washington. Surface tidal currents were approximately 3 knots. A sacrificial zinc was attached in the immediate vicinity of the spacer rings. When the instrument was recovered on 28 May 1995, it was immediately noted that the zinc had been totally consumed. Upon disassembly, the severe corrosion (see figs. 1-1 and 1-2) of the rings was noted, as well as the fact that they were both heavily coated with a brown slime. At the time, it was assessed that if the corrosion had proceeded much further, the pressure boundary would have been breached, the experiment flooded out, and its data lost.

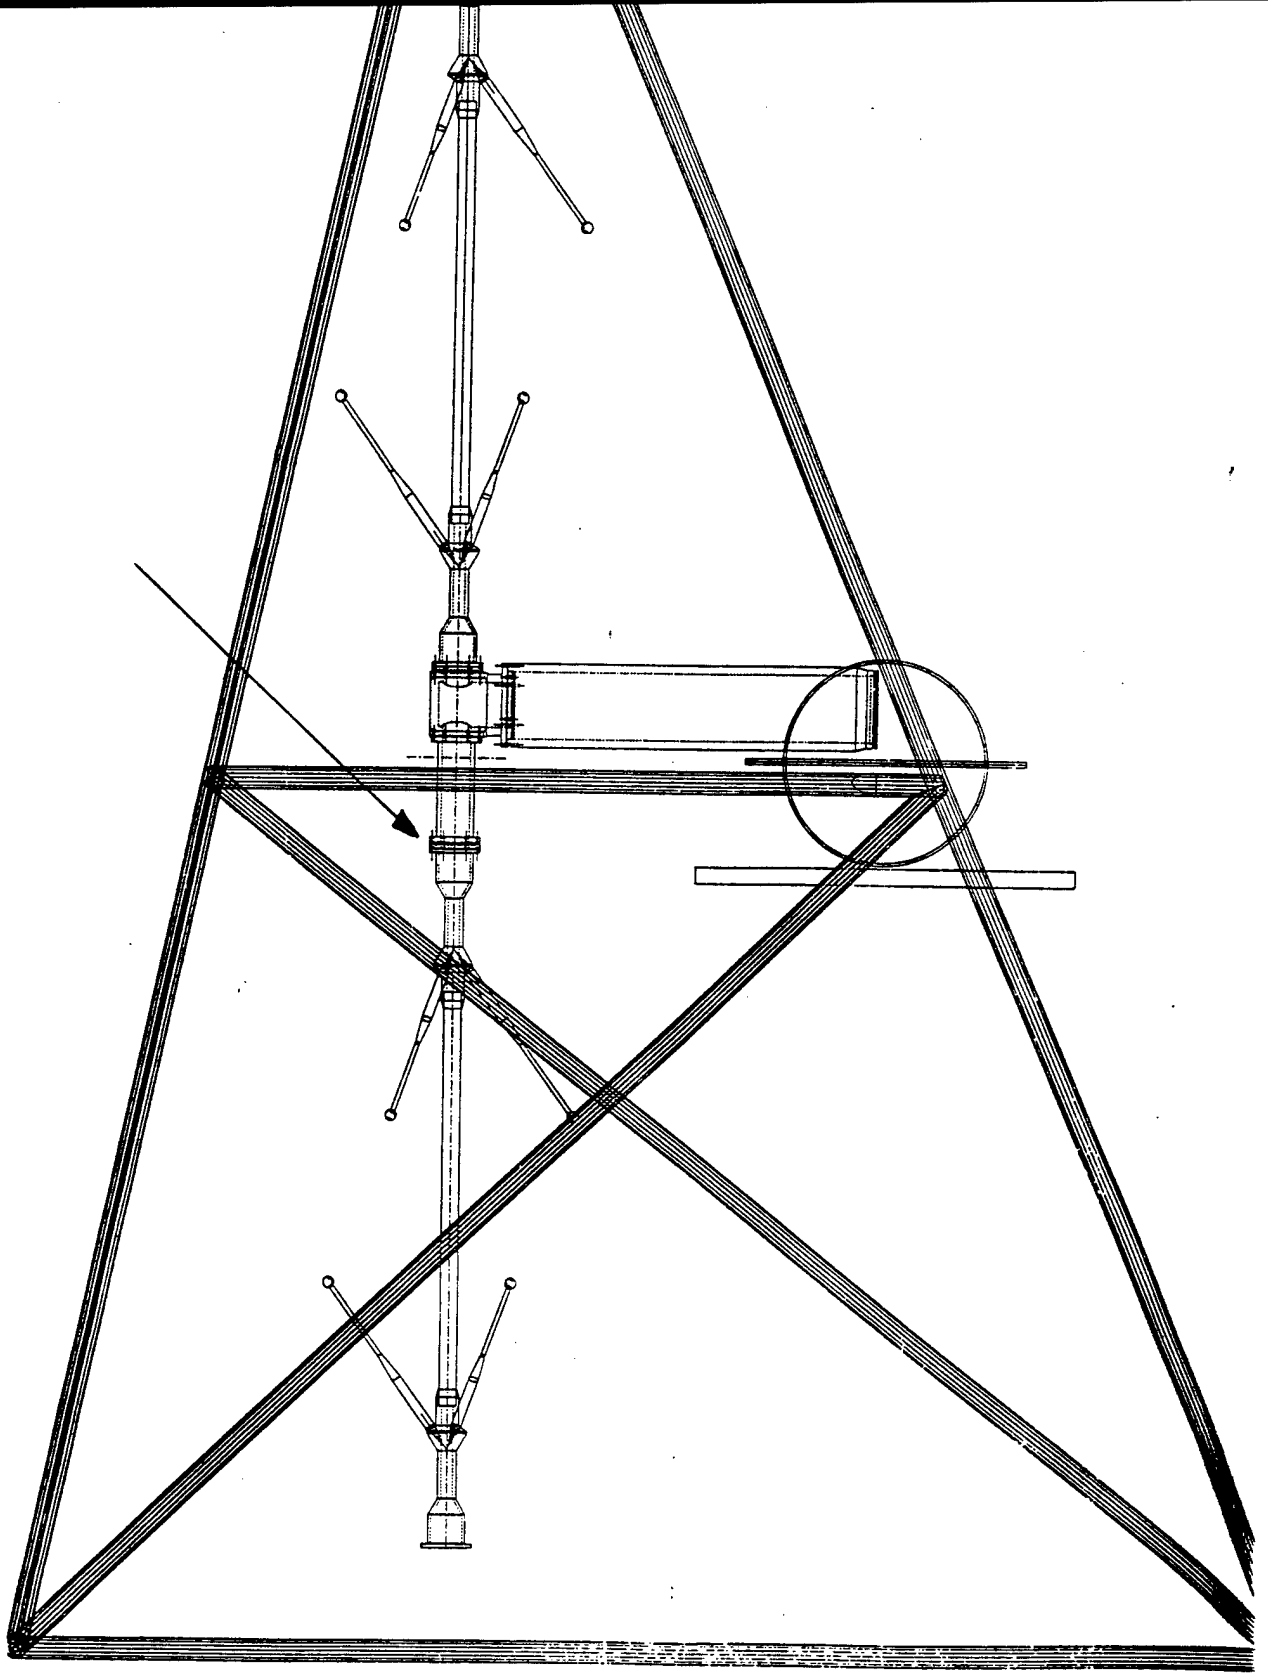
Figure 1-3: Line Drawing of Vorticity Instrument within Support Pyramid
